Umm er-Rasas

Restoration of the Stylite Tower

Mission Report

Architect:
Davide Sicilia

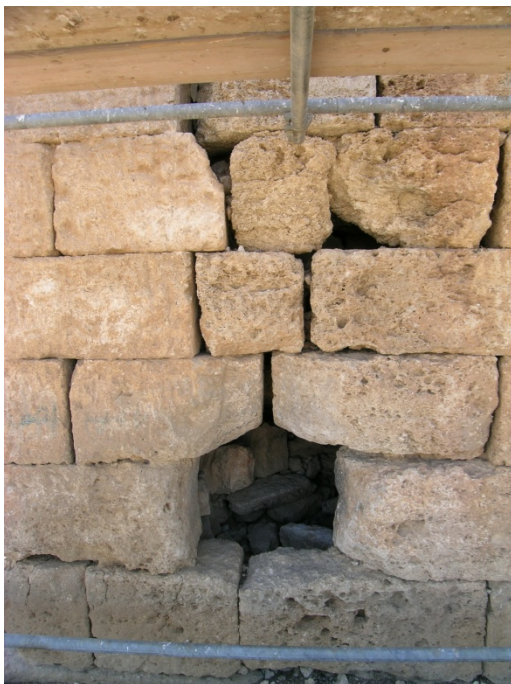
Opening at the basis of the north side

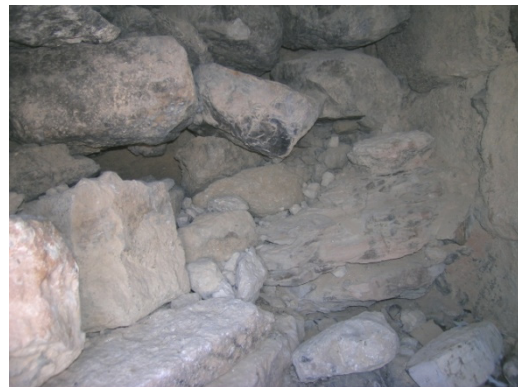
Inside the base of the tower

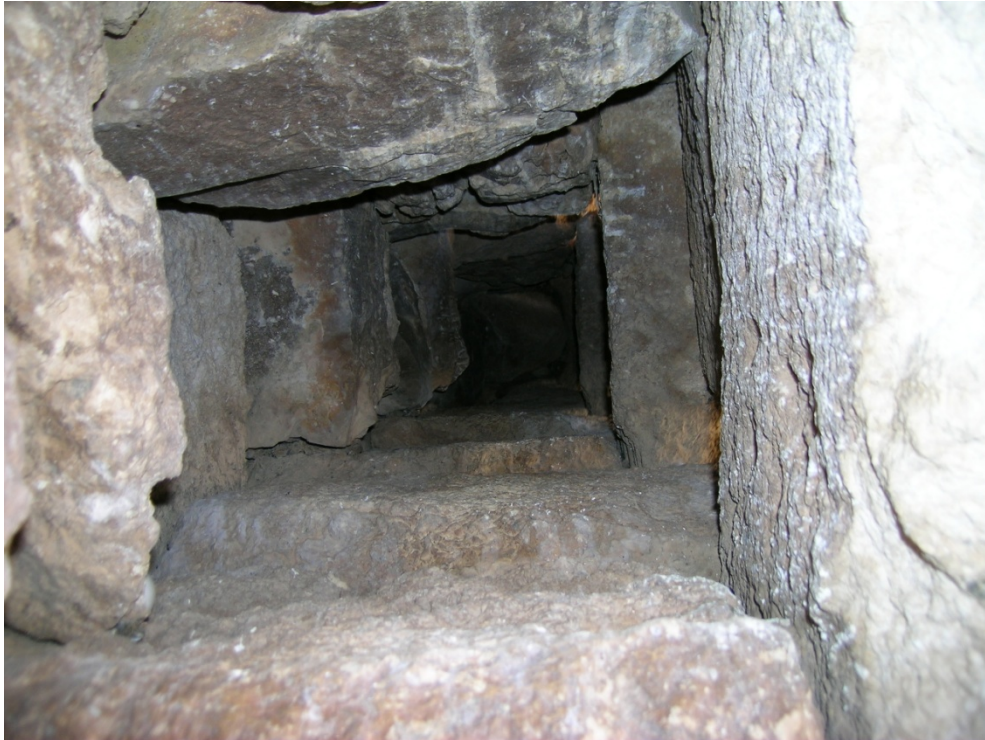
VERTICAL GALLERY

At the base of the tower, on the north side, there is an opening through which one reaches a niche, perhaps once vaulted. In the north-west corner, inside the tower, there is a square and vertical gallery, which served as a liaison with the *cella*. One possible explanation for this gallery is that the pilgrims, after having passed through the church, could communicate with the saint by this gallery asking him for prayers and giving him offerings. This gallery with a width of 45 cm by 45 cm is blocked at the 17th row of stones, probably after the fall of stones of the dome.

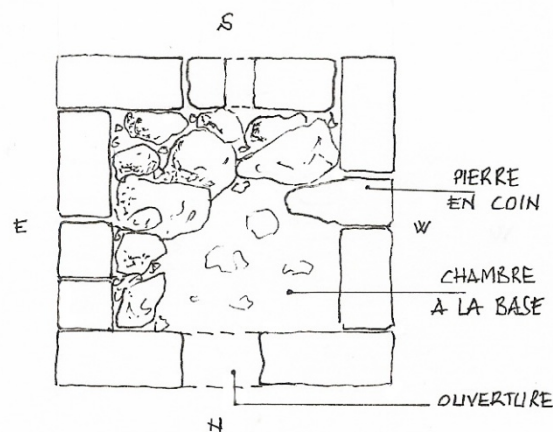
COUPE SUR LA 2^e RANGÉE

The tower has a square base sides of 2.50 meters. The stones of the outer perimeter are regularly cut and well matched. In its interiors, the tower is filled in all its height by irregular stones; one can see occasionally larger stones laid on their straighter side. It is likely that each two or three rows narrower and longer stones exist. These stones, located in the middle of the row and having an end with a cone-shaped (arch stone shape), are designed to block the assembly and the inside infilling. This could be confirmed by an as-built drawing which will be made on the spot shortly.

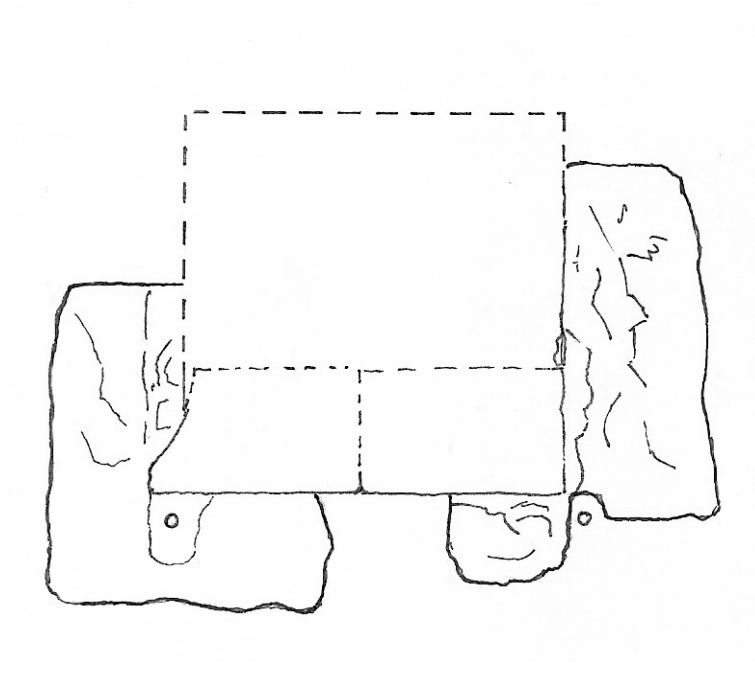
BASIS OF FOUNDATIONS OF THE STYLITE TOWER
Location of the excavations

The tower lays directly on the rock. Excavations have been requested at the north, east and west sides. One can notice that the first row of the tower base rests on carved stones being more than 40 cm tall. These foundation stones are supported on the rock and, despite the superficial poll one may imagine that in some places the rock was directly carved to form the basis of foundation. It would be necessary to carry out further surveys and cores ground near the foundations in order to assess the composition, internal consistency and compressibility of the ground.

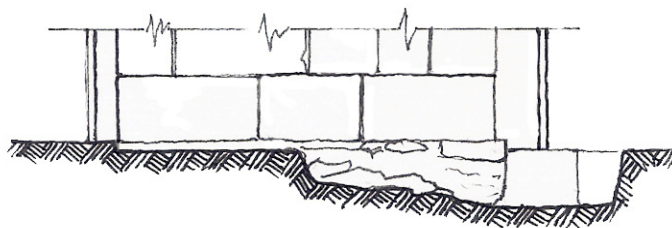
EAST FACADE

North-East angle: the rock is levelled at the lower level of the tower.

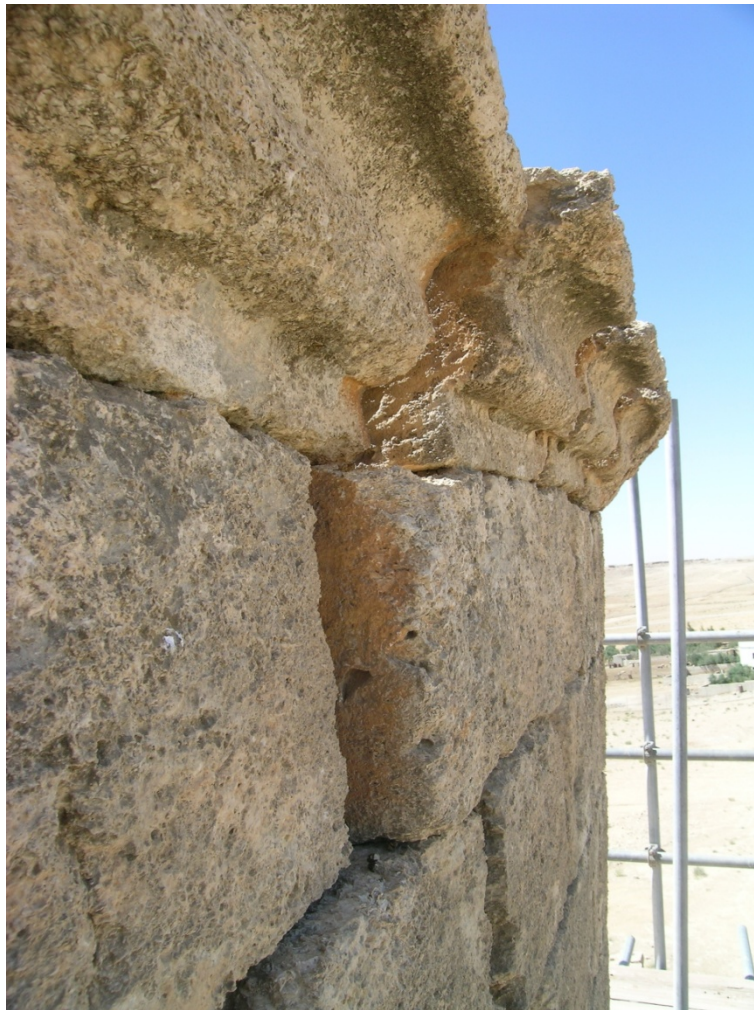
WEST FACADE LINTEL

The decor of the capital is erased by erosion.

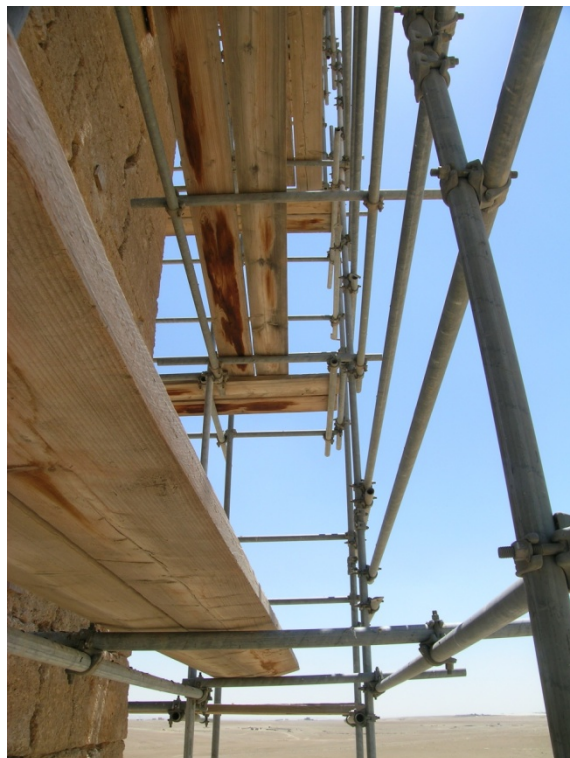
The tower is surrounded of scaffolding for more than two years. This metal structure with corridors in planks of wood, is in very poor condition for various reasons:

- Support of the scaffolding on the ground directly on the ground without crossing distribution.
- Vertical tubular structure on the scaffolding without wind braces, tubes diagonals tubes lack of the four facades across the height.
- The wooden corridors are not protected and they often lack of the wooden planks to cover the entire width of corridors. Several boards are cracked. The corridors in several place are not adjacent to exterior walls of the tower but at a distance between 50 and 70 cm (very dangerous situation), no protection is assured.
- Lack of safety net.
- At the *cella* level the scaffolding stops at 1.50 m from the lower ridge, so there is no umbrella roof of protection for the upper part of the tower.
- Only the stairs to the corridors is more stable (presence of diagonal bars, wooden planks are framed in metal structures).

The wooden corridors do not cover the entire width

They are superimposed without any fixation.
