Report on Mission to Evaluate the State of Conservation of THE PAOAY CHURCH (The Philippines)

22-29 July 2000

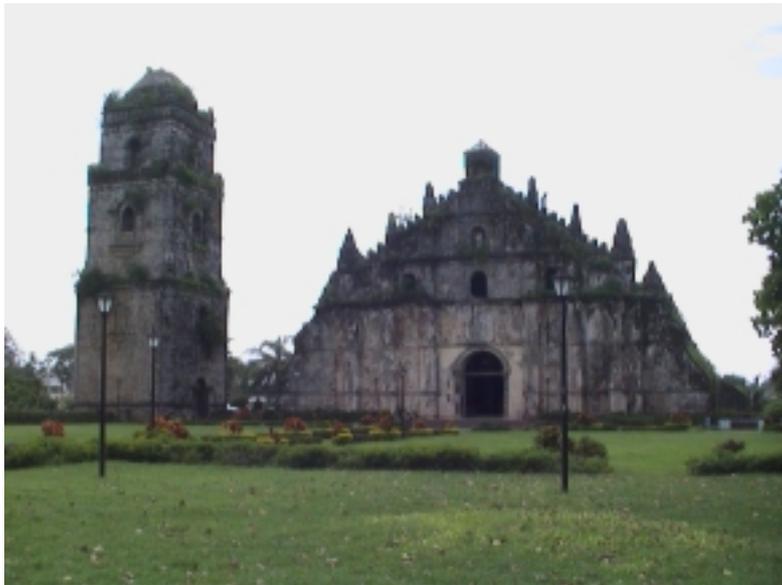
Photo 1 The Paoay Church

The Paoay church (the Church of San Agustín, see Photo 1) is one of the Baroque Churches of the Philippines included on the UNESCO World Heritage List. Although this church has been struck not only by strong earthquakes but also by heavy typhoons, it has survived for three centuries by grace of its excellent design. However, during various phases of the monument's history, deterioration of the structural materials and deformation of the structure have occurred, necessitating restoration.

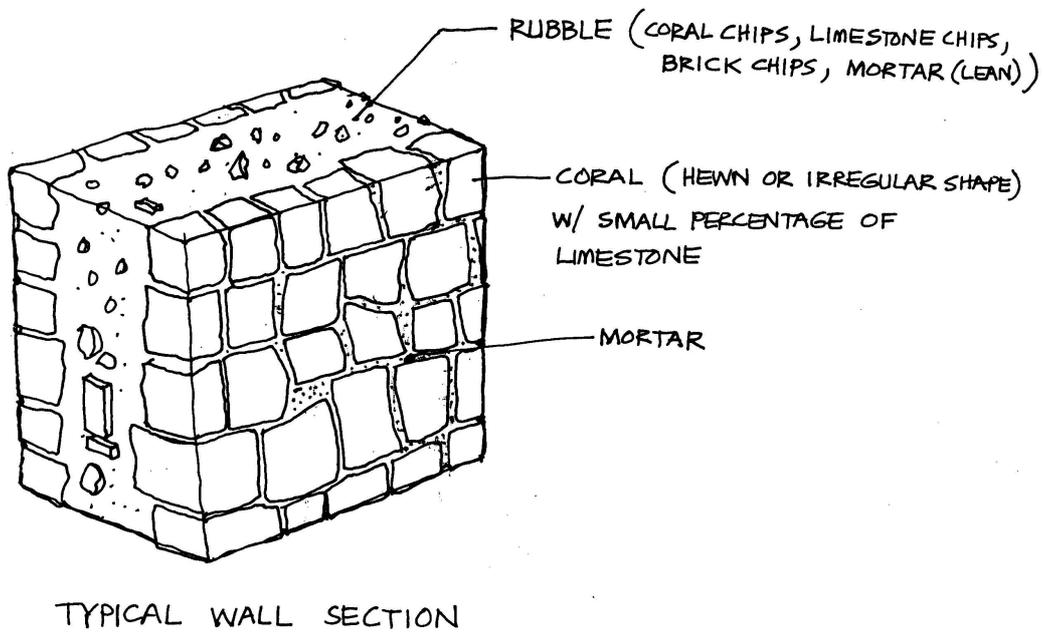
Fig. 11 Typical section of wall with coral stone

The maps of both the exterior and interior surface materials and the section of the structure were drawn by Paoay architects in order to understand the structural conditions. The exterior surface materials of the building were coral stones or bricks. Figures 11 and 12 illustrate typical sections of the wall on the basis of the visual inspection, also showing a typical section of the facade. As shown in these figures, the coral stones and bricks cover the traditional local concrete made up of mortars mixed with rubble. These figures indicate that this traditional local concrete is a more important material from a structural point of view. However, no information is available about the mechanical properties of the traditional local concrete.

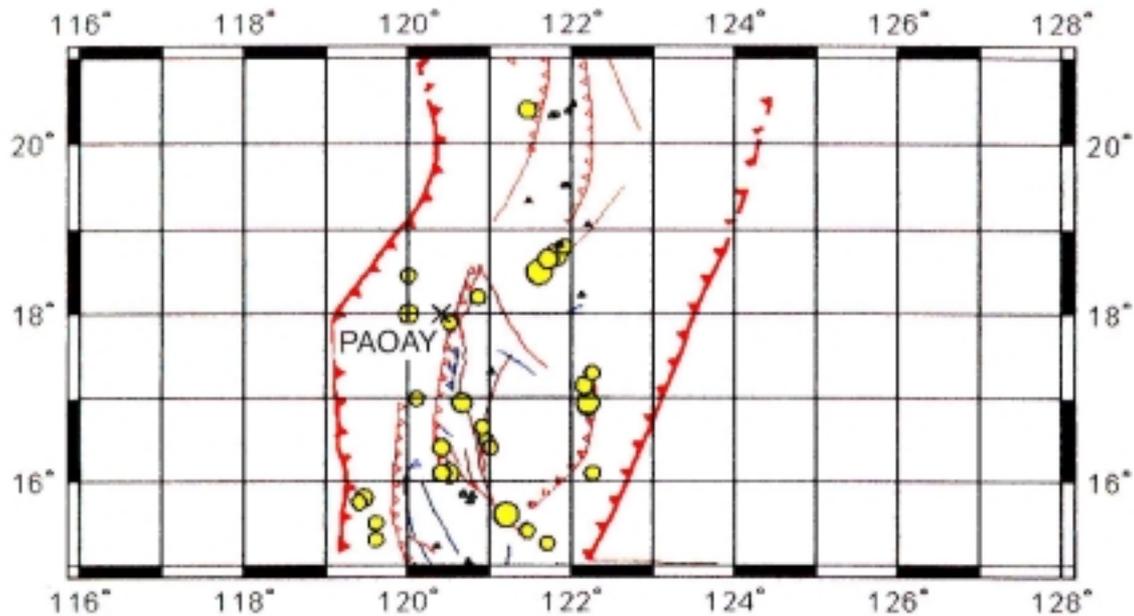
Fig. 14 Active faults and historical earthquakes of magnitude 6–9 from 1500 to 1897
(from the Philippine Institute of Volcanology and Seismology)

Figure 14 is a map of the active faults and historical earthquakes in North Luzon. North Luzon is in the Philippine fault zone where the Philippine plate is subducting. Major earthquakes of the magnitude higher than 7.0 can be anticipated in this region.
