**Mission to  
Dubrovnik and Ston**

**Earthquake  
5th September 1996**

### TECHNICAL REPORT

Mission to Dubrovnik and Ston after the earthquake of September 1996

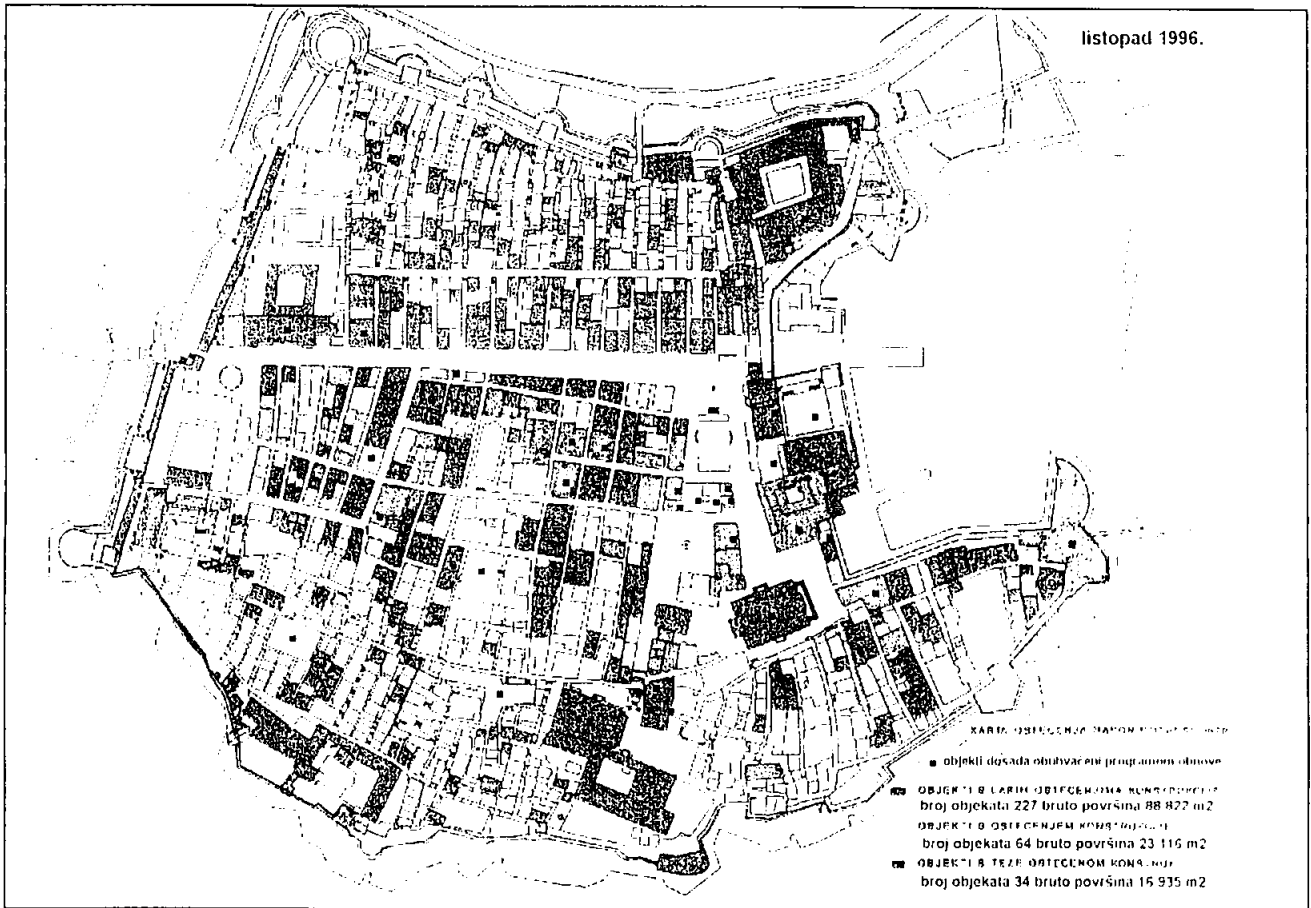
Fig. 9 Map of Dubrovnik with the damage produced by the earthquake of 1979 (from "Institute for the Restoration of Dubrovnik")

The earthquake of September 1996 didn't produce relevant damage in Dubrovnik: only some old cracks, dating back to the earthquake of 1979 (fig. 9), increased.

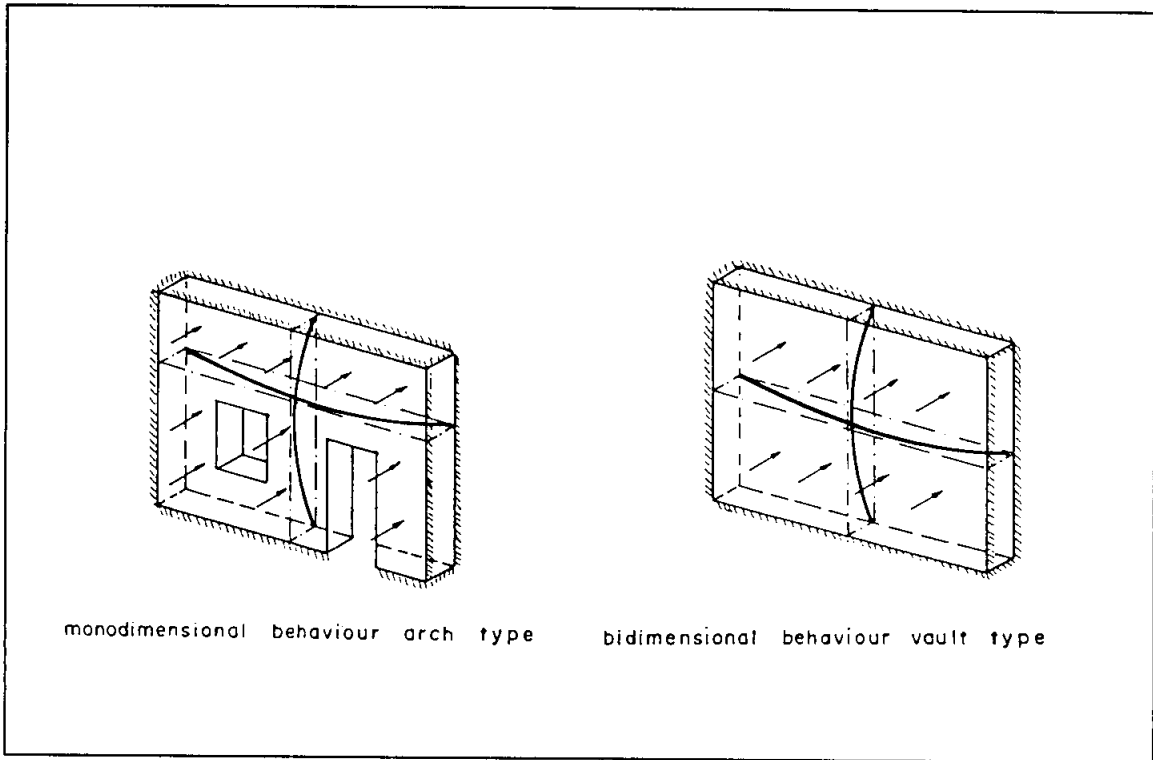
Fig. 12 Scheme of the development of the "arch effect"

As regard its intrinsic stability it is necessary to develop an "arch effect" (fig. 12) and therefore to have appropriate restraints at the boundaries.

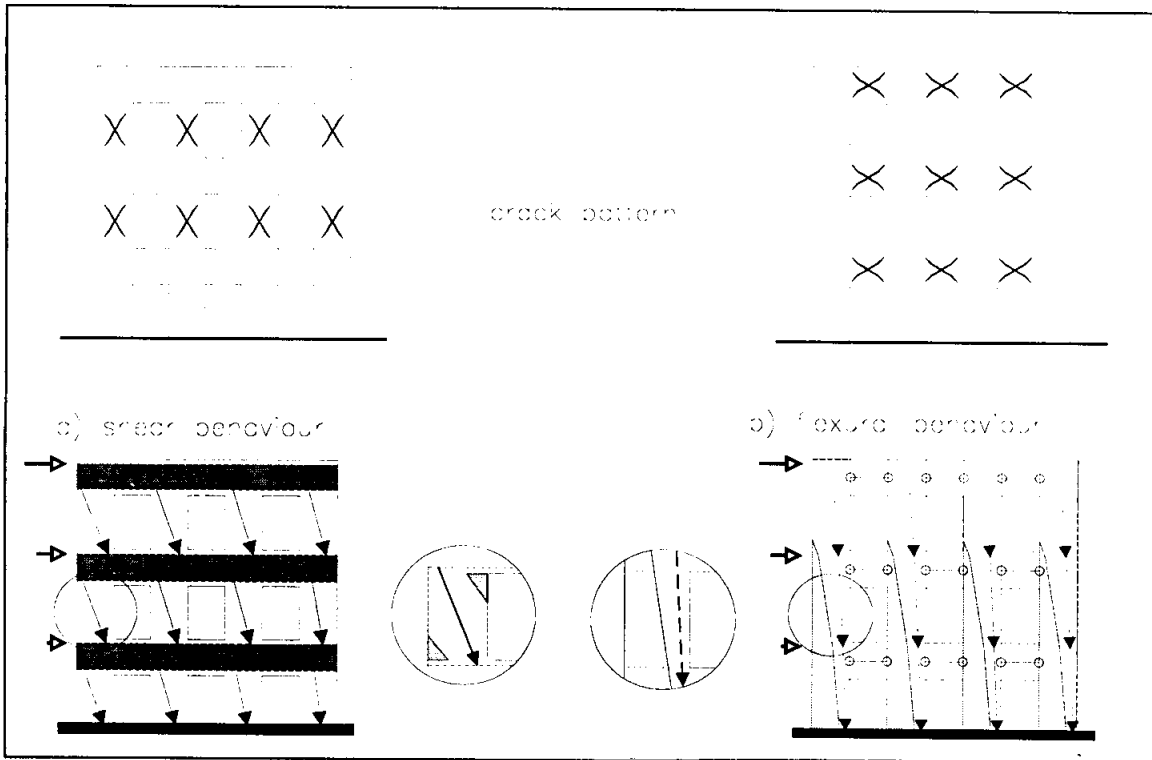
Fig. 13 Typical crack patterns and structural behaviours of walls parallel to the seismic action

1. Cracks in the zone under and over the windows, showing an independent cantilever flexural behaviour (fig. 13b)
2. Slippage of the window posts

This building show, as a whole, a good structural behaviour, highlighting that when the masonry fabric is of good quality his typology can bear even high level earthquakes; cracks are concentrated only in the weakest zone that are those under the windows (fig. 13b)

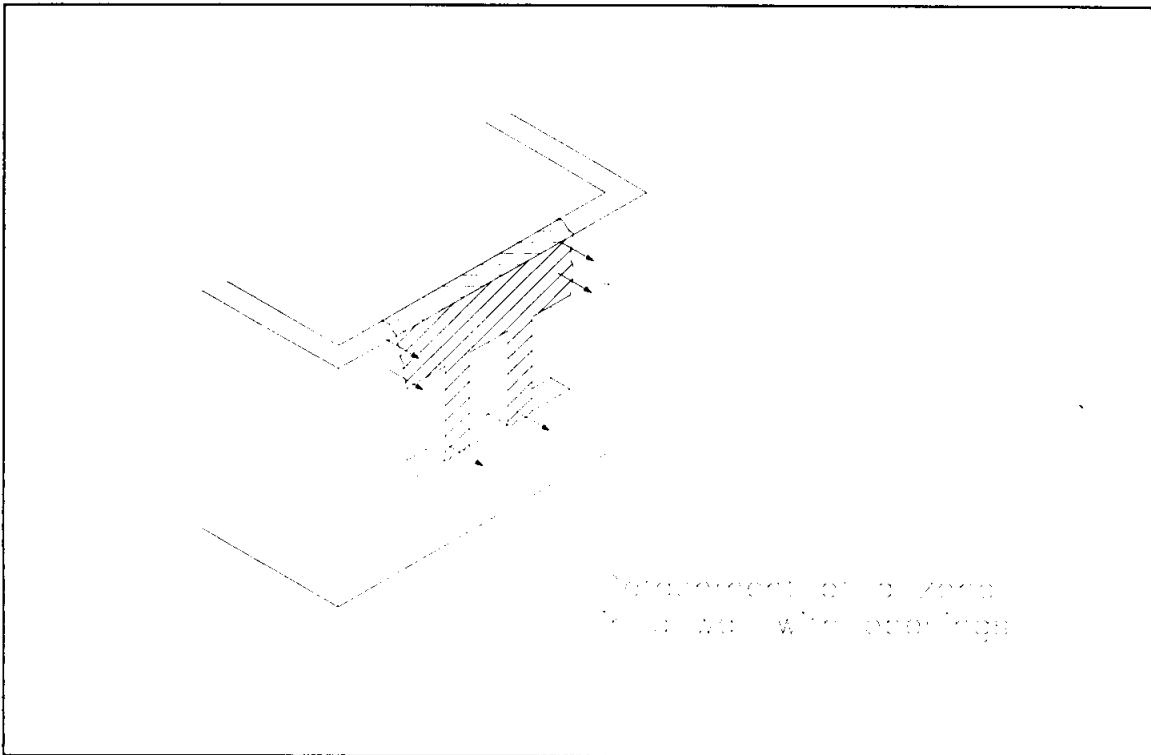
**Fig. 14 Possible shear collapse of the zone under the roof**

1. Detachment of the portion of wall between the roof and the windows (fig. 14); detail in form n° 5, 6
2. Detachment of portion of the external layer of the sack masonry due to the intrinsic weakness of the material
3. Detachment of the window posts and of the lintels

The East façade is almost perpendicular to the seismic action; the detachment of the portion of wall between the windows and the roof is a damage typically produced by horizontal forces; the shear resistance of this portion of wall was not sufficient to support the horizontal actions transmitted by the roof (fig. 14)

1. The most evident damage is localised in the zones of intrinsic weakness of the wall, i. e. in small band of wall between the roof and the window (fig. 14), and in a portion of wall between the windows, which do not lay on the same vertical line.
2. Cracking and falling of lintels and window post is due to an insufficient connection to the wall
3. Expulsion of stones in the cracked zones is due to an insufficient bond between the facing stones and the filling of the sack masonry, increased by the particular shape of the stones; detail in form n° 9

In this particular of the west façade, almost perpendicular to the seismic action, some damage mentioned in the form 20 are highlighted; in particular, it is possible to see the complete detachment of the portion of wall between the roof and the windows (fig. 14), the falling of part of the roof and its disconnected structure.

If the horizontal band under the roof is not enough resistant, the horizontal component of the seismic force acting perpendicularly to the wall, added to the thrust of the roof, can produce the collapse of the band (upper photo, fig. 14).

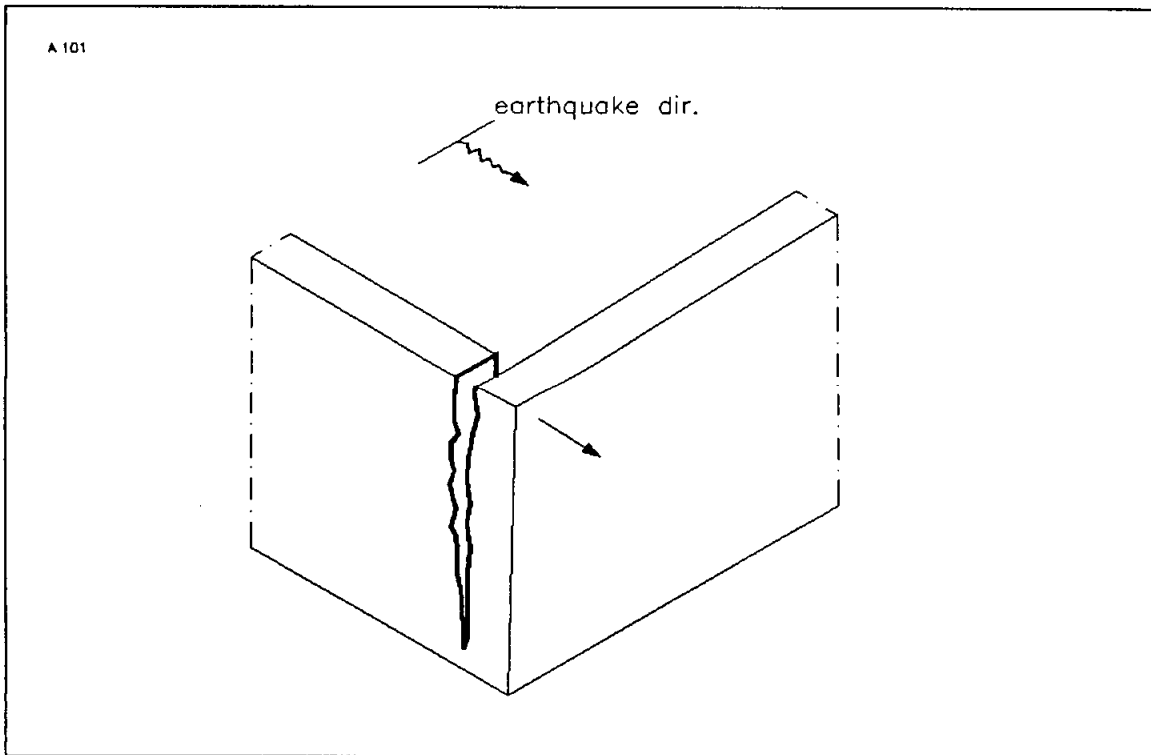
**Fig. 15 Detachment of perpendicular walls**

1. Inclined cracks at the corner (fig. 16)
2. Detachment of the perpendicular wall (fig. 15)

1. Detachment of the two perpendicular walls at the corner (fig. 15); it must be noticed that the presence of a chain (see detail in form n° 22) has probably avoided the complete collapse of the wall of the west façade, on the right of the photo)
2. Detachment of the portion of wall between the roof and the windows (fig. 14); detail in form n° 21,
3. Detachment of portion of wall due to the intrinsic weakness of the material; detail in form n° 22
4. Falling of part of the roof, not enough connected to the structure; detail in form n° 21

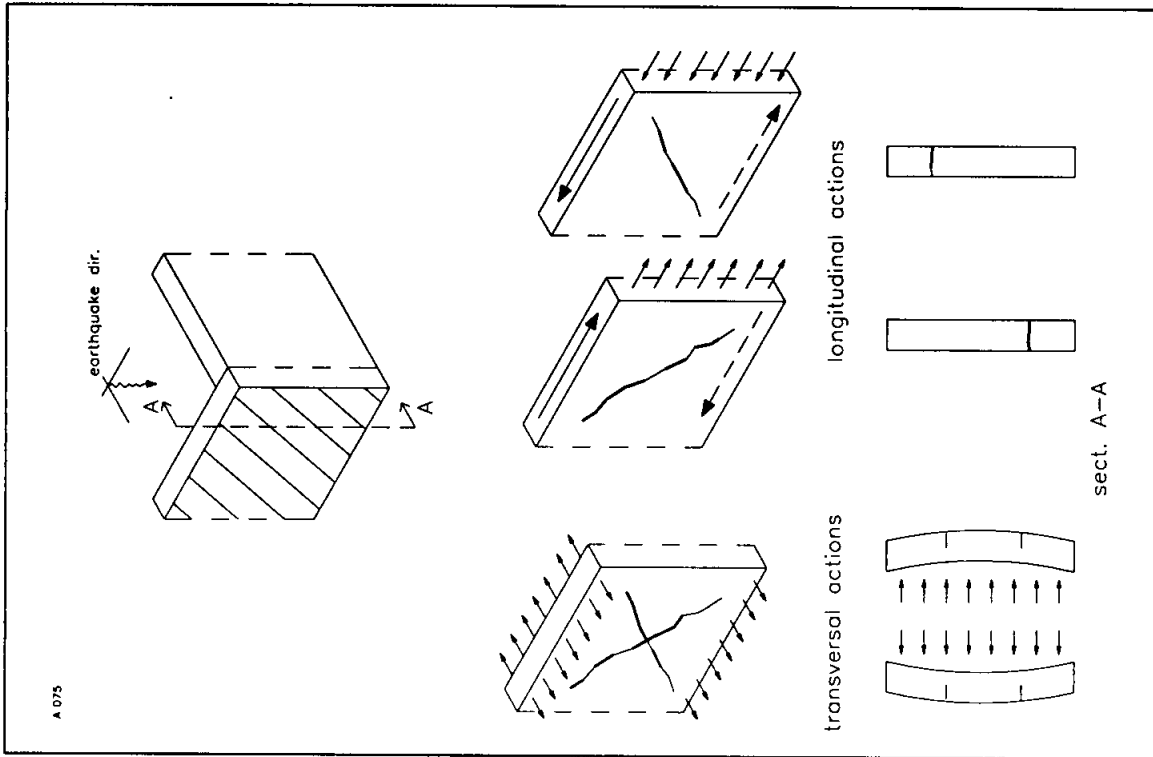
Fig. 16 Cross cracks in the walls

1. Diagonal cracks are clearly visible (fig. 16)
2. Detachment of stone blocks, and of blocks of the wall rosace are due to an insufficient bond between the stones and the fill
3. The displacement of the base of the spire is due to an insufficient connection to the structure
4. The displacement of the key of the arch is due to the horizontal relative movement of the two parts separated by the cracks; see detail in form 18

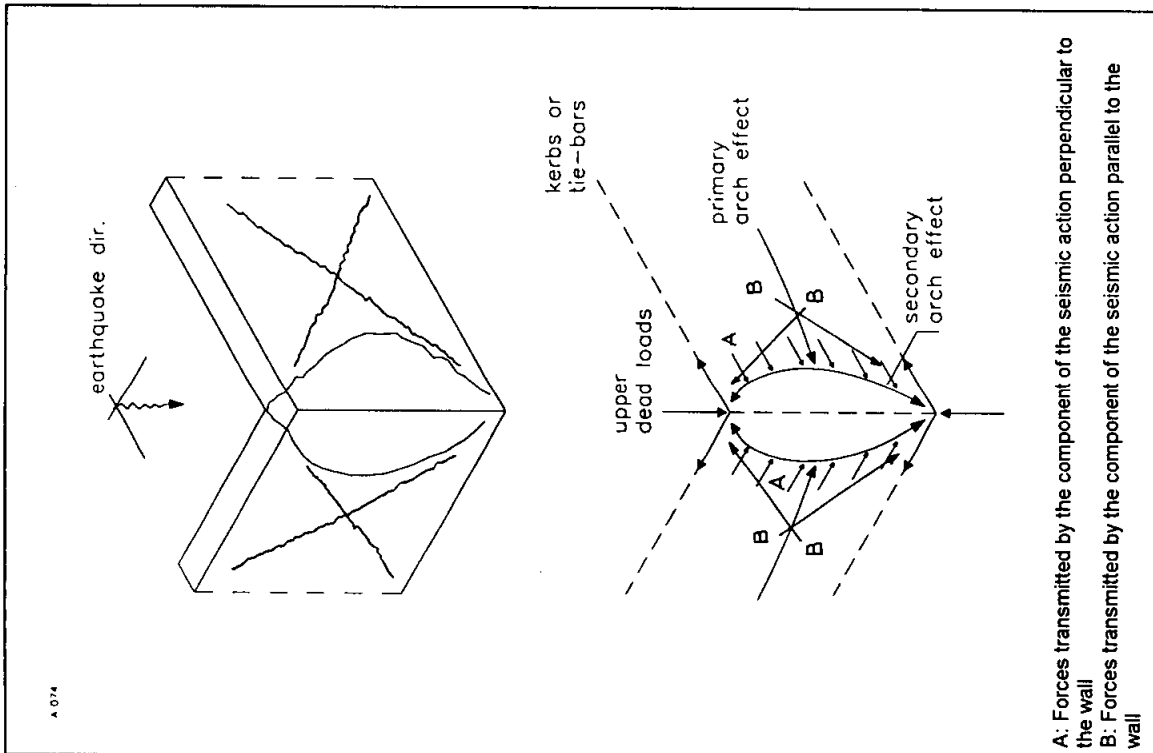
Fig. 17 Detachment of the corner

The detachment of the corner is a type of damage frequently occurring, due to both the components of the seismic actions parallel (cross cracks) and perpendicular (thrust due to the arch effect) to the walls.
