PHILIPPINES

Baroque Churches of the Philippines

II.1 Introduction

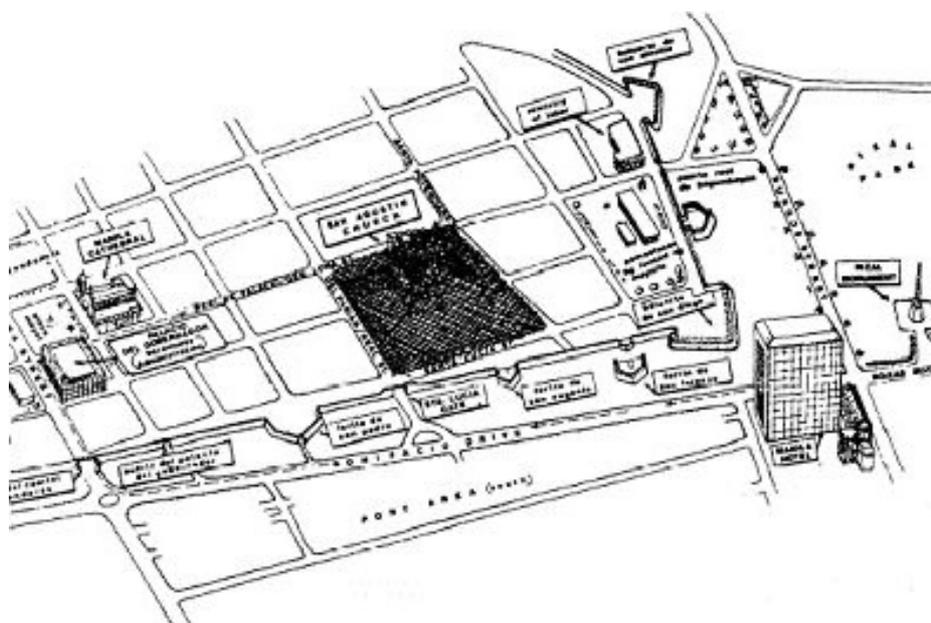
3D plan of St. Agustin Intramuros Church, with its Buffer zone (in grey)

- Sto Tomas is threatened by excessive “beautification” and San Agustin (Intramuros) has suffered from inappropriate use of concrete in repair works.
- “There is an increasing impact of air pollution and vibrations caused by tourist influx and other activities surrounding the Churches.”
