*Culture, Tourism & Antiquities Department
Government of Sindh (Pakistan)*

**STATE OF CONSERVATION REPORT
HISTORICAL MONUMENTS AT MAKLI, THATTA (PAKISTAN) (C 143)
DECISION: 41 COM 7B.97**

November 28, 2018

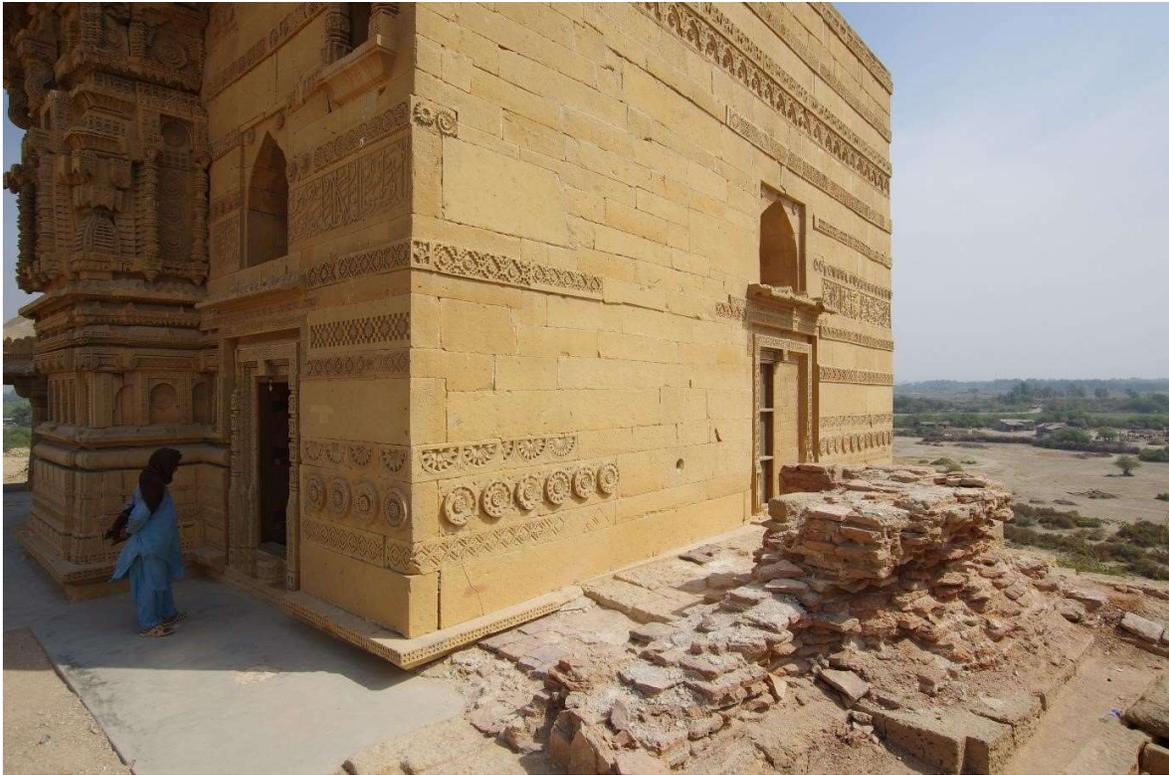
Image 3: South-west corner with remnants of an older sepulchral structure south of Jam Nizam al Din.

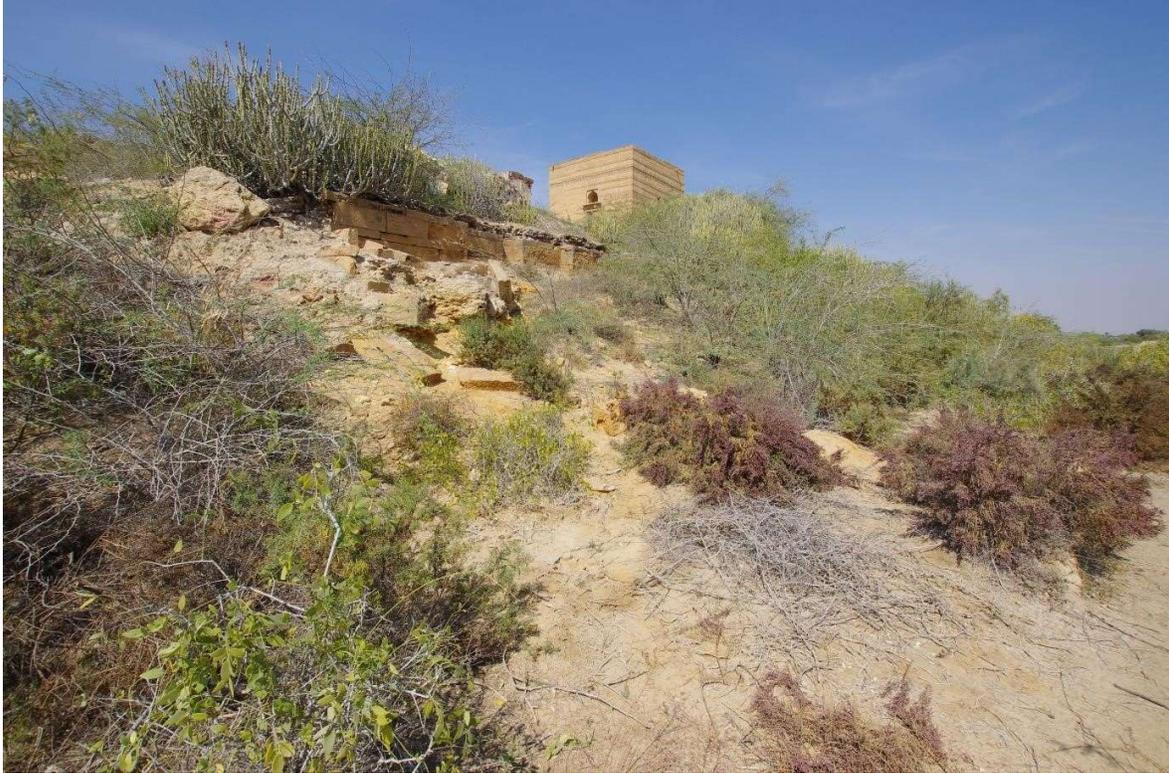
The term “shale” is used by ces to identify “dense silt”, a clayish loam with markedly plastic behaviour. The physical properties of the material change if inundated or exposed to water for a longer period. In this instance, the stiffness of the material decreases noticeably. Furthermore, if exposed to the weather, this material can deteriorate and disintegrate quite rapidly. The erosion process of the cliff was already described by ces in their final report: since the soft layer of loam erodes quite quickly under atmospheric exposure, it leads to the landslip of the limestone layer above. The ongoing erosion of the bluff can be witnessed at the example of a sepulchral structure below Jam Nizam al Din, which has been partly carried away due to the ongoing degradation of the slope (See image 7).

Image 7: Remnants of a tomb structure south-east of Jam Nizam al Din. The structure collapsed due to the erosion of the slope.

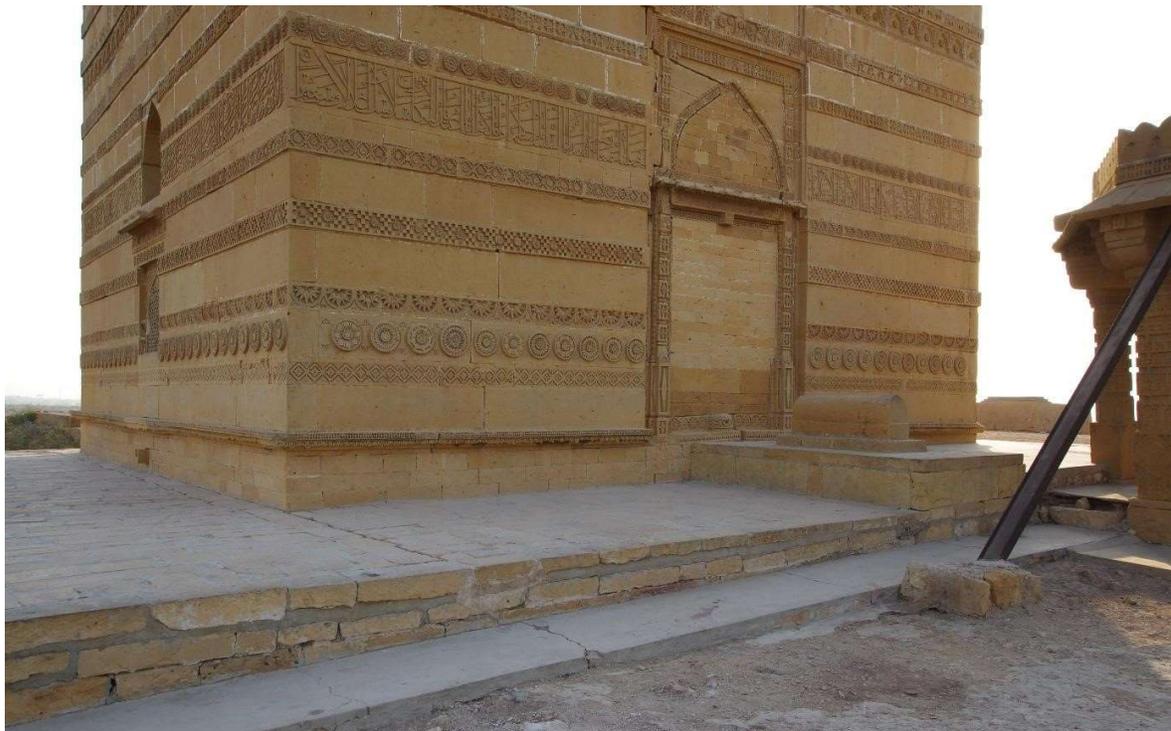
Image 10: North-eastern corner of the building with the masonry encased retaining wall installed in 1994 and (in the foreground) the concrete apron installed in 1996.

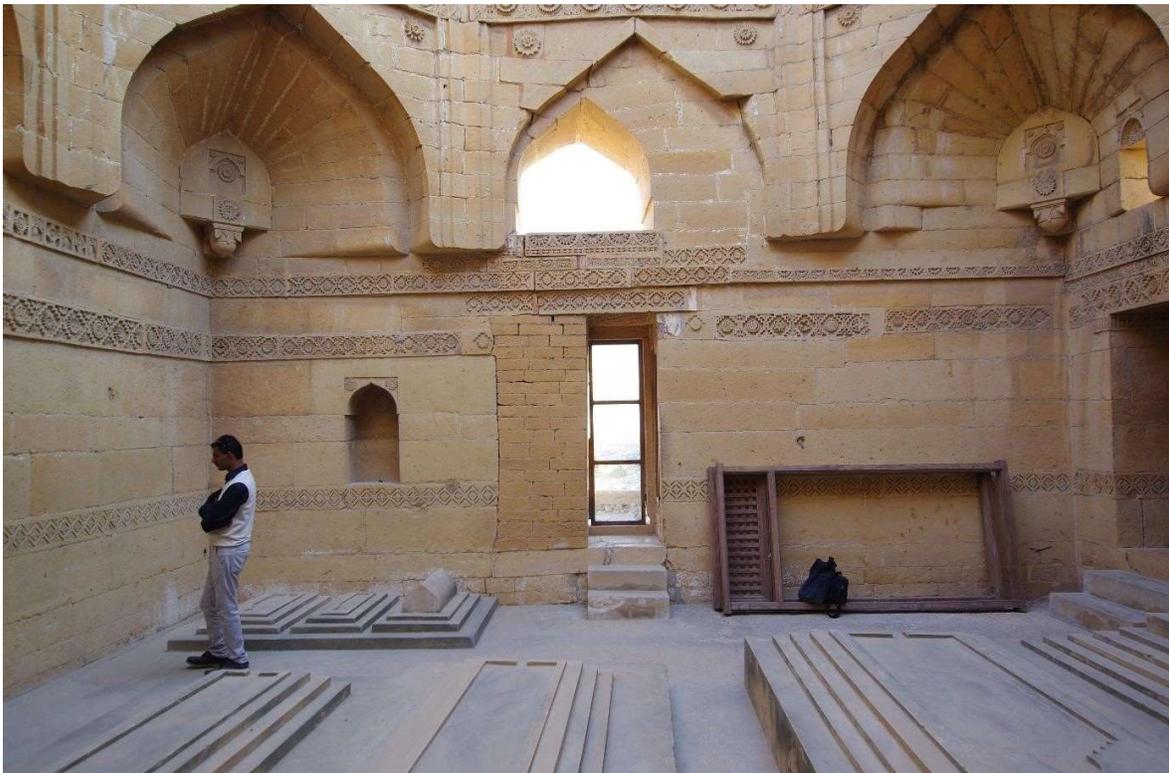
Image 16: Central space of the tomb, looking south (the infill of the south gateway was most likely added in 1956).

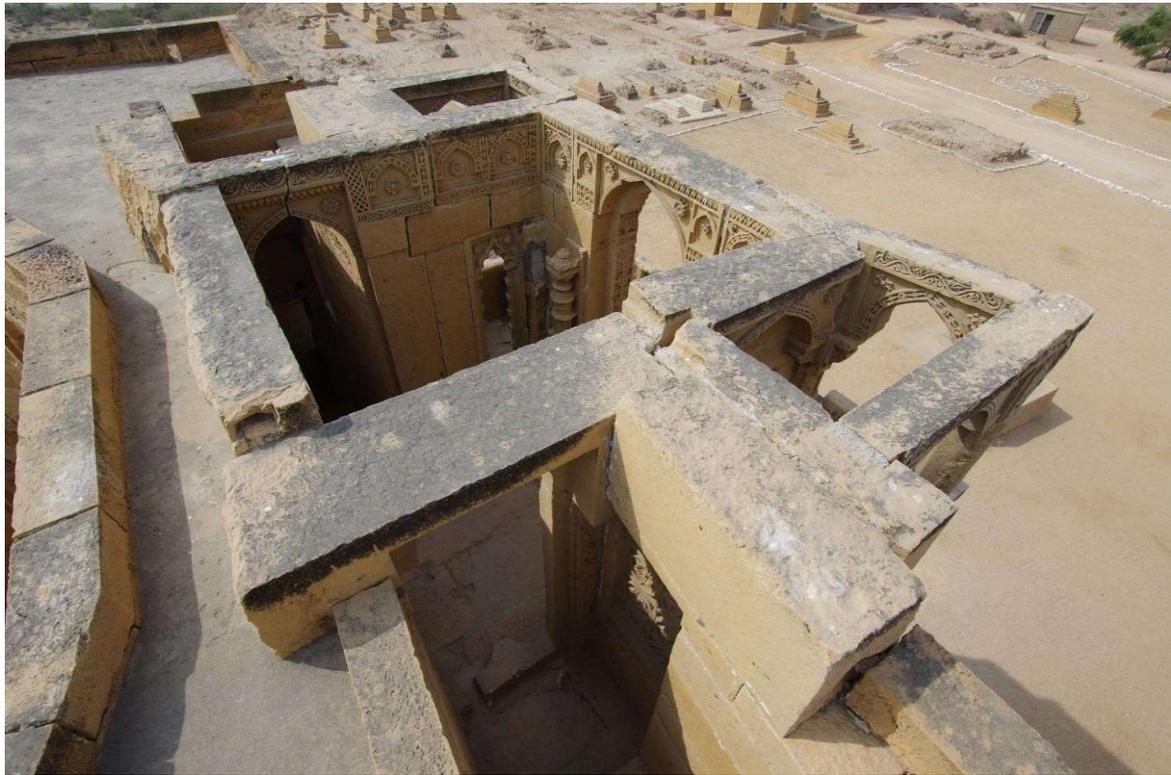
Image 34: Top view of the balcony structure, showing the severe dislodgements and misalignments.

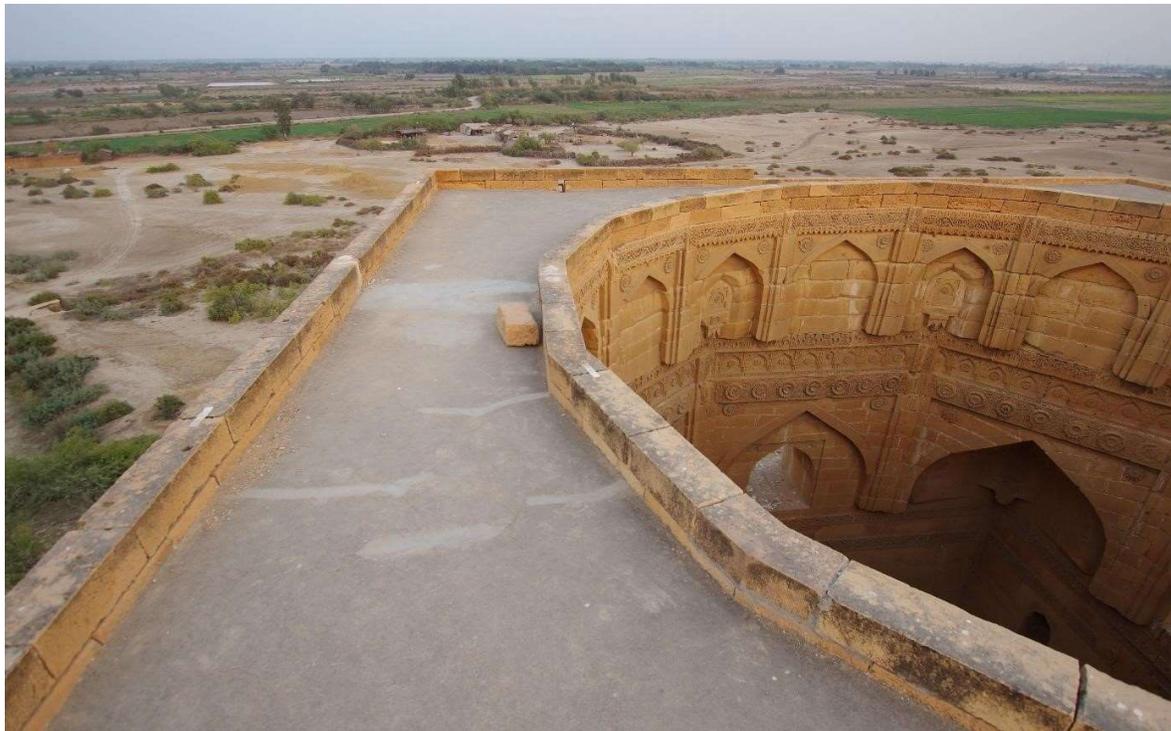
Image 35: Top level with cement flooring and the two added courses of stones (1956).

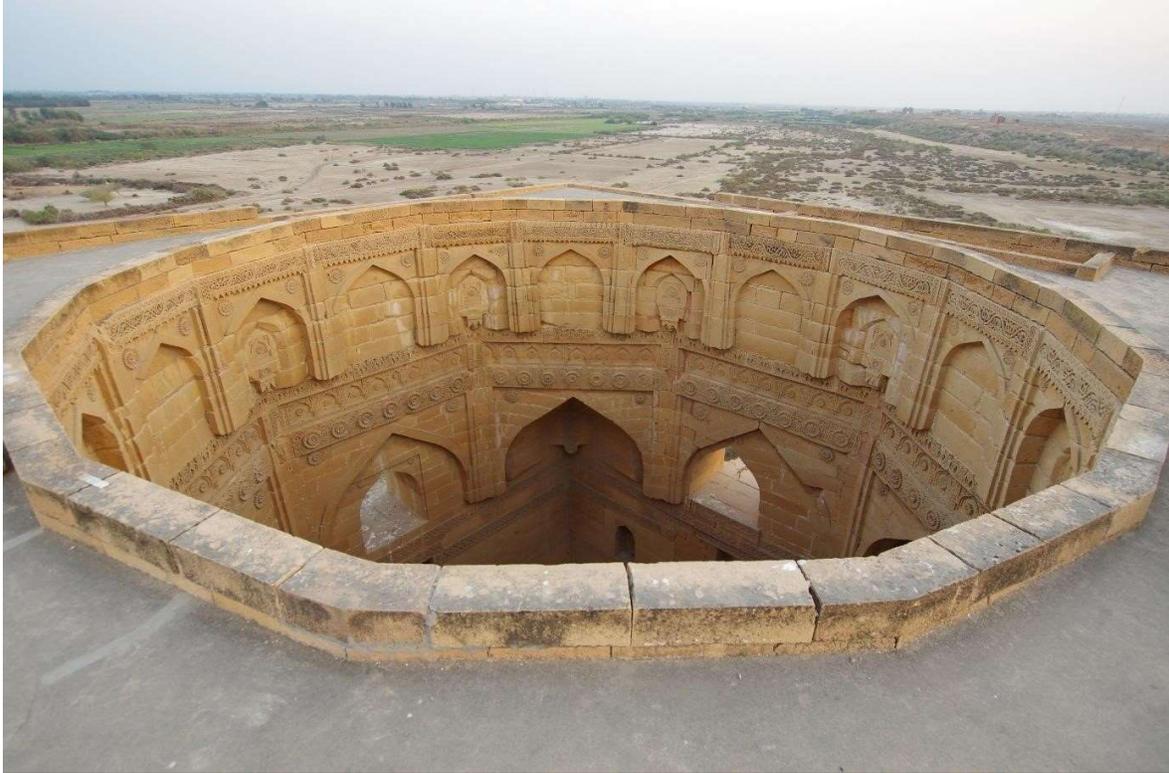
Image 36: Top level with cement flooring and the two added courses of stones (probably carried out in 1956 by the department of public works).

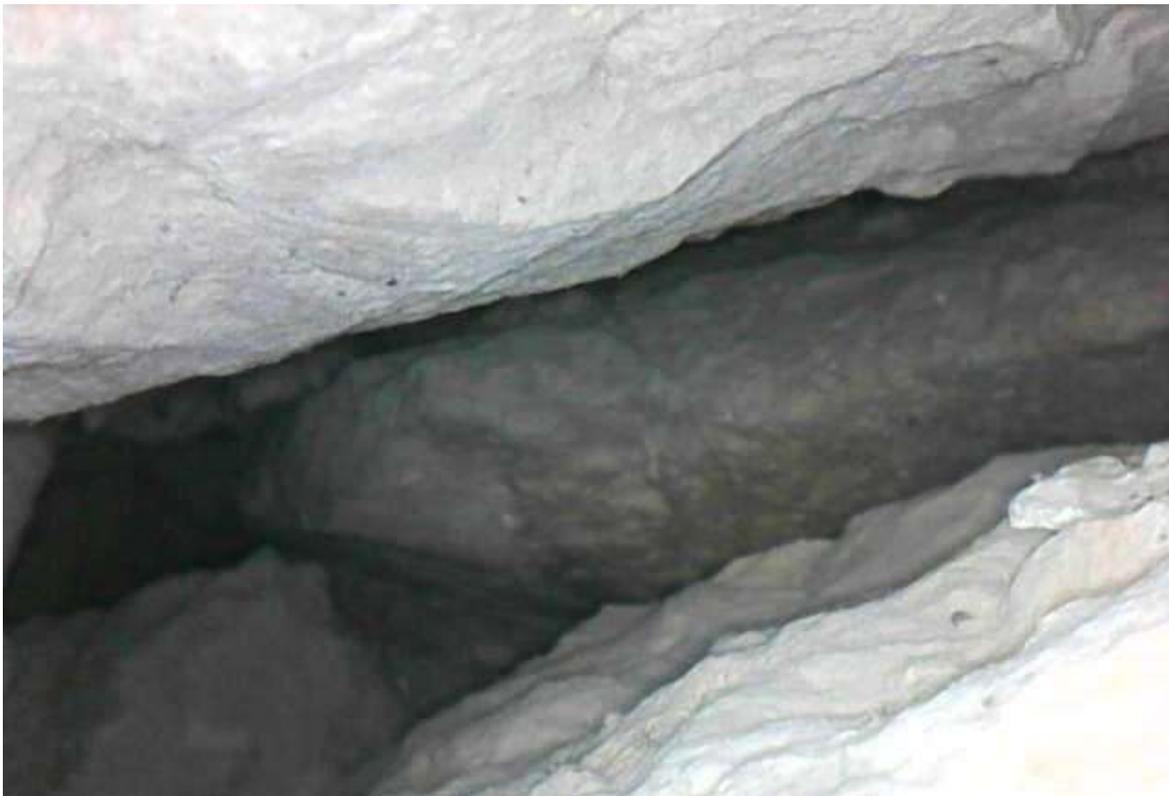
The outer faces of the walls consist of dressed drystone masonry (ashlar). Most likely, the walls are composed of two faces of dressed stone masonry with a layer of rubble infill in between. This construction method was widely used for the vast majority of coeval monuments in the area. This assumption was further corroborated by an endoscopic survey (image 37).

Image 37: Endoscopic view of a cavity next to the gateway at the northern wall, showing the inner layer of rubble stones.

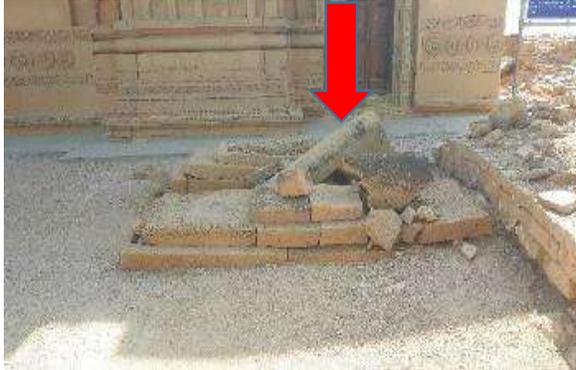
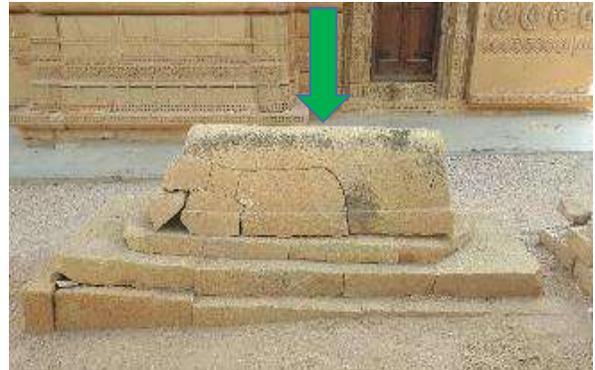
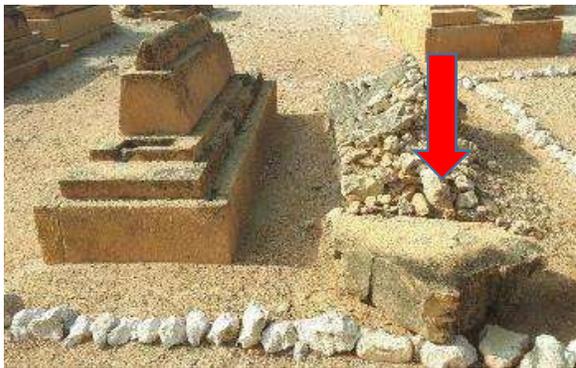
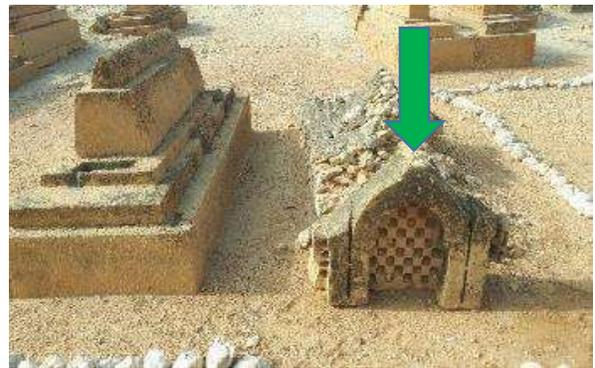
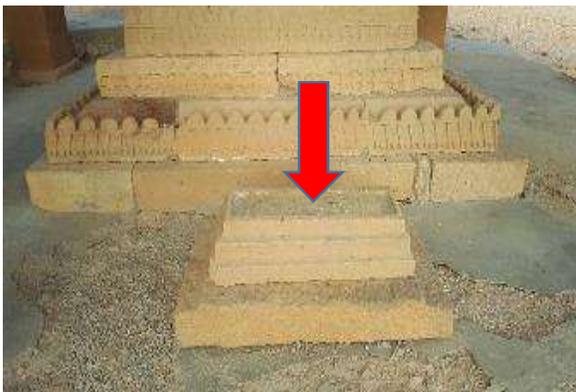
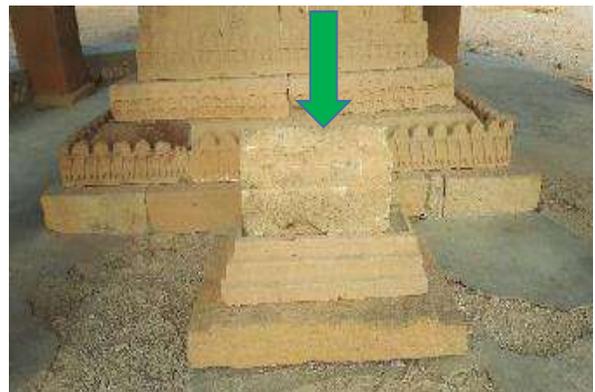
The site management staff carried out a detailed damage assessment for documentation and ascertaining the nature and scope of damage. From the outset, it appears that the suspect focused the graves whose stones were already cracked. There is no sign of breaking and it appears that he simply dislodged the gravestones and made them look like rubble. Following pictorial account gives a fair understanding of the damage. All desecrated graves are unknown. The pictures with the red arrows show the damage and the green arrows show the re-assembly (Anastylosis) of the grave stones.

1. An FIR (formal complaint) was lodged at the Police Station
2. The prime suspects are in custody and the matter is being investigated
3. A detailed damage assessment was carried out and documented using historic photographs
4. The dislodged grave stones were re-assembled (Anastylosis) to their original position
5. An urgent meeting of 'Makli Steering Committee' was called at the site on 3rd October, 2018 for assessing the situation and suggesting appropriate measures
6. Security at the Samma Cluster has been increased by hiring additional guards. The cluster is now guarded 24/7
7. Vehicular movement inside the site premises is stopped
8. The wooden door that was broken is repaired
9. New crack monitors have been re-installed
10. Cooperation with the police is underway
11. Work with the surrounding community is being undertaken. The motivations behind such an attack must be understood.

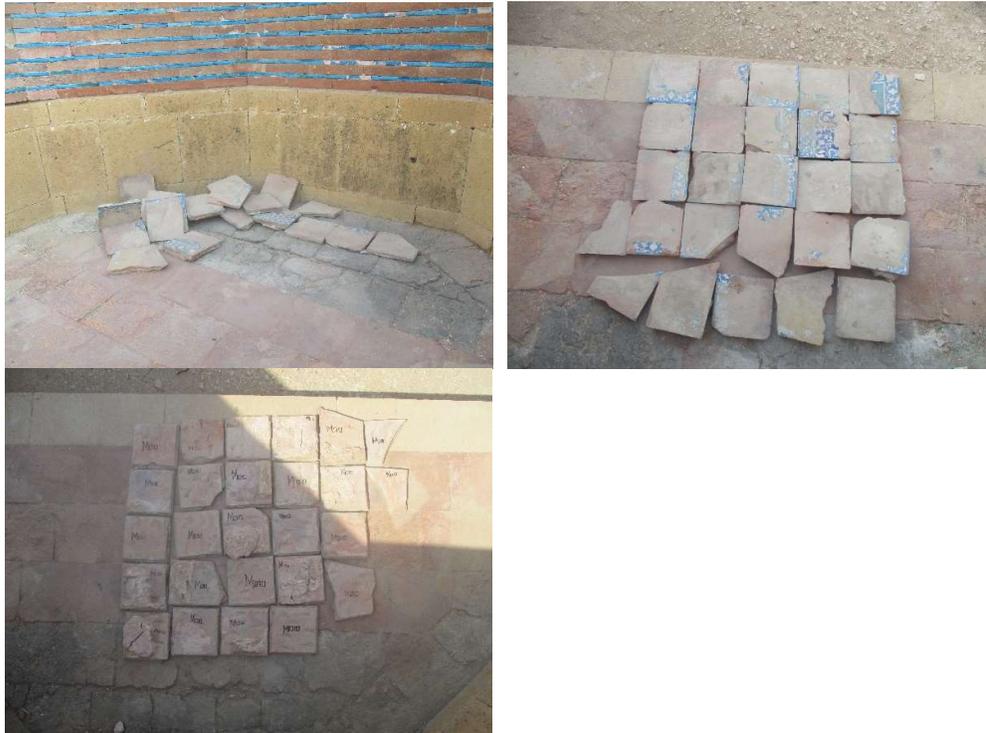
Figure 3 – Fallen decorative elements at the tomb of Baki Beig, included documentation before movement, the context, photography of the decorative surface, numbering and storage in the central office.

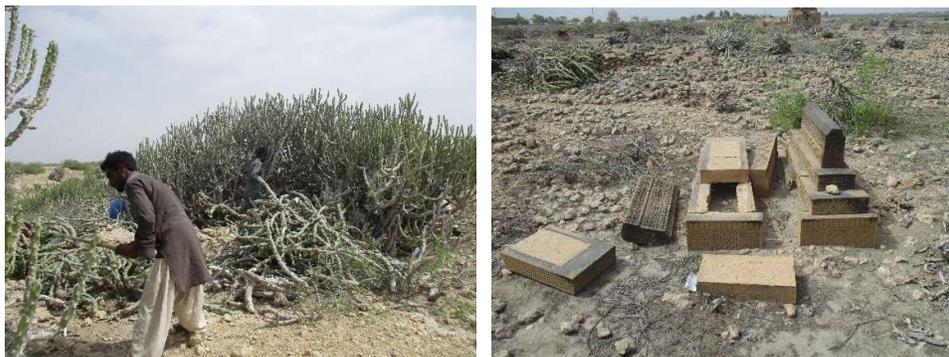
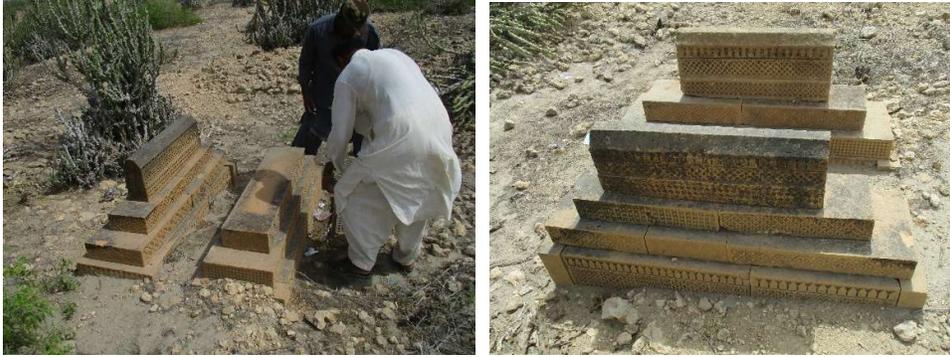
Figure 4 – Repositioned stones in the tombs after clearing the brush, west of the tomb of Sultan Quas. It should be noted that the inventory photo documentation of this type is being captured before, during, and after this process.

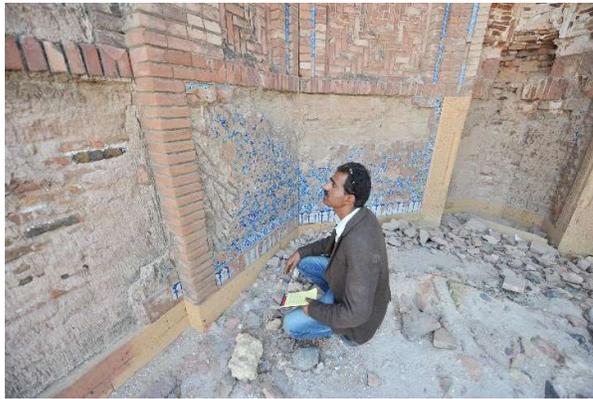
Figure 6 – Extant tile investigation and inspection at an Unknown Tomb east of Sultan Ibrahim

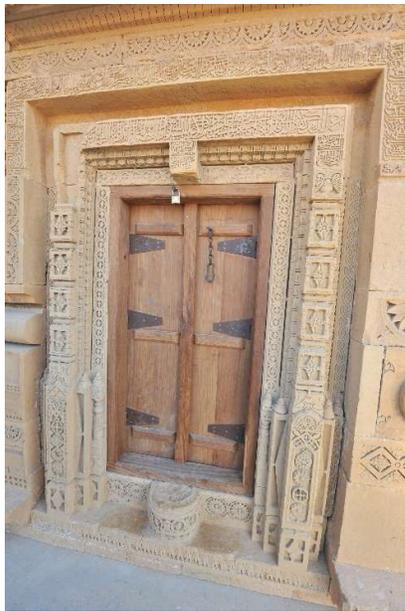
Figure 17 – the new door at Jam Nizamuddin prevents unauthorized entry – many of these new wood doors have been installed throughout the site

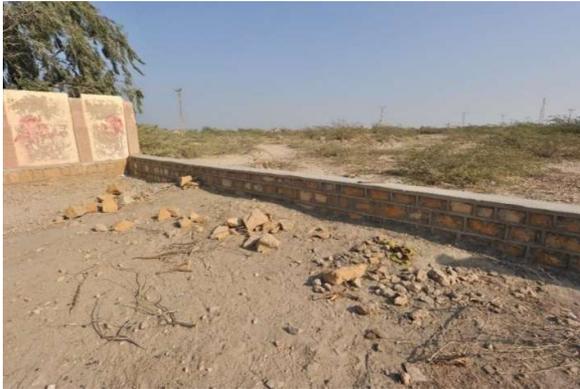
Figure 24 – A new short barrier wall was constructed to halt the illegal settlements and vehicular access to the west of the site

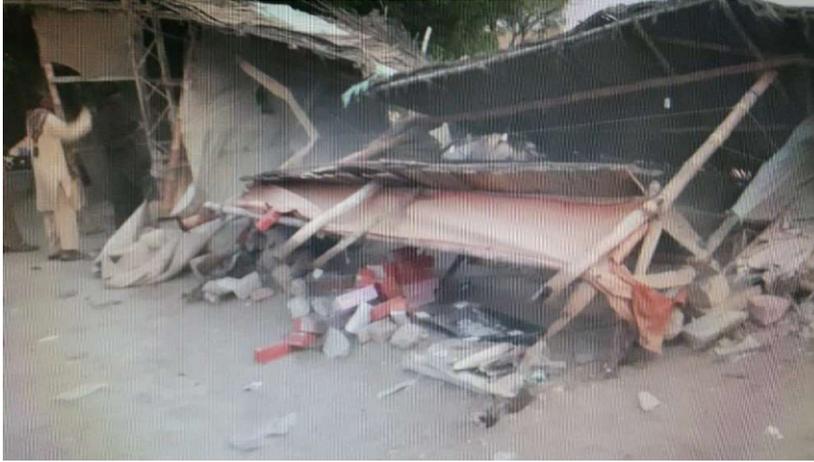
Figure 26 – Removal of illegal encroaching structures

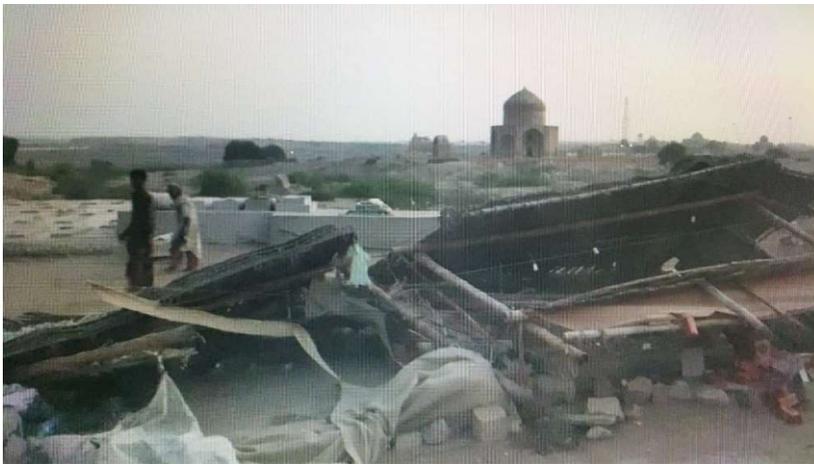
Figure 27 – Removal of illegal encroaching structures

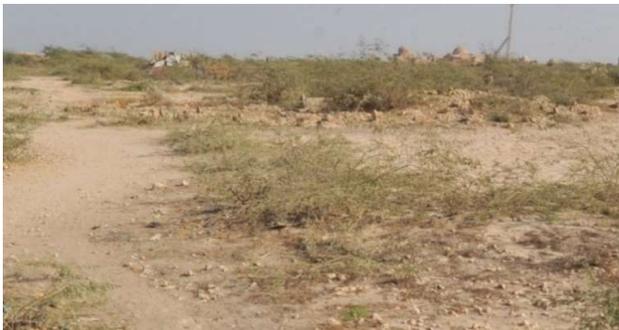
Figure 28 – The new barrier wall has closed off vehicular access at one portion on the western side of the site. A number of illegal tent structures have been removed. While there are still some illegal tent structures, the government has set aside 15 acres, and they have agreed to move. The debris has been removed, and empty areas will be restored.

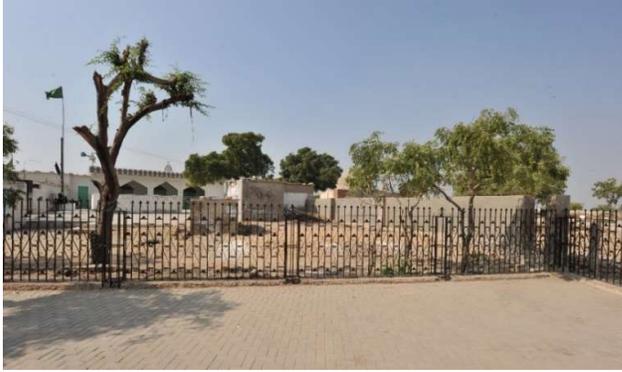
Figure 29 – Illegal encroachment structures have been removed at the entry to the site

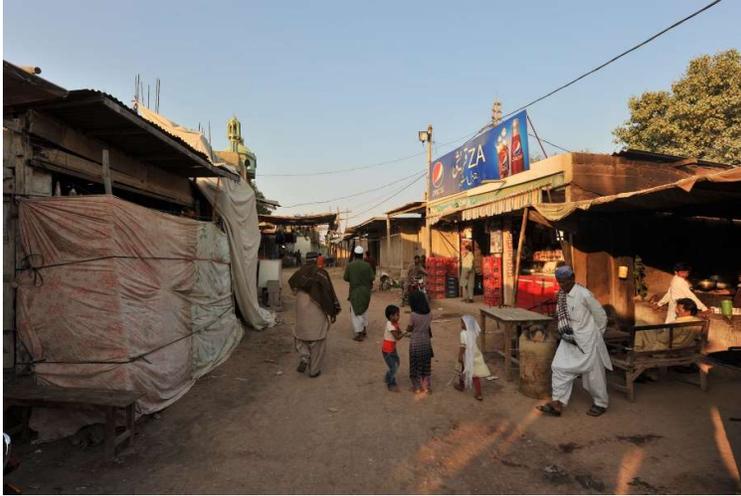
Figure 37 – Illegal structures toward the center-east of the site. The boundary of the site runs through the center of the street of an active market. To the right is outside the boundaries to the left is inside the boundaries. Several stalls have been closed, but it is an ongoing challenge.

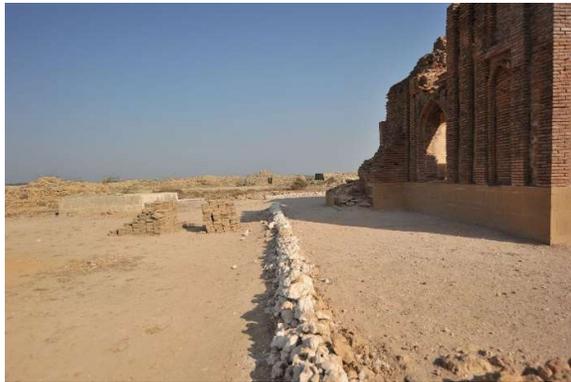
Figure 43 – Area around Samma group has been cleaned and vehicles prevented from coming close to the monuments

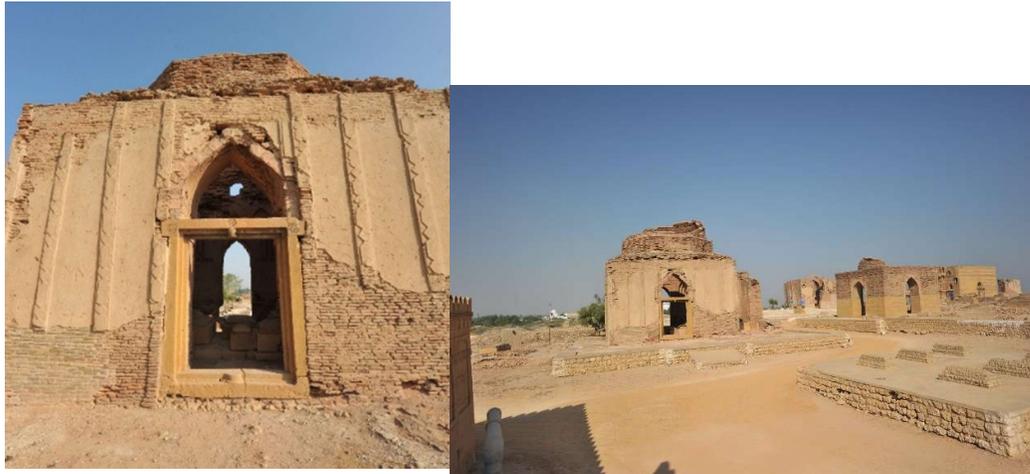
Figure 47 – Fatah Kahn and the entire area around the Samma Group has been kept clean of rubbish and vegetation. Rocks have been painted with lime and line the road to discourage parking near the tombs.

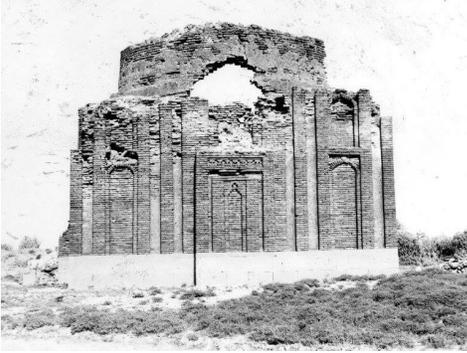
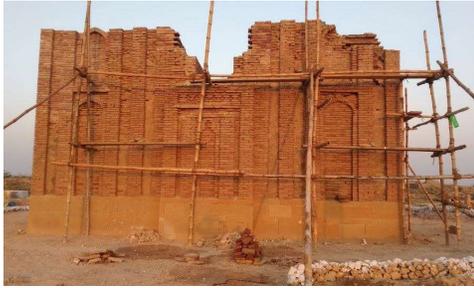
Figure 48 – Juman Jatti tomb

This tomb has undergone cleaning, brick and stone consolidation and wall capping. There was archival research also undertaken with the discovery of historic images from the mid-20th century. However, additional work must be undertaken after more in-depth studies.

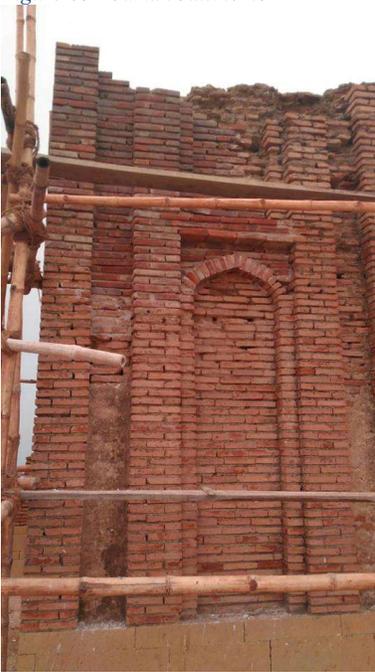
Figure 49 – Brick corner reinforcement

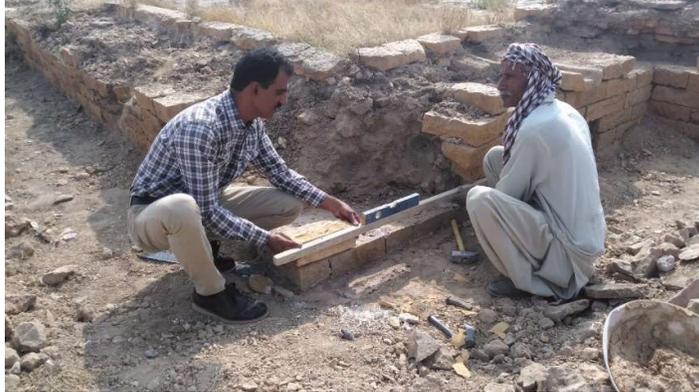
Figure 50 – Work on site to stabilize the corner of this minor tomb platform

Structural stabilization of the platform of this minor tomb and removal of wild growth. While not as significant as other tombs it was relatively easy to address as work crews were nearby and there was ample material. It is also near the road thus seen by many visitors.

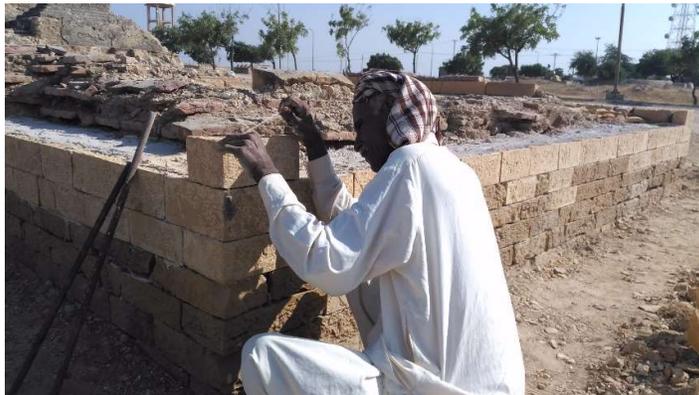
Figure 51 – Stabilization work on the unknown tomb platform

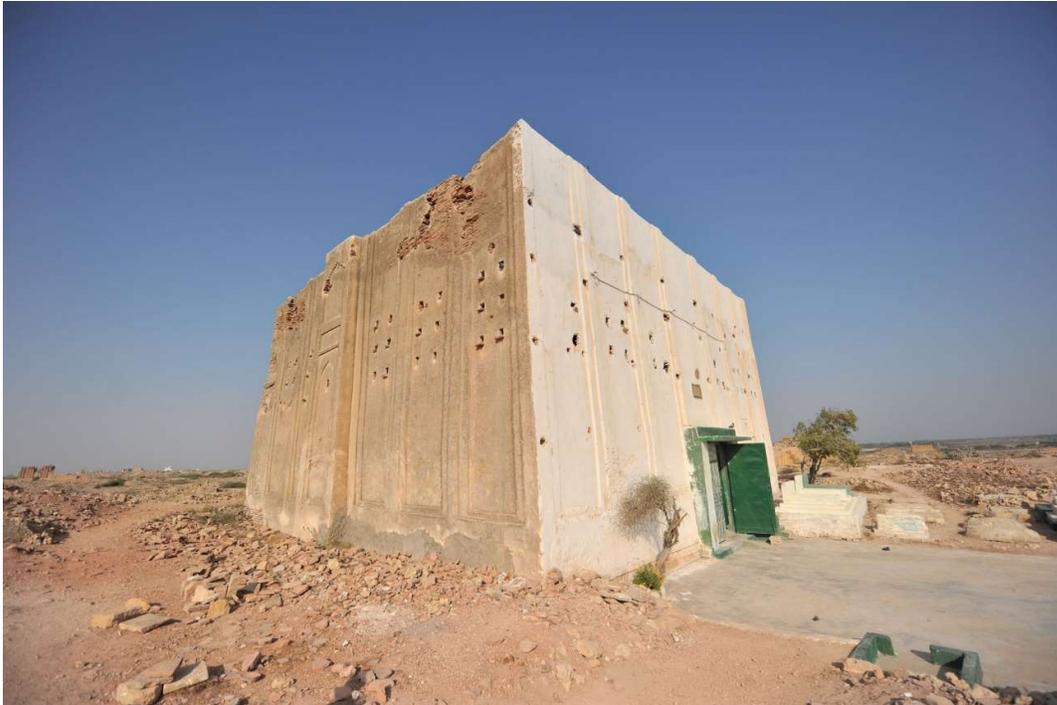
This active shrine and tomb have not had any conservation work as there has been a conflict with its active caretakers. The caretakers have been installing electrical cables and carrying out their own works including portland cement patching and incompatible painting. These works have occurred even after meetings between the site manager and the caretakers in 2016 and again in January 2017. Throughout 2017 the site manager has engaged with the caretakers and has sought legal action to enforce control over the work on this important monument. Since his actions, the electrical cables have been removed and works halted. There are no serious structural issues with the tomb, but minor issues must be addressed including stabilization of the upper portions of the masonry, plaster consolidation, and removal of inappropriate materials.

Figure 52 – Shaikh Geo as it appeared in January 2018. Notice the portland cement patching on the lower western façade. This area currently traps water and drainage will need to be addressed in the future.

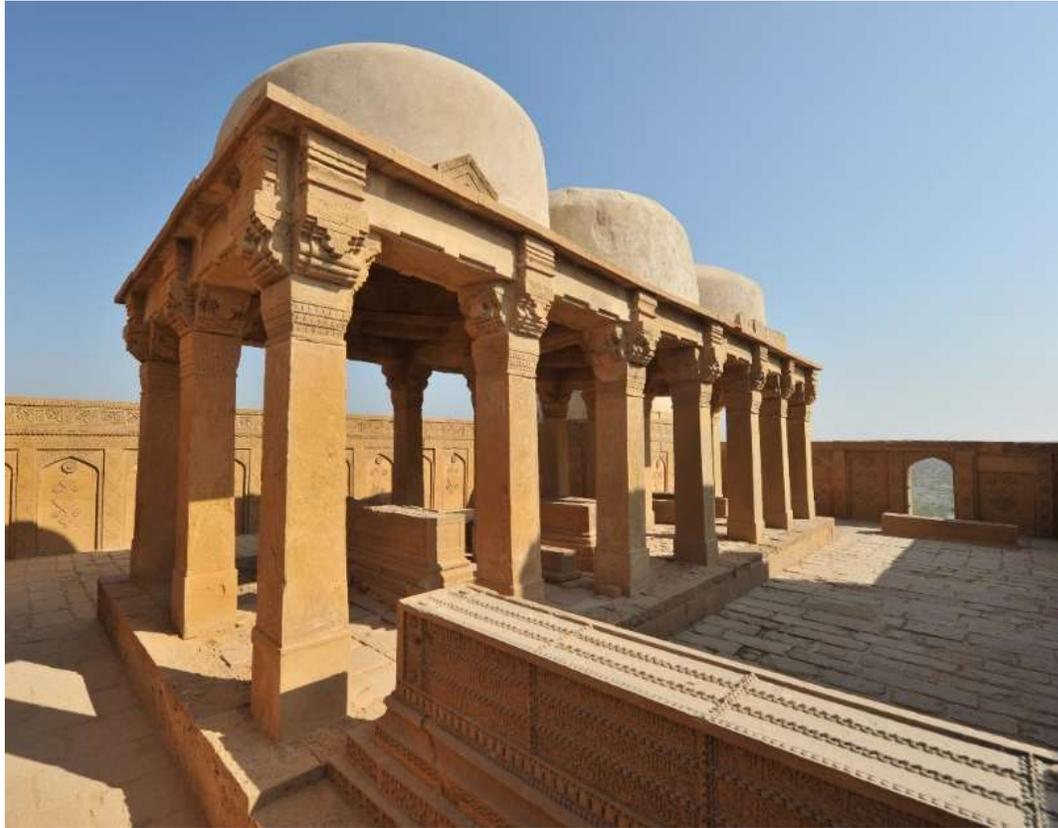
This was a project by the Heritage Foundation Pakistan and was completed with funding by the German Government. It is now in stable condition. Only one dome was the extent, and through an innovative, reversible technique two new bamboo domes which were plastered were installed to complete the visual impact of the monument and keep out rainwater. A new glass door was installed with the lock, but this was broken as of January 2018. The interior of the tomb and approach has been kept clean by the on-site staff.

Figure 53 – the Recently finished tomb of Jan Baba... by Heritage Foundation Pakistan

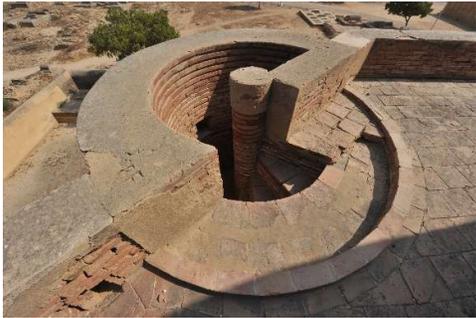
A project has been planned by the Endowment Fund Trust. The scope of this project remains unknown, and the site manager will officially request more information. Also some detached fallen tiles were detected, and these have been cataloged, photographed, and stored. The drainage below the dome was an issue, therefore, the scuppers were cleaned and a small course of compatible brick installed at the stair as water was entering the tomb from this stairway. New wood doors and locks were installed at the boundary wall and at each of the staircases. Crack monitors were installed at the southern portion of the roof and were monitored throughout 2017. There has not been any movement observed.

Figure 54 – Small brick course to direct surface flow water from entering the stair

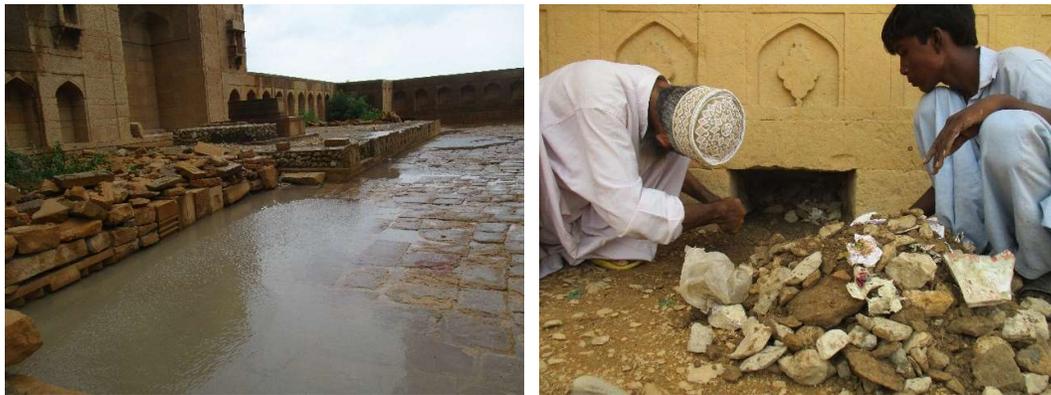
This very significant tomb has structural deficiencies at the northwest corner. These are currently being monitored with the installation of crack monitors, and there has been no movement observed. However, there were collapses in the past sometime in the decade of the 1970s or 1990s. Beside seismic activity, it is thought that this is caused by the retention of rainwater on site and indeed there is a low lying area. The historic drains became blocked and had since been cleaned out. All are functioning with the exception of one at the northwest corner. A deposit of sculpted historic and replacement stone was deposited at this corner and prevents the historic drain from functioning. It was discussed that this would be move and the original pieces separated from the replacement pieces. This drain will then be cleaned again, and if necessary, an open drain will be created outside the boundary wall of the tomb to direct water away from the monument. This drainage channel could be installed to the north between the monument and asphalt road. It was discussed that this was important not to simply move the water to another tomb but that an absorption or evaporation pit could be created possibly in an existing lime pit used for the conservation of another tomb. In addition, there was significant graffiti on the outside boundary wall of this tomb. This graffiti has since been removed. The small domes have also been repaired.

Figure 56 – Cleaned historic drains at the tomb of Isa Kahn

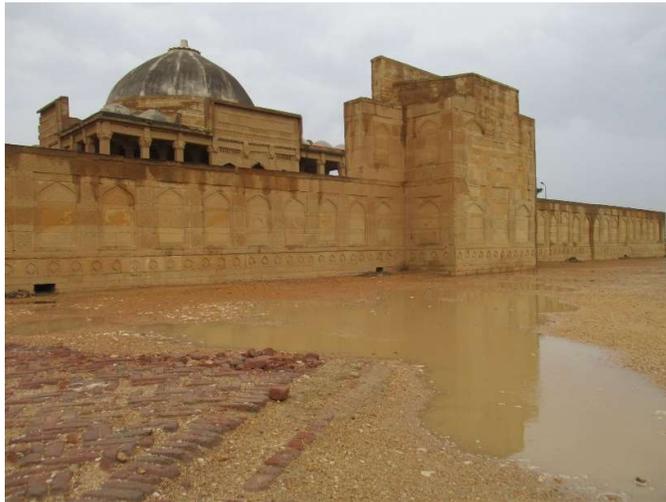
Figure 57 – The exterior of Isa Kahn after the monsoon rains. Although the drains were cleaned out the water is still ponding to the north of the structure. Extensive discussions were held on draining this water to the east and using an open area as a percolation/evaporation pit.

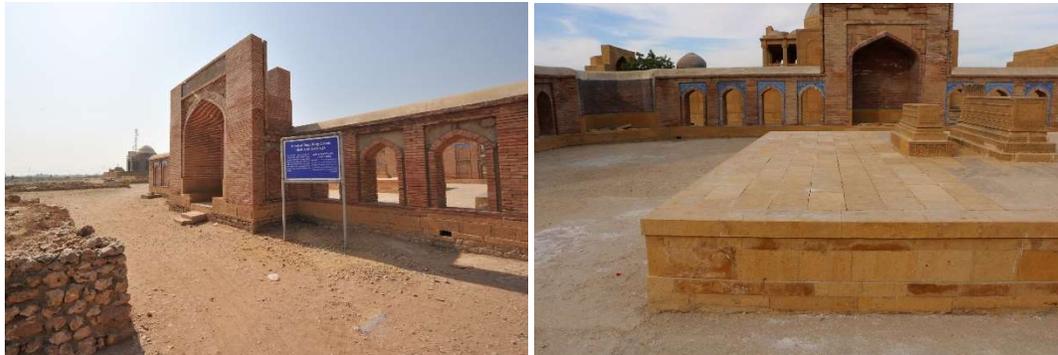
The platform conservation was completed, vegetation removed and new wooden doors with locks installed. A new notice board was installed. Stabilization of brick work and repointing occurred in early 2017 to stabilize the arches. The historic scuppers were cleaned, and the built-up earth area to the south outside the tomb was removed to provide drainage.

Figure 59 – The entire area around this tomb was cleaned and now water drains away from the structures to the right is the restored tomb platform (Serfraz Nawaz)

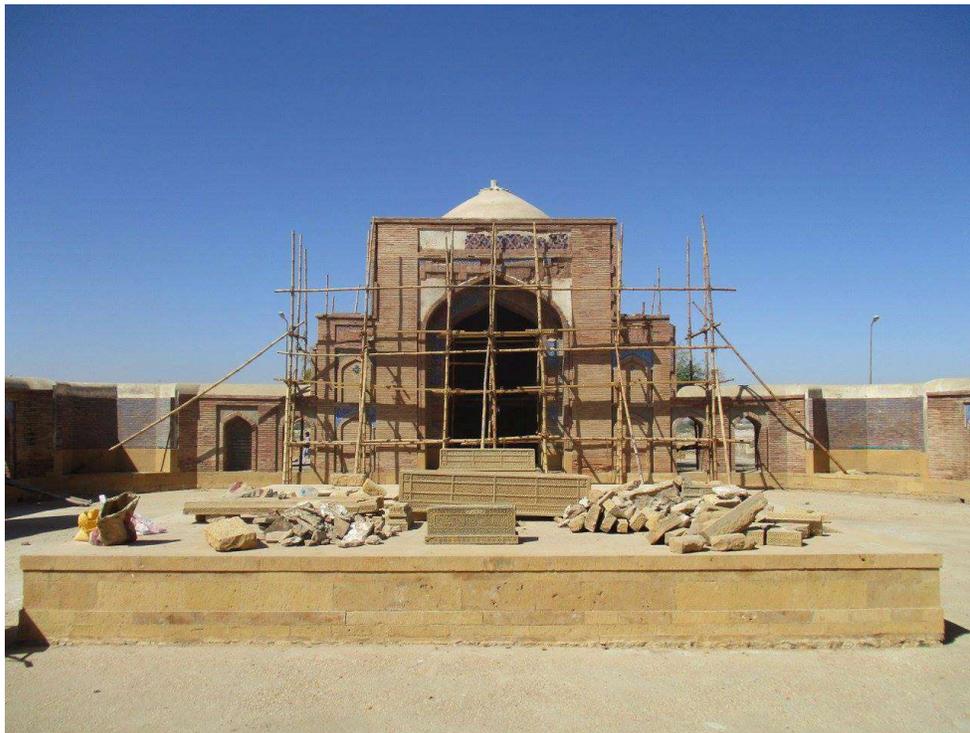
Figure 60 – Consolidation around the historic tile and repointing of the brick arch and restoration of the tomb platform (Serfraz Nawaz)

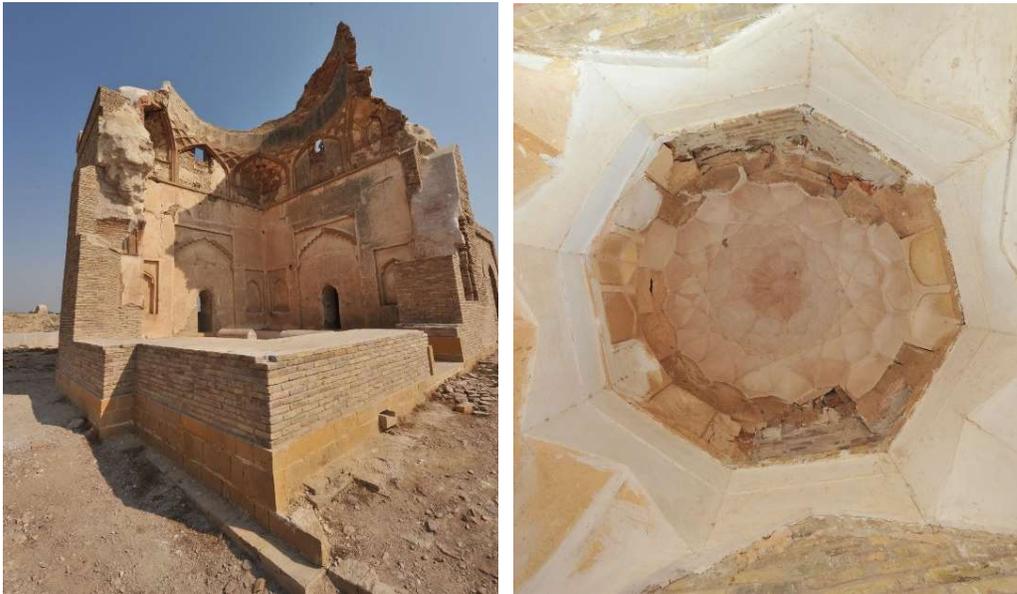
Extensive conservation works were carried out here in late 2016 and 2017. The remaining portions of the main dome and two walls were stabilized and the three smaller domes to the east stabilized. Several portions of the smaller domes required reconstruction in order to stabilize the remaining portions. Three large buttresses were constructed on the eastern (downhill) façade in order to stabilize the entire structure. These are massive and not in keeping with the original form of the building thus have come under criticism for their size when viewed from the east. This highlights a point for Jam Nizamuddin as the monuments should be seen from every vantage point and any intervention should not be overly intrusive. There were also discussions of grouting behind the remains of plaster and use of reinforcement ties and stitching of masonry cracks.

Figure 61 – Lali Mosque works including stabilization of the platform and interior tombs including stabilization of the interior of the plaster in the small domes

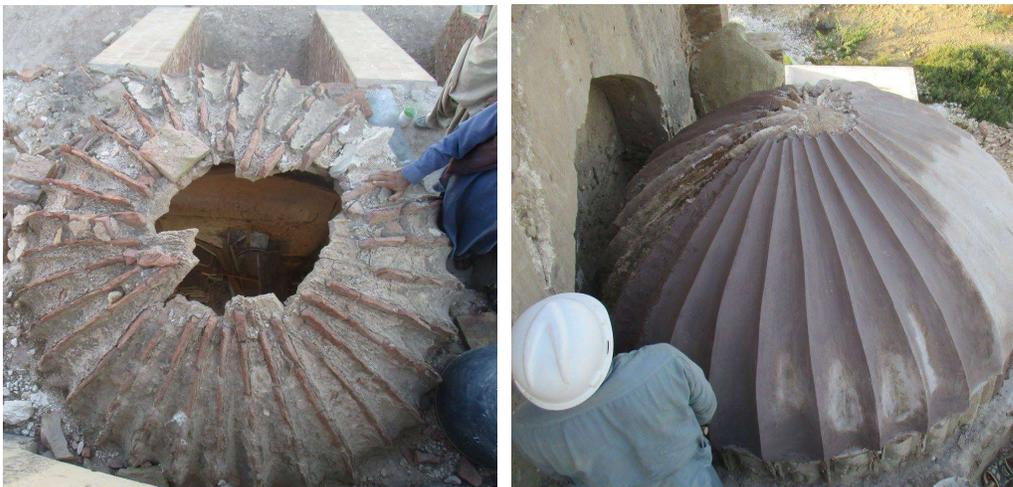
Figure 62 – Lali Mosque restoration of sections of the dome (Serfraz Nawaz)

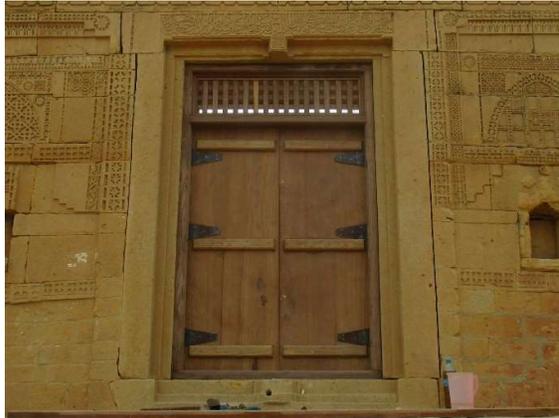
General cleaning, brush removal, emergency stabilization, removal of bird droppings and notice boards and new wooden doors were installed at various monuments.

Figure 63 – New wooden doors installed for security at Doolah Diryakhan /Serfraz Nawaz)

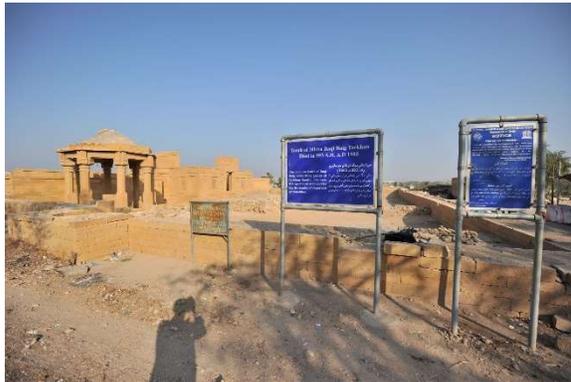
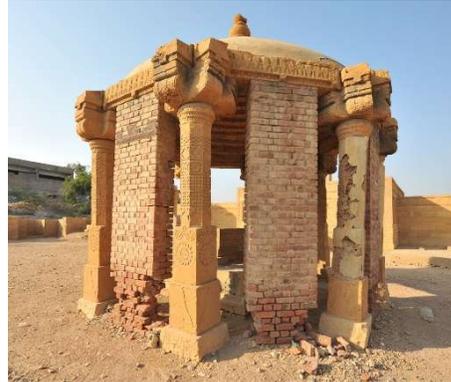
Figure 64 – The cleaning and installation of signs have let the surrounding community know these monuments are being addressed and this has greatly reduced rubbish with no graffiti observed in January 2018. However, there are immediate issues that must be addressed
