*Culture, Tourism & Antiquities Department
Government of Sindh (Pakistan)*

**STATE OF CONSERVATION REPORT
HISTORICAL MONUMENTS AT MAKLI, THATTA (PAKISTAN) (C 143)
DECISION: 41 COM 7B.97**

November 28, 2018

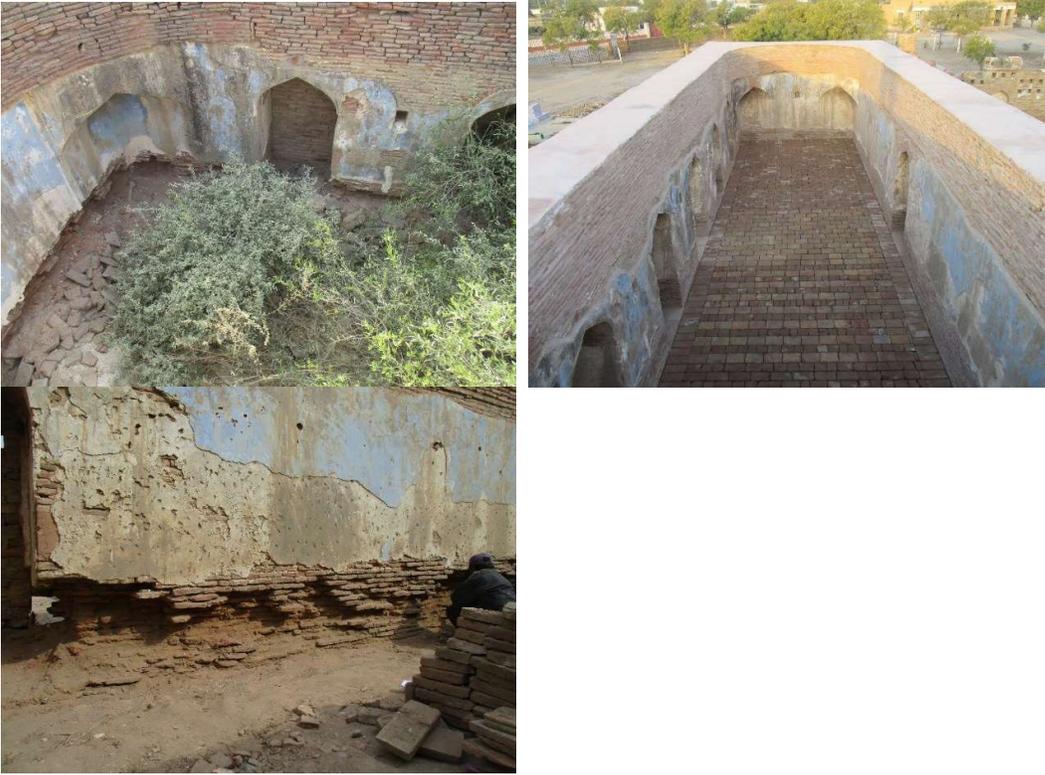
Figure 66 – Unknown compound before and after cleaning and intervention (Serfraz Nawaz)

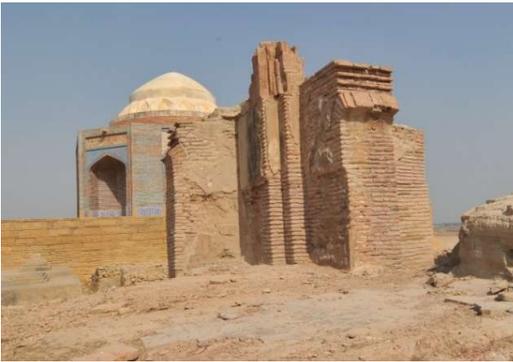
General cleaning on the surrounding walls but there have not been any works on the canopy itself.

Figure 67 – Various smaller stabilization projects were conducted in this area

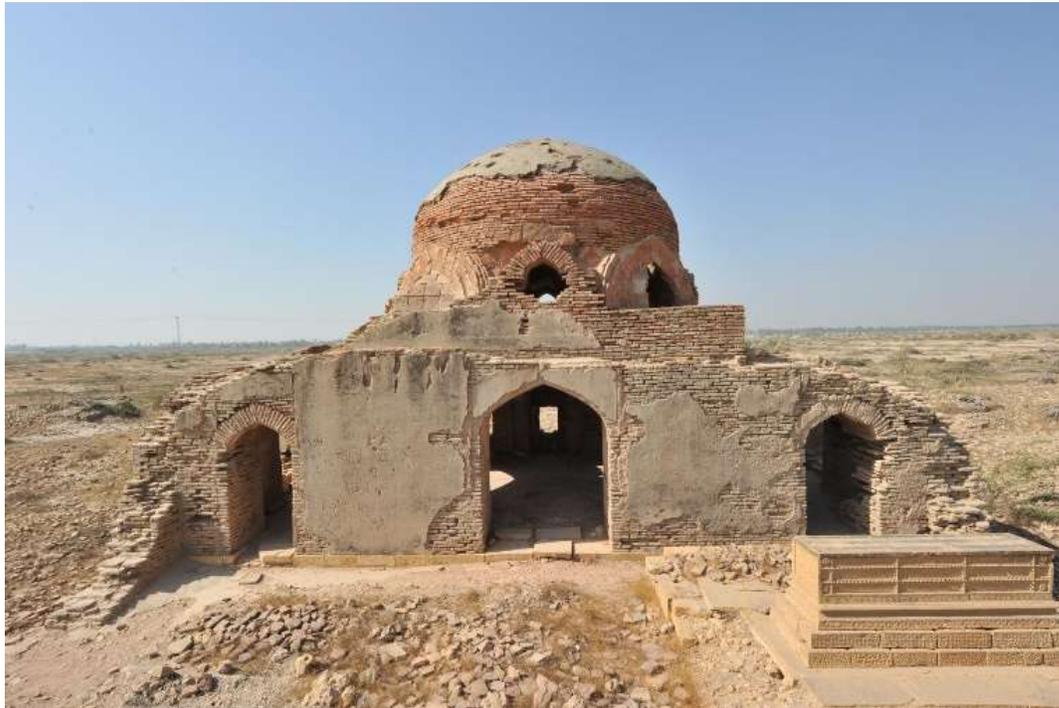
Figure 68 – Ali Muhammad, east façade

This small brick domed tomb has isolated some distance from the other tombs and has not yet been addressed for conservation needs. Therefore it was used a model to discuss the preparation a conservation project. Initial photography was captured along with dimensions and a rapid condition assessment. Discussions were held about the values and significance of the tomb, its condition, what measures should be taken. Some of these included urgent conservation of the one extant dome, fabrication of two lighter domes over the opening which were lost such as at Jan Baba. If the boundary walls should be restored and to what extent. Following this office exercises were held to rectify the images and develop drawings, bills of quantity and a trial specification. This project has been interrupted as the site manager is currently at ICCROM but will be the subject of a follow-up in late 2018.

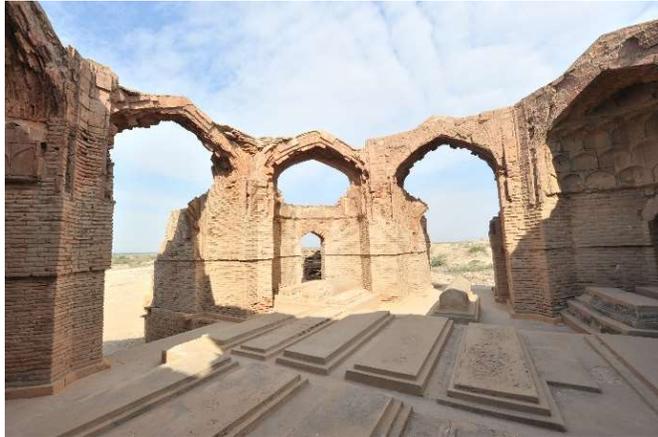
This important tomb was stabilized in the 1990s, however, requires attention. It has been selected by the Heritage Foundation Pakistan for an upcoming conservation project. It was selected as it has important remains of decorative tile that require consolidation and protection from the weather. Also, the idea from Jan Baga of a lightweight reversible dome to keep out the rain and complete the profile is an interesting topic. Therefore only maintenance work, cleaning, brush removal and a new sign were the only work carried out in 2017.

Figure 69 – important extant tile is a defining element of Makli's Outstanding Universal Value

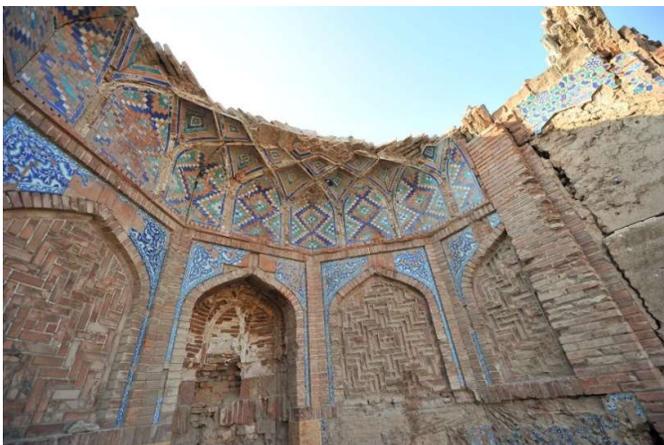
This is an important tomb but located to the east at the edge of the slope thus away from frequent visitors. It has numerous areas of extant decorative tiles. It is at risk from the instability of the slope and is open to the weather. This monument was visited in 2018 and options discussed for its stabilization. The Heritage Foundation Pakistan, following their work at Sultan Ibrahim, has received a grant from the Prince Claus Fund and has submitted a request to conserve this tomb. The site manager held a meeting with the Director General of Antiquities and encouraged this project but with the condition that the on-site staff is involved in preparing the project and monitoring the conservation work.

Figure 70 – substantial areas of glazed decorative tile adorn this tomb

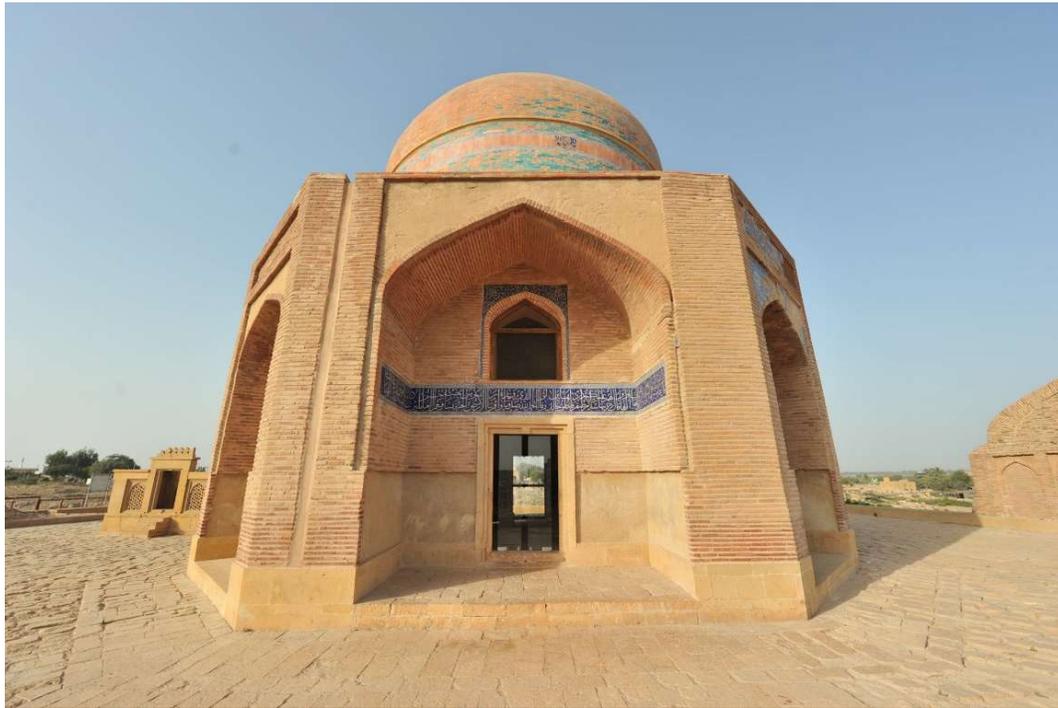
Figure 71 – the recently completed tomb of Sultan Ibrahim by the Heritage Foundation
