**Document d'information : Rapport de la mission conjointe UNESCO-ICOMOS-Le  
Gouvernement de Sa Majesté du Népal sur l'état de conservation de la Vallée de  
Kathmandu, site du patrimoine mondial, et plan d'action à échéances fixes des mesures  
correctives (résumé analytique en français)**

# **UNESCO-ICOMOS-His Majesty's Government of Nepal Joint Mission**

10 March - 14 April 1998

## **Report on the State of Conservation and Time Bound Action Plan of Corrective Measures for Enhanced Management of the Kathmandu Valley World Heritage Site**

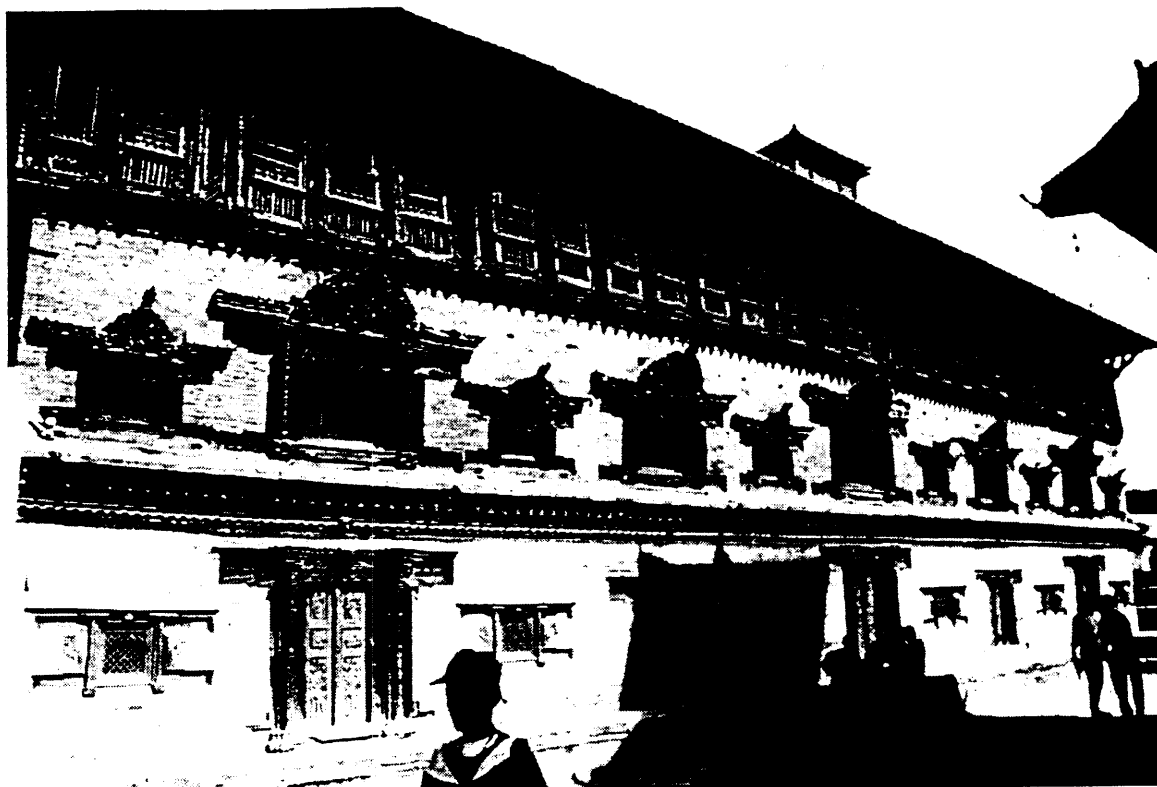
III. Kathmandu Valley 3. 55-Window Palace, Bhaktapur Darbar Square MZ, dated 1697. The World Heritage Fund is providing technical co-operation for conducting a thorough structural survey. (© DM)

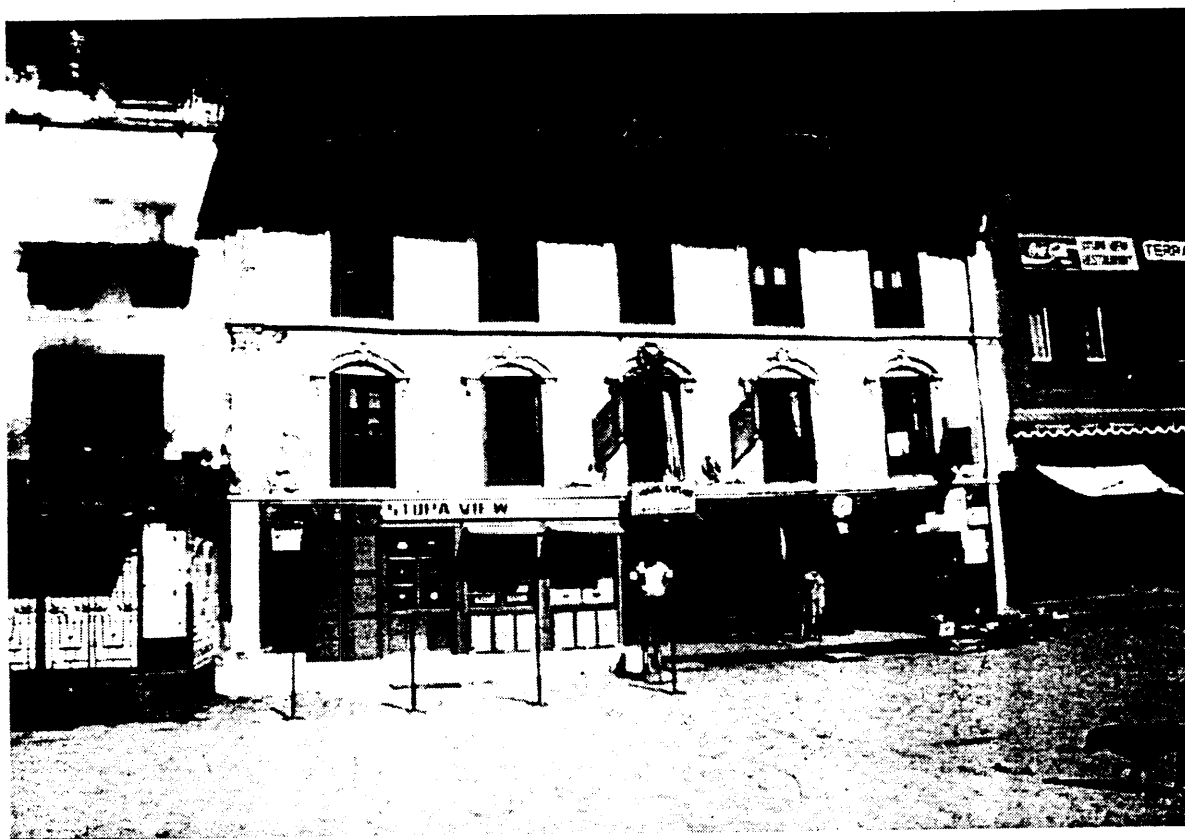
III. Kathmandu Valley 6. The Chiniya Lama's old *darbar* at Baudddhanath MZ. This is a building which must not be demolished, as its maintenance ensures the integrity of the essential setting of the stupa. (© DM)

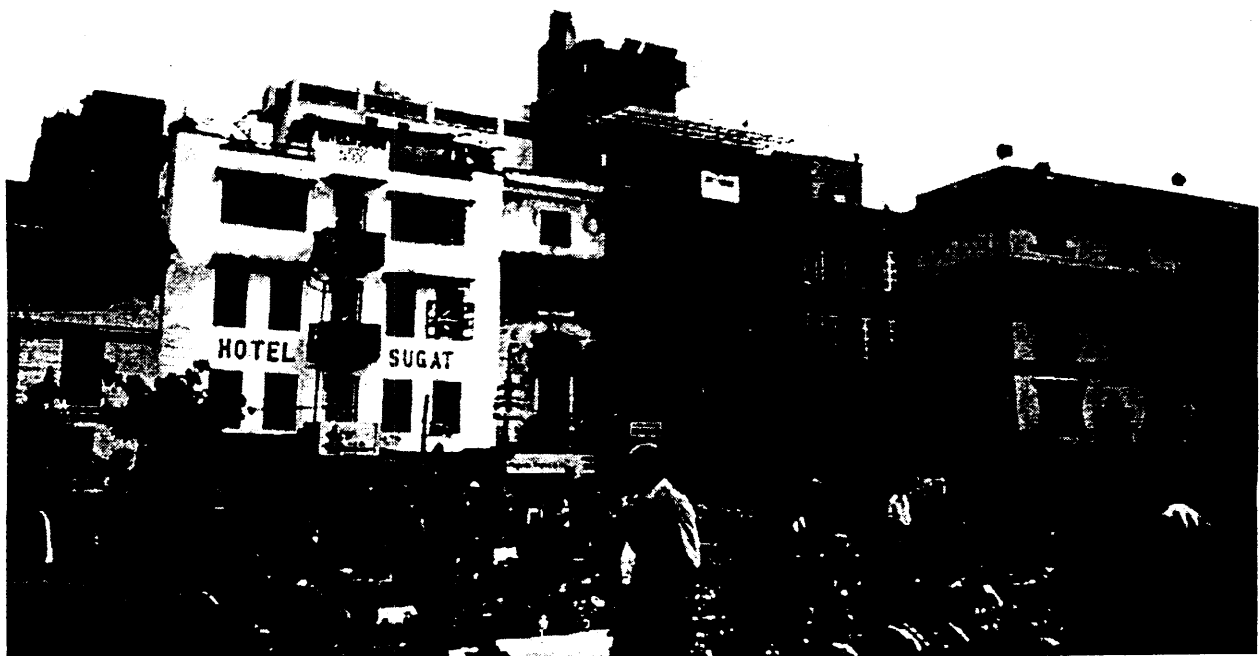
**III. Hanuman Dhoka 3.** Illegal modern buildings directly facing the historic palace at Basantpur Square; Hanuman Dhoka Darbar Square MZ. ICOMOS has recommended corrective measures for two buildings here. (See Ch. 3, Corr. meas. Nos 7-8). (© GP)

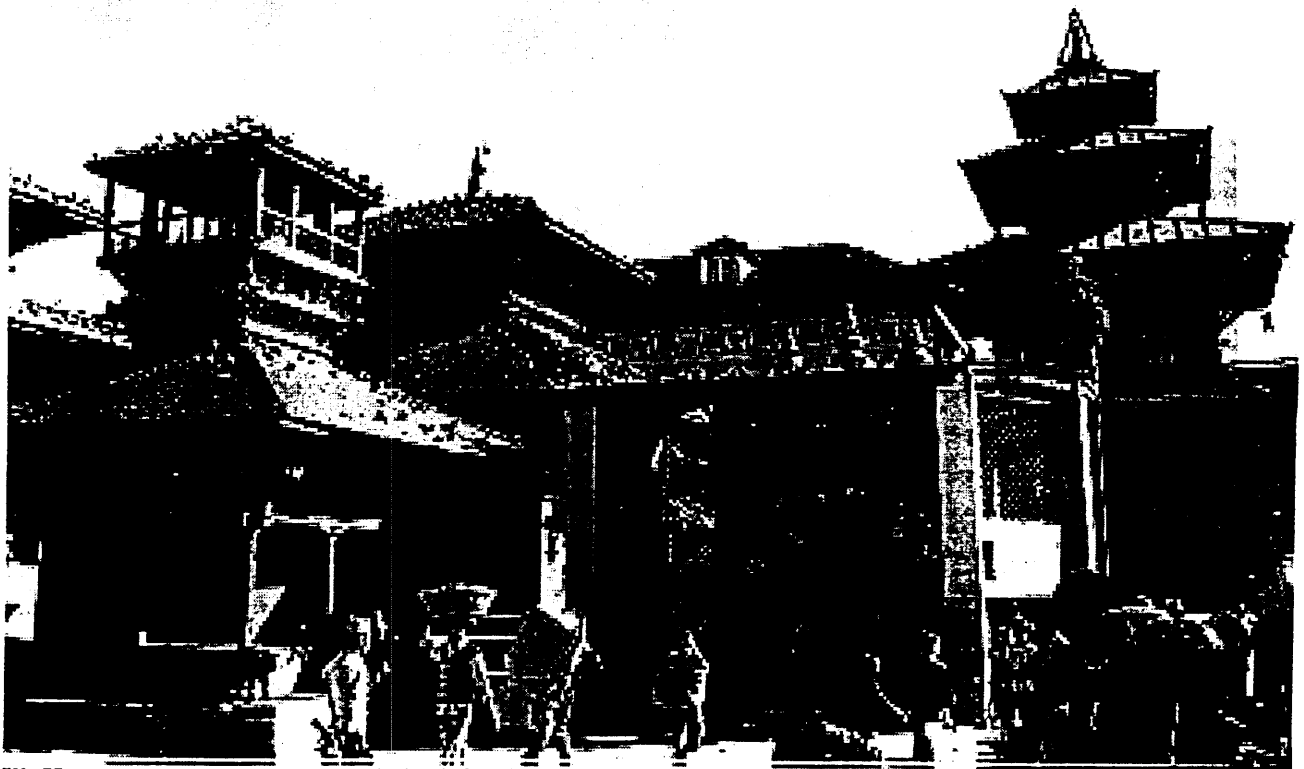
III. Hanuman Dhoka 9. Kal Bhairab Shrine (dated 1660) in Darbar Square, Hanuman Dhoka Darbar Square MZ (see Ch.3, ICOMOS state of conservation report, Ref. no. 30 [K-177]). This shrine, composed of a huge sculpture of a six-armed Bhairab, is surrounded unsympathetically in renewed grey marble, built around 1980. The Joint Mission was informed that this renewal was done without the consent of the statutory authorities. Behind the Kal Bhairab Shrine are the buildings of Hanuman Dhoka Palace complex. It is unfortunate that the use of new building material (marble) has disrupted the architectural fabric of the Darbar Square. (© JT)

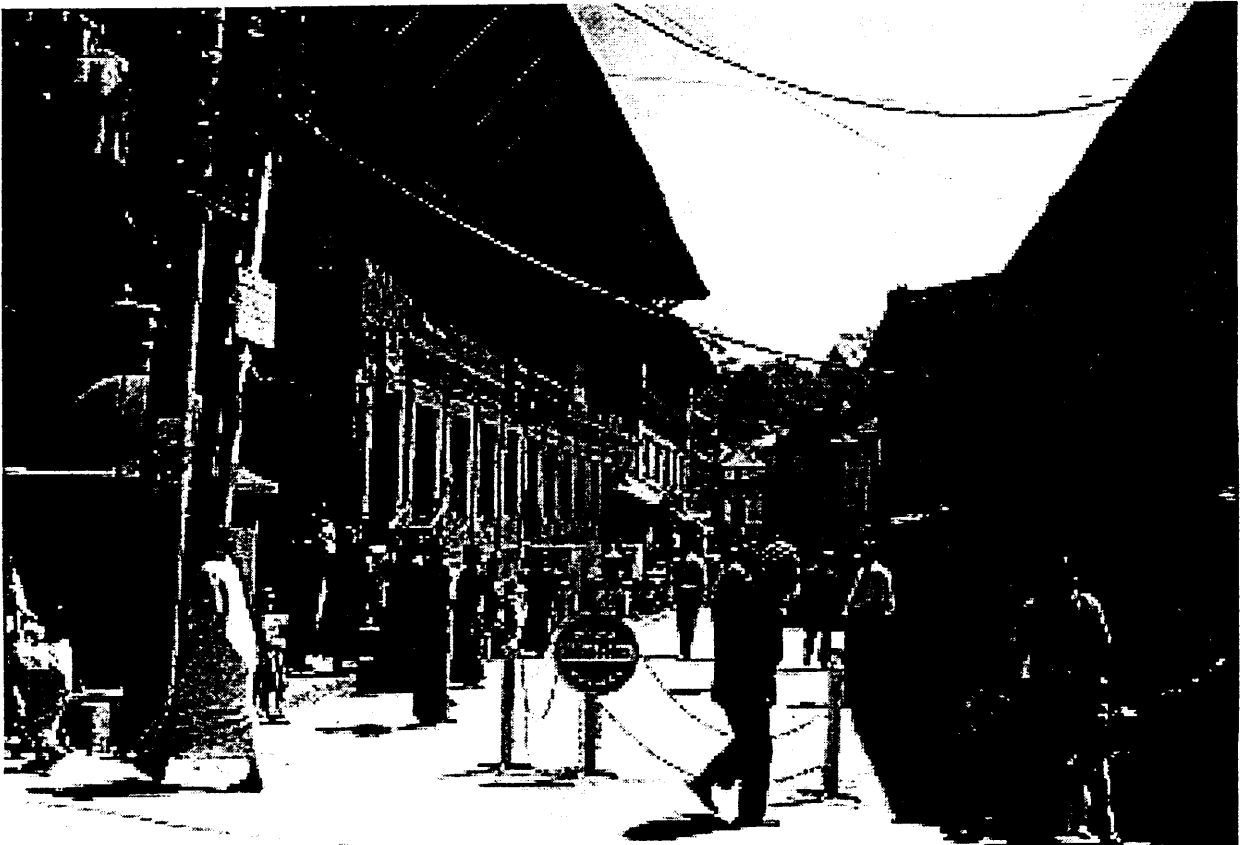
III. Pashupati 5. The street of houses which lead up to Pashupati Temple at Pashupatinath MZ is threatened by an environmental improvement scheme which would clear all the traditional houses along this main street (see Ch.8, ICOMOS state of conservation report, village of Deopatan). (© JT)

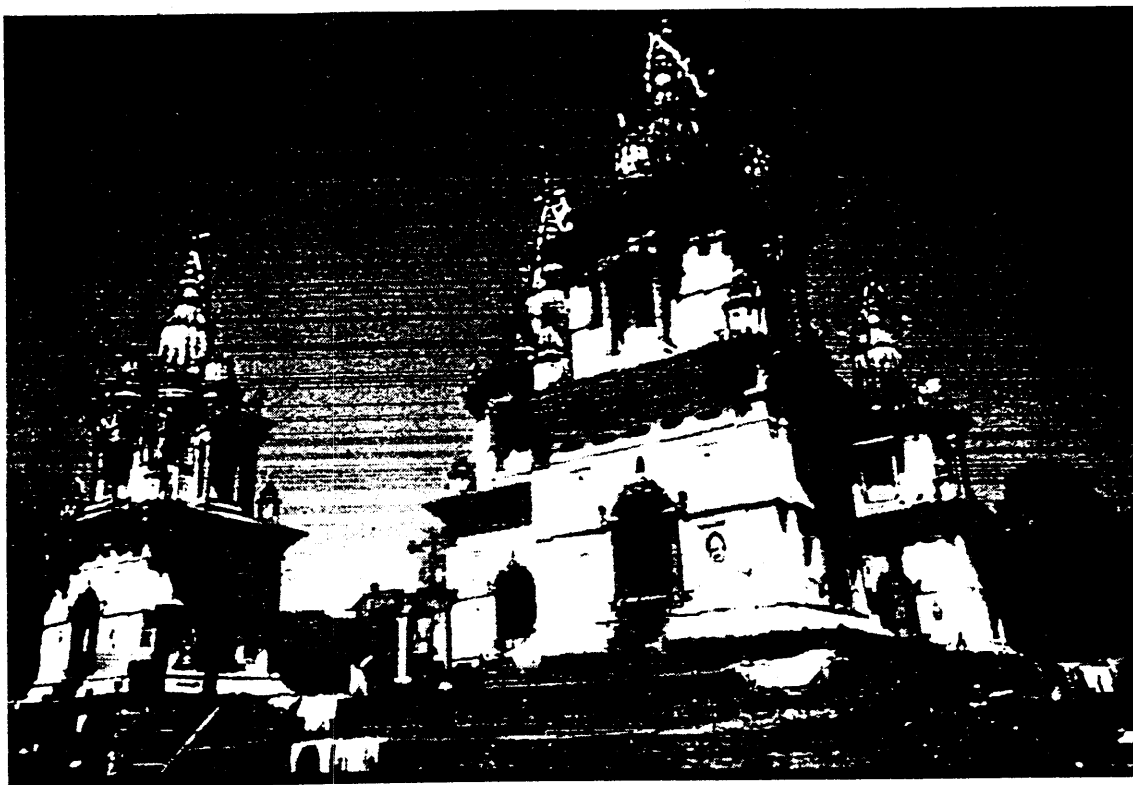
III. Pashupati 6. The Panchadeval Temple, a major monument of the Shaha period at Pashupatinath MZ, is located within the proposed "consonant area" of the new master plan. The Joint Mission considered that an even level of protection should be provided over the whole MZ. (See Ch. 8 ICOMOS state of conservation report, No. 5). (© DM)
