UNESCO-ICOMOS-His Majesty's Government of Nepal Joint Mission

10 March - 14 April 1998

Report on the State of Conservation and Time Bound Action Plan of Corrective Measures for Enhanced Management of the Kathmandu Valley World Heritage Site

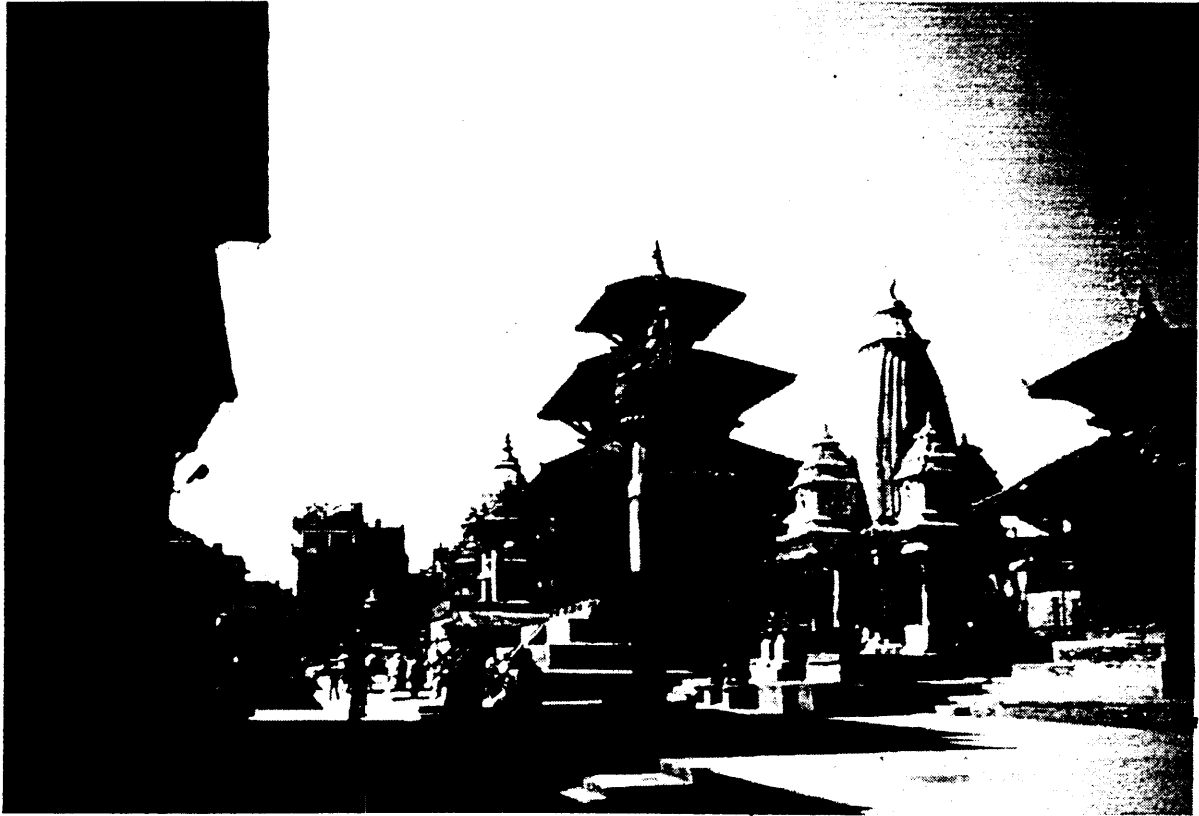
III. Patan 1. Patan Darbar Square of Patan Darbar Square MZ, looking south. The illegally high Taleju Restaurant towers above adjacent traditional buildings.(© GP)

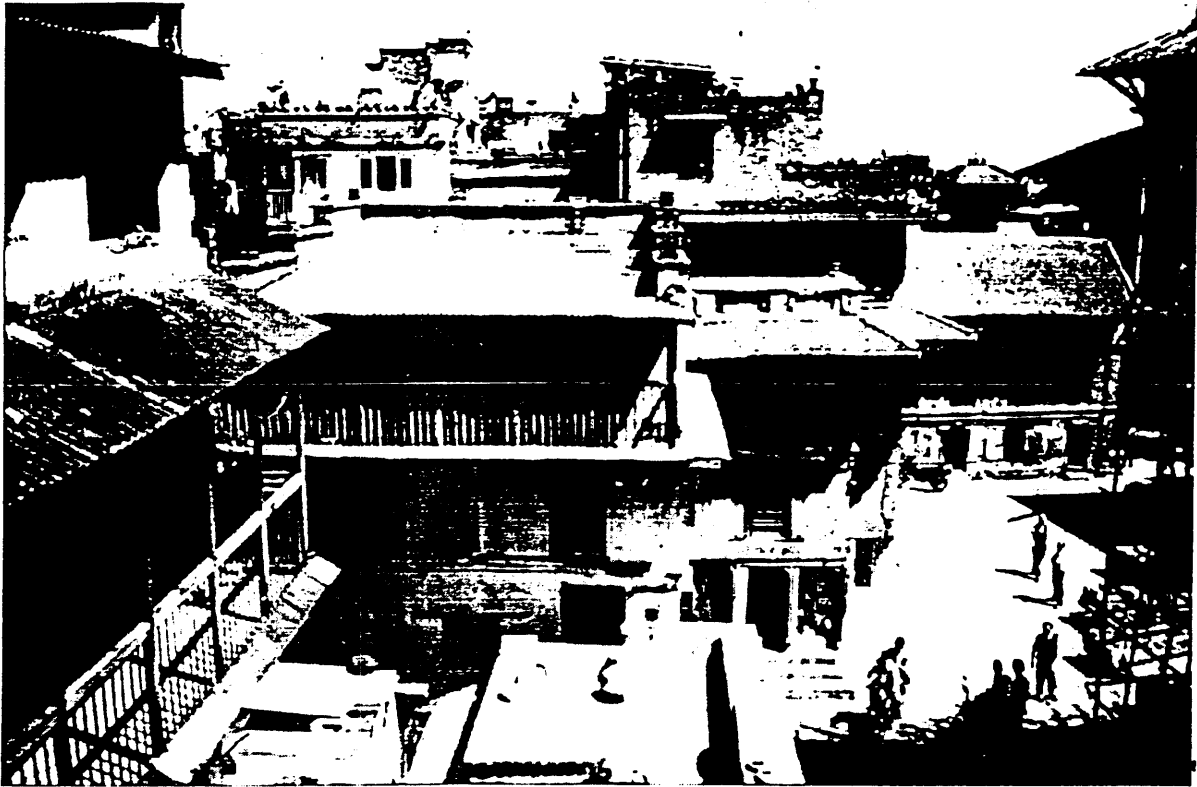
III. Patan 4. The house of Mr Maitreya Shakyas at Patan Darbar Square MZ provides an important setting to Krishna Mandir, one of the most important monuments within KVWHS. However, this house is currently under threat from development pressure (See Ch. 4 ICOMOS state of conservation Darbar Square). (© GP)

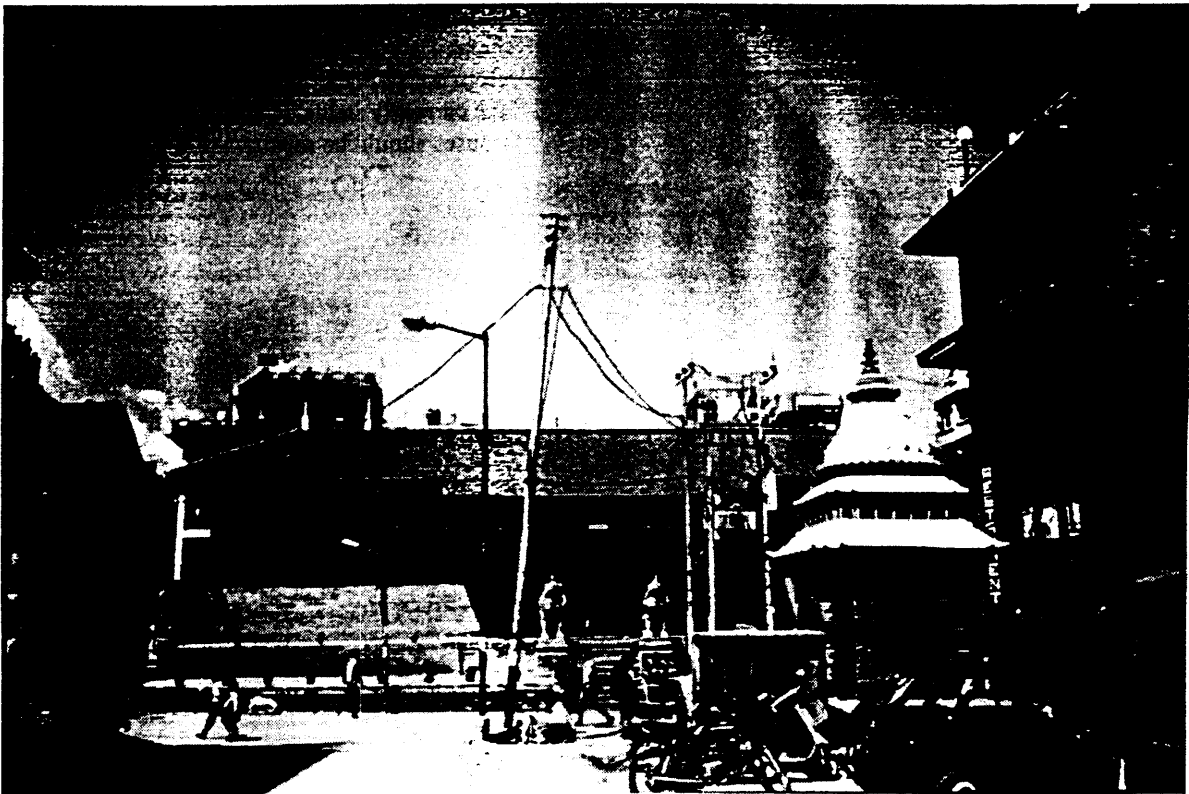
III. Patan 5. Intrusive electrical installations mar the view of the facade of I Baha Bahi at Patan Darbar Square MZ. This building was restored with the support of the Nippon Institute of Technology (See Ch. 4, ICOMOS state of conservation report, No. 26). (© GP)

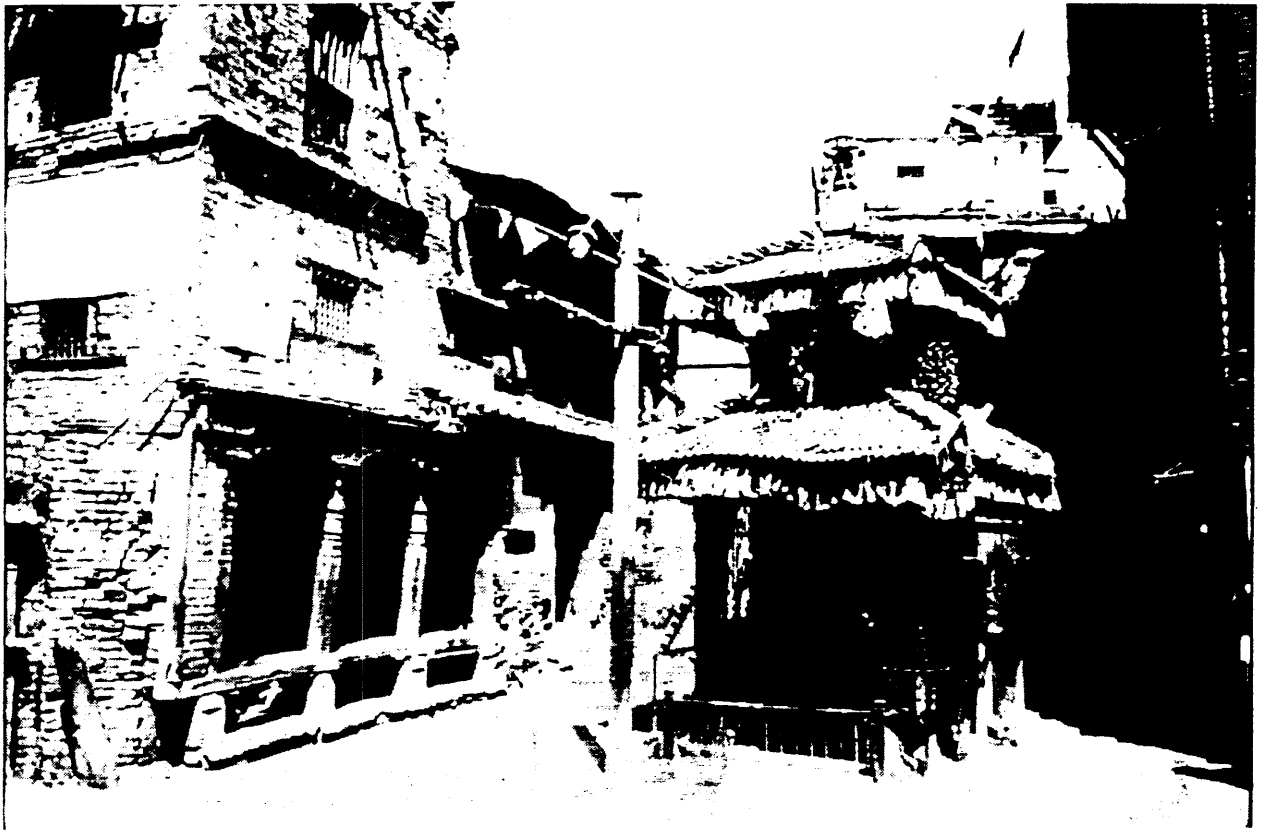
Ref. no./ Ref. no. in nomination form	Monument name, date (if available) ICOMOS assessment on the state of conservation
8 [B-13].	Balakhu Ganesh Temple A small two-storey pagoda-style temple. It is derelict and requires urgent repair.
	Fifty-five Windows Palace 1697 [Ill. Kathmandu Valley 3] A three-storey palace building of exceptional quality. It was extensively rebuilt following the 1934 earthquake, when an upper carved timber gallery was altered. Structural movement appears to be occurring and there is a programme of investigation underway, supported by the WH Fund, which will lead to the development of a repair strategy.

III. Bhaktapur 3. The Balakhu Ganesh Temple at Bhaktapur Durbar Square MZ needs roof repairs. It stands in front of the derelict Pasu Kha Jhha Dyochhe, circa 15th century (See Ch. 5, ICOMOS state of conservation report, Darbar Square; No. 8). (© GP)

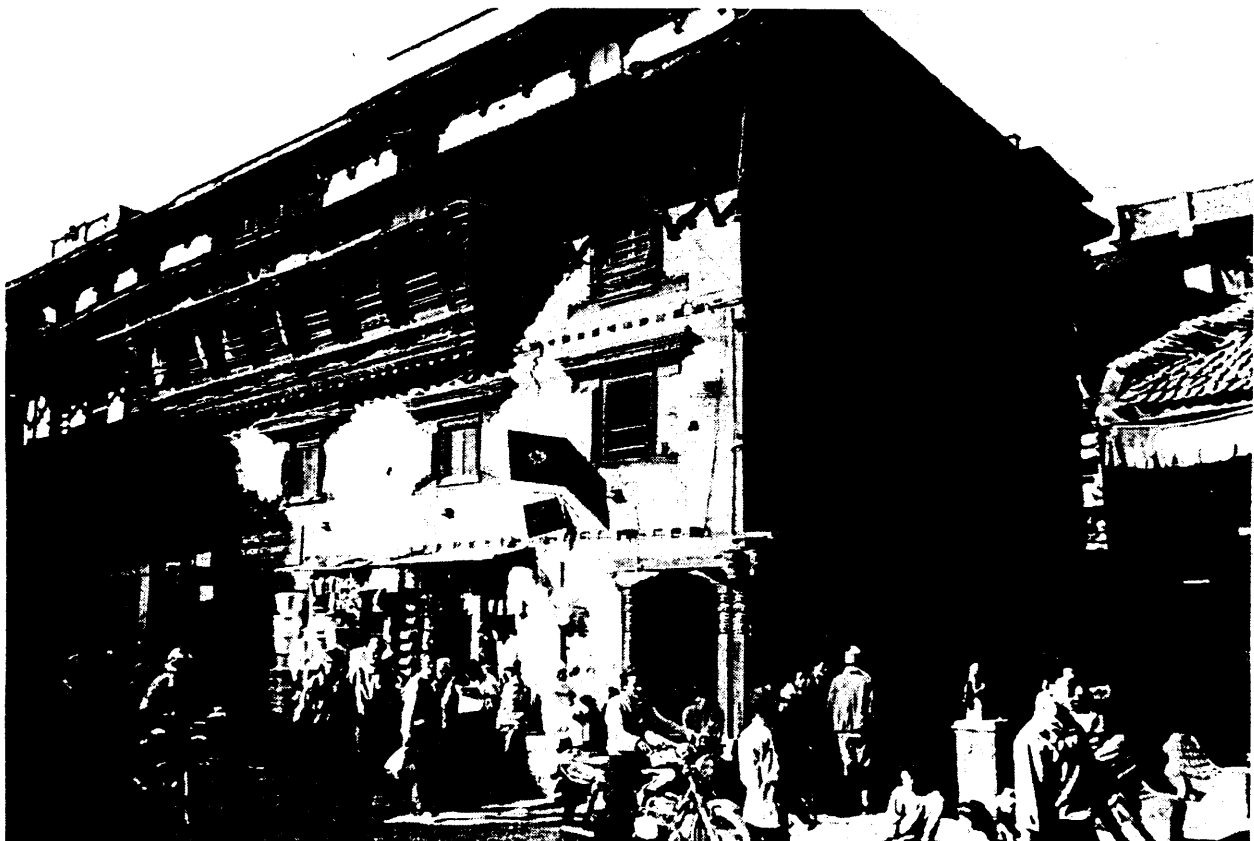
III. Bhaktapur 6. Subha Ghar is the finest house on the main street connecting Tamaudhi Square and Dattatreya Square, added to the MZ in 1997. Repairs are required to the skirt roof and settlement requires monitoring (See Ch. 5, ICOMOS state of conservation report, main street)

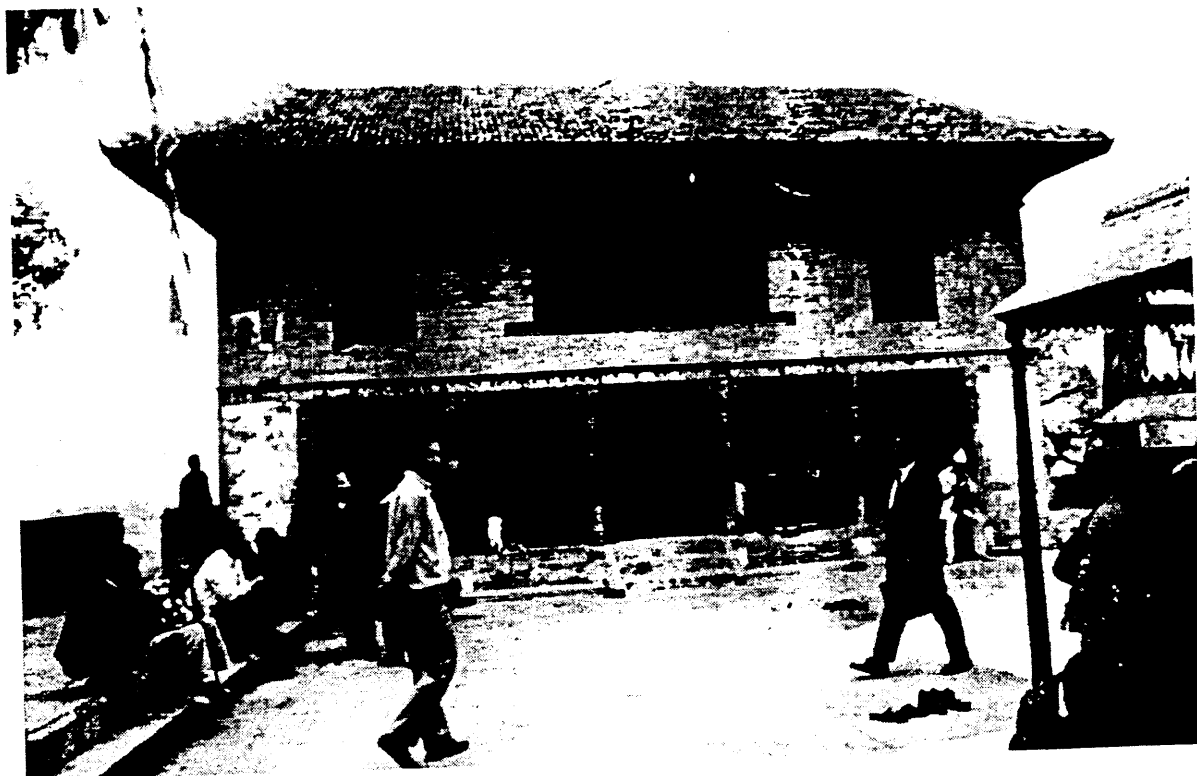
III. Swayambhu 3. The DoA has reconstructed the Majusri Sattal at Swayambhunath MZ since 1993 in a traditional style, replacing a concrete structure which was inappropriate to the setting of the MZ. (See Ch. 6, ICOMOS state of conservation report, setting) (© DM)

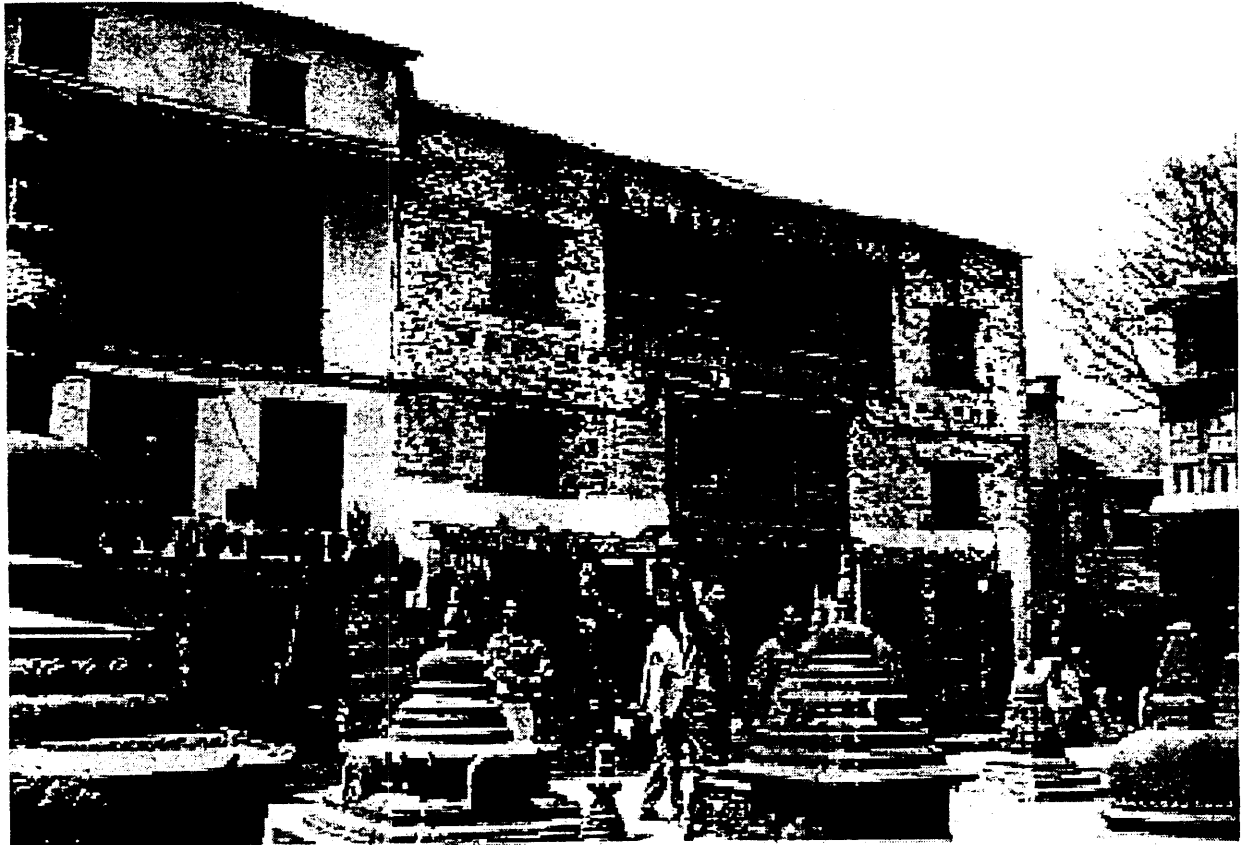
III. Swayambhu 4. The Joint Mission was informed that the large traditional house behind the group of *caityas* at Swayambhunath MZ would be restored (see Ch.6, ICOMOS state of conservation report, setting). (© JT)

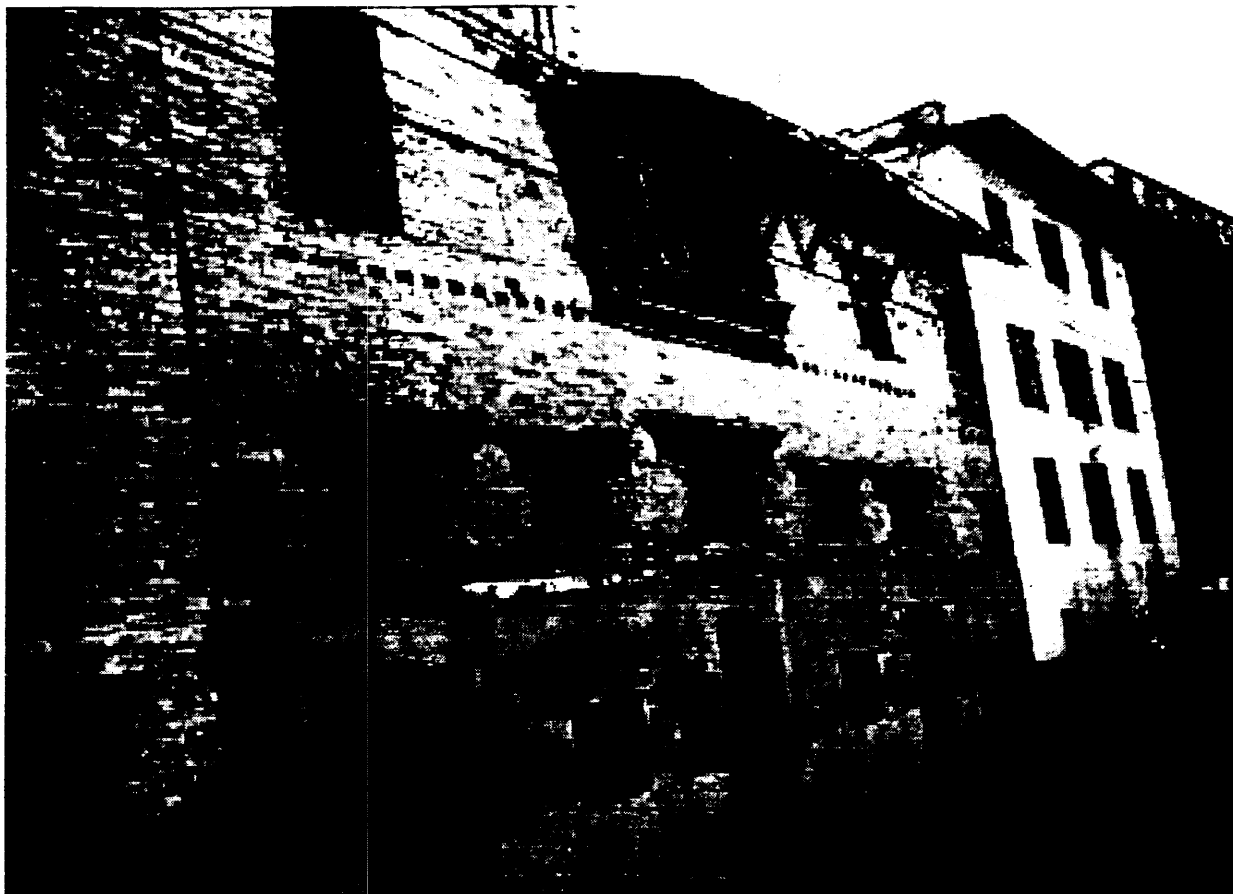
III. Pashupati 2. This early house in the village of Deopatan at Pashpatinath MZ is in need of repair (See Ch. 8, ICOMOS state of conservation report, village of Deopatan) (© DM)

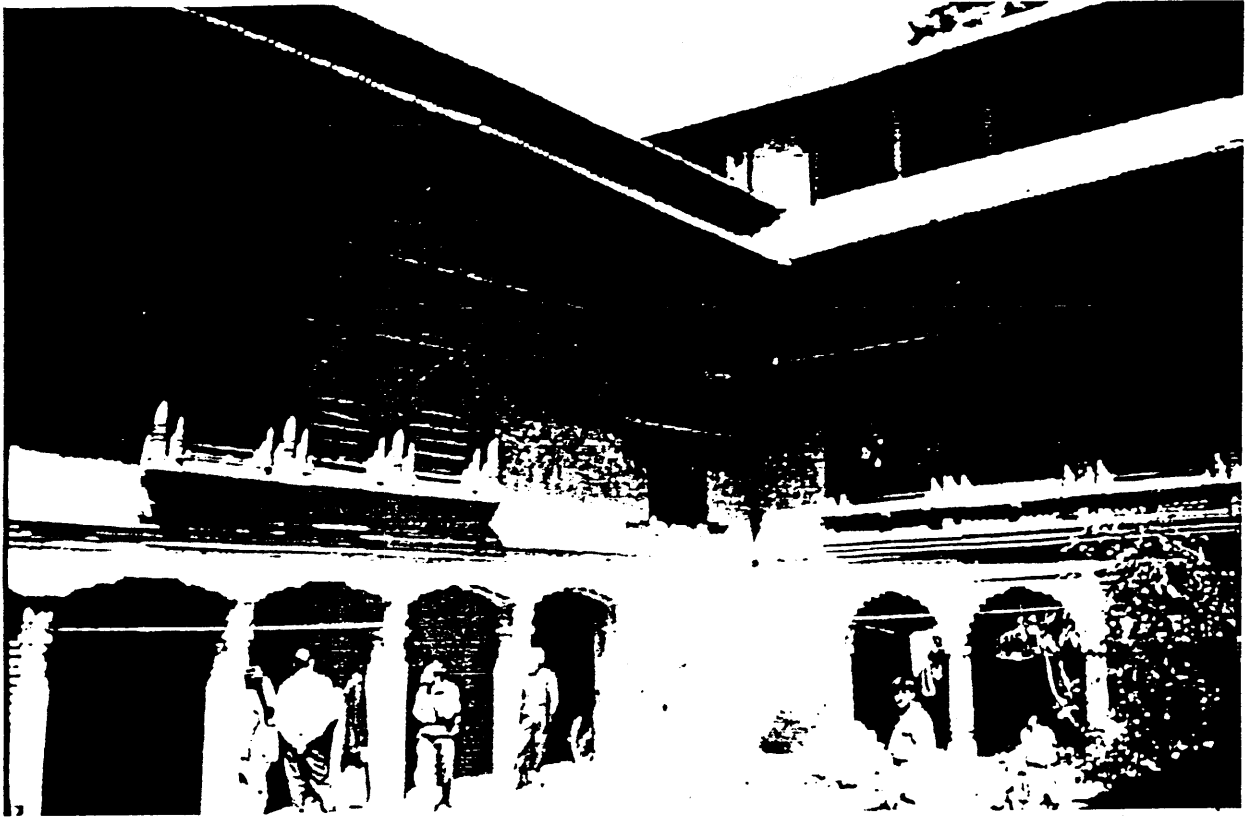
III. Pashupati 4. The restoration of the Sudavarta Sattal, a large monument of the Shaha period, at Pashupatinath MZ, is scheduled to start in 1999 (See Ch. 8, ICOMOS state of conservation report, village of Deopatan) (© DM)

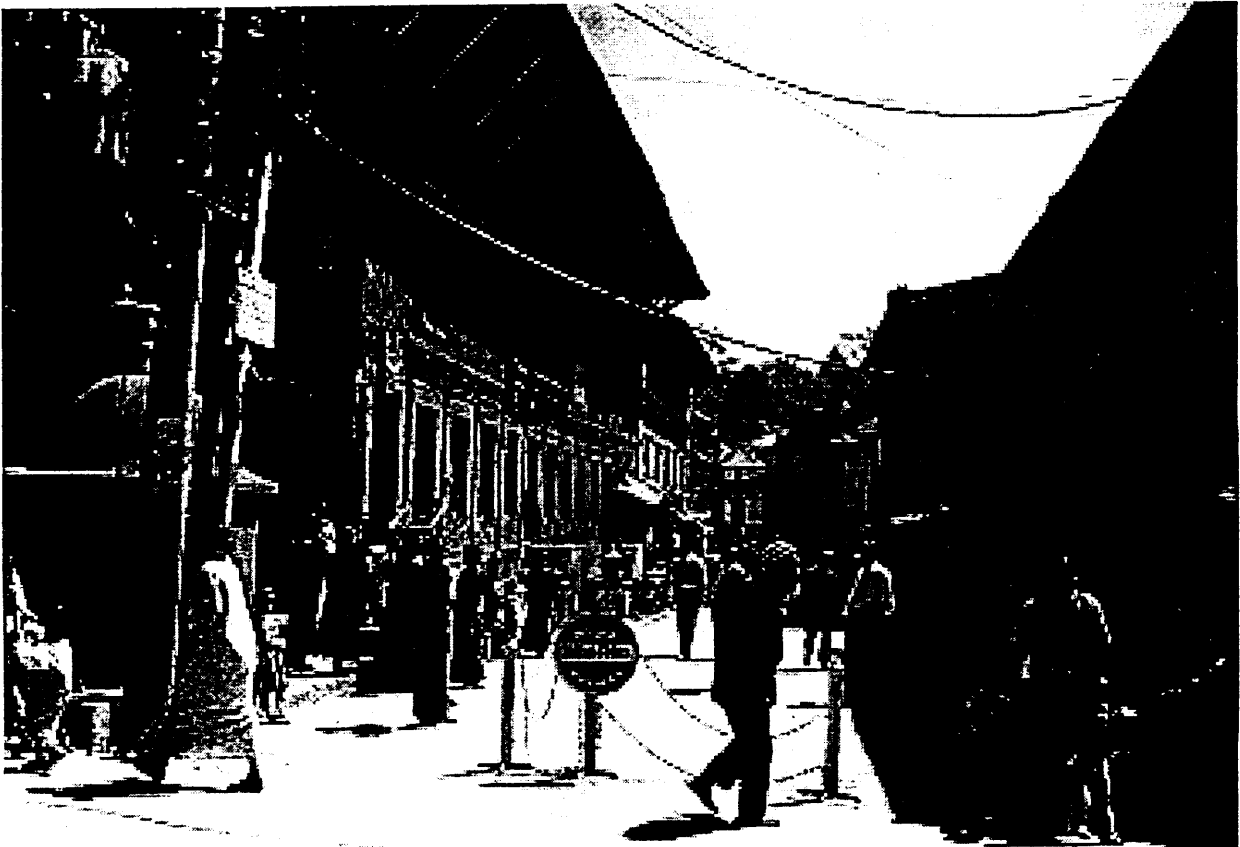
III. Pashupati 5. The street of houses which lead up to Pashupati Temple at Pashupatinath MZ is threatened by an environmental improvement scheme which would clear all the traditional houses along this main street (see Ch.8, ICOMOS state of conservation report, village of Deopatan). (© JT)

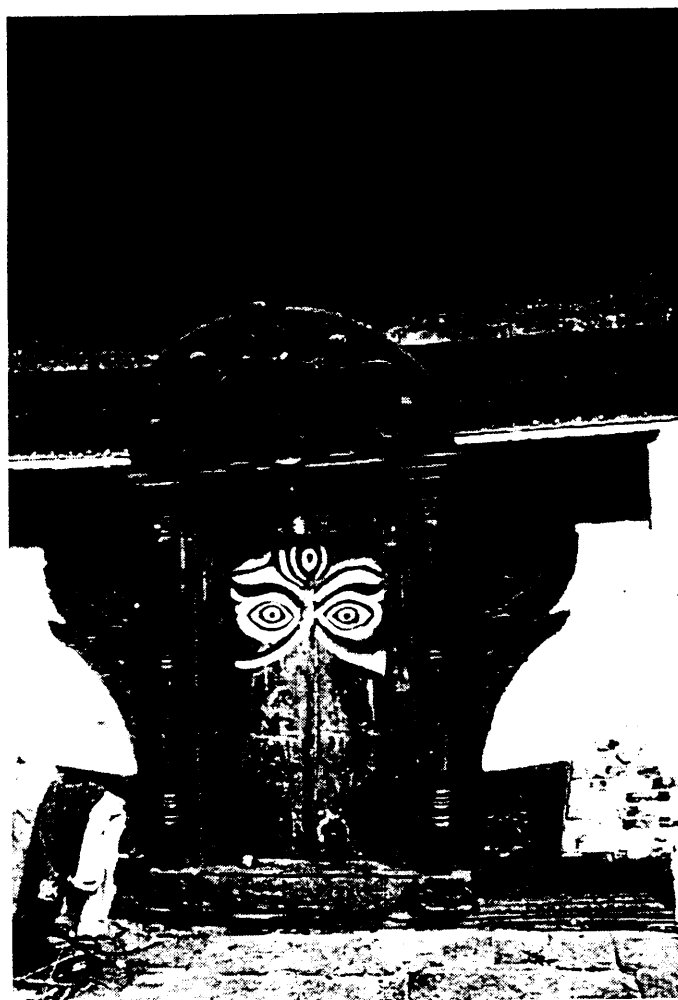
Ill. Pashupati 9. Taleju Mandir at Pashupatinath MZ, an important Malla-period monument, is located in the proposed “consonant area”. However this valuable monument should be protected at the same level as the monuments within the proposed “core area” (See Ch. 8 ICOMOS state of conservation report, No. 17). (© DM)

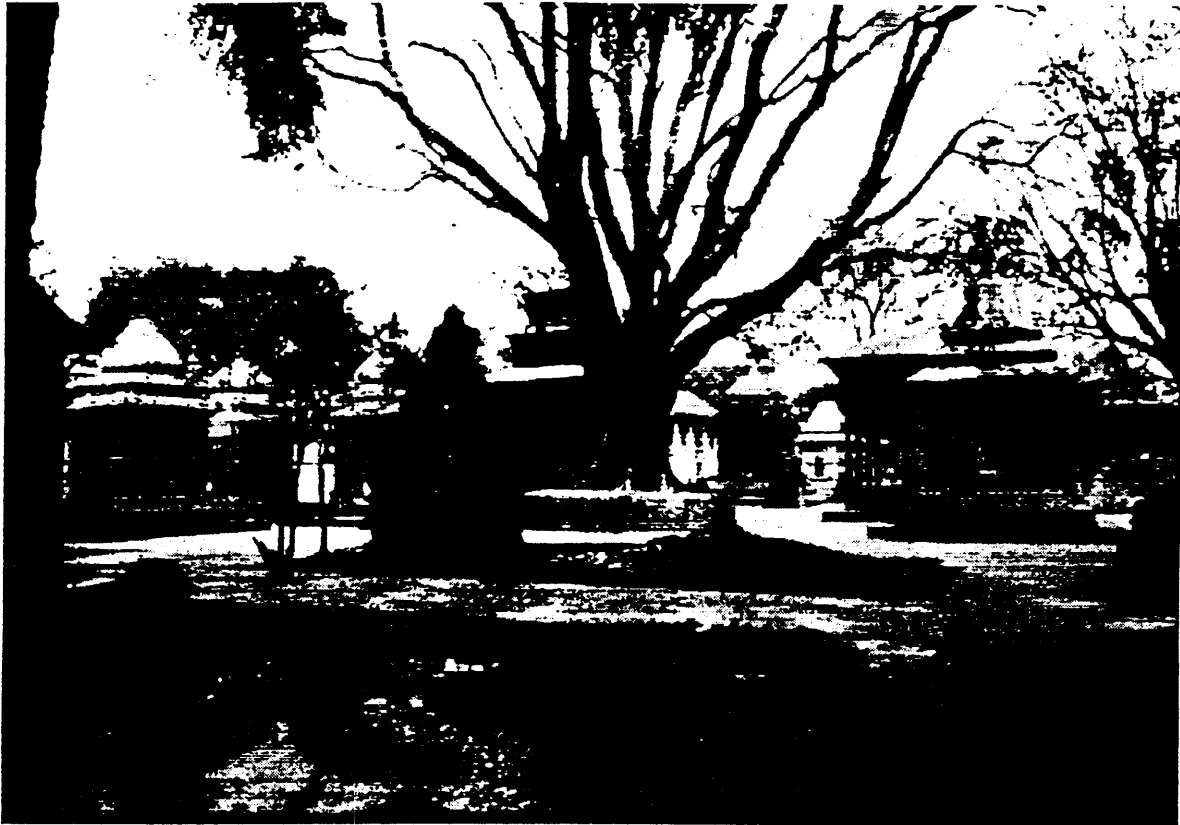
III. Pashupati 12. The large complex of shrines and *sattals* between Vishvarupa and Goraknath Temples at Pashupatinath MZ requires a planned sustainable conservation programme (See Ch. 8 ICOMOS state of conservation report, No. 27). (© DM)

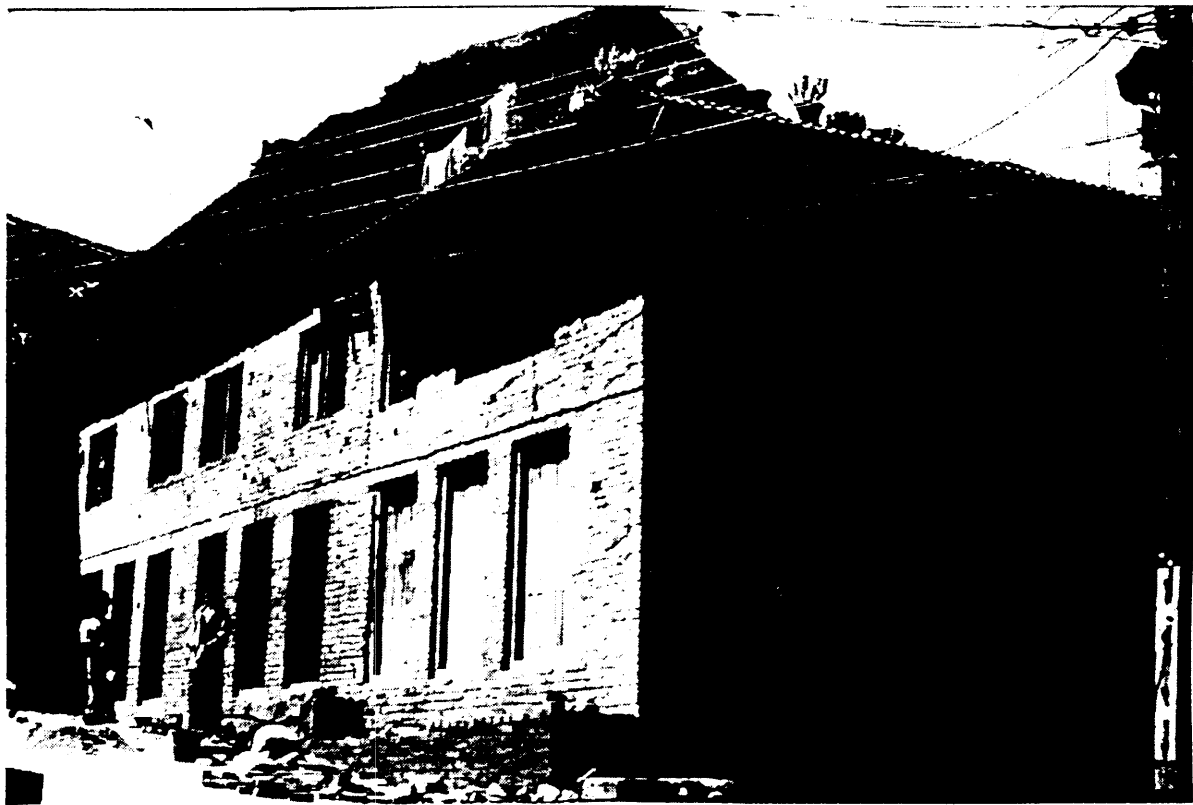
III. Changu 3. This illustration shows the illegal extension of the traditional house of Mr Ratna Bir Shrestha at Changu Narayan MZ. This extension can be corrected to conform to existing bylaws by adding a pitched roof (See Ch. 9 ICOMOS state of conservation, village of Changu Narayan). (c DM)

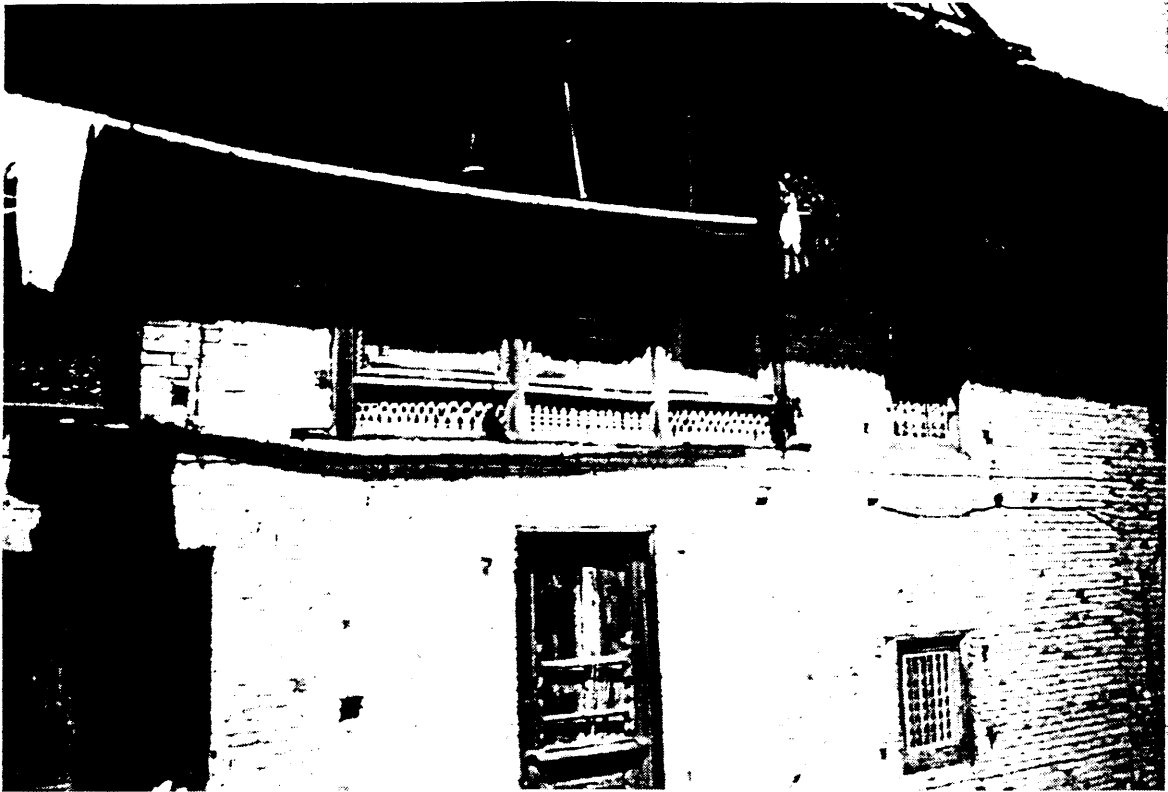
III. Changu 4. Mr Vaisnav Raj Shrestha recently carried out commendable repairs to the windows of his traditional village house in Changu Narayan MZ, shown in this illustration (See Ch. 9 ICOMOS state of conservation report, village of Changu Narayan). (© DM)
