# KATHMANDU VALLEY WORLD HERITAGE PROPERTY NEPAL

Ref. 121bis

## STATE OF CONSERVATION REPORT 2022

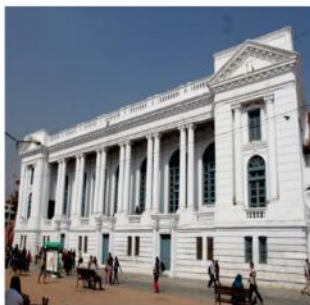
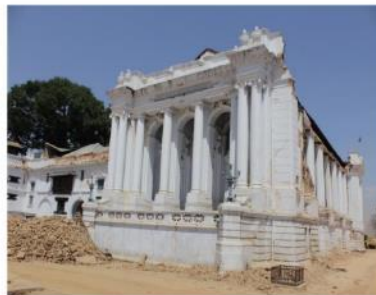
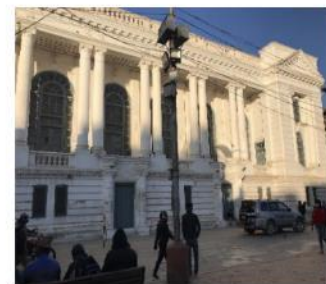
**Gaddi Baithak (Restoration by Miyamoto Global Relief Foundation-AFCP)**

| s. no. | Name of the monument (Location) | Status of Monument after earthquake | Damage assessment of Monument: | Architectural Documentation of monument | Type of conservation Method applied for conservation | Management of material to be reused | Implementation Modality | Changes made in material and technology during conservation process | Specific traditional technology and material found during execution |
|---|---|---|---|---|--|---|---|---|---|
| 6 | Gaddi Baithak | Partially damaged | yes | yes | Traditional technology | Inside the courtyard | Tendering process | yes | No |

**Remarks:-Restoration has been completed**

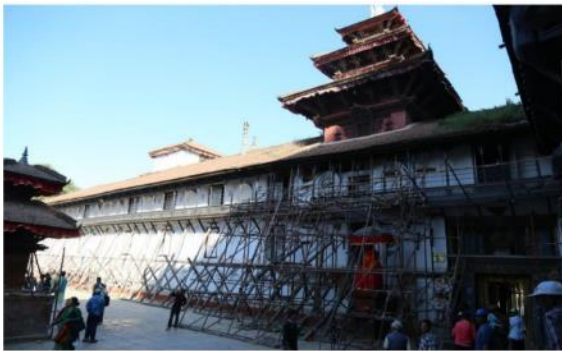
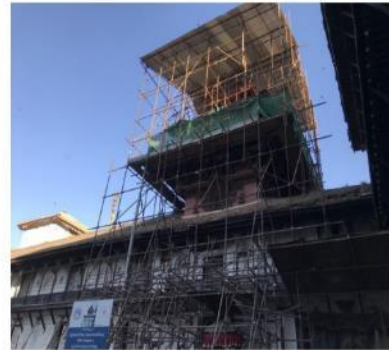
| s. no. | Name of the monument (Location) | Status of Monument after earthquake | Damage assessment of Monument: | Architectural Documentation of monument | Type of conservation Method applied for conservation | Management of material to be reused | Implementation Modality | Changes made in material and technology during conservation process | Specific traditional technology and material found during execution |
|---|---|---|---|---|--|---|---|---|---|
| 10 | Aagan Temple | Partially damaged | Yes | Yes | Traditional technology | Inside the courtyard | Tendering process | No | No |

Soon after Earthquake-2015 Restoration in progress-2020

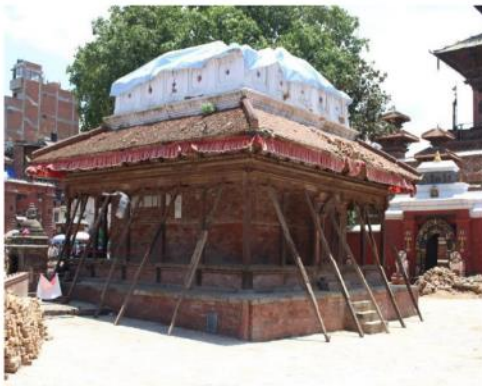
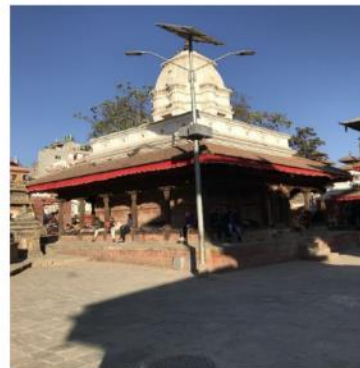
Kageshwar Temple (Restoration by Kathmandu Valley Preservation Trust)

Restoration has been completed

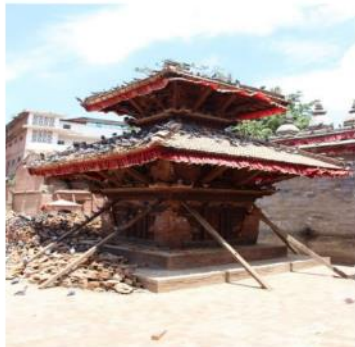
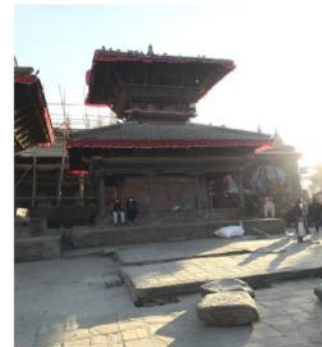
Laxmi Narayan Temple (Restoration by Kathmandu Valley Preservation Trust)

| s. no. | Name of the monument (Location) | Status of Monument after earthquake | Damage assessment of Monument: | Architectural Documentation of monument | Type of conservation Method applied for conservation | Management of material to be reused | Implementation Modality | Changes made in material and technology during conservation process | Specific traditional technology and material found during execution |
|---|---|---|---|---|--|---|---|---|---|
| 12 | Laxmi Narayan Temple | Partially damaged | | | Traditional technology | Inside the courtyard | Tendering process | No | No |

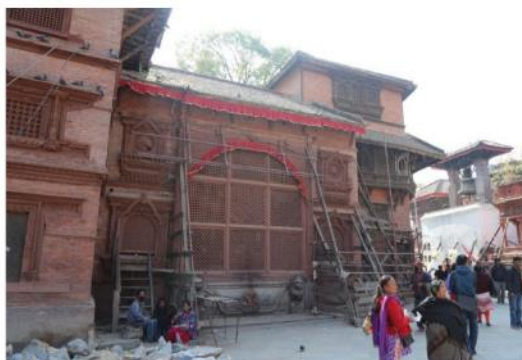
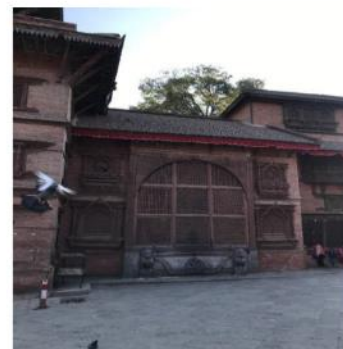
Shwet Bhairab Restoration by (Hanumandhoka Durbar Museum Development Committee)

Remarks:-Restoration has been completed

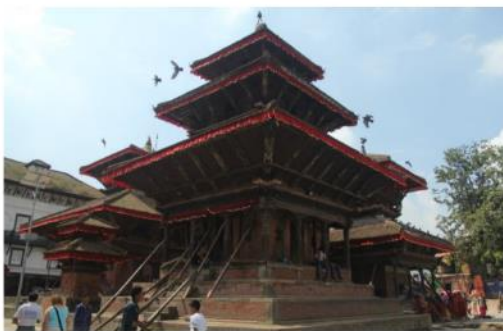
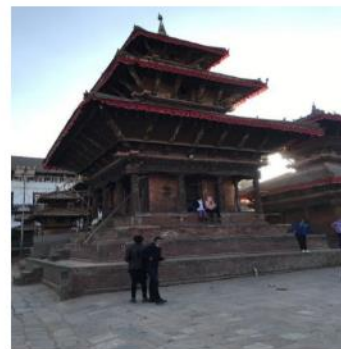
| s. no. | Name of the monument (Location) | Status of Monument after earthquake | Damage assessment of Monument: | Architectural Documentation of monument | Type of conservation Method applied for conservation | Management of material to be reused | Implementation Modality | Changes made in material and technology during conservation process | Specific traditional technology and material found during execution |
|---|---|---|---|---|--|---|---|---|---|
| 15 | Gopinath Temple | Partially damaged | | | Traditional technology | Inside the courtyard | Tendering process | No | No |

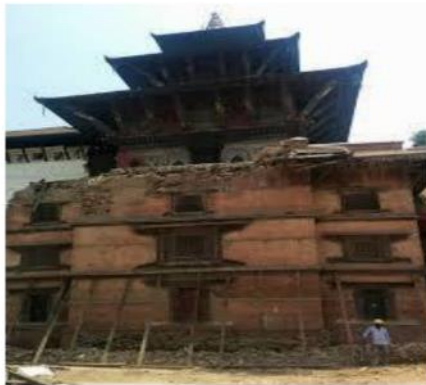
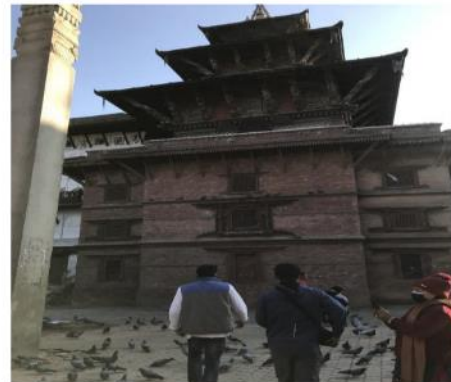
Middle part of Nauttalle and gaddi Baithak(Hanumandhoka Durbar Museum Development Committee)

**Remarks:- Restoration works has been completed**

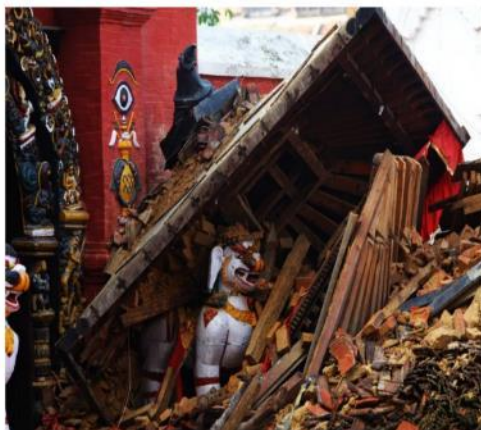
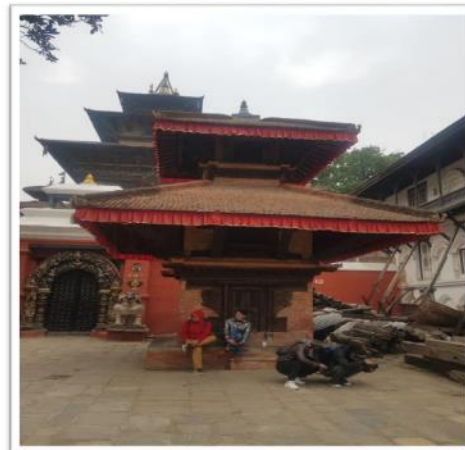
**Mahadev Temple II(Local Community)**

**Remarks:- Reconstruction works has been completed**

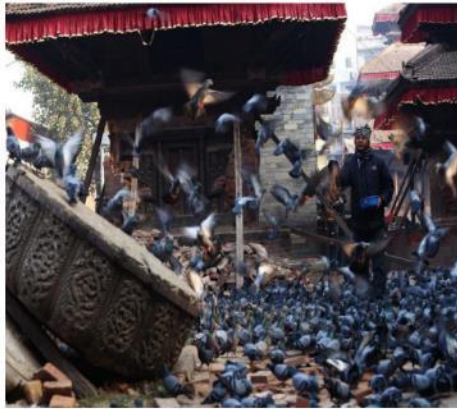
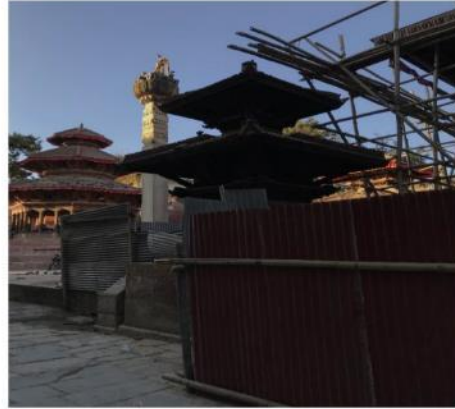
Pratap Malla(Hanumandhoka Durbar Museum Development Committee)

Remarks:- Restoration works has been completed

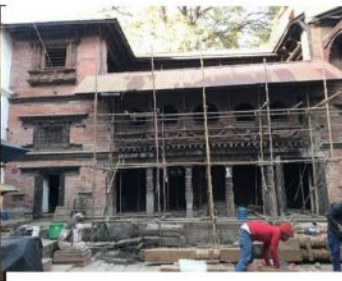
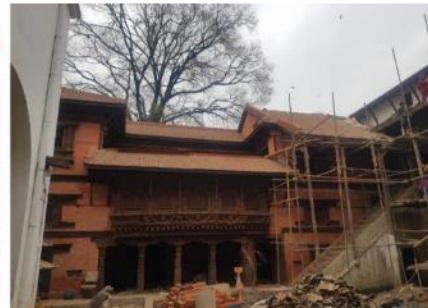
Prithivi Narayan Shayan Khasya(Hanumandhoka Durbar Museum Development Committee)

Remarks:-Works in Progress

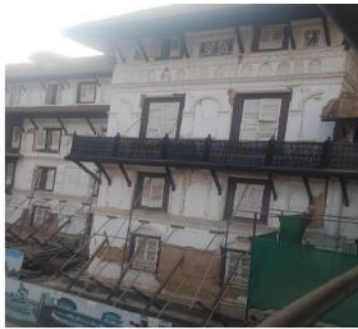
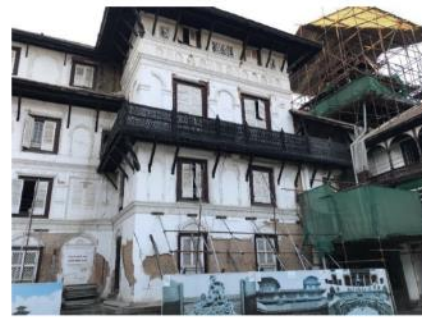
Tribhuvan Smriti Shangrahalaya(Hanumandhoka Durbar Museum Development Committee)

Remarks:-Works in Progress

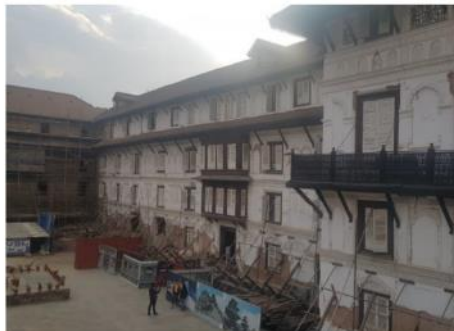
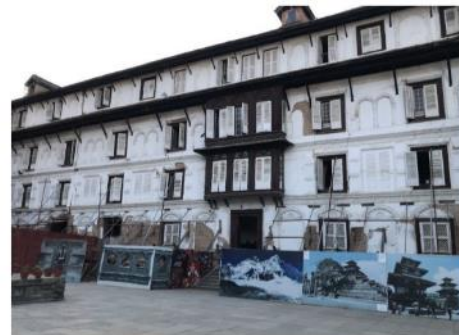
Nasal chowk west Long Rana Kalin Bhawan(Hanumandhoka Durbar Museum Development Committee)

Remarks:-Works in Progress

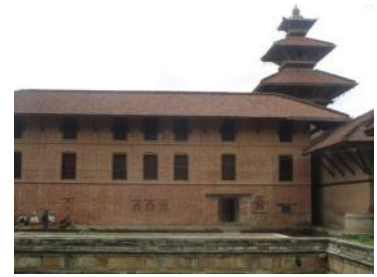
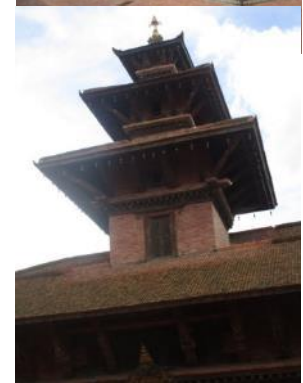
**1. Conservation of Mul Chowk and Sundari Chowk, Patan Durbar**

2. The conservation work of Mul Chowk and Sundari Chowk has been completed. KVPT has got the approval from the Department to work on those monuments before earthquake. But the western wing of the Sundari Chowk was collapsed by the earthquake; and the top roof of both of Taleju temple also was collapsed as well. The collapsed part of Sundari Chowk was restored in its original status using all the traditional technique and materials immediately after the earthquake. The Southern Taleju temple conservation work was completed 2016 and the Northern Taleju temple also has been completed 2018. The conservation project implementation process applied by KVPT is different than the methods applied by other organizations. The daily wage based system under the management of KVPT is common in all project conducted by KVPT.

3. Status of Monument after earthquake
  - a. Partially damage
  - b. Totally damage
  - c. Partially collapsed✓
4. Damage assessment of Monument: Detail damage assessment was done before the conservation.

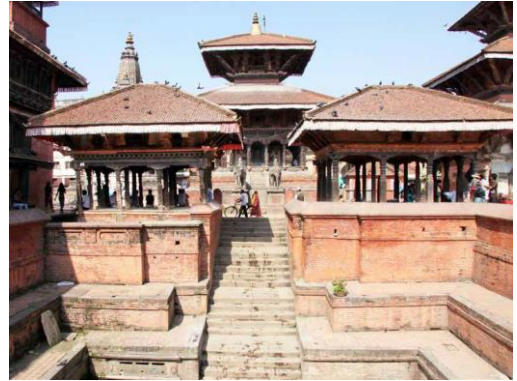
The Manimandap, the twin public rest shelter, in front of Mangahiti, water spout, was completely collapsed above the plinth level by the earthquake.

As reported in previous report both of these structures were collapsed and almost all columns, brackets, struts were identified and inventoried; and those all are reused in the present restoration of the structure. As there are two structures of rest house,

both of the structures are completed. The restoration project was executed in the management of KVPT with approval and close supervision of Department of Archaeology through it's Patan Office.

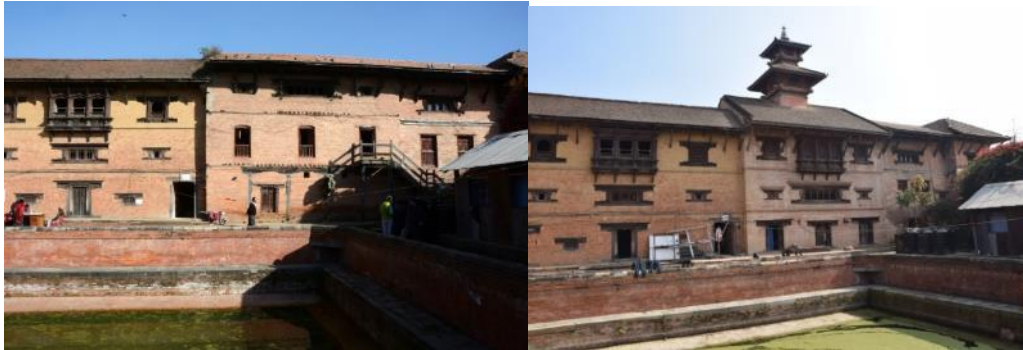
### **1. National Art Gallery Building, Bhaktapur**

2. Project Description: The Western wing of the National Art Gallery Building was restored just after the earthquake. The museum building is the part of Bhaktapur Palace.

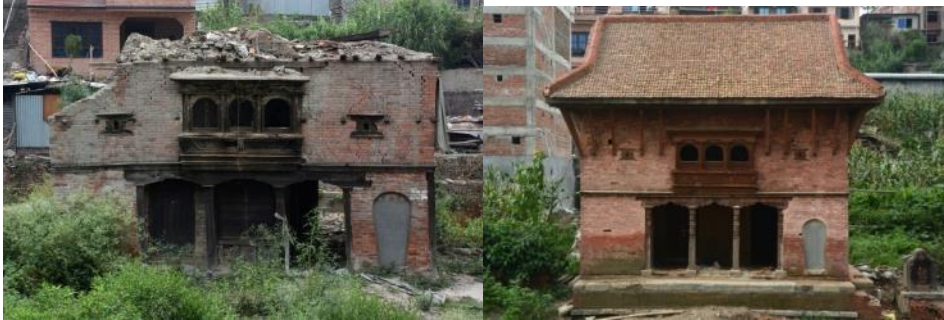
### **1. Maaheshwori Pith Satal, Bhaktapur**

2. Project Description: The restoration completed in 2077-78. The Sattal dedicated to Goddess Maheswari was collapsed by the earthquake. The Sattal with its beautiful window has been already restored; however, very few of the old material could be reused in the restoration work.

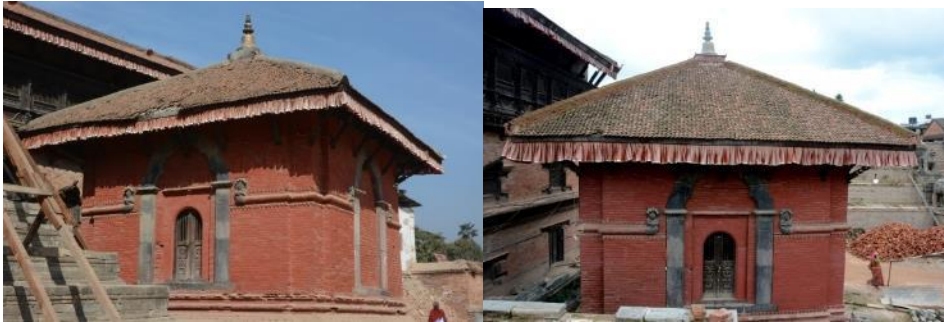
### **1. YantraBatsala, Bhaktapur**

2. Project Description: The YantraBatsala was the first monument conserved after the 2015 earthquake. The temple was partially damaged and already conserved within 3 months of the earthquake.

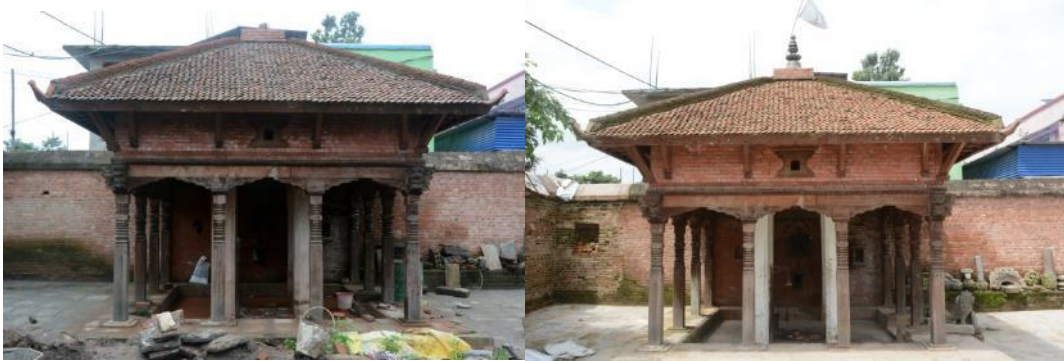
### **1. DuimajuChok Temple, Bhaktapur**

2. Project Description: The Duimaju is an important shrine beside the Taleju temple of Bhaktapur. The one roofed shrine with wooden columns was also damaged partially by the earthquake. The temple was conserved with common fund of DoA and Bhaktapur Municipality. It was completed already in Fiscal Year 2075-76.

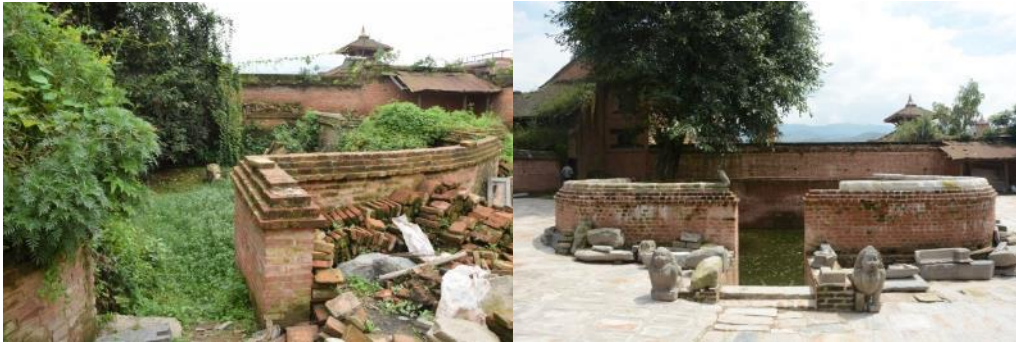
### **1. DuimajuChok Pond, Bhaktapur**

2. Project Description: The DuimajuPokhari, the religious water tank on the name of Duimaju beside the Duimaju temple of Bhaktapur has been restored. isis an important shrine beside the Taleju temple of Bhaktapur. The one roofed shrine It was in dilapidated condition even before the earthquake. It was conserved by Department of Archaeology.

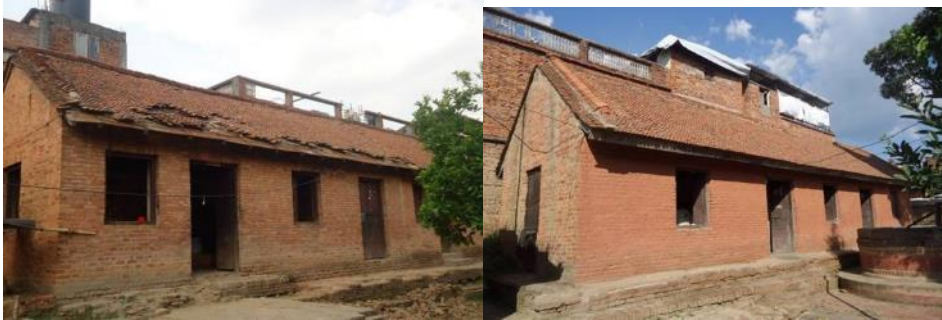
### **1. Horse Stable, Bhaktapur**

2. Project Description: The Horse Stable is the traditional structure built for the Horse of Taleju. It was partially damaged by the earthquake. The structure was restored by DoA.

a. Partially Damage: ✓

4. Damage Assessment of Monument: Only a general observation report was prepared.

8. Changes made in material and technology during conservation process: Nothing has been changed in the temple. Only few new bricks and roof tiles are replaced by new one of the same original design.

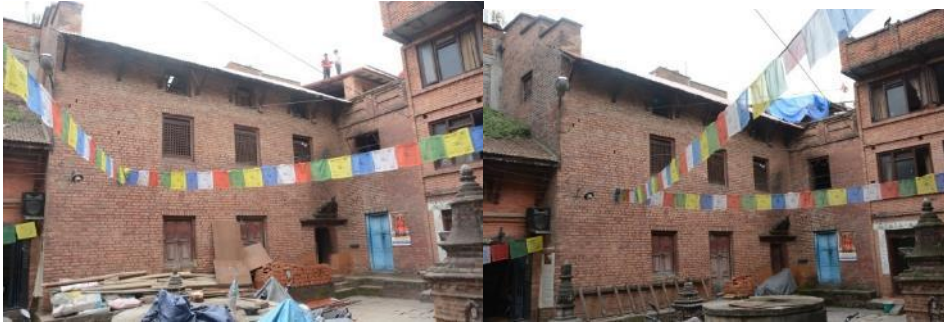
### **1. KumariGhar,Nagpokhari**

2. Project Description: The KumariGhar, the house of Living Goddess Kumari has been completed. The structure in simple design of traditional house was partially damaged by the earthquake.

a. Partially Damage: ✓

8. Changes made in material and technology during conservation process: Nothing has been changed in the temple. Only few new bricks and roof tiles are replaced by new one of the same original design.

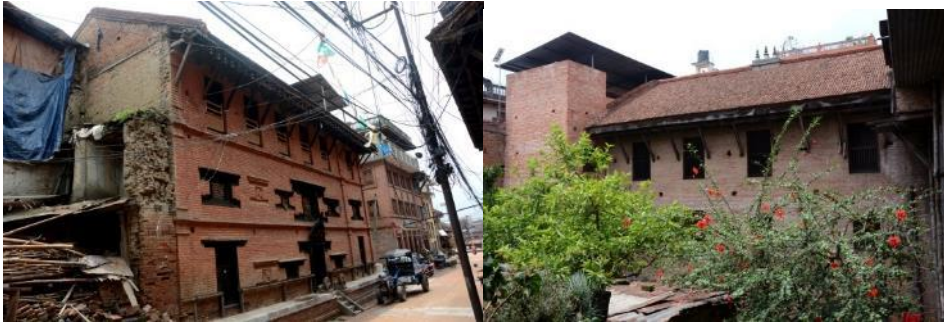
### **1. MahalaxmiDyochhein, Bhaktapur**

2. Project Description: The Dyochhen, a god's house of Mahalaxmi was partially damaged by the earthquake and it has been already conserved.

a. Partially Damage: ✓

8. Changes made in material and technology during conservation process: Nothing has been changed in the temple. Only few new bricks and roof tiles are replaced by new one of the same original design.

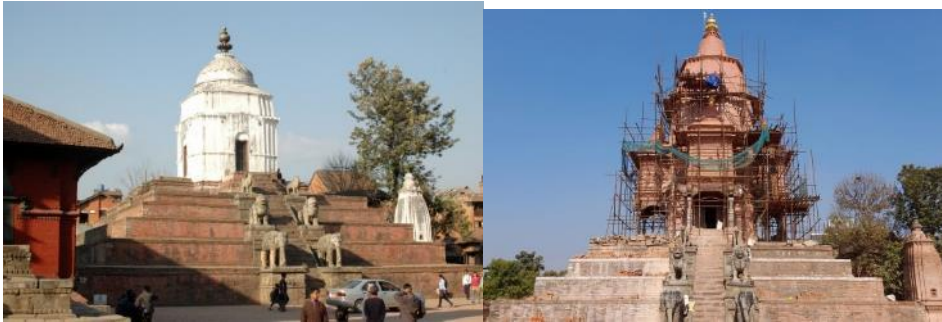
### **1. SiluMahadev Temple, Bhaktapur**

2. Project Description: Renovation of SiluMahadev temple is ongoing in its final phase. The temple structure collapsed by 2015 earthquake was the structure rebuilt after the 1934 earthquake but in differently than its original style. In present renovation the temple of SiluMahadev is being revived in its original style of before 1934.

b. Totally Damage: ✓

4. Damage Assessment of Monument: Detail assessment and structural analysis has been done for this renovation work.

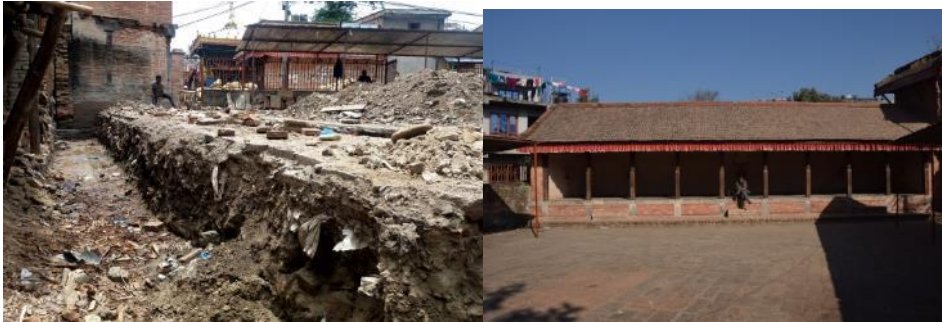
### **1. Barahi Pith Pati, Bhaktapur**

2. Project Description: The Barahi Pith Pati has been completed recently. It was partially damaged by the earthquake, however had to be rebuilt from the very foundation.

3. Status of Monument after Earthquake:
  - a. Partially Damage: ✓
  - b. Totally Damage:
4. Damage Assessment of Monument: Only general observation report prepared.

7. Implementation Modality:
  - a. User's Group:
  - b. Tendering Process: ✓
  - c. Foreign Agencies:
8. Changes made in material and technology during conservation process: There is no change in architecture and style. Only the old and unusable materials are replaced by new one.

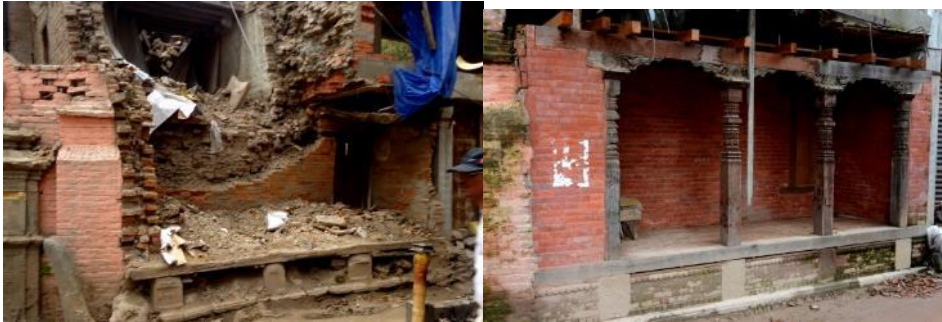
### **1. BalakhuPati, Bhaktapur**

2. Project Description: BalakhuPati is the public rest house dedicated to Balakhu Ganesh. The Pati is built in the ground floor of a private house. The house including the Pati was collapsed by the earthquake. Department of Archaeology restored the Pati portion of the house but yet to be rebuilt the upper portion of house by house owner.

b. Totally Damage: ✓

8. Changes made in material and technology during conservation process: There is no change in architecture and style. Only the old and unusable materials are replaced by new one.

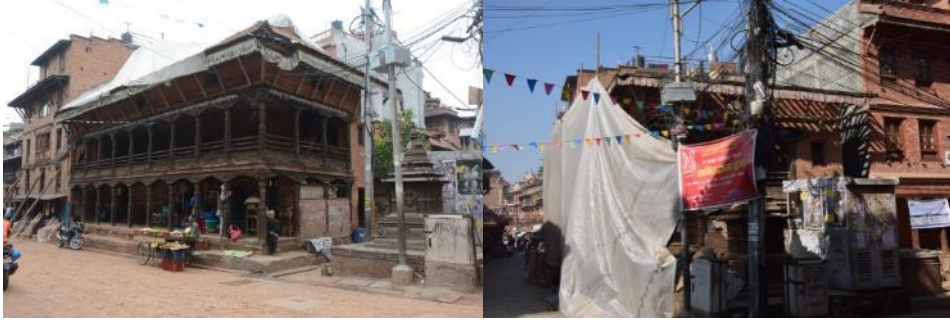
### **1. Bangshi Gopal BhajanGhar, Bhaktapur**

2. Project Description: BansiGopalBhajanGhar is under restoration. The three story BhajanGhar is a stylish architecture with artistic wooden elements. The old artistic wooden elements are being reused as much as possible in present restoration work.

a. Partially Damage: ✓

4. Damage Assessment of Monument: A general observation report has been prepared as conservation note before starting conservation work.

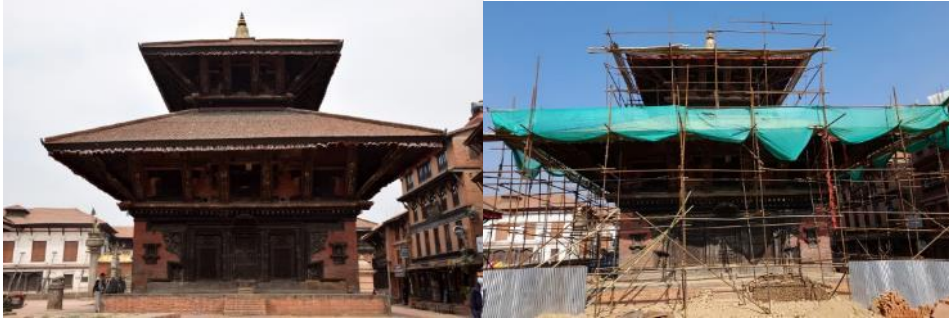
### **1. Yakshyashwor Temple, Bhaktapur**

2. Project Description: Yakshaswar is one of the oldest temple architecture of Bhaktapur built in 15<sup>th</sup> century. It was only partially damaged by the earthquake. Without dismantling the temple structure, it is being restored carefully. The project will be completed within running fiscal year.

a. Partially Damage: ✓

4. Damage Assessment of Monument: Detail assessment has been done.

8. Changes made in material and technology during conservation process: There is not being any change in its original style. Only the damage part and elements will be replaced.

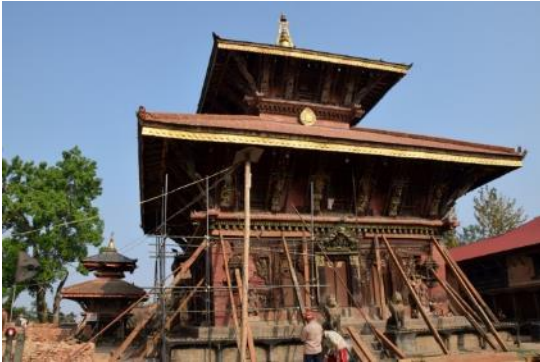
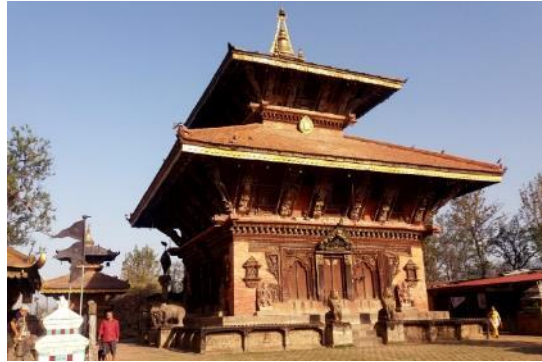
1. Name of Project & Location : Changu Narayan Temple, Changu Narayan

2. Project Description: The conservation work of the Changu Narayan temple has been already completed. The temple was only partially damaged by the earthquake. However, various structural elements of the temple were observed rotten and damaged. Some heavy cracks on the corner of the brick wall were observed. Therefore, the Changu Narayan temple was studied in detail and conserved carefully without dismantling the entire structure. The damaged wall was carefully removed and restored applying adequate wooden member to strengthen the entire temple structure.

a. Partially Damage: ✓

4. Damage Assessment of Monument: Detail architectural and structural assessment was done before prior to start conservation work.

8. Changes made in material and technology during conservation process: Replacing the mud mortar Lime-shurkhi mortar has been applied in the present conservation work. The local low grade wood are replaced by strong Sal wood.

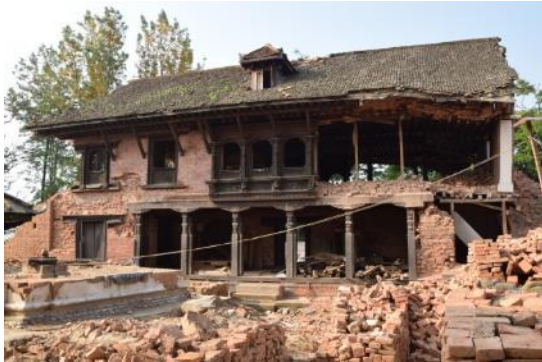
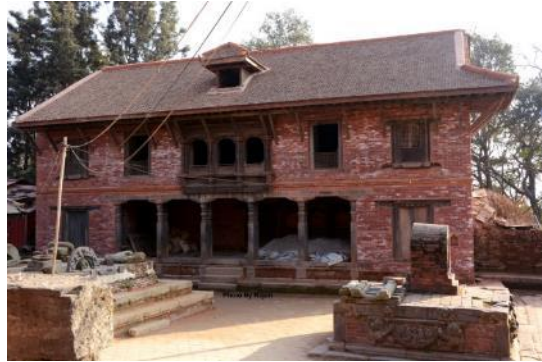
1. Name of Project & Location : Amatya Satal, Changu Narayan

2. Project Description: Amatya Sattal has been already restored. It was restored by the same NGO and same funding as the Kileswar Mahadev temple was conserved. The structure was restored just few years ago of the earthquake. Therefore, almost all carved wooden elements, wooden timbers, bricks and traditional roof tile are reused in present conservation. Since it has to dismantle from the very ground level for the conservation, it was considered as collapsed one, however listed as partially damaged in the preliminary inventory of the DoA.

a. Partially Damage: ✓

8. Changes made in material and technology during conservation process: Nothing has been changed in present conservation work. Mud mortar has been applied as it was before. Only the wooden elements without carving are replaced by new one.

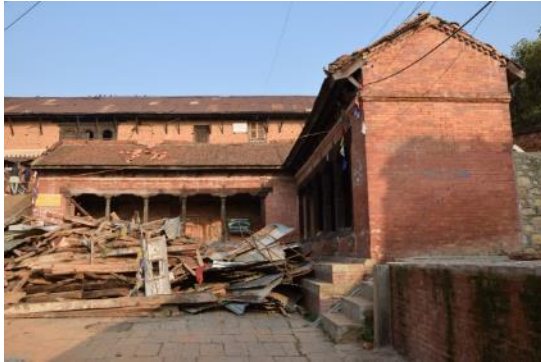
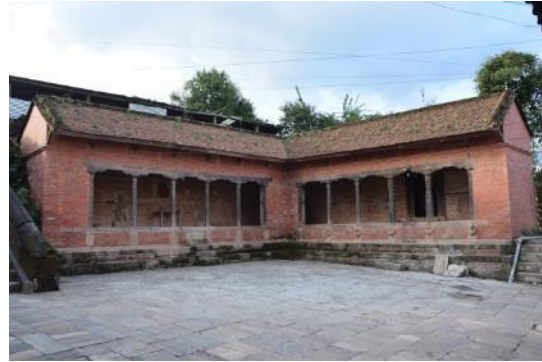
1. Name of Project & Location : Bhimsen Pati, Changu Narayan

2. Project Description: Bhimsen Pati located outside the Changu Narayan temple premises in the eastern front. The Pati built in L shape is known as Bhimsen Pati, since there is also enshrined God Bhimsen . The Pati was partially damaged by earthquake. The Pati has been restored from very foundation.

a. Partially Damage: ✓

8. Changes made in material and technology during conservation process: Nothing in the architecture has been changed in present conservation work. However, mud mortar has been replaced by Lime mortar.

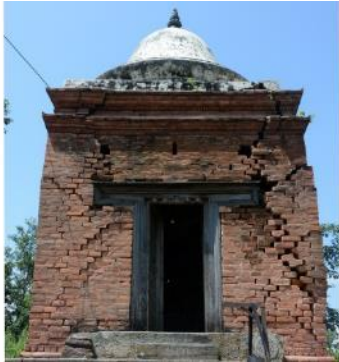
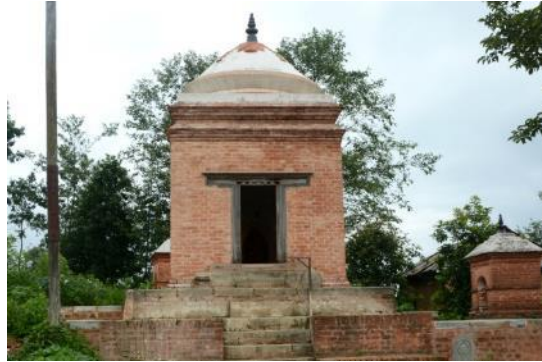
1. Name of Project & Location : Saraswati Temple, Changu Narayan

2. Project Description: The Saraswati temple located in the northern end of Changu Narayan Protected Monument Zone has been already conserved. The temple was not collapsed and also listed as partially damaged monument in the preliminary inventory of DoA, but the cracks and damage in the structure was severe and there was not any other way of preserving it without restoring from the very ground level. Dismantling the damaged structure carefully it is well restored now. It was funded by DoA and entire restoration work was executed by Bhaktapur office of DoA.

a. Partially Damage: ✓

4. Damage Assessment of Monument: General observation report and conservation note was prepared before starting the conservation work.

8. Changes made in material and technology during conservation process: Nothing in the architecture has been changed in present conservation work. However, mud mortar has been replaced by Lime mortar.

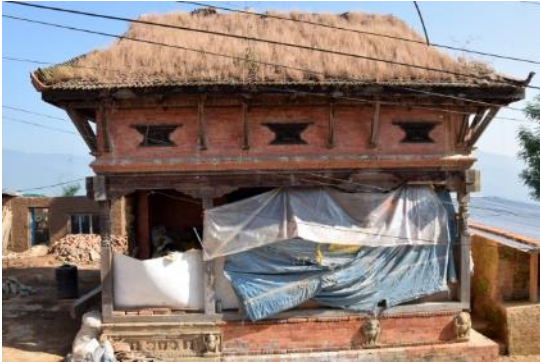
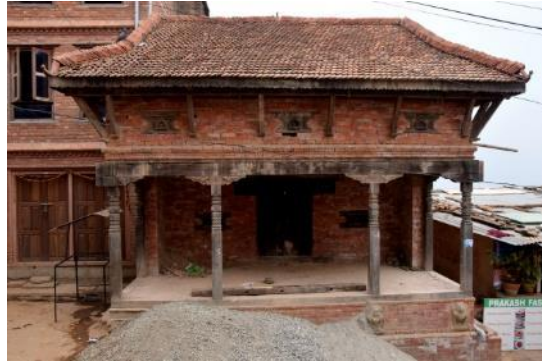
1. Name of Project & Location : Balambu Pati(A), Changu Narayan

2. Project Description: There are two Pati as twain in Changu Narayan. Both Patis are known as Balambu Pati. This is the one known as Balambu Pati (A) and it was partially damaged by the earthquake. Now the Pati has been conserved in its original form. Since the Pati was restored few years ago, almost all the wooden elements were reused in present conservation work. It was funded by Department of Archaeology and project was executed by Bhaktapur office of DoA.

a. Partially Damage: ✓

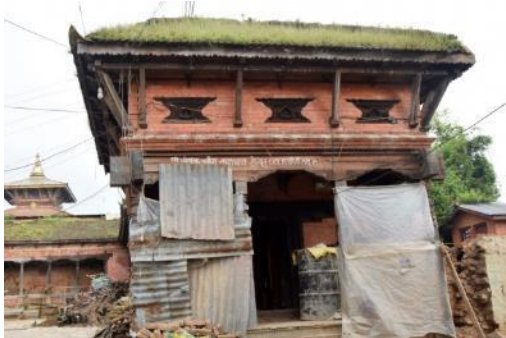
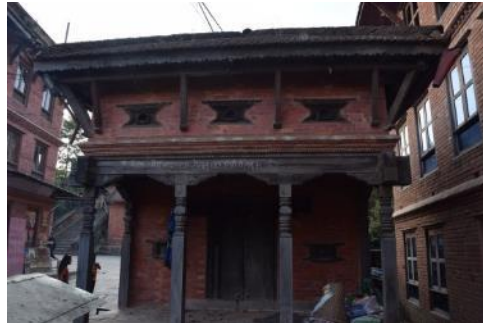
1. Name of Project & Location : Balambu Pati(B),Changunarayan

2. Project Description: There are two Pati as twain in Changu Narayan. Both Patis are known as Balambu Pati. This is the one known as Balambu Pati (B) and it was partially damaged by the earthquake. Now the Pati has been conserved in its original form. Since the Pati was restored few years ago, almost all the wooden elements were reused in present conservation work. It was funded by Department of Archaeology and project was executed by Bhaktapur office of DoA.

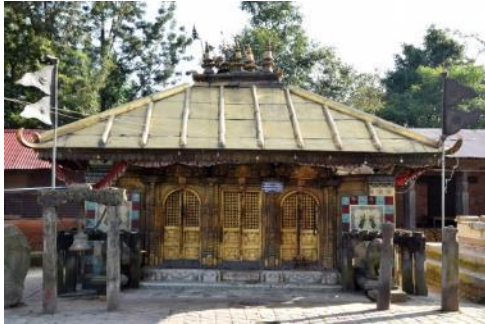
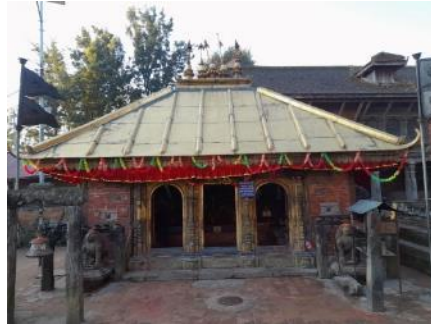
1. Name of Project & Location : Chinnamasta Temple, Changu Narayan

2. Project Description: The Chinnamasta temple in the Changu Narayan temple premises is another most worshipped temple of this place. It was partially damaged by the earthquake. The temple was conserved without dismantling the entire structure. The conservation work was already completed in Fiscal Year 2075-76.

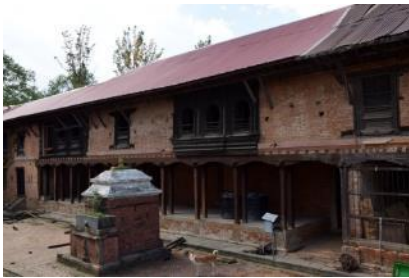
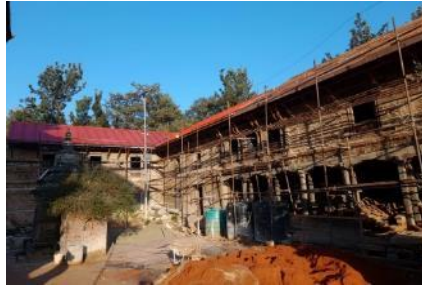
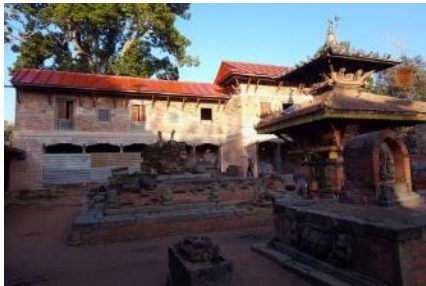
1. Name of Project & Location : Chaughera Satal, Changu Narayan

2. Project Description: The restoration work of Chaughera Satal is ongoing. The Satal was partially collapsed by the earthquake. It is the largest conservation project executed in Changu Narayan Protected Monument Zone. Since the structure was restored few years before the earthquake; therefore, several wooden elements and also the bricks are being reused in present conservation work.
