**STATE OF CONSERVATION REPORT
HISTORICAL MONUMENTS AT MAKLI, THATTA (PAKISTAN) (C 143)
DECISION: 45 COM 7B.170**

Updated as of December, 2023

Field Mission Report 2022 Monsoon

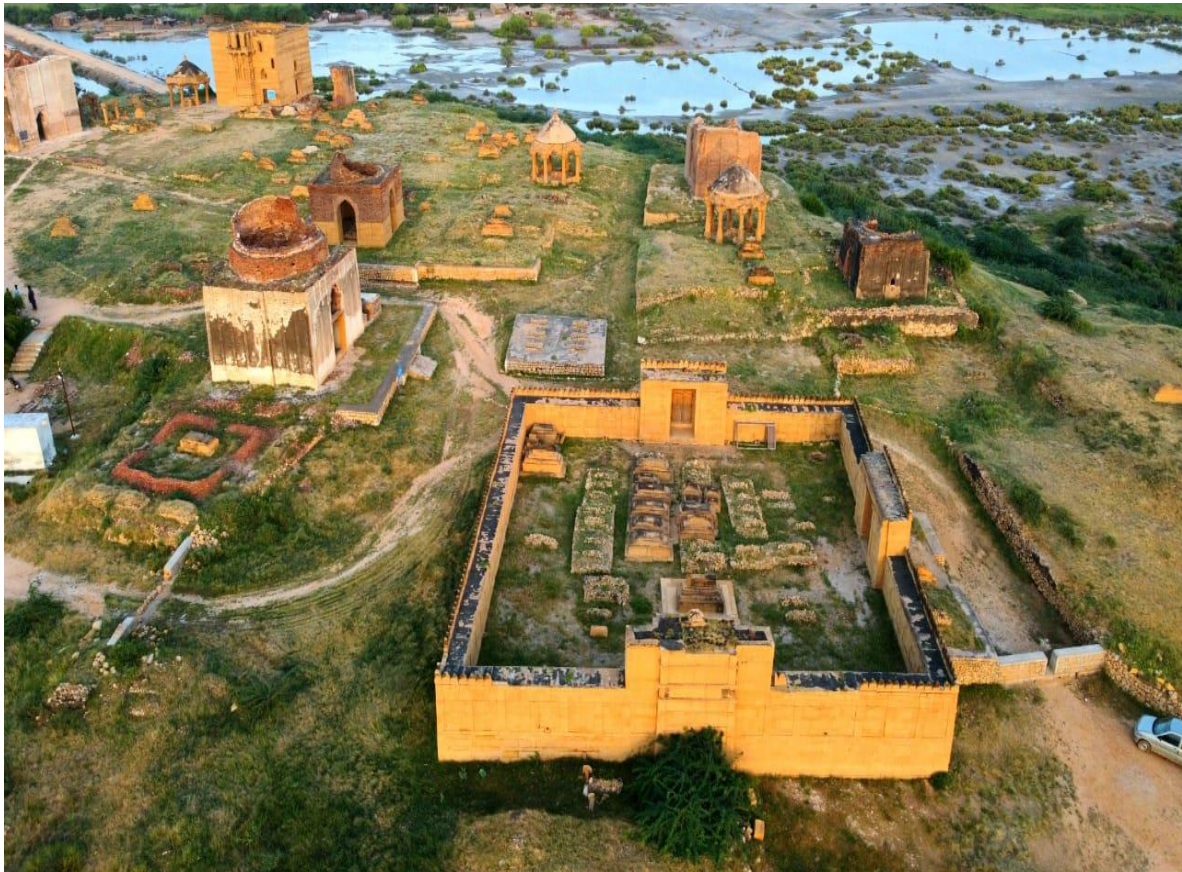
Aerial view of one portion of site after 2022-Monsoon Flooding

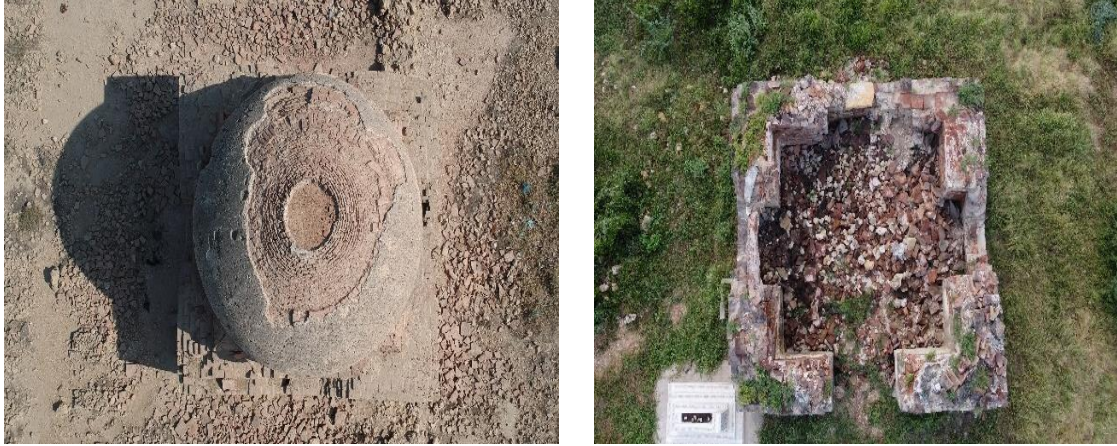
TOMB OF HAZRAT PEER AASAAT

Unfortunately, a dome of a tomb (unknown) in the middle of the Makli Necropolis collapsed due to the heavy rains. This structure was not worked on before the 2022 monsoon. The documentation of this tomb was done before the collapse. The significance of this tomb was its dome and contribution to the landscape of the necropolis. Because the documentation was conducted and the original materials are in place, it could be reconstructed.

Aerial view of Dome of Hazrat Peer Aasaat tomb before and after rains.

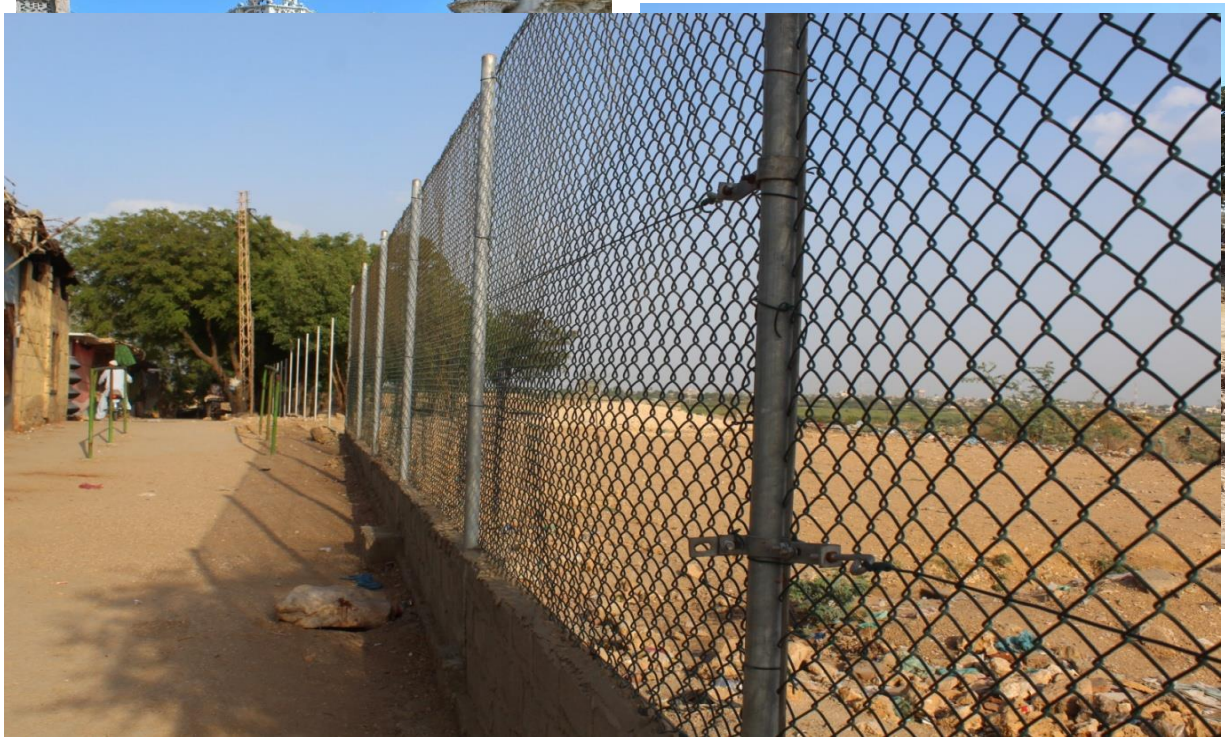
(B) PICTURES OF FENCE NEAR SHRINE OF ABDULLAH SHAH ASHABI

Near the tomb of Hazrat Abdullah Shah Ashabi there was an open space from where stray dogs, donkeys, goats etc used to enter into site. Therefore, we installed a net grill there to stop the entry of wild animals and to maintain the visitor management plan.

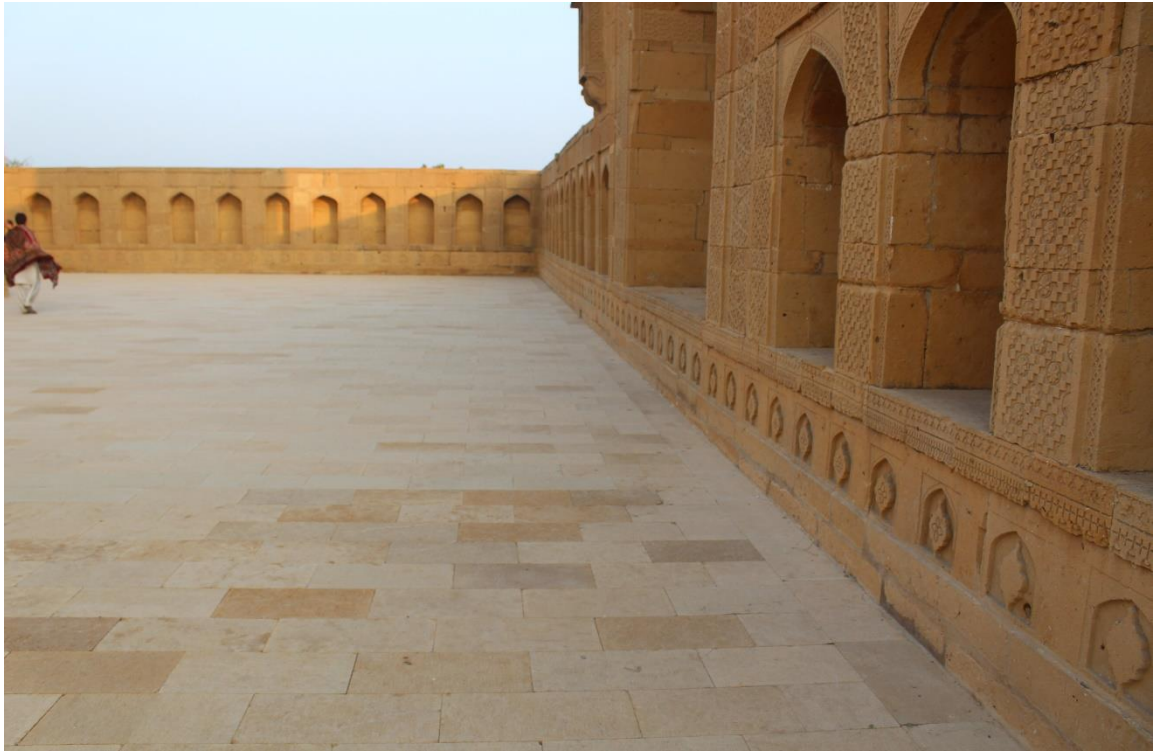
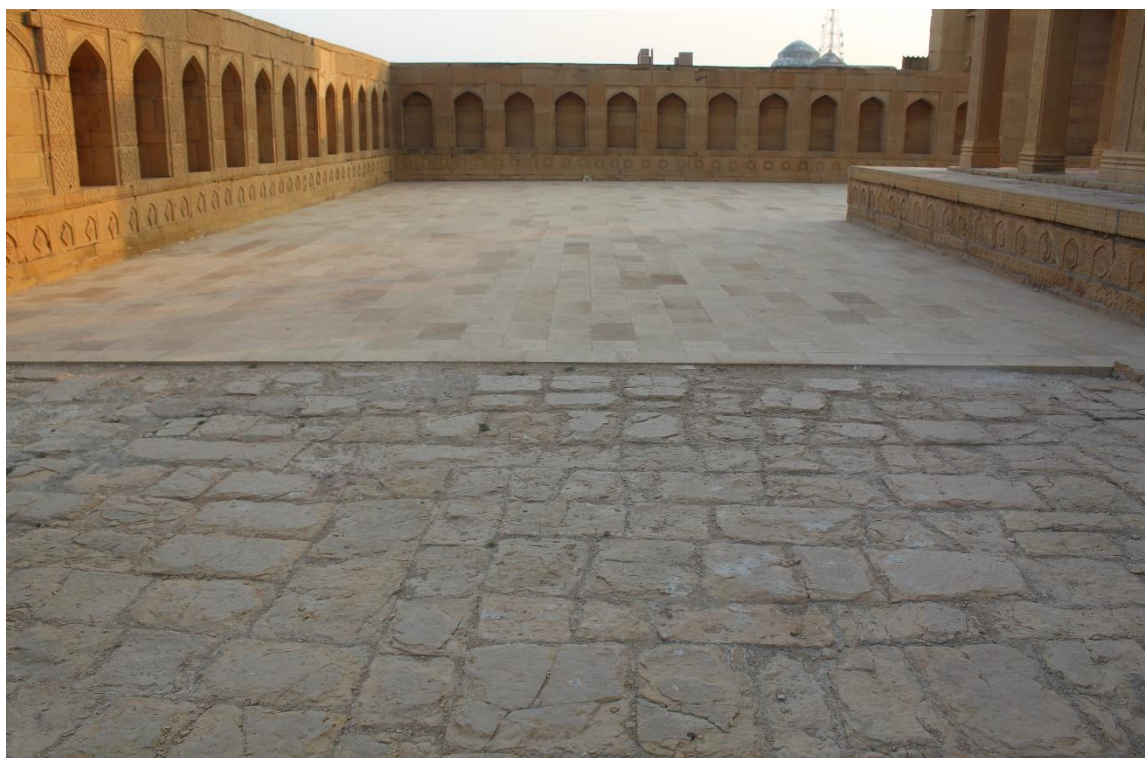
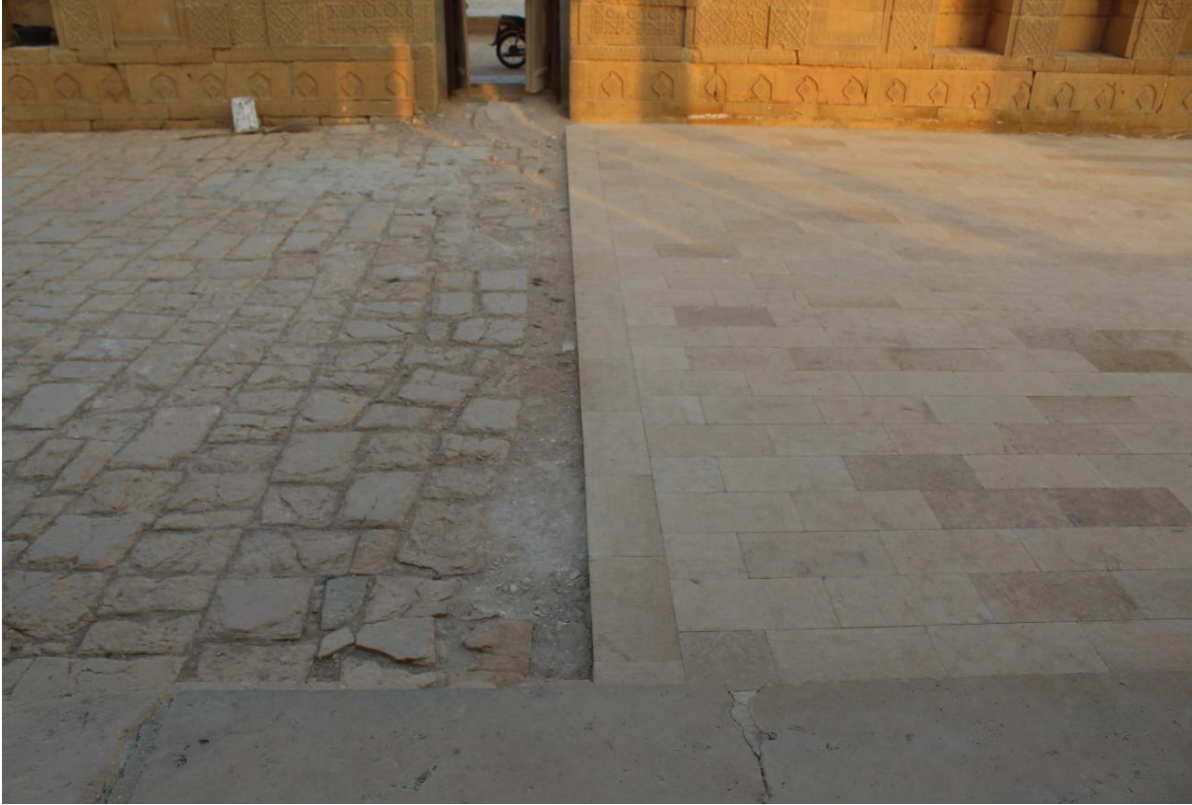
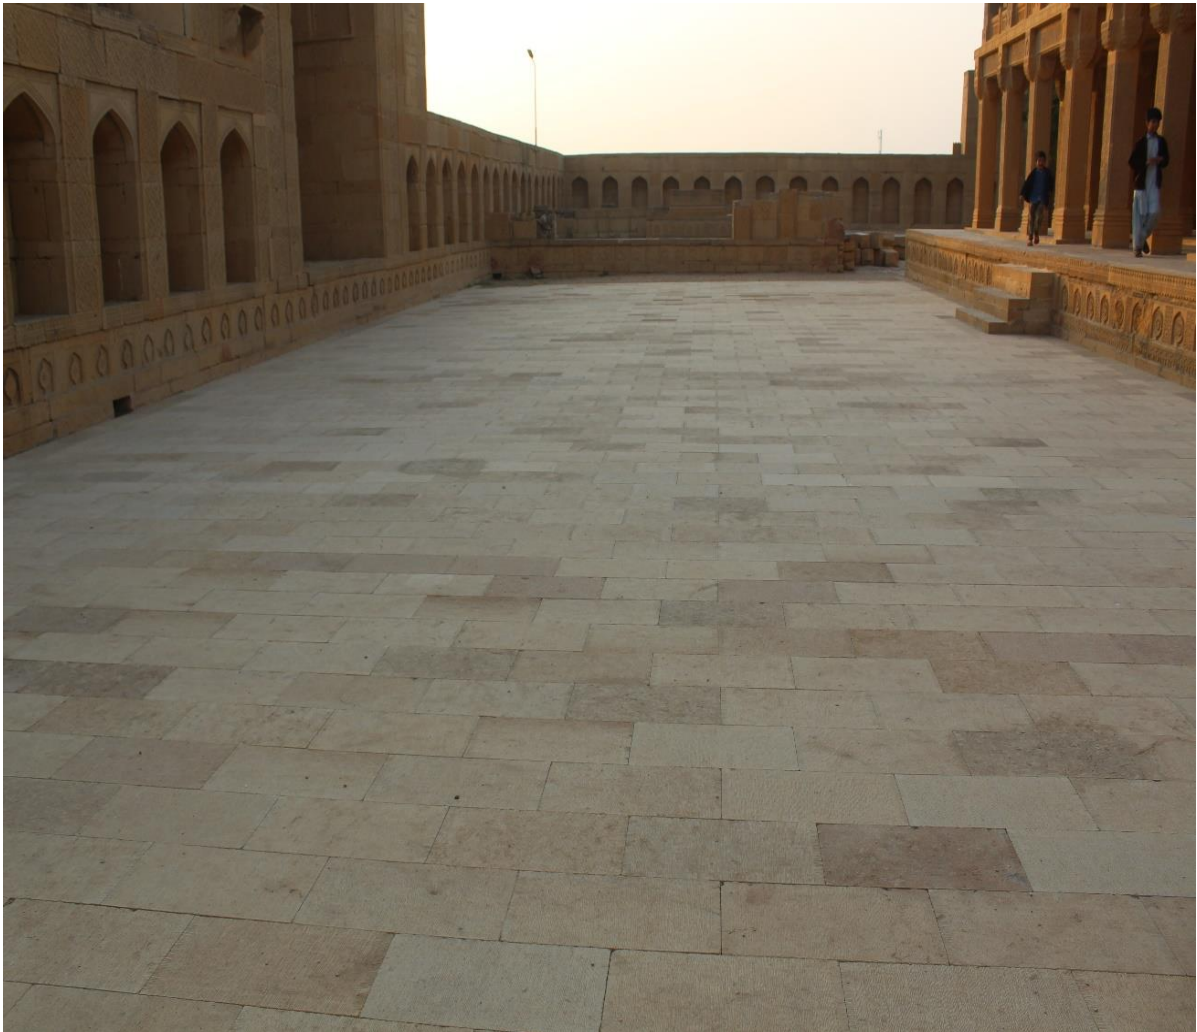
PICTURES OF NEW PAVING IN THE AREA OF MAUSOLEUM OF ISA KHAN TARKHAN-II

If the new pavement had not been provided the rainwater would have penetrated into the foundation of mausoleum and resulted in more damage to this significant structure.

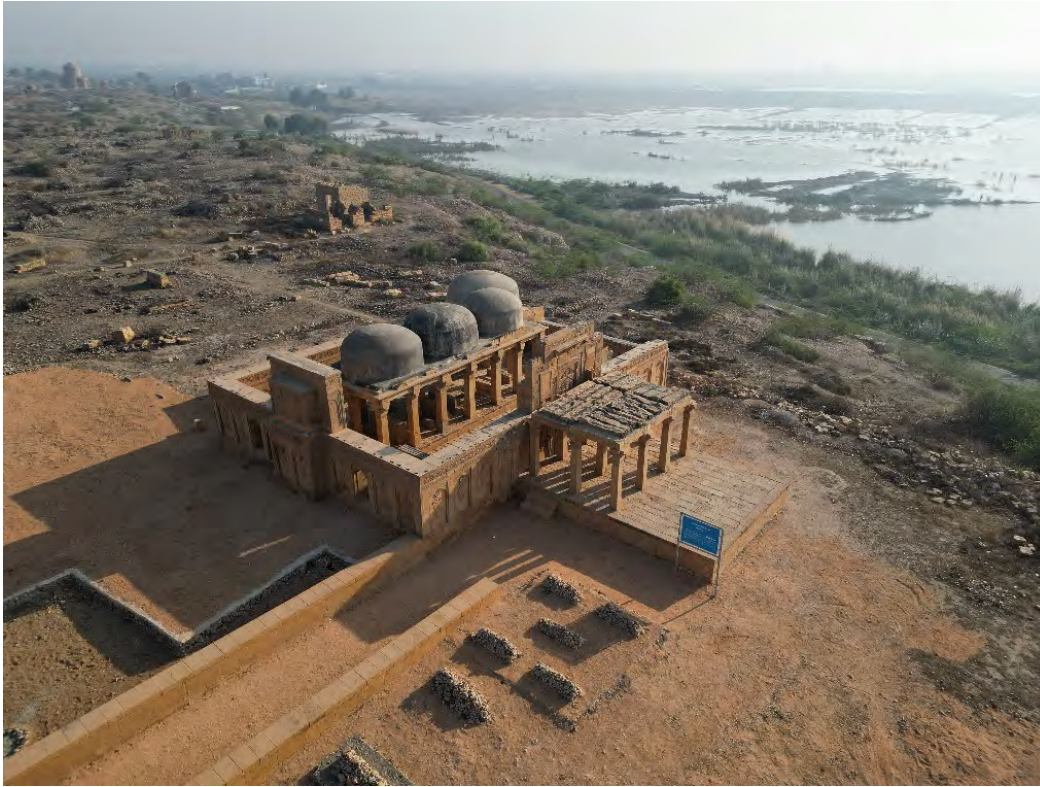
Figure 1 The tomb of Meerza Jan Baba at the edge of the site with flooded lowlands in the distance (Eppich)

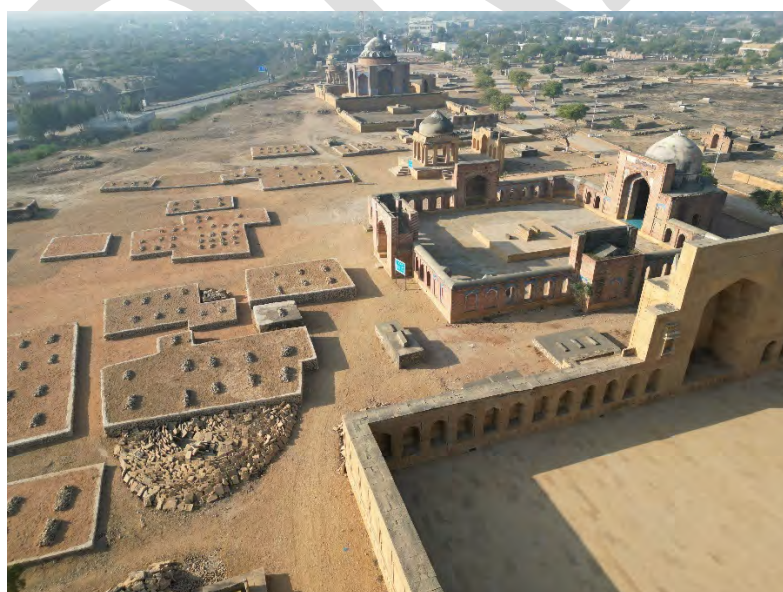
Figure 2 Overview of the Mungul period cluster near the main entry after improvements in drainage, cleaning of burned areas, and consolidation of the platform tombs (Eppich)

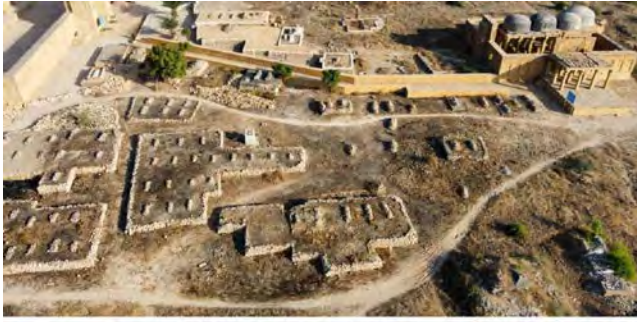
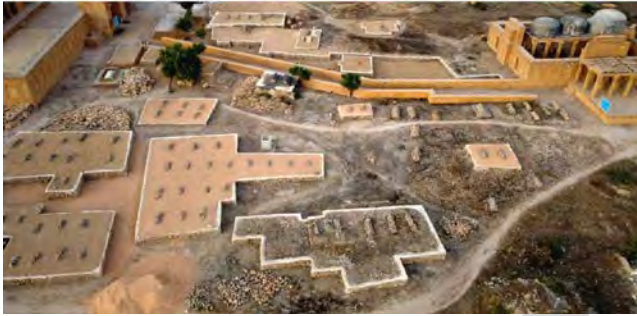
Figure 6 Aerial foto, above, before, blow after of the areas of cleaning and improved drainage in between the tombs of Isa Khan II and Jan Baba (Daud Jatoi)

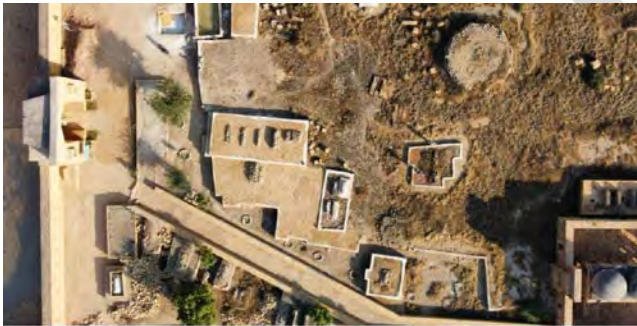
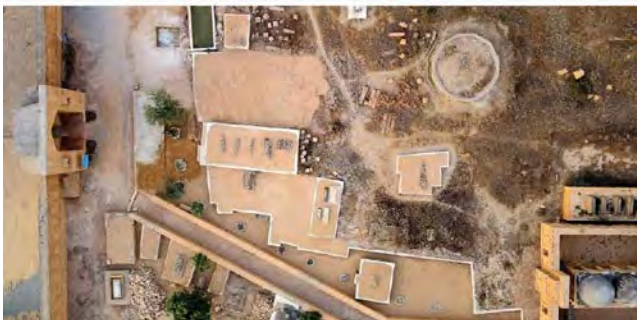
Figure 7 Aerial foto, above, before, blow after of the areas of cleaning and improved drainage in between the tombs of Isa Khan II and Jan Baba (Daud Jatoi)

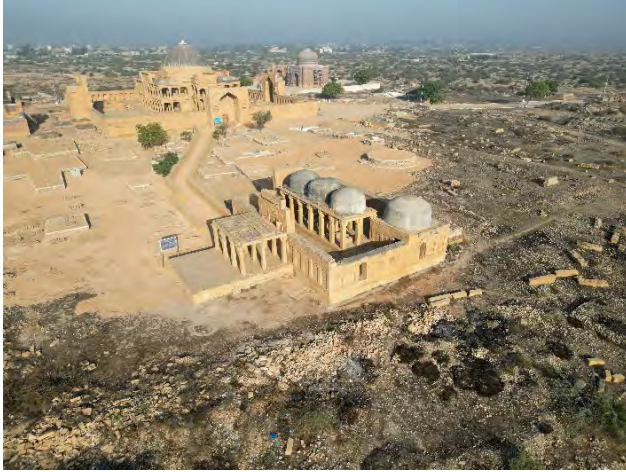
Figure 8 Another view of the tomb of Meerza Jan Baba. The recent interventions can easily be seen in and around this tomb which extends around the tomb of Isa Kahn II (Eppich).

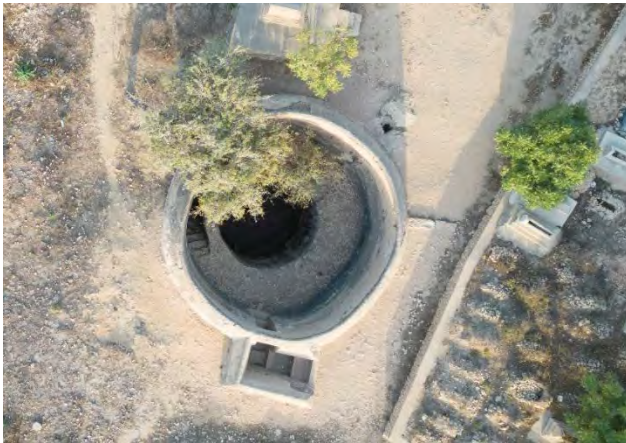
Figure 9 The historic stepwell was cleaned, and preliminary investigations into the drainage channels that lead to this well were conducted. However, more in-depth archaeological research must be undertaken to determine if these can be reutilized for drainage

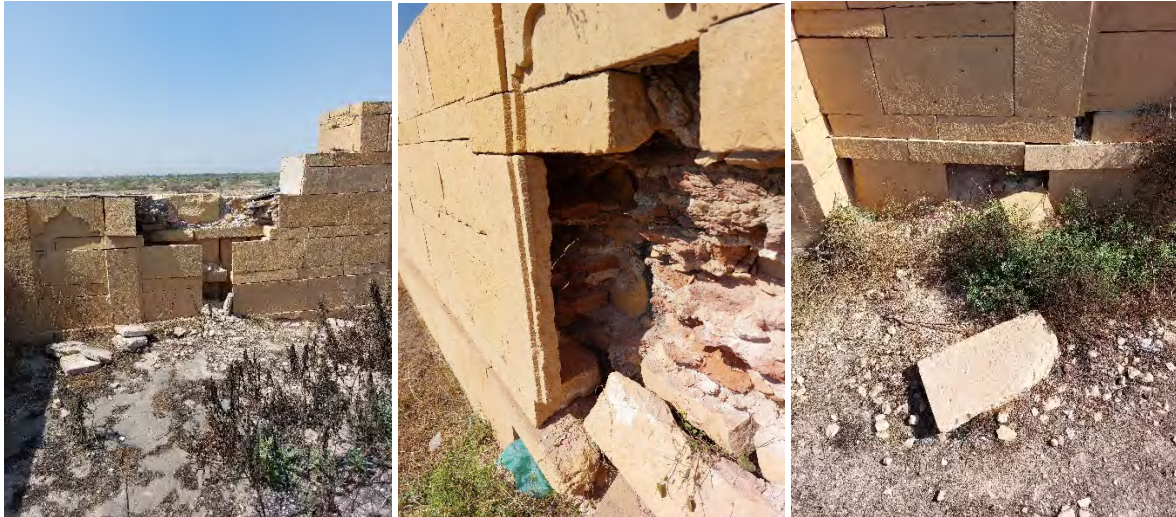
To the north of Shiek Jeo, along the main road, there are three enclosed tombs, and the enclosed tomb of Hazrat Peer Mirran Mohammad Shah suffered from a loss of facing ashlar. These are not monumental tombs, and the damage is not severe, but if the problems are unaddressed, it will lead to continued loss of the facing ashlar. The work is not intensive, and the tombs are close to the road; thus, the consolidation work could proceed easily and quickly. One element that must be addressed is the wall capping on these enclosure tombs and an assessment of any possible underground vaulted tombs.

Figure 14 Small unknown enclosure tomb (Eppich)

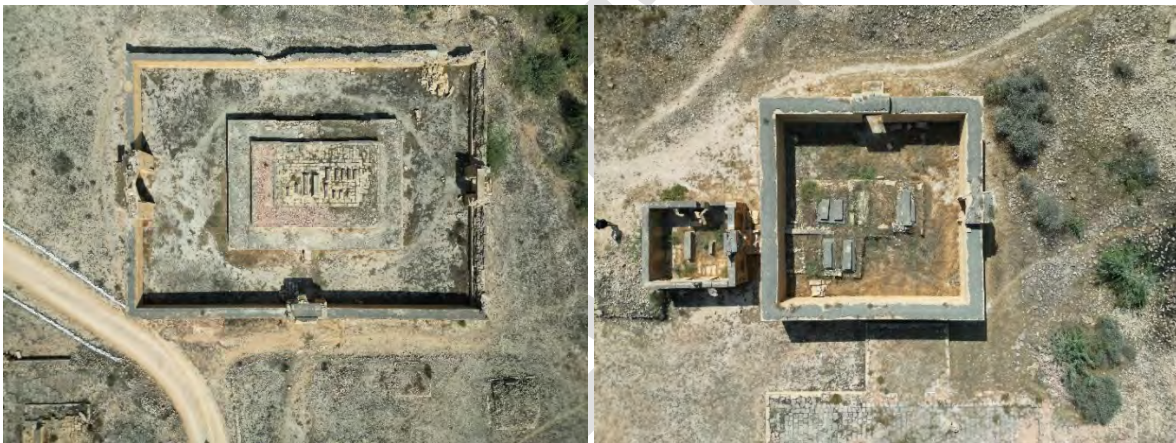
Figure 15 Unknown enclosure tombs that have suffered from a loss of facing ashlars (Eppich)

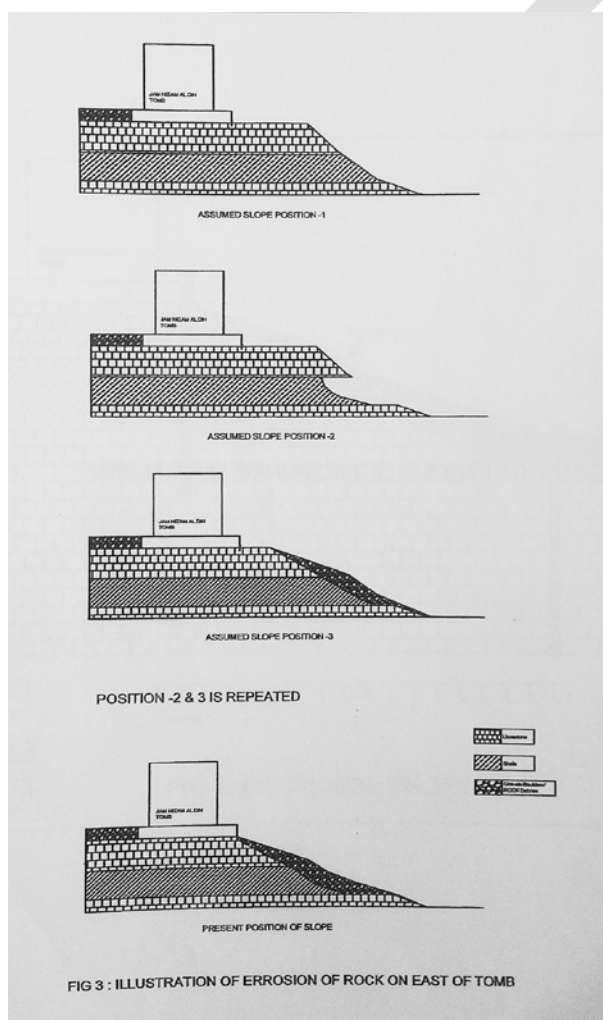
Figure 18 Slope erosion to the east of Jam Nizamuddin (Consolidated Engineering Services PVT Lt.) The legend reads from top to bottom, limestone, shale, rock debris

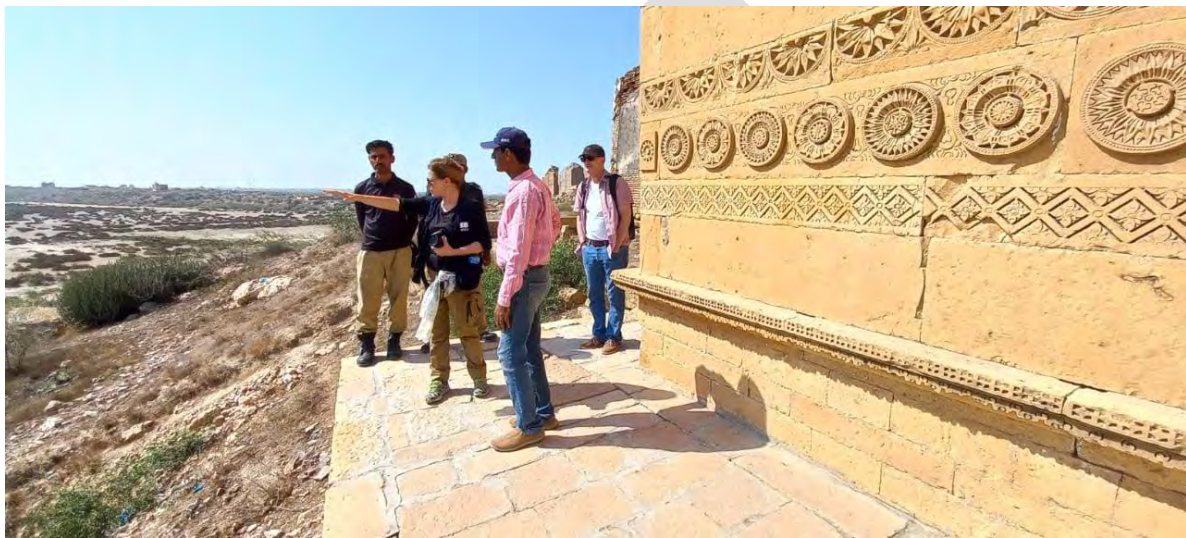
Of particular importance is the monumental tomb of Jam Nizamuddin. Every visit to Makli must include an inspection of this tomb, given its significance and the precarious location at the head of the bluff, which is subjected to continual erosion. Fortunately, the previous inspection in November 2022 revealed that the tomb had not been damaged and suffered from little or no movement. Nevertheless, constant vigilance must be maintained. In addition, there should be some work on the tomb, including reinstallation of the polycarbonate crack monitors, downloading of the data from the RissFox Mini Data logger, and infilling of the crack at the base with lime putty to prevent additional water infiltration and possible erosion between the monument and base that was added in the 20th century. Even though it appears that the monsoon of 2022 did not seriously impact Jam Nizamuddin, a long-term project must be made for the stabilization of the monument immediately, given its significance and contribution to the Outstanding Universal Values of Makli.

Figure 19 Inspection of Jam Nizamadin (Department of Archaeology photographer)

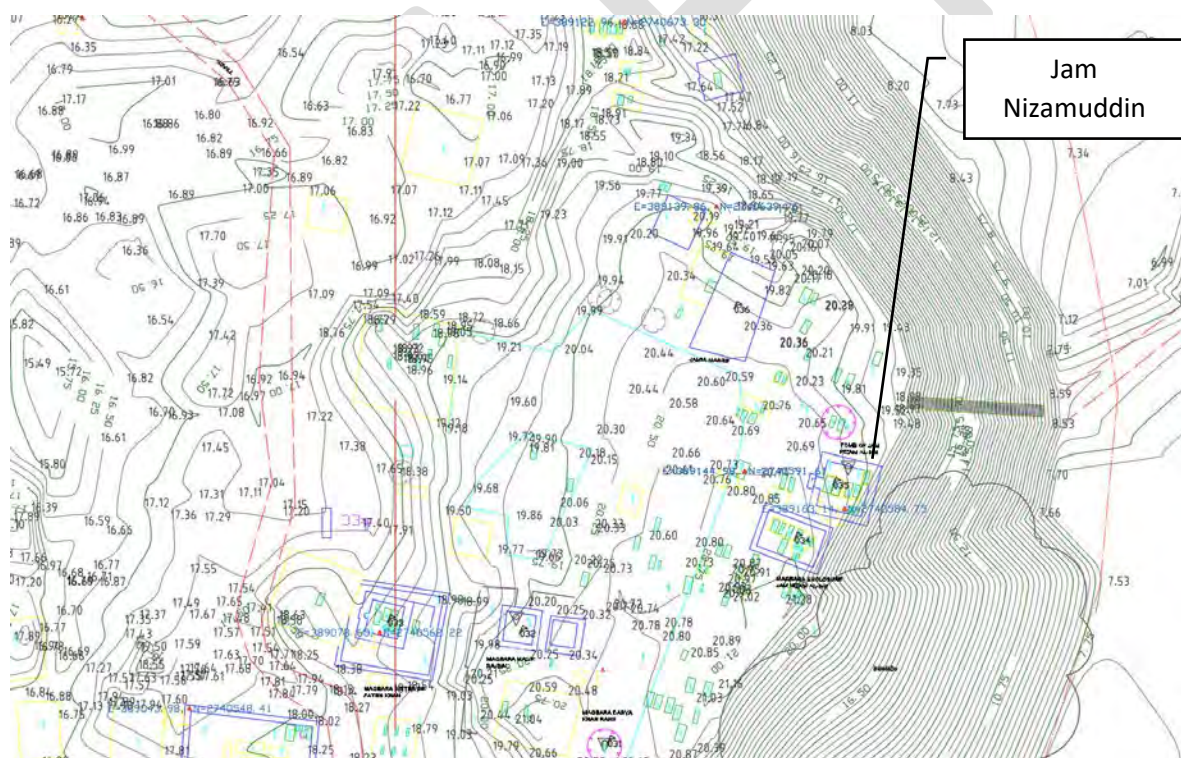
Figure 23 A detail from the topographical survey of 2016 near Jam Nizamuddin shows the relationship of the tombs to the head of the slope, north is up, N.T.S.

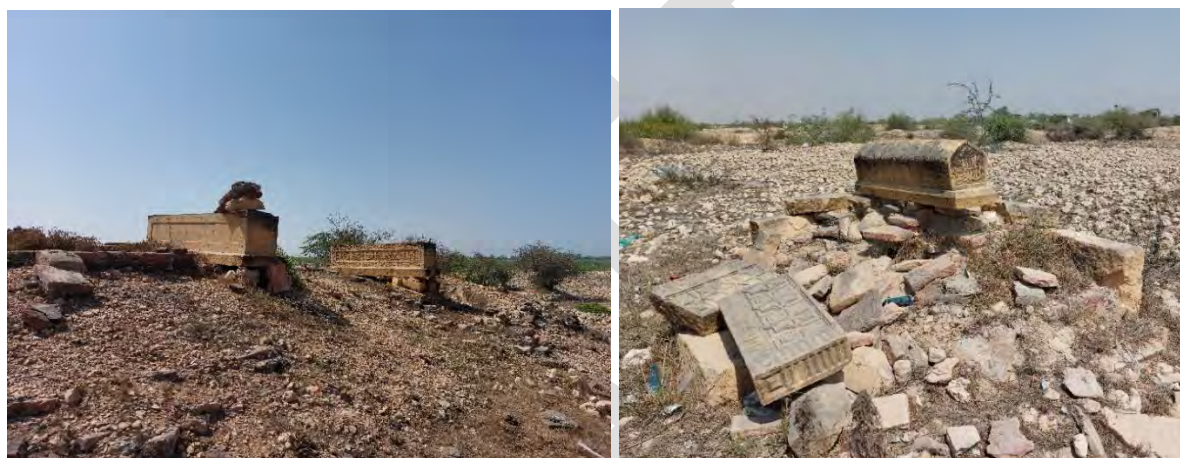
Figure 24 Small unknown grave markers at the eastern edge of the site. Many of these smaller grave markers were displaced during the 2022 monsoon due to unstable geology and heavy rains. These are some of the most vulnerable elements at Makli as they are small, not monumental, and often go unnoticed (Eppich).

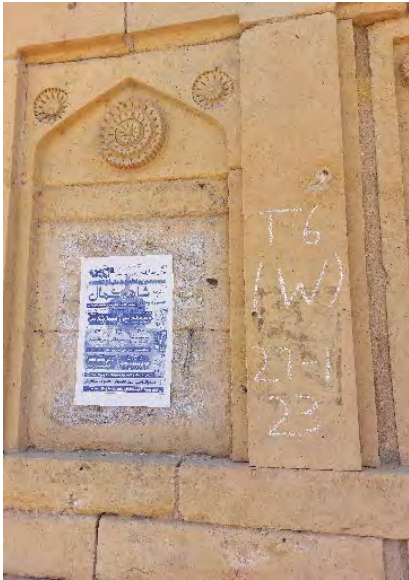
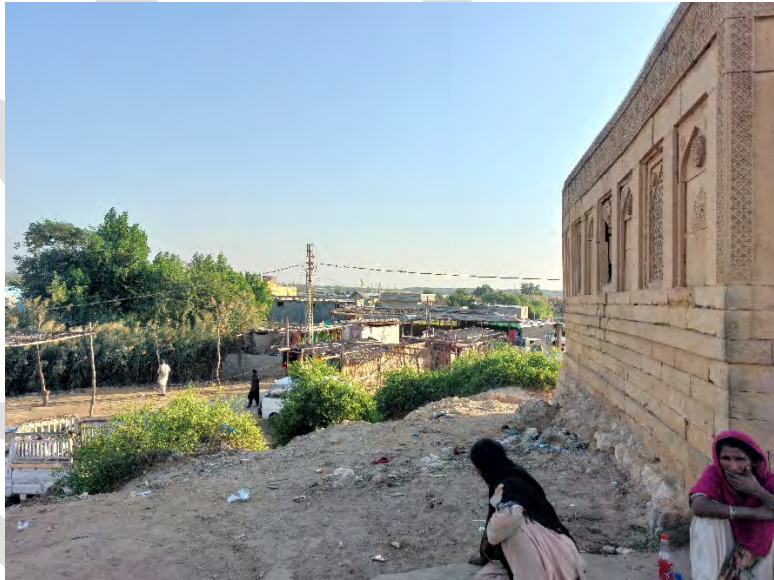
Figure 29 Advertisements and graffiti appeared in only one place on the enclosure tomb of Amir Habshad Bai. Although this only appeared in one location, diligence is necessary to prevent the placement of more placards. Right, the same tomb was inspected for erosion on the downhill side. While this is not a monumental tomb, nevertheless, it is a contributing tomb to Makli (Eppich).

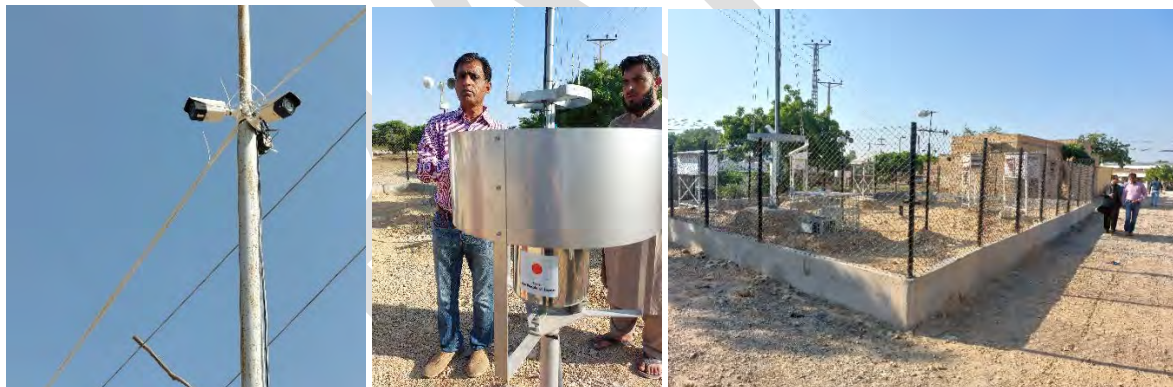
Figure 30 Installation of CCTV cameras at the Administrative Area, installation of a new weather station by Japan, and the new storage building with important elements of decorated stone (Eppich).

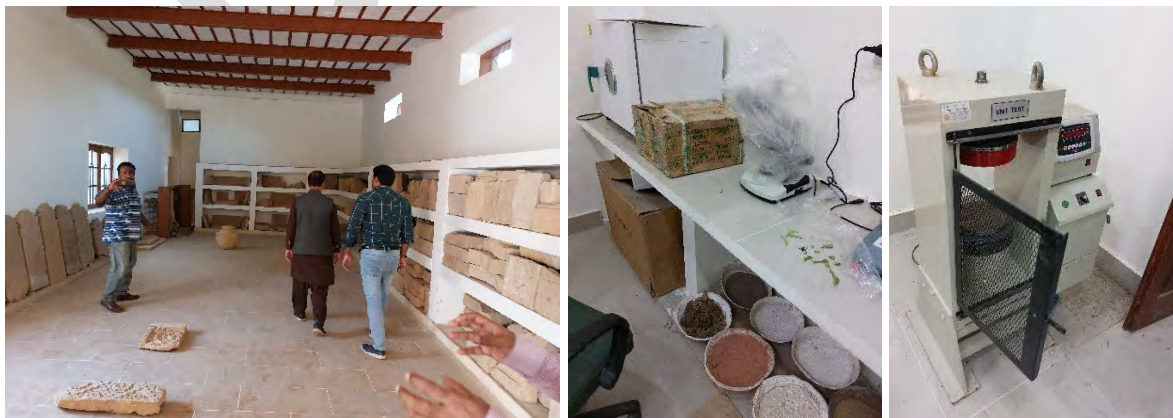
Figure 31 Storage warehouse continues to operate, as well as the onsite conservation lab. These will come into more use following conservation efforts after the monsoon.

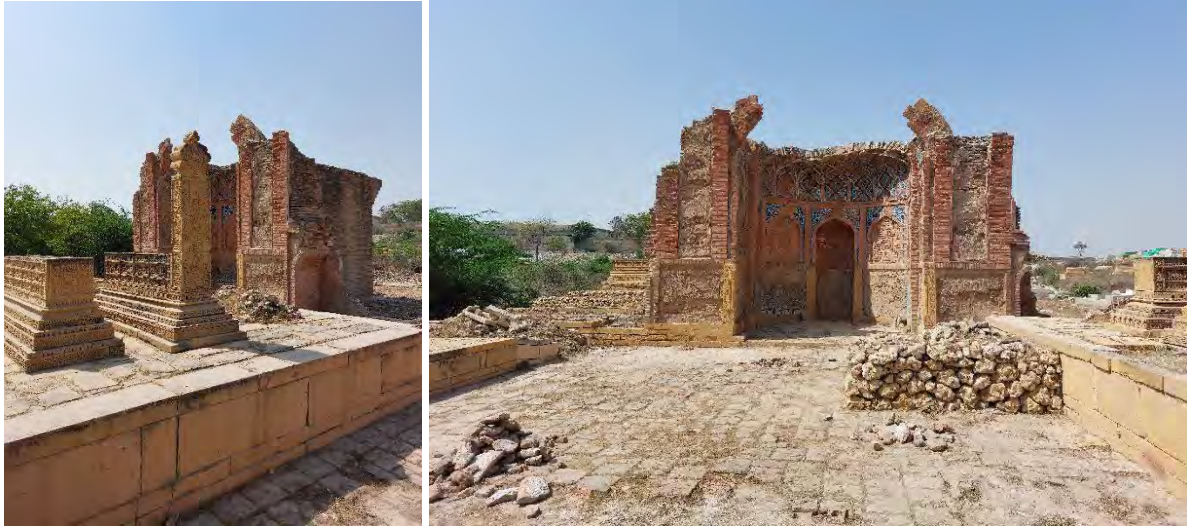
Figure 33 Left, the site has been cleaned and the bamboo scaffolding removed since the 2022 report, but Kashi tile and historic masonry consolidation must be immediately begun.

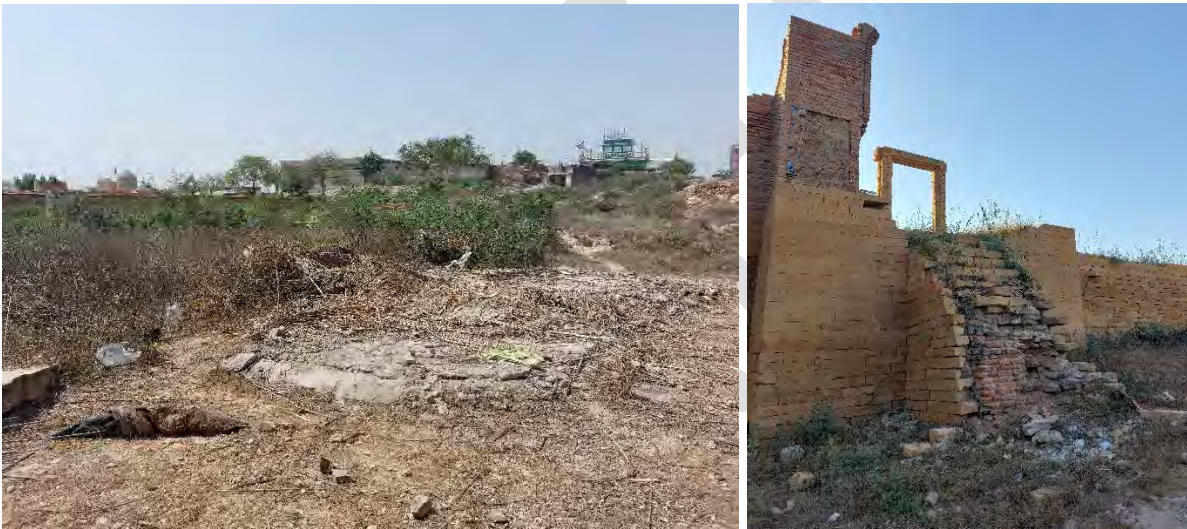
Figure 34 The bamboo huts have been dismantled and removed, but the site still requires significant cleanup. Right, the masonry entry steps and wall tops require consolidation.

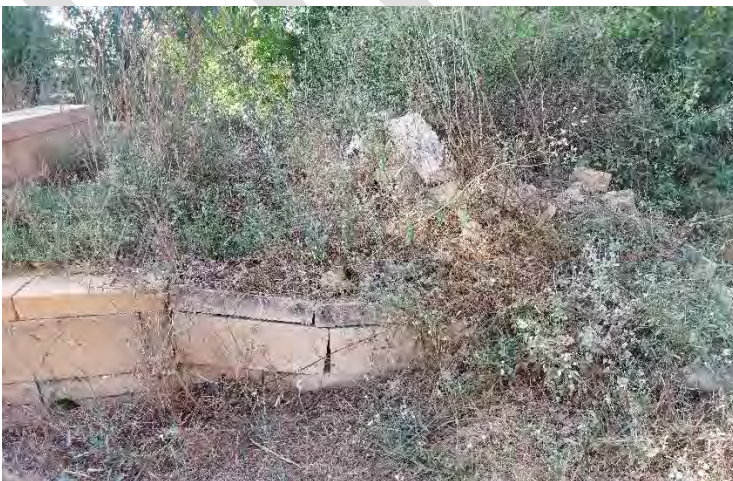
Figure 35 Of particular concern is the subsidence of the surface masonry that makes up the main platform. By all indications, there exists an underground vault that requires structural stabilization. During the monsoon, many other tombs with platforms suffered from near collapse as these vaults were unknown. This situation should be investigated immediately.

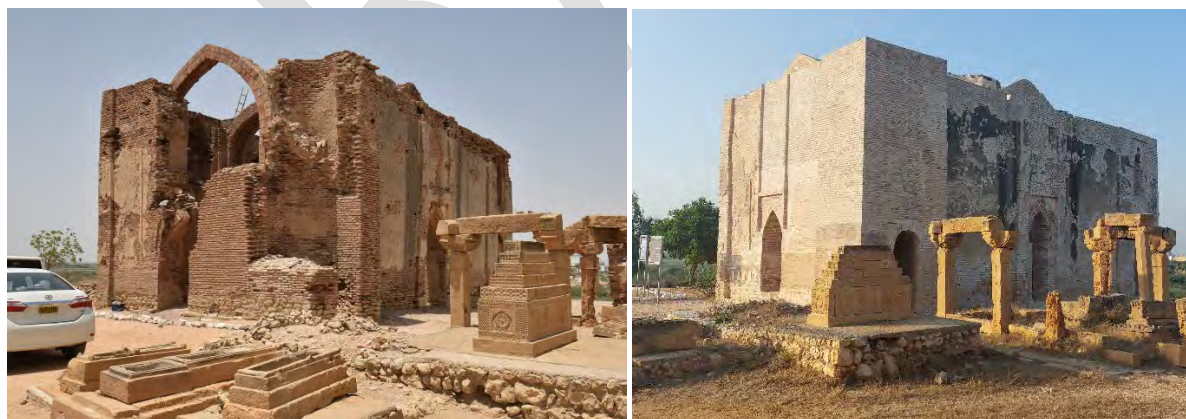
Figure 36 Left, Jamia Masjid Mai Makli before work by the EFT and right after (EFT)

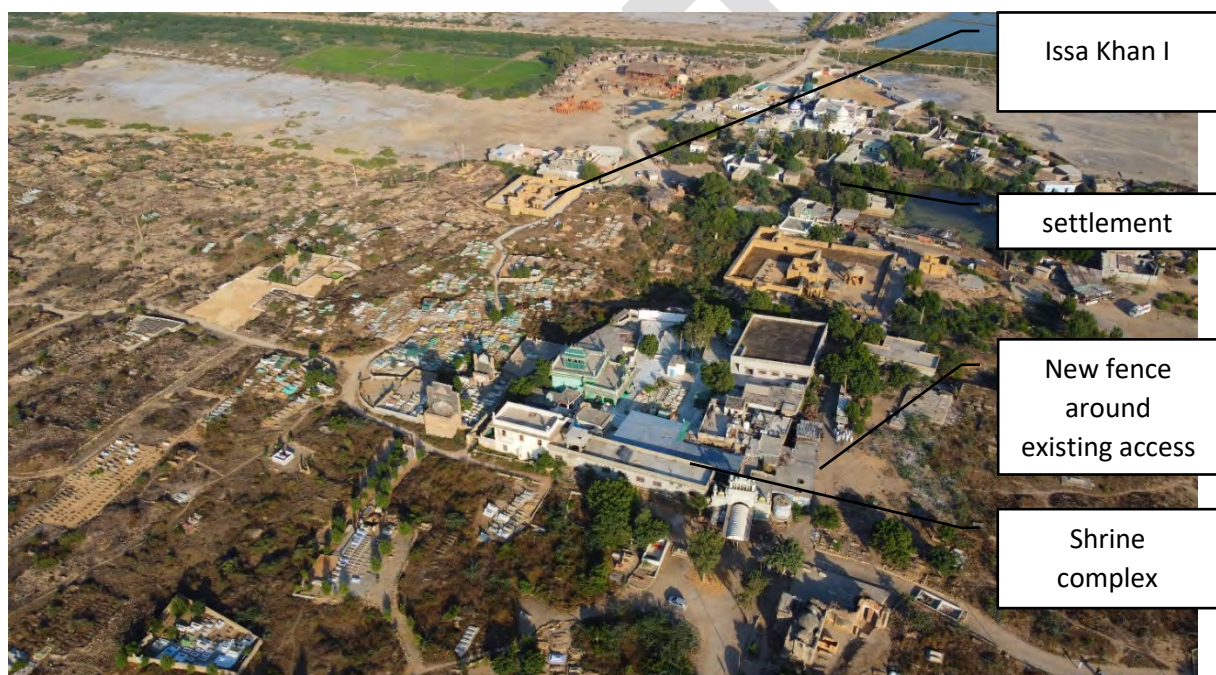
Figure 37 The situation at the eastern edge of the site at the Darbar Syed Abdullah Shah Ashabi Alaihrehma Shrine

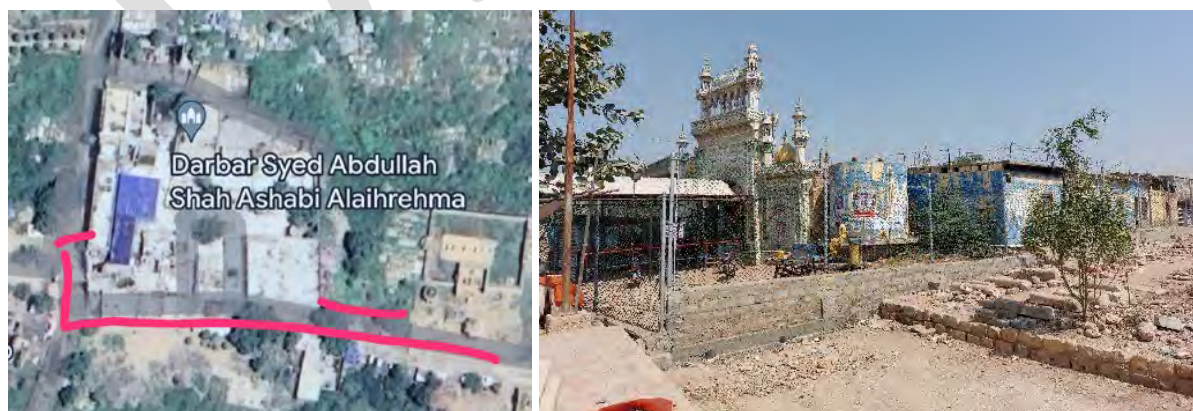
Figure 38 Darbar Syed Abdullah Shah Ashabi Alaihrehma Shrine with the location of the fence and image from the ground

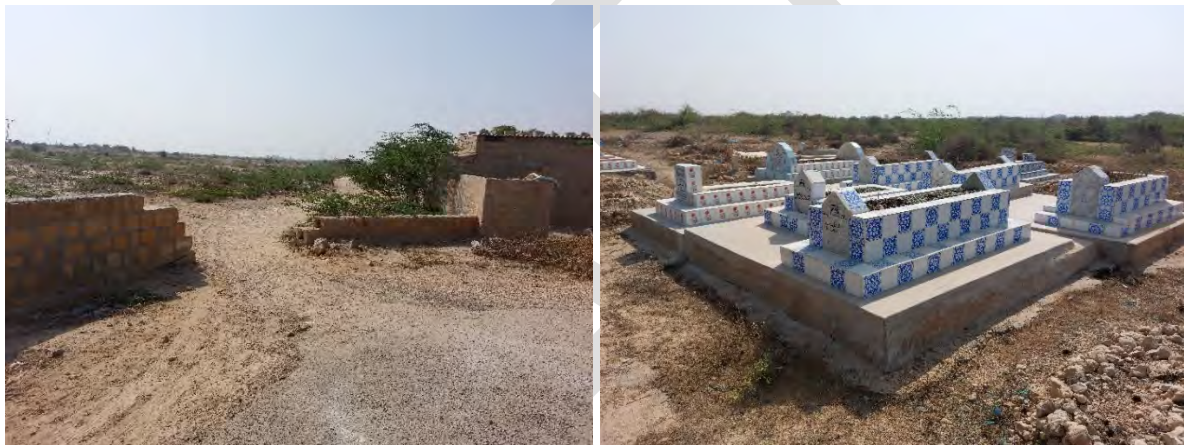
Figure 39 Left, opening in the boundary wall for the small settlement within the site.

Figure 40 Right, new burials are just inside the boundary wall to the west of the site.

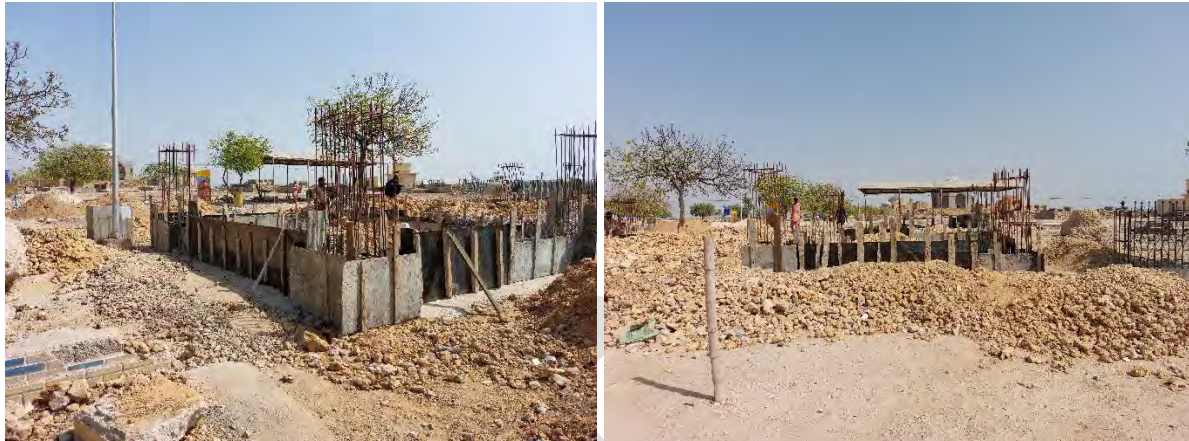
Another issue not related to the scope of this mission or the impact of the monsoon is the construction of a new entrance gate. The decision to construct this gate should have proceeded with a Heritage Impact Assessment (HIA) in line with the Operational Guidelines of the World Heritage Convention. It will be a monumental gate constructed of modern materials and will most likely block key views of the southernmost cluster of monuments.

Figure 42 The foundation of the new gate and view from the entry

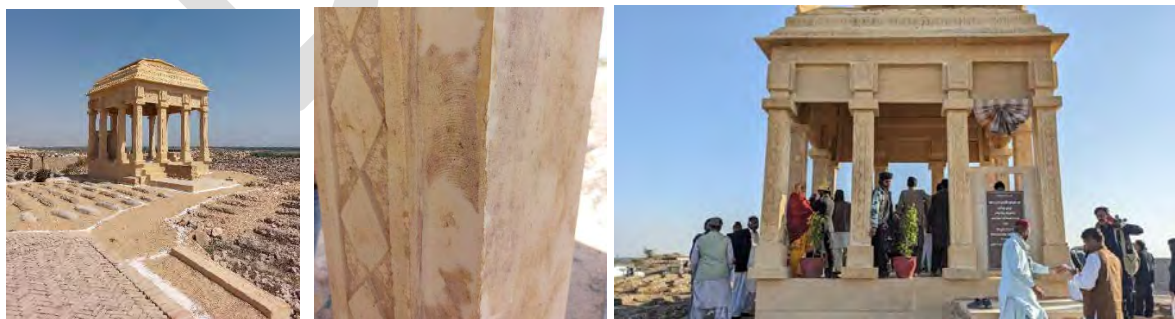
There is also a new memorial canopy tomb located midway between the southern entry gate and Jam Nizamuddin. This is to celebrate an important historian of Sindh, Mir Ali Sher Qana Ji Akher Aramgah. As with the new entry gate, the new memorial should have been preceded by a Historic Impact Assessment (HIA) in line with the Operational Guidelines. This is an effort of the Endowment Fund Trust (EFT), mentioned earlier in this report. The new monument is appropriately constructed of local stone, of which most of the historical monuments are constructed, but the execution, construction, form, and workmanship could have been improved. Construction could have served as a capacity-building opportunity for the use of traditional techniques, tools, and materials, but this new canopy was constructed with machine tools such as grinders and resin epoxy. This new memorial has proven to be popular as its inauguration was well attended by the community and continues the living aspects of Makli in celebrating a noted Sindh historian.

Figure 43 Overview of the new canopy and detail of the workmanship, right inaugural celebration (EFT).

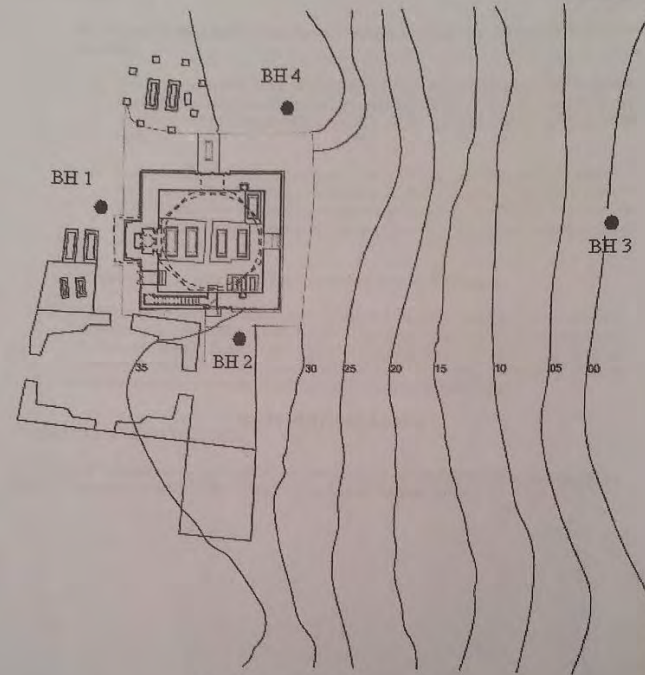
FIG 1; BORE HOLE LOCATION
GEOTECHNICAL INVESTIGATION AT JAM NIZAM AL DIN TOMB,

A total of four boreholes were drilled to the depth of 15m at specified locations, as shown in Fig-1 and EXHIBITS 1, 2, 3 & 4. Three boreholes were drilled at the level of Tomb pedestal (top of hill) while one borehole was drilled at the foot of the hill.
