**STATE OF CONSERVATION REPORT
HISTORICAL MONUMENTS AT MAKLI, THATTA (PAKISTAN) (C 143)
DECISION: 45 COM 7B.170**

Updated as of December, 2023

Field Mission Report 2022 Monsoon

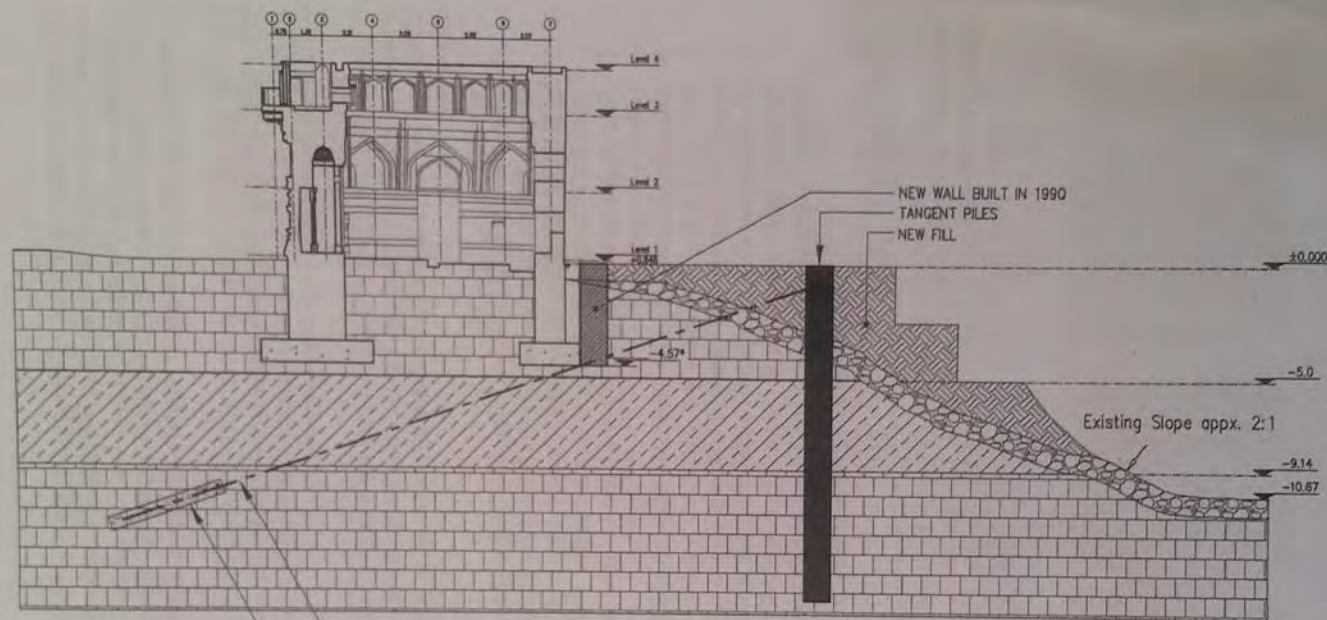
SITE SECTION

- Fig-2 presents Sectional Profile, developed on the basis of borehole logs included in this report as well as physical observations at site. The thickness of top loose debris is an estimate only. The profile shows a layer of SHALE (Pseudo-Rock) sandwiched between LIMESTONE layer at top & bottom. The physical characteristics, as determined from laboratory tests, show that the SHALE is essentially of Silty in nature and lacks cementation/cohesion. Such formations, when exposed to atmosphere, are prone to degradation and slake to soil like formations. It is our opinion that originally the Tomb was placed at a distance well clear of the edge of slope (on East side of Tomb). The Rock on the east side eroded over period of time with the result that Tomb is just at the edge of slope. We believe that the exposure of SHALE to atmosphere resulted in its slaking into soil like formation which eroded away over period of time, leaving top LIMESTONE overhanging. The cantilevered LIMESTONE collapsed and drifted away along the slope. The repetition of this process has produced the present slope on east of Tomb. The process of erosion of Rock on east of Tomb and development of present slope is illustrated in Fig-3.
