Report to UNESCO: Gebel Barkal and the Sites of the Napatan Region

National Corporation for Antiquities and Museums, Sudan Dr. Abdelrahman Ali January 25, 2019 Compiled with the assistance of Dr. Geoff Emberling, University of Michigan

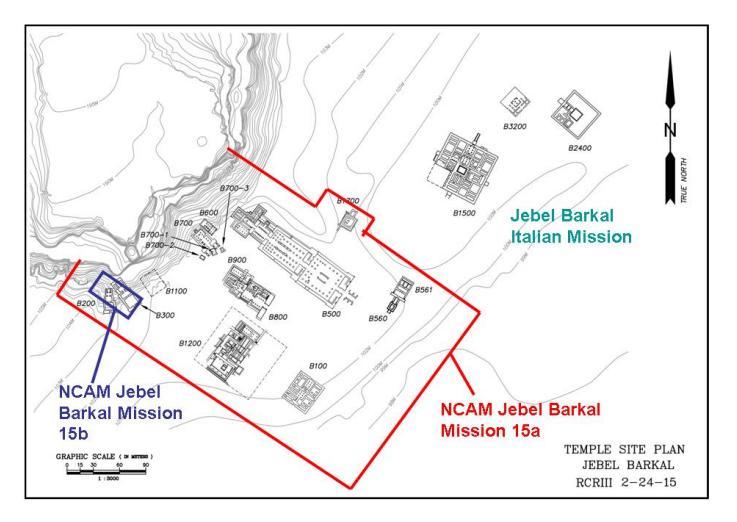
Approximately 260 x 300 m, extending from the edge of the Jebel Barkal cliff in a southeasterly direction to the old roadway in front of the mountain, incorporating all of the major temple or palace structures, from B 500, B 1700, and B 561 on the northeast side to B 200, B 1200, and B 100 on the southwest side. (The NCAM Mission has assumed responsibility for investigating, recording and publishing the rock cut chambers of the Mut Temple (B 300) and of undertaking steps to preserve and protect them (Fig. 1).

Figure 1: Site Map of the Jebel Barkal Temples, showing the licensed areas of the Missions

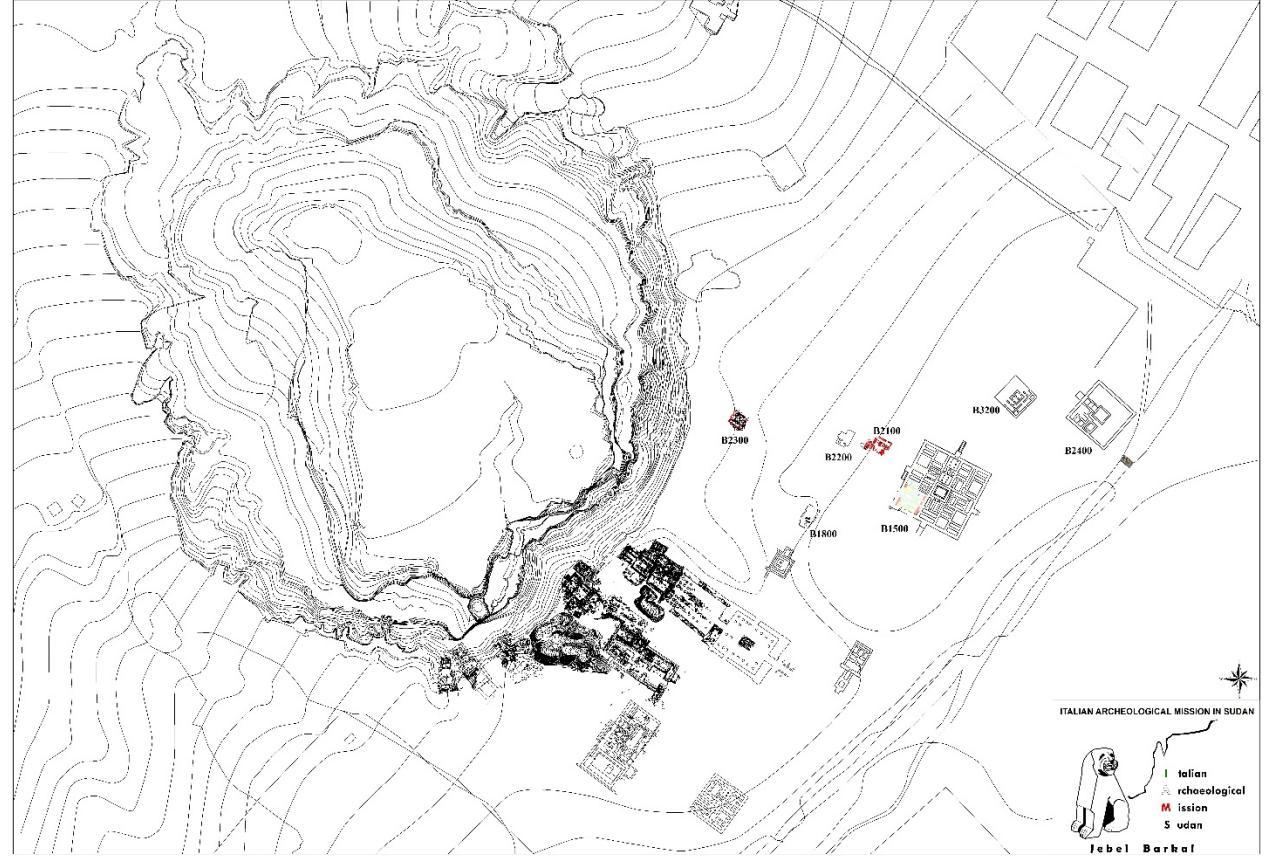
GEBEL BARKAL GENERAL SITE PLAN

Figure 2: Map of the monuments excavated in the Meroitic Royal City by the Italian Archaeological Mission in Sudan – Jebel Barkal.

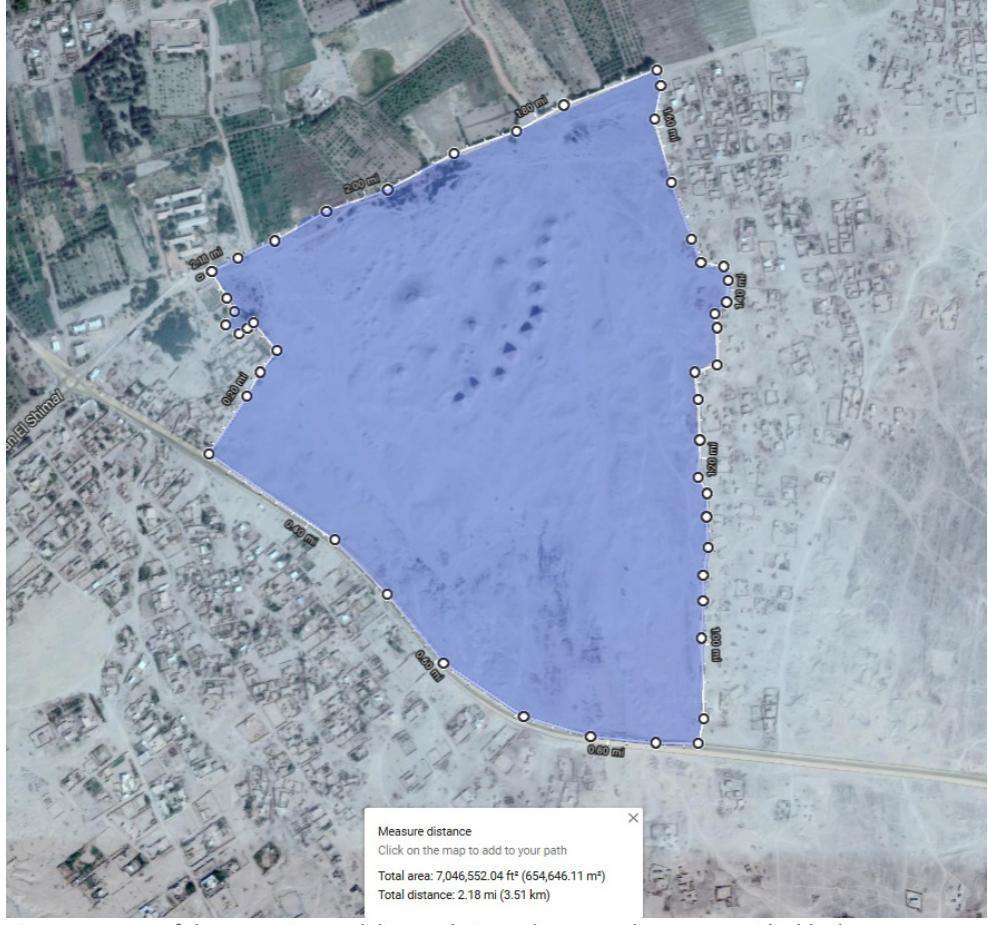
Figure 45: Map of the approximate delineated site and protected area at Nuri (in blue)

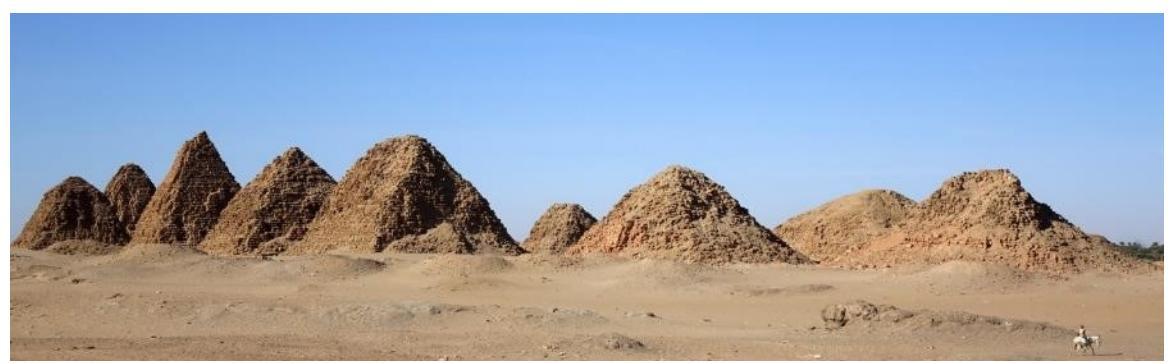
The features above ground at Nuri reflect their considerable age, exposure to the elements, and long history as items of curiosity to people living or passing through the area. The use of comparatively soft stone with coarse grains in construction of the monuments has resulted in significant erosion, primarily as a result of a harsh natural environment. Faces of monuments exposed to the northeast are in the worst condition, being constantly sandblasted by the strong winds, which blow N/NE to S/SW for most of the year (Fig. 47). Additionally, these same monuments tend be have been built near the end of the site's primary period of use and appear to have been of lesser initial quality of construction than those on the western (better protected) portion of the site. Heavy rains have also contributed to the denuding of the monuments, leaving some to appear more as mounds than pyramids. Human activity in the intervening ca. 2500 years has not, as a whole, improved the condition of the ancient structures.

Figure 47: N/NE to the right of the image; note the poorer state of preservation for monuments taking the brunt of the prevailing winds

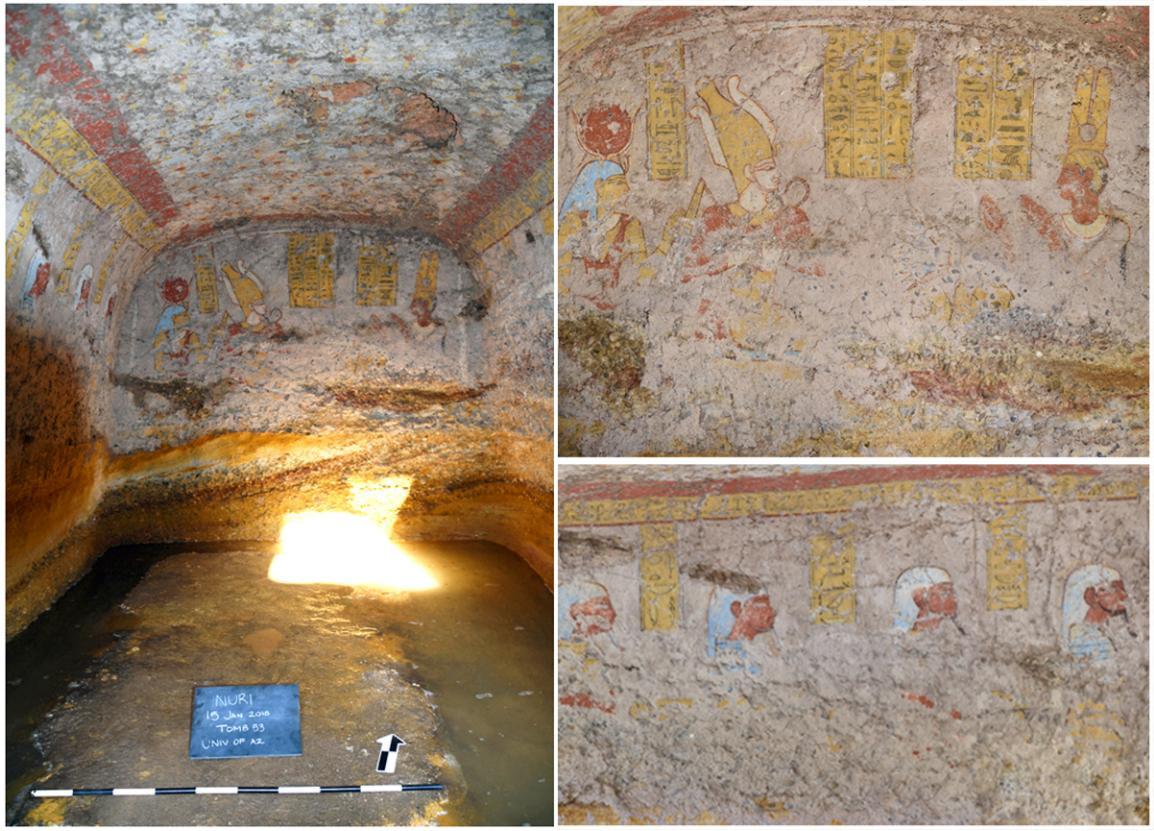
In 2018, three subterranean features at the site were re-excavated and entered in order to evaluate their condition. These three features, almost entirely devoid of material culture as a result of Reisner's thorough work in them, were in better condition than was anticipated. For example, a considerable amount of previously unknown text and artistic content was found in Nu. 53, the tomb of Yeturow (Fig. 48). The tomb paintings that were expected were more vibrant and better preserved than as suggested in records and publications resulting from Reisner's work. Each tomb very closely matched the general measurements taken in the 1910s, suggesting they have not degraded (e.g., collapsed, spalled). The subterranean features excavated appeared to have been untouched since Reisner.

Figure 48: Nu. 53 – the tomb of Queen Yeturow

However, of concern for all subterranean features at Nuri is rising groundwater (see Fig. 48). It appears that the groundwater levels at Nuri have risen three to five vertical meters since Reisner's excavations. The water level rise in the two-plus millennia from their original creation to Reisner's excavations appears to have been approximately 0.5m total. The exponential recent rise is likely due to climate change and the construction of the Fourth Cataract dam. It is likely that all of the large and deep tombs (i.e., king's burials) at Nuri are now fully submerged. Though submerged, this does not put them out of reach for archaeological and scientific inquiry, but complicates such an endeavor.

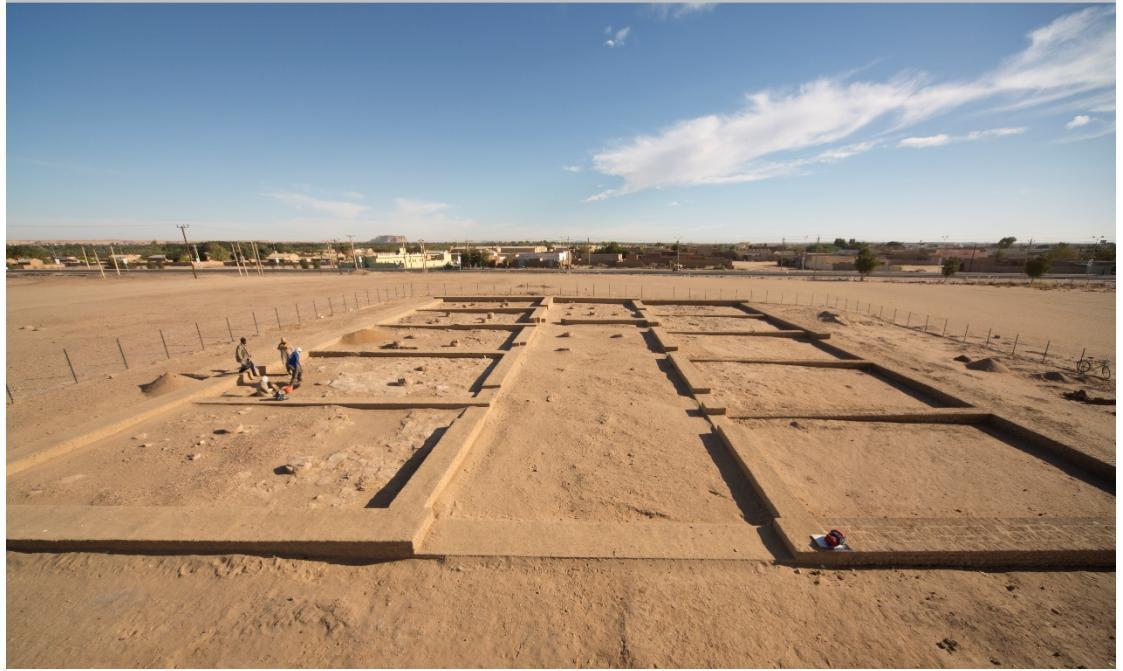
In 2015 we were able to fully restore the building SA.K 300 (which we had excavated in previous years), and to erect around it a protective metal fence allowing people to have a full view of it (Fig. 49). The results have been positive. Three years later, the building appears to be in good condition. In addition to the restoration work, the 3D reconstruction of the building helps the public to understand both its structure and purpose (Fig. 50).

Figure 49: SA.K 300 with metal fence

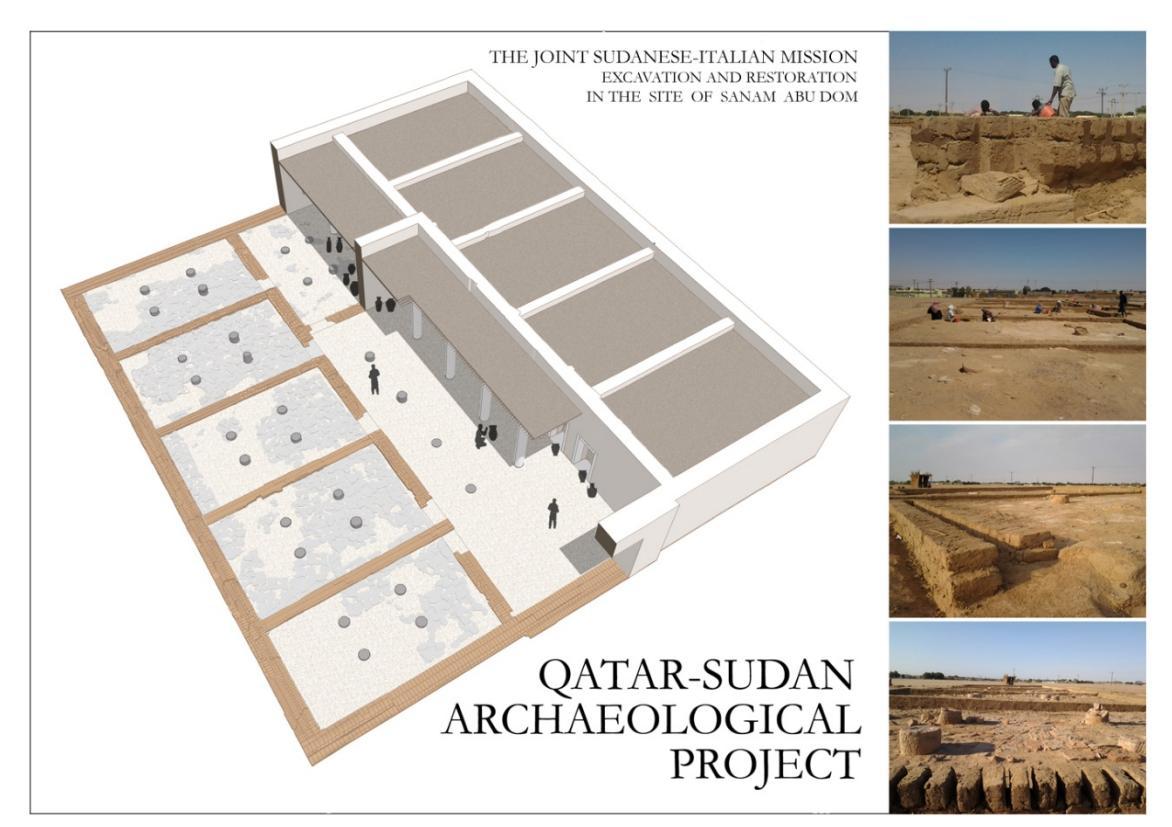
Figure 50: SA.K 300 plan and reconstruction

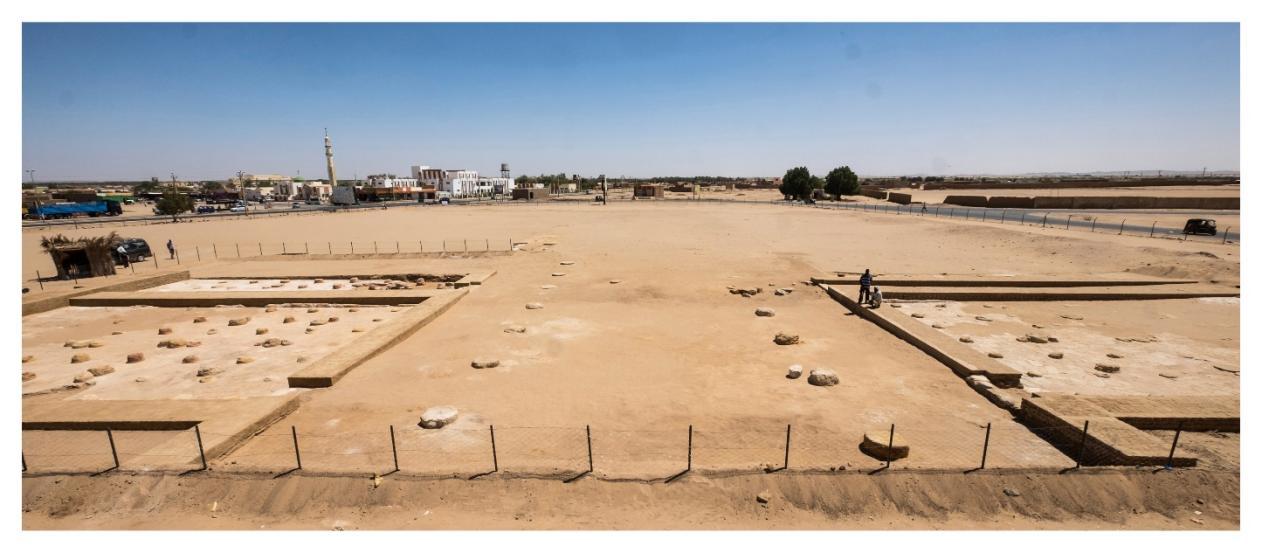
comes up to ground level and at its deepest is only 50 cm below it. This is why the structure has deteriorated so badly, in addition to the fact that both sandstone and mud bricks are in themselves extremely fragile materials. The TST (total station theodolite) survey undertaken the first year of our activities, yielded results which, over the years, have had to be modified.

Figure 51: The Treasury showing porticos

We began excavating the central north and south rooms, 104N, 104S, 105N, 105S with the porticoes and courtyard in between (Fig. 51). The conditions in which they have been found were critical. The South walls had been completely plundered along with about half of the North and West walls as well as the corner between these two walls. The restoration work has been significant: walls have been completely rebuilt thus preventing the stone slabs of the floors from sliding down.

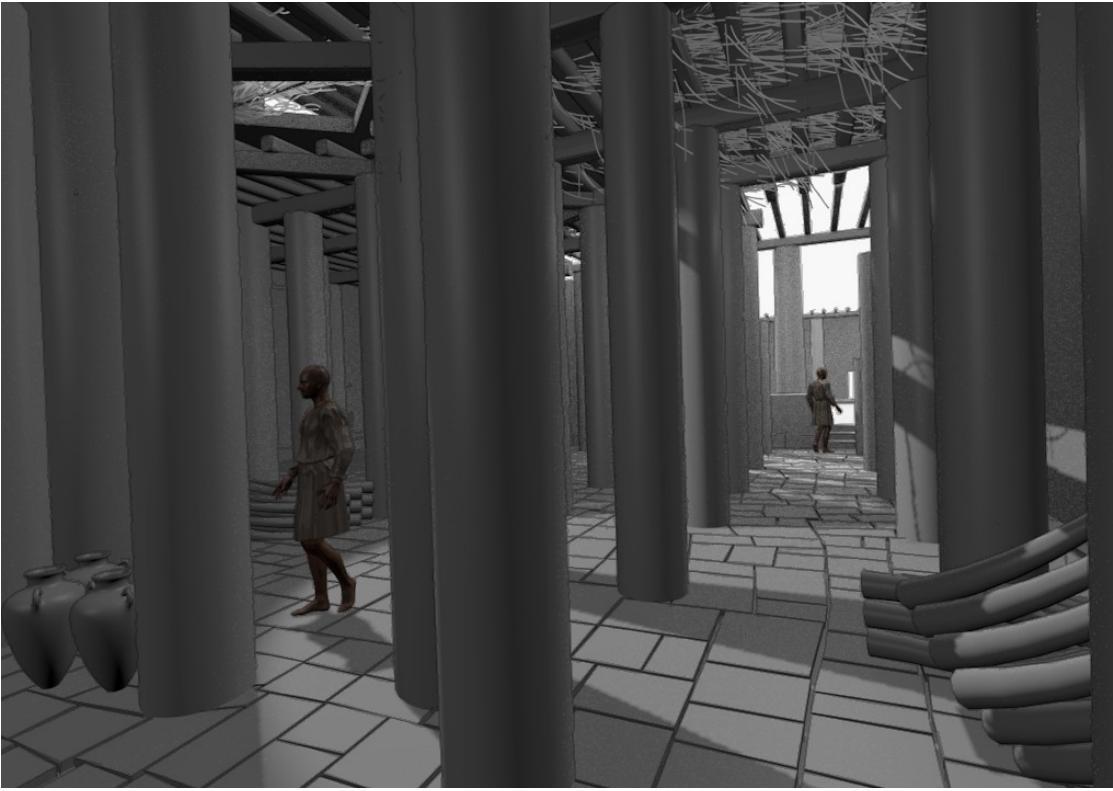
A 3D reconstruction has been created to help understanding the whole structure (Fig. 52).

Figure 52: 3D reconstruction of Room 8 in the Treasury

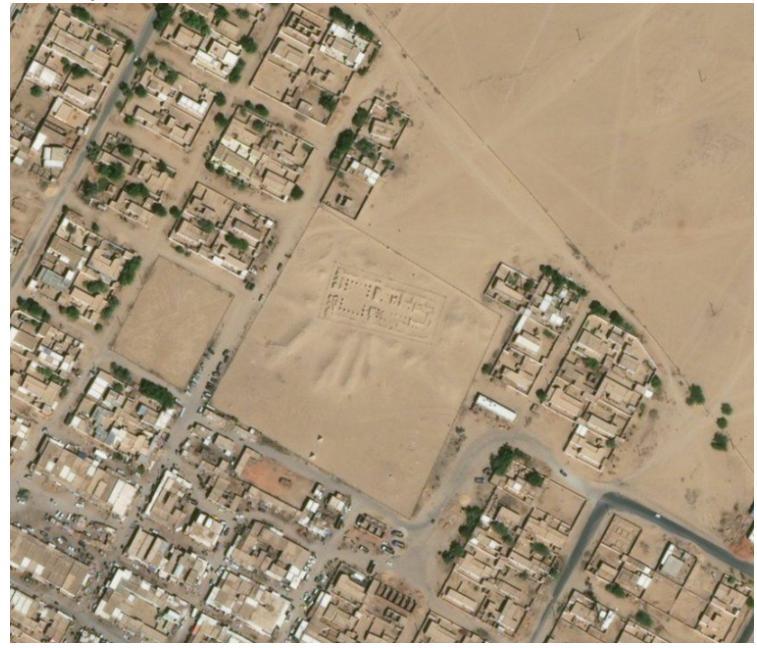
Figure 54: Sanam temple

The site comprises a sandstone temple and surrounding areas, as delineated by the NCAM-installed fence seen in Fig. 54. The temple is mostly covered by windblown sand, which protects it from environmental and other damage; those parts of the temple still exposed have been subject to weathering and loss, due to the friable quality of the local sandstone from which the temple is constructed. The walls stand to a maximum height of approximately 1.8m when cleared of sand, with a maximum of approximately 1m exposed above the sand.

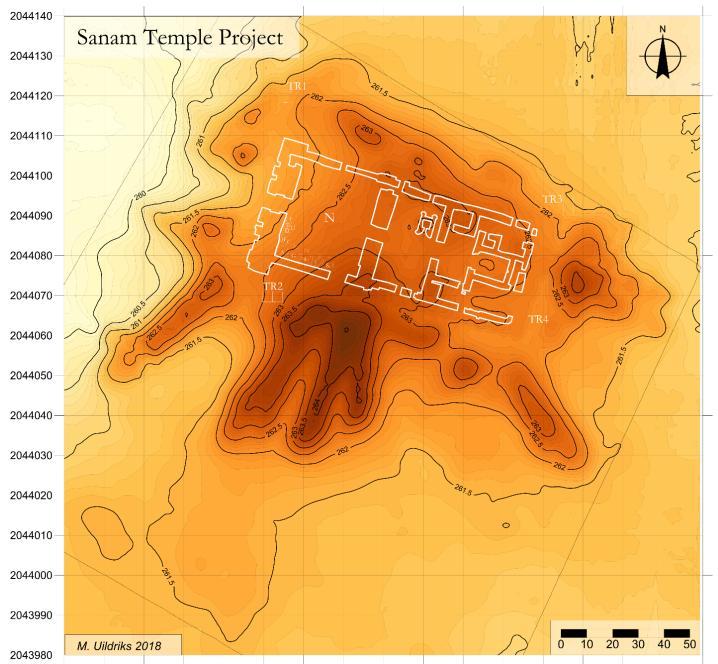
375240 375260 375280 375270 375280 375290 375300 375310 375320 375330 375340 375350 375360 375360 375380 375380 375400 Figure 55: Plan of Sanam Temple

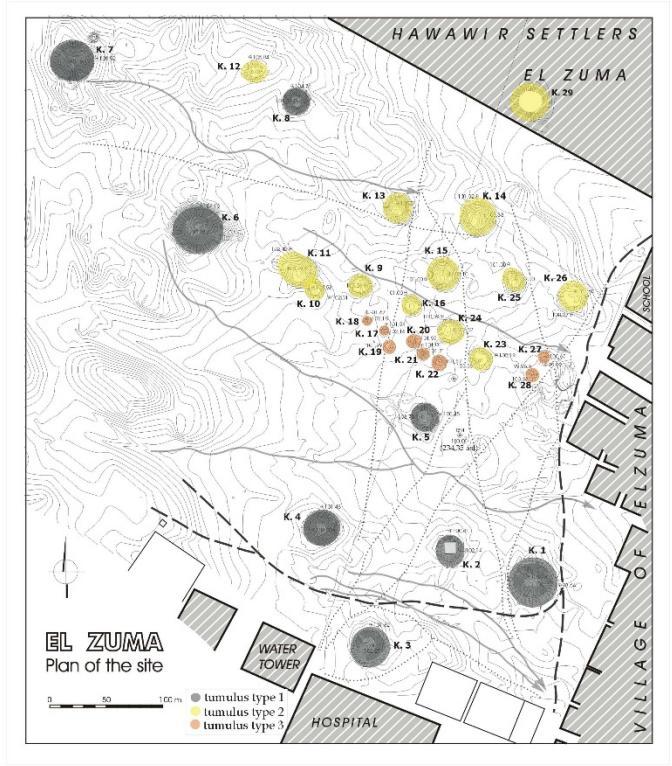
Figure 58: General plan of the El-Zuma site

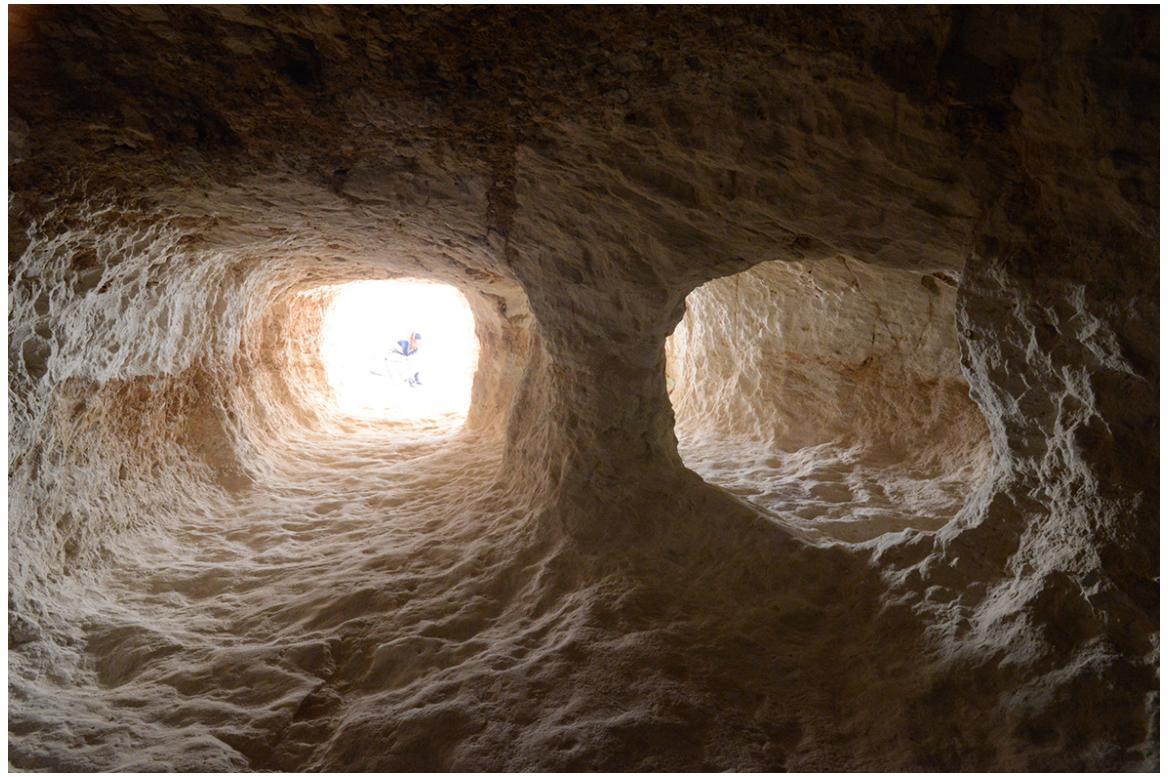
Unfinished work that is still waiting is the exploration of two highly important burial chambers located in tumuli (T.6 and T.7). Exploration of these two chambers, which is expected to throw more light on their nature, needs special preparation of safety measures, which is an expensive operation. Yet, so far there is no funding on the horizon.

Figure 61: View of the tunnel of T.6, looking south, photo A. Kamrowski

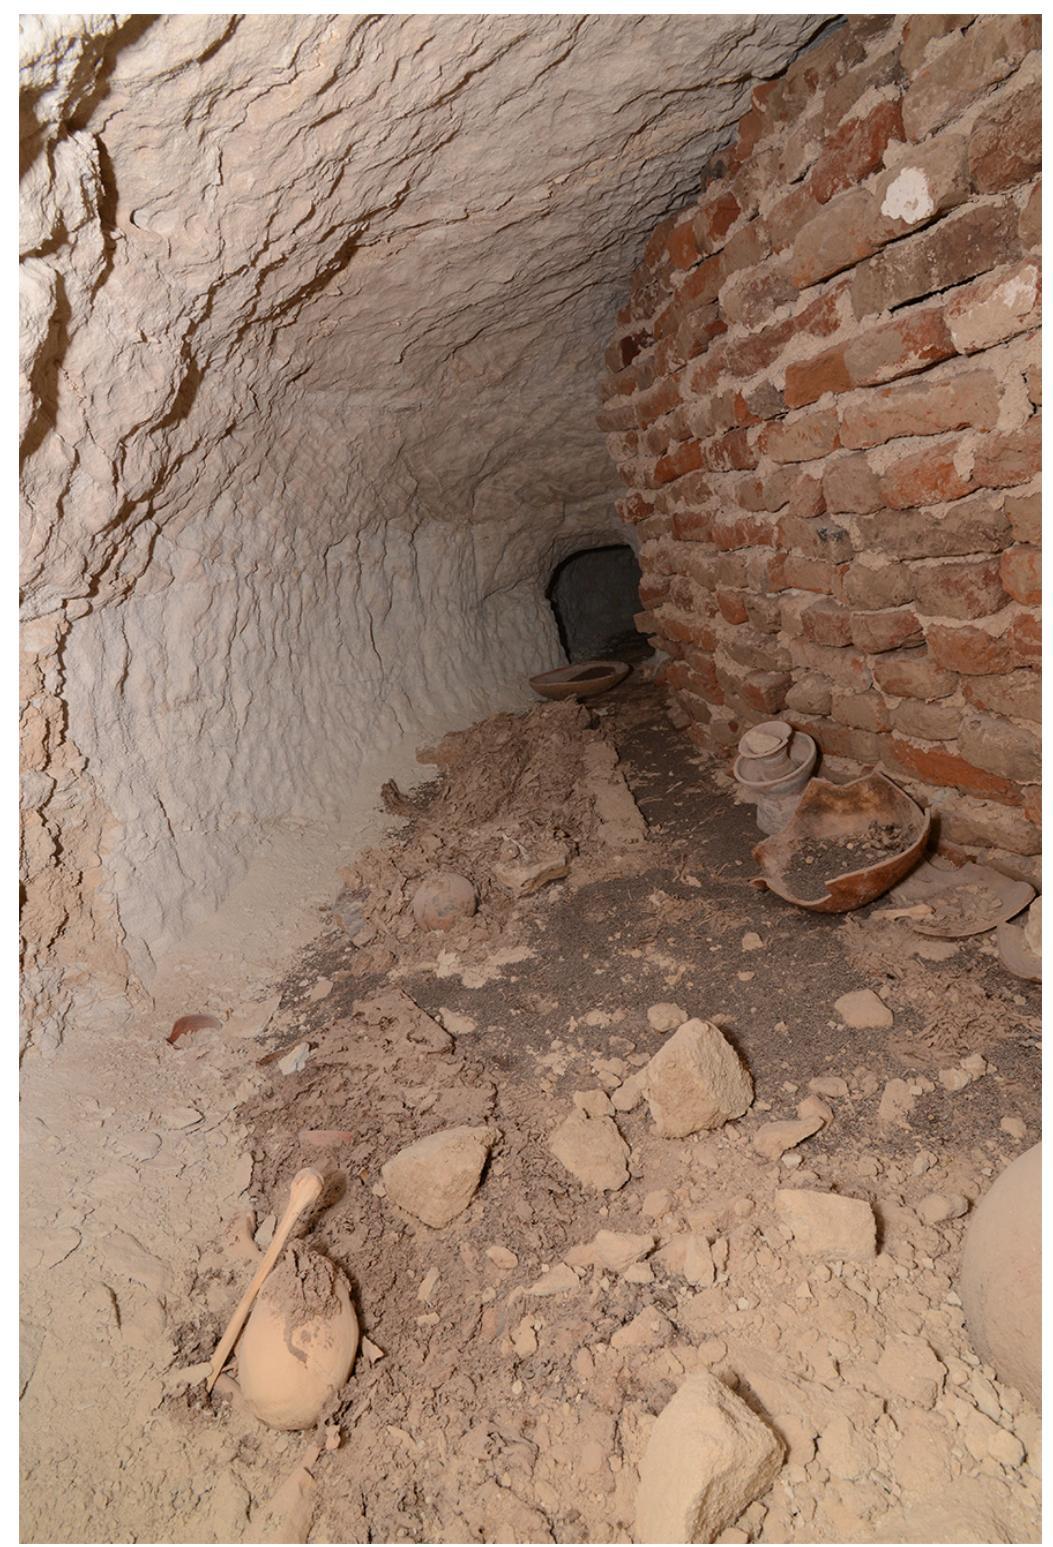
Figure 62: T.6, view of the unexplored burial chamber, photo A. Kamrowski

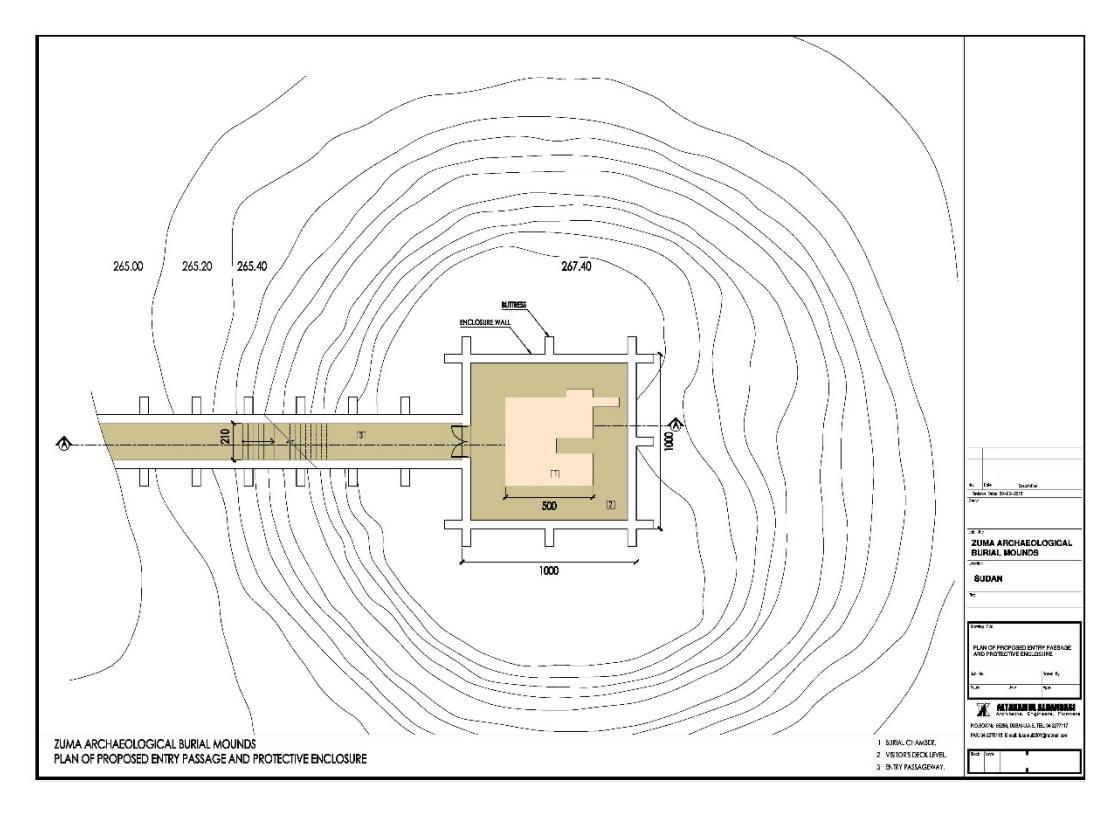
Figure 74: Reconstruction of a tumulus (plan), Altakamul Alhandasi Architects and Engineers

Beside the research program, a major project for conservation and reconstruction of El-Zuma burial field is planned. The project aims at turning this important site into an archaeological park and cultural center to serve local inhabitants of the area and tourists as well. The rehabilitation plan includes building of a museum on the site, all needed infrastructure and reconstruction of the excavated tumuli.

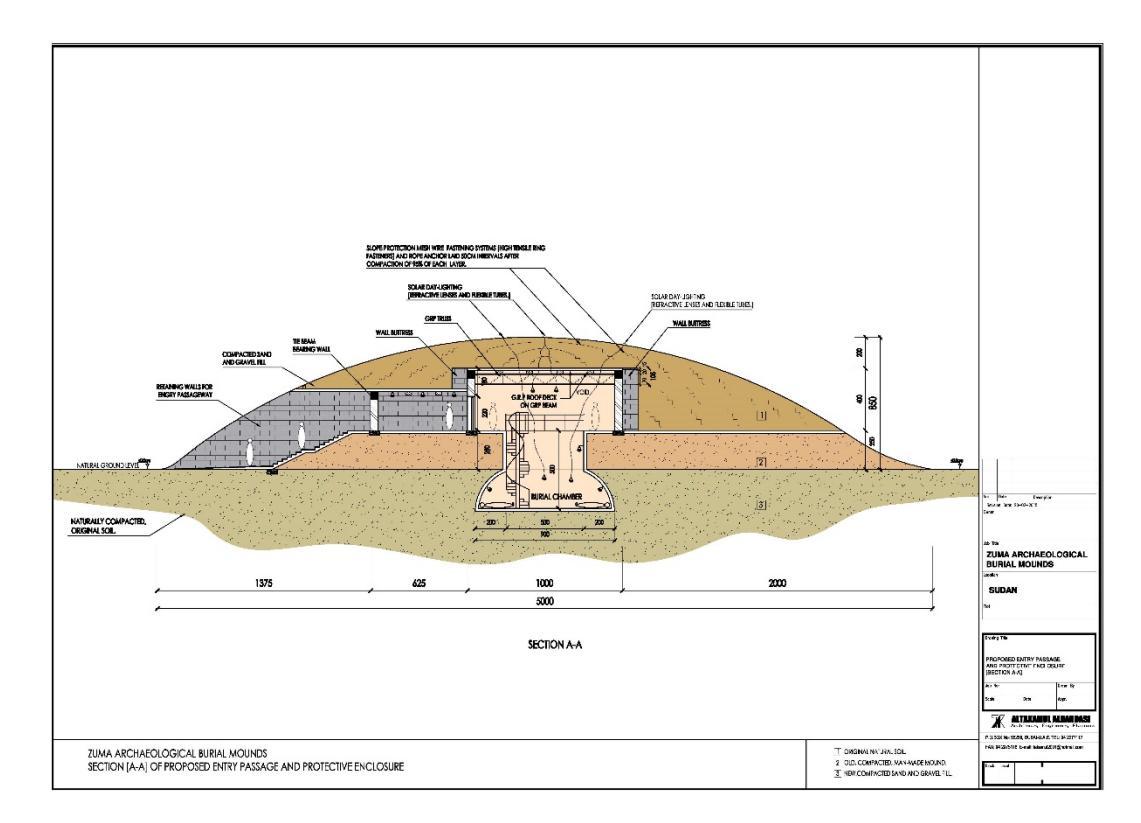
Figure 75: Reconstruction of a tumulus (section), Altakamul Alhandasi Architects and Engineers
