### State of Conservation report of Sassanid Archaeological Landscape of Fars Region World Heritage Site

Tehran 2020

### SOC of Qale Dokhtar

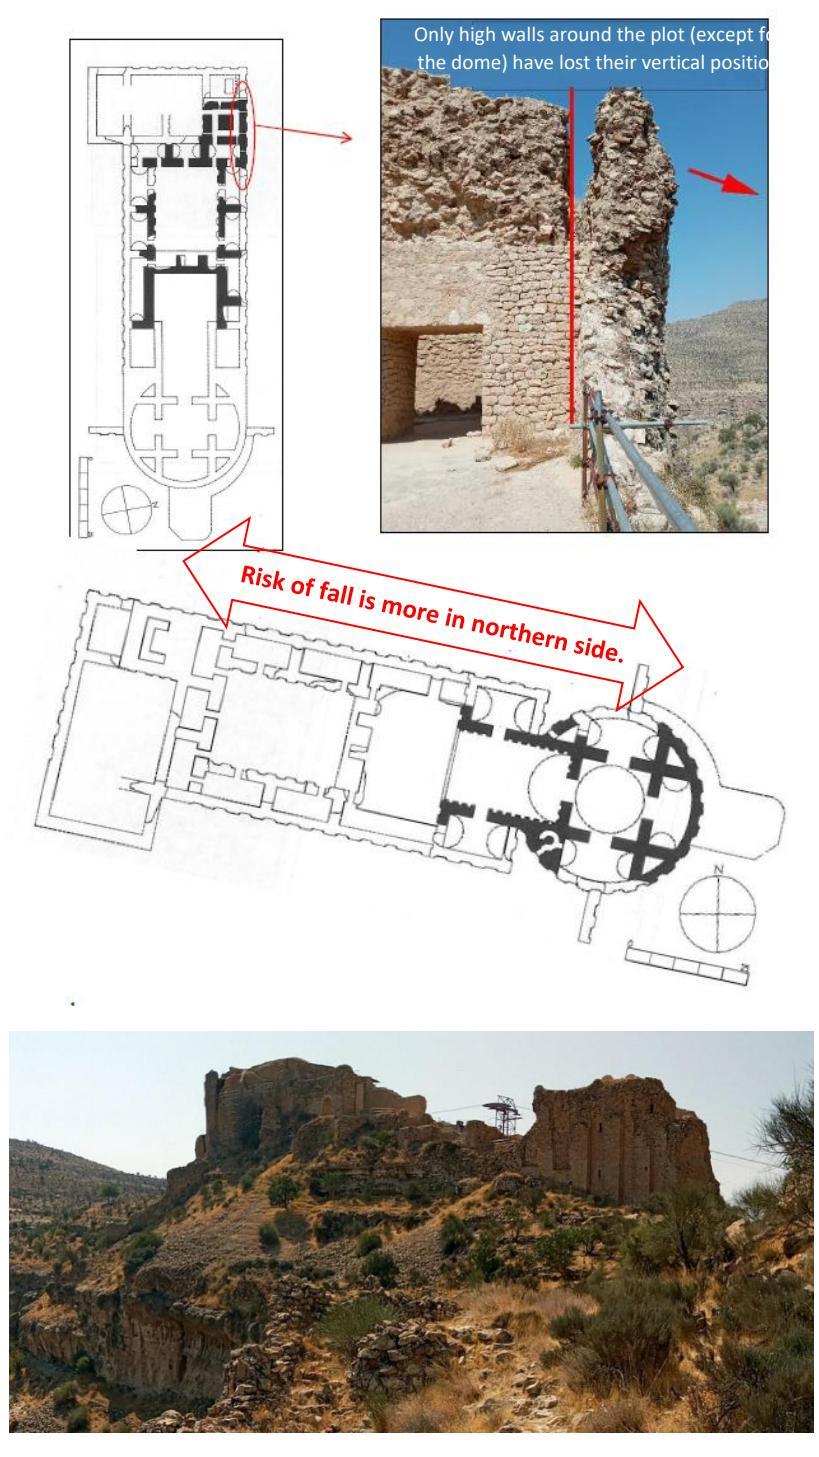
Northern Front of Fort

Over time, the rocks slid down and foundation and floor of the fort lost their strength. Slope of the mountain in this side is significant and therefore, this problem needs to be addressed.

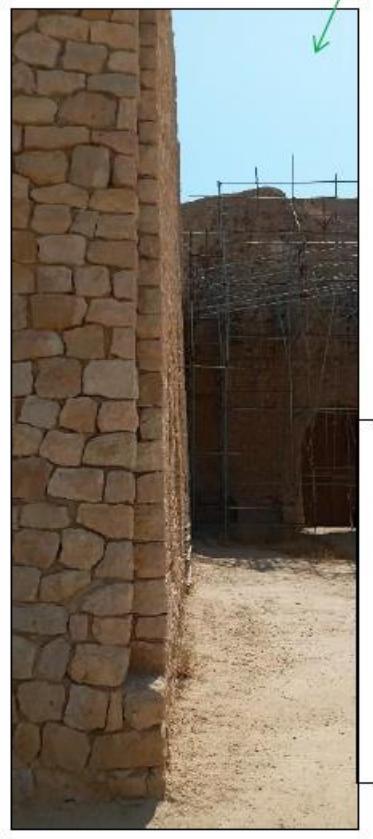
Walls of the portico are no longer vertical and they should go through emergency conservation operation

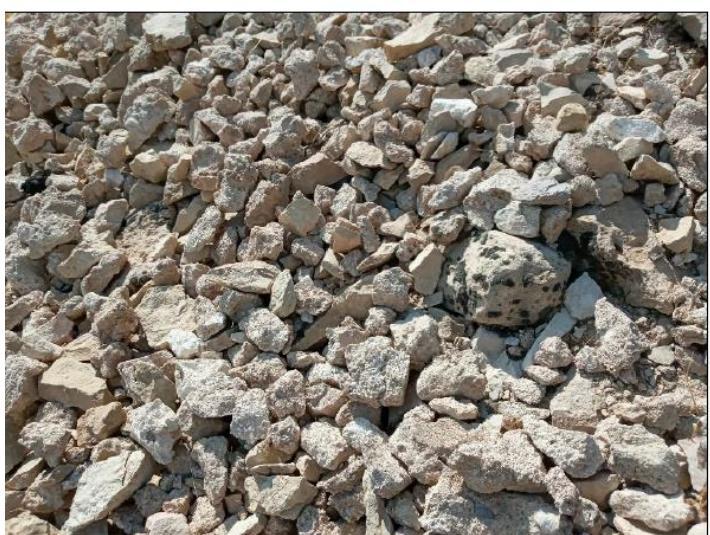
Parts of the fort's body, especially its northern side, are unstable and they are experiencing emergency conservation operation.

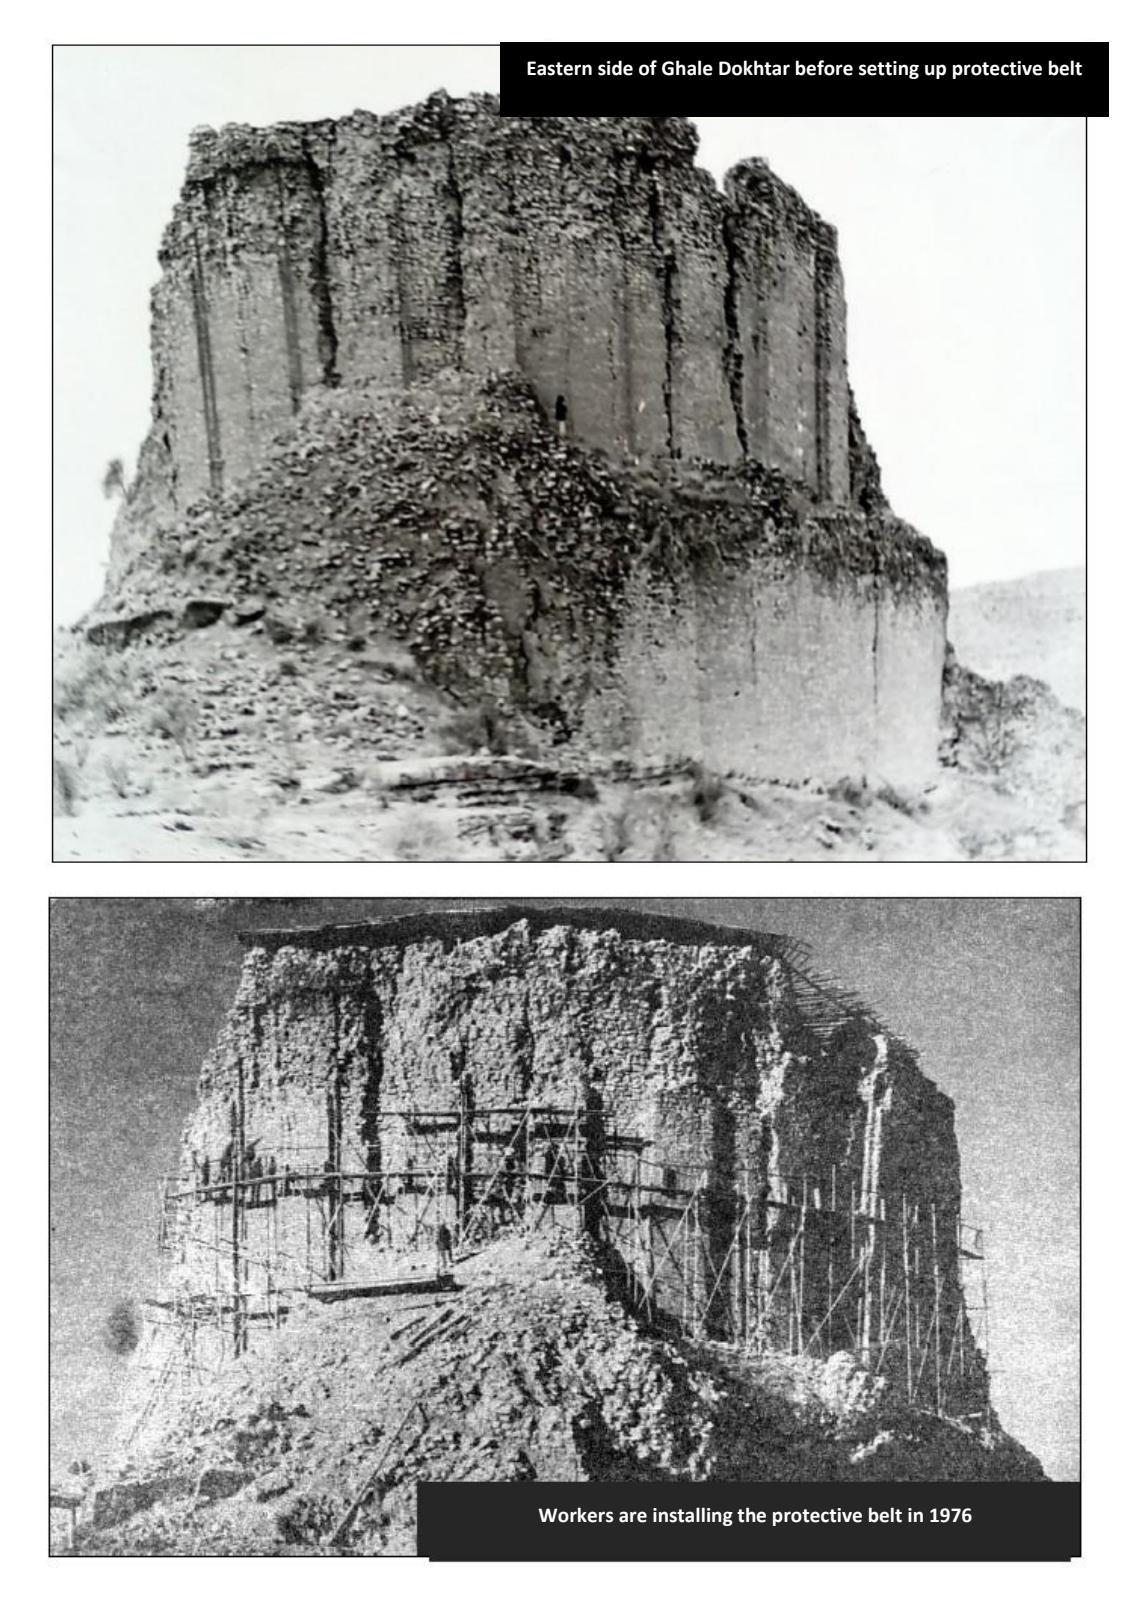
### **Protective Belt**

In 1976, a protective belt was set up by a Swiss group around the dome. Now, parts of the wall require structural and performance recovery.

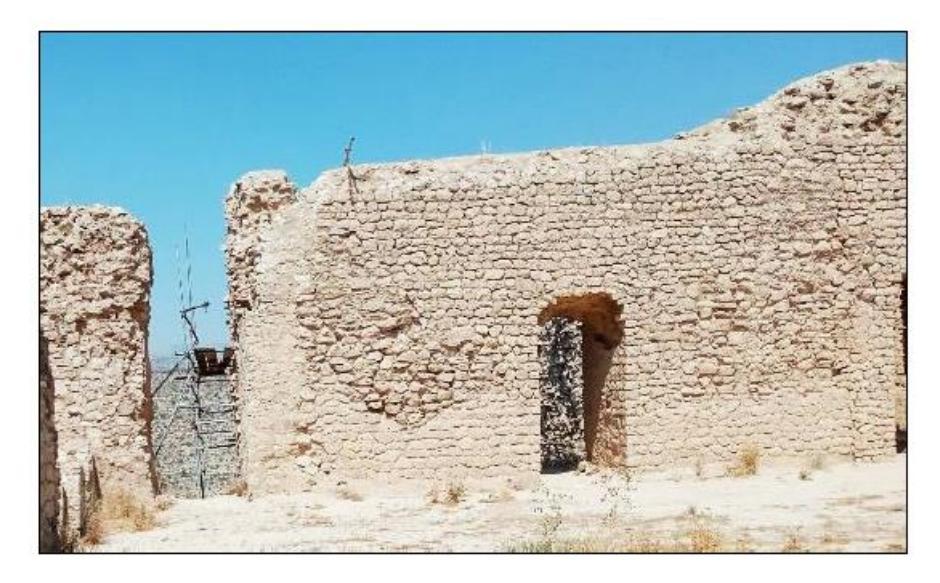
**Restoration of Stones**

Over the years, one of the frequent measures has been restoration of stone. Repair of existing sections, reconstruction of destroyed sections and laying usable stones have been done in many corners of the property. Moreover, skill of local workers and masons in laying stones with gypsum mortar has increased gradually due to years of restoration of Sassanid properties in Firuzabad and it is a point of strength.

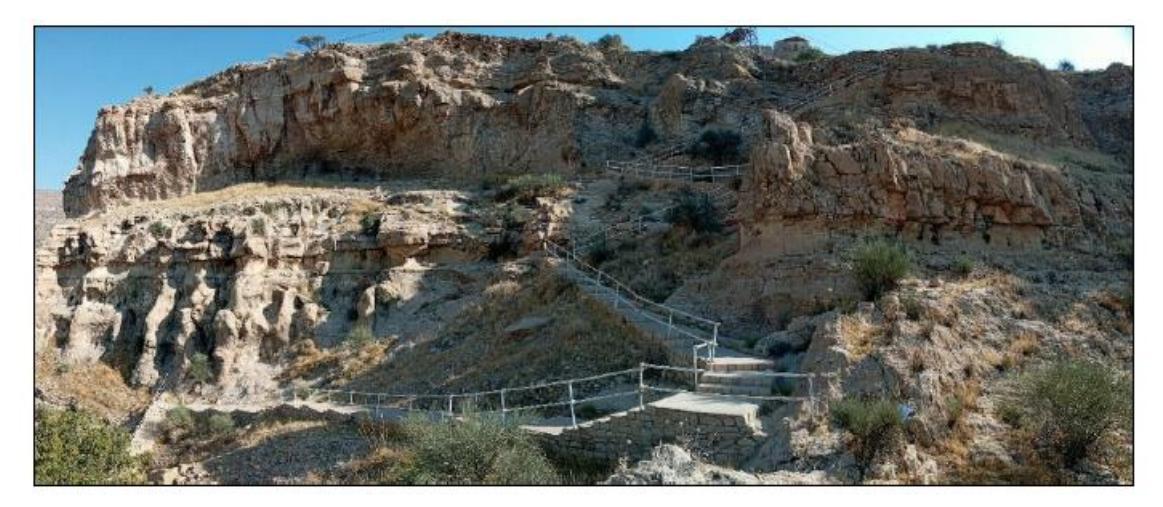
### Visit Routes

Definition and reconstruction of tourists' visit rout was done by improving the tough paths of accessing the fort by setting up stairs on its western side.

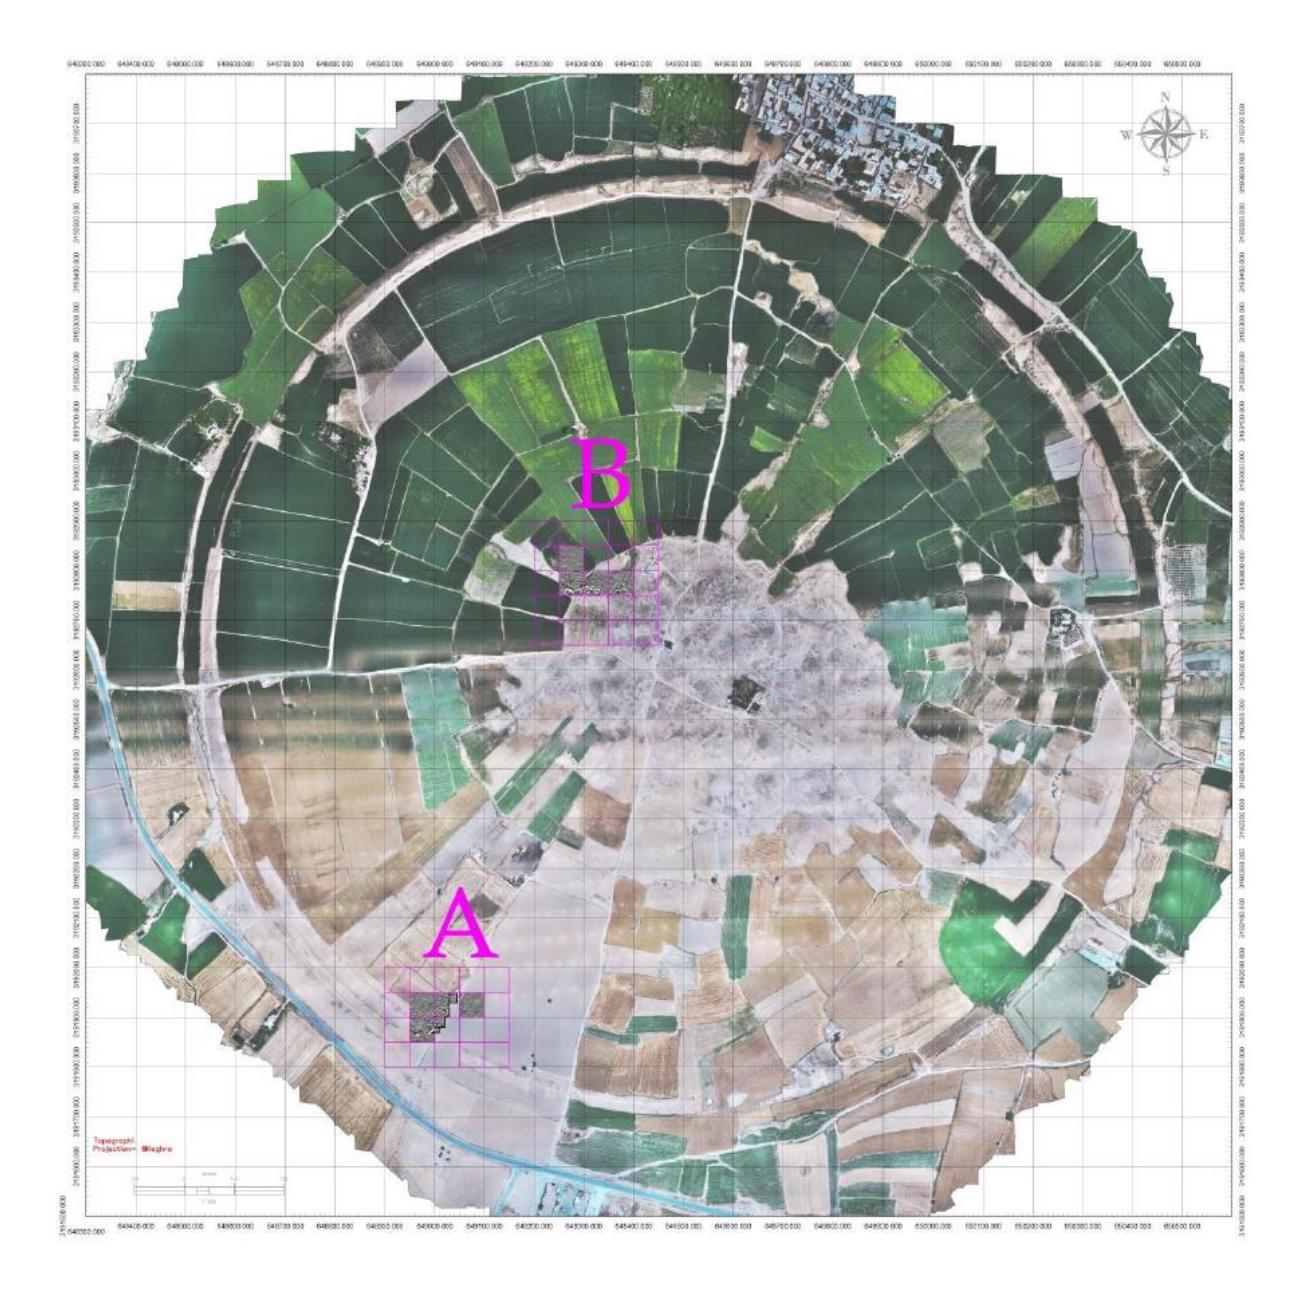
Figure.2-Documented grid of Goor City: Geophysical survey of Site A and Site B.

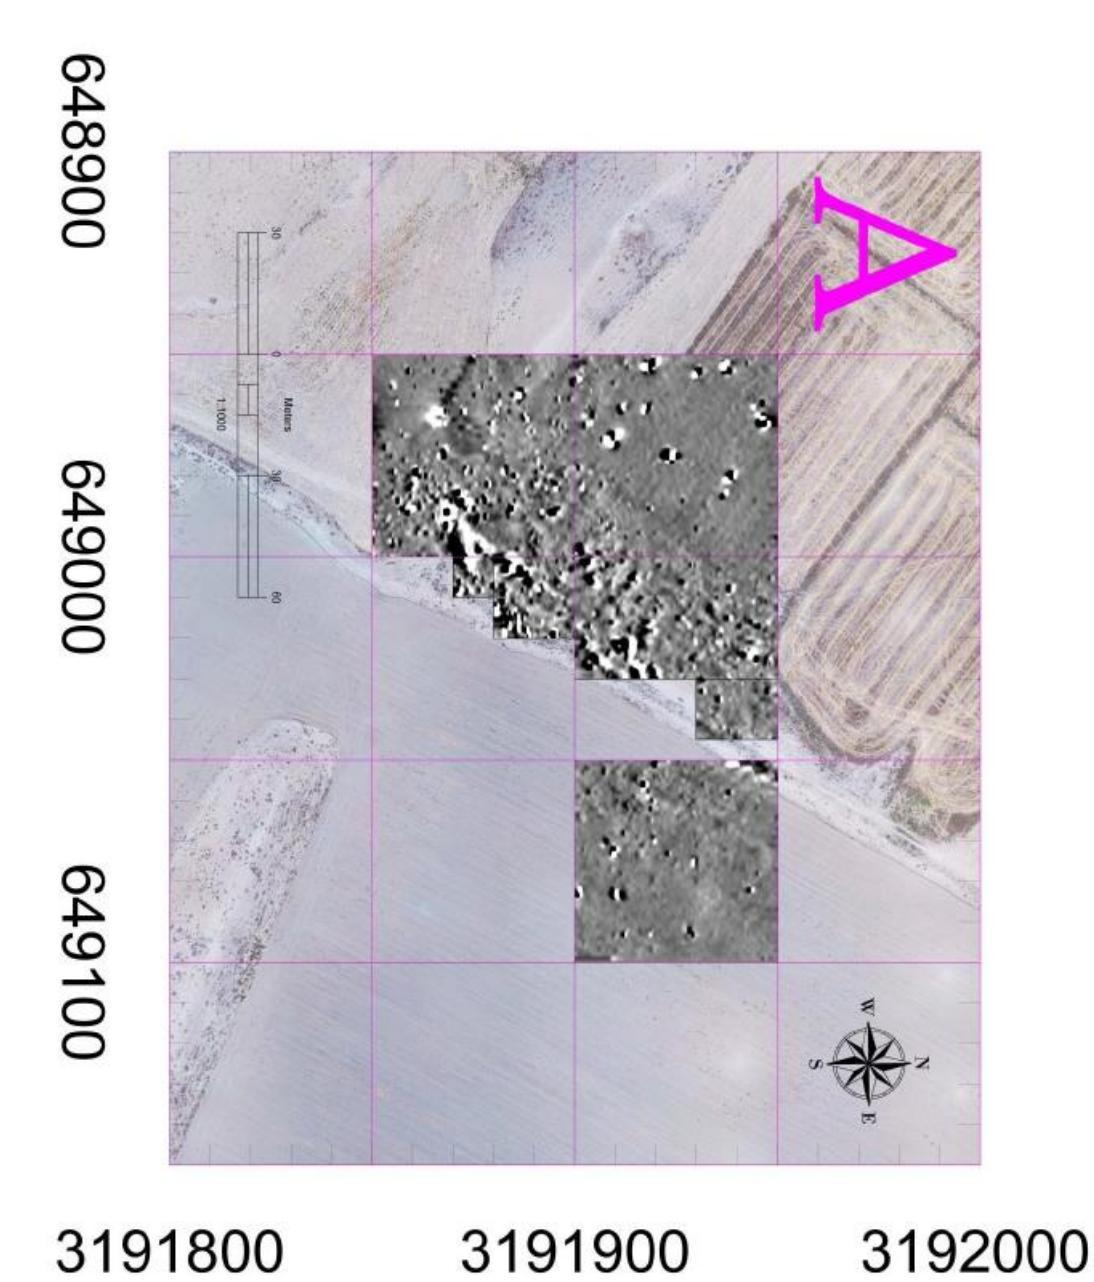
The magnetic survey results for both sites revealed significant anomalies there. In site B which covered a part of the fencing wall, linear anomalies were found which might be associated with architectural constructions but their exact nature cannot be determined due to the sheer extent of destruction (building roads, farming lands and destruction of likely structures in the site). There were many bipolar anomalies in the site, too which were suspected to be due to heated sections. The anomalies could be related to accumulation of heated materials, bricks or ruins of architectural structures. In the central part of the second site, the revealed anomalies pointed to likely foundations around the central part of the city especially the circle-shaped structure. The latter anomalies require further surveys and conservative measures. Resumption of magnetic surveys for finding other remains of the circle-shaped structure is significant since there are farming lands and agricultural activities going on in this site. Over the farm lands, no regular patterns of architectural plan were found but the sheer volume of ruins suggest that there were architectural structures over there which got destroyed over time. Multiple large and highly magnetic bipolar anomalies in this site suggested that there was either stacked-up ruins or a heated structure below the surface.

Figure. 3-Magnetic map of Site A and its overlap with aerial image of the site (Goor City, Firuzabad).

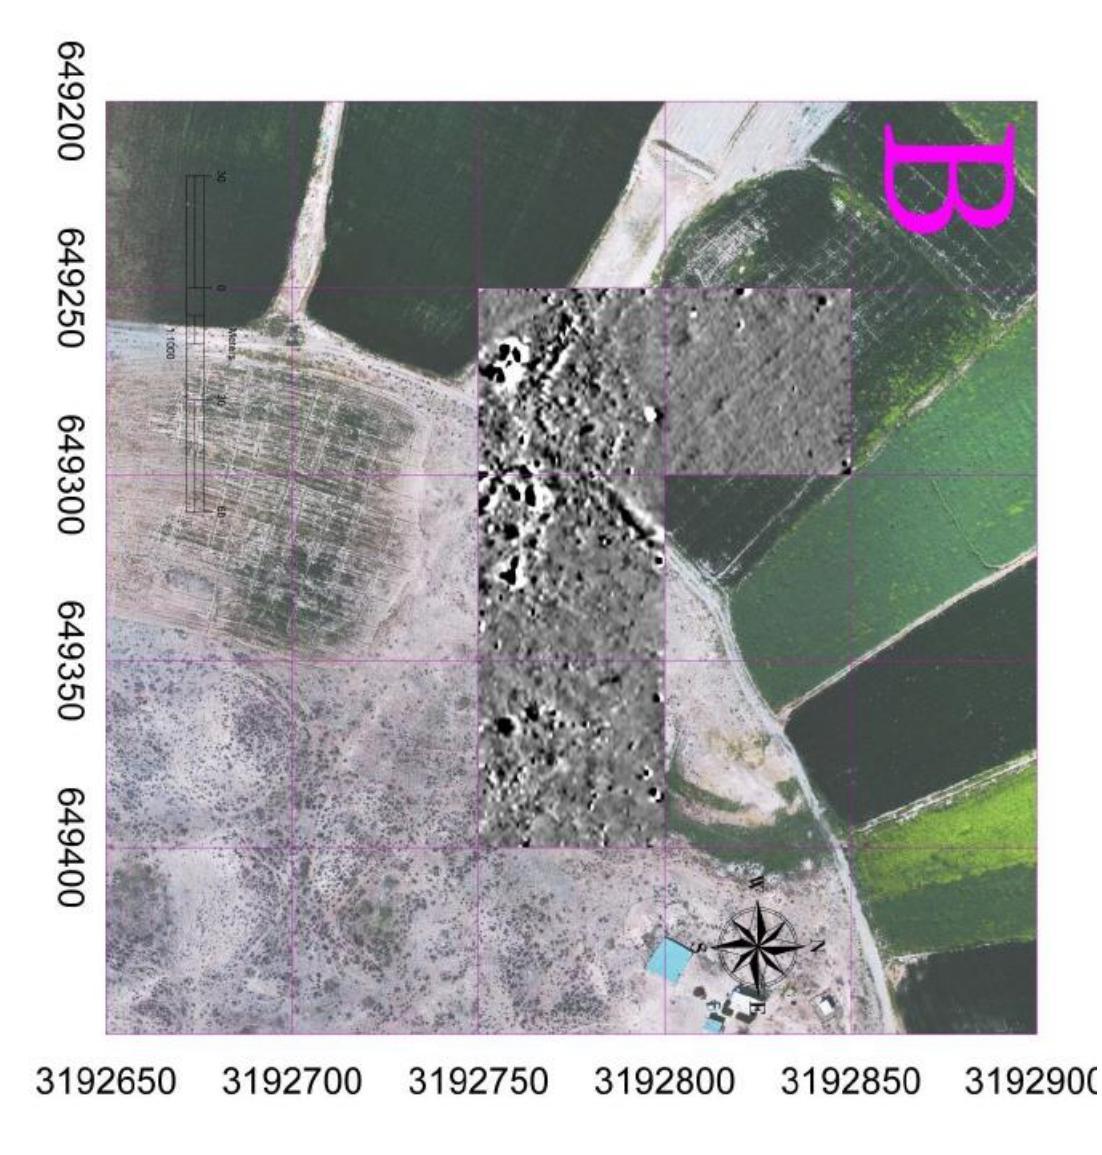
Figure. 4-Magnetic map of site B and its overlap with the aerial map (Goor City, Firuzabad).
