**ON THE ICOMOS REACTIVE MONITORING MISSION TO WORLD**

**UM ER-RASAS (JORDAN)**

**(30 March – 3 April 2005)**

**Reactive monitoring mission to Um er-Rasas (Jordan)  
MISSION REPORT**

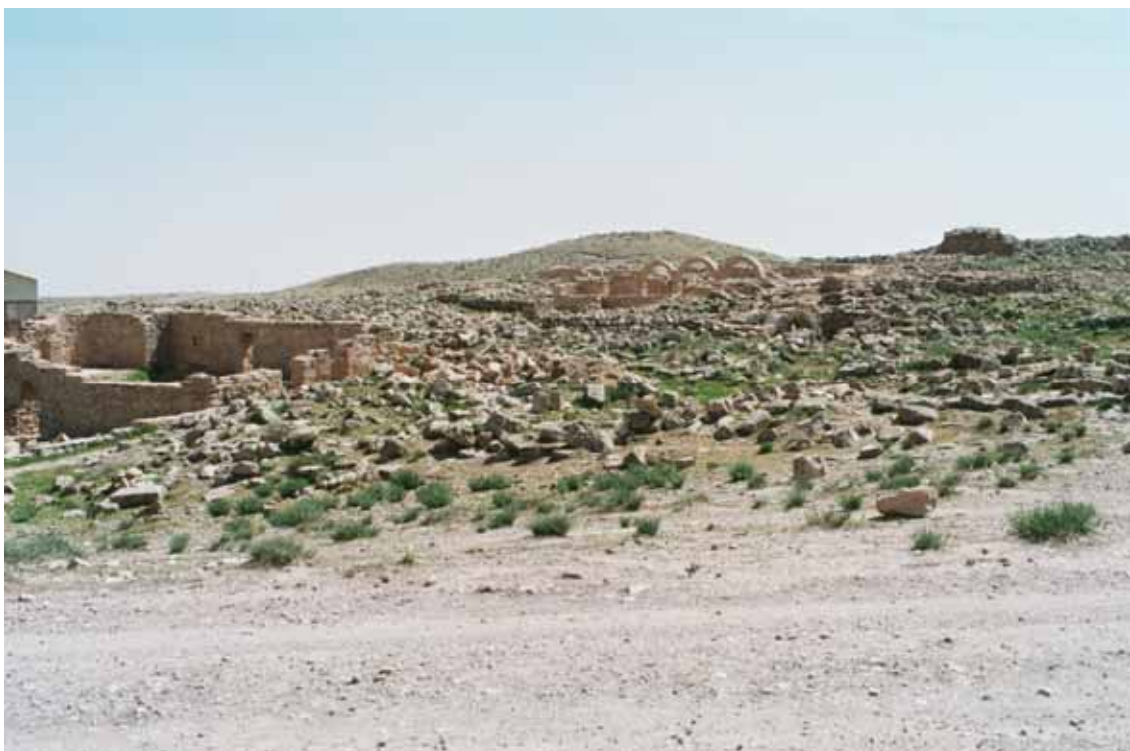
- b. the northern settlement area, which extends over 6 ha, includes several churches from the Byzantine to the Umayyad period (fig. 1). The only excavated structures on the site are for the most part churches: they show significant, superb mosaic floors. St. Stephen's Church, in particular, has the largest and probably the most complete of Jordan's church mosaic, showing a representation, and identification, of ancient towns in Palestine, Jordan and Egypt. Bedouin families occupied this area during the past 150 years leaving characteristic traditional houses in the site (fig. 3).

Fig. 1 – the northern settlement viewed from North

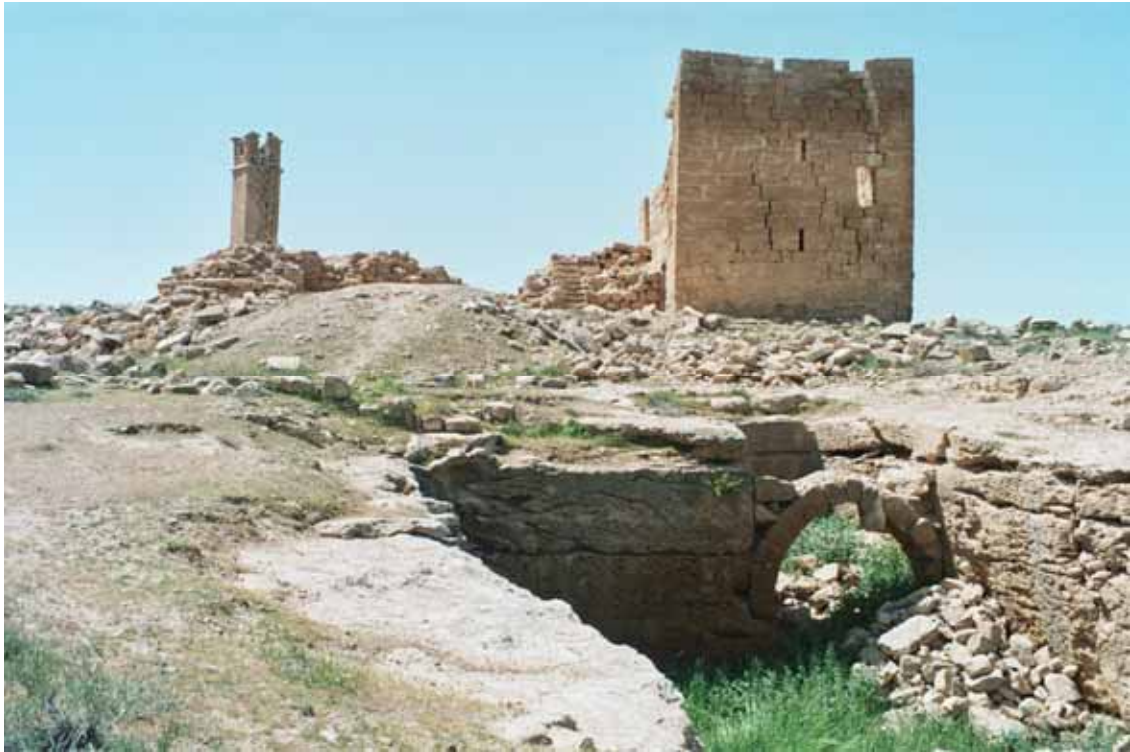
- c. the Tower complex, 1,5 km North of the *castrum*, comprising a 14 meter high stone tower, identified with a Stylite tower from Byzantine era. The tower is associated with a small three-nave church annex, two ruined buildings, quarries and cisterns (fig. 2).

Fig. 2 – the tower complex

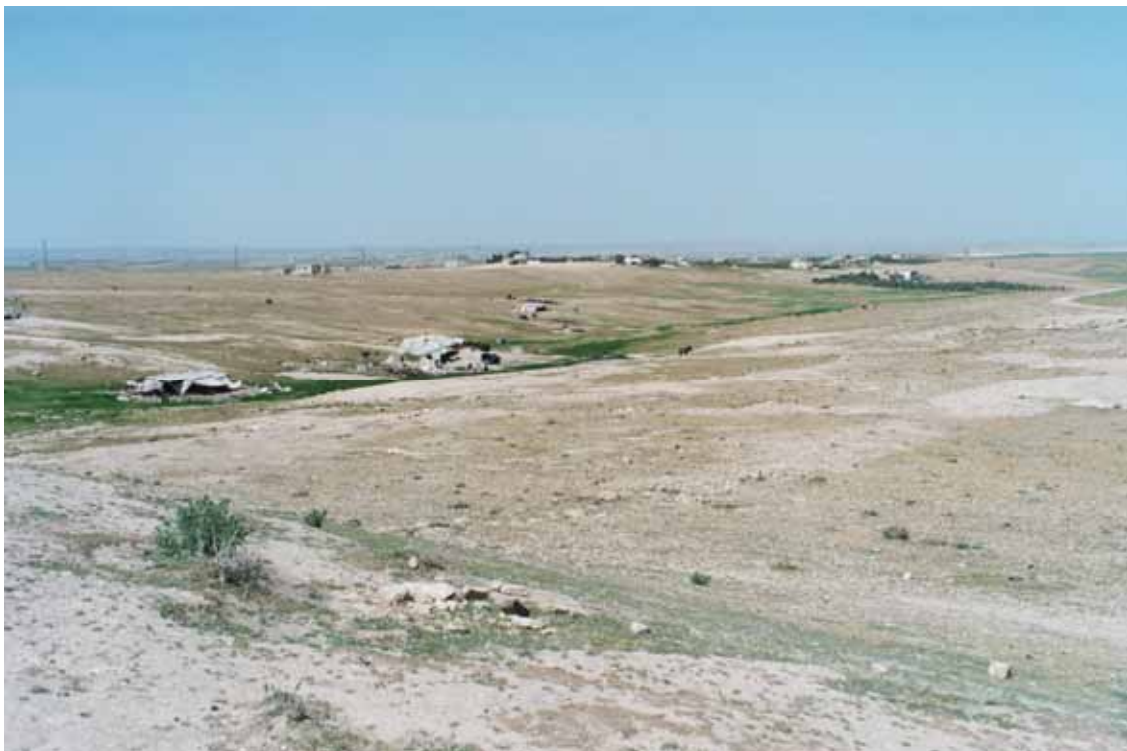
Some nomadic Bedouins live in tents in and outside the archaeological site.

*Fig. 4 – the area between the northern settlement and the tower with Bedouins' tents*

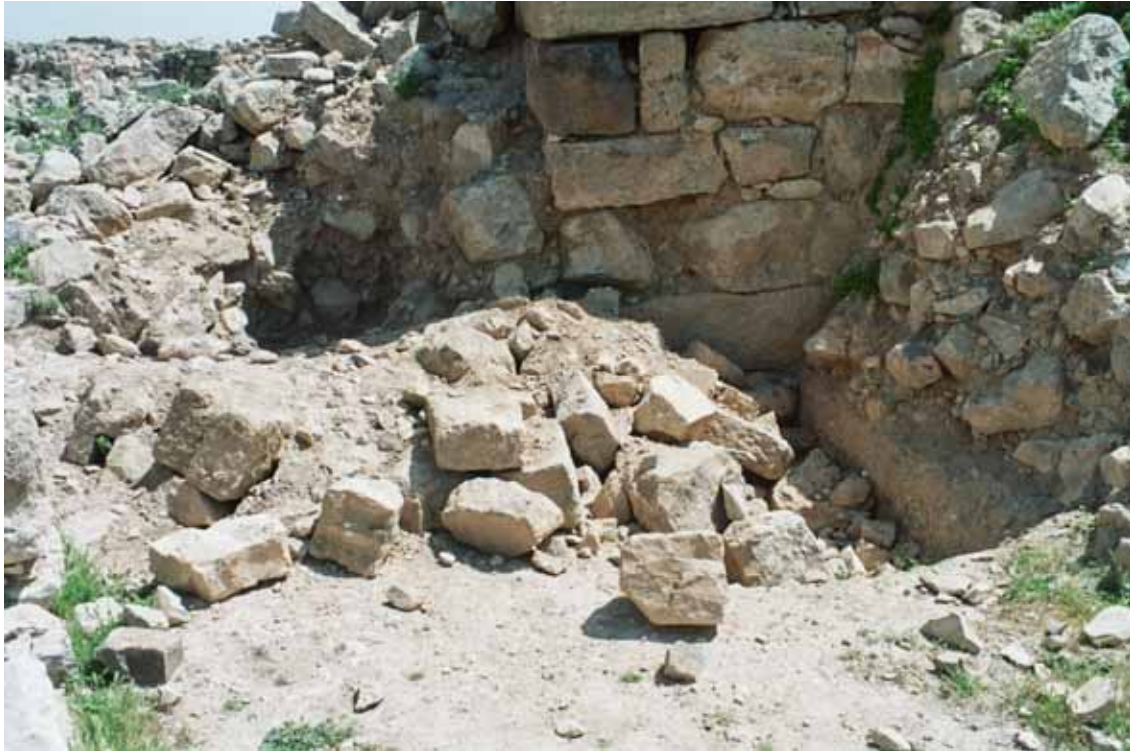
Neither excavation works nor conservation interventions are being conducted on the site at this time. However, very limited soundings, near the northern gate of the *castrum*, seem recent (fig. 5-6); it is not clear who made them, but they certainly cannot be considered real archaeological searching both for size and the inadequate method used.

*Fig. 5 – recent archaeological (?) sounding*

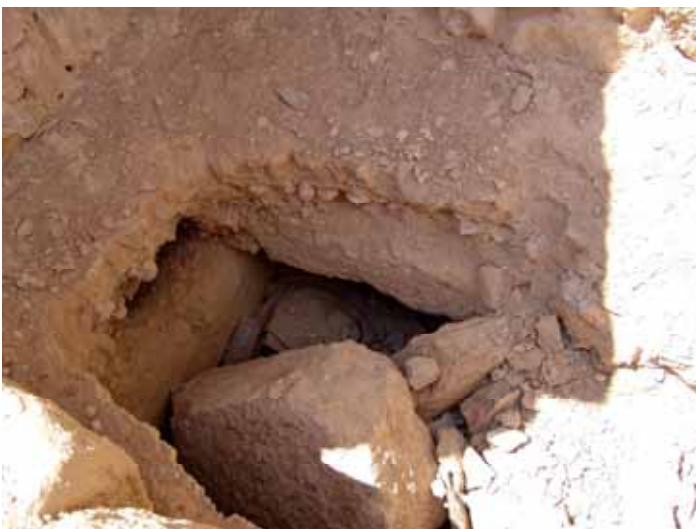
*Fig. 6 – recent archaeological (?) sounding*

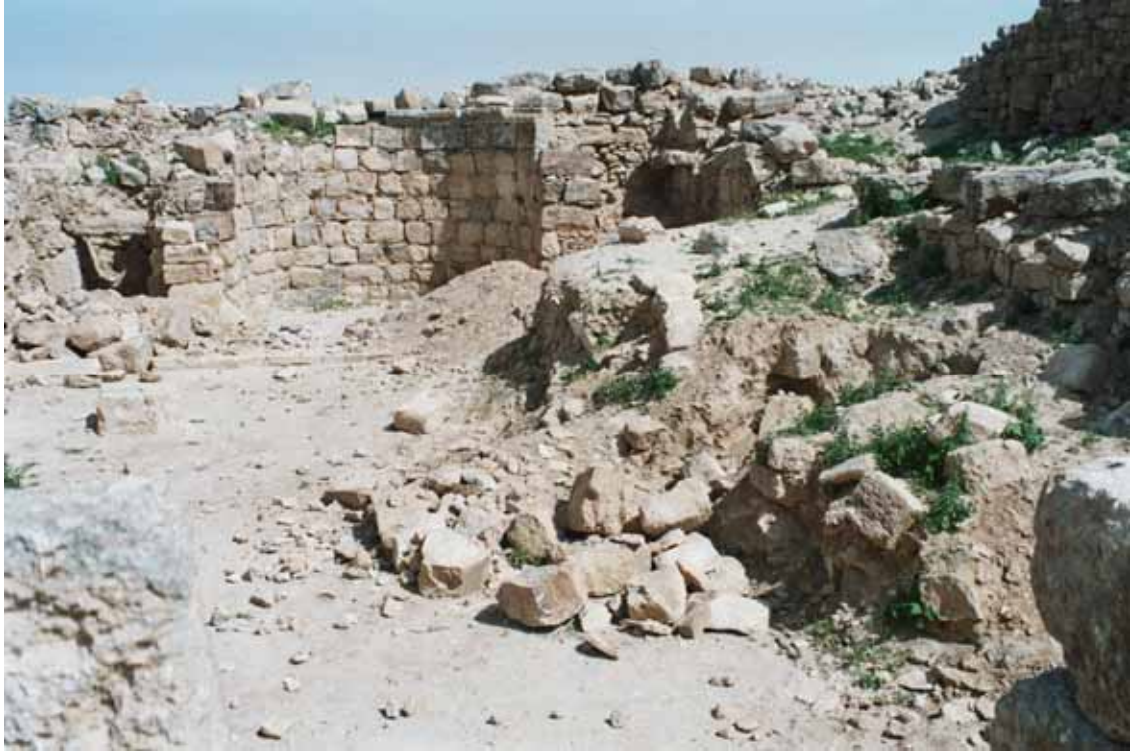
Serious structural problems affect the site, which, apart from collapses due to past earthquakes, has been also quarried to provide building material. Besides the risk of further deterioration for the monuments, the present situation is highly dangerous for visitors; uncovered archaeological soundings and deep trenches make the situation worse. Also for this reason certain parts of ancient buildings would require urgent consolidation interventions (fig. 7-8).

*Fig. 7 – dangerous situation for visitors and structure*

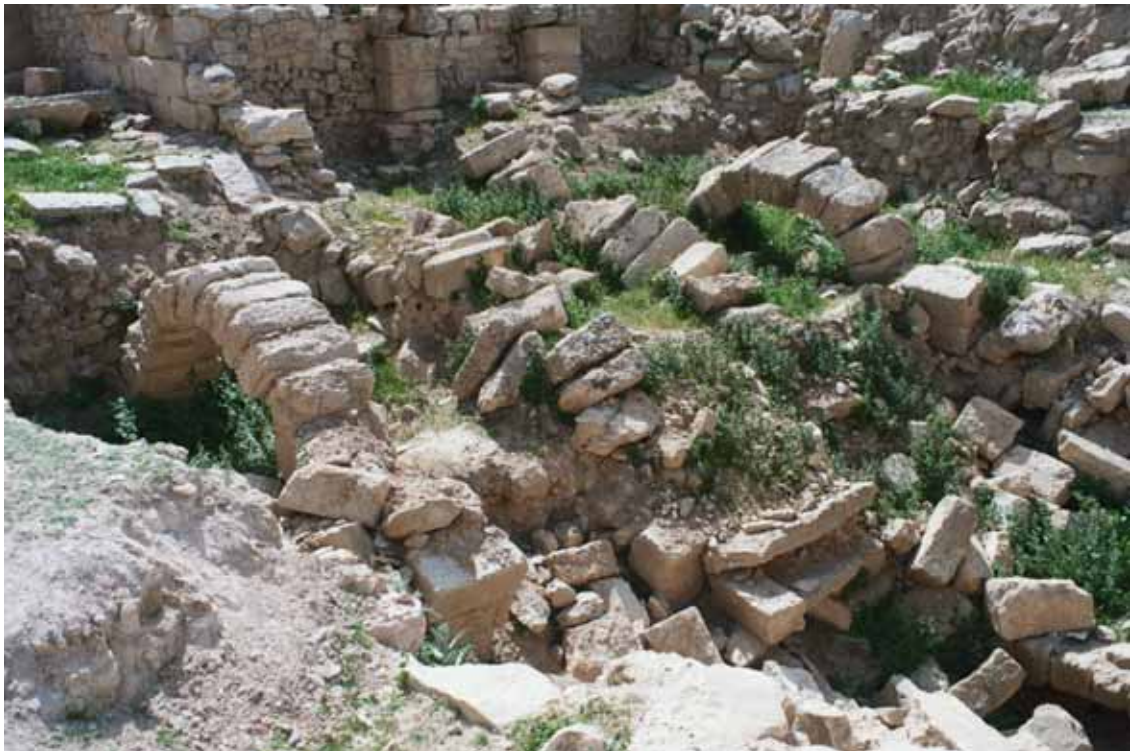
*Fig. 8 – ancient structures at the risk of collapse*

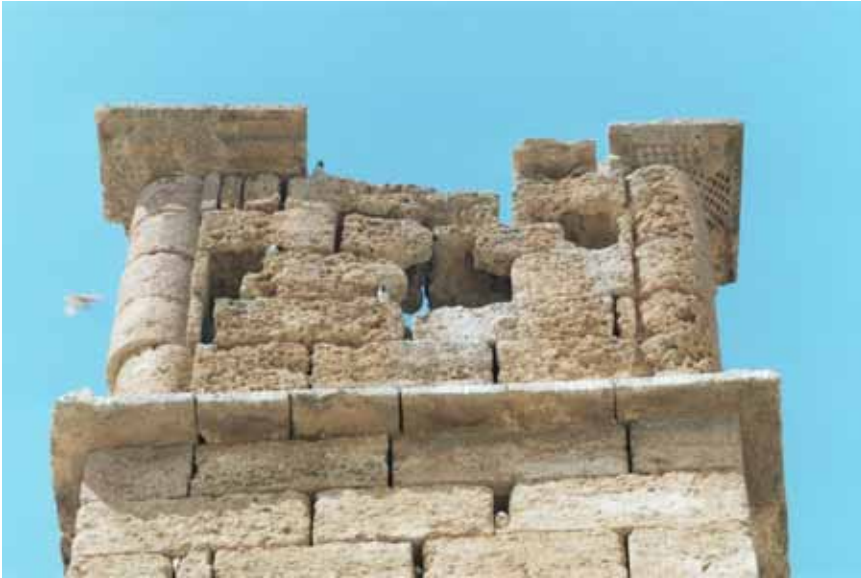
Moreover some structures, built with local shell-limestone, exposed to atmospheric condition show erosion phenomena; the erosion is particularly clear on some types of limestone, such as the one used for architectural elements (fig. 9).

*Fig. 9 – serious erosion damage on the top of the Stylite Tower*

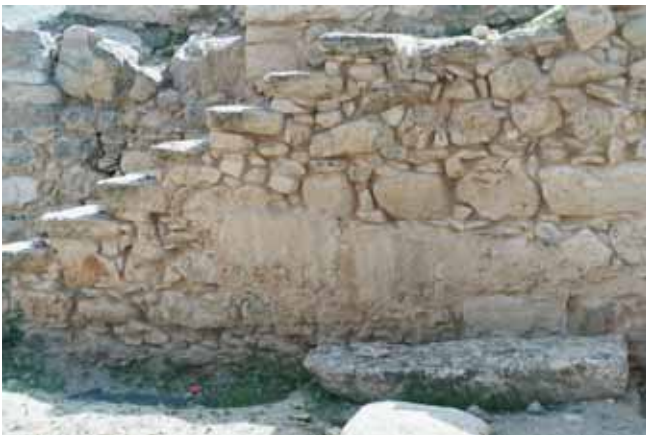
It possible to see rare fragments of plaster on the walls, which are often detaching (fig. 10-11).

*Fig. 10 – fragmented wall plaster*

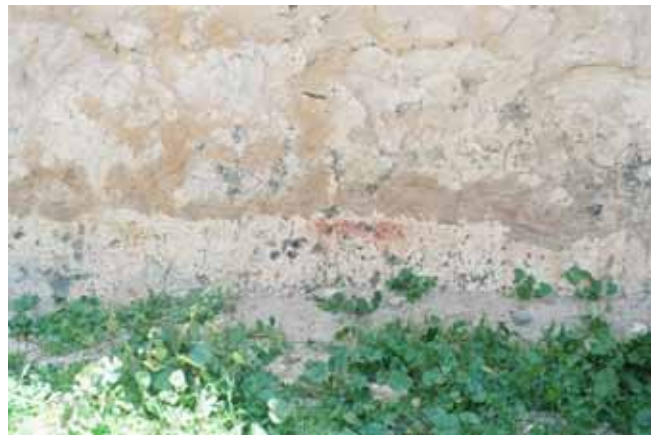
*Fig. 11 – fragmented wall painting*

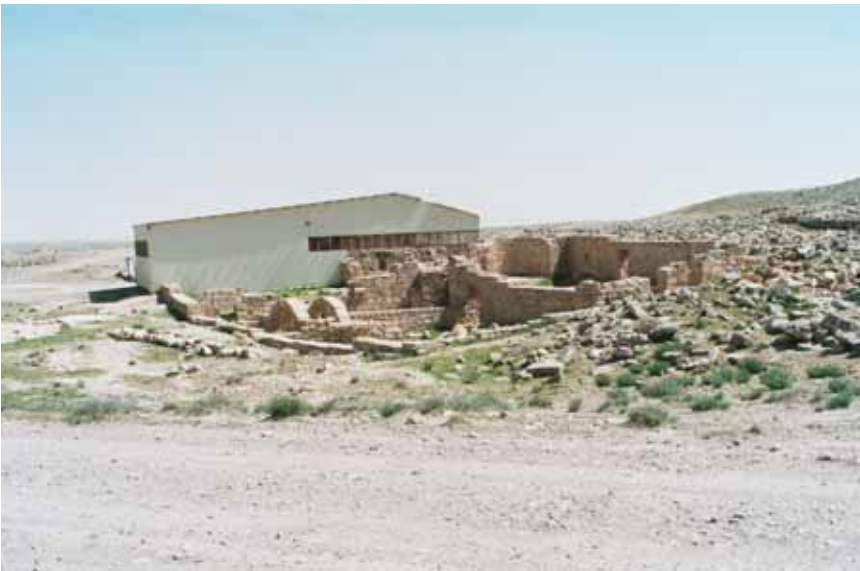
In 1990 an hangar-like shelter was built to protect mosaic floors of St. Stephen's Church (fig. 12); the same shelter covers also the apse of St. Sergius Bishop. Suspended walkways allow people to visit the monument without walking on the fragile floorings (fig. 13). However, the protective structure shows some damage today and does not work very well because of the lack of a rain-water drainage system: on west side, in particular, water becomes stagnant under the shelter, favouring biological deterioration phenomena over the mosaics of the apse of St. Sergius Bishop Church (fig. 14).

*fig. 13 – the shelter covering St. Stephen Church's mosaics*

- Concerning the new physical protection in substitution of the existing shelter on the St. Stephen's Church complex, the feasibility of such proposed structure needs to be better verified not only with respect to possible ancient structures adjacent the complex, but also with regard to the strong impact which such a shelter will have on the archaeological landscape and environment. Furthermore it is highly recommended to install control units for the measurement of microclimate data (temperature, relative humidity and wind speed/direction) both within and outside sheltered area. These microclimatic data, monitored and collected at least over two seasonal cycles, will be processed and integrated with environmental parameters to draw up useful indicators for assessing adequacy and effectiveness of the shelter (fig. 27).

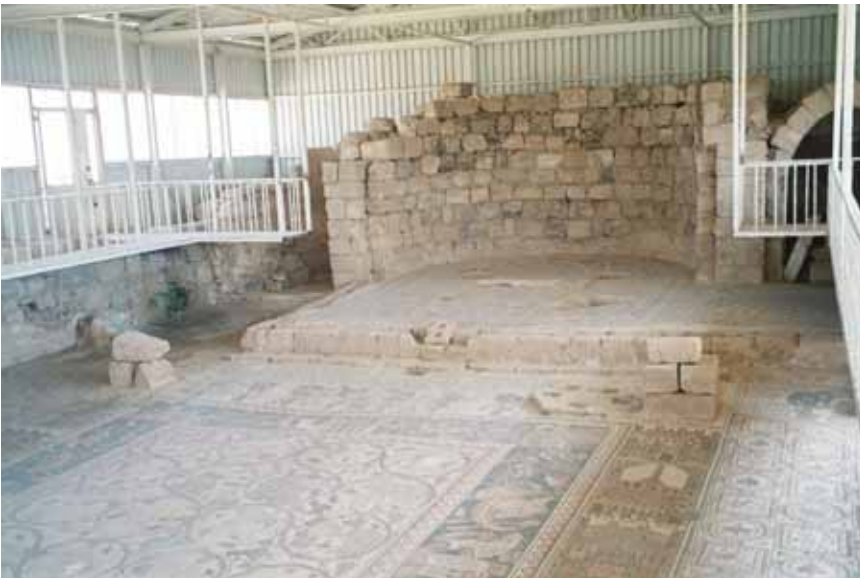
*fig. 14 – suspended walkways under the shelter*

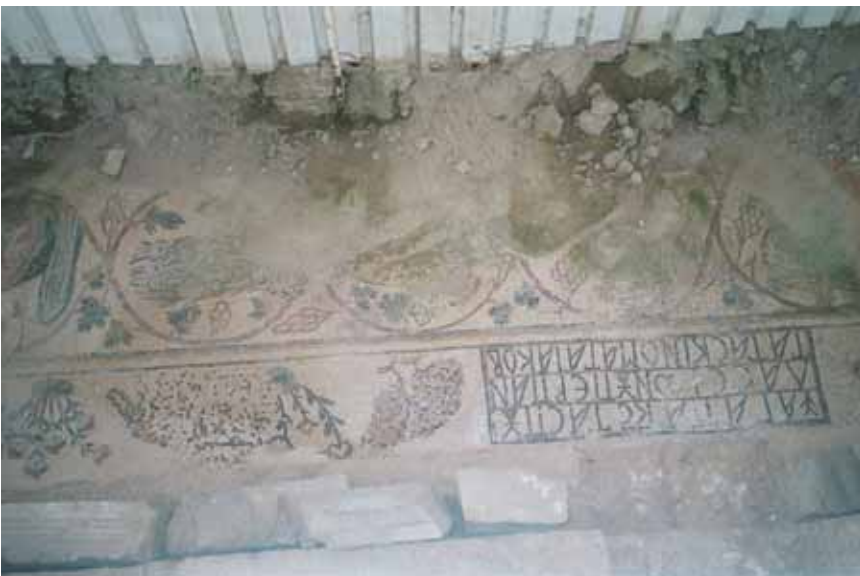
*fig. 15 biological deterioration phenomena affect the mosaic of S. Sergius Bishop Church*

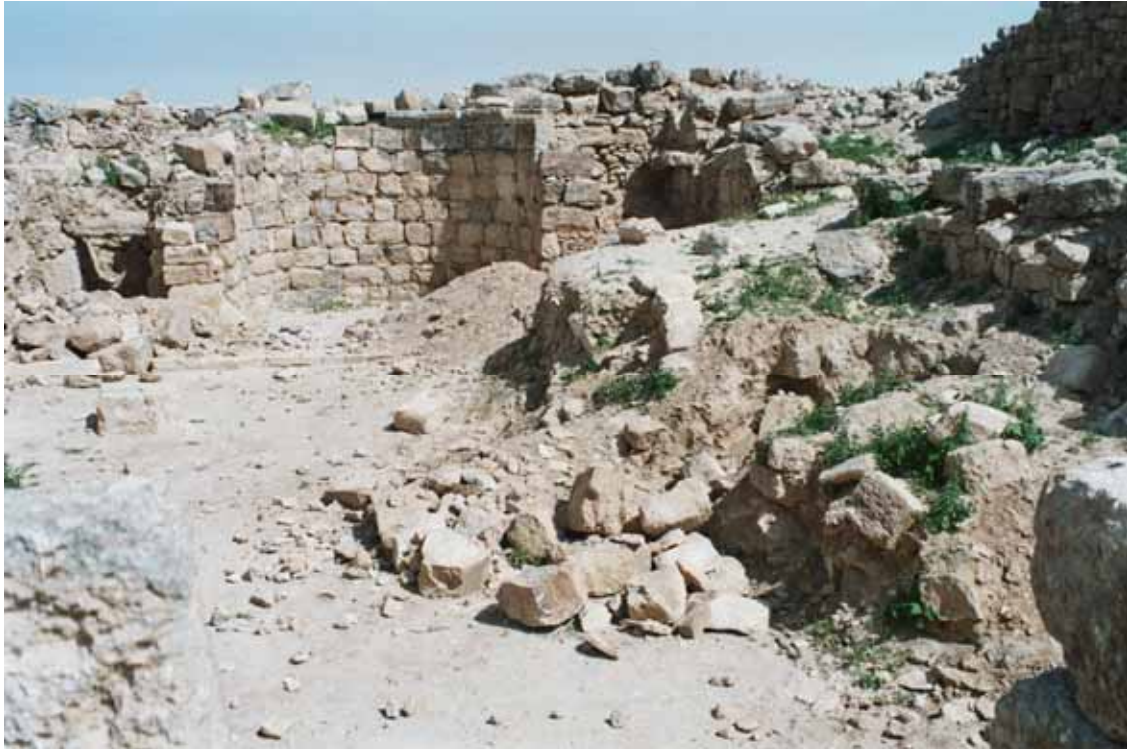
In general, collapses due to past earthquakes, as well the chaos in which the various areas covered with scattered architectural and structural elements are left, make most of the site incomprehensible to visitors, and also very difficult to access (fig. 17-18).

*Fig. 17 - chaos left by recent collapses*

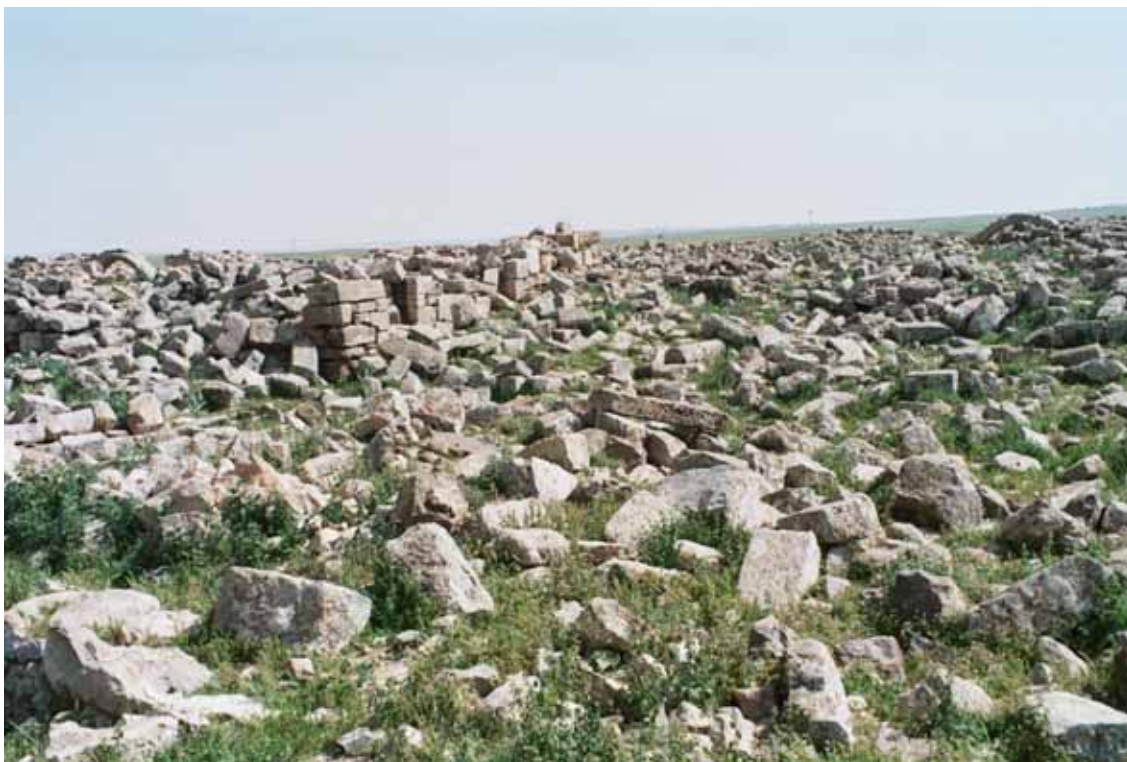
*Fig. 18 – unexcavated areas inside the castrum*

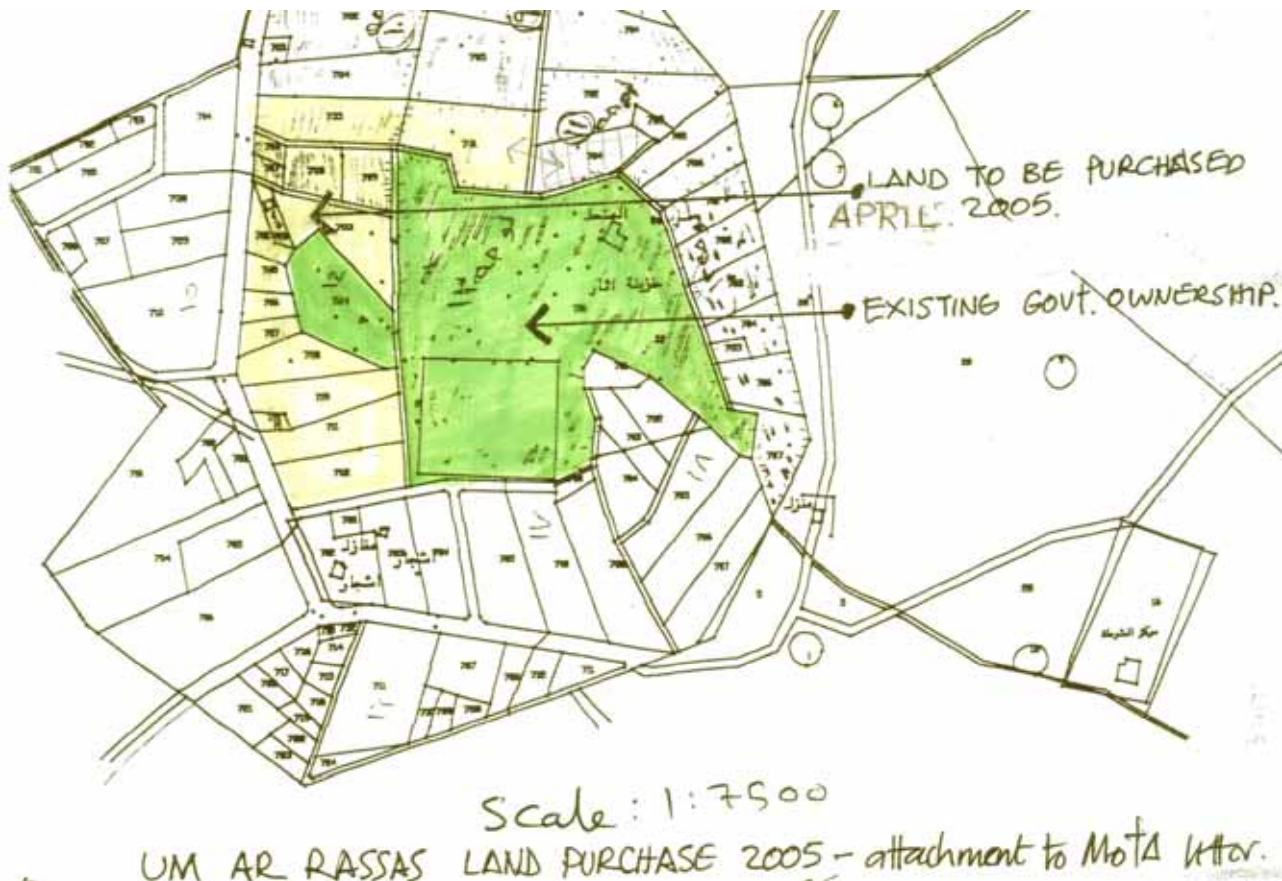
- Under EC Programme all land inside WHS boundary will be owned by the Government and be administrated by the WHS Management Unit.  
Most of the land surrounding the northern settlement will have been purchased by April 2005.

Fig. 19 – map showing lands that will be land by april 2005

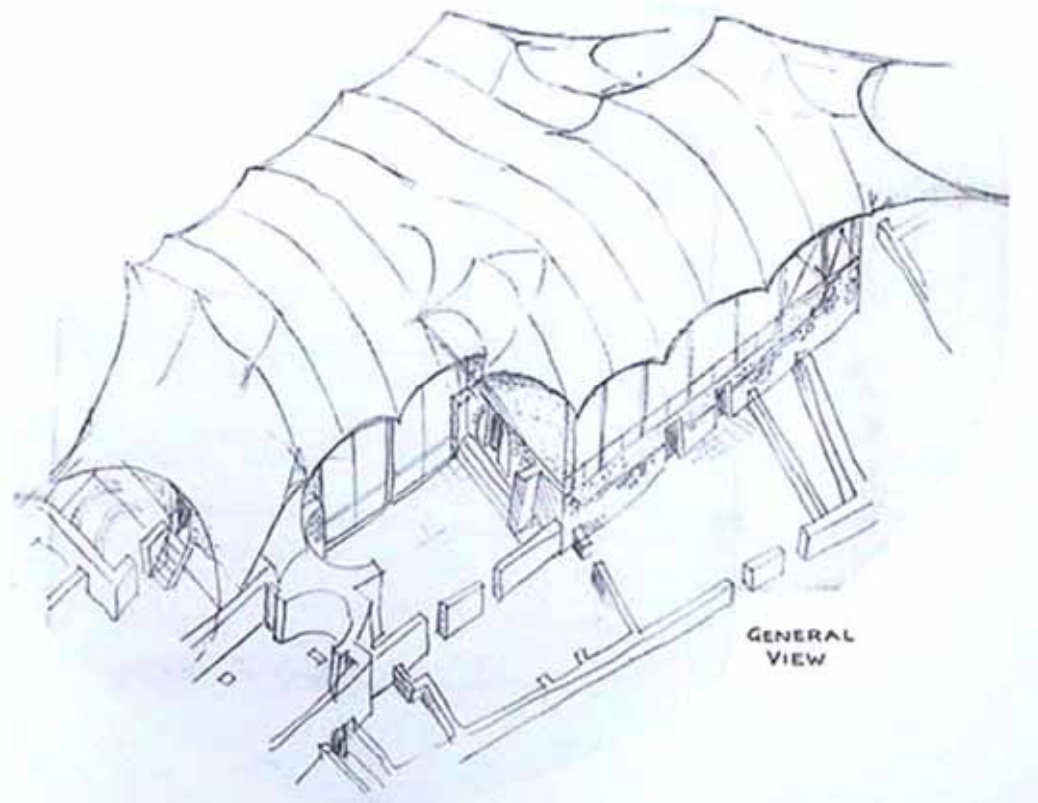
- EC-funded work at Um er-Rasas includes international technical assistance to draw up a plan for the preservation and presentation of the mosaics discovered to date. The works includes a new shelter that will cover the whole St. Stephen's Church complex displaying for the first time the spatial relationship between the Churches and their mosaics (fig. 21). Tent roof will be drawn over the edges to produce

classical tented form (fig. 20). The design phase is almost completed. Procedure for work will be completed by October 2005.

*Fig. 20 – shelter designed for St. Stephen complex*

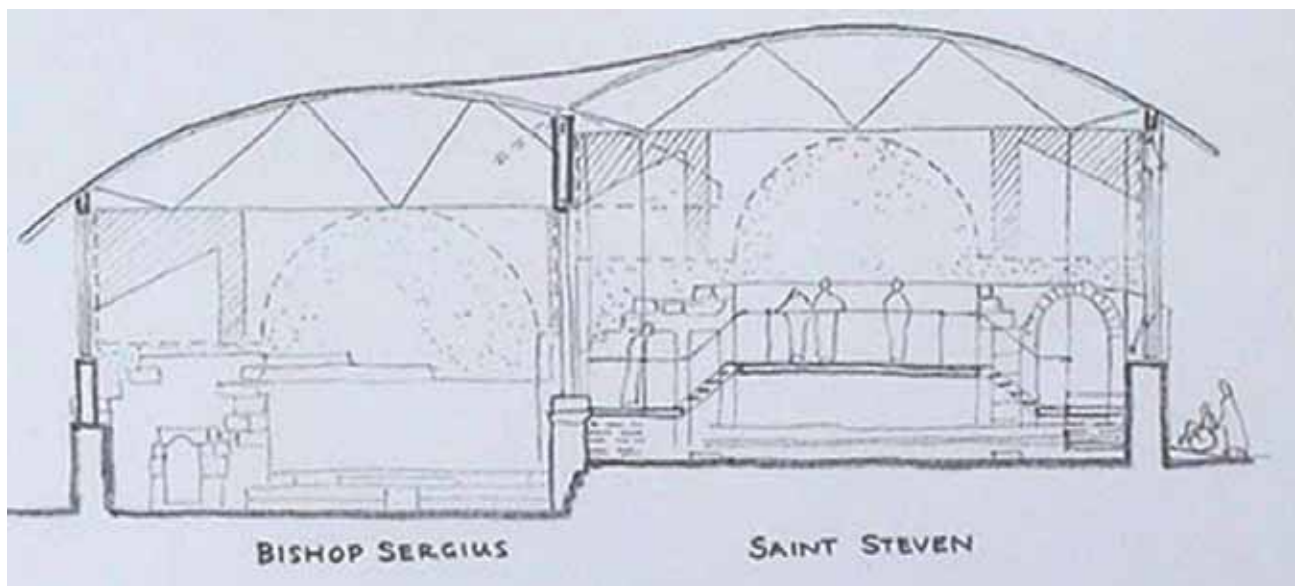
*Fig. 21 – shelter designed for St. Stephen complex*

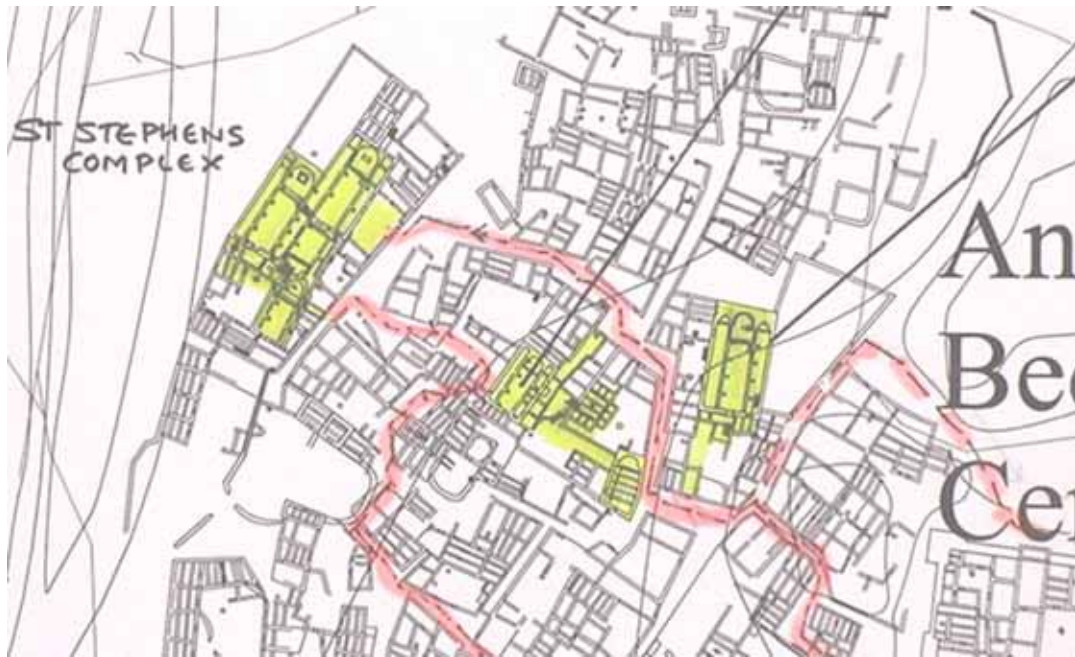
- A Preservation and Conservation Specialist Study is underway by the Department of Antiquities, coordinated by Mr. Wolfgang Koellisch.
- Access footpaths, signage and viewing platforms are being planned. Footpaths will provide safe access to the most important parts of the site (fig. 22), and be fenced to prevent access to unexcavated areas making easier visitor management.

Fig. 22 – Hypothesis for pathway in the area of northern settlement

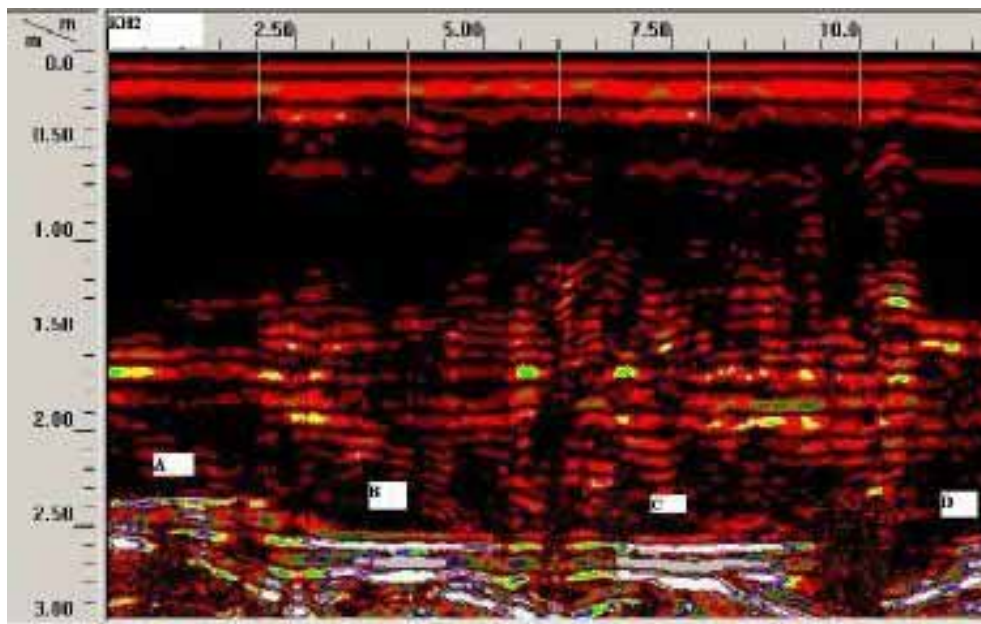
Different types of measurements (magnetic, gravity, resistivity and ground penetrating radar-GPR) were collected over the mosaic floors of St. Stephen and Bishop Sergius Churches and at the Lions Church (see Annex 1). The presence of the shelter over the St. Stephen Church has limited geophysical surveys, but integrated different systems have allowed to map, in remarkable detail, underground buildings with arches shape of walls oriented north-south under that church (fig. 23) and subsurface building system with rooms under the Lion Church.

Fig. 23 – interpreted 400 MHz GPR section along one survey line at St. Stephen Church

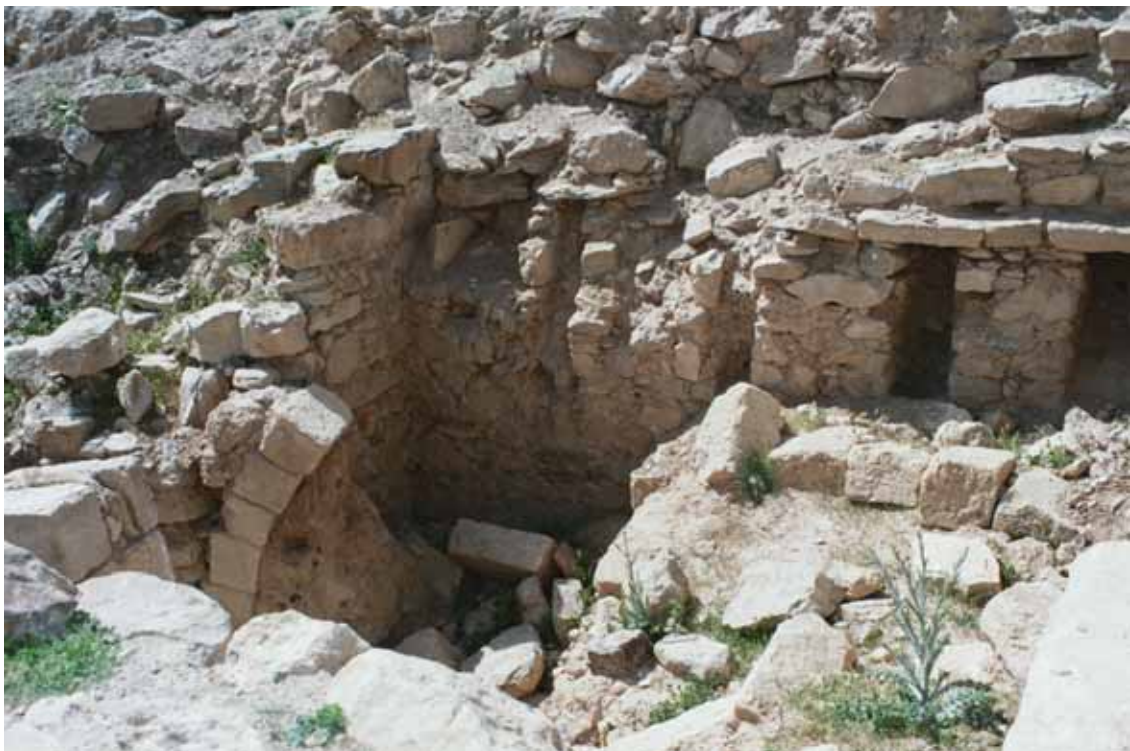
*Fig. 24 – an excavation uncovered at the risk of collapse near S. Paul Church*

- Before for the implementation of the project in progress, it would be advisable to improve general situation of the archaeological area from the point of view of security, backfilling deep trenches and soundings and fencing some areas that there is the risk of collapses, such as the area near St. Paul Church (fig. 24).

- To channel people straightaway onto pre-established paths could be important also in order to avoid unintentional damage and losses caused by visitors or local people crossing the site and walking or trampling upon the ancient structures.
- Some structures in danger of imminent collapse would need to be urgently consolidated by means of masonry supports.

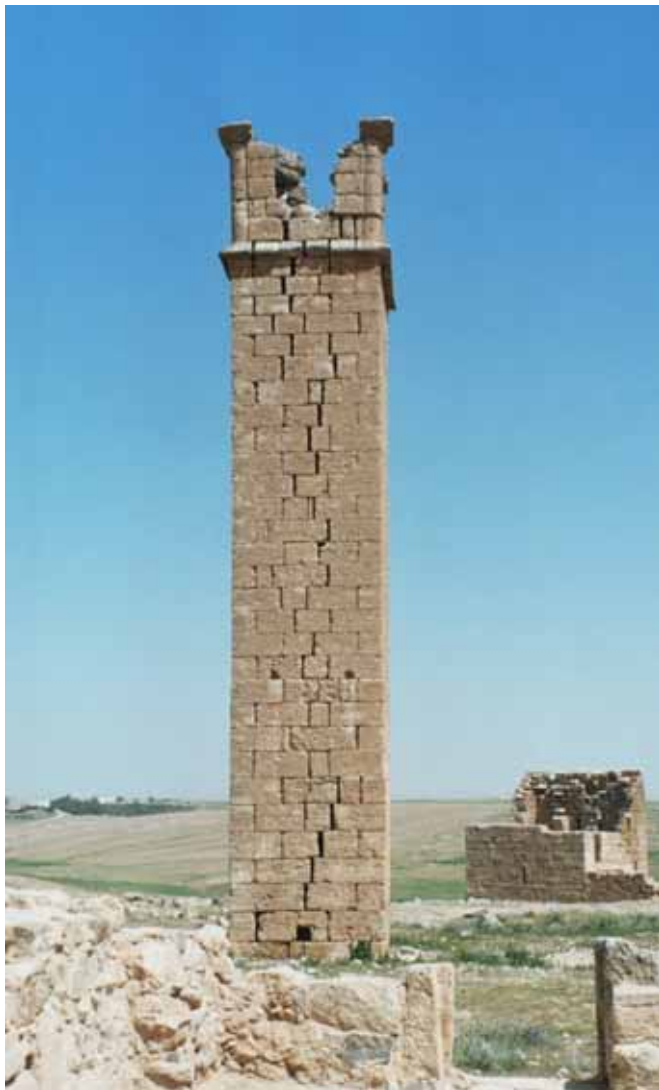
- Concerning the Stylite Tower and other monuments, they show less structural problems (fig. 25-26), which may be solved with limited conservation actions and a suitable and constant maintenance.

Fig. 25 – The Stylite tower

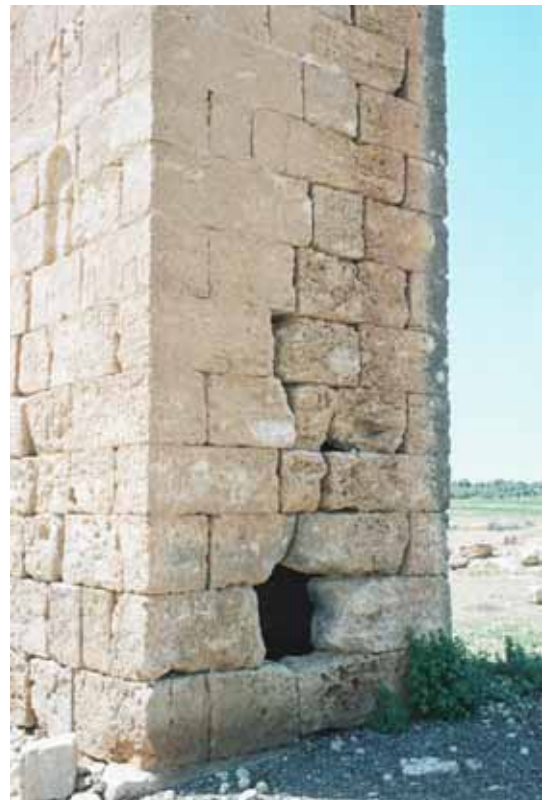
Fig. 26 – structural and erosion damage on the Stylite tower

Generally, on archaeological sites seismic events can have a stronger impact only on standing elements and slender structures, such as the Stylite tower. For this reason it will be necessary to pay particular attention in conducting the vulnerability assessment on such monuments; since the methods of analyses prepared for modern building cannot be applied to a ruin, in order to define its structural vulnerability it will be necessary to analyse the probabilities with which such an event can produce damage, beginning by examining the damage that similar events produced in the past on it. The earthquake vulnerability analysis has to consider also an accurate study of the monument, aimed at identifying the possible constructive stratifications, reuses, modifications, repairs, etc.

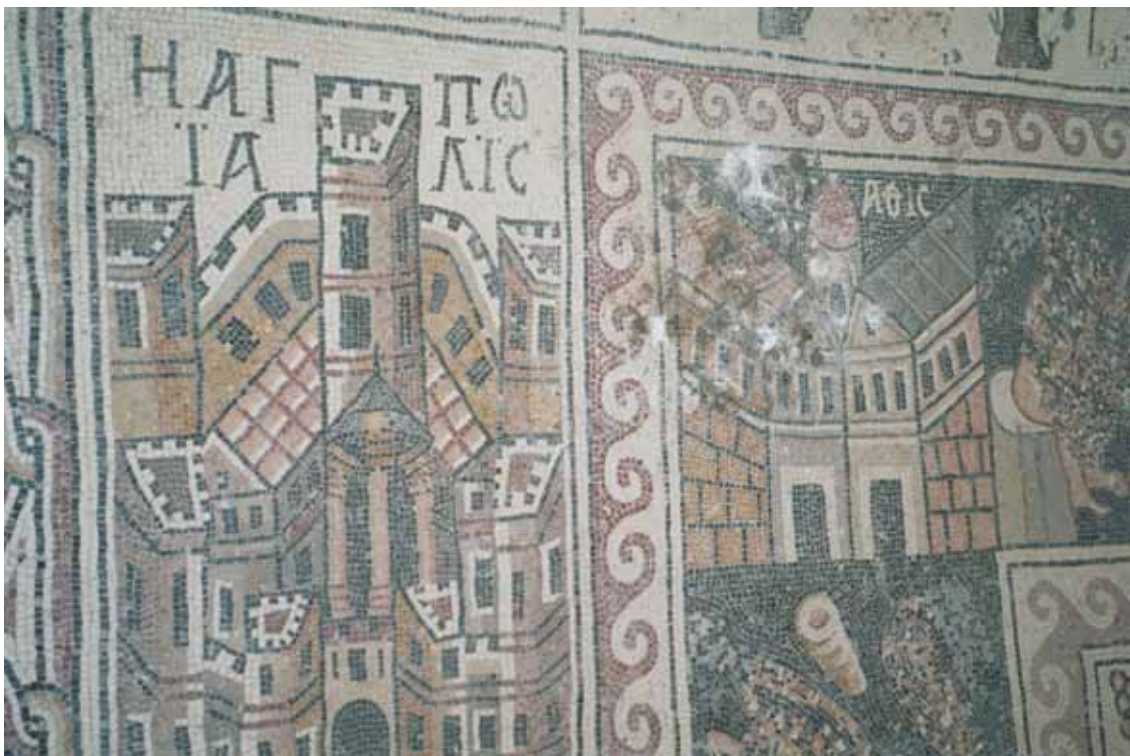
*Fig. 27 – damage from humidity on mosaic floor of sheltered St. Stephen Church*

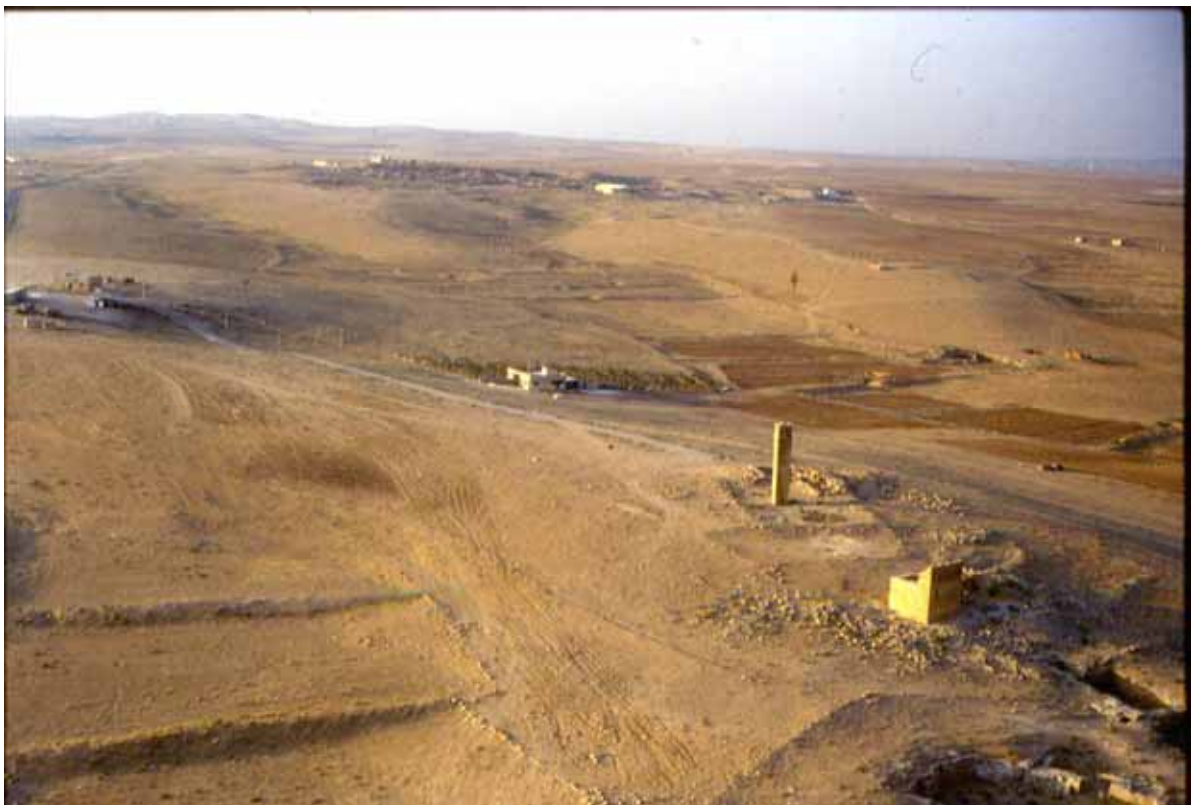
*Fig. 28 – The area surrounding the Tower complex*

- Earth mounds left by previous excavations within and close to the archaeological area should be moved, to facilitate the understanding of the site.
- Appropriate facilities for the tourists should be developed according to a plan that takes into account the traditional vernacular architecture to ensure that no alteration is caused to the cultural and landscape values of the area (fig. 28).
