Earthen architecture in today's world

Proceedings of the UNESCO International Colloquium on the
Conservation of World Heritage Earthen Architecture

UNESCO Headquarters, Room XI – Paris, France
17 – 18 December 2012

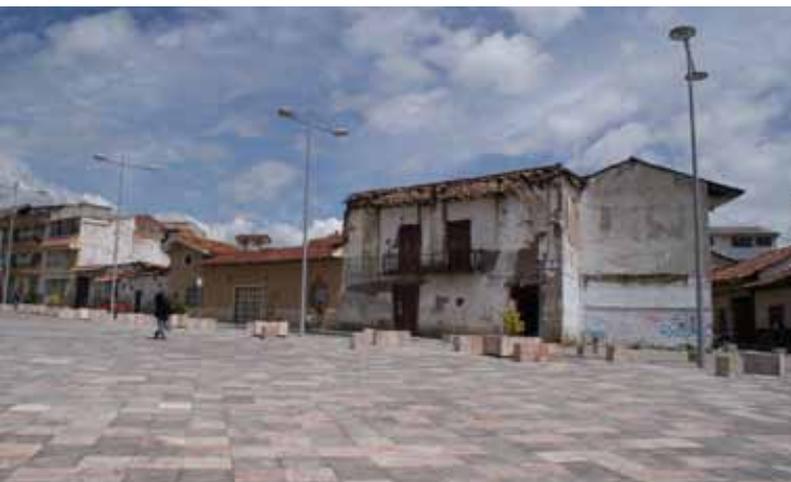
Figure 6: Renovations in the Plaza del Vado, 2011, and adjacent earthen buildings in poor condition. © María de Lourdes Abad

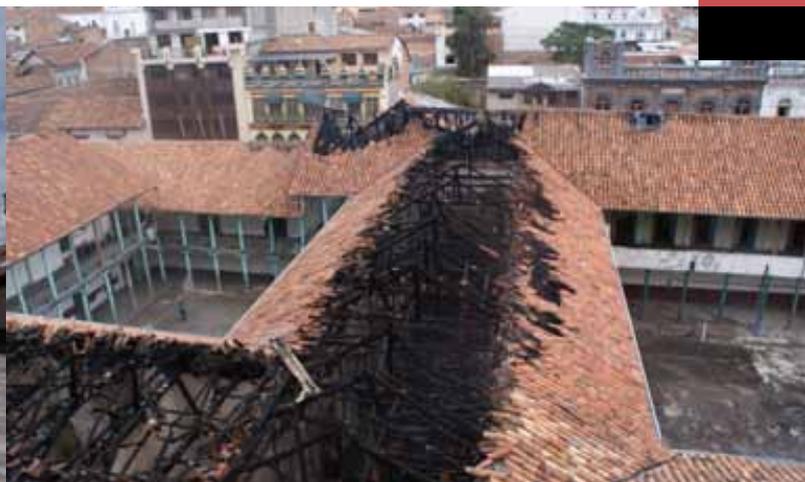
Figure 7: San Luis Seminary, after the fire, August 2012. © María de Lourdes Abad

The lack of economic resources, together with the prohibition against public spending on private holdings, has led to the abandonment of old buildings. These were some of the reasons for the fire that damaged one of the most important historic monuments in the city, the Old San Luis Seminary, noted for its magnitude, its location and its historical significance. The fire destroyed the central part of its roof as well as an interior chapel that contained wall murals and had recently been restored.

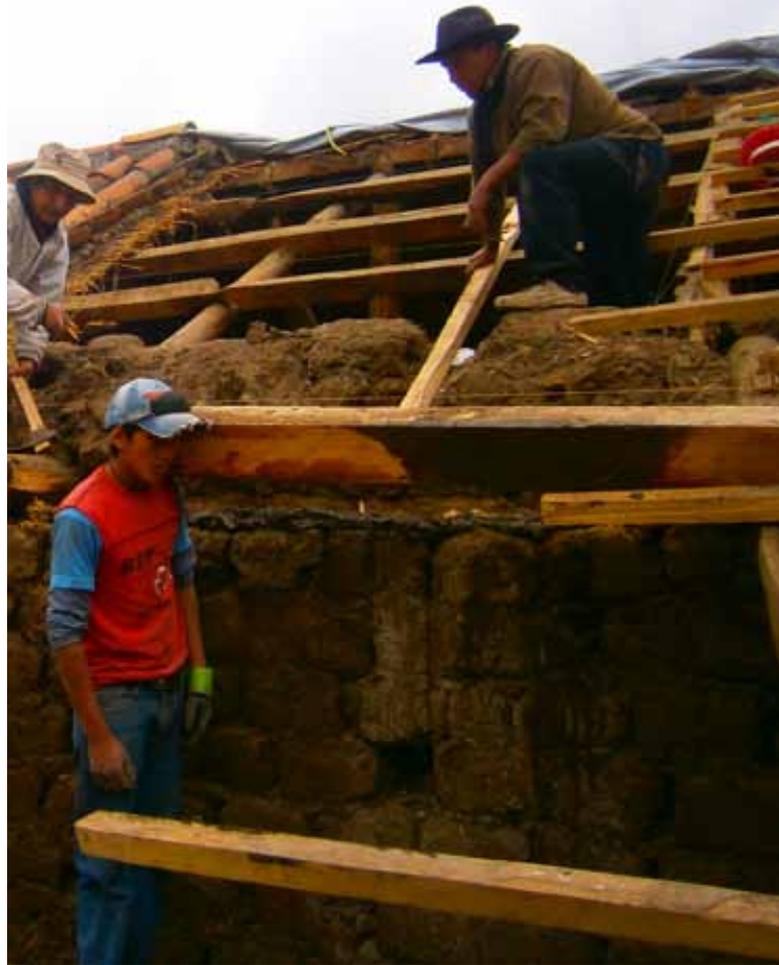
Figure 10: Tile roof with wood, bamboo and mud support structure. © María de Lourdes Abad

Another common problem is that the wooden structures used to hold roofs and floors lack support beams to distribute weight uniformly. This leads to deformations in roofs and floors. The use of bamboo and mud as a base underneath the tile roofs compensates for the deformations in the wooden structures and helps to prevent leaks.

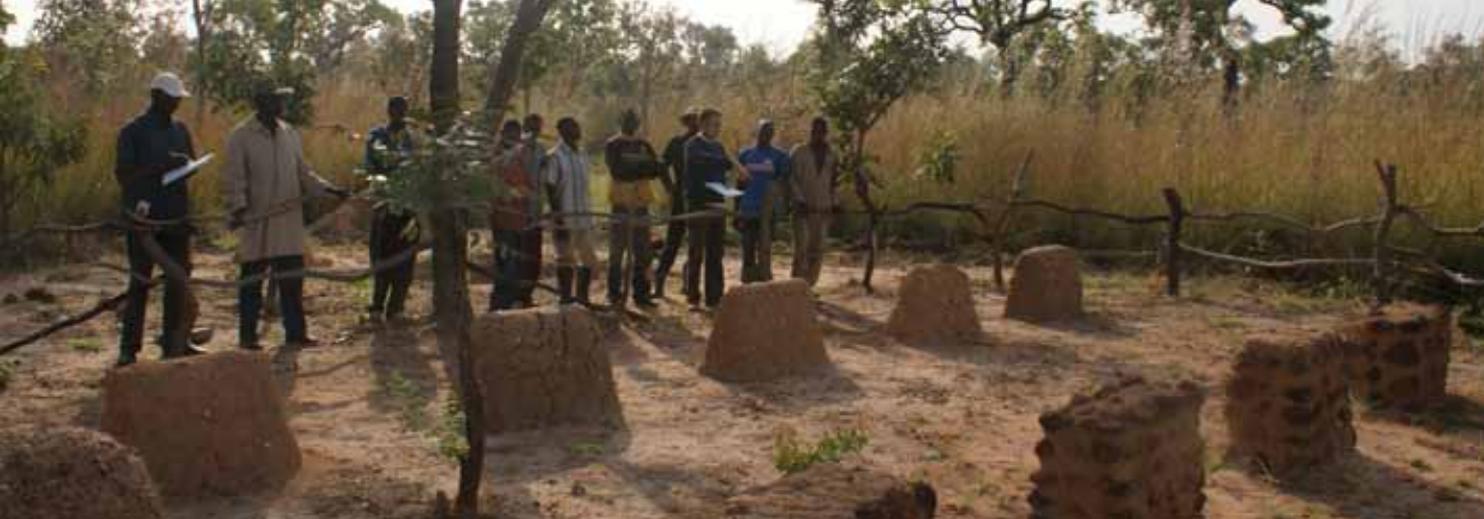
Figure 6 : Vue de murets tests. © L. Simporé

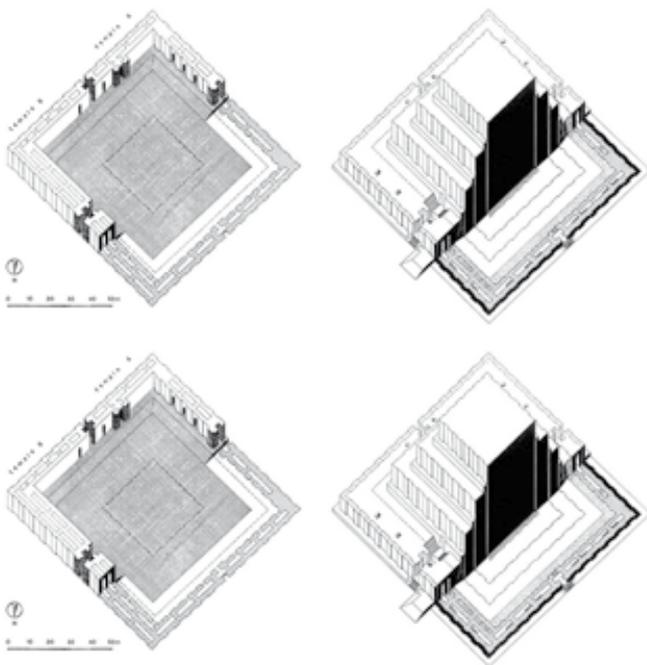
Figure 3: The first and second phases of the construction of the Ziggurat. © R. Ghirshman

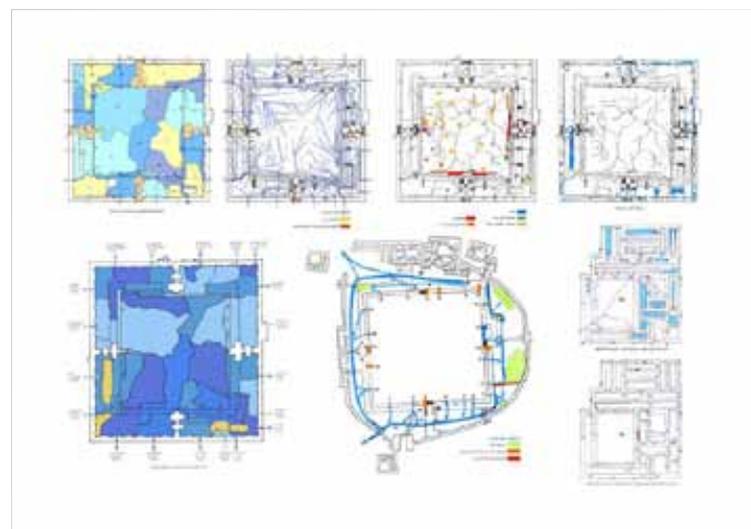
Figure 4: Monitoring map of the drainage system. © M. H. Talebian

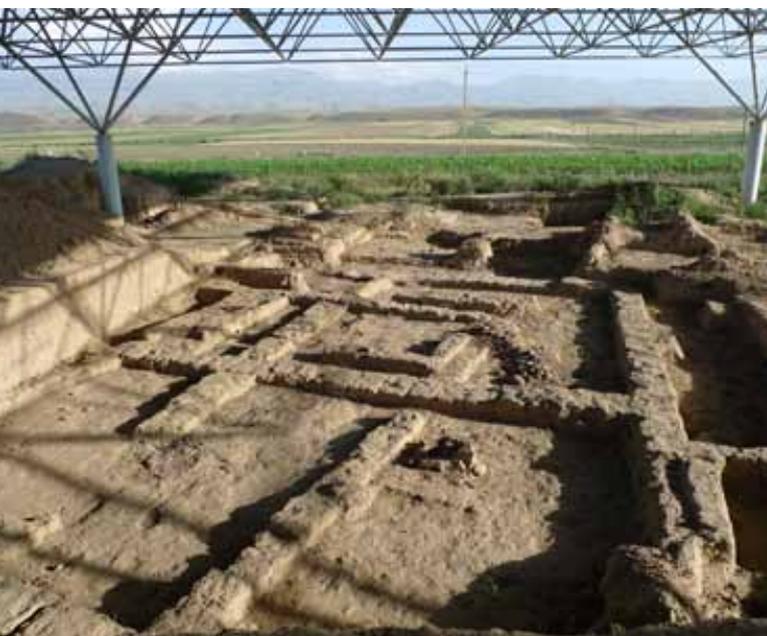
Figure 3 : Secteur 9. Les vestiges d'architecture sont conservés sur une à deux arases de briques de terre crue. © CRAterre-ENSAG

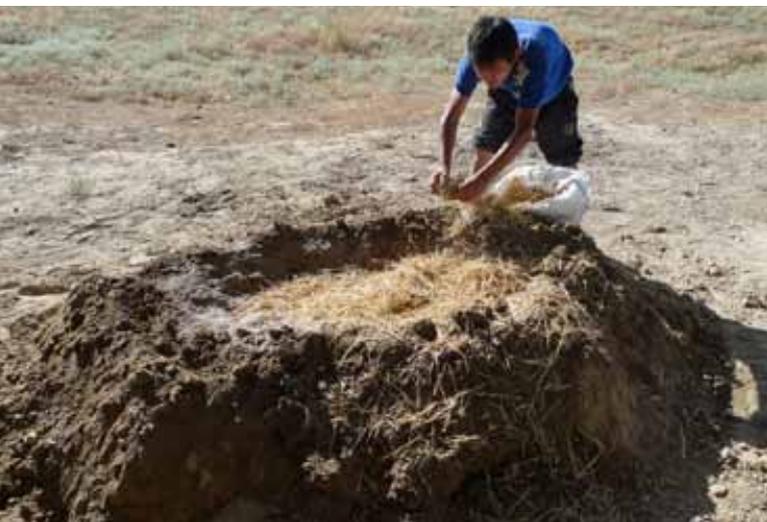
Figure 5 : Préparation du mélange de terre, balle de riz et paille.
© CRAterre-ENSAG

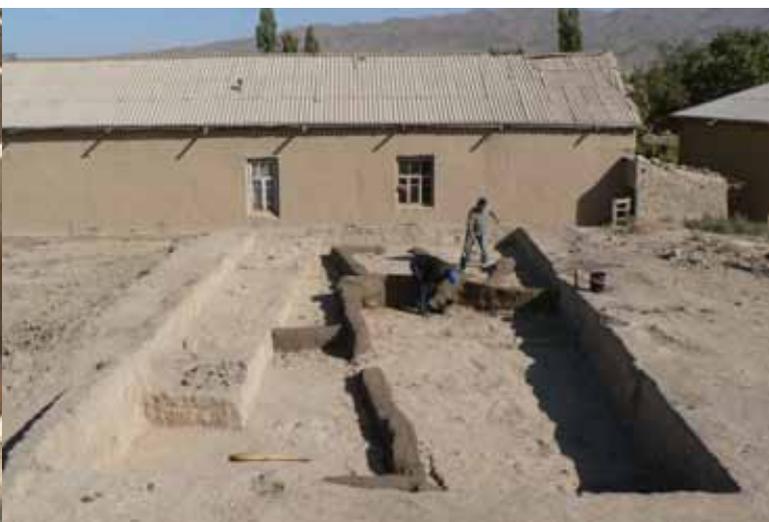
Figure 7 : Secteur 16. Protection des structures en terre entre deux campagnes de fouilles. © CRAterre-ENSAG

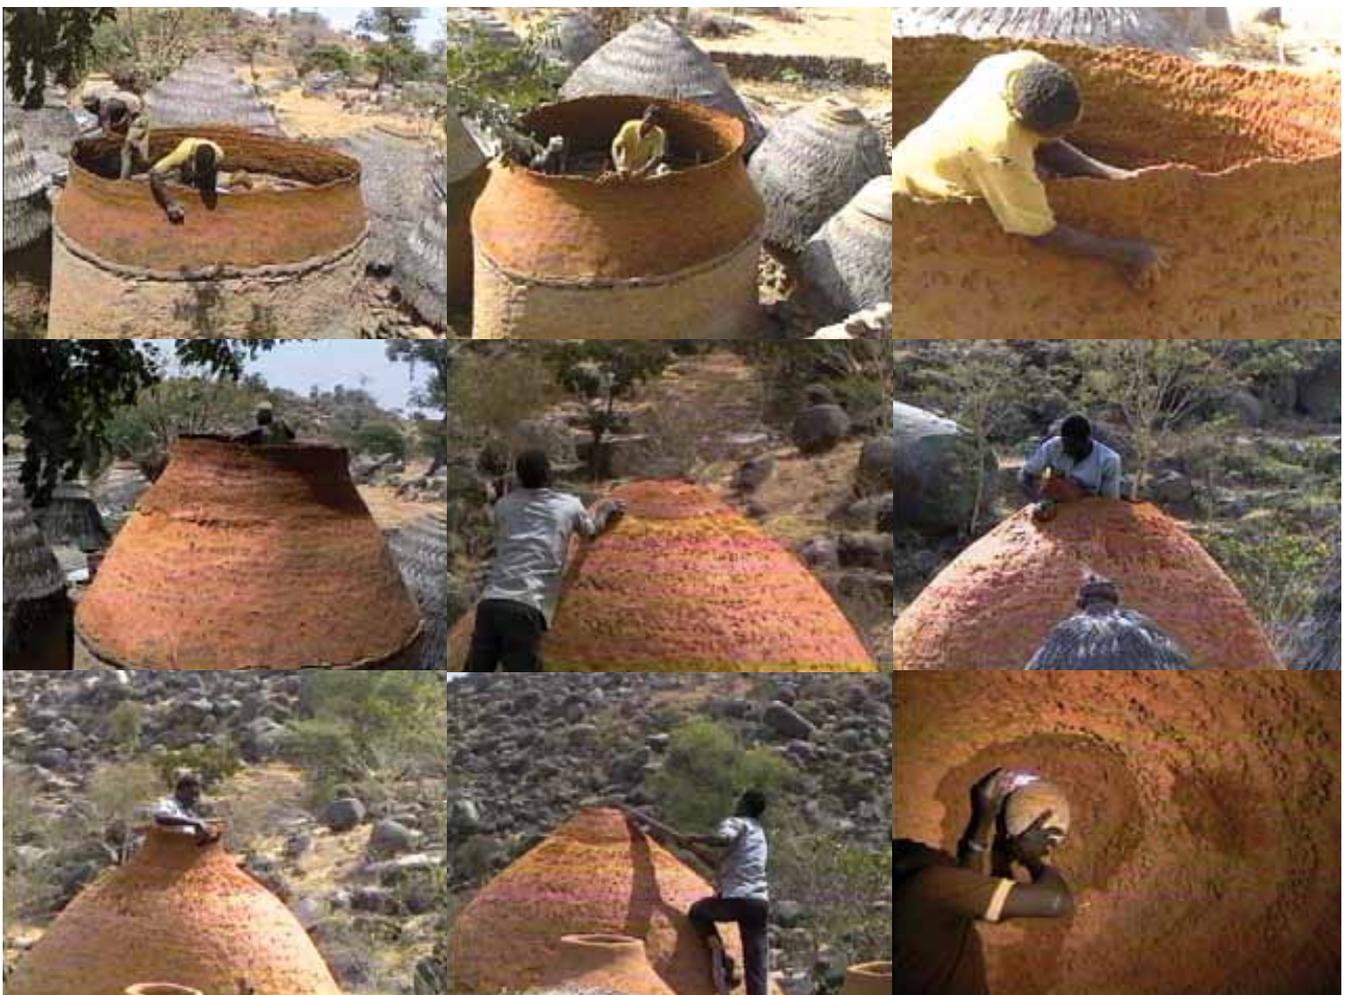
Figure 5: Construction of a Sakun vaulted ceiling, or *huruk*. © David, 2010

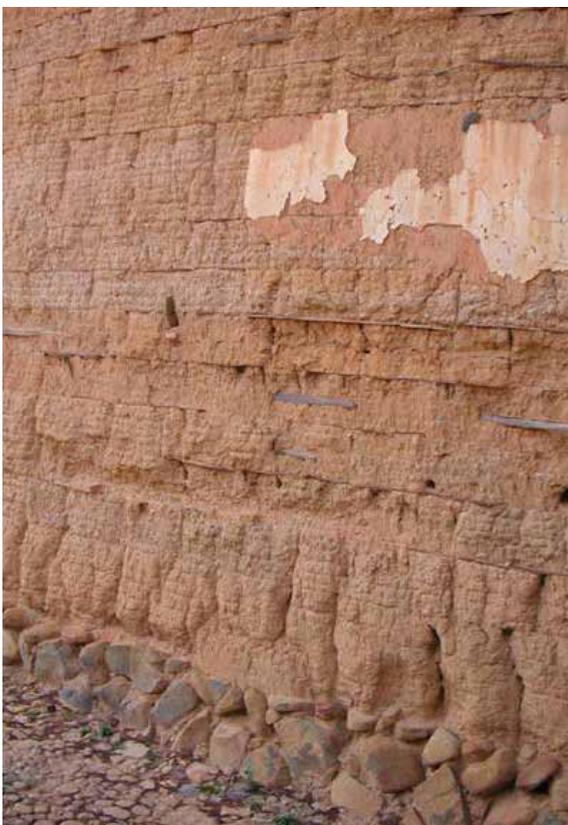
Figure 6: Features of *tulou* construction: a stone basement wall showing the bamboo wall bones. Source: http://amuseum.cdstm.cn/AMuseum/hakla/image/jianzhuzhijianzhu_082_1.jpg

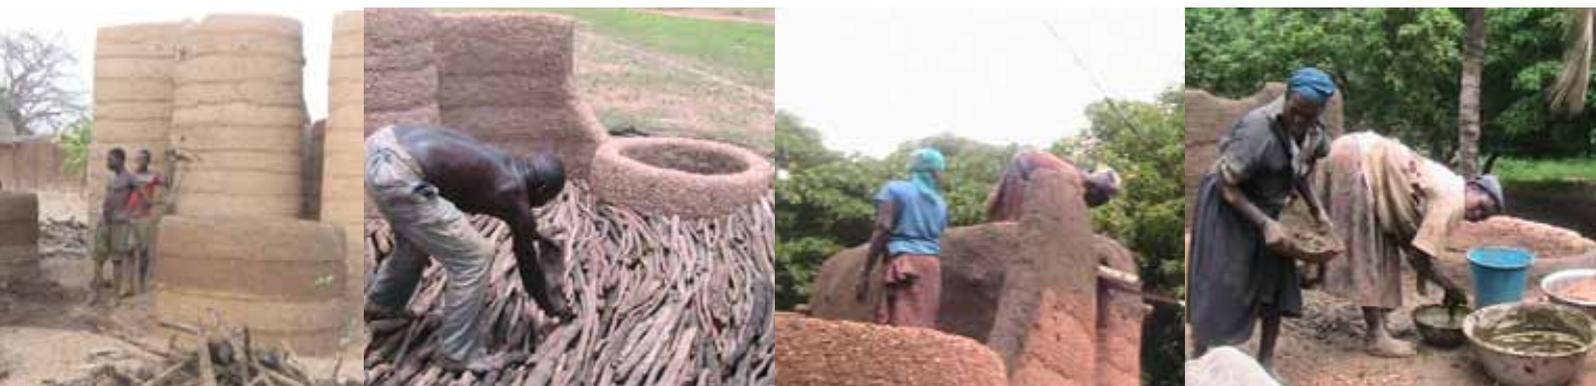
Figures 2, 3, 4 et 5 : Étapes de construction : dallage, crépissage et enduits lors de la mise en oeuvre du projet de réhabilitation des tatas. Projet financé par la Fondation Prince Claus des pays Bas en 2011. © A. B. Karka/Site Koutammakou

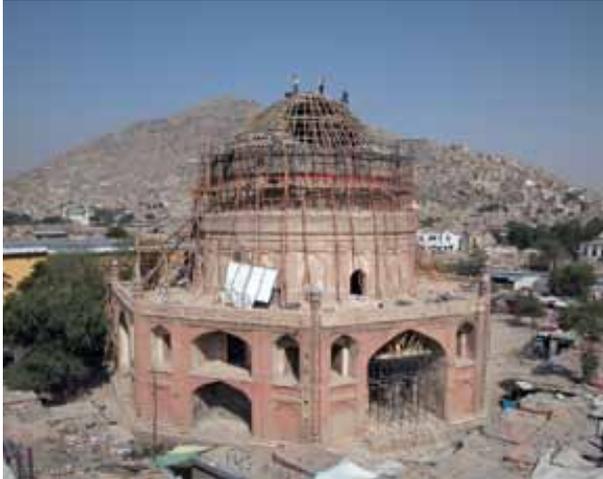
Figure 3: Timur Shah Mausoleum, Kabul, during restoration.
© Aga Khan Cultural Service-Afghanistan

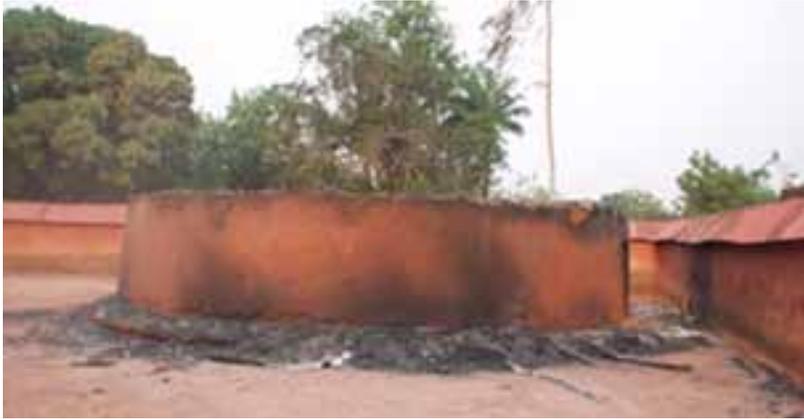
Photo 10 : Tombe des 41 épouses de Ghezo après l'incendie. © L. Ahonon

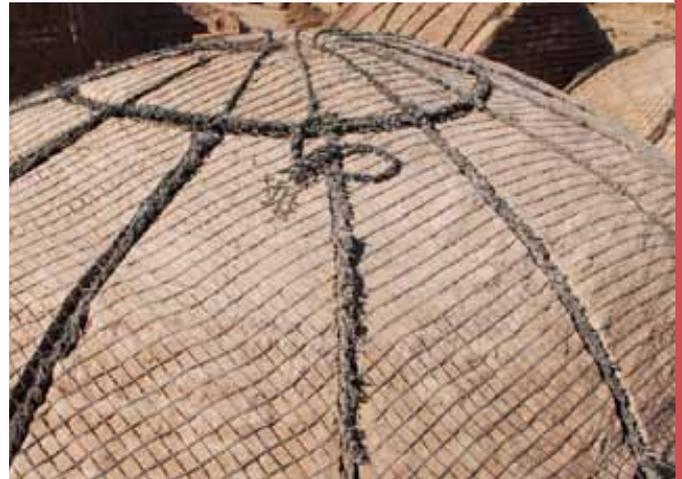
Figure 1: A dome covered in Geogrid mesh.

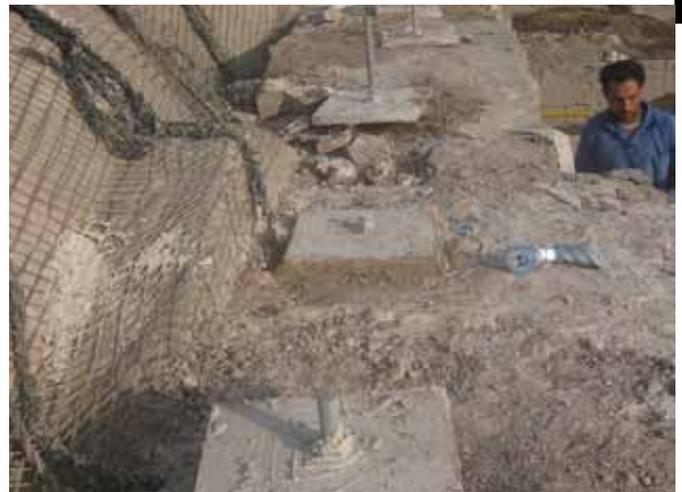
Figure 2: Strengthening the join between a pillar and an arch with Geogrid mesh and plastic (Teflon) plate.

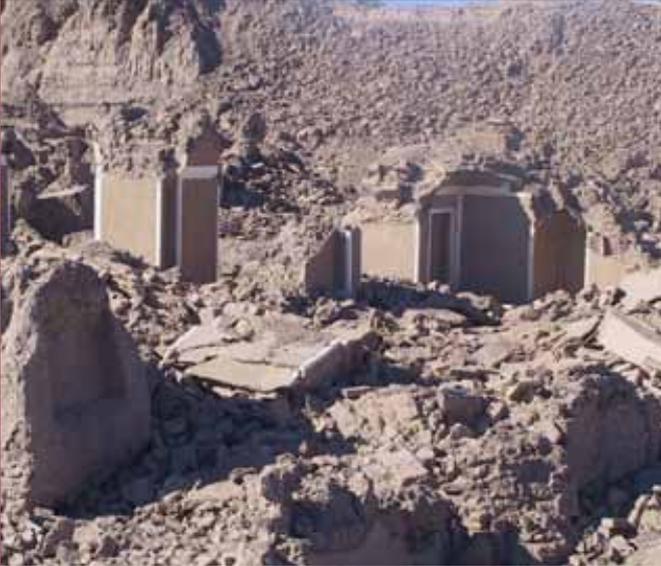
Figure 3: Remains of the Payambar Mosque immediately after the earthquake.

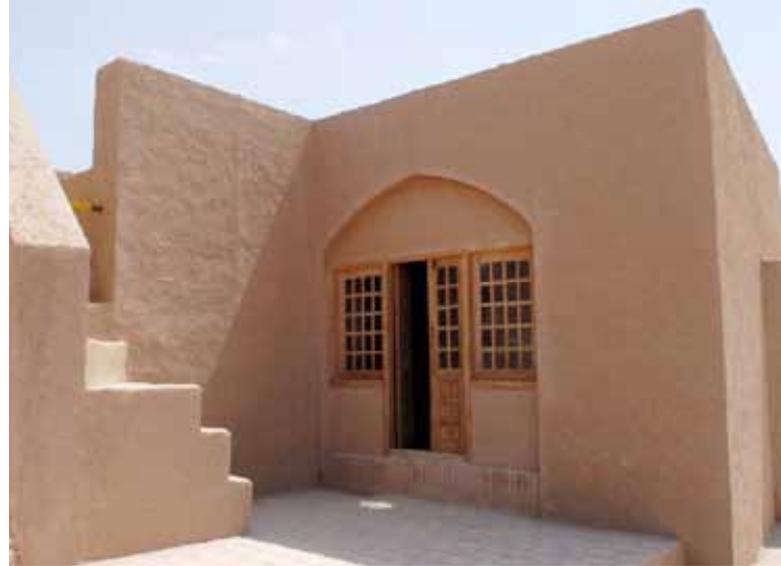
Figure 4: The Payambar Mosque after restoration.

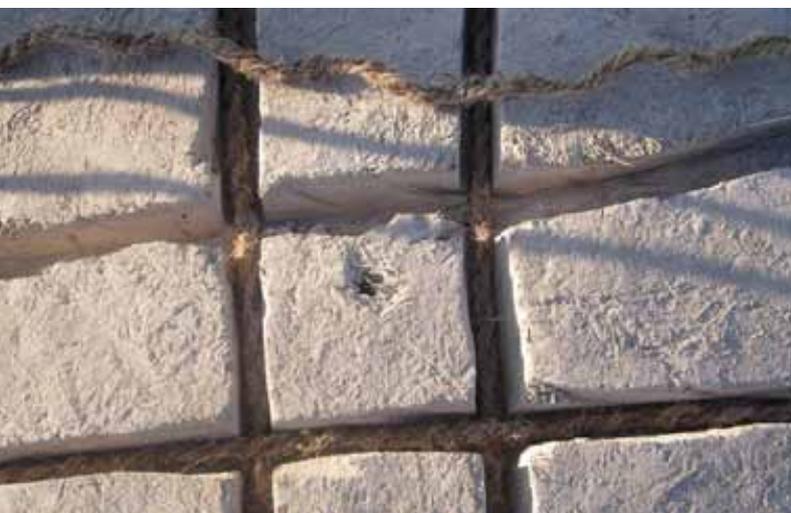
Figure 5: Detail of strengthening a dome by inserting rope made from palm fibre (SIS).

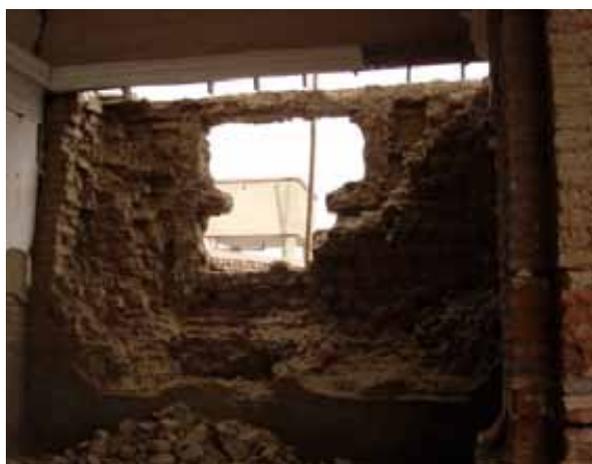
Figure 6: Specifications for wall openings. The relief of the buttresses must be equal to 'b'.

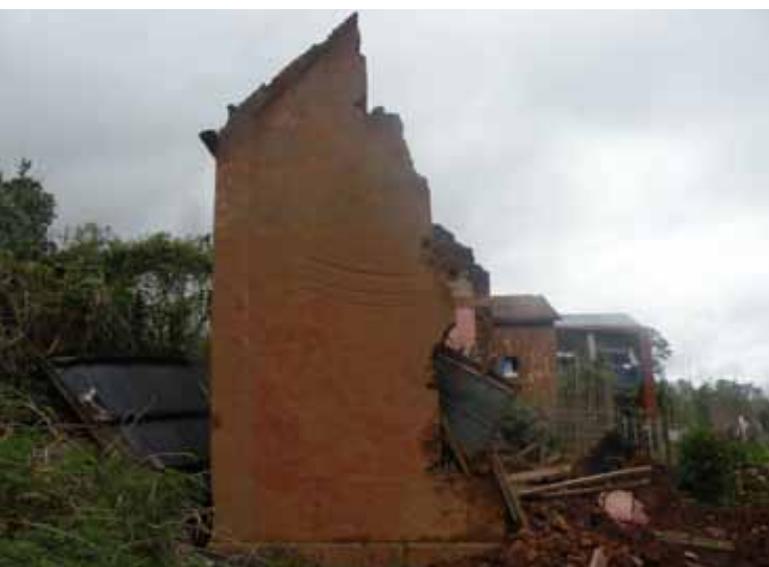
Photo 3 : Maison écroulée partiellement. © Marie Hortense Razafindramboa

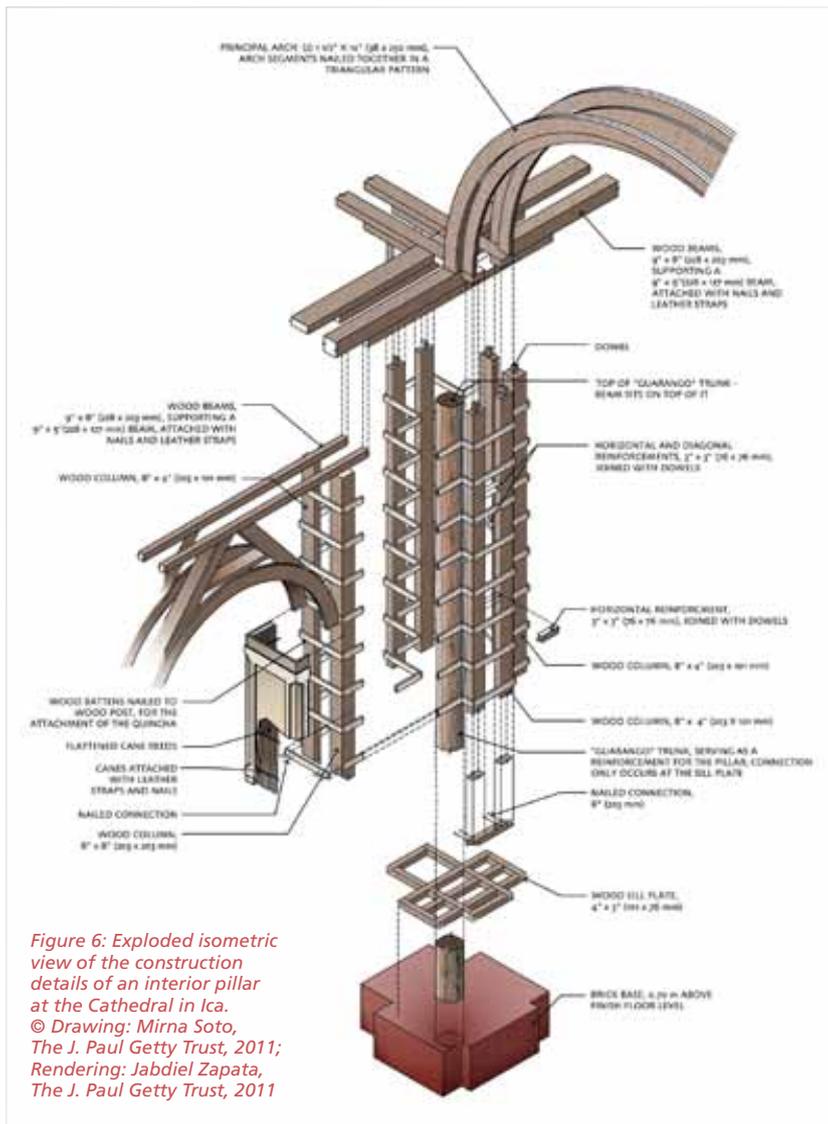
Figure 6: Exploded isometric view of the construction details of an interior pillar at the Cathedral in Ica. © Drawing: Mirna Soto, The J. Paul Getty Trust, 2011; Rendering: Jabdiel Zapata, The J. Paul Getty Trust, 2011

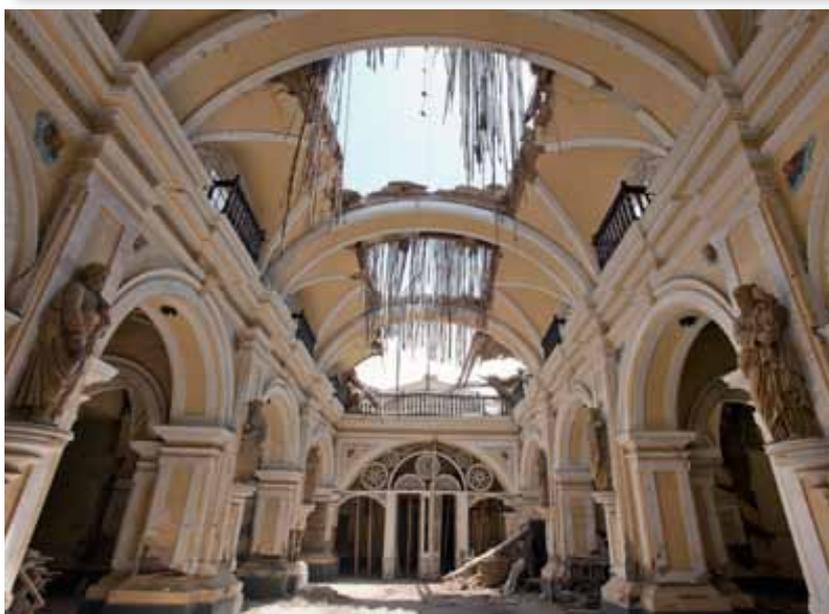
Figure 7: Interior view of the central nave of Ica Cathedral, damaged by earthquakes in 2007 and 2011. © Scott Warren, The J. Paul Getty Trust, 2011

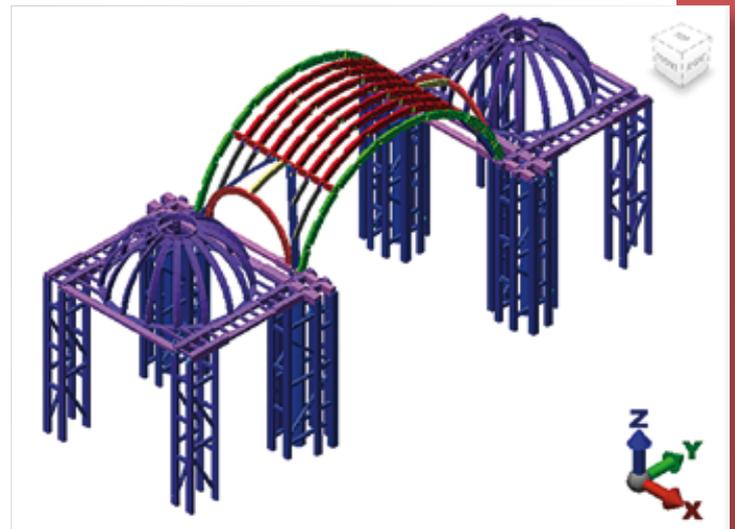
Figure 11: Partial numerical model of a representative bay of the nave and side aisles of Ica Cathedral, where the most important timber joints are simulated using realistic stiffness values obtained during the experimental campaign performed by PUCP. © Image and model: Carina Fonseca Ferreira, UCL, The J. Paul Getty Trust, 2013
