# Tserkvas of the Carpathian Region (Poland and Ukraine) No 1424

Wooden Tserkvas of the Carpathian Region in Poland and Ukraine

## Brief description

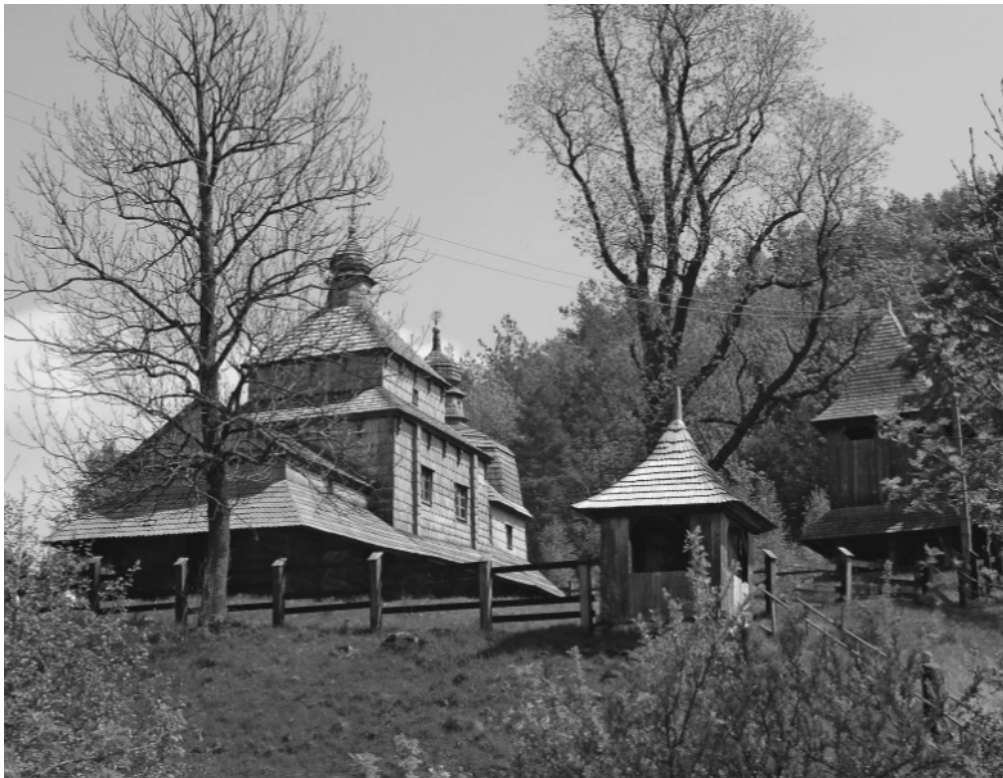
Early Halych group – Potelych, general view

The Tserkva of the Descent of the Holy Spirit was built in 1502 with the traditional double-tiered, pyramid roof over the nave, but in 1753 its form was altered by the addition of a helmet-shaped dome over the sanctuary. The interior polychrome decoration dates from the 17<sup>th</sup> and 18<sup>th</sup> centuries. Walls and roofs above and including the skirt roof are all shingle clad; the walls below are clad in board and batten. During repair works in 1923 all the shingles on the roofs and walls were replaced with metal, but this was reversed during the restoration project of 1970-2. The iconostasis and a donor's pew date from the 17<sup>th</sup> century. The nominated component includes the surrounding wooden fence and two low guard towers with shingled pyramidal roofs, as well as a two-tiered, square belfry to the south-east built at the same time as the original tserkva. It also includes the associated old and new cemeteries. The tserkva is one of the oldest to survive in the region. It is currently in ecclesiastical use by the Ukrainian Greek Catholic community. The nominated property area is 0.19ha surrounded by a buffer zone of 1.10ha.

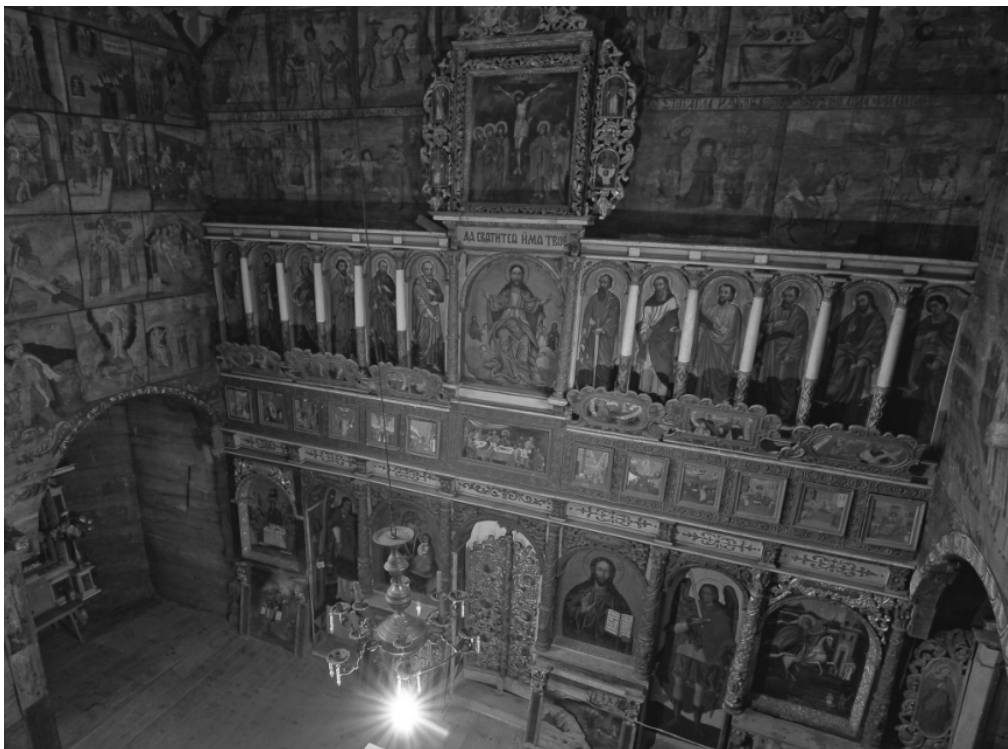
Later Halych group – Drohobych, iconostasis

The Tserkva of Saint George was built in the second half of the 17<sup>th</sup> century in the typical tri-partite form with octagonal drums and domes over the narthex, nave and sanctuary. It is distinguished by the two polygonal choir bays (*cliros*) either side of the nave which are also roofed with small domes above a double skirt roof, and by an external gallery running around the chapel in the choir loft above the narthex. All roofs and walls above the lowest skirt are shingled and walls are decorated with arcaded relief encircling each of the three parts immediately below each skirt roof. The lower skirt encircles the whole church and provides an arcaded veranda around the sides of the nave, extending to form a wider veranda area at the west end of the narthex. The iconostasis and wall paintings in the nave, narthex and choir loft, and paintings to the interior of the drum and cupola over the nave date from the 17<sup>th</sup> century. The nominated component includes the surrounding traditional wooden, shingle-roofed fence and gateways, and the freestanding, three-tiered wooden, domed bell tower, in which wooden fixtures beneath three bells survive on the third tier. The tserkva is considered to represent the pinnacle of wooden dome construction technology. It was built as an urban tserkva for the Ruthenian community and is currently used as a museum. The nominated property area is 0.18ha surrounded by a buffer zone of 1.06ha.

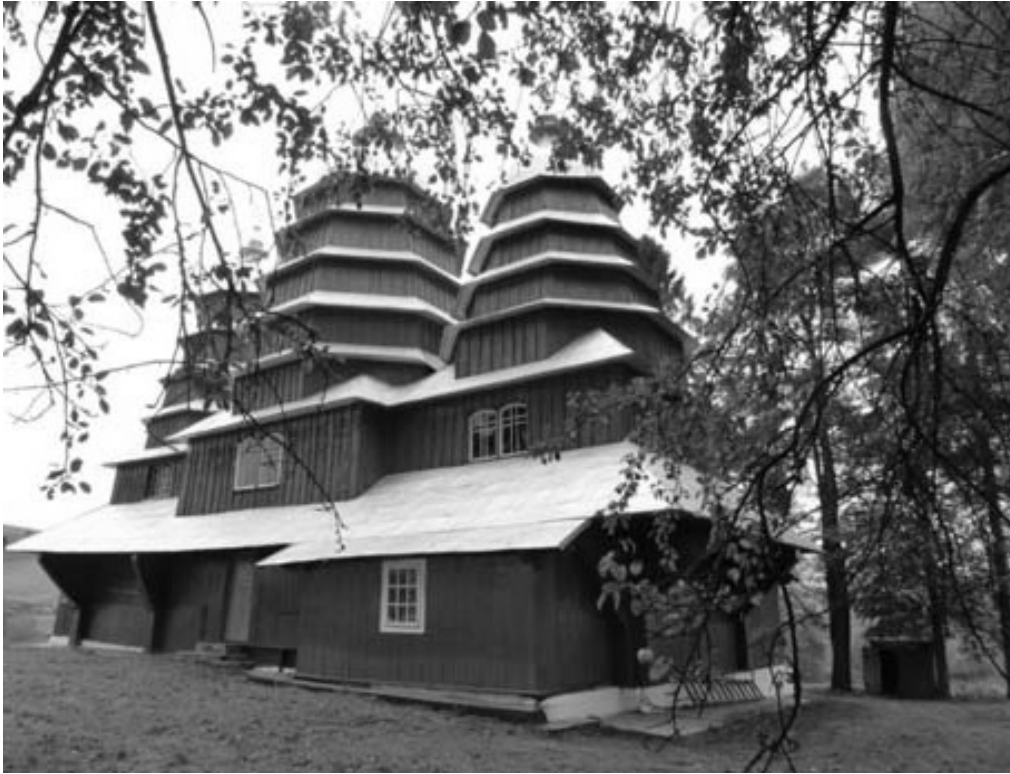
Boyko group – Matkiv, general view

The Tserkva of the Synaxis of the Blessed Virgin Mary was built in 1838 with three high, octagonal, multi-tiered pagoda-like towers surmounted by small domes, bulbs and finials. Two sacristies were added either side of the sanctuary in 1930 beneath the skirt roof that encircles the building. The walls are clad in board and batten; the domes and roofs in sheet metal. The three-arched porch along the west side of the narthex was enclosed in 1989. The interior space, formerly open up to the roof, was covered with dome vaulting at the level of the first tier in 1939. A choir loft runs around three sides of the narthex. The original iconostasis, altars and donor's pew are preserved. Interior wall paintings date from the late 19<sup>th</sup> century. The nominated component includes the fenced churchyard and the wooden two-tiered belfry with metal clad, hip roof in its south-west corner. The tserkva is located on a raised mound and is considered the best of this distinctive 19<sup>th</sup> century style due to its striking silhouette within the landscape. It was reconsecrated in 1989 as St Dmytro's and is currently used as a church by the Ukrainian Greek Catholic community. The nominated property area is 0.16ha surrounded by a buffer zone of 1.16ha.

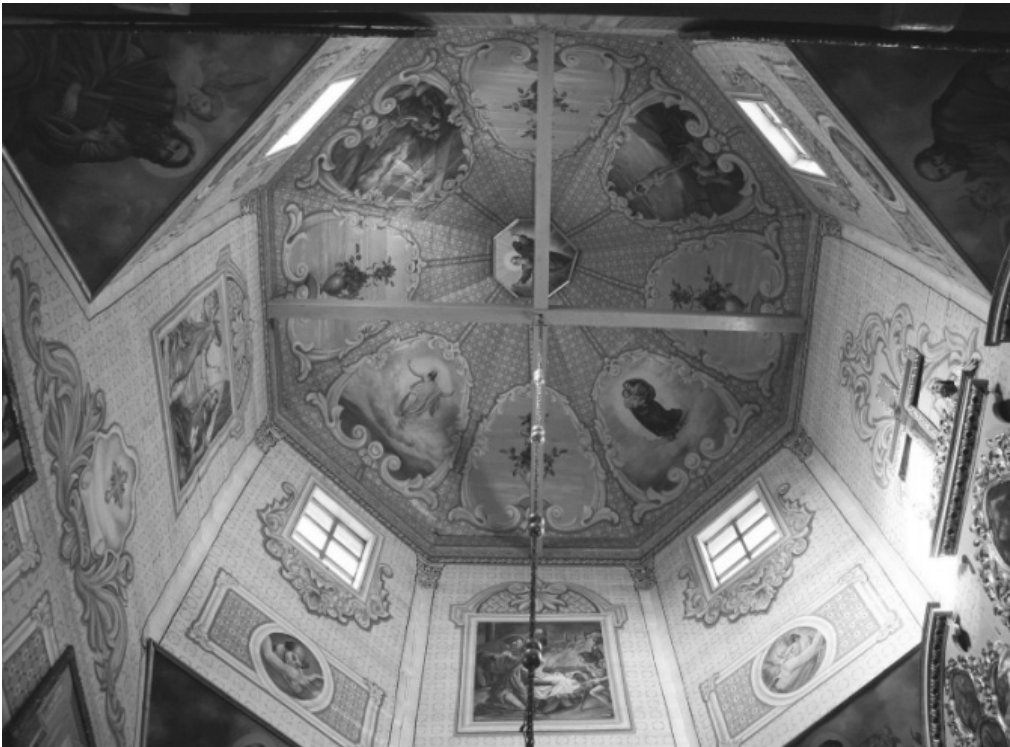
Hutsul group – Nyzhniy Verbizh, interior view

The Tserkva of the Nativity of the Blessed Virgin Mary built in 1808-10 takes a cruciform plan of four almost equal arms with polygonal ends extending from the central nave, all crowned with five domes surmounted by bulbs and finials. The tserkva was relocated from the village of Sheparivtsi in 1876 following which the walls were lined with linen and decoratively painted. This was renewed in the late 1980s. The domes and roofs were metal clad in 1956 and the walls received sheet metal cladding with embossed and chased decoration including images of saints in 1990. The interior polychrome decoration extends into the spaces beneath the cupolas and dates from the late 20<sup>th</sup> century; the original iconostasis and altars date from the beginning of the 19<sup>th</sup> century. An enclosed porch has been added to the southern entrance to the narthex, and a sacristy on the north side of the sanctuary. The nominated component includes the churchyard within the concrete wall constructed in 1937; the old cemetery, single-story brick chapel, wooden service house and the wooden two-tiered bell tower located north-west of the tserkva. The pyramidal roof, skirt roof and walls of the second tier of the bell tower are clad with engraved sheet metal. The tserkva is considered to be of high artistic value and unique in the region. It is currently used as a Ukrainian Orthodox church of the Kiev patriarchy. The nominated property area is 2.22ha surrounded by a buffer zone of 31.11ha. The new cemetery extends west from the old cemetery and is located in the buffer zone.

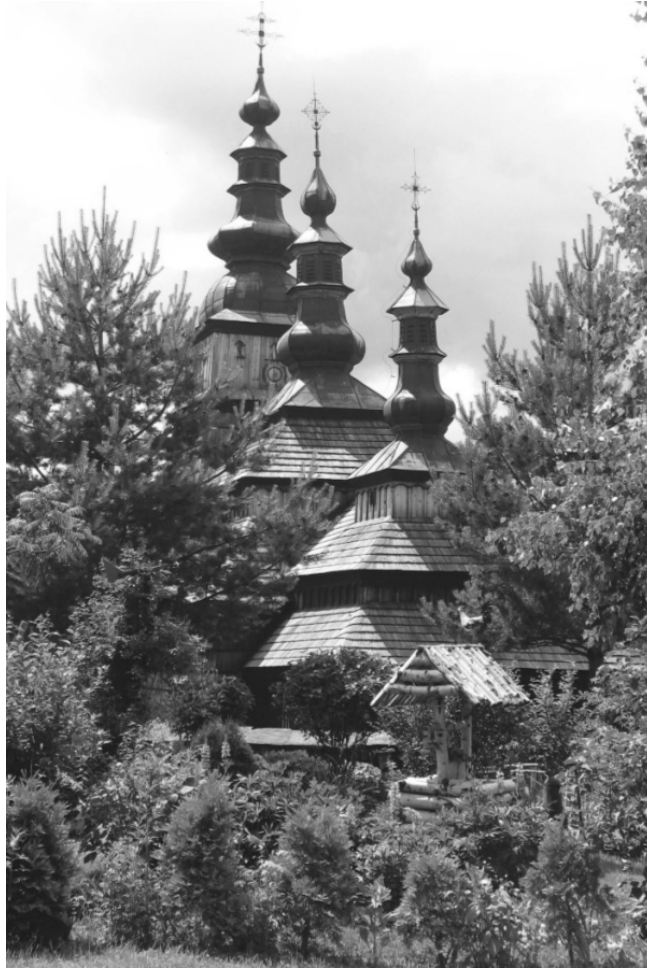
Lemko group – Owczary, general view

The Tserkva of Our Lady's Protection dates from 1653. Its walls and roofs are shingle clad, but the onion domes, bulbs and finials are clad in sheet metal. The sanctuary was rebuilt in 1701 and the tower over the narthex was erected in 1783. The narthex was enlarged to the width of the nave in 1870; hence two posts of the tower are inside it. The iconostasis, furnishings and decoration date from the 17<sup>th</sup>-19<sup>th</sup> centuries, with figural polychrome decoration added in 1938 to commemorate the 950<sup>th</sup> anniversary of Ruthenia's conversion to Christianity. In the 1980s sheet metal cladding to the lower roofs and walls was replaced with shingles. The nominated property component includes its stone enclosing wall incorporating a two-storey masonry gateway surmounted by a belfry built in 1928 to the west on the longitudinal axis of the tserkva, with a tent roof topped by an onion dome and cross. A second timber gateway to the south has a tent roof topped with small dome. The property includes the former graveyard and extends a considerable distance to the west. It is now used as a Roman Catholic church but shared with the Ukrainian Greek Catholic community. The nominated property area is 0.38ha surrounded by a buffer zone of 2.87ha.
