The Victorian & Art Deco Ensemble of Mumbai

Submission To UNESCO As A WORLD HERITAGE SITE

ANNEXURE A- DOCUMENTATION PART II-BUILDING INVENTORIES

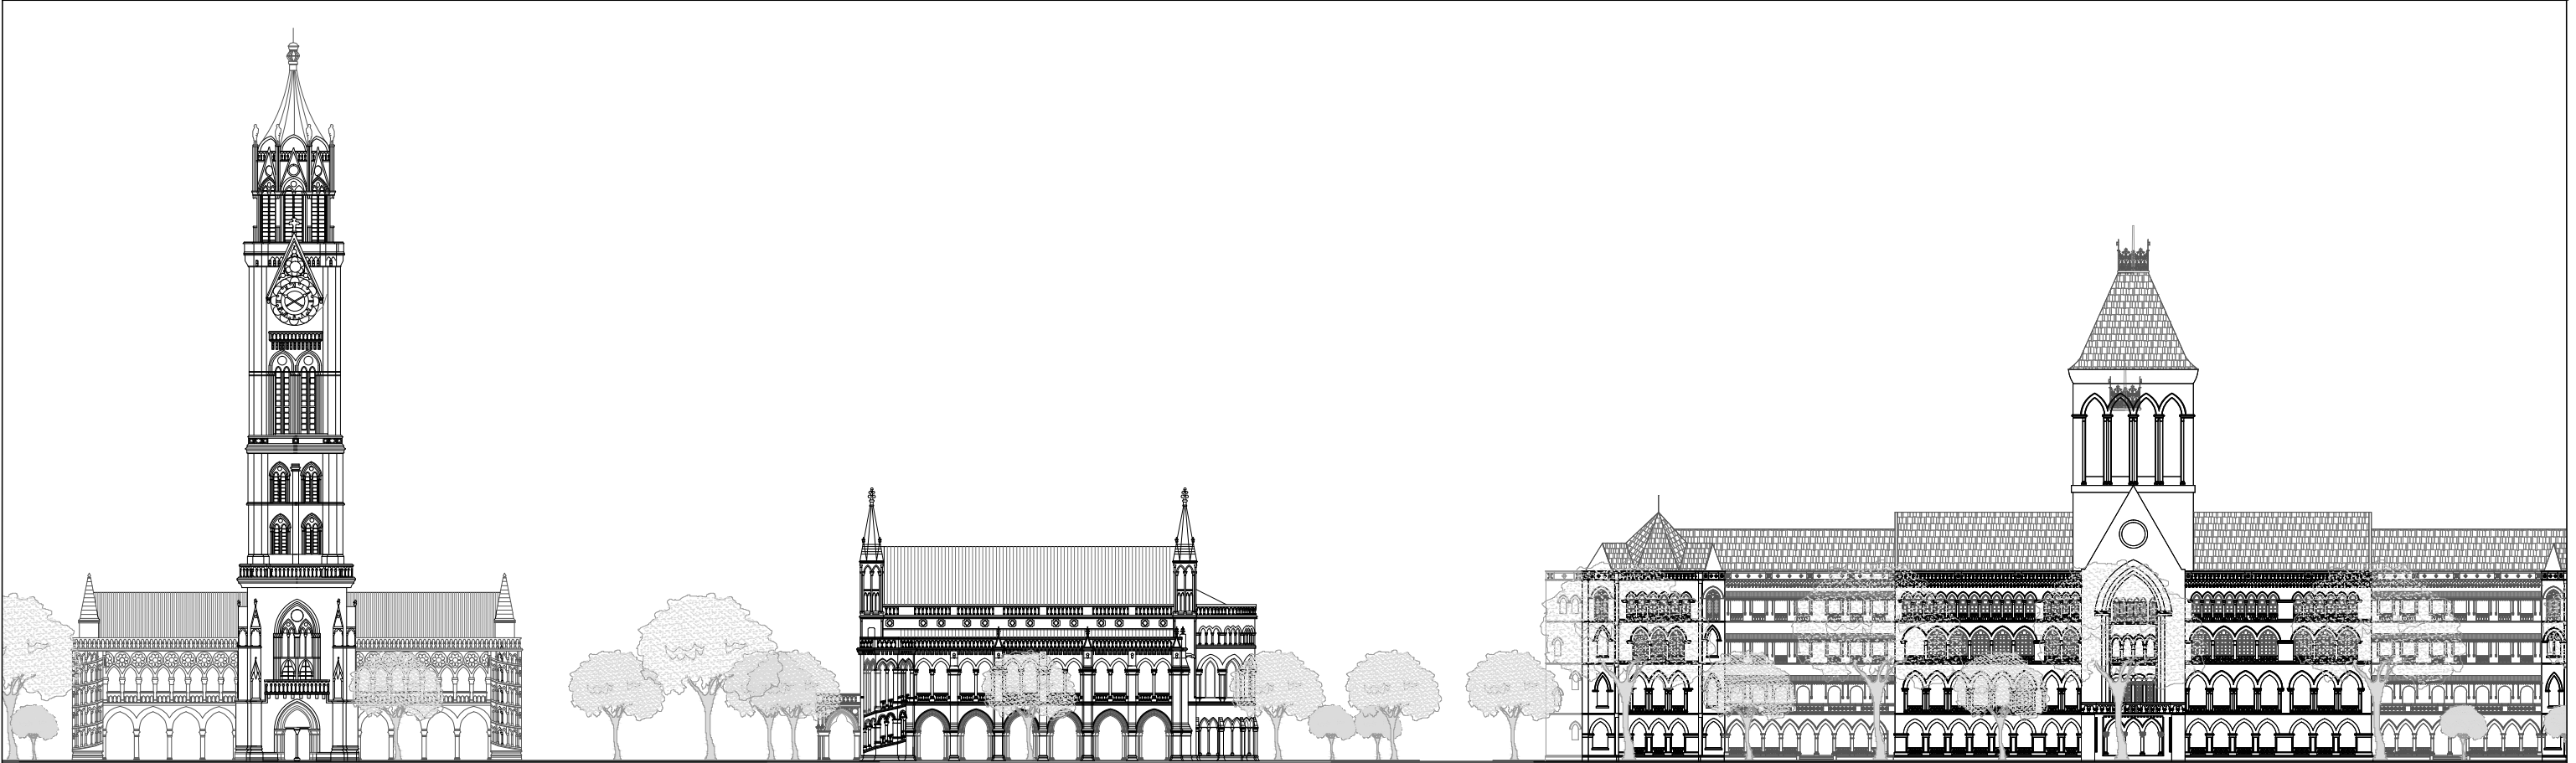
V2b UNIVERSITY LIBRARY
Copyright of Rahul Mehrotra Associates on loan for the UNESCO dossier

V2a SIR CAWASJI JAHANGIR CONVOCATION HALL
Copyright of Rahul Mehrotra Associates on loan for the UNESCO dossier

V1 CITY CIVIL & SESSIONS COURT
Copyright of Abha Narain Lambah & Associates on loan for the UNESCO dossier

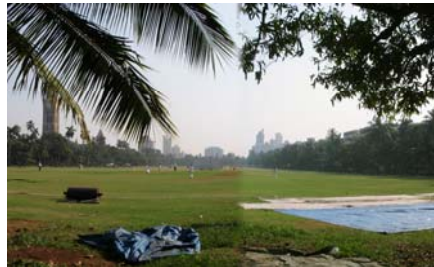
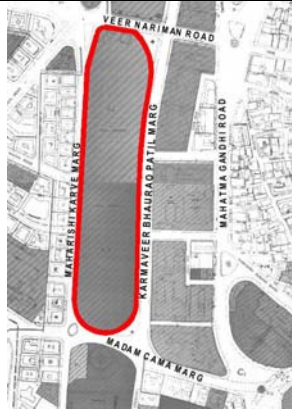
Common Ref No: 075

9.8	Services	-
9.9	Out Buildings	Poor – East side sheds are not maintained well.
9.10	Overall Conditions	Good Maintenance level Good
10.0		Transformation
	Form	-
	Structure	Bus stop and BMC Sheds have sprung up on the eastern edge.
	Articulation & Finishes	-

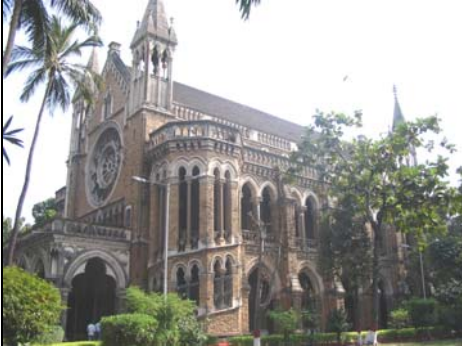
Common Ref No: 076(a)

9.0		Condition
9.1	Plinth	Good
9.2	Walls	Good
9.3	Floor	Good
9.4	Stairs	Good
9.5	Openings	Good
9.6	Roofing	Good
9.7	Articulation & Finishes	Good
9.8	Services	Good

9.9	Out Buildings	-
9.10	Overall Conditions	Good Maintenance level: Good
10.0		Transformation
	Form	-
	Structure	-
	Articulation & Finishes	Intricate stone carvings inside the interiors have been painted over. Cement pointing done over stone dressed courses.

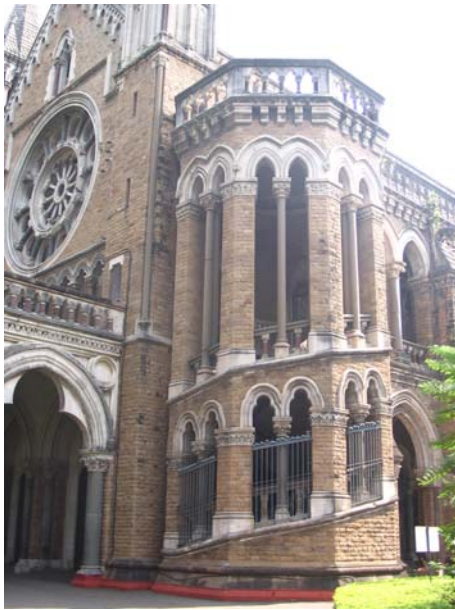
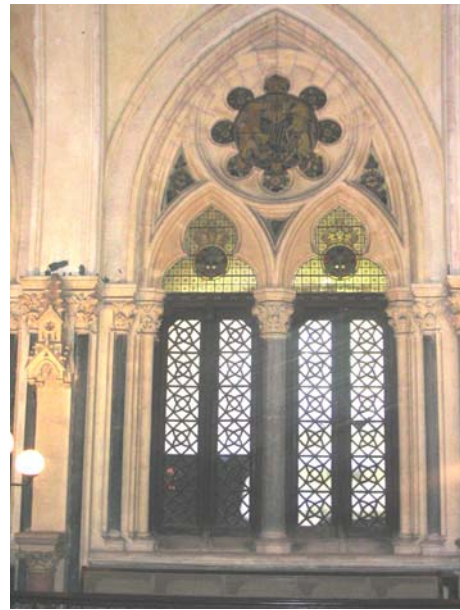
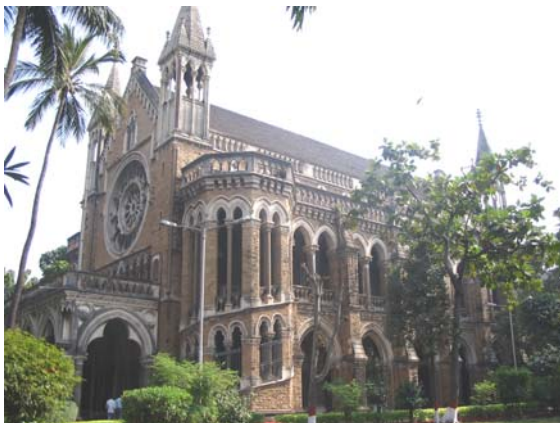
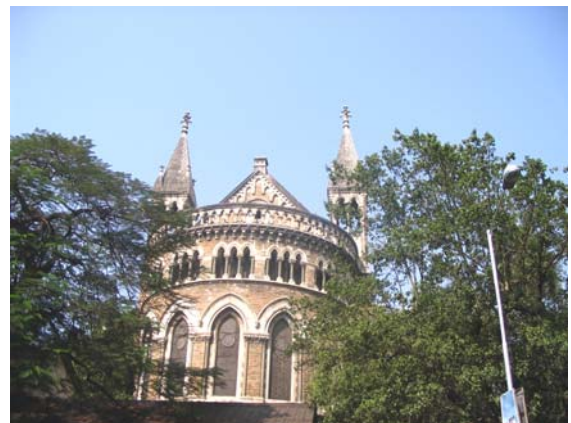
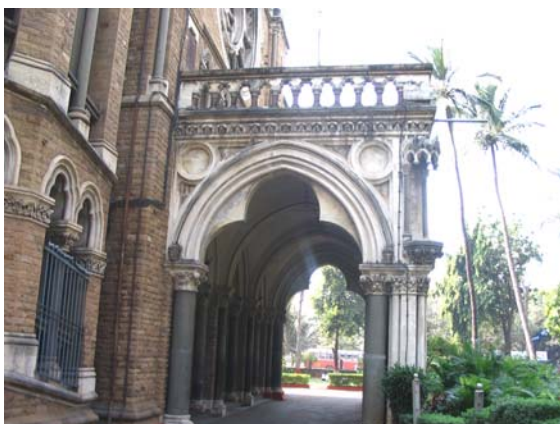
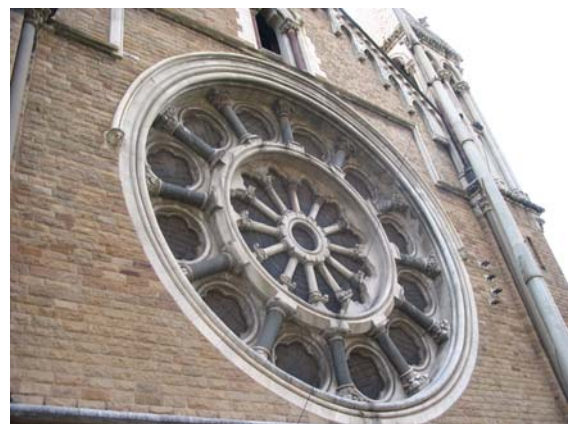
076(a)

7.5	Openings	Large pointed arch openings with smaller arches and circular openings within. Double shutter door openings, outer wooden louvered and inner glazed geometric sash panels. Varied color and design of stained glass panels in arch and circular ventilators.

7.8	Finishes	Malad stone ashlar course dressed in external and verandah walls. Ornamental carved features in soft Porbander stone. Plastered painted internally. Granite circular columns supporting entrance arches. Minton floor tiling and stained glass panels in window and ventilator openings. Decorative Iron brackets supporting projecting gallery and parapet railings.

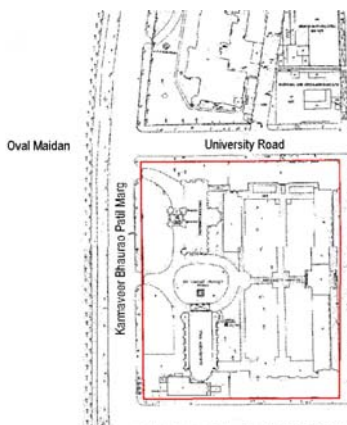
Annex building		Common Ref No: 076(b)

9.0		Condition		
9.1	Plinth	Good		
9.2	Walls	Good		
9.3	Floor	Fair – stacking areas have some exposed reinforcement in ceiling.		
9.4	Stairs	Good		
9.5	Openings	Good

9.6	Roofing	Indeterminable		
9.7	Articulation & Finishes	Good		
9.8	Services	Fair – electrical wiring runs haphazardly.		
9.9	Out Buildings	-		
9.10	Overall Condition	Good	Maintenance level	Good

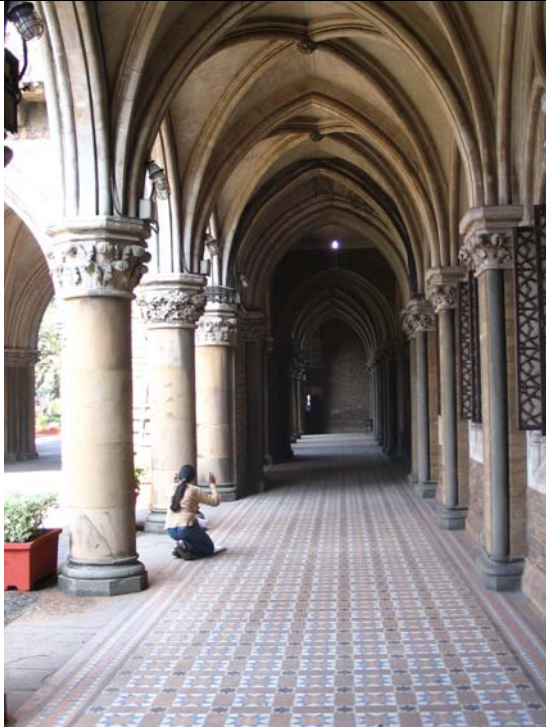
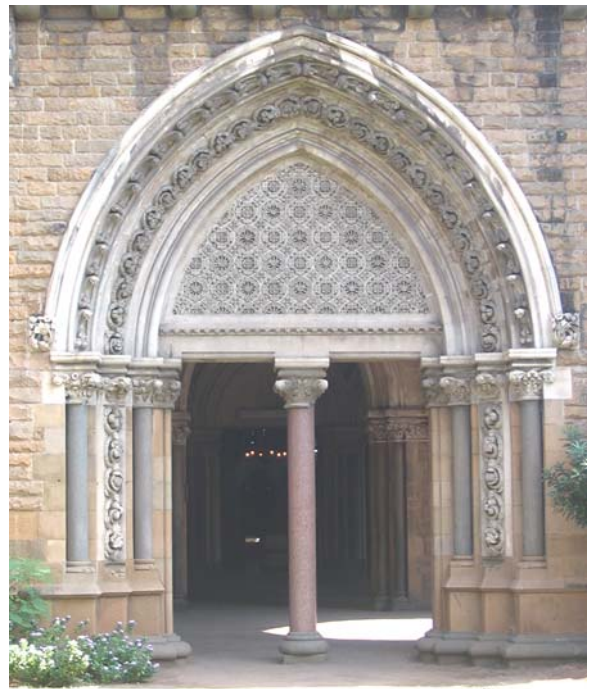
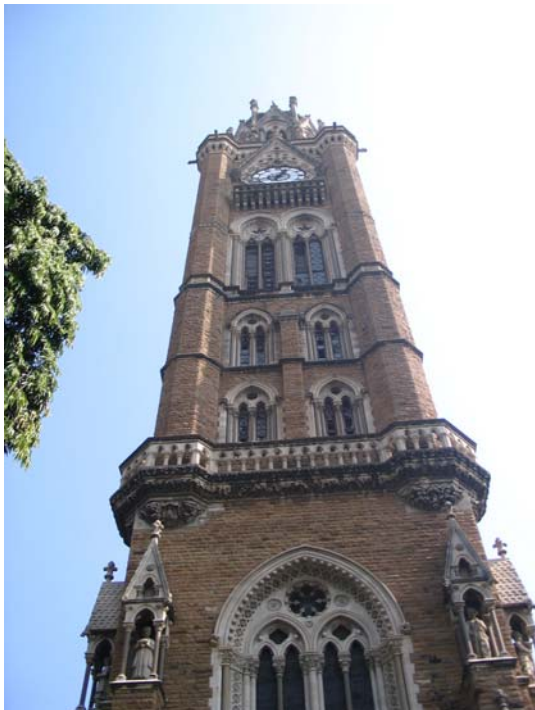
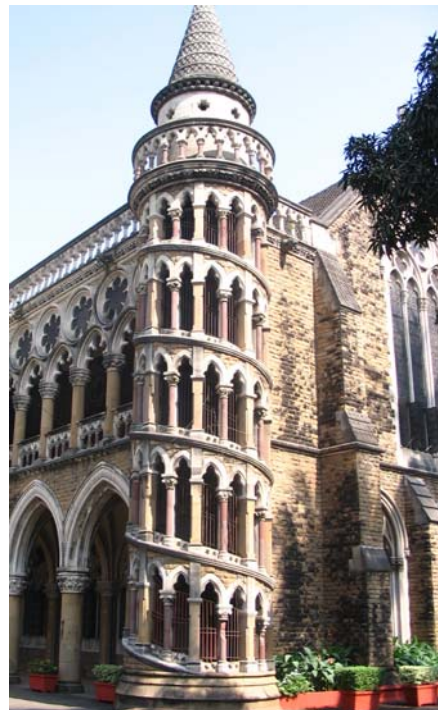
7.3	Floor	Floor rests on ribbed-groined vault in arcade and ground floor hall and has coffered ceiling in the adjacent two rooms.		
7.4	Stairs	Six staircases are present. The main central staircase is a grand stone spiral staircase with stain glass windows, decorative Corinthian column capitals and animal form post and stone balusters. Two spiral stone staircases are at the two corners in front of the building while one staircase is inside the Rajabai tower. Two cast iron staircases are also found in the book stacking area of which one was spiral and other doglegged.

V2 b-c University Library and Annexe building			076(b)	
7.5	Openings	Large pointed arch openings with smaller arches and circular openings within. Double shutter door openings, outer wooden louvered and inner glazed geometric sash panels. Varied color and design of stain glass panels in arch and circular ventilators.

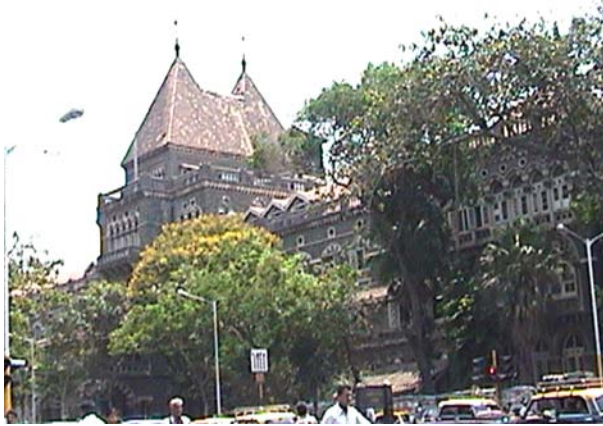
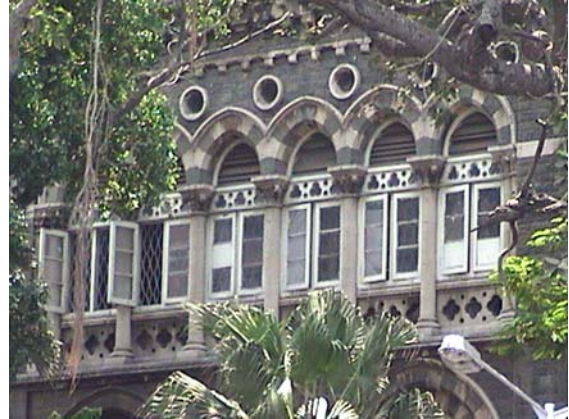
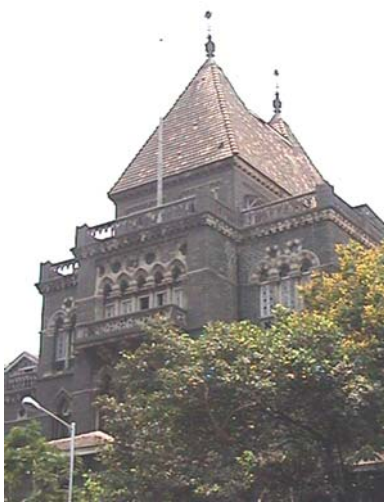
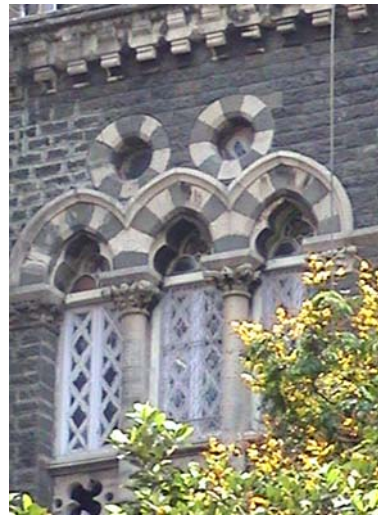
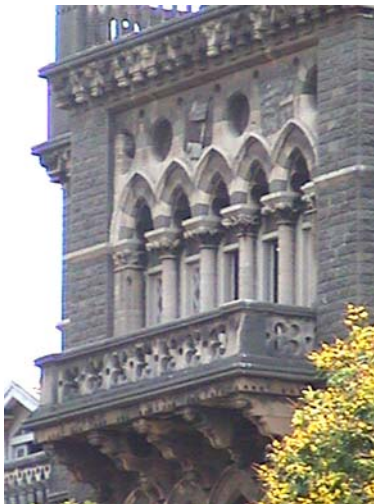
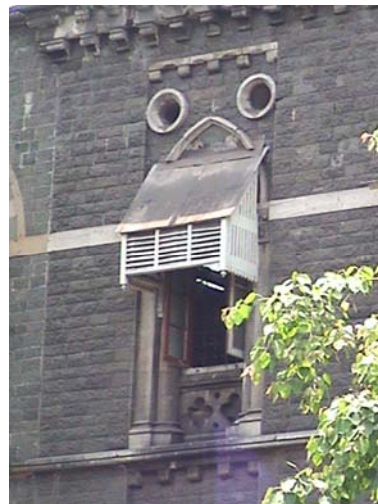
8.6	Fire Precaution	Indeterminable	
8.7	Other (HVAC/BMS/Security Systems)	Indeterminable	
9.0		Condition	
9.1	Plinth	Good no evident damages seen. Blackening of stone.

9.10	Overall Conditions	Good	Maintenance level Good

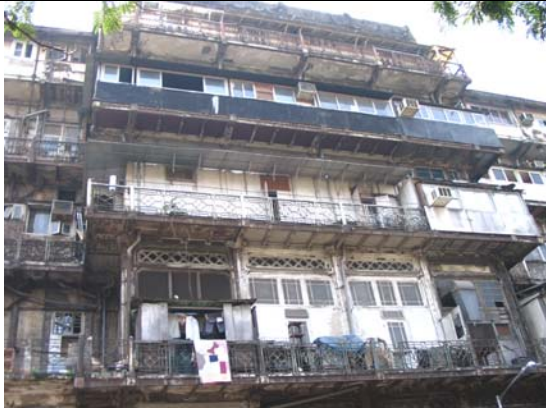
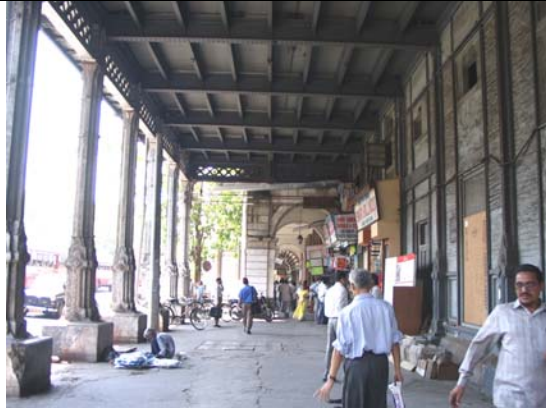
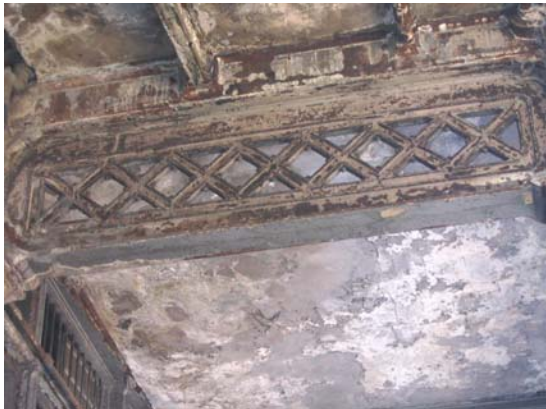
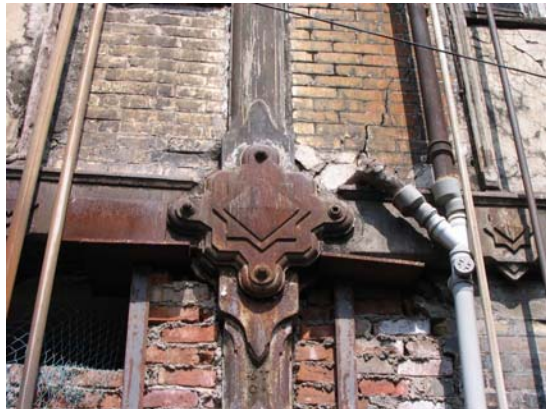
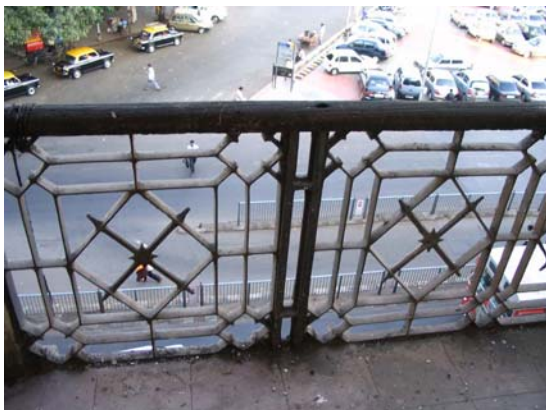
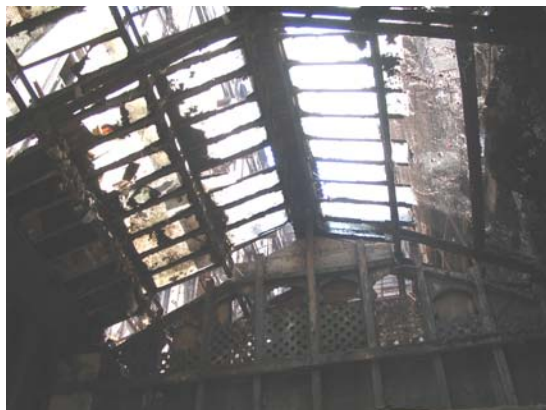
V5 Mahendra Mansion (Watson's Hotel)

9.2	Walls	Poor - All external as well as internal walls are in a state of neglect and dilapidated; issues of ficus growth
9.3	Floor	Poor - Wooden floorboards damaged and unlevelled, insensitively covered with varied tiling and plain cement, cracks visible

9.4	Stairs	Poor - poor maintained state of the once grand staircase.
9.5	Openings	Poor - lack of maintenance
9.6	Roofing	Poor - in need of repair and waterproofing

9.7	Articulation & Finishes	Poor - transformation visible
9.8	Services	Poor - Various additions and modifications in services
9.9	Out Buildings	-
9.10	Overall Conditions	Poor Maintenance level: Poor

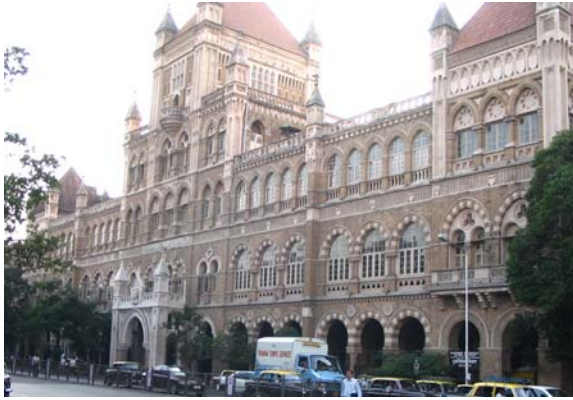
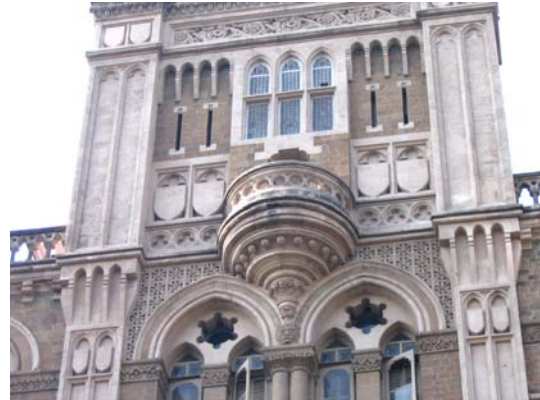
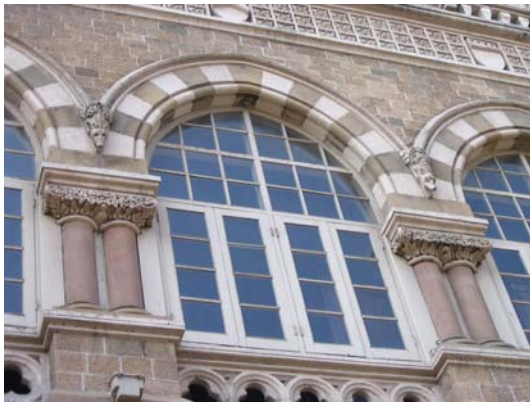
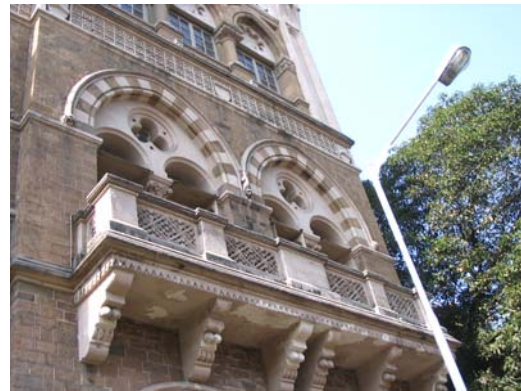
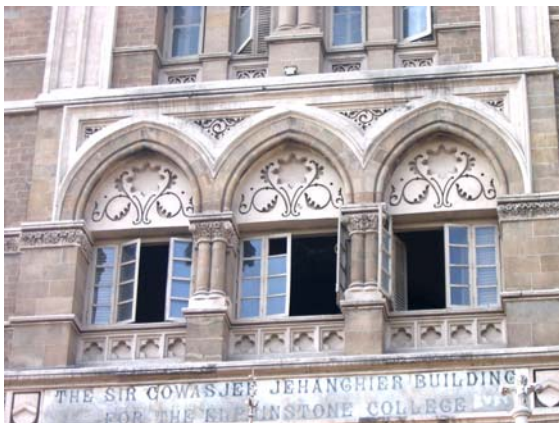
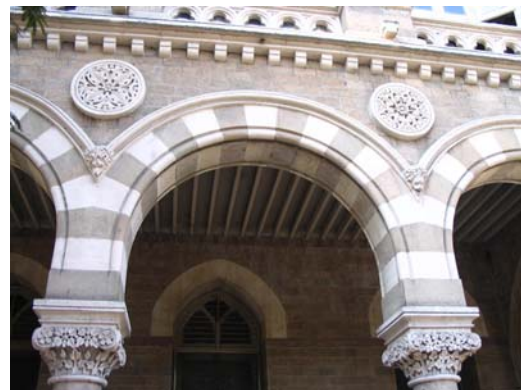
8.6	Fire Precaution	Fire extinguishers only.
8.7	Other (HVAC/BMS/Security Systems)	Window unit A.C.
9.0		Condition
9.1	Plinth	Good
9.2	Walls	Good
9.3	Floor	Fair

9.4	Stairs	Good
9.5	Openings	Good
9.6	Roofing	Good
9.7	Articulation & Finishes	Good
9.8	Services	Fair, with minor repairs required.
9.9	Out Buildings	Fair
9.10	Overall Conditions	Good Maintenance level: Good

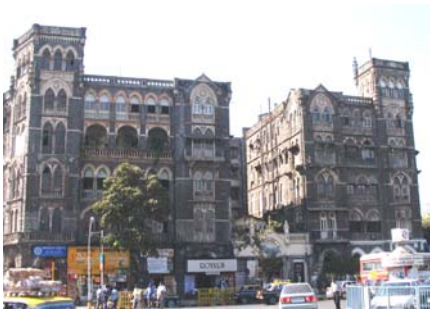
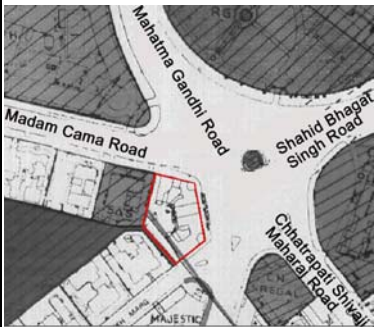
V9 Indian Mercantile Mansion (Waterloo Mansion)				151

8.6	Fire Precaution	-	
8.7	Other (HVAC/BMS/Security Systems)	Individual tenants have installed window and split air conditioners.	
9.0		Condition	
9.1	Plinth	Fair

9.10	Overall Conditions	Fair	Maintenance level Fair
10.0		Transformation	
	Form	Addition of a wing on rear side.	
	Structure	-	
	Articulation & Finishes	Hoardings cover the ground floor of the building façade. Alterations and additions have been insensitively done

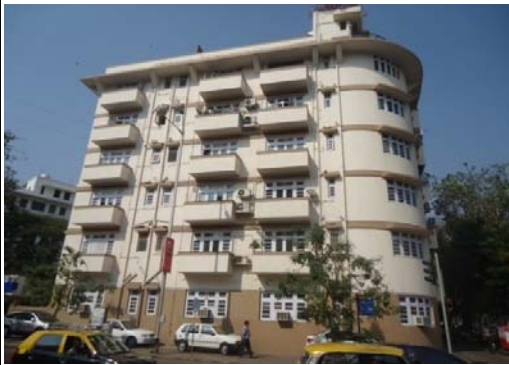
8.7	Other (HVAC/BMC/Security Systems)	Not provided (independent air conditioning units in the houses)
9.0		CONDITION
9.1	Plinth	Good
9.2	Walls	Good
9.3	Floor	Good

9.4	Stairs	Good (no structural damage but needs cleaning and polishing)
9.5	Openings	Good
9.6	Roofing	Good
9.7	Articulation & Finishes	Good

A1	MOONLIGHT	
9.8	Services	Good (Drainage pipe needs no replacement)
9.9	Outbuildings	Good
9.10	Overall Condition	Good
10.0		TRANSFORMATION
10.1	Form	Additional apartment on the terrace level
10.2	Structure	No transformation
10.3	Articulation & Finishes	Recently painted
11.0	DPREMARKS/PERCEIVEDTHREATS	Plot falls under Residential Zone in DP
12.0	ADDITIONAL NOTES/REFERENCES/DOCUMENTS AVAILABLE/RECOMMENDATIONS & SUGGESTIONS FOR IMPLEMENTATION	Documents: C.S. sheets, D.P. Sheets, Eicher City Maps-Mumbai, Dwivedi, Mehrotra Bombay, The Cities within Bombay 1995

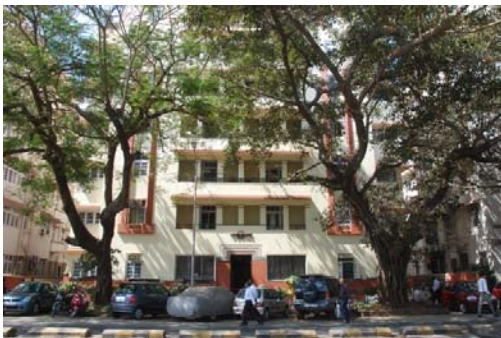
A2		SUNSHINE

9.0		CONDITION
9.1	Plinth	Good
9.2	Walls	Good
9.3	Floor	Good
9.4	Stairs	Good (no structural damage but needs cleaning and polishing)
9.5	Openings	Good
9.6	Roofing	Good

A 2	SUNSHINE	
9.8	Services	Good (Drainage pipe needs no replacement)
9.9	Outbuildings	Good
9.10	Overall Condition	Good
10.0		TRANSFORMATION
10.1	Form	No transformation
10.2	Structure	No transformation
10.3	Articulation & Finishes	Recently painted
11.0	DPREMARKS/PERCEIVEDTHREATS	Plot falls under Residential Zone in DP
12.0	ADDITIONAL NOTES/REFERENCES/DOCUMENTS AVAILABLE/RECOMMENDATIONS & SUGGESTIONS FOR IMPLEMENTATION	Documents: C.S. sheets, D.P. Sheets, Eicher City Maps-Mumbai, Dwivedi, Mehrotra Bombay, The Cities within Bombay 1995

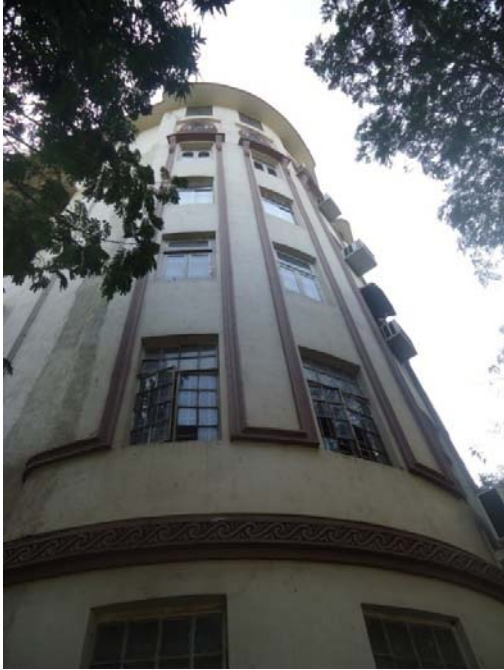
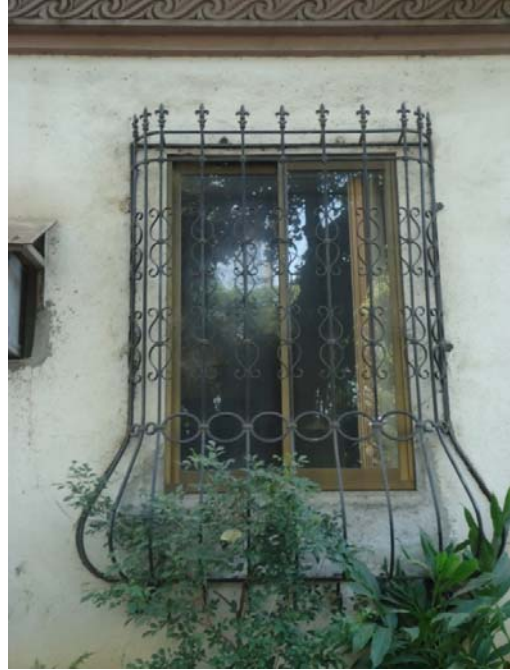
9.0		CONDITION
9.1	Plinth	Good
9.2	Walls	Good
9.3	Floor	Good
9.4	Stairs	Good (no structural damage but needs cleaning and polishing)
9.5	Openings	Good
9.6	Roofing	Good

9.7	Articulation & Finishes	Good
9.8	Services	Good (Drainage pipe needs no replacement)
9.9	Outbuildings	Good
9.10	Overall Condition	Good

A3	IVORINE	
10.0		TRANSFORMATION
10.1	Form	No transformation
10.2	Structure	No transformation
10.3	Articulation & Finishes	Recently painted
11.0	DPREMARKS/PERCEIVEDTHREATS	Plot falls under Residential Zone in DP
12.0	ADDITIONAL NOTES/REFERENCES/DOCUMENTS AVAILABLE/RECOMMENDATIONS & SUGGESTIONS FOR IMPLEMENTATION	Documents: C.S. sheets, D.P. Sheets, Eicher City Maps-Mumbai, Dwivedi, Mehrotra Bombay, The Cities within Bombay 1995

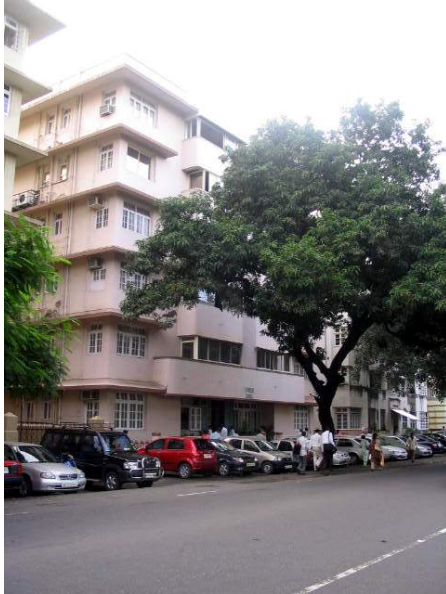
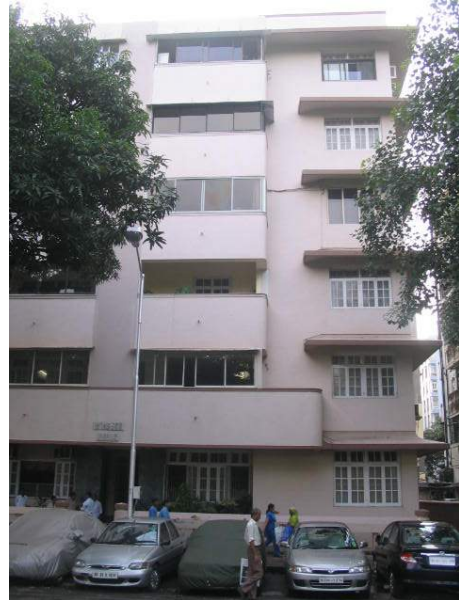
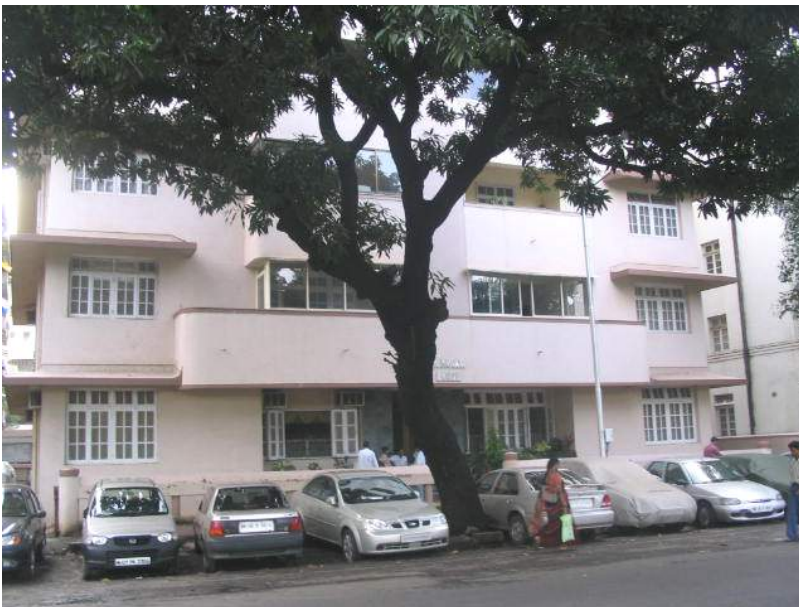
A11 WINDSOR HOUSE

9.0		CONDITION	
9.1	Plinth	Good (No settlement or cracks observed)	
9.2	Walls	Good (No dampness or cracks observed)	
9.3	Floor	Good	
9.4	Stairs	Good (Wooden members need maintenance)

9.5	Openings	Good	
9.6	Roofing	Good (No leakage observed)	
9.7	Articulation & Finishes	Good	
9.8	Services	Good (Drainage pipes need no replacement)	
9.9	Outbuildings	Good

9.10	Overall Condition	Good	Maintenance level Good
10.0		TRANSFORMATION	
10.1	Form	No transformation	
10.2	Structure	No transformation	
10.3	Articulation & Finishes	No transformation

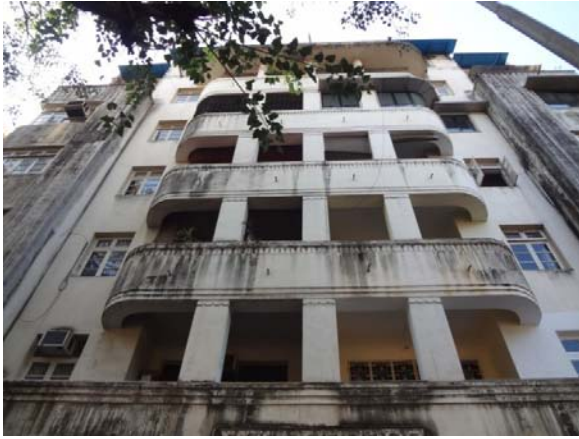
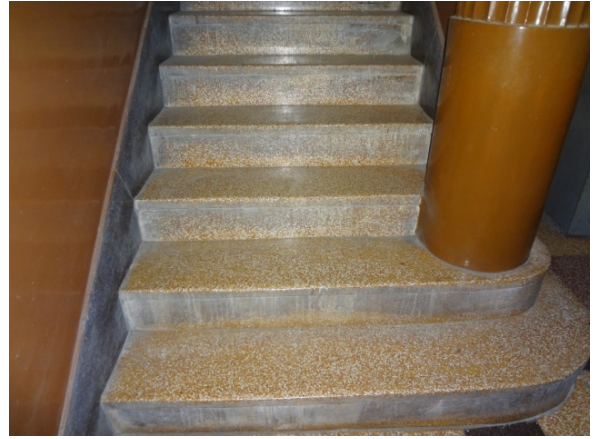
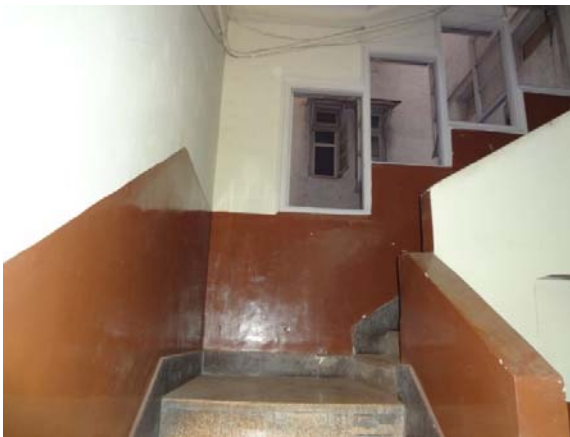
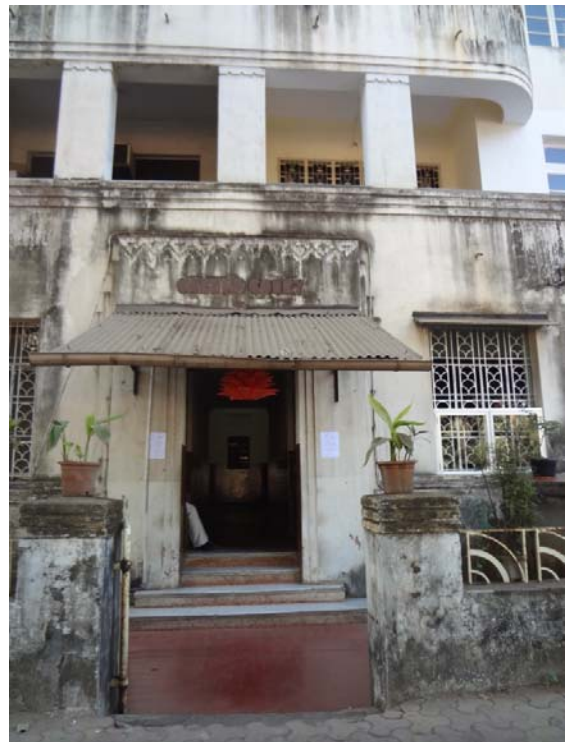
9.0		CONDITION
9.1	Plinth	Good
9.2	Walls	Good(exterior walls need painting)
9.3	Floor	Good
9.4	Stairs	Good
9.5	Openings	Good
9.6	Roofing	Good
9.7	Articulation & Finishes	Good

9.8	Services	Average (Needs cleaning and repairs)
9.9	Outbuildings	Average(Shows cracks needs repairs)
9.10	Overall Condition	Good

A12	QUEEN'S COURT	
10.0		TRANSFORMATION
10.1	Form	Additional box grills , A.C.P. canopies and chajjas
10.2	Structure	No transformation
10.3	Articulation & Finishes	No major transformations
11.0	DPREMARKS/PERCEIVEDTHREATS	Plot falls under Residential Zone in DP
12.0	ADDITIONAL NOTES/REFERENCES/DOCUMENTS AVAILABLE/RECOMMENDATIONS & SUGGESTIONS FOR IMPLEMENTATION	Documents: C.S. sheets, D.P. Sheets, Eicher City Maps-Mumbai, Dwivedi, Mehrotra Bombay, The Cities within Bombay 1995

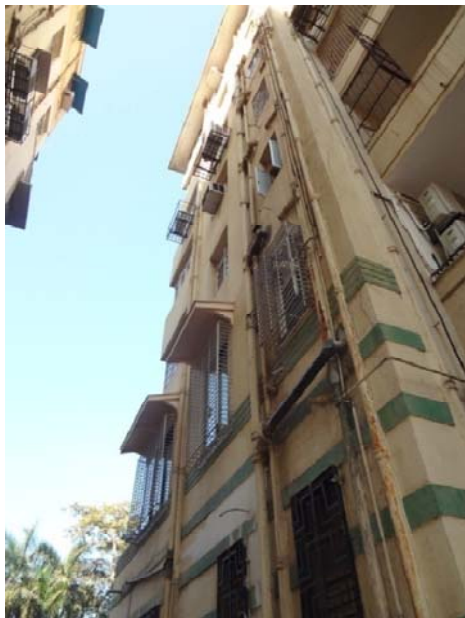
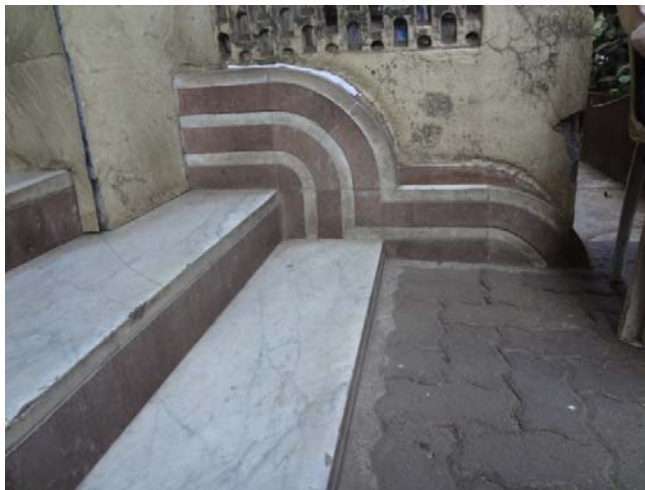
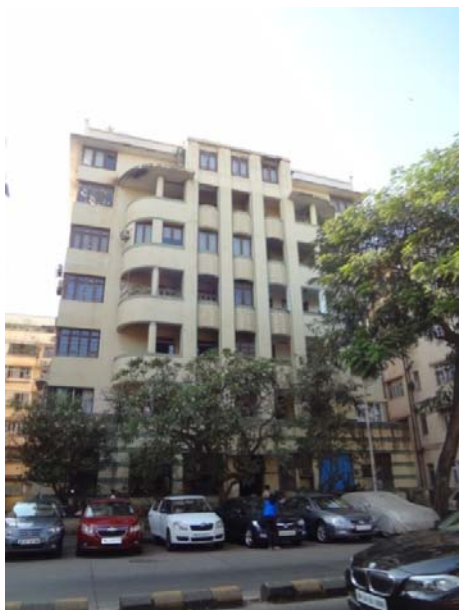
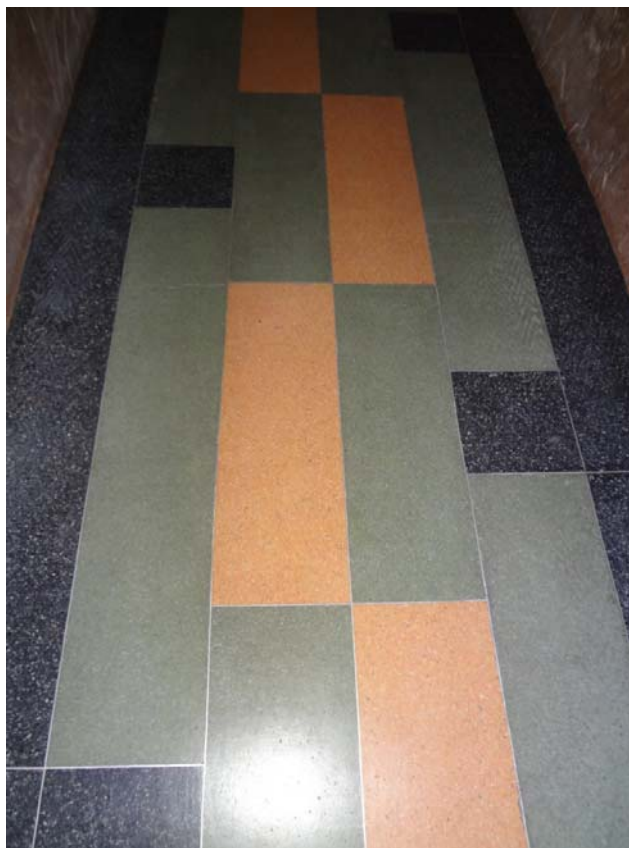
9.0		CONDITION
9.1	Plinth	Good
9.2	Walls	Good(exterior walls need painting)
9.3	Floor	Good
9.4	Stairs	Good
9.5	Openings	Good
9.6	Roofing	Good
9.7	Articulation & Finishes	Good

9.8	Services	Average (Needs cleaning)
9.9	Outbuildings	Average(Needs cleaning and repairs)
9.10	Overall Condition	Good

A13	GREEN FIELDS	
10.0		TRANSFORMATION
10.1	Form	Additional box grills , A.C.P. canopy and chajjas
10.2	Structure	No transformation
10.3	Articulation & Finishes	No major transformation
11.0	DPREMARKS/PERCEIVEDTHREATS	Plot falls under Residential Zone in DP
12.0	ADDITIONAL NOTES/REFERENCES/DOCUMENTS AVAILABLE/RECOMMENDATIONS & SUGGESTIONS FOR IMPLEMENTATION	Documents: C.S. sheets, D.P. Sheets, Eicher City Maps- Mumbai, Dwivedi, Mehrotra Bombay, The Cities within Bombay 1995

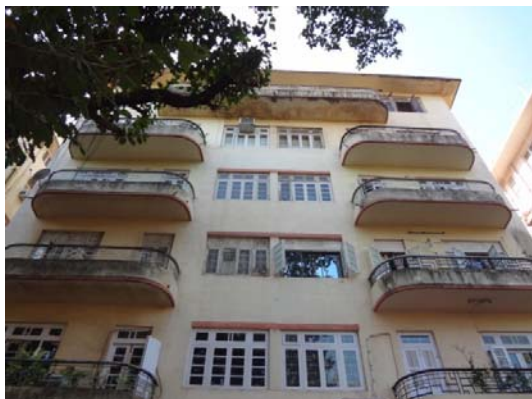
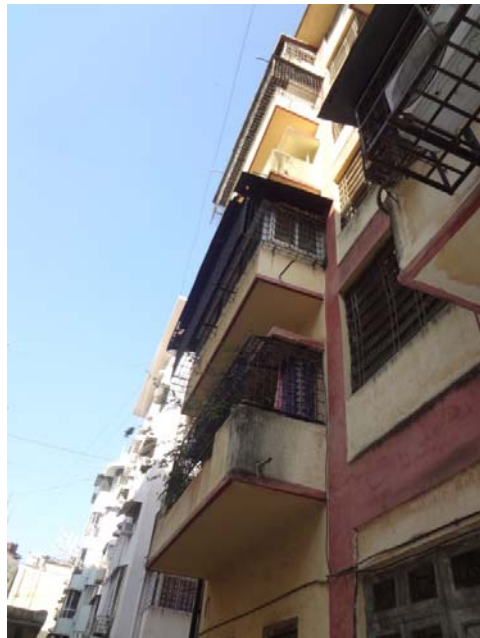
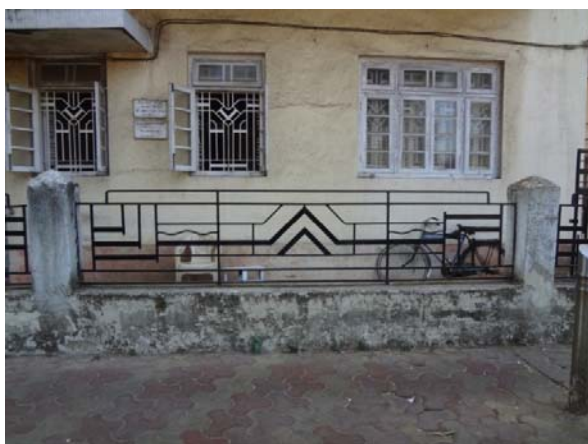
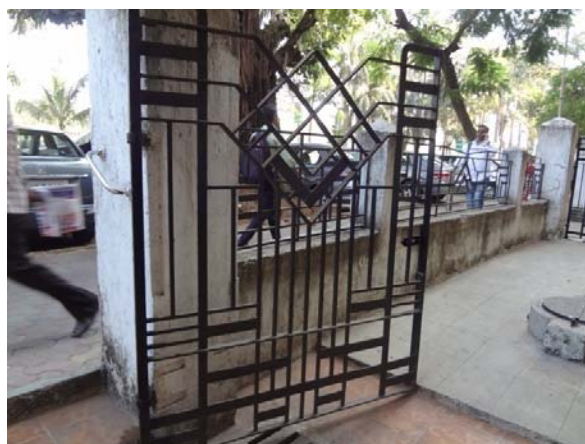
9.0		CONDITION
9.1	Plinth	Good
9.2	Walls	Good
9.3	Floor	Good
9.4	Stairs	Good
9.5	Openings	Good
9.6	Roofing	Good
9.7	Articulation & Finishes	Good
9.8	Services	Average (Needs cleaning)

9.9	Outbuildings	Good
9.10	Overall Condition	Good

A14	SWASTIK COURT	
10.0		TRANSFORMATION
10.1	Form	Additional box grills and A.C.P. chajjas
10.2	Structure	No transformation
10.3	Articulation & Finishes	No major transformation
11.0	DPREMARKS/PERCEIVEDTHREATS	Plot falls under Residential Zone in DP
12.0	ADDITIONAL NOTES/REFERENCES/DOCUMENTS AVAILABLE/RECOMMENDATIONS & SUGGESTIONS FOR IMPLEMENTATION	Documents: C.S. sheets, D.P. Sheets, Eicher City Maps-Mumbai, Dwivedi, Mehrotra Bombay, The Cities within Bombay 1995

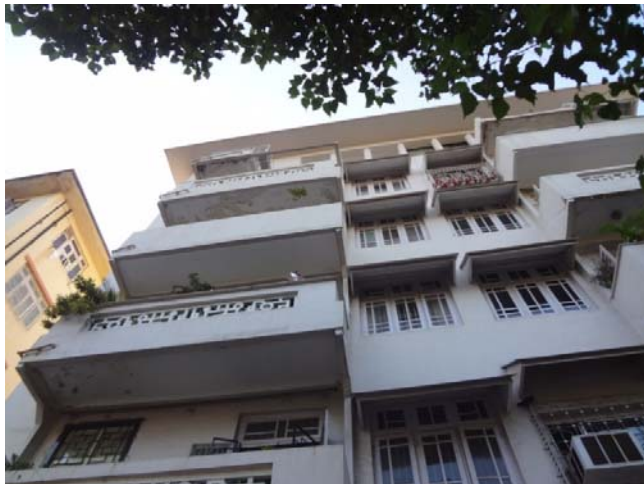
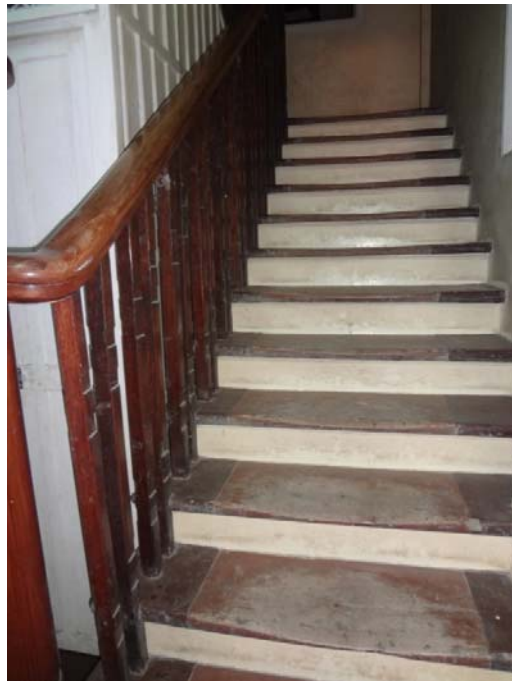
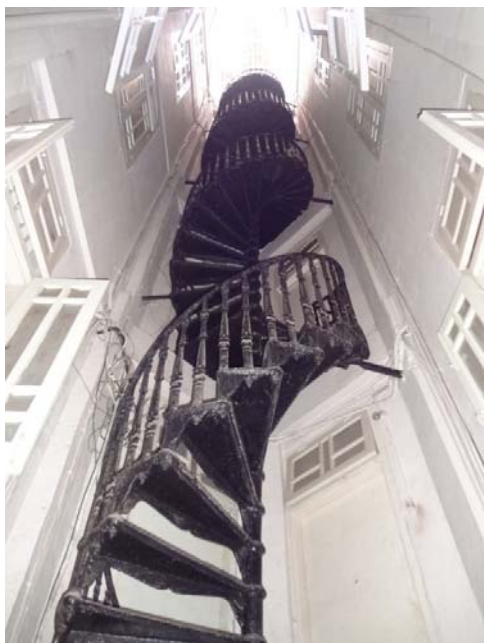
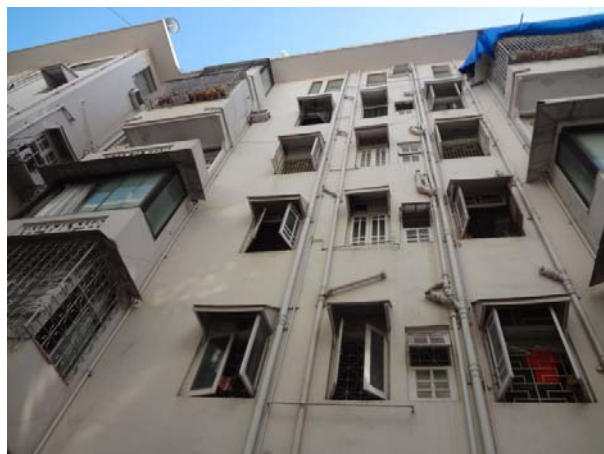
9.0		CONDITION
9.1	Plinth	Good
9.2	Walls	Good(Paint scraping off in a few places due to moisture)
9.3	Floor	Good
9.4	Stairs	Good
9.5	Openings	Good
9.6	Roofing	Good

9.7	Articulation & Finishes	Good
9.8	Services	Good
9.9	Outbuildings	Good
9.10	Overall Condition	Good

A15	MOTABHOY MANSION	
10.0		TRANSFORMATION
10.1	Form	Additional box grills , Additional canopy on the left of the building.
10.2	Structure	No transformation
10.3	Articulation & Finishes	No major transformation
11.0	DPREMARKS/PERCEIVEDTHREATS	Plot falls under Residential Zone in DP
12.0	ADDITIONAL NOTES/REFERENCES/DOCUMENTS AVAILABLE/RECOMMENDATIONS & SUGGESTIONS FOR IMPLEMENTATION	Documents: C.S. sheets, D.P. Sheets, Eicher City Maps-Mumbai, Dwivedi, Mehrotra Bombay, The Cities within Bombay 1995

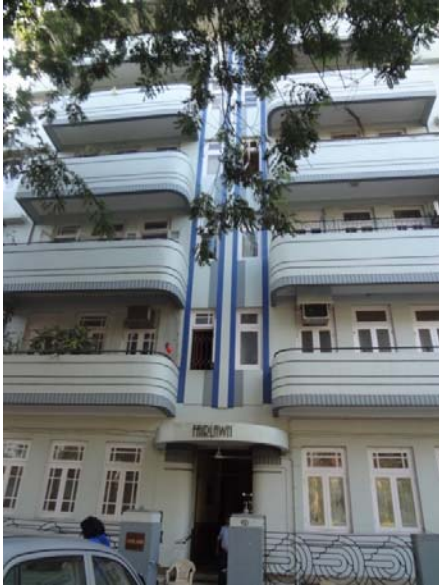
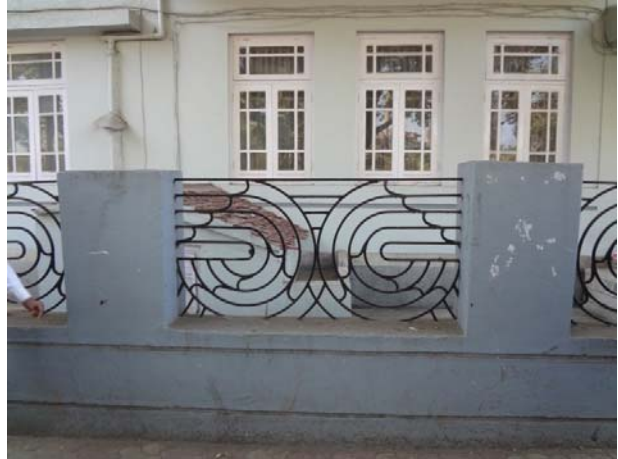
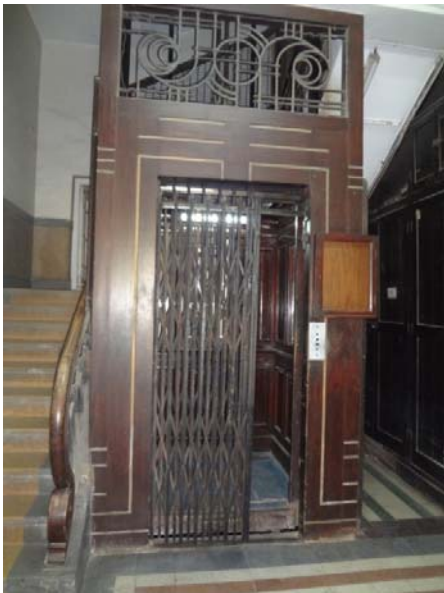
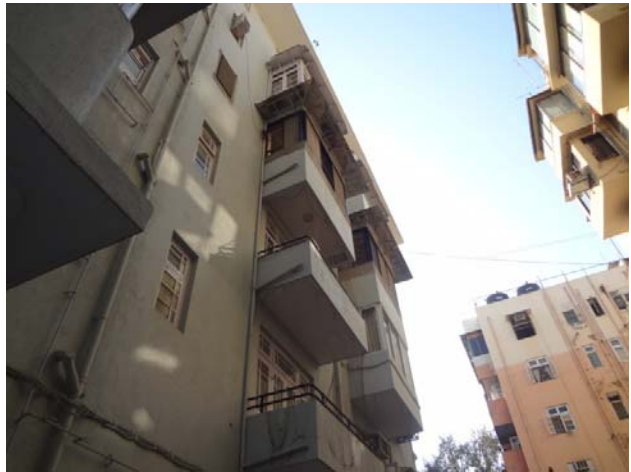
9.0		CONDITION
9.1	Plinth	Good
9.2	Walls	Good
9.3	Floor	Good
9.4	Stairs	Good
9.5	Openings	Good
9.6	Roofing	Good
9.7	Articulation & Finishes	Good
9.8	Services	Good

9.9	Outbuildings	Good
9.10	Overall Condition	Good

A16	FAIR LAWN	
10.0		TRANSFORMATION
10.1	Form	Additional box grills and the balconies on the sides are enclosed.
10.2	Structure	No transformation
10.3	Articulation & Finishes	No transformation
11.0	DPREMARKS/PERCEIVEDTHREATS	Plot falls under Residential Zone in DP
12.0	ADDITIONAL NOTES/REFERENCES/DOCUMENTS AVAILABLE/RECOMMENDATIONS & SUGGESTIONS FOR IMPLEMENTATION	Documents: C.S. sheets, D.P. Sheets, Eicher City Maps-Mumbai, Dwivedi, Mehrotra Bombay, The Cities within Bombay 1995

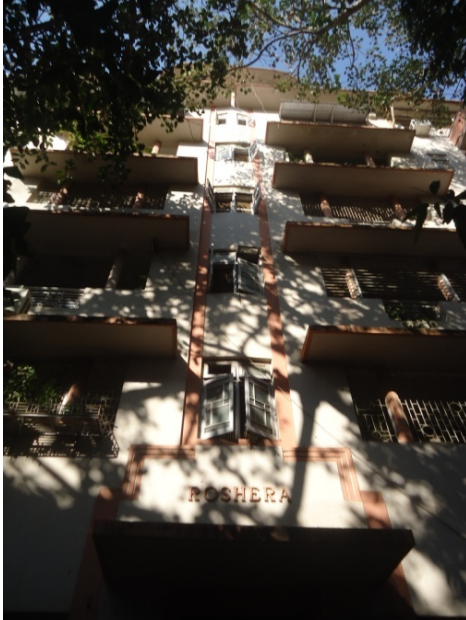
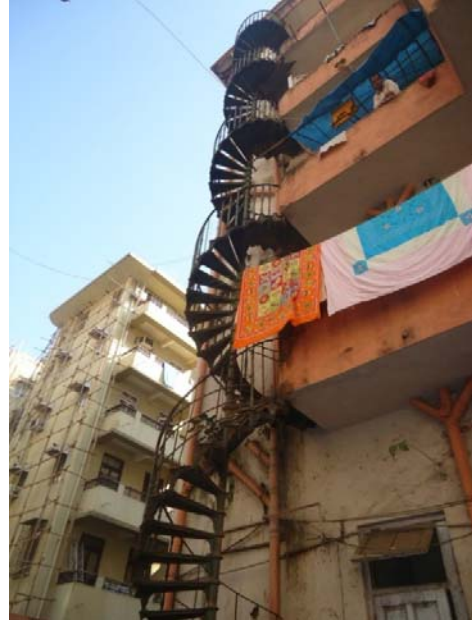
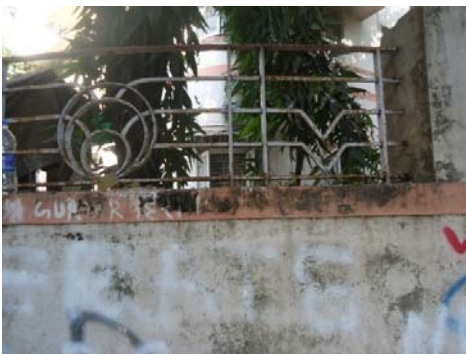
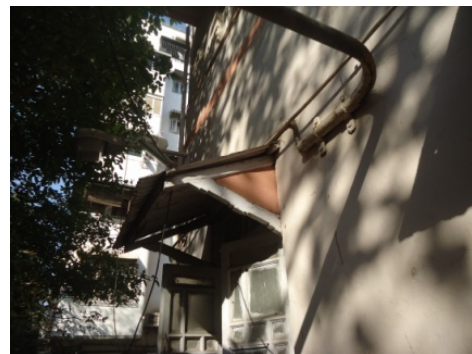
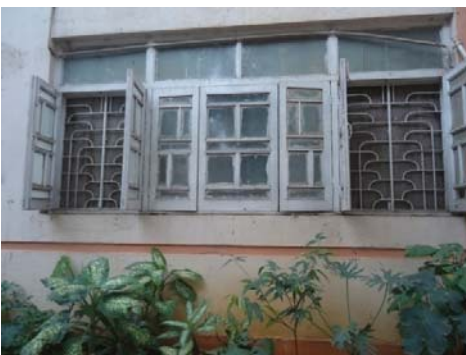
A24 ROSHERA

9.0		CONDITION
9.1	Plinth	Good
9.2	Walls	Average (exterior walls need repairs and painting, show vegetation growth)
9.3	Floor	Average
9.4	Stairs	Average
9.5	Openings	Average

9.6	Roofing	Good
9.7	Articulation & Finishes	Average
9.8	Services	Average (Needs cleaning and repairs, compound wall tilted)
9.9	Outbuildings	Average(Shows cracks needs repairs)

9.10	Overall Condition	Average
