The Victorian & Art Deco Ensemble of Mumbai

Submission To UNESCO As A WORLD HERITAGE SITE

ANNEXURE A- DOCUMENTATION PART II-BUILDING INVENTORIES

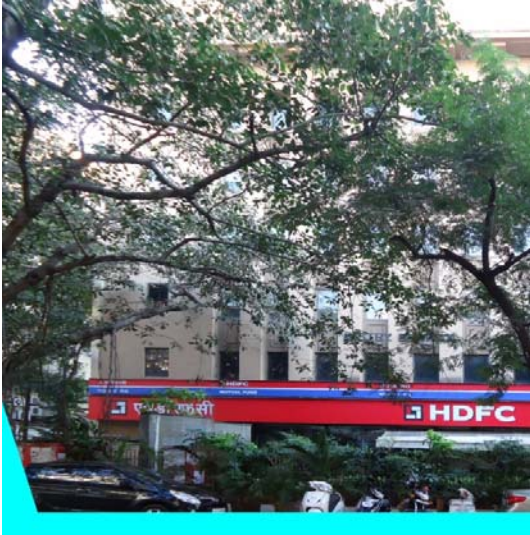
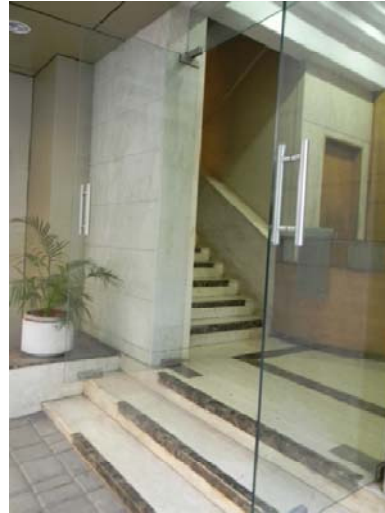
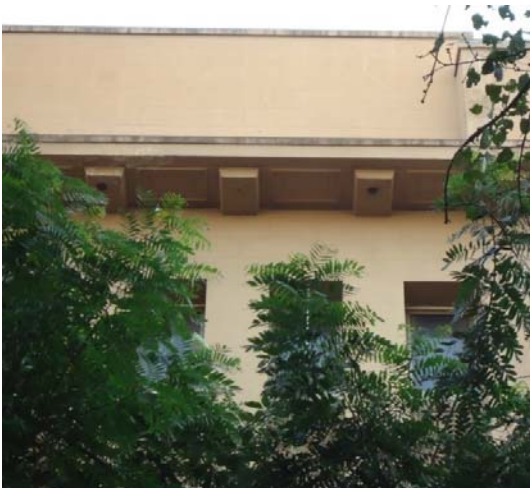
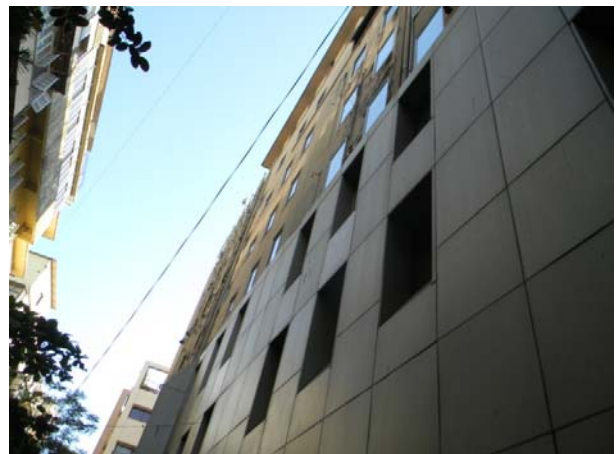
A28 MISTRY BHAWAN

9.0		CONDITION
9.1	Plinth	Good
9.2	Walls	Good
9.3	Floor	Good
9.4	Stairs	Good
9.5	Openings	Good
9.6	Roofing	Good
9.7	Articulation & Finishes	Good
9.8	Services	Good

9.9	Outbuildings	Good
9.10	Overall Condition	Good
10.0		TRANSFORMATION
10.1	Form	No transformation
10.2	Structure	No transformation
10.3	Articulation & Finishes	No major transformation

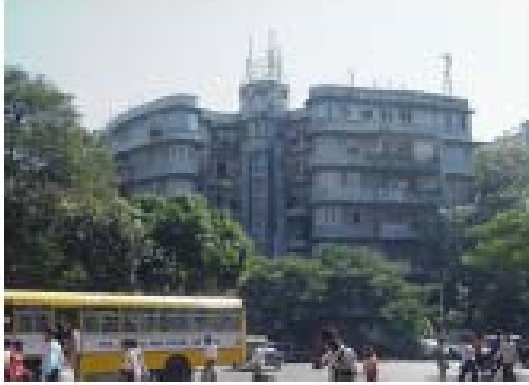
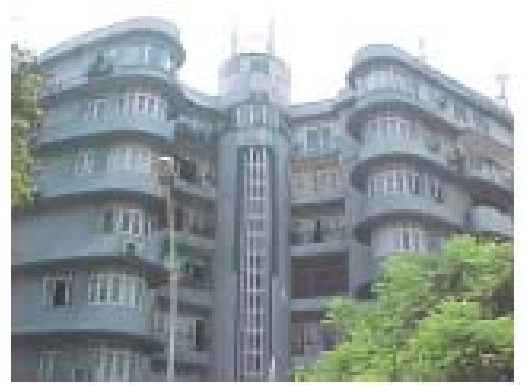
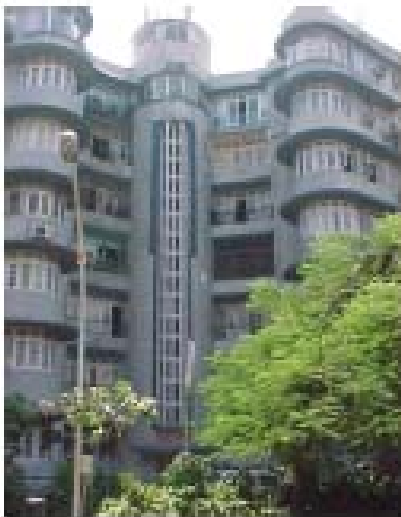
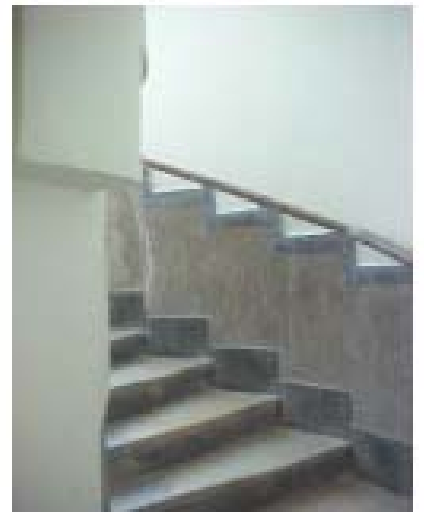
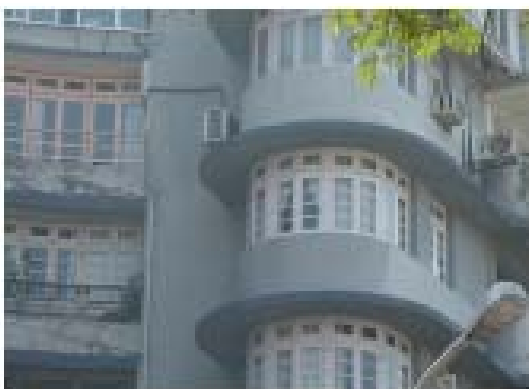
8.7	Other (HVAC/BMC/Security Systems)	Window air-conditioning units at some places
9.0		CONDITION
9.1	Plinth	Good (No settlement or cracks observed)
9.2	Walls	Good (No dampness or cracks observed)

9.3	Floor	Good
9.4	Stairs	Good (Wooden members in good condition)
9.5	Openings	Good
9.6	Roofing	Good (No leakage observed)
9.7	Articulation & Finishes	Good

A 29	RAM MAHAL			
9.8	Services	Good (Drainage pipes need no replacement)		
9.9	Outbuildings	Good		
9.10	Overall Condition	Good	Maintenance level	Good
10.0		TRANSFORMATION		
10.1	Form	Sliding windows and grills added later.		
10.2	Structure	No transformation		
10.3	Articulation & Finishes	No transformation		
11.0	DP REMARKS/PERCEIVED THREATS	Plot falls under Residential Zone in DP		
12.0	ADDITIONAL NOTES/REFERENCES/DOCUMENTS AVAILABLE/RECOMMENDATIONS & SUGGESTIONS FOR IMPLEMENTATION	Documents: C.S. sheets, D.P. Sheets, Eicher City Maps – Mumbai, Dwivedi, Mehrotra Bombay, The Cities Within Bombay 1995

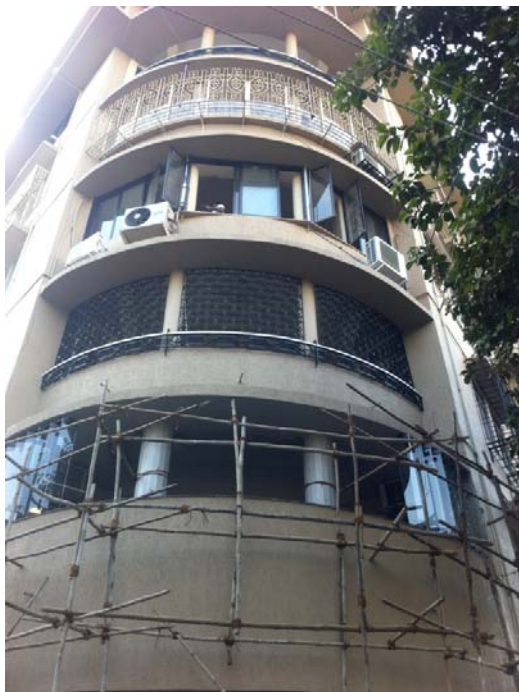
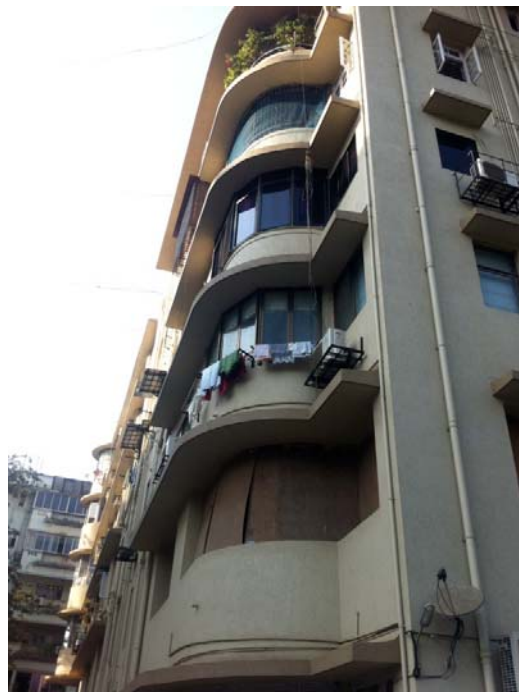
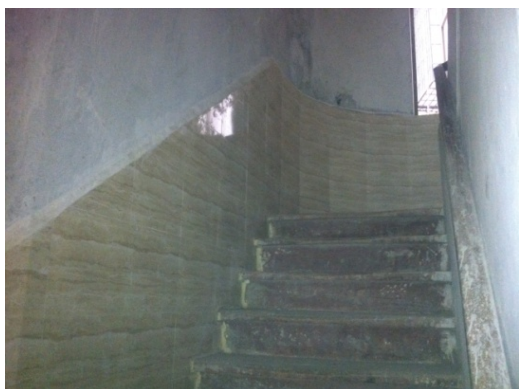
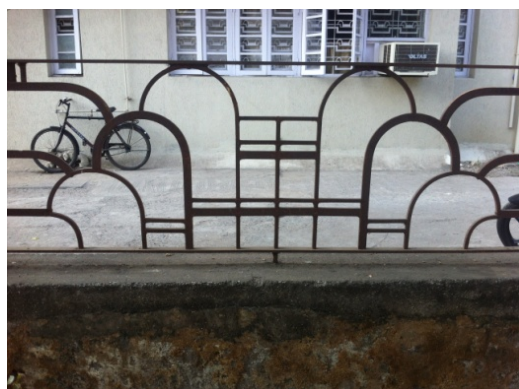
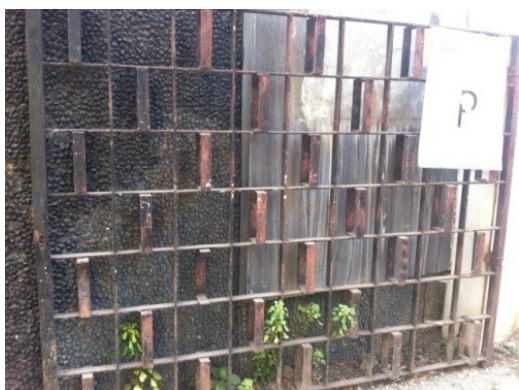
A30 RAVINDRA MANSION

8.7	Other (HVAC/BMC/Security Systems)	Not provided (independent air conditioning units)
9.0		CONDITION
9.1	Plinth	Good(Lift lobby needs repairs)
9.2	Walls	Good

9.3	Floor	Good
9.4	Stairs	Good
9.5	Openings	Good
9.6	Roofing	Good
9.7	Articulation & Finishes	Good
9.8	Services	Good
9.9	Outbuildings	Average(Needs repairs and cleaning)

A 30	RAVINDRA MANSION	
10.0		TRANSFORMATION
10.1	Form	Balconies enclosed, Additional box grills, antennas on the façade of the building, garage doors changed
10.2	Structure	No transformation
10.3	Articulation & Finishes	No major transformation
11.0	DPREMARKS/PERCEIVEDTHREATS	Plot falls under Residential Zone in DP
12.0	ADDITIONAL NOTES/REFERENCES/DOCUMENTS AVAILABLE/RECOMMENDATIONS & SUGGESTIONS FOR IMPLEMENTATION	Documents: C.S. sheets, D.P. Sheets, Eicher City Maps-Mumbai, Dwivedi, Mehrotra Bombay, The Cities within Bombay 1995

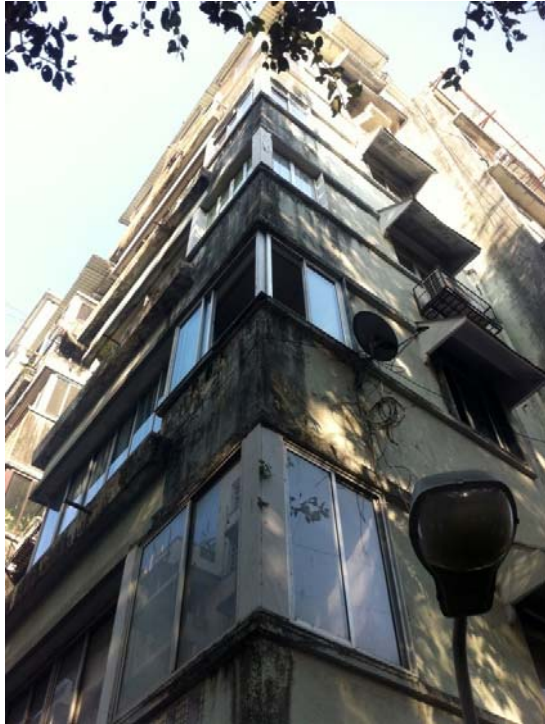
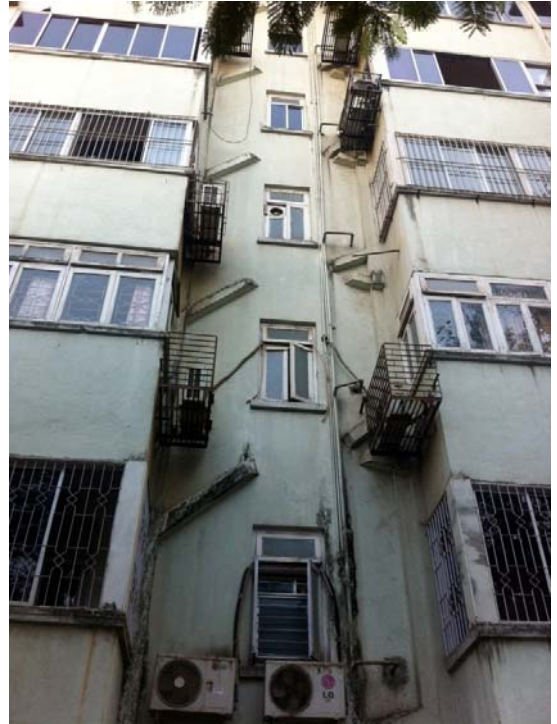
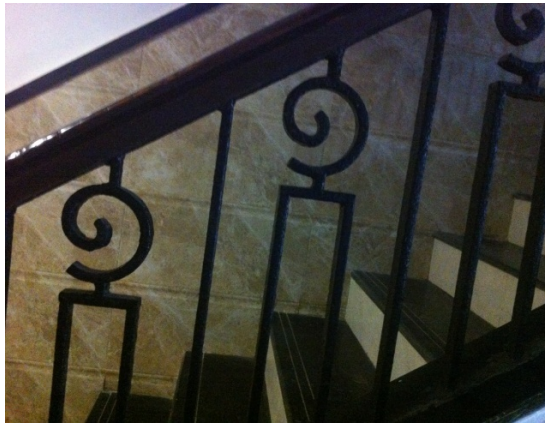
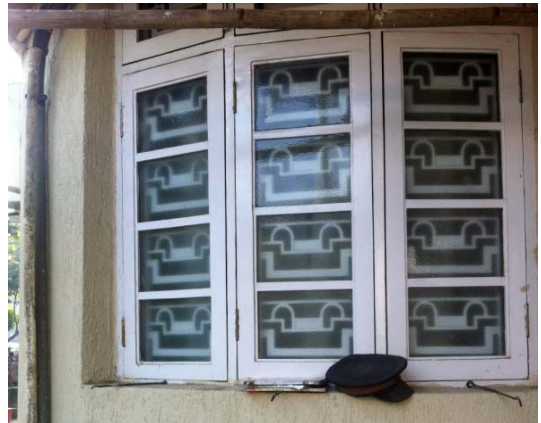
A31 YASHODHAN

9.0		CONDITION
9.1	Plinth	Good
9.2	Walls	Average(Needs repairs and painting)
9.3	Floor	Good
9.4	Stairs	Good
9.5	Openings	Good
9.6	Roofing	Good
9.7	Articulation & Finishes	Good

A 31	YASHODHAN	
10.0		TRANSFORMATION
10.1	Form	Additional box grills , balconies enclosed
10.2	Structure	No transformation
10.3	Articulation & Finishes	No major transformation
11.0	DPREMARKS/PERCEIVEDTHREATS	Plot falls under Residential Zone in DP
12.0	ADDITIONAL NOTES/REFERENCES/DOCUMENTS AVAILABLE/RECOMMENDATIONS & SUGGESTIONS FOR IMPLEMENTATION	Documents: C.S. sheets, D.P. Sheets, Eicher City Maps-Mumbai, Dwivedi, Mehrotra Bombay, The Cities within Bombay 1995

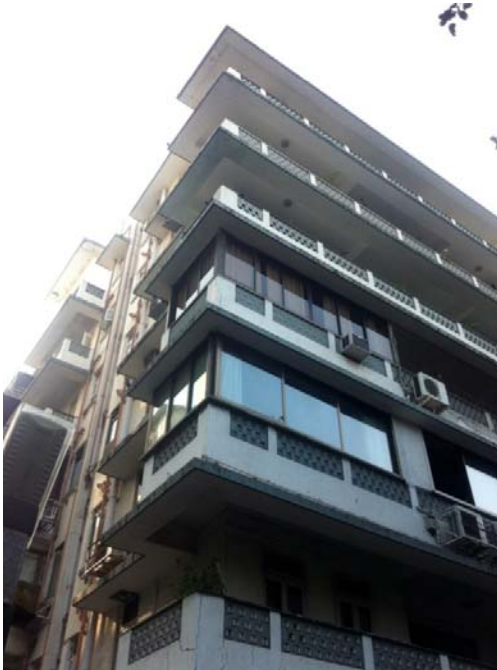
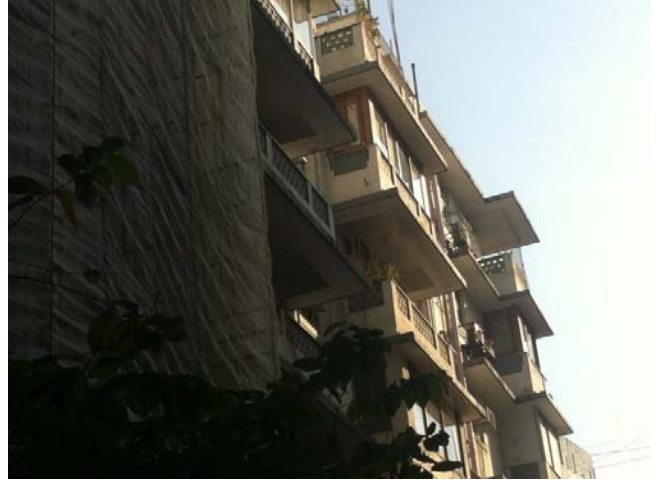
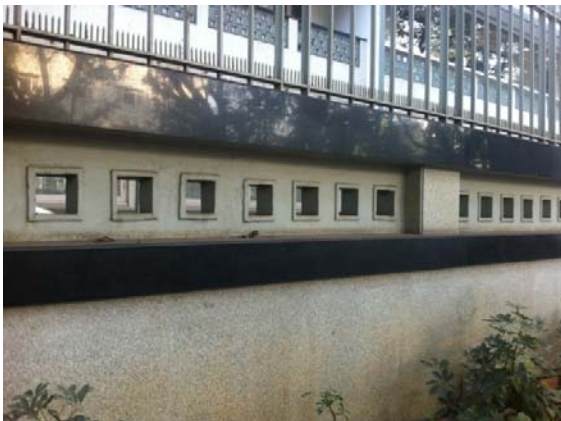
A32 CCI CHAMBERS

9.0		CONDITION
9.1	Plinth	Good
9.2	Walls	Good
9.3	Floor	Good
9.4	Stairs	Good
9.5	Openings	Good
9.6	Roofing	Good
9.7	Articulation & Finishes	Good
9.8	Services	Good

A 3 2	CCI CHAMBERS	
10.0		TRANSFORMATION
10.1	Form	Additional grills, security rod for vehicles
10.2	Structure	No transformation
10.3	Articulation & Finishes	No major transformation
11.0	DPREMARKS/PERCEIVEDTHREATS	Plot falls under commercial zone in DP
12.0	ADDITIONAL NOTES/REFERENCES/DOCUMENTS AVAILABLE/RECOMMENDATIONS & SUGGESTIONS FOR IMPLEMENTATION	Documents: C.S. sheets, D.P. Sheets, Eicher City Maps-Mumbai, Dwivedi, Mehrotra Bombay, The Cities within Bombay 1995

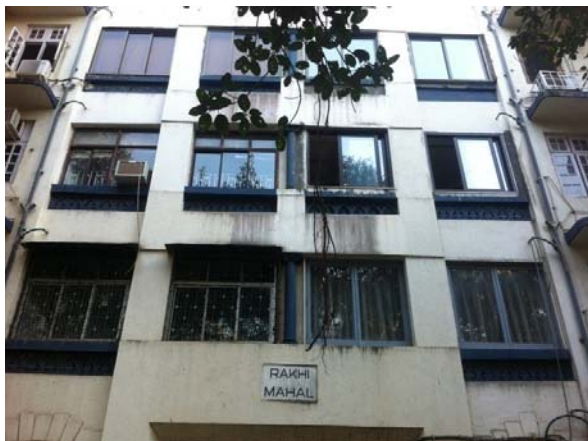
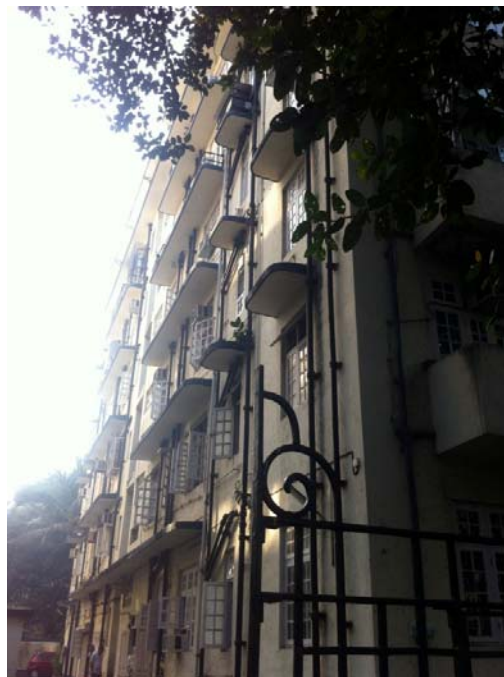
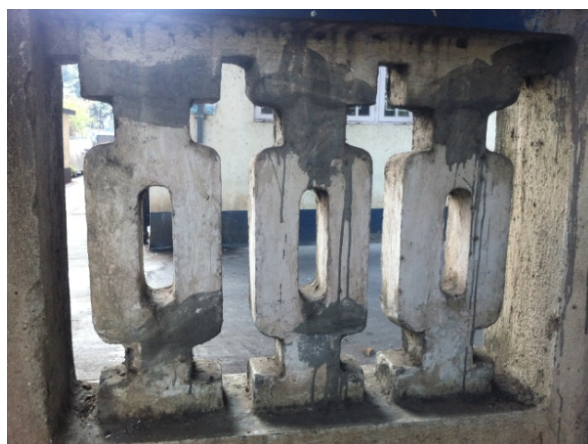
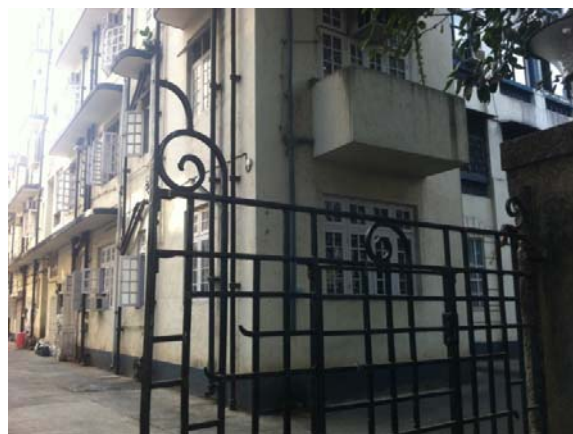
A33 RAKHI MAHAL

9.0		CONDITION
9.1	Plinth	Good
9.2	Walls	Good(exterior walls need painting)
9.3	Floor	Good
9.4	Stairs	Good
9.5	Openings	Good
9.6	Roofing	Good
9.7	Articulation & Finishes	Good

9.8	Services	Good
9.9	Outbuildings	Average(Needs repairs and cleaning)
9.10	Overall Condition	Good

A 3 3	RAKHI MAHAL	
10.0		TRANSFORMATION
10.1	Form	Additional box grills ,chajjas, balconies enclosed
10.2	Structure	No transformation
10.3	Articulation & Finishes	No major transformation
11.0	DPREMARKS/PERCEIVEDTHREATS	Plot falls under Residential Zone in DP
12.0	ADDITIONAL NOTES/REFERENCES/DOCUMENTS AVAILABLE/RECOMMENDATIONS & SUGGESTIONS FOR IMPLEMENTATION	Documents: C.S. sheets, D.P. Sheets, Eicher City Maps-Mumbai, Dwivedi, Mehrotra Bombay, The Cities within Bombay 1995

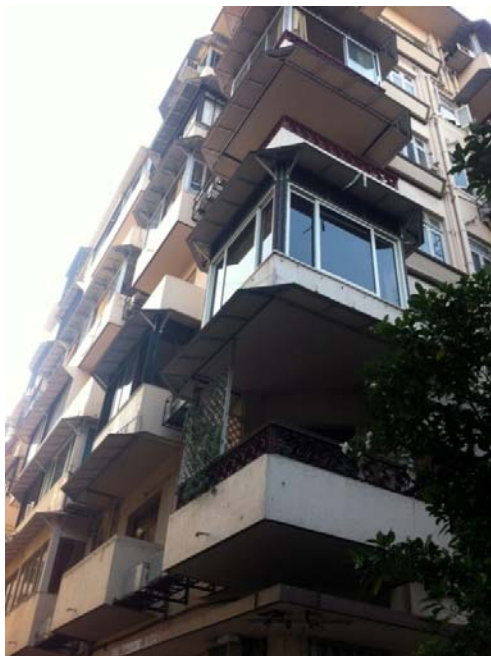
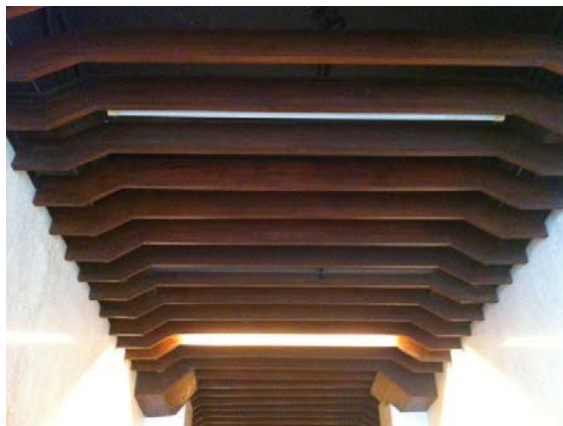
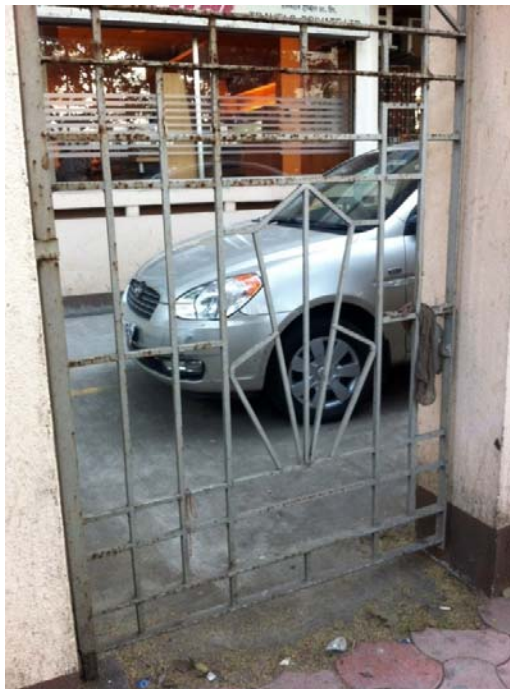
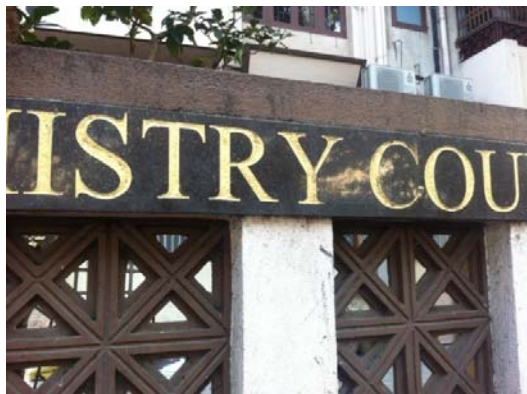
9.0		CONDITION
9.1	Plinth	Good
9.2	Walls	Good(exterior walls need painting)
9.3	Floor	Good
9.4	Stairs	Good
9.5	Openings	Good
9.6	Roofing	Good
9.7	Articulation & Finishes	Good

9.8	Services	Good
9.9	Outbuildings	Average(Shows cracks needs repairs)
9.10	Overall Condition	Good

A34	MISTRY COURT	
10.0		TRANSFORMATION
10.1	Form	Additional box grills , A.C.P. chajja, added toilet in the compound
10.2	Structure	No transformation
10.3	Articulation & Finishes	
11.0	DPREMARKS/PERCEIVEDTHREATS	Plot falls under Residential Zone in DP
12.0	ADDITIONAL NOTES/REFERENCES/DOCUMENTS AVAILABLE/RECOMMENDATIONS & SUGGESTIONS FOR IMPLEMENTATION	Documents: C.S. sheets, D.P. Sheets, Eicher City Maps-Mumbai, Dwivedi, Mehrotra Bombay, The Cities within Bombay 1995

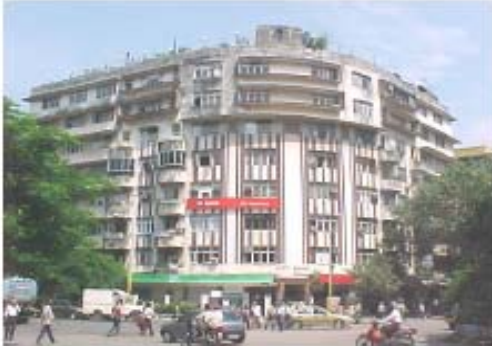
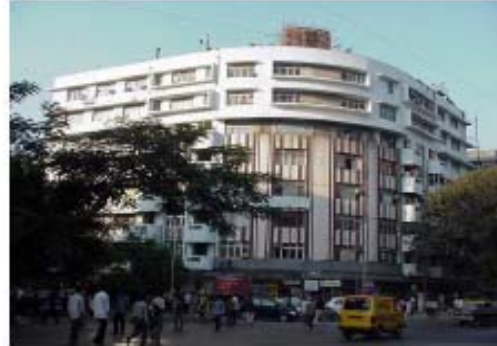
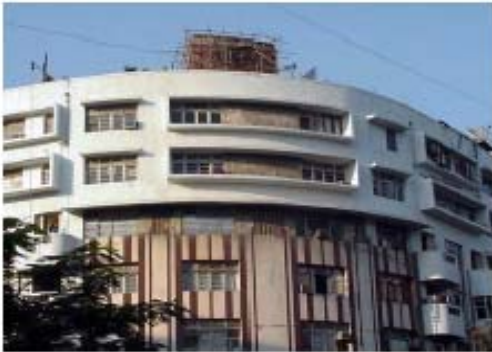
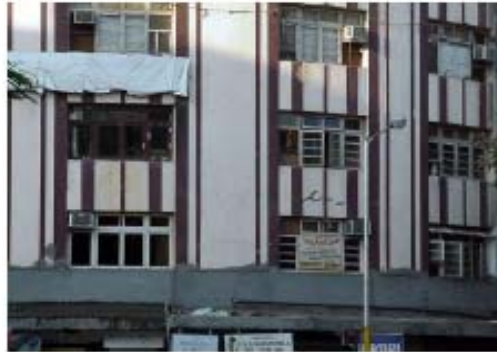
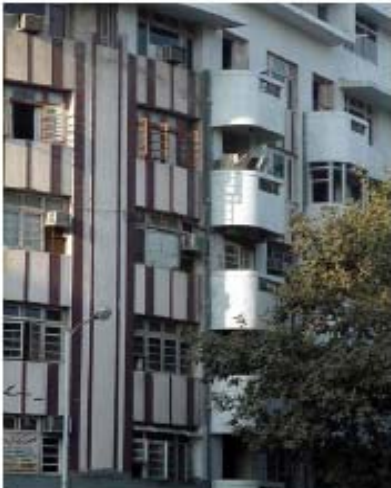
9.1	Plinth	Fair (No settlement or cracks observed but needs maintenance)
9.2	Walls	Fair
9.3	Floor	Fair

A 36	MOTI MAHAL			
9.4	Stairs	Fair (Needs maintenance)		
9.5	Openings	Fair		
9.6	Roofing	Fair (No leakage observed)		
9.7	Articulation & Finishes	Fair		
9.8	Services	Fair (Drainage pipes need maintenance)		
9.9	Outbuildings	Fair		
9.10	Overall Condition	Fair	Maintenance level	Fair
10.0		TRANSFORMATION		
10.1	Form	No transformation		
10.2	Structure	Top two floors added later.		
10.3	Articulation & Finishes	No transformation		
11.0	DP REMARKS/PERCEIVED THREATS	Plot falls under Residential Zone in DP		
12.0	ADDITIONAL NOTES/REFERENCES/DOCUMENTS AVAILABLE/RECOMMENDATIONS & SUGGESTIONS FOR IMPLEMENTATION	Documents: C.S. sheets, D.P. Sheets, Eicher City Maps – Mumbai, Dwivedi, Mehrotra Bombay, The Cities Within Bombay 1995

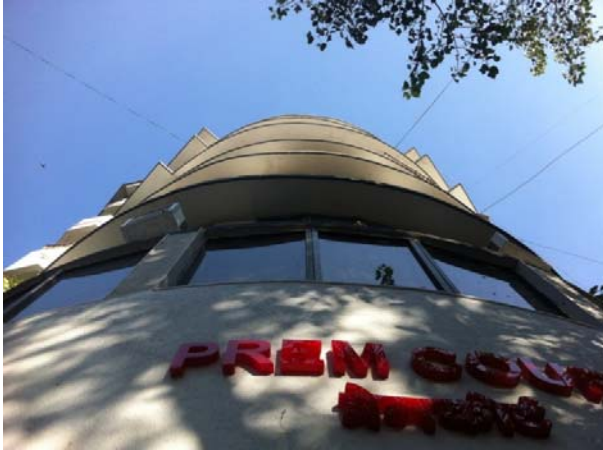
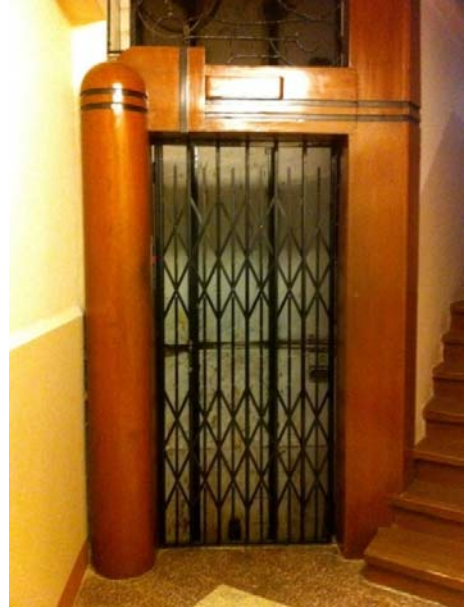
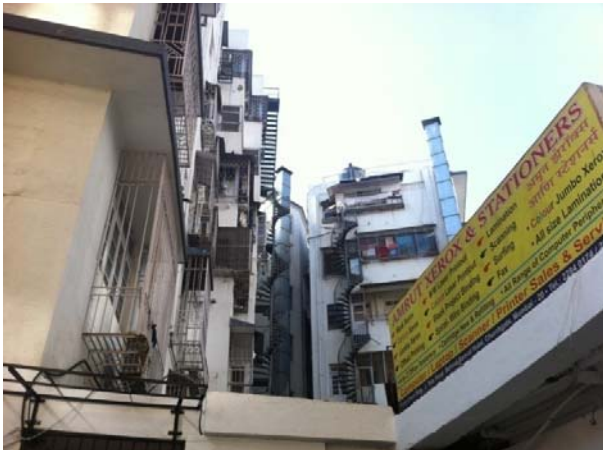
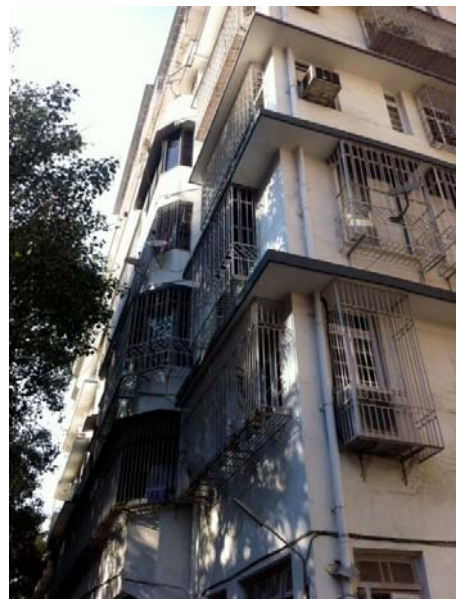
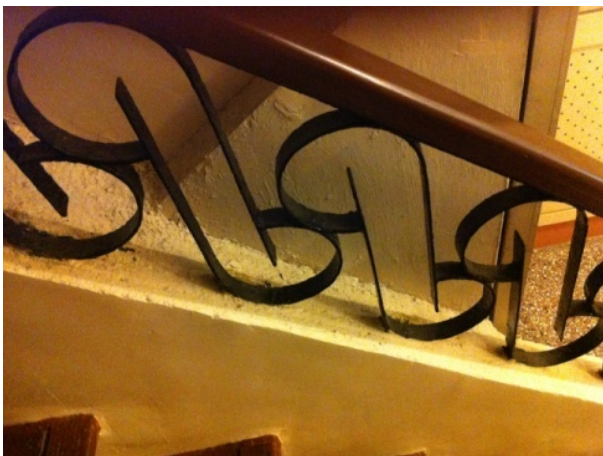
A37	PREM COURT	
9.0		CONDITION
9.1	Plinth	Good
9.2	Walls	Good
9.3	Floor	Good
9.4	Stairs	Good
9.5	Openings	Good
9.6	Roofing	Good
9.7	Articulation & Finishes	Good
9.8	Services	Good
9.9	Outbuildings	Good
9.10	Overall Condition	Very Good
10.0		TRANSFORMATION
10.1	Form	Additional box grills, Added canopy for the seating of samrat restaurant. External staircase for samrat restaurant.
10.2	Structure	No transformation
10.3	Articulation & Finishes	HVAC connections in the compound and additional wires on the wall
11.0	DPREMARKS/PERCEIVEDTHREATS	Plot falls under Residential Zone in DP
12.0	ADDITIONAL NOTES/REFERENCES/DOCUMENTS AVAILABLE/RECOMMENDATIONS & SUGGESTIONS FOR IMPLEMENTATION	Documents: C.S. sheets, D.P. Sheets, Eicher City Maps- Mumbai, Dwivedi, Mehrotra Bombay, The Cities within Bombay 1995

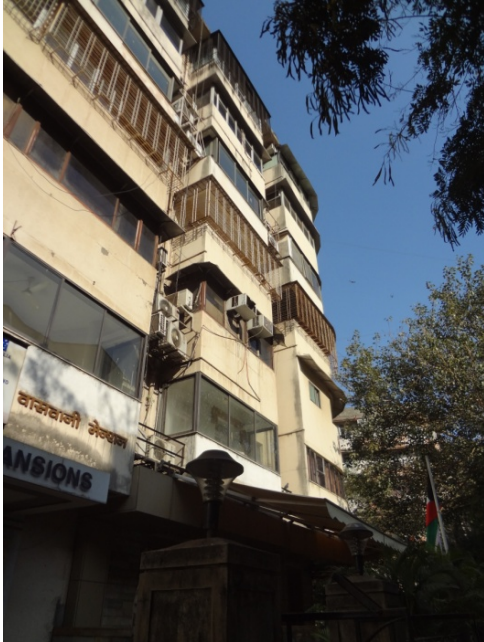
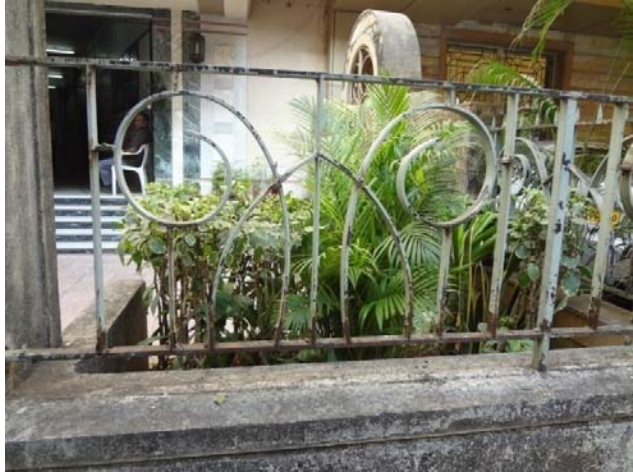
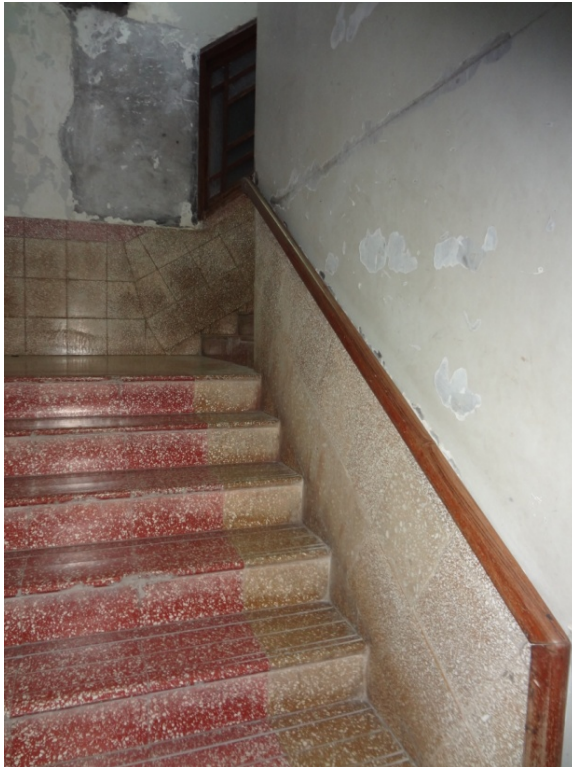
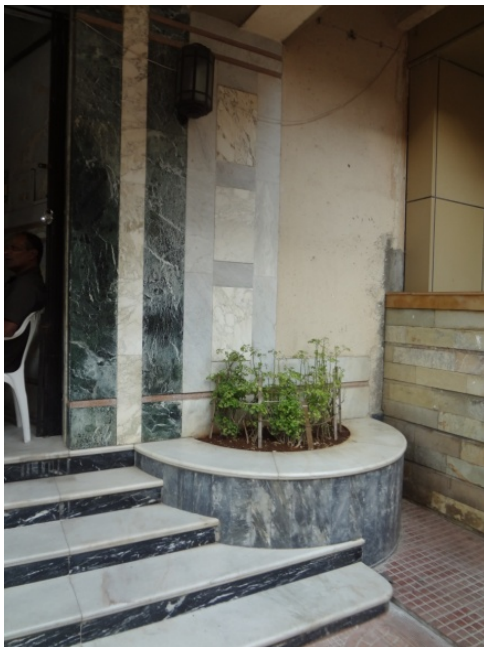
A38 VASWANI MANSIONS

9.0		CONDITION
9.1	Plinth	Good
9.2	Walls	Good
9.3	Floor	Good
9.4	Stairs	Good
9.5	Openings	Good
9.6	Roofing	Good
9.7	Articulation & Finishes	Good
9.8	Services	Good

9.9	Outbuildings	Good
9.10	Overall Condition	Good

A 38	VASWANI MANSIONS	
10.0		TRANSFORMATION
10.1	Form	Additional box grills, most of the balconies enclosed, additional gate dividing the compound of the building.
10.2	Structure	Few buildings completely enclosed.
10.3	Articulation & Finishes	No major transformation
11.0	DPREMARKS/PERCEIVEDTHREATS	Plot falls under Commercial Zone in DP
12.0	ADDITIONAL NOTES/REFERENCES/DOCUMENTS AVAILABLE/RECOMMENDATIONS & SUGGESTIONS FOR IMPLEMENTATION	Documents: C.S. sheets, D.P. Sheets, Eicher City Maps-Mumbai, Dwivedi, Mehrotra Bombay, The Cities within Bombay 1995

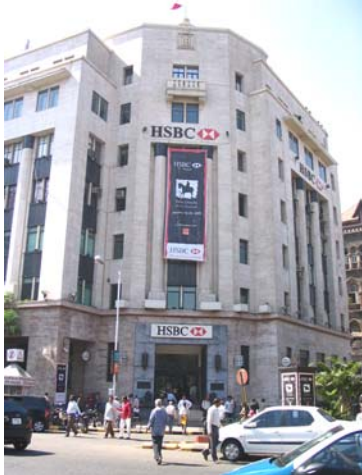
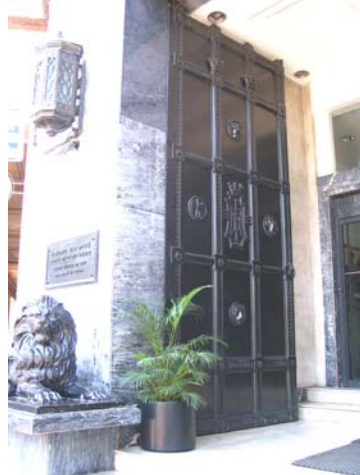
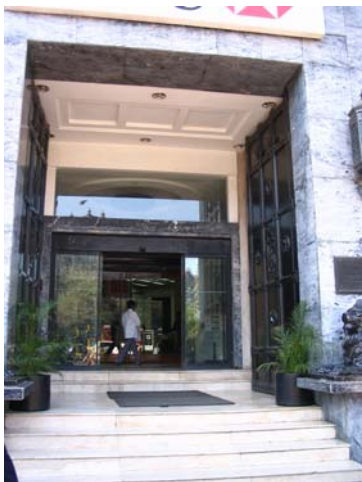
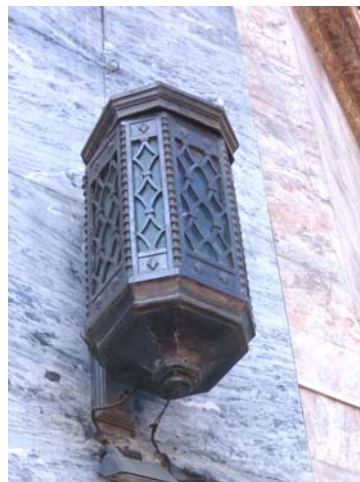
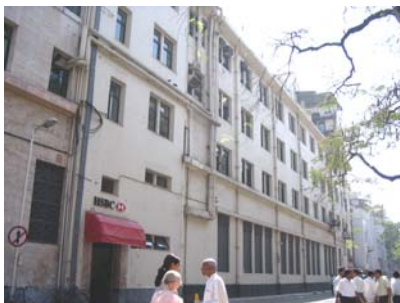
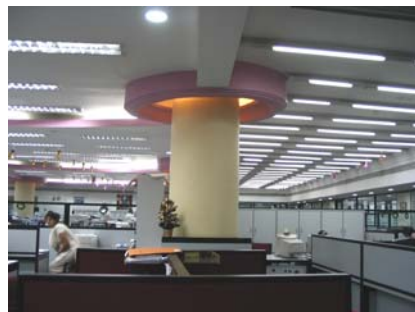
A39 Hong Kong Bank Building

9.7	Articulation & Finishes	Fair - Externally the building is in good condition, at certain places plaster and paint was peeling off.	
9.8	Services	Good - Well maintained.

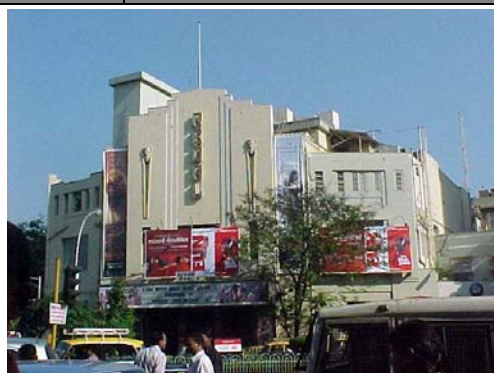
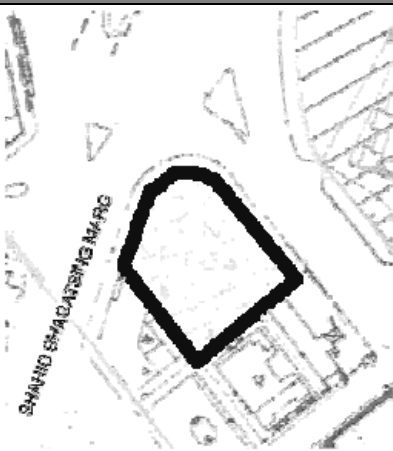
A41		REGAL CINEMA

8.7	Other (HVAC/BMC/Security Systems)	Central air-conditioning unit
9.0		CONDITION
9.1	Plinth	Good (No settlement or cracks observed)
9.2	Walls	Good (No dampness or cracks observed)

9.3	Floor	Good (No sagging observed)
9.4	Stairs	Good
9.5	Openings	Good
9.6	Roofing	Good (No leakage observed)

A 41	REGAL CINEMA			
9.7	Articulation & Finishes	Good		
9.8	Services	Good (Drainage pipes need no replacement)		
9.9	Outbuildings	Good		
9.10	Overall Condition	Good	Maintenance level	Good
10.0		TRANSFORMATION		
10.1	Form	No transformation		
10.2	Structure	No transformation		
10.3	Articulation & Finishes	No transformation		
11.0		DP REMARKS/PERCEIVED THREATS		
		Plot demarcated for Social Amenities in DP		
12.0		ADDITIONAL NOTES/REFERENCES/DOCUMENTS AVAILABLE/RECOMMENDATIONS & SUGGESTIONS FOR IMPLEMENTATION		
		Documents: C.S. Sheets, D.P. Sheets, Eicher City Maps-Mumbai, Dwivedi, Mehrotra Bombay, The Cities Within Bombay 1995

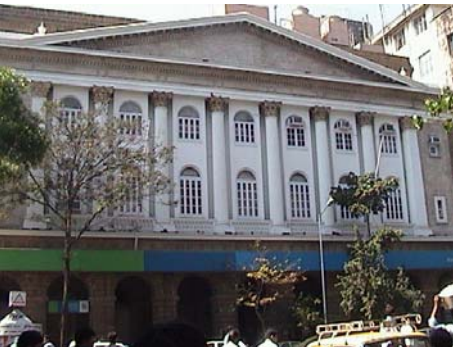
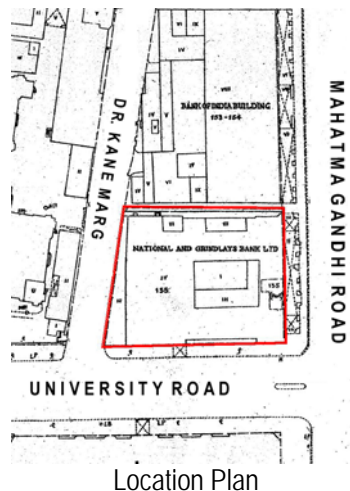
N1 Standard Chartered Bank building (Grindlay's Bank)				172

9.4	Stairs	Good - Except minor cracks & wear tear.		
9.5	Openings	Good - Except modifications made to door & window shutters.		
9.6	Roofing	Indeterminable

9.10	Overall Conditions	Good	Maintenance level	Good
10.0		Transformation		
	Form	-		
	Structure	-		
	Articulation & Finishes	Signage strip runs continuously at first floor level affecting the stone clad façade. White wash to arches and ornamental features. Gold color applied over internal column capitals.

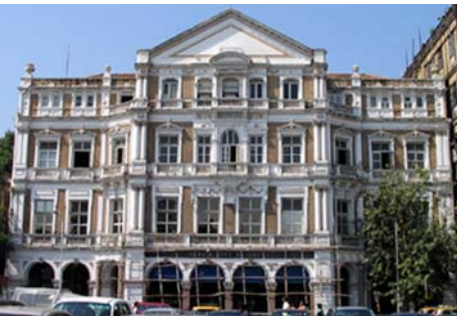
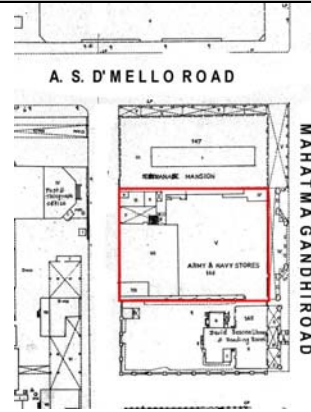
N2 Army and Navy Building

9.0		Condition
9.1	Plinth	Good
9.2	Walls	Good
9.3	Floor	Good- The floor seems to be stable in most places.
9.4	Stairs	Good
9.5	Openings	Good
9.6	Roofing	Good

9.7	Articulation & Finishes	Good
9.8	Services	Good
9.9	Out Buildings	Good
9.10	Overall Conditions	Good Maintenance level: Good
10.0		Transformation
	Form	No change
	Structure	Mezzanine floors have been added. The building originally had a central courtyard, which was closed during major renovation work in 1950's
	Articulation & Finishes	Detailing has been insensitively painted.

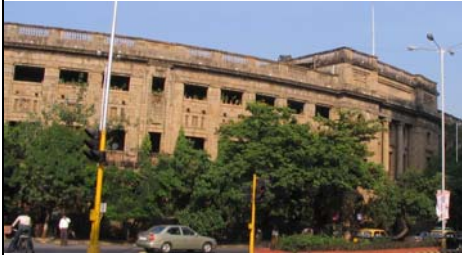
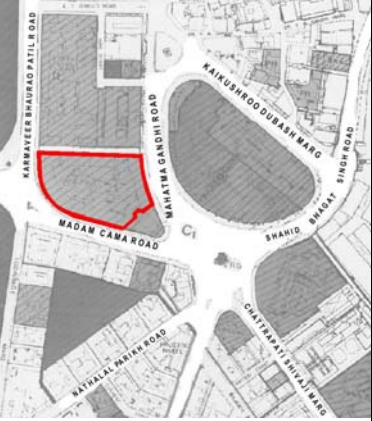
N3 Institute of Science		155

9.0		Condition
9.1	Plinth	Good
9.2	Walls	Good
9.3	Floor	Fair
9.4	Stairs	Fair
9.5	Openings	Good
9.6	Roofing	Good
9.7	Articulation & Finishes	Good
9.8	Services	Fair

9.9	Out Buildings	Fair
9.10	Overall Conditions	Good Maintenance level: Good
10.0		Transformation
	Form	Annex building has been added along the north side
	Structure	-
	Articulation & Finishes	Cement pointing has been carried out on stone dressed facades.

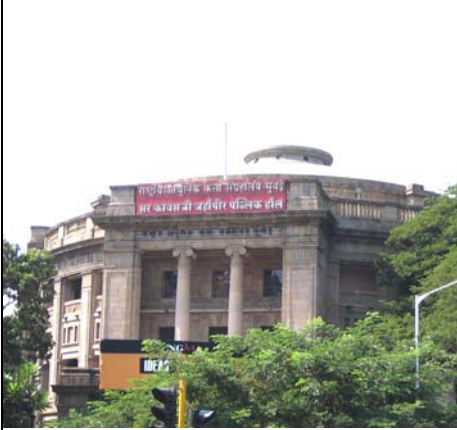
N4 Sir Cawasji Jahangir Hall- NGMA

9.1	Plinth	Good- organic growth and weathering has deteriorated the stone courses.	
9.2	Walls	good - rainwater seepage has led to deterioration of stone masonry in the staircase block. The interior is modified with gypsum board panel for exhibition.

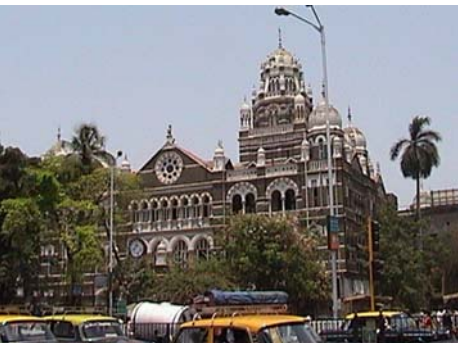
I1 Western Railway Headquarters				163

9.4	Stairs	Indeterminable	
9.5	Openings	Fair - At some places shutters have been replaced.	
9.6	Roofing	Indeterminable	
9.7	Articulation & Finishes	Good	
9.8	Services	Indeterminable

9.9	Out Buildings	Indeterminable	
9.10	Overall Conditions	Good	Maintenance level Good
10.0		Transformation	
	Form	No visible changes from outside	
	Structure	No visible changes from outside	
	Articulation & Finishes	No visible changes from outside

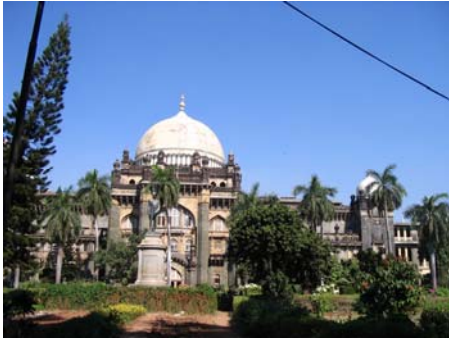
I2 Chhatrapati Shivaji Vastu Sangrahalaya (Prince of Wales Museum)			164

9.1	Plinth	Good	
9.2	Walls	Good	
9.3	Floor	Good	
9.4	Stairs	Good	
9.5	Openings	Good	
9.6	Roofing	Good	
9.7	Articulation & Finishes	Good	
9.8	Services	Good - Regular maintenance is done, overall in good condition.

9.9	Out Buildings		
9.10	Overall Conditions	Good.	Maintenance level: Good
10.0		Transformation	
	Form	Addition of annex wing.	
	Structure	Addition of I-section in ground floor to strengthen the structural system.	
	Articulation & Finishes	Painted internal arches and domes.

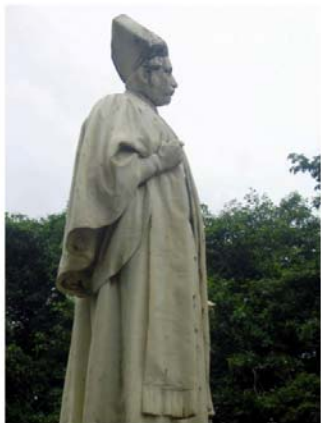
(a)

Marble carved statue

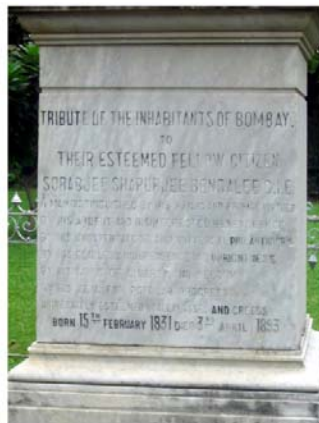
(b)

Inscriptions on the marble plaque below the statue

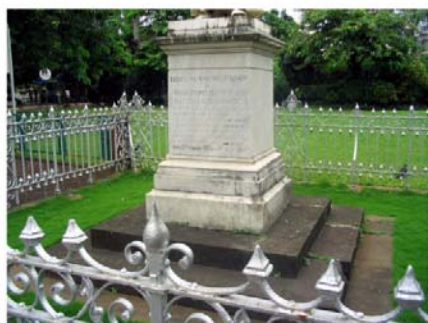
(c)

Decorative fencing around he statue

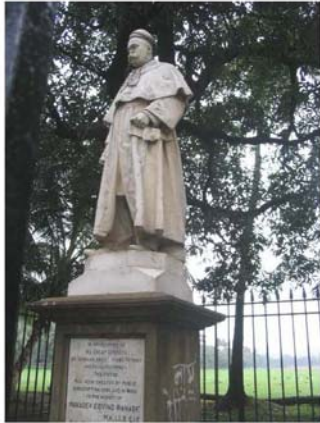
(a)

Marble carved statue of Mahadev Govind Ranade

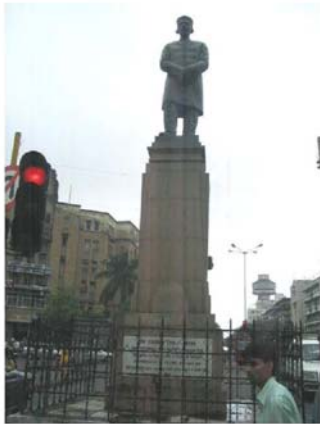
(a)

Prominently stands near Churchgate station

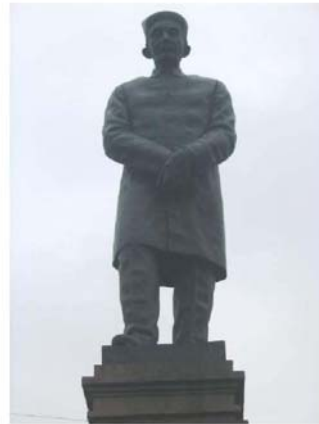
(b)

Height of the the statue above the plinth is approximately 5' 7"

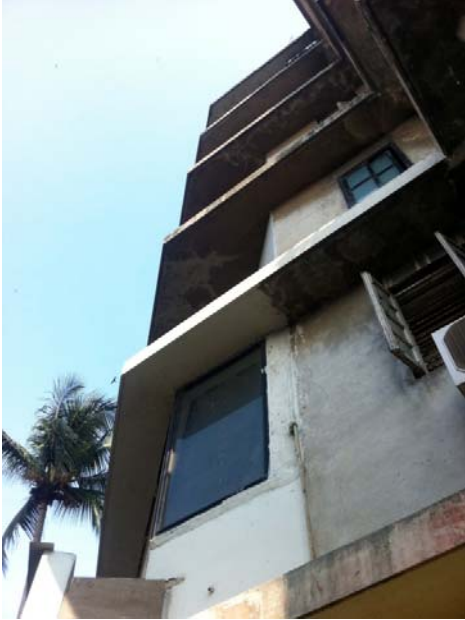
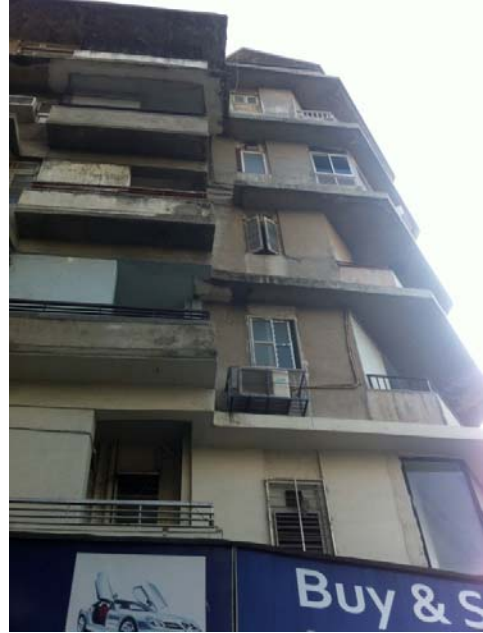
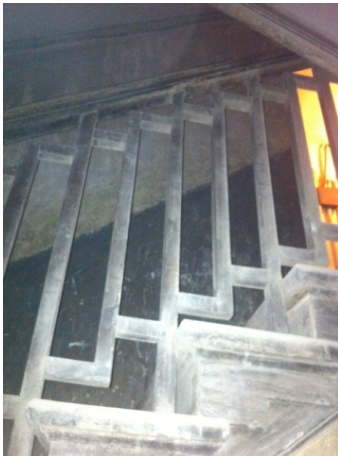
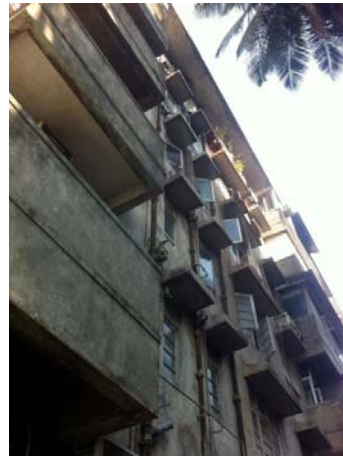
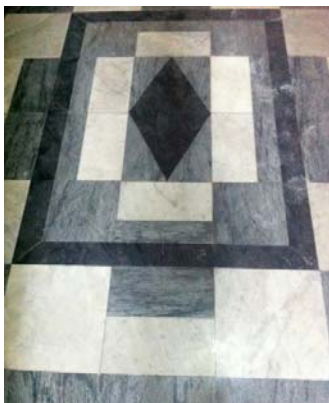
AD2 | SHALIMAR APARTMENTS

9.0		CONDITION
9.1	Plinth	Good
9.2	Walls	Fair(exterior walls need painting and repairs)
9.3	Floor	Good
9.4	Stairs	Poor(Shaky , needs structural repairs and polishing)

9.5	Openings	Good
9.6	Roofing	Good
9.7	Articulation & Finishes	Poor(Needs painting)
9.8	Services	Fair (Needs cleaning and repairs)
9.9	Outbuildings	Poor(Needs cleaning and repairs)

AD 2	SHALIMAR APARTMENTS	
10.0		TRANSFORMATION
10.1	Form	Additional box grills , A.C.P. canopies and chajjas , Balconies enclosed
10.2	Structure	No transformation
10.3	Articulation & Finishes	No major transformation
11.0	DPREMARKS/PERCEIVEDTHREATS	Plot falls under Residential Zone in DP
12.0	ADDITIONAL NOTES/REFERENCES/DOCUMENTS AVAILABLE/RECOMMENDATIONS & SUGGESTIONS FOR IMPLEMENTATION	Documents: C.S. sheets, D.P. Sheets, Eicher City Maps-Mumbai, Dwivedi, Mehrotra Bombay, The Cities within Bombay 1995

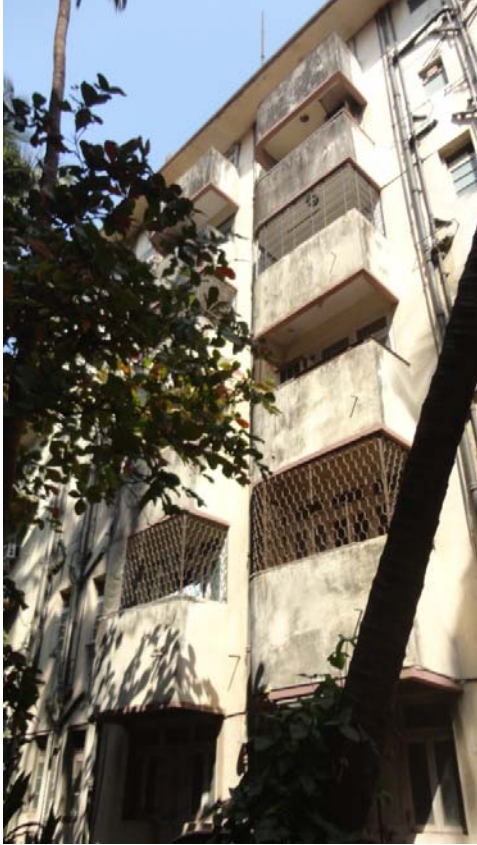
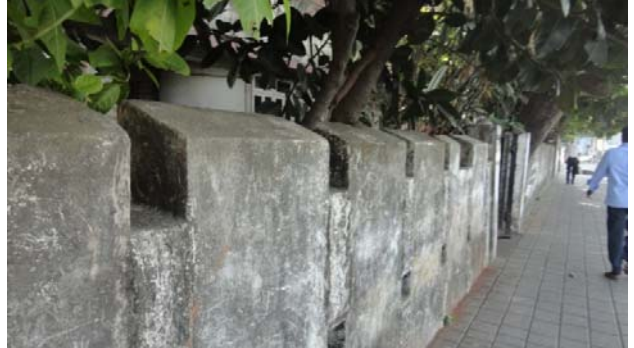
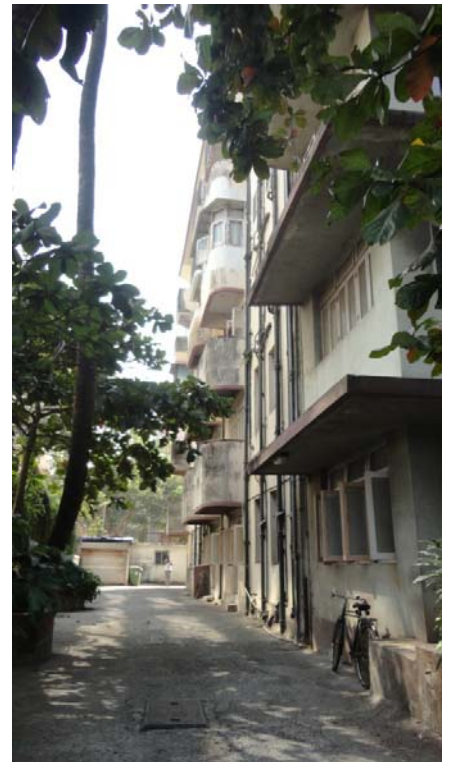
8.7	Other (HVAC/BMC/Security Systems)	Not provided (independent air conditioning units in the houses)
9.0		CONDITION
9.1	Plinth	Good
9.2	Walls	Good(exterior walls need painting)

9.3	Floor	Good
9.4	Stairs	Good
9.5	Openings	Good
9.6	Roofing	Good
9.7	Articulation & Finishes	Average(Needs painting)
9.8	Services	Good
9.9	Outbuildings	Average(Shows cracks needs repairs)

AD4	OCEANA	
10.0		TRANSFORMATION
10.1	Form	Additional box grills , A.C.P. chajjas
10.2	Structure	No transformation
10.3	Articulation & Finishes	
11.0	DPREMARKS/PERCEIVEDTHREATS	Plot falls under Residential Zone in DP
12.0	ADDITIONAL NOTES/REFERENCES/DOCUMENTS AVAILABLE/RECOMMENDATIONS & SUGGESTIONS FOR IMPLEMENTATION	Documents: C.S. sheets, D.P. Sheets, Eicher City Maps-Mumbai, Dwivedi, Mehrotra Bombay, The Cities within Bombay 1995

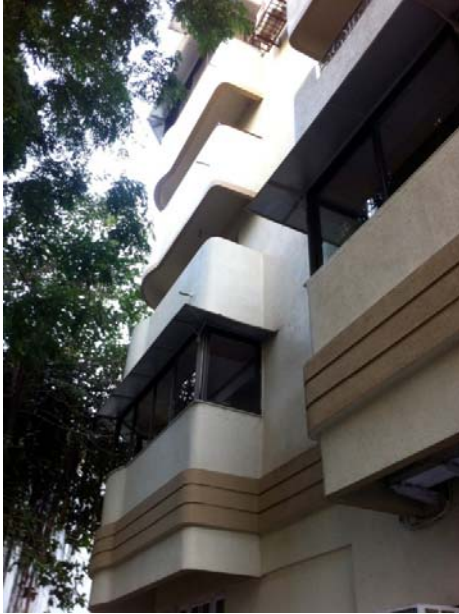
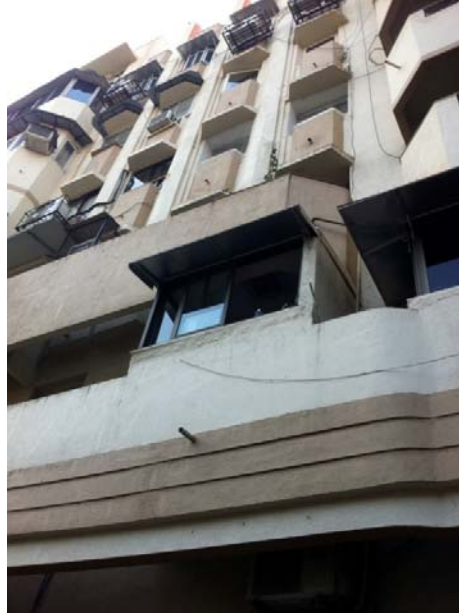
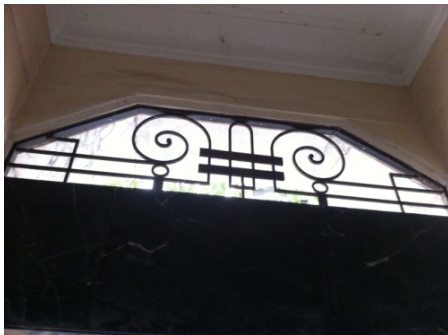
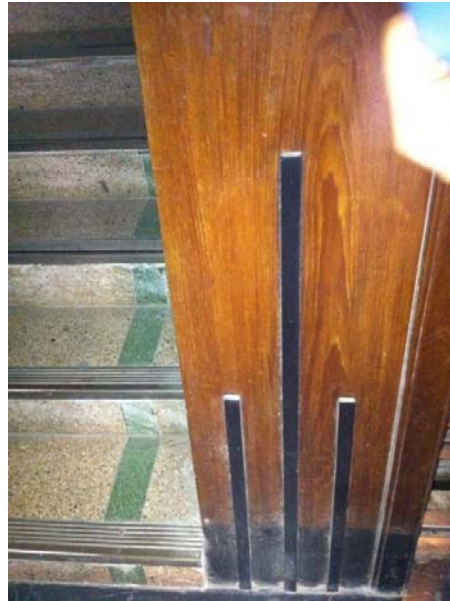
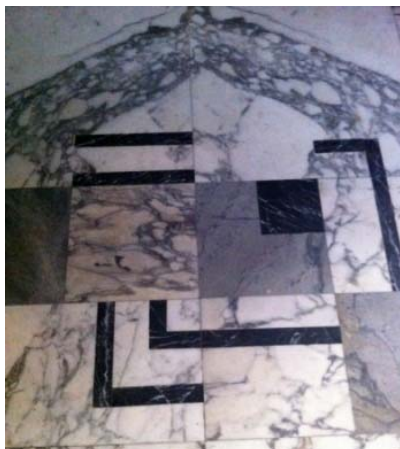
AD6	ST.JAMES COURT	
10.0		TRANSFORMATION
10.1	Form	Additional box grills , A.C.P. chajjas , balconies enclosed
10.2	Structure	No transformation
10.3	Articulation & Finishes	
11.0	DPREMARKS/PERCEIVEDTHREATS	Plot falls under Residential Zone in DP
12.0	ADDITIONAL NOTES/REFERENCES/DOCUMENTS AVAILABLE/RECOMMENDATIONS & SUGGESTIONS FOR IMPLEMENTATION	Documents: C.S. sheets, D.P. Sheets, Eicher City Maps-Mumbai, Dwivedi, Mehrotra Bombay, The Cities within Bombay 1995
