The Victorian & Art Deco Ensemble of Mumbai

Submission To UNESCO As A WORLD HERITAGE SITE

ANNEXURE A- DOCUMENTATION PART II-BUILDING INVENTORIES

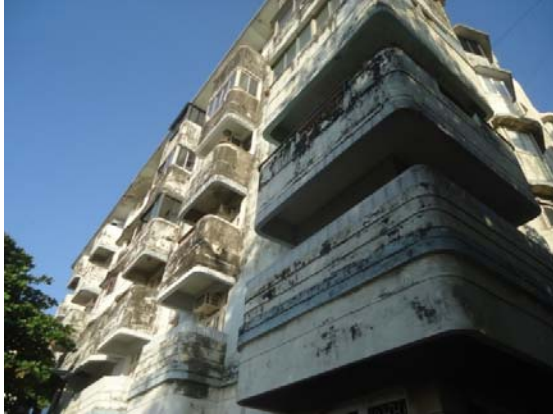
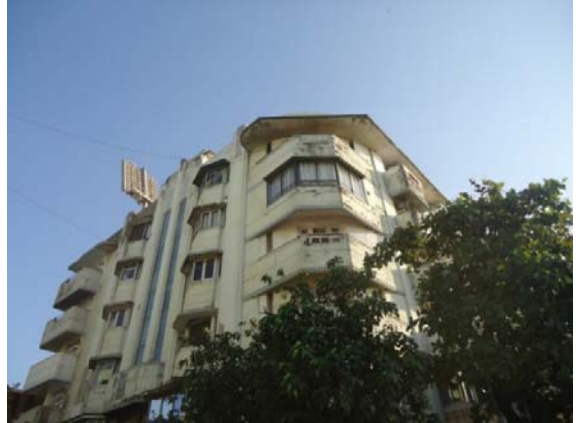
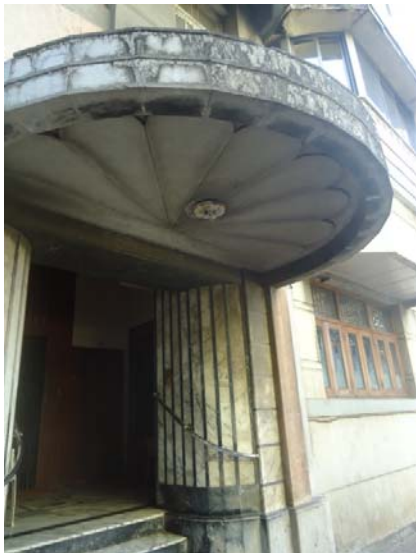
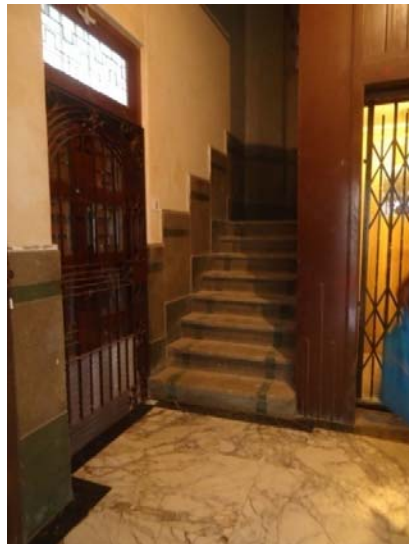
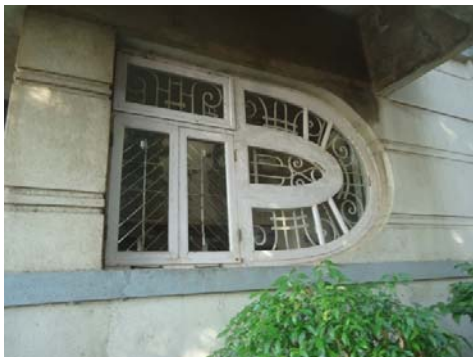
AD7 | FRAMROZ COURT

9.2	Walls	Good(exterior walls need few repairs and painting)
9.3	Floor	Good
9.4	Stairs	Good
9.5	Openings	Good
9.6	Roofing	Good
9.7	Articulation & Finishes	Good

AD7	FRAMROZ COURT	
9.10	Overall Condition	Good
10.0		TRANSFORMATION
10.1	Form	Additional box grills , chajjas, balconies enclosed
10.2	Structure	No transformation
10.3	Articulation & Finishes	
11.0	DPREMARKS/PERCEIVEDTHREATS	Plot falls under Residential Zone in DP
12.0	ADDITIONAL NOTES/REFERENCES/DOCUMENTS AVAILABLE/RECOMMENDATIONS & SUGGESTIONS FOR IMPLEMENTATION	Documents: C.S. sheets, D.P. Sheets, Eicher City Maps-Mumbai, Dwivedi, Mehrotra Bombay, The Cities within Bombay 1995

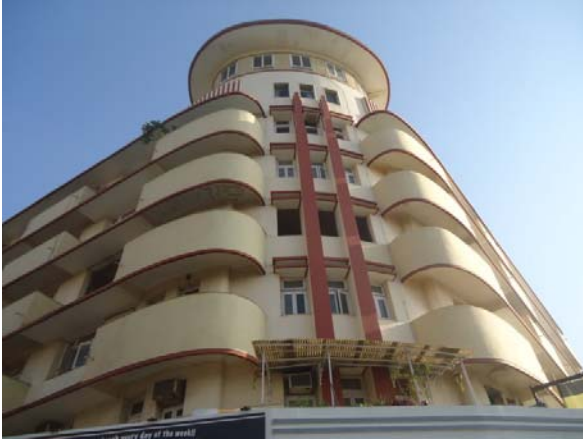
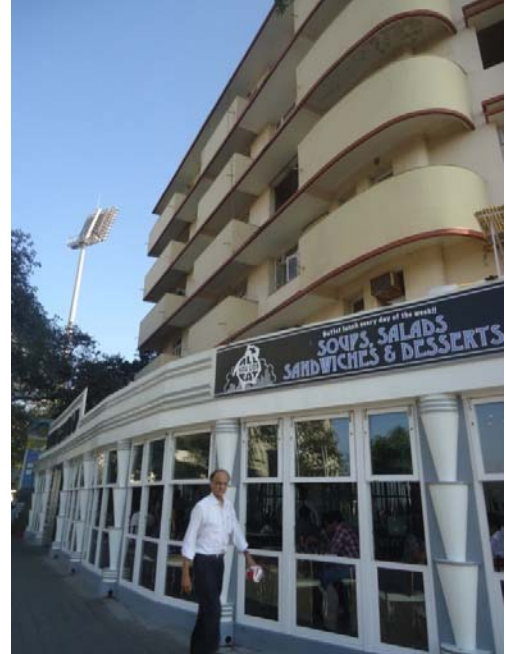
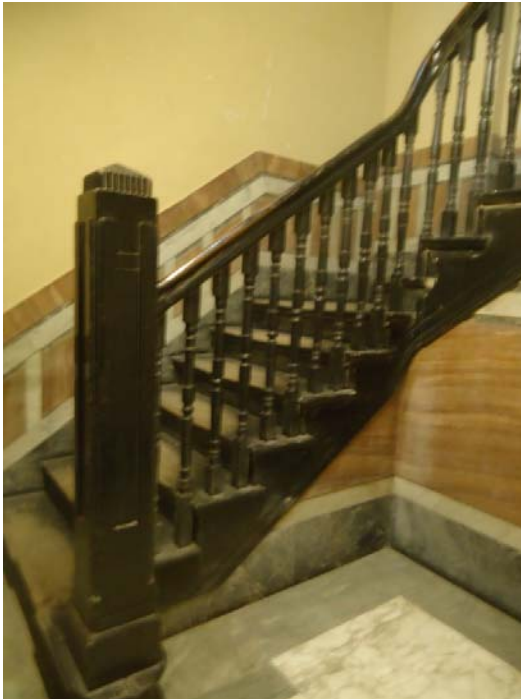
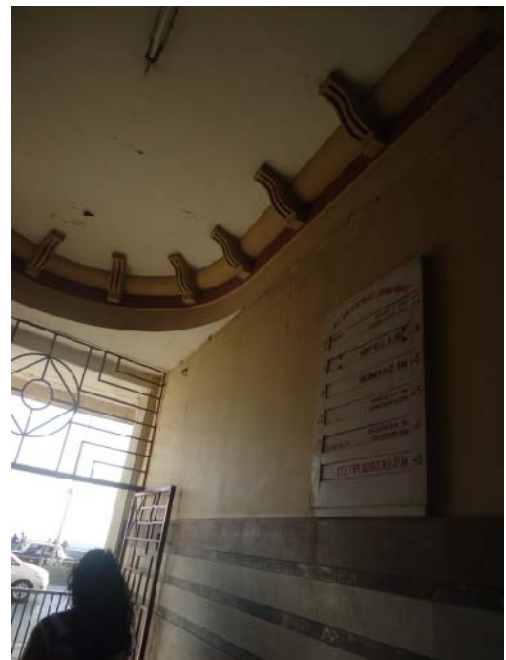
AD9	SOONA MAHAL	
9.10	Overall Condition	Good
10.0		TRANSFORMATION
10.1	Form	Additional box grills , A.C.P. canopies and chajjas , enclosed balconies.
10.2	Structure	No transformation
10.3	Articulation & Finishes	No major transformation
11.0	DPREMARKS/PERCEIVEDTHREATS	Plot falls under Commercial Zone in DP
12.0	ADDITIONAL NOTES/REFERENCES/DOCUMENTS AVAILABLE/RECOMMENDATIONS & SUGGESTIONS FOR IMPLEMENTATION	Documents: C.S. sheets, D.P. Sheets, Eicher City Maps-Mumbai, Dwivedi, Mehrotra Bombay, The Cities within Bombay 1995

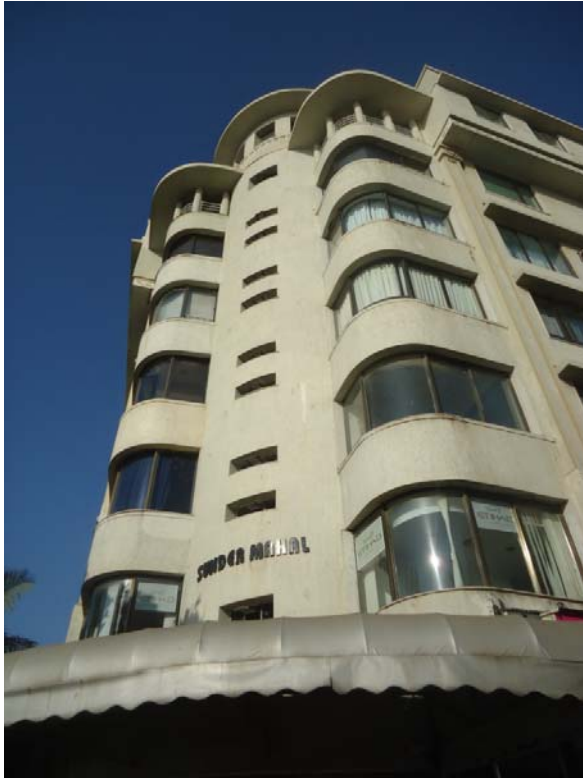
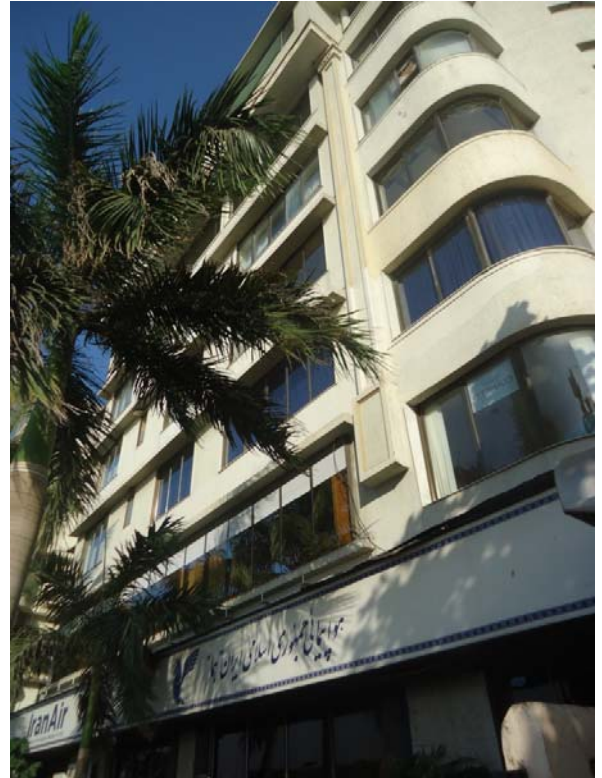
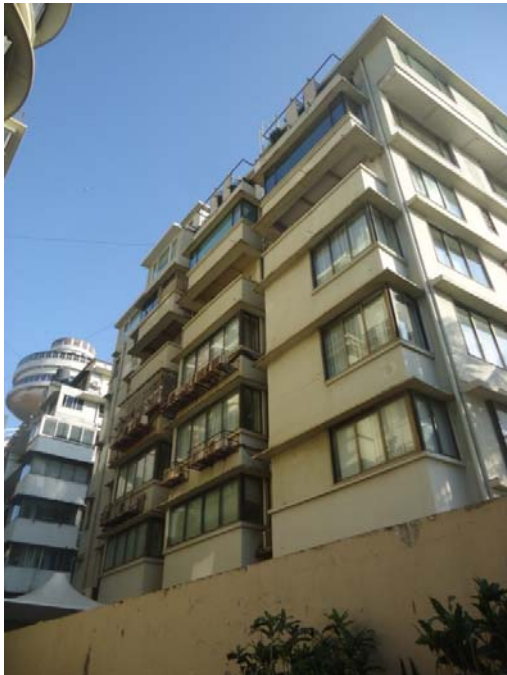
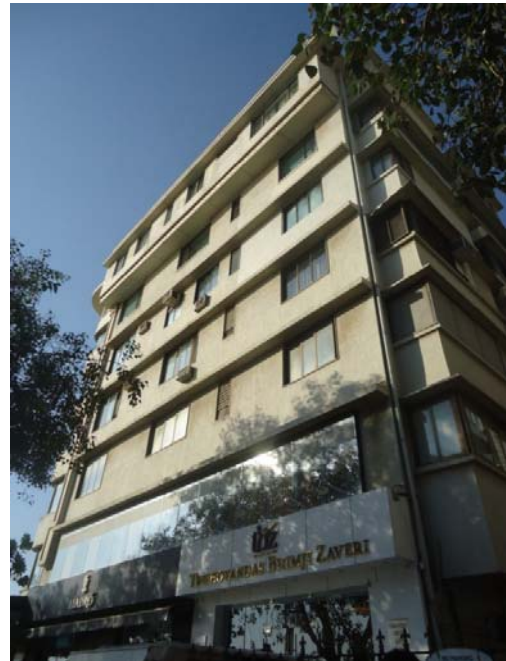
9.9	Outbuildings	Average(Compound wall needs painting)
9.10	Overall Condition	Good

AD10	SUNDER MAHAL	
10.0		TRANSFORMATION
10.1	Form	Additional box grills, Balconies enclosed, Additional canopies in the compound, Additional Steps for the shops, Compound wall broken down and opened for the seating and public entrance. Additional entrances and gates for different entries.
10.2	Structure	No transformation
10.3	Articulation & Finishes	No major transformation
11.0	DPREMARKS/PERCEIVEDTHREATS	Plot falls under Residential Zone in DP
12.0	ADDITIONAL NOTES/REFERENCES/DOCUMENTS AVAILABLE/RECOMMENDATIONS & SUGGESTIONS FOR IMPLEMENTATION	Documents: C.S. sheets, D.P. Sheets, Eicher City Maps-Mumbai, Dwivedi, Mehrotra Bombay, The Cities within Bombay 1995

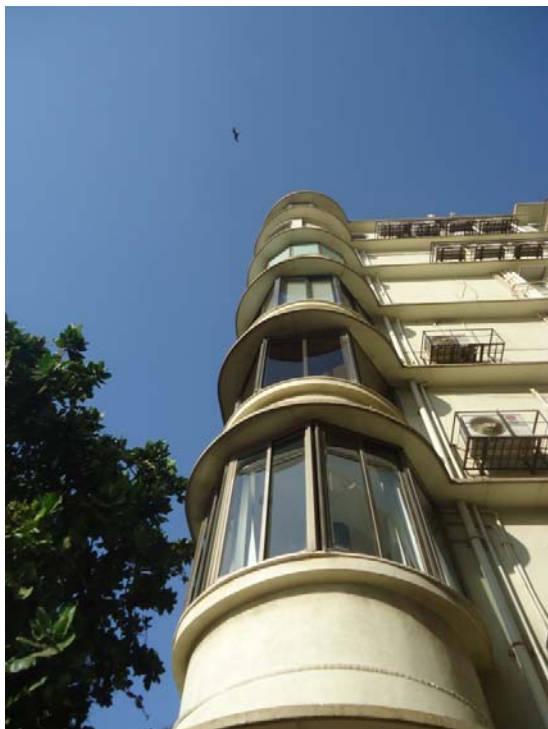
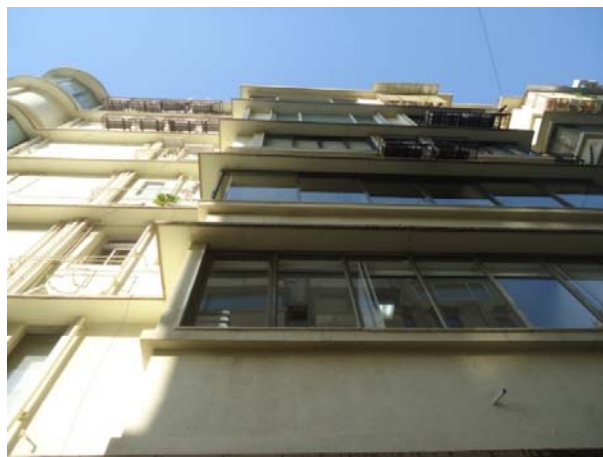
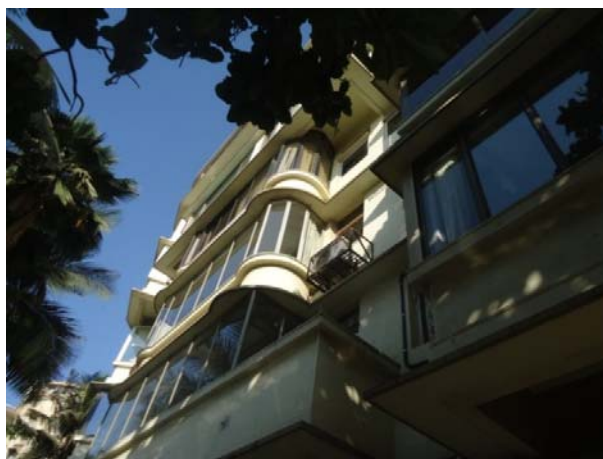
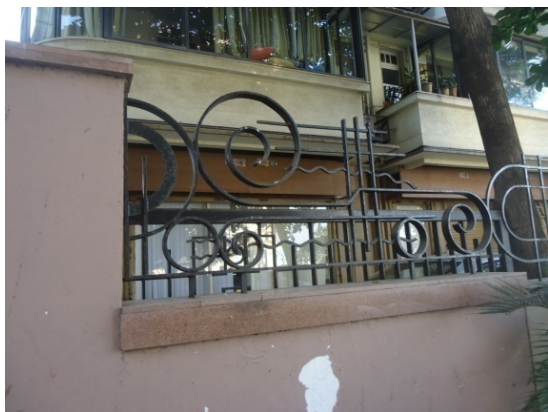
AD11 | PODAR HOUSE

9.9	Outbuildings	Good(needs cleaning)
9.10	Overall Condition	Good

AD11	PODAR HOUSE	
10.0		TRANSFORMATION
10.1	Form	Additional box grills , Enclosed balconies, Grills for the A.C. units.
10.2	Structure	No transformation
10.3	Articulation & Finishes	
11.0	DPREMARKS/PERCEIVEDTHREATS	Plot falls under Residential Zone in DP
12.0	ADDITIONAL NOTES/REFERENCES/DOCUMENTS AVAILABLE/RECOMMENDATIONS & SUGGESTIONS FOR IMPLEMENTATION	Documents: C.S. sheets, D.P. Sheets, Eicher City Maps-Mumbai, Dwivedi, Mehrotra Bombay, The Cities within Bombay 1995

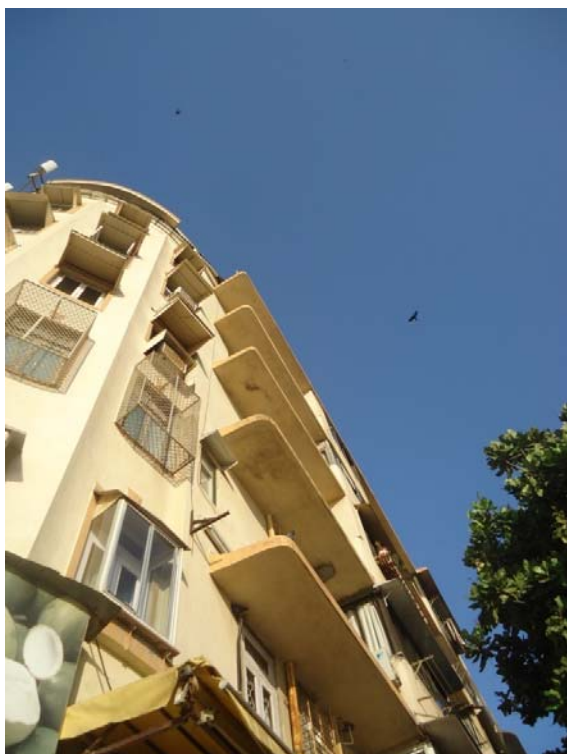
9.0		CONDITION
9.1	Plinth	Good
9.2	Walls	Good(exterior walls need painting)
9.3	Floor	Good
9.4	Stairs	Good
9.5	Openings	Good
9.6	Roofing	Good
9.7	Articulation & Finishes	Good

9.8	Services	Good
9.9	Outbuildings	Average (Needs cleaning and repairs)
9.10	Overall Condition	Good

AD12	JYOTI SADAN	
10.0		TRANSFORMATION
10.1	Form	Additional box grills, Most of the balconies taken in completely and enclosed.
10.2	Structure	No transformation
10.3	Articulation & Finishes	No major transformation
11.0	DPREMARKS/PERCEIVEDTHREATS	Plot falls under Residential Zone in DP
12.0	ADDITIONAL NOTES/REFERENCES/DOCUMENTS AVAILABLE/RECOMMENDATIONS & SUGGESTIONS FOR IMPLEMENTATION	Documents: C.S. sheets, D.P. Sheets, Eicher City Maps-Mumbai, Dwivedi, Mehrotra Bombay, The Cities within Bombay 1995

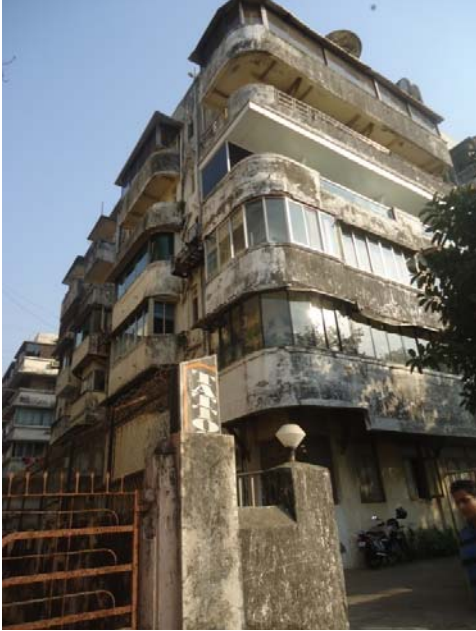
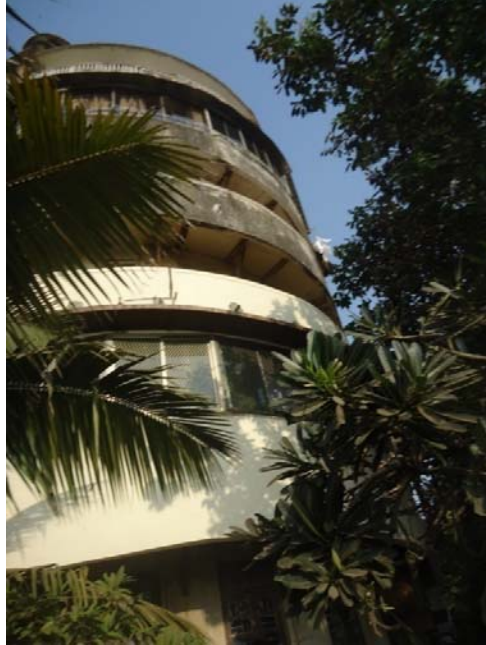
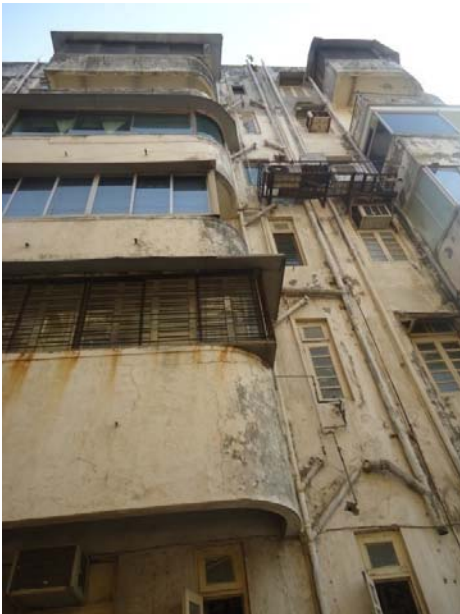
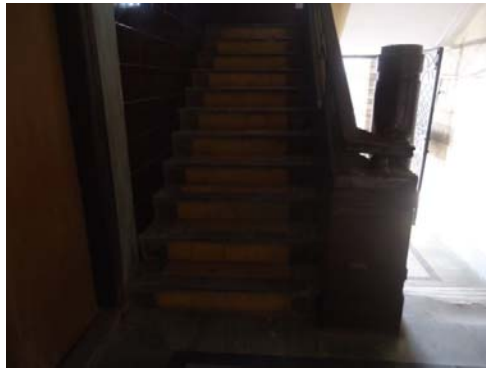
8.7	Other (HVAC/BMC/Security Systems)	Not provided (independent air conditioning units in the houses)
9.0		CONDITION
9.1	Plinth	Good
9.2	Walls	Good(exterior walls need painting)

9.3	Floor	Good
9.4	Stairs	Good (need cleaning)
9.5	Openings	Fair (Shutters of few windows are broken)
9.6	Roofing	Good
9.7	Articulation & Finishes	Good
9.8	Services	Good

9.9	Outbuildings	Average (needs cleaning and repairs)
9.10	Overall Condition	Fair

AD14	CHATEAU MARINE	
10.0		TRANSFORMATION
10.1	Form	Additional box grills , chajjas , balconies are enclosed
10.2	Structure	No transformation
10.3	Articulation & Finishes	
11.0	DPREMARKS/PERCEIVEDTHREATS	Plot falls under Residential Zone in DP
12.0	ADDITIONAL NOTES/REFERENCES/DOCUMENTS AVAILABLE/RECOMMENDATIONS & SUGGESTIONS FOR IMPLEMENTATION	Documents: C.S. sheets, D.P. Sheets, Eicher City Maps-Mumbai, Dwivedi, Mehrotra Bombay, The Cities within Bombay 1995

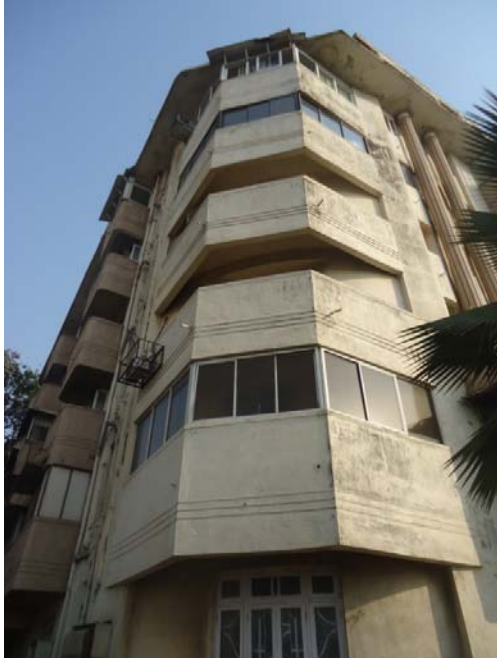
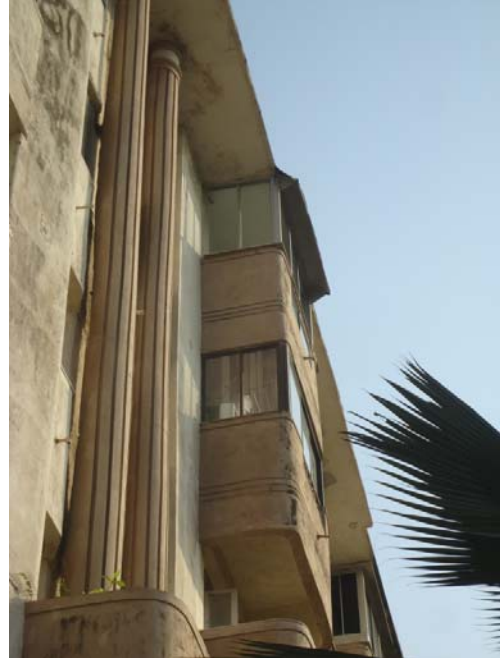
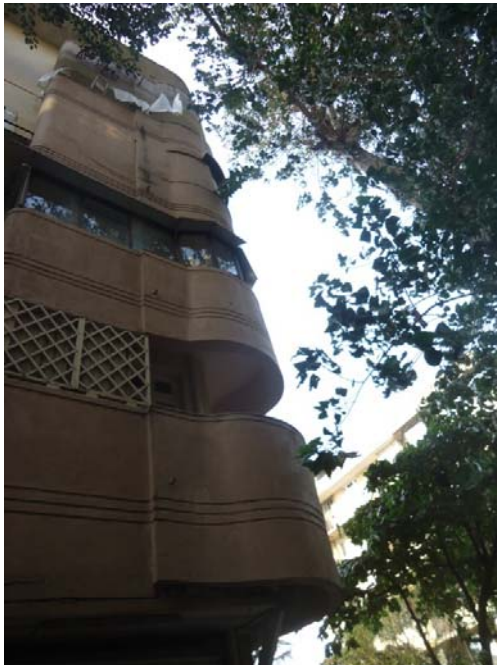
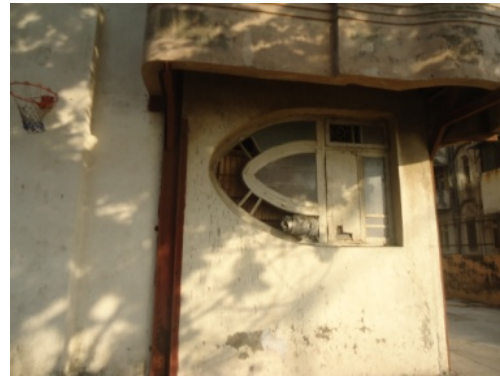
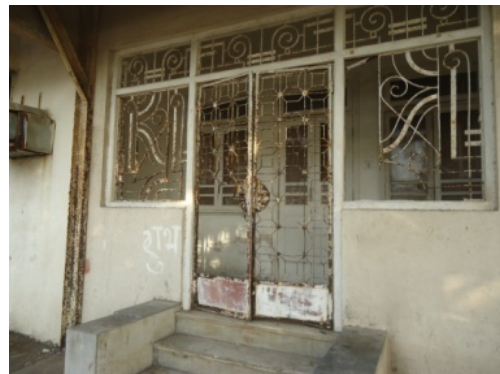
AD15 SHIV SADAN

8.7	Other (HVAC/BMC/Security Systems)	Not provided (independent air conditioning units in the houses)
9.0		CONDITION
9.1	Plinth	Good
9.2	Walls	Average(shows leakage in a few places in the interiors)

9.3	Floor	Good
9.4	Stairs	Good
9.5	Openings	Average(Shows members rusted in few openings)
9.6	Roofing	Good
9.7	Articulation & Finishes	Fair(Needs painting)

9.8	Services	Fair
9.9	Outbuildings	Average(Shows cracks needs repairs)
9.10	Overall Condition	Fair

AD 15	SHIV SADAN	
10.0		TRANSFORMATION
10.1	Form	Additional box grills , balconies enclosed.
10.2	Structure	No transformation
10.3	Articulation & Finishes	No major transformation
11.0	DPREMARKS/PERCEIVEDTHREATS	Plot falls under Residential Zone in DP
12.0	ADDITIONAL NOTES/REFERENCES/DOCUMENTS AVAILABLE/RECOMMENDATIONS & SUGGESTIONS FOR IMPLEMENTATION	Documents: C.S. sheets, D.P. Sheets, Eicher City Maps-Mumbai, Dwivedi, Mehrotra Bombay, The Cities within Bombay 1995

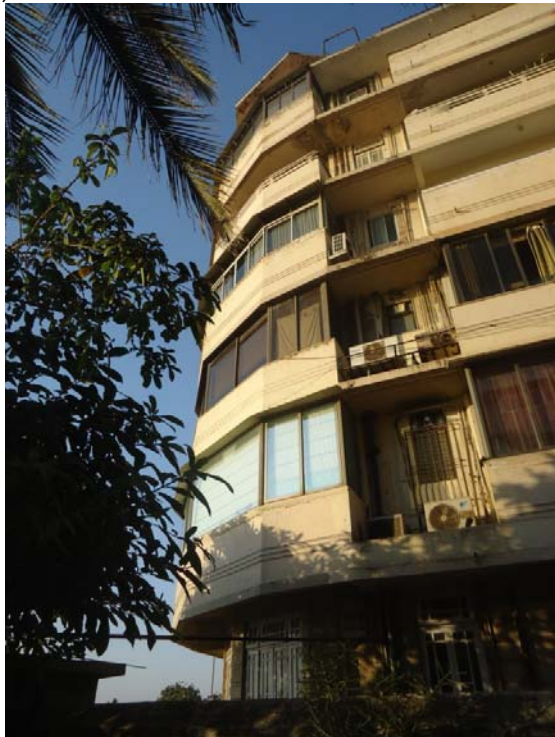
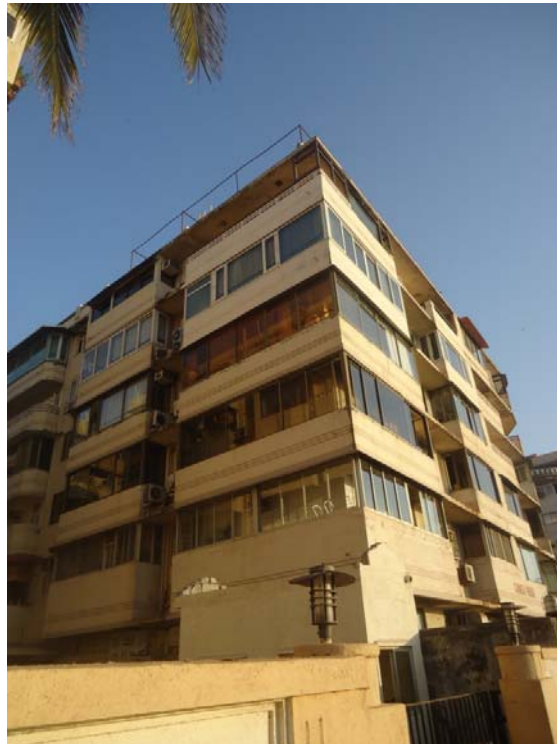
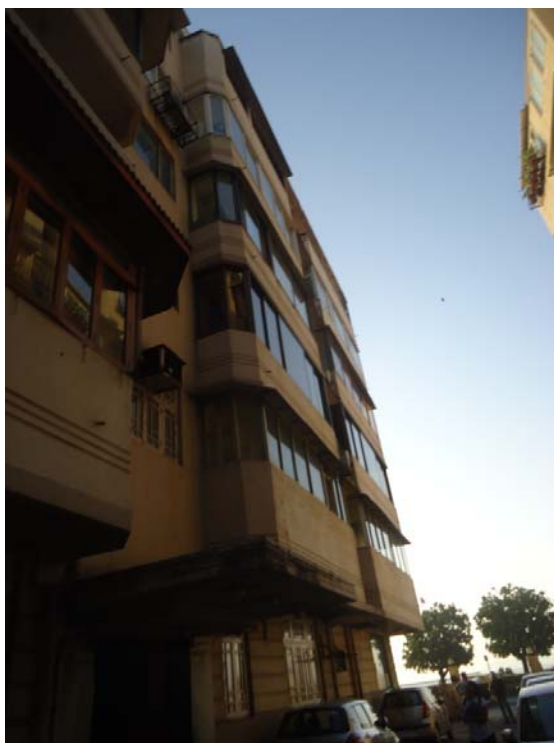
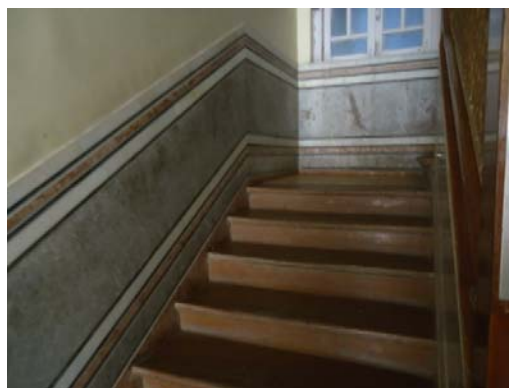
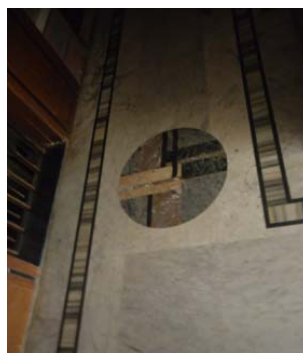
AD16 | GANGA VIHAR

9.0		CONDITION
9.1	Plinth	Good
9.2	Walls	Good(needs painting)
9.3	Floor	Good
9.4	Stairs	Good
9.5	Openings	Good
9.6	Roofing	Good
9.7	Articulation & Finishes	Good

9.8	Services	Good
9.9	Outbuildings	Good(needs painting)
9.10	Overall Condition	Good

AD16	GANGA VIHAR	
10.0		TRANSFORMATION
10.1	Form	Additional box grills , chajjas, balconies enclosed
10.2	Structure	No transformation
10.3	Articulation & Finishes	
11.0	DPREMARKS/PERCEIVEDTHREATS	Plot falls under Residential Zone in DP
12.0	ADDITIONAL NOTES/REFERENCES/DOCUMENTS AVAILABLE/RECOMMENDATIONS & SUGGESTIONS FOR IMPLEMENTATION	Documents: C.S. sheets, D.P. Sheets, Eicher City Maps-Mumbai, Dwivedi, Mehrotra Bombay, The Cities within Bombay 1995

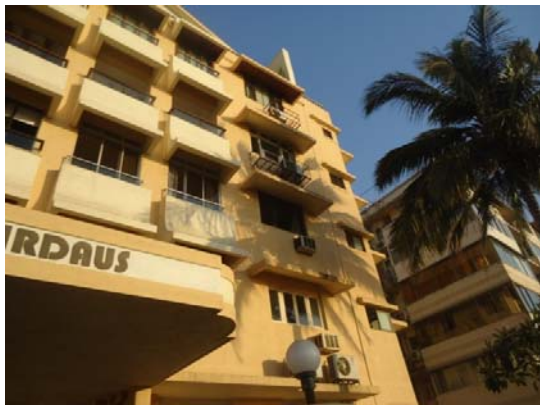
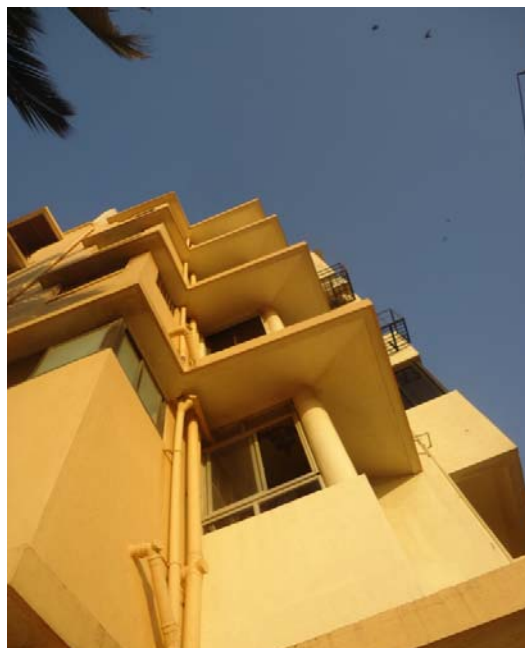
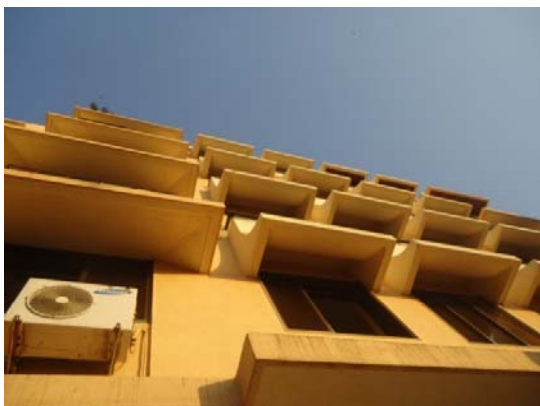
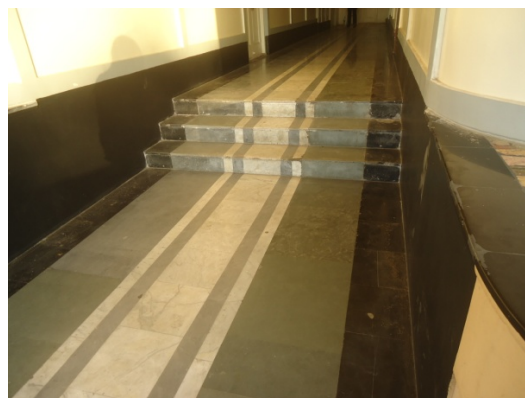
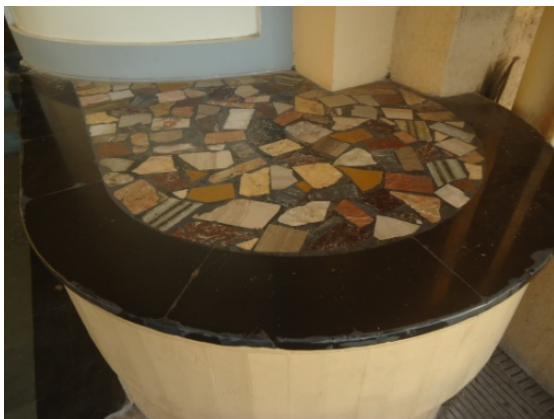
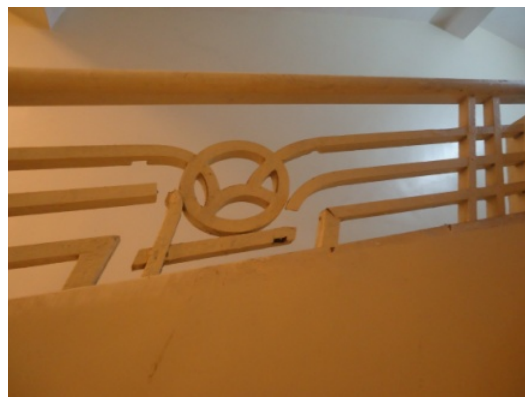
AD17 | FIRDAUS

9.0		CONDITION
9.1	Plinth	Good
9.2	Walls	Good(exterior walls need painting)
9.3	Floor	Good
9.4	Stairs	Good
9.5	Openings	Good
9.6	Roofing	Good
9.7	Articulation & Finishes	Good

9.8	Services	Good
9.9	Outbuildings	Good (needs cleaning and painting)
9.10	Overall Condition	Good

AD17	FIRDAUS	
10.0		TRANSFORMATION
10.1	Form	Additional box grills , enclosed balconies, parking shed given for laundry shop , additional security cabin ,
10.2	Structure	No transformation
10.3	Articulation & Finishes	No major transformation
11.0	DPREMARKS/PERCEIVEDTHREATS	Plot falls under Residential Zone in DP
12.0	ADDITIONAL NOTES/REFERENCES/DOCUMENTS AVAILABLE/RECOMMENDATIONS & SUGGESTIONS FOR IMPLEMENTATION	Documents: C.S. sheets, D.P. Sheets, Eicher City Maps-Mumbai, Dwivedi, Mehrotra Bombay, The Cities within Bombay 1995

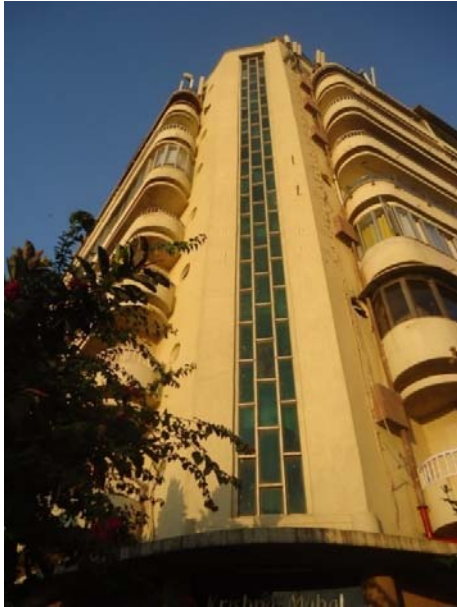
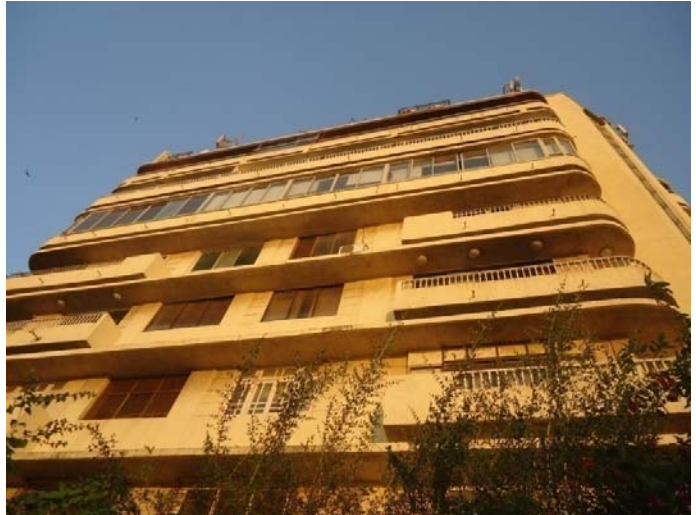
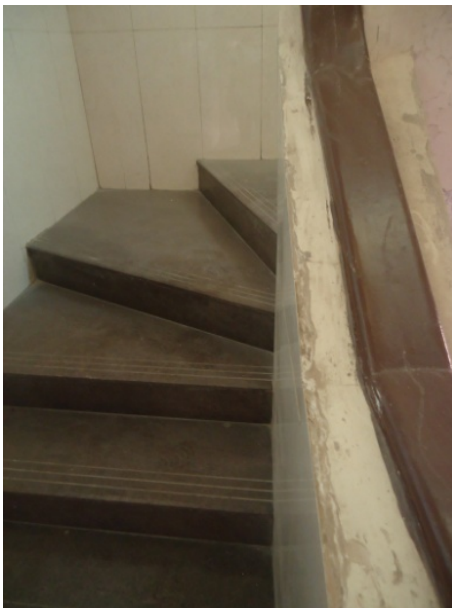
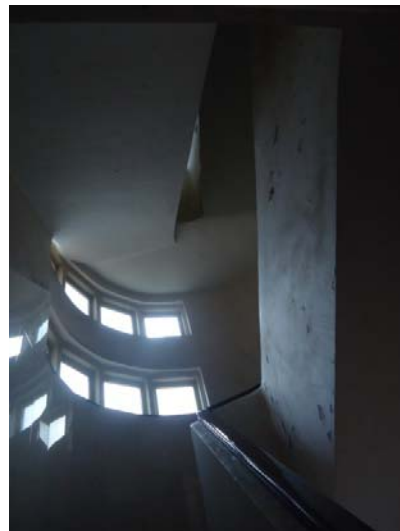
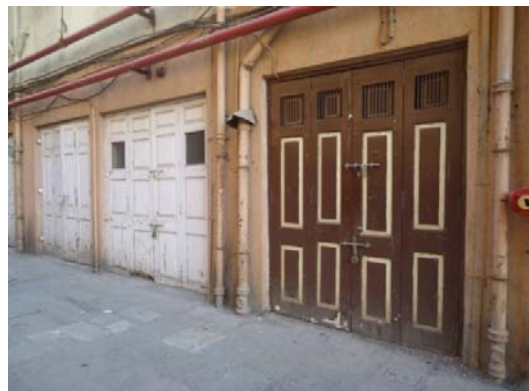
9.0		CONDITION
9.1	Plinth	Good
9.2	Walls	Good(exterior walls need painting)
9.3	Floor	Good
9.4	Stairs	Good
9.5	Openings	Good
9.6	Roofing	Good
9.7	Articulation & Finishes	Good

9.8	Services	Good
9.9	Outbuildings	Good (Need cleaning and painting)
9.10	Overall Condition	Good

AD18	KRISHNA MAHAL	
10.0		TRANSFORMATION
10.1	Form	Additional box grills , Balconies enclosed, additional parking spaces, additional chajjas
10.2	Structure	No transformation
10.3	Articulation & Finishes	
11.0	DPREMARKS/PERCEIVEDTHREATS	Plot falls under Residential Zone in DP
12.0	ADDITIONAL NOTES/REFERENCES/DOCUMENTS AVAILABLE/RECOMMENDATIONS & SUGGESTIONS FOR IMPLEMENTATION	Documents: C.S. sheets, D.P. Sheets, Eicher City Maps-Mumbai, Dwivedi, Mehrotra Bombay, The Cities within Bombay 1995

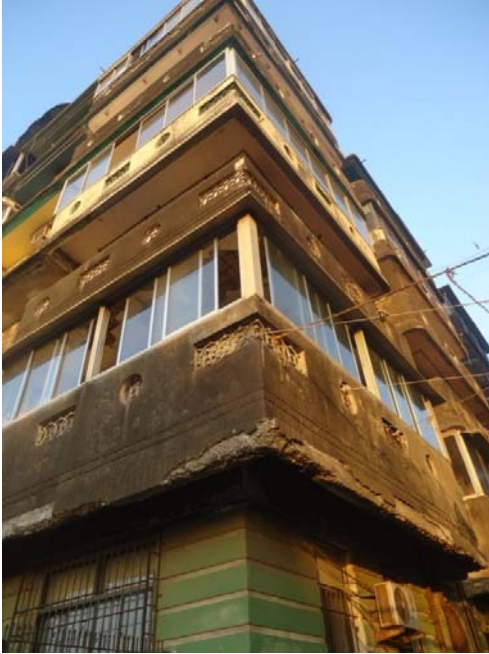
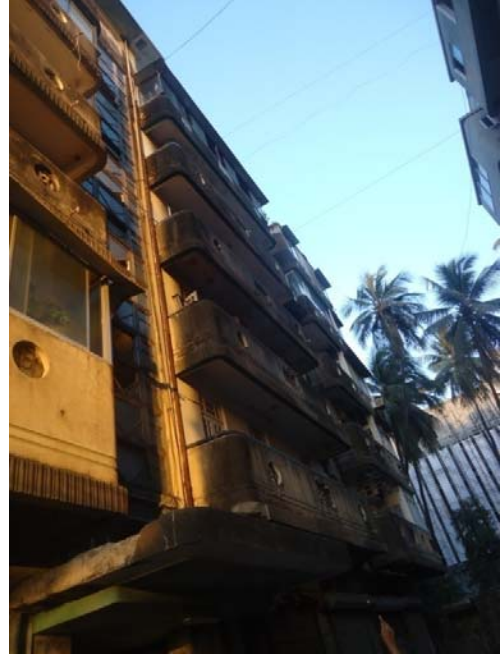
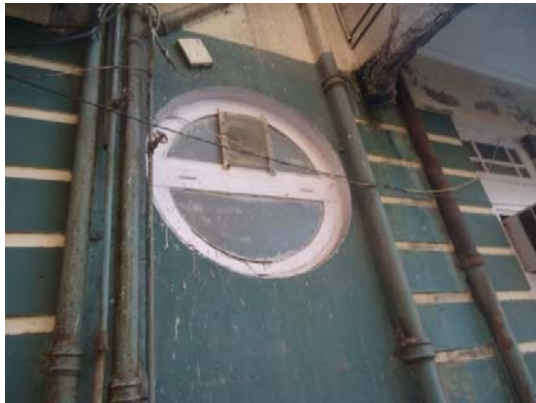
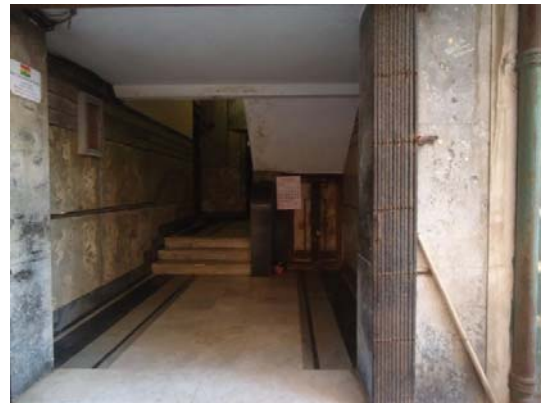
8.7	Other (HVAC/BMC/Security Systems)	Not provided (independent air conditioning units in the houses)
9.0		CONDITION
9.1	Plinth	Good
9.2	Walls	Average(exterior walls need painting)

9.3	Floor	Good
9.4	Stairs	Good
9.5	Openings	Good
9.6	Roofing	Good
9.7	Articulation & Finishes	Good
9.8	Services	Good
9.9	Outbuildings	Average
9.10	Overall Condition	Good

AD20	KAPUR MAHAL	
10.0		TRANSFORMATION
10.1	Form	Additional box grills , A.C.P. chajjas, balconies enclosed
10.2	Structure	No transformation
10.3	Articulation & Finishes	
11.0	DPREMARKS/PERCEIVEDTHREATS	Plot falls under Residential Zone in DP
12.0	ADDITIONAL NOTES/REFERENCES/DOCUMENTS AVAILABLE/RECOMMENDATIONS & SUGGESTIONS FOR IMPLEMENTATION	Documents: C.S. sheets, D.P. Sheets, Eicher City Maps-Mumbai, Dwivedi, Mehrotra Bombay, The Cities within Bombay 1995

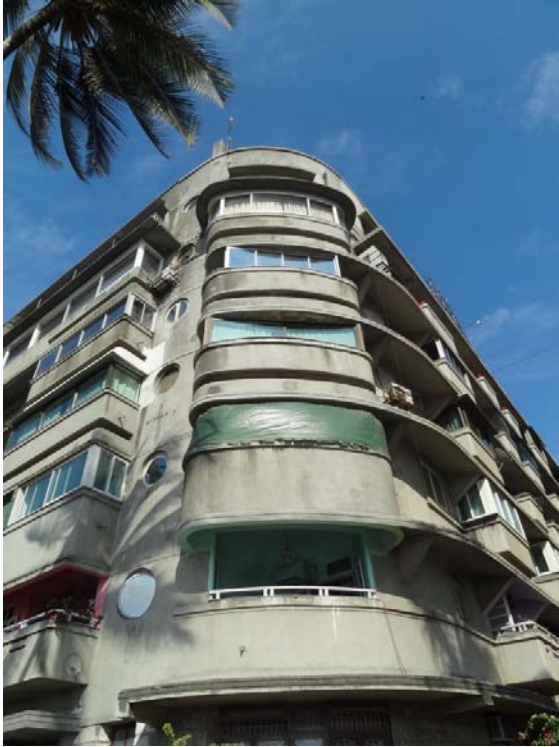
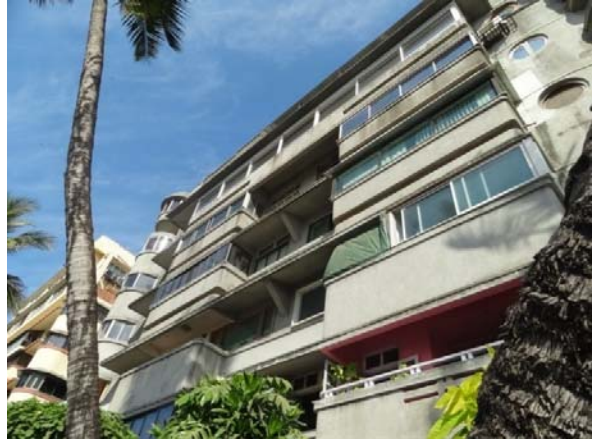
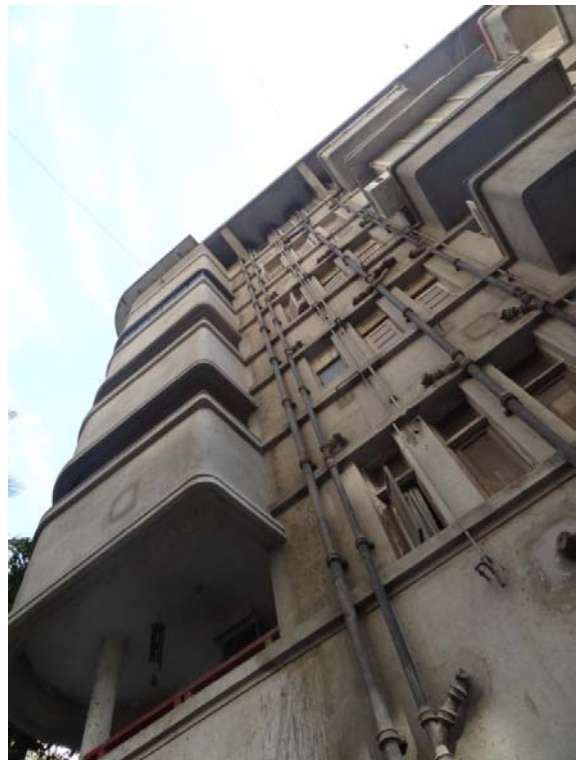
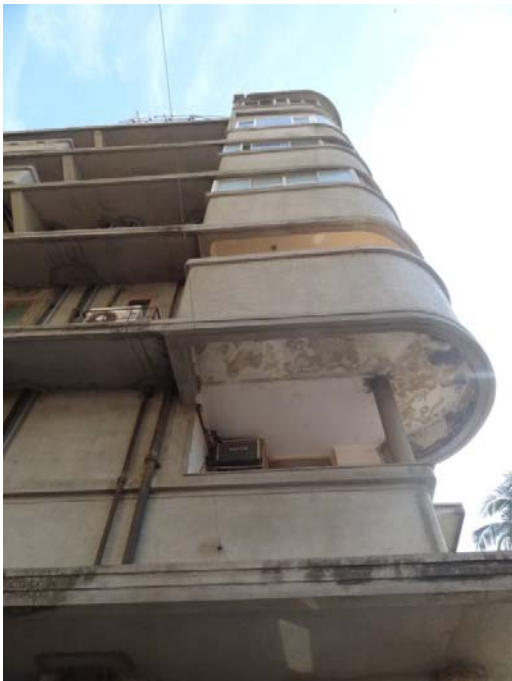
9.0		CONDITION
9.1	Plinth	Good
9.2	Walls	Good
9.3	Floor	Good
9.4	Stairs	Good
9.5	Openings	Good
9.6	Roofing	Good
9.7	Articulation & Finishes	Good
9.8	Services	Good

9.9	Outbuildings	Good(needs cleaning)
9.10	Overall Condition	Good

AD22	SONAWALA BUILDING	
10.0		TRANSFORMATION
10.1	Form	Enclosed balconies, Garage shutters changed.
10.2	Structure	No transformation
10.3	Articulation & Finishes	Painting going on
11.0	DPREMARKS/PERCEIVEDTHREATS	Plot falls under Commercial Zone in DP
12.0	ADDITIONAL NOTES/REFERENCES/DOCUMENTS AVAILABLE/RECOMMENDATIONS & SUGGESTIONS FOR IMPLEMENTATION	Documents: C.S. sheets, D.P. Sheets, Eicher City Maps-Mumbai, Dwivedi, Mehrotra Bombay, The Cities within Bombay 1995

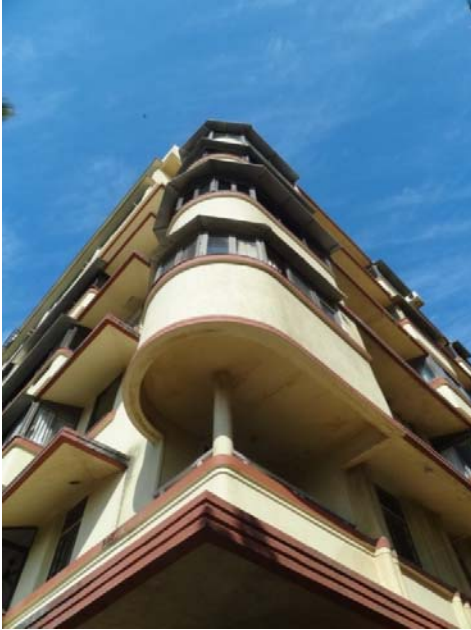
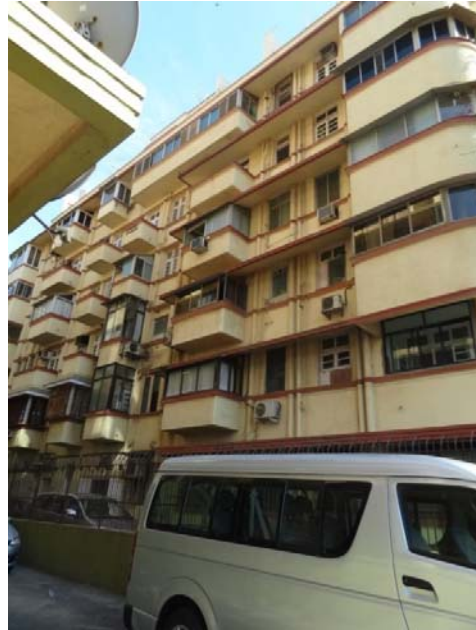
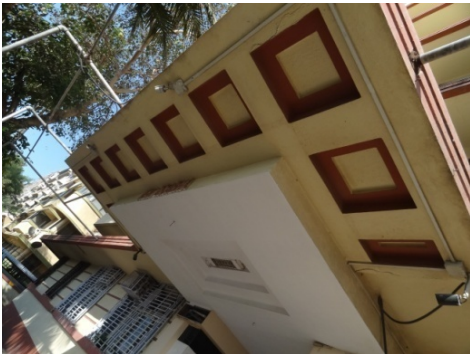
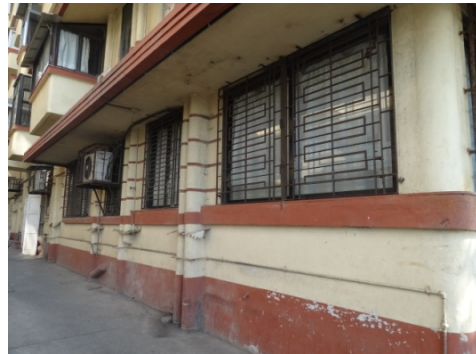
9.0		CONDITION
9.1	Plinth	Good
9.2	Walls	Good
9.3	Floor	Good
9.4	Stairs	Good
9.5	Openings	Good
9.6	Roofing	Good
9.7	Articulation & Finishes	Good
9.8	Services	Good

9.9	Outbuildings	Average(Needs cleaning and repairs)
9.10	Overall Condition	Good

AD23	HEMPRABHA	
10.0		TRANSFORMATION
10.1	Form	Additional box grills , A.C.P. chajjas , enclosed balconies, pipe lines from the canopy to the planters.
10.2	Structure	No transformation
10.3	Articulation & Finishes	
11.0	DPREMARKS/PERCEIVEDTHREATS	Plot falls under Residential Zone in DP
12.0	ADDITIONAL NOTES/REFERENCES/DOCUMENTS AVAILABLE/RECOMMENDATIONS & SUGGESTIONS FOR IMPLEMENTATION	Documents: C.S. sheets, D.P. Sheets, Eicher City Maps-Mumbai, Dwivedi, Mehrotra Bombay, The Cities within Bombay 1995

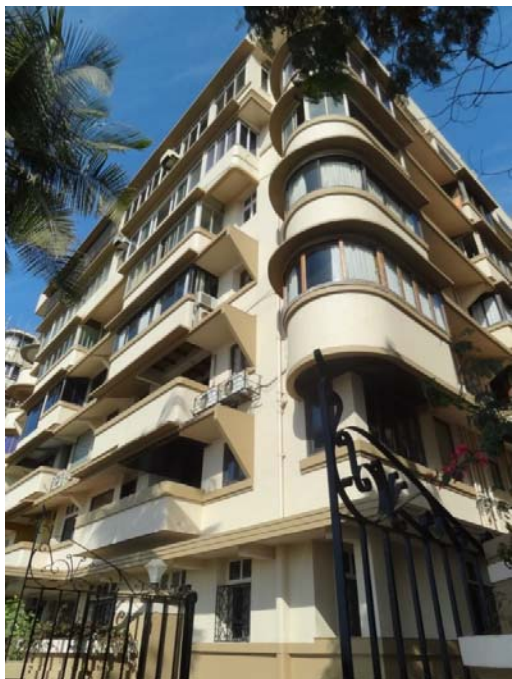
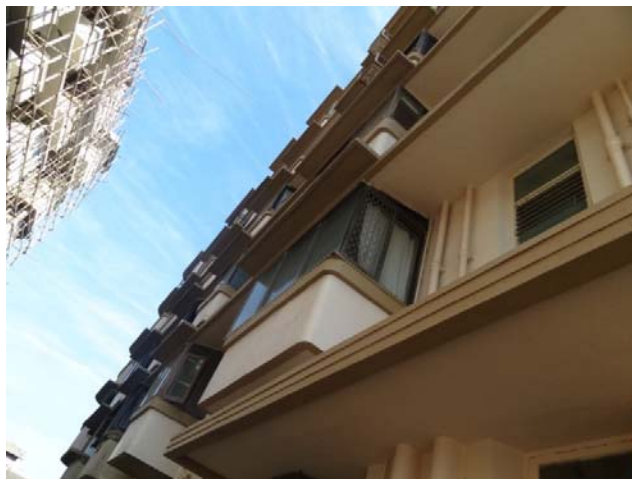
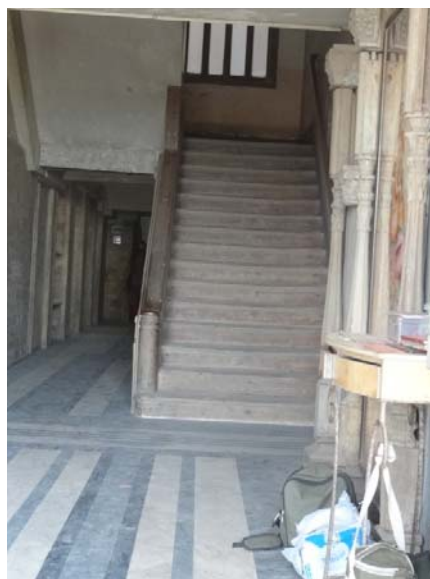
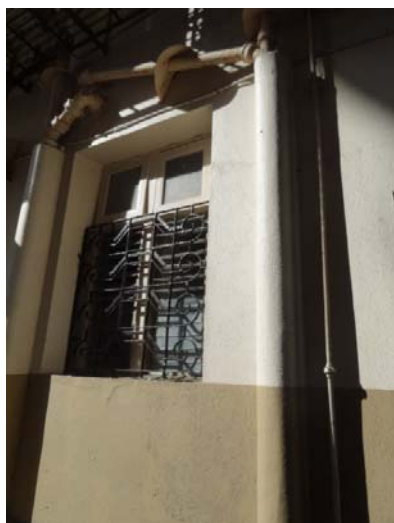
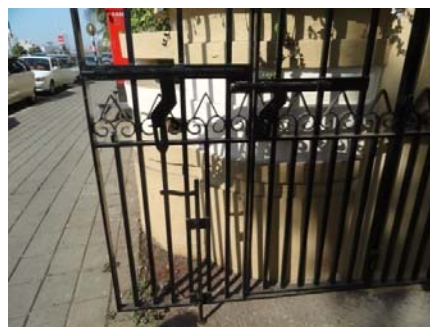
AD25 MATRUCHHAYA

9.0		CONDITION
9.1	Plinth	Good
9.2	Walls	Good
9.3	Floor	Good
9.4	Stairs	Good
9.5	Openings	Good
9.6	Roofing	Good
9.7	Articulation & Finishes	Good
9.8	Services	Good

9.9	Outbuildings	Average(Shows cracks needs repairs)
9.10	Overall Condition	Good
10.0		TRANSFORMATION
10.1	Form	Additional grills , balconies enclosed
10.2	Structure	No transformation

10.3	Articulation & Finishes	Recently painted
11.0	DPREMARKS/PERCEIVEDTHREATS	Plot falls under Residential Zone in DP
12.0	ADDITIONAL NOTES/REFERENCES/DOCUMENTS AVAILABLE/RECOMMENDATIONS & SUGGESTIONS FOR IMPLEMENTATION	Documents: C.S. sheets, D.P. Sheets, Eicher City Maps-Mumbai, Dwivedi, Mehrotra Bombay, The Cities within Bombay 1995

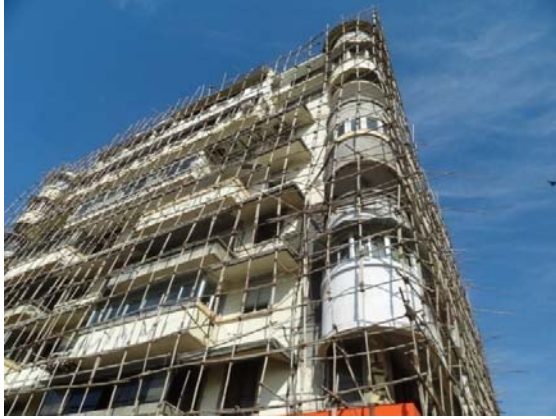
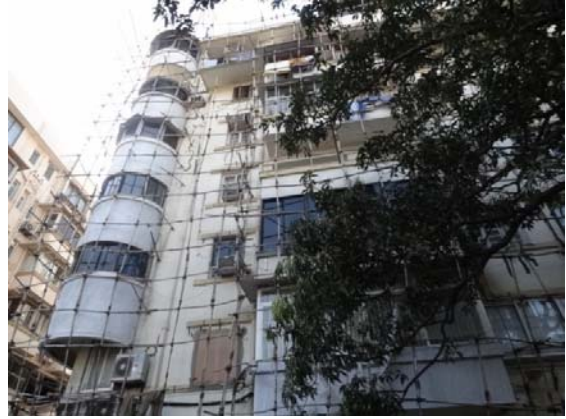
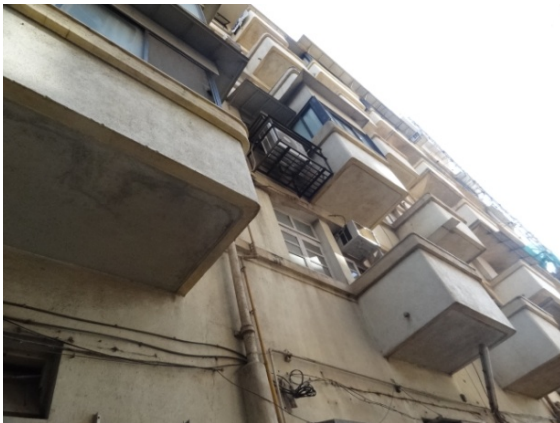
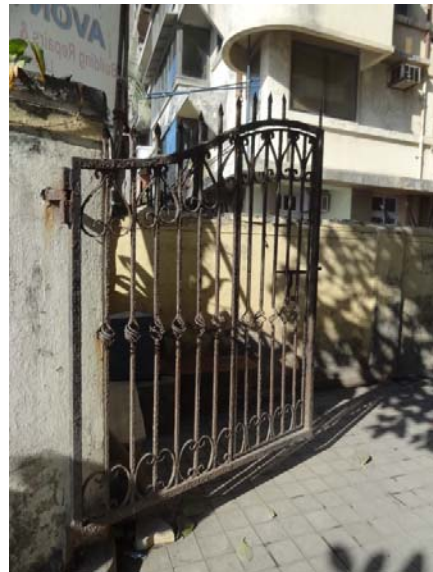
9.0		CONDITION
9.1	Plinth	Good
9.2	Walls	Good
9.3	Floor	Good
9.4	Stairs	Good
9.5	Openings	Good
9.6	Roofing	Good
9.7	Articulation & Finishes	Good
9.8	Services	Good

9.9	Outbuildings	Average(needs cleaning)
9.10	Overall Condition	Good

AD26	GIRI KUNJ	
10.0		TRANSFORMATION
10.1	Form	Additional box grills , A.C.P. chajjas, balconies enclosed.
10.2	Structure	No transformation
10.3	Articulation & Finishes	Under renovation
11.0	DPREMARKS/PERCEIVEDTHREATS	Plot falls under Residential Zone in DP
12.0	ADDITIONAL NOTES/REFERENCES/DOCUMENTS AVAILABLE/RECOMMENDATIONS & SUGGESTIONS FOR IMPLEMENTATION	Documents: C.S. sheets, D.P. Sheets, Eicher City Maps-Mumbai, Dwivedi, Mehrotra Bombay, The Cities within Bombay 1995

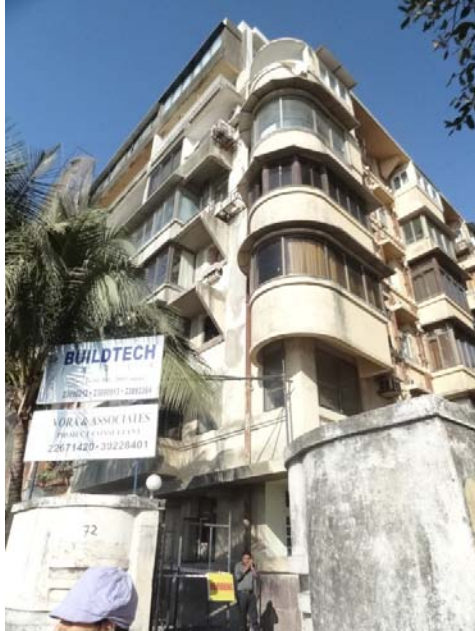
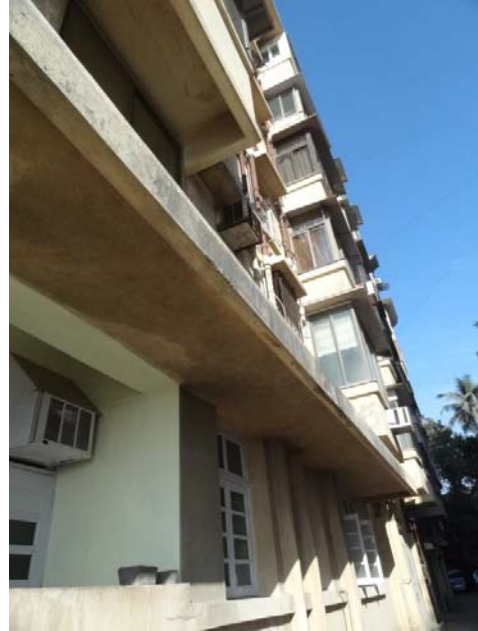
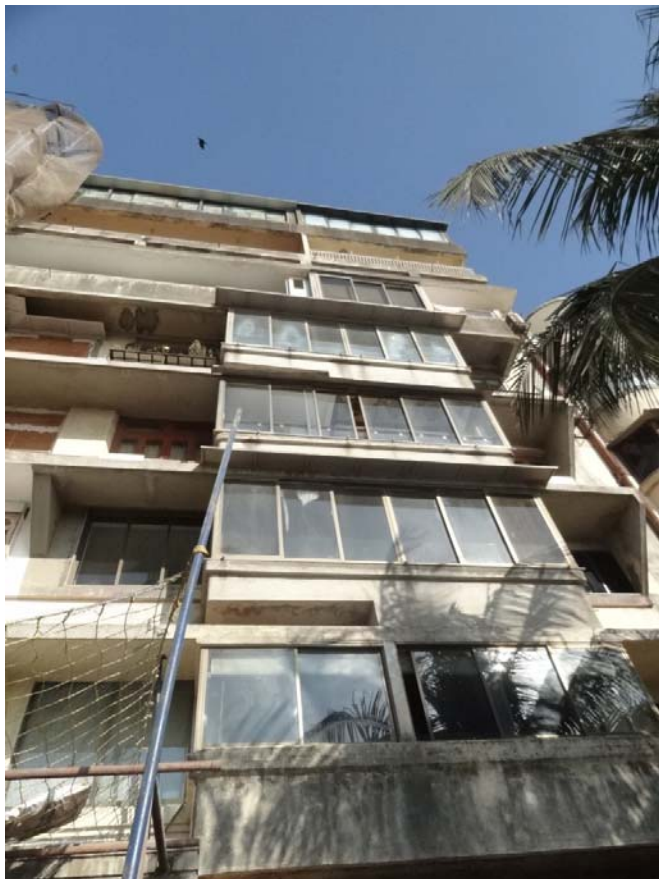
AD27 | BHARATIYA BHAVAN

9.0		CONDITION
9.1	Plinth	Good
9.2	Walls	Good
9.3	Floor	Good
9.4	Stairs	Good
9.5	Openings	Good
9.6	Roofing	Good
9.7	Articulation & Finishes	Good
9.8	Services	Good

9.9	Outbuildings	Average(Needs cleaning and repairs)
9.10	Overall Condition	Good

AD27	BHARATIYA BHAVAN	
10.0		TRANSFORMATION
10.1	Form	Additional box grills , A.C.P. chajjas , balconies enclosed.
10.2	Structure	No transformation
10.3	Articulation & Finishes	No major transformation
11.0	DPREMARKS/PERCEIVEDTHREATS	Plot falls under Residential Zone in DP
12.0	ADDITIONAL NOTES/REFERENCES/DOCUMENTS AVAILABLE/RECOMMENDATIONS & SUGGESTIONS FOR IMPLEMENTATION	Documents: C.S. sheets, D.P. Sheets, Eicher City Maps-Mumbai, Dwivedi, Mehrotra Bombay, The Cities within Bombay 1995
