The Victorian & Art Deco Ensemble of Mumbai

Submission To UNESCO As A WORLD HERITAGE SITE

ANNEXURE A- DOCUMENTATION PART II-BUILDING INVENTORIES

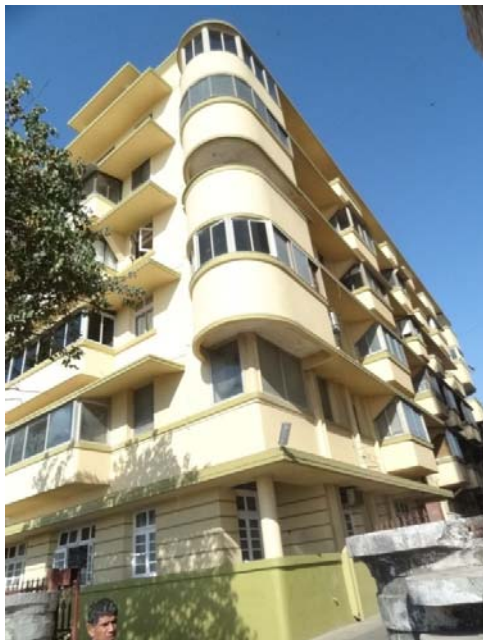
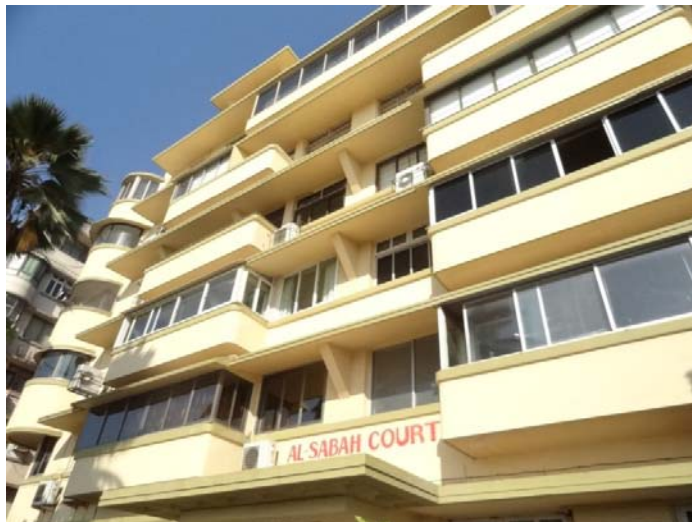
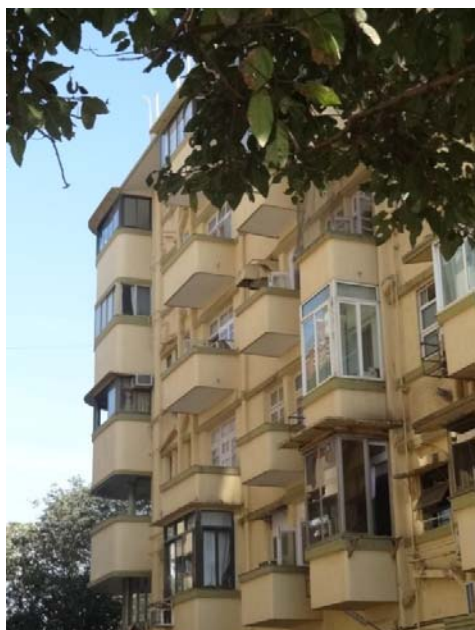
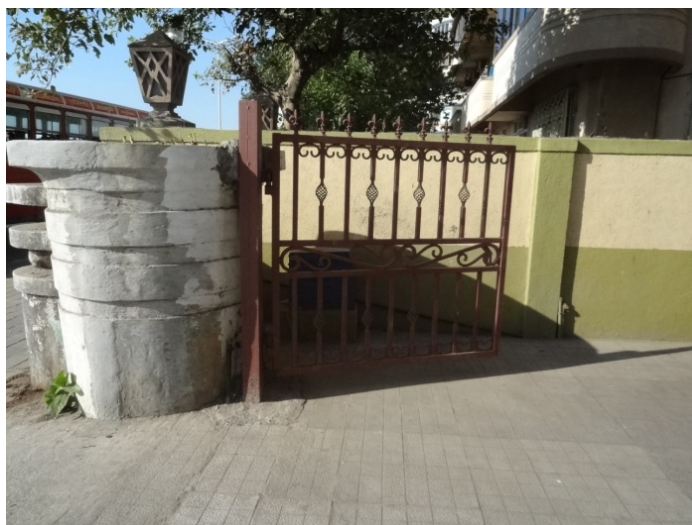
AD28 | AL-SABAH COURT

9.0		CONDITION
9.1	Plinth	Good
9.2	Walls	Good
9.3	Floor	Good
9.4	Stairs	Good
9.5	Openings	Good
9.6	Roofing	Good
9.7	Articulation & Finishes	Good
9.8	Services	Good

9.9	Outbuildings	Good
9.10	Overall Condition	Good

AD28	AL-SABAH COURT	
10.0		TRANSFORMATION
10.1	Form	Additional box grills , A.C.P. chajjas , balconies enclosed
10.2	Structure	No transformation
10.3	Articulation & Finishes	No major transformation
11.0	DPREMARKS/PERCEIVEDTHREATS	Plot falls under Residential Zone in DP
12.0	ADDITIONAL NOTES/REFERENCES/DOCUMENTS AVAILABLE/RECOMMENDATIONS & SUGGESTIONS FOR IMPLEMENTATION	Documents: C.S. sheets, D.P. Sheets, Eicher City Maps-Mumbai, Dwivedi, Mehrotra Bombay, The Cities within Bombay 1995

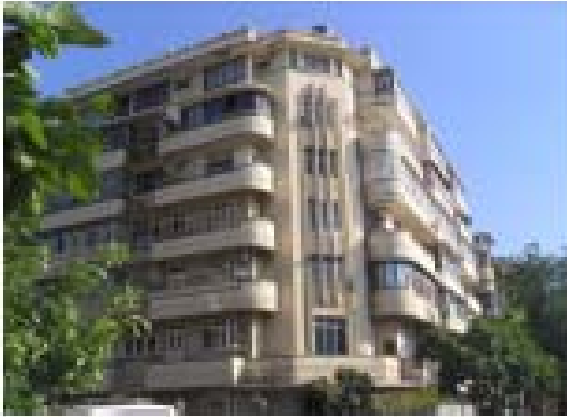
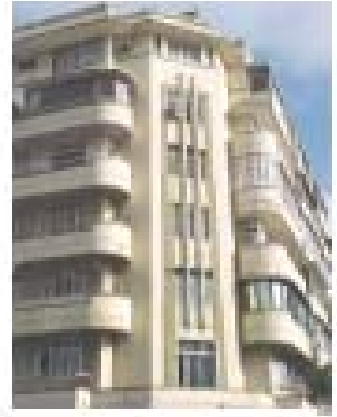
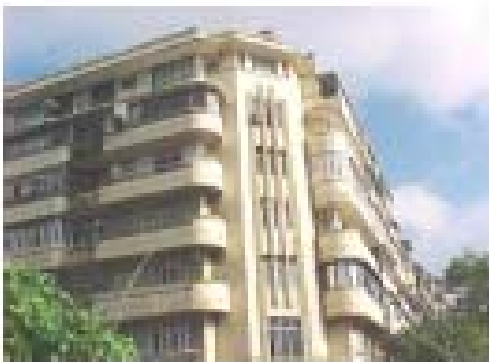
AD29	SEKSARIA		
8.6	Fire Precaution	Not provided	
8.7	Other (HVAC/BMC/Security Systems)	Not provided	
9.0		CONDITION	
9.1	Plinth	Good (No settlement or cracks observed)

9.2	Walls	Good (No dampness or cracks observed)	
9.3	Floor	Good	
9.4	Stairs	Good	
9.5	Openings	Good	
9.6	Roofing	Good (No leakage observed)	
9.7	Articulation & Finishes	Good

9.8	Services	Good (Drainage pipes need no replacement)	
9.9	Outbuildings	Good	
9.10	Overall Condition	Good	Maintenance level Good
10.0		TRANSFORMATION	
10.1	Form	Balconies enclosed on many floors.

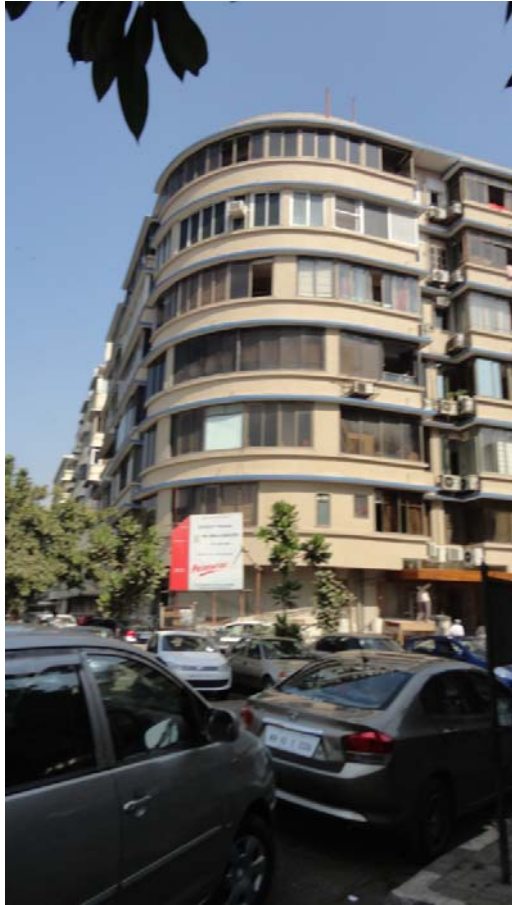
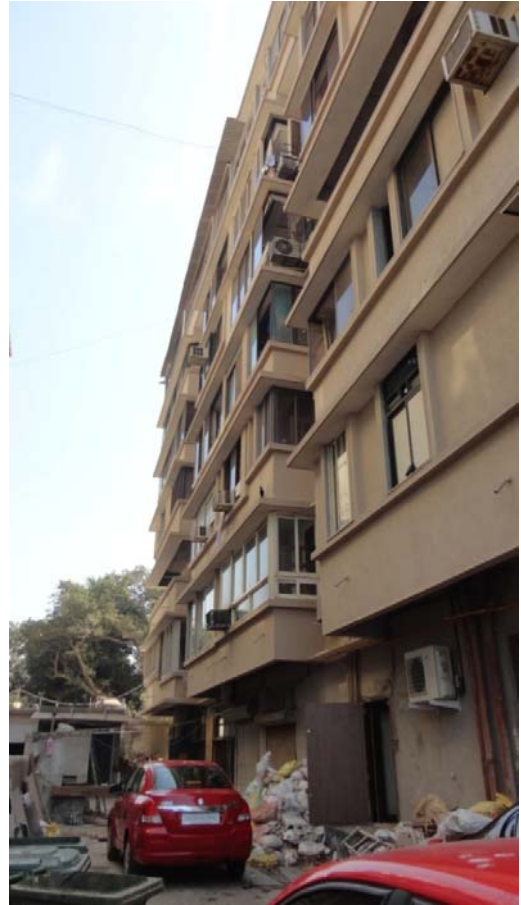
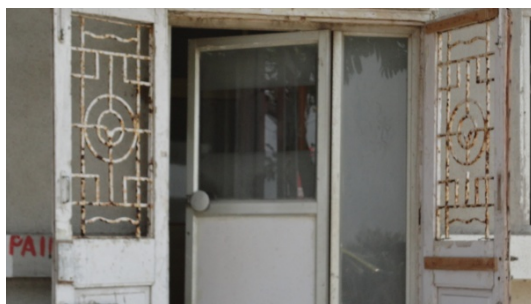
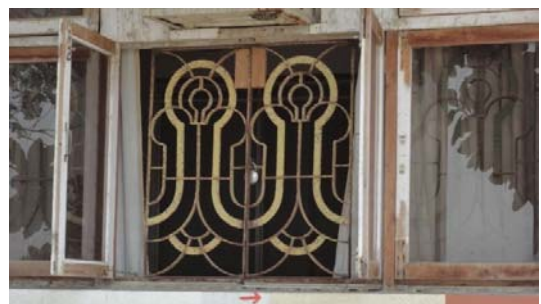
9.0		CONDITION
9.1	Plinth	Good
9.2	Walls	Good
9.3	Floor	Good
9.4	Stairs	Good
9.5	Openings	Good
9.6	Roofing	Good
9.7	Articulation & Finishes	Good
9.8	Services	Good

9.9	Outbuildings	Average(Needs cleaning and repairs)
9.10	Overall Condition	Good

AD30	BHARAT MAHAL	
10.0		TRANSFORMATION
10.1	Form	New grills, A.C.P. chajjas, balconies enclosed. Parking shed converted to a storage space
10.2	Structure	No transformation
10.3	Articulation & Finishes	No major transformation
11.0	DPREMARKS/PERCEIVEDTHREATS	Plot falls under Commercial Zone in DP
12.0	ADDITIONAL NOTES/REFERENCES/DOCUMENTS AVAILABLE/RECOMMENDATIONS & SUGGESTIONS FOR IMPLEMENTATION	Documents: C.S. sheets, D.P. Sheets, Eicher City Maps-Mumbai, Dwivedi, Mehrotra Bombay, The Cities within Bombay 1995

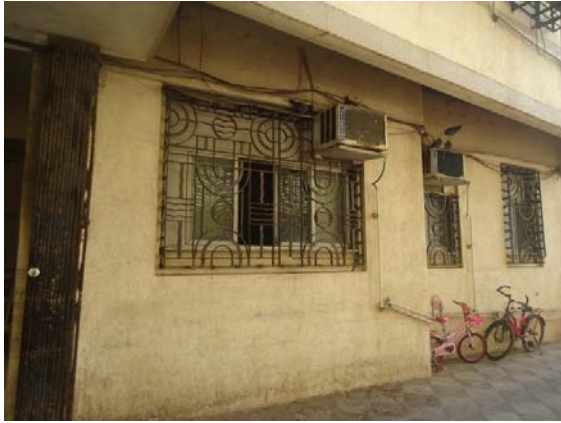
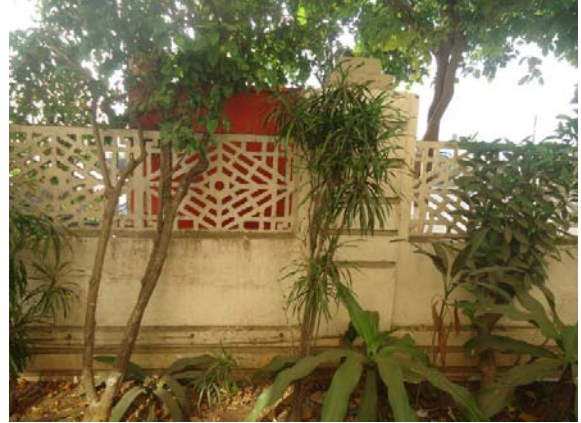
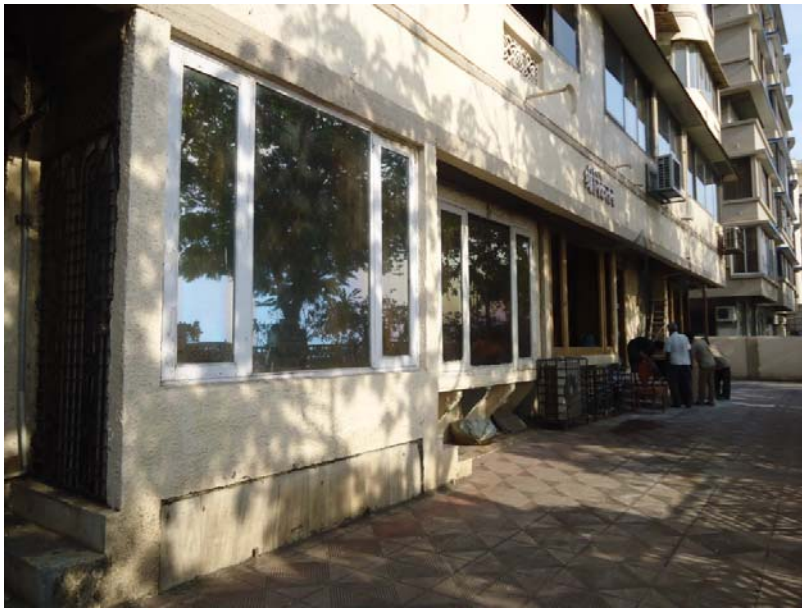
9.0		CONDITION
9.1	Plinth	Good
9.2	Walls	Good
9.3	Floor	Good
9.4	Stairs	Good
9.5	Openings	Good
9.6	Roofing	Good
9.7	Articulation & Finishes	Good
9.8	Services	Good

AD31	SHRI NIKETAN	
10.0		TRANSFORMATION
10.1	Form	New grills, A.C.P. chajjas , balconies enclosed.
10.2	Structure	No transformation
10.3	Articulation & Finishes	
11.0	DPREMARKS/PERCEIVEDTHREATS	Plot falls under Residential Zone in DP
12.0	ADDITIONAL NOTES/REFERENCES/DOCUMENTS AVAILABLE/RECOMMENDATIONS & SUGGESTIONS FOR IMPLEMENTATION	Documents: C.S. sheets, D.P. Sheets, Eicher City Maps-Mumbai, Dwivedi, Mehrotra Bombay, The Cities within Bombay 1995

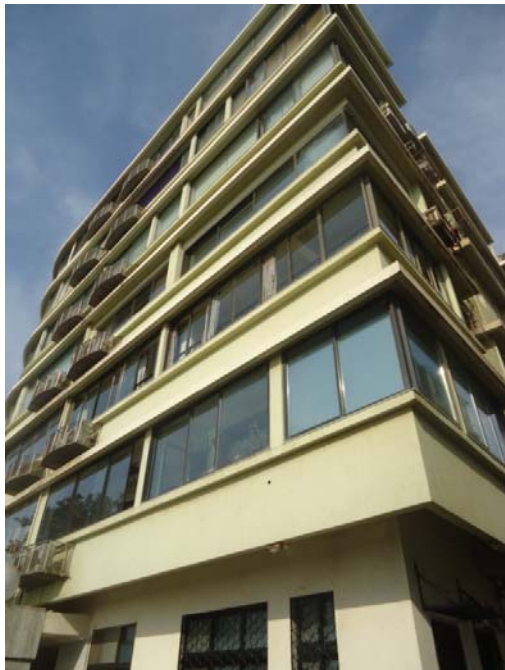
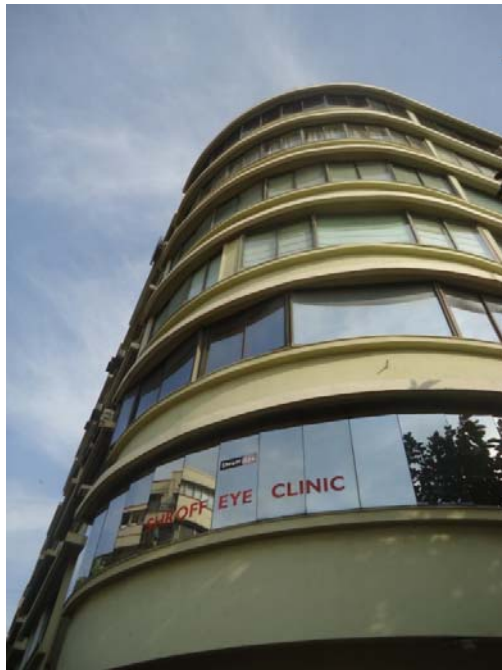
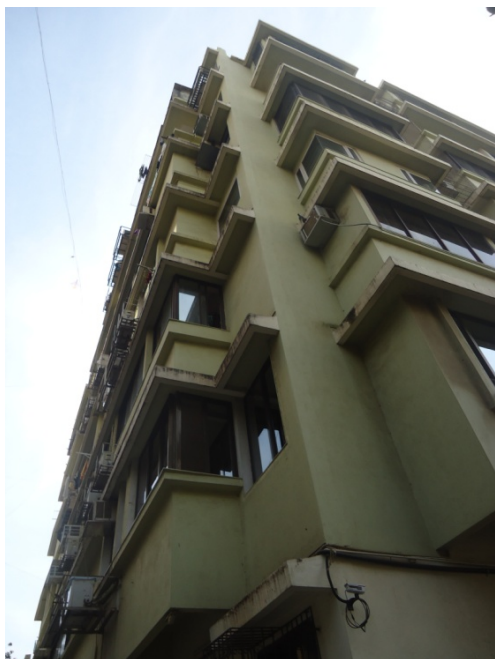
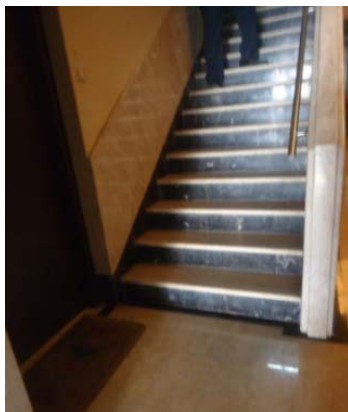
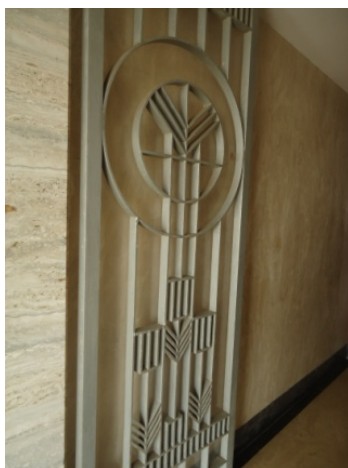
AD32 | GOBIND MAHAL

9.0		CONDITION
9.1	Plinth	Good
9.2	Walls	Good
9.3	Floor	Good
9.4	Stairs	Good
9.5	Openings	Good
9.6	Roofing	Good
9.7	Articulation & Finishes	Good
9.8	Services	Good

AD32	GOBIND MAHAL	
10.0		TRANSFORMATION
10.1	Form	Additional grills, A.C.P. chajjas , balconies enclosed. Parking shed shutters are new
10.2	Structure	No transformation
10.3	Articulation & Finishes	
11.0	DPREMARKS/PERCEIVEDTHREATS	Plot falls under Commercial Zone in DP
12.0	ADDITIONAL NOTES/REFERENCES/DOCUMENTS AVAILABLE/RECOMMENDATIONS & SUGGESTIONS FOR IMPLEMENTATION	Documents: C.S. sheets, D.P. Sheets, Eicher City Maps-Mumbai, Dwivedi, Mehrotra Bombay, The Cities within Bombay 1995

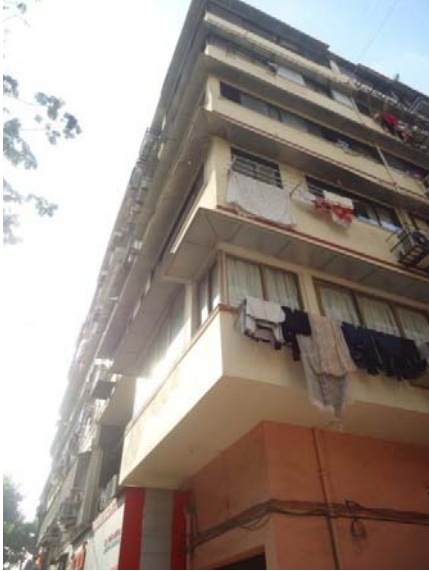
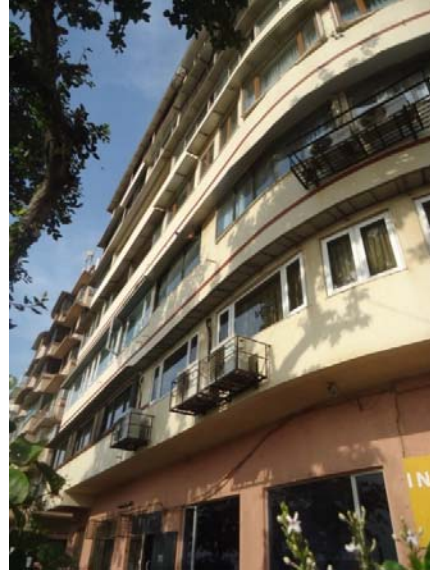
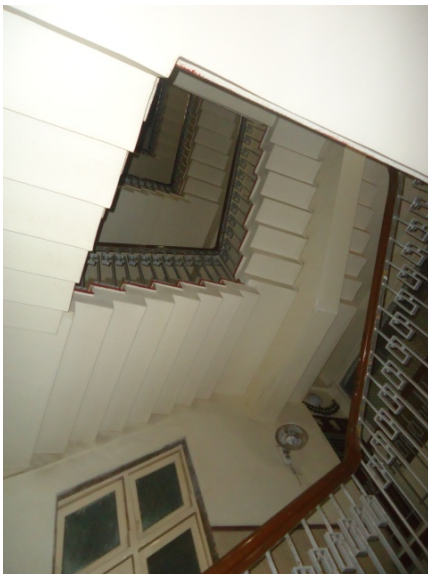
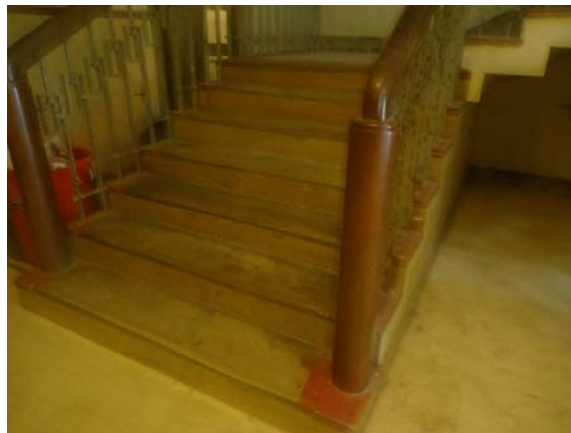
AD33 | PARIJAT

9.0		CONDITION
9.1	Plinth	Good
9.2	Walls	Good
9.3	Floor	Good
9.4	Stairs	Good
9.5	Openings	Good
9.6	Roofing	Good
9.7	Articulation & Finishes	Good
9.8	Services	Good

AD33	PARIJAT	
10.0		TRANSFORMATION
10.1	Form	Additional grills , A.C.P. chajjas ,
10.2	Structure	No transformation
10.3	Articulation & Finishes	
11.0	DPREMARKS/PERCEIVEDTHREATS	Plot falls under Residential Zone in DP
12.0	ADDITIONAL NOTES/REFERENCES/DOCUMENTS AVAILABLE/RECOMMENDATIONS & SUGGESTIONS FOR IMPLEMENTATION	Documents: C.S. sheets, D.P. Sheets, Eicher City Maps-Mumbai, Dwivedi, Mehrotra Bombay, The Cities within Bombay 1995

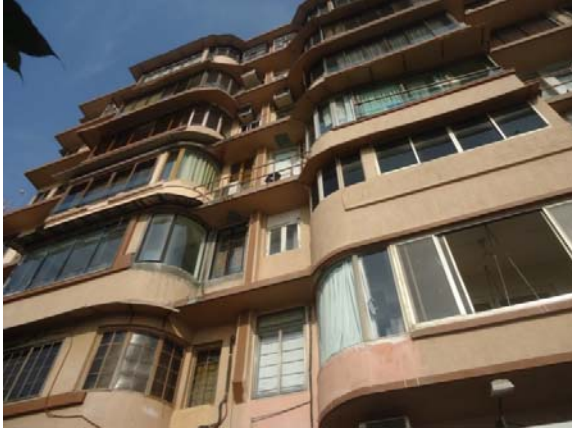
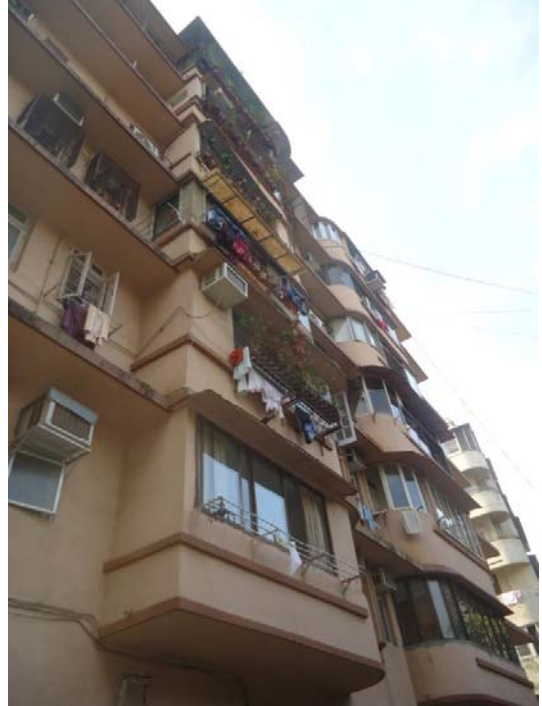
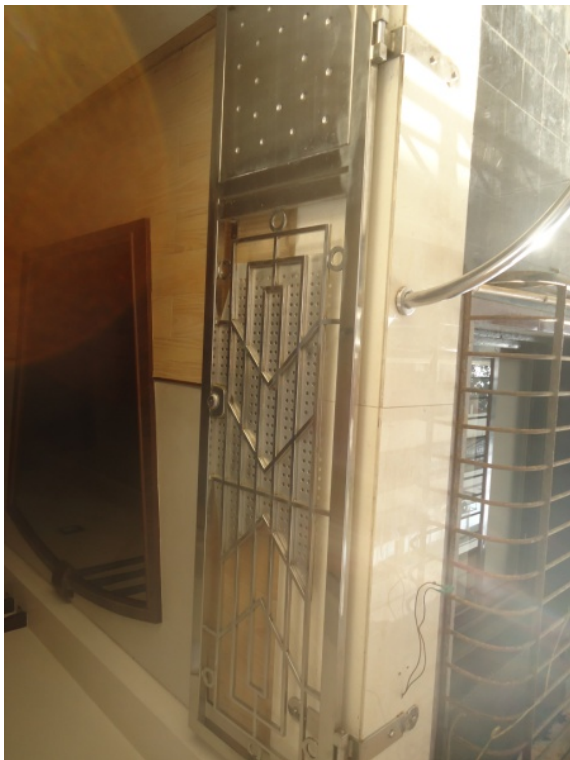
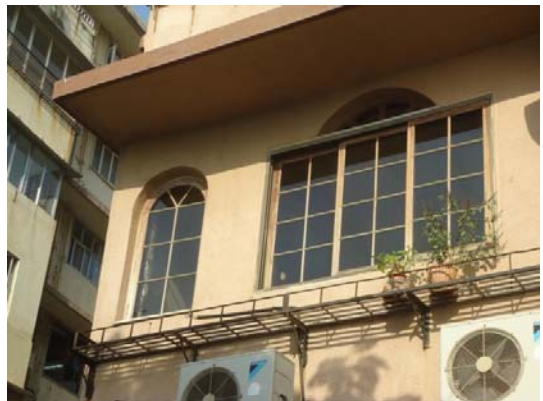
AD34 | SHANTI NIKETAN

9.0		CONDITION
9.1	Plinth	Good
9.2	Walls	Good
9.3	Floor	Good
9.4	Stairs	Good
9.5	Openings	Good
9.6	Roofing	Good
9.7	Articulation & Finishes	Good
9.8	Services	Good

9.9	Outbuildings	Average(Needs cleaning and repairs)
9.10	Overall Condition	Good

AD 34	SHANTI NIKETAN	
10.0		TRANSFORMATION
10.1	Form	Additional box grills , A.C.P. chajjas , balconies enclosed.
10.2	Structure	No transformation
10.3	Articulation & Finishes	
11.0	DPREMARKS/PERCEIVEDTHREATS	Plot falls under Residential Zone in DP
12.0	ADDITIONAL NOTES/REFERENCES/DOCUMENTS AVAILABLE/RECOMMENDATIONS & SUGGESTIONS FOR IMPLEMENTATION	Documents: C.S. sheets, D.P. Sheets, Eicher City Maps-Mumbai, Dwivedi, Mehrotra Bombay, The Cities within Bombay 1995

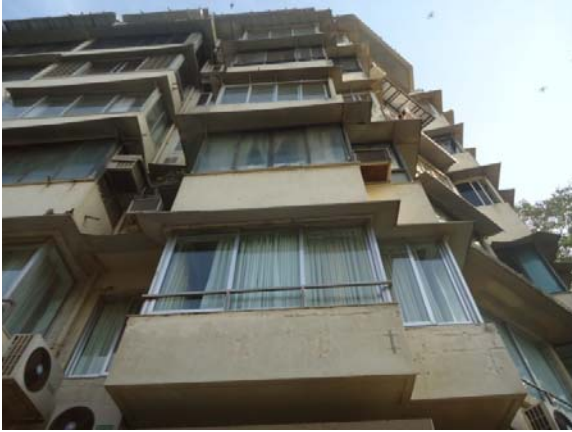
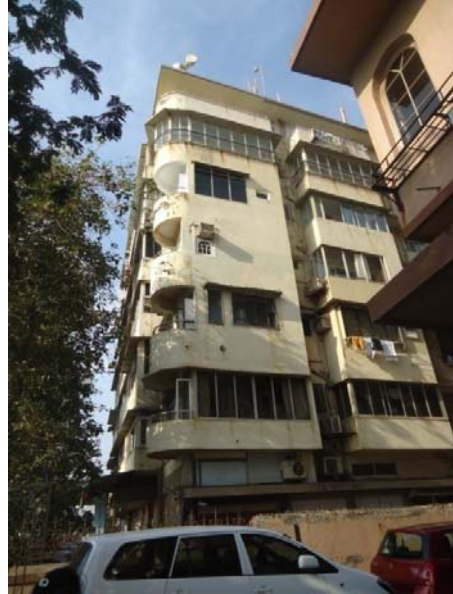
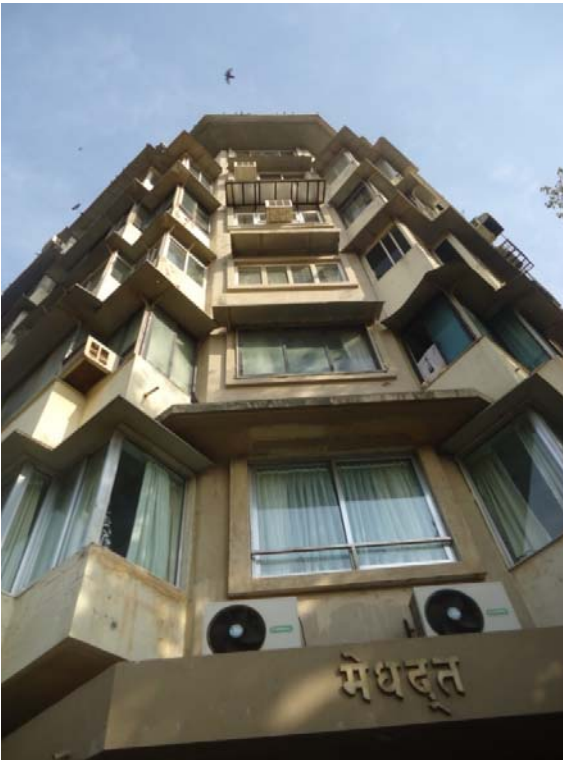
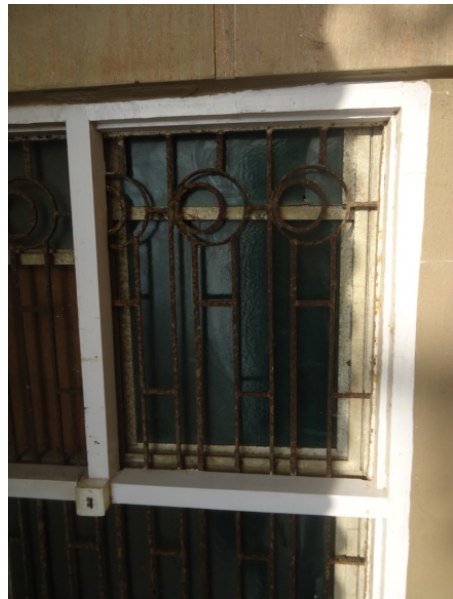
9.0		CONDITION
9.1	Plinth	Good
9.2	Walls	Good
9.3	Floor	Good
9.4	Stairs	Good
9.5	Openings	Good
9.6	Roofing	Good
9.7	Articulation & Finishes	Good
9.8	Services	Good

AD35	MEGHDOOT	
10.0		TRANSFORMATION
10.1	Form	Additional grills , A.C.P. chajjas , balconies enclosed.
10.2	Structure	No transformation
10.3	Articulation & Finishes	
11.0	DPREMARKS/PERCEIVEDTHREATS	Plot falls under Residential Zone in DP
12.0	ADDITIONAL NOTES/REFERENCES/DOCUMENTS AVAILABLE/RECOMMENDATIONS & SUGGESTIONS FOR IMPLEMENTATION	Documents: C.S. sheets, D.P. Sheets, Eicher City Maps-Mumbai, Dwivedi, Mehrotra Bombay, The Cities within Bombay 1995
