BAPTISM SITE
BETHANY BEYOND THE JORDAN “AL-MAGHTAS”
MANAGEMENT PLAN

Revised September 2016

Rami Farouk Daher

TURATH: Architecture & Urban Design Consultants

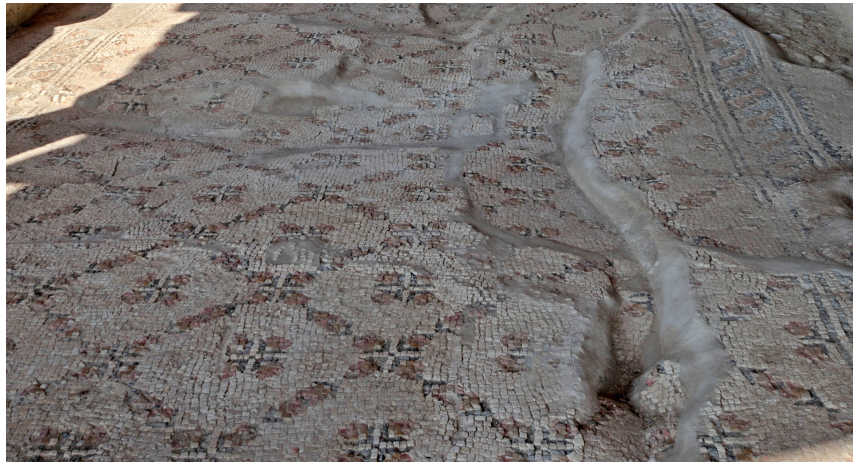
Image (17): The Mosaic Floor of the Northern Church

The floor of the church was covered with a colored mosaic floor composed of a frame and crosses with geometrical designs. Pillars along the northern wall of the church were designed to support the roof. No roof tiles were recovered from the excavations, pointing to the possibility that the roof consisted of wooden beams that were washed away. The internal walls of the church were covered with a layer of smooth white plaster. Other buildings associated with the Church near the northern wall were severely damaged by natural factors during later periods.

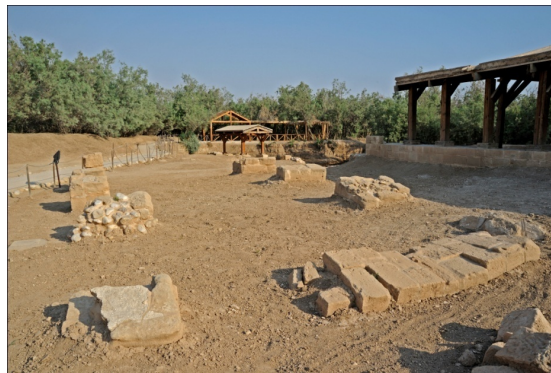
The foundations vary in size but they are constructed of fieldstones of average size bound together by a cementing material of gray color with plaster remains noticed at the surface of some of the foundations. The pillars also vary in size. Sandstone ashlar were used in building the outer sides of the pillars, whereas the core consisted of field stones and cementing material. The pillars were raised to a minimum height of 2.5m judging from the remains of one of them. A large number of sandstone ashlar were found between several of the piers; some of these ashlar were covered with a whitish plaster. Some fragments of white, medium-sized mosaic tesserae were also found just to the east of two of the piers. We can therefore conclude that these sets of pillars were designed to carry or support a large platform that, in turn, might have supported or formed the elevated floor of a monastery, basilica or other structure. The lack of a floor supports the identification of the set of pillars as the substructure for an elevated building (Mkhjian & Kanellopoulos 2003, p 9-10).

Image (26): Remains of John the Baptist Church (Pillared Hall)

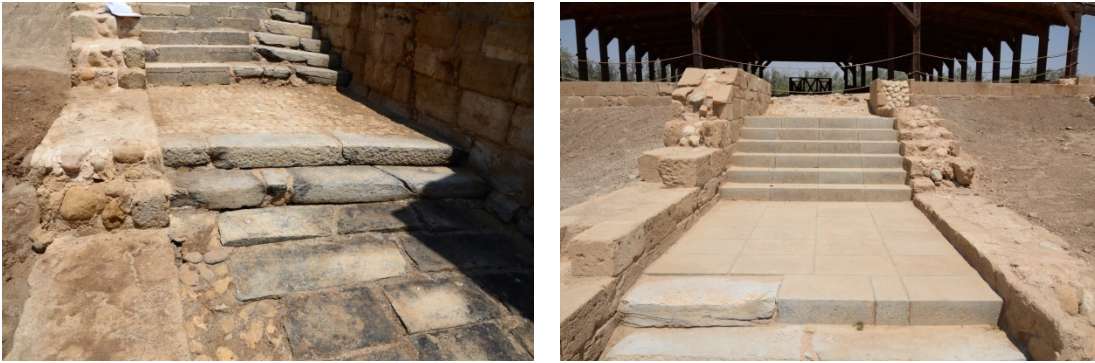
Image (31): The Marble Steps.

These steps were discovered and are still preserved in situ, descending eastward from the church of St. John the Baptist towards the water of the cruciform baptismal pool. Descriptions of the area matching the archaeological remains are also found in Arculfus (670 AD), who also saw a wooden cross in the middle of the river, a little church built on four piers, and a large monastery on a nearby hill (*“Right at the river’s edge stands a small rectangular church which was built, so it is said, at the place where the Lord’s clothes were placed while he was baptized. The fact that it is supported on four stone vaults makes it usable, since the water, which comes in from all sides, is underneath it. It has a tiled roof. This remarkable church is supported, as we have said, by arches and vaults, and stands in the lower part of the valley through which the Jordan flows. But in the upper part there is a great monastery for monks, which has been built on the brow of a small hill nearby, overlooking the church. There is also a church built there in honour of Saint John Baptist which, together with the monastery, is enclosed in a single masonry wall”*) (Wilkinson 2002:190-191). Willibald in the first half of the eighth century saw a church raised on stone piers, as well as the same wooden cross in the middle of the river. All these accounts coincide between them in their descriptions and are confirmed by the remains found at the site, in particular the church on piers, the steps leading to the cruciform baptistery in the river, and the Chapel of the Mantle.

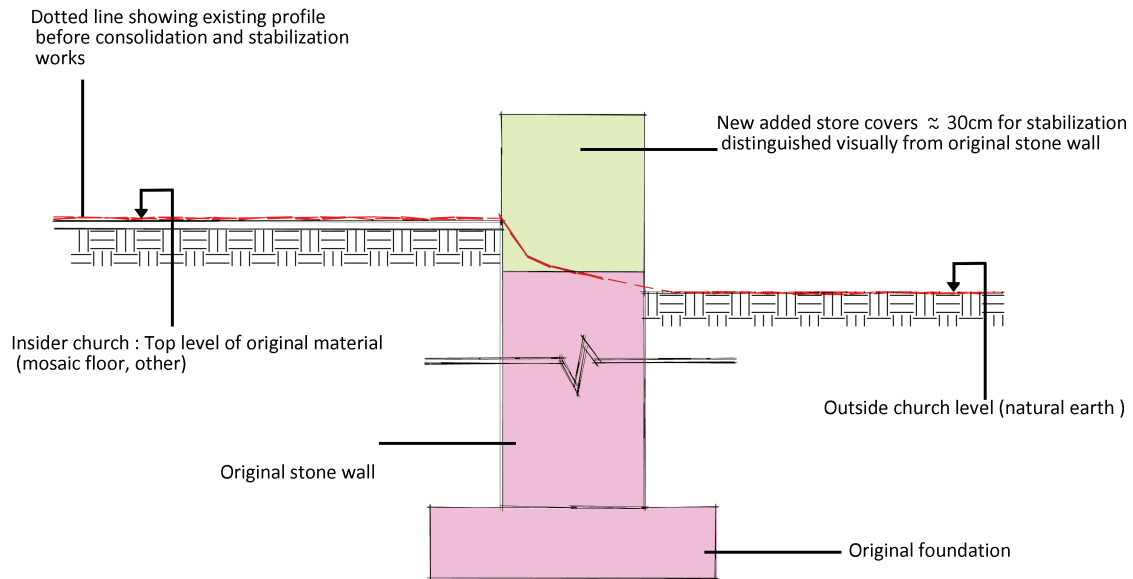
Figure (3): Approach for Consolidation Stabilization works

Approach for Consolidation Stabilization works

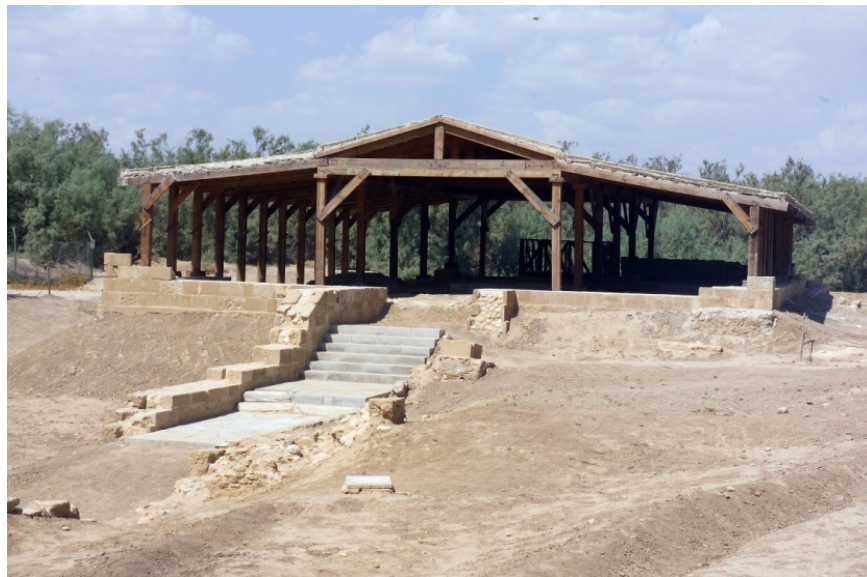
Image (159): The Basilica from the east after restoration and the addition of a protective shelter

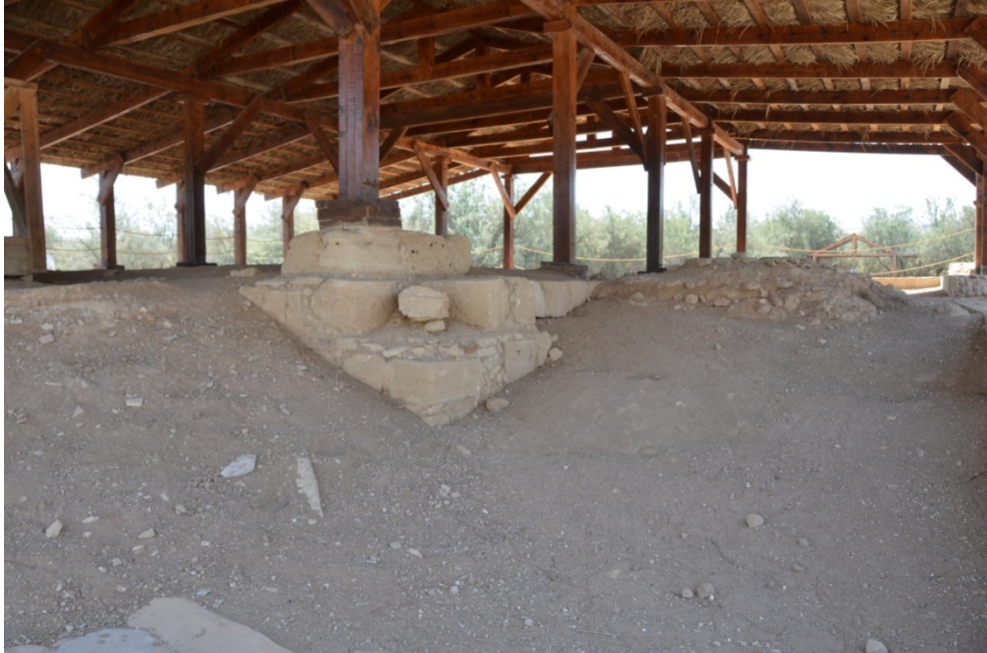
Image (160): The basilica after the addition of a Protective Shelter

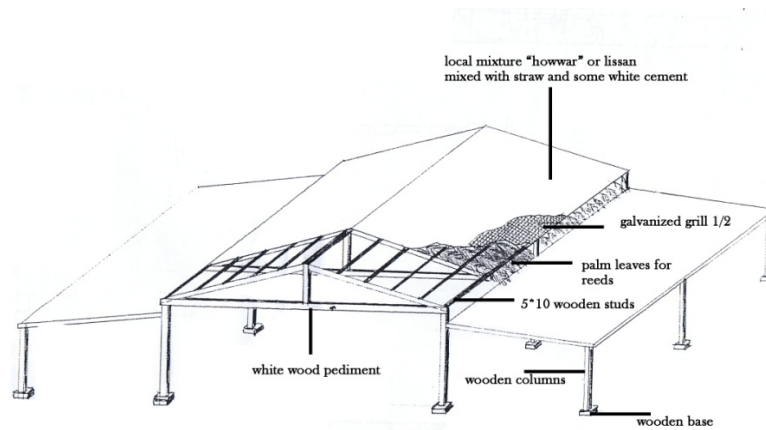
Figure (5): An Illustrative drawing explaining the details of the protective shelter the Upper Basilica within the complex of "St John the Baptism" Area

An Illustrative drawing explaining the details of the protective shelter the Upper Basilica within the complex of "St John the Baptism" Area

These shelters were not (by any means) considered as attempts for reconstruction, but rather a level of intervention that falls within the approach of stabilization and minimal intervention. Furthermore, these protective shelters are affordable and sustainable, contrary to other examples of protective shelters in other Jordanian archaeological sites that were extremely expensive and needed continuous maintenance which was high-tech and not affordable. The local community was involved in the building of these protective shelters gaining a sense of ownership and stewardship with the Site.

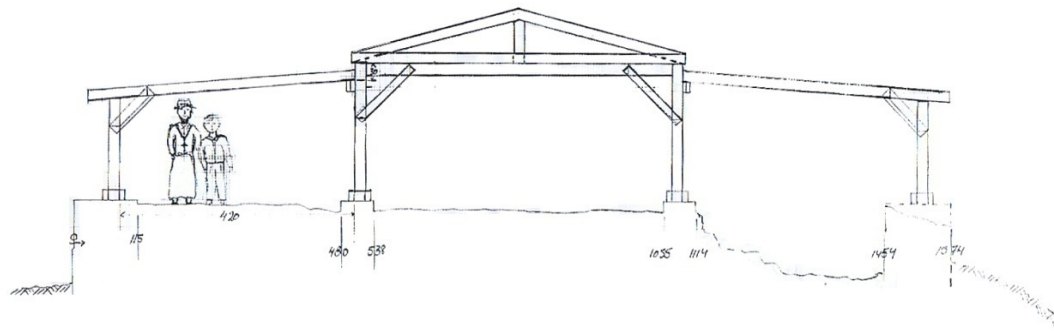
Figure (6): Section through the shelter looking east

Section through the shelter looking east

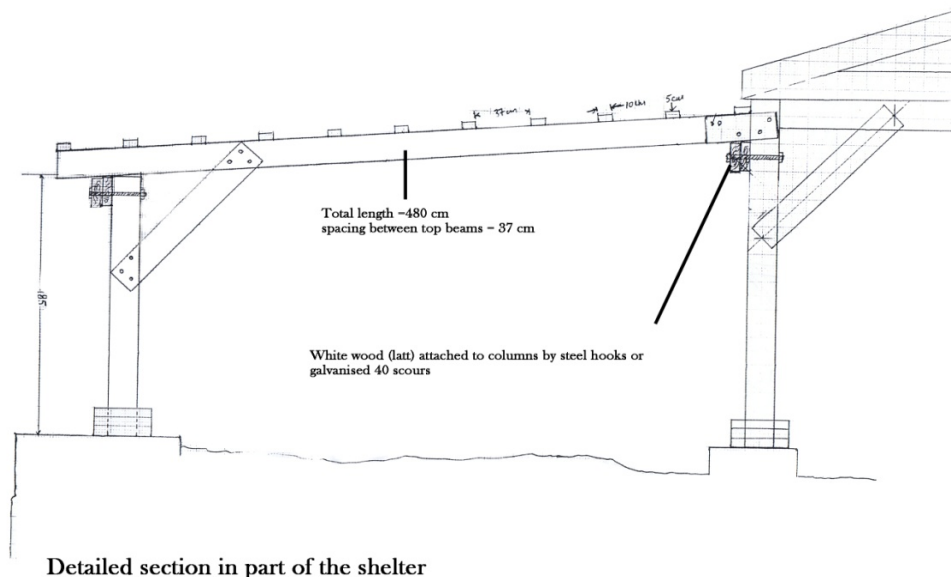
Detailed section in part of the shelter

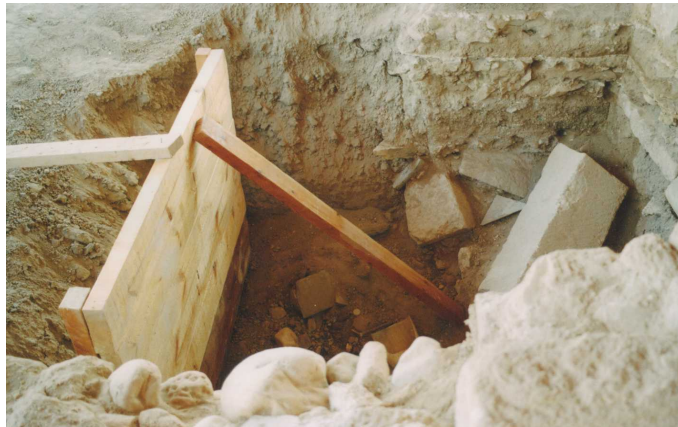
Image (183): A Wooden Retaining Wall Being Built

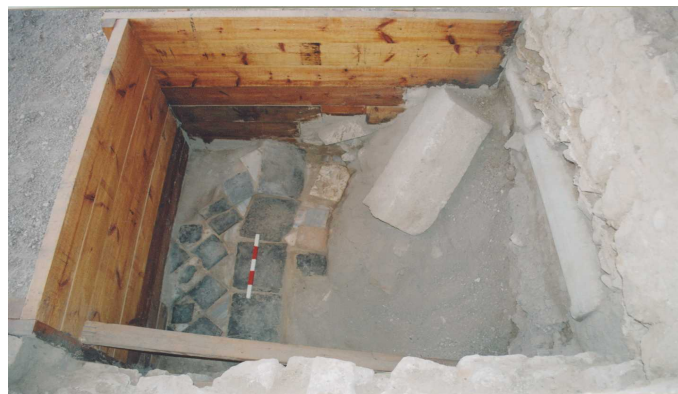
Image (184): The Floor of the Lower Basilica after it has been Preserved and Protected

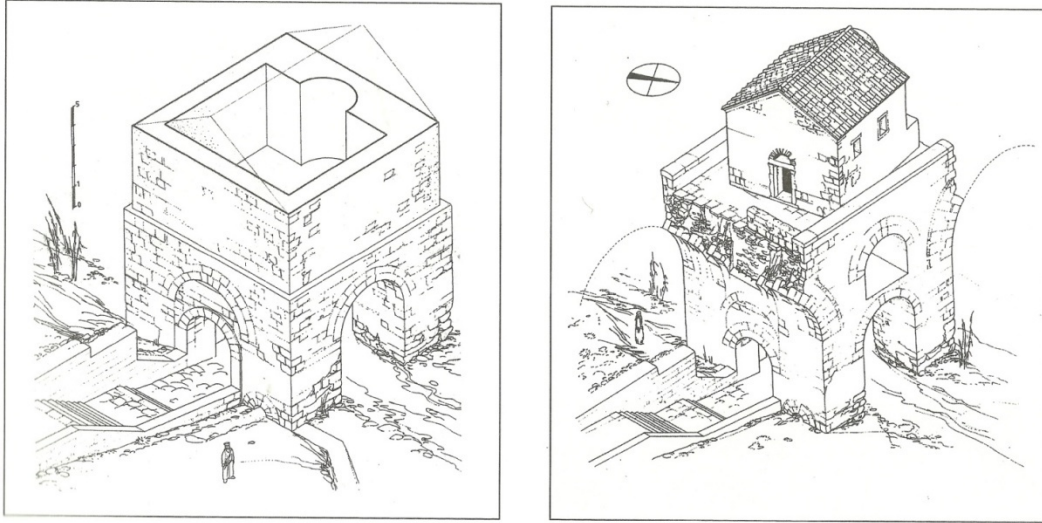
Image (186): Hypothetical reconstruction of the “small chapel” church built on the piers of an older, ruined bridge over Wadi Al-kharrar (drawing by Chrysanthos Kanellopoulos)

- Floods and/or earthquakes had destroyed whatever superstructure the four piers carried, and debris filled the area. Archaeologists reconstruction rendering assume that the 4 piers were the foundation of a mantle chapel that stood over the 4 piers and no longer exists today. After the destruction of the Mantel Chapel, a small chapel was built on the ruins of the NW base (pier).
- The baptistery area below the structure of the four piers was no longer in use.
- The staircase had partially collapsed and was covered by alluvial deposits.
