## Monitoring, Periodical Review & Revision

Baptism Site “Bethany Beyond the Jordan” (Al-Maghtas)/ Additional Information  
3<sup>rd</sup> November 2014

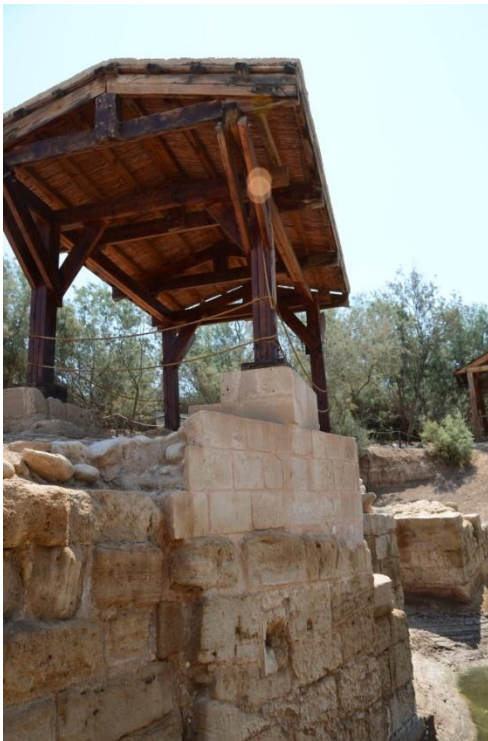
**Image (102):**Eastern part of monastery walls after intervention

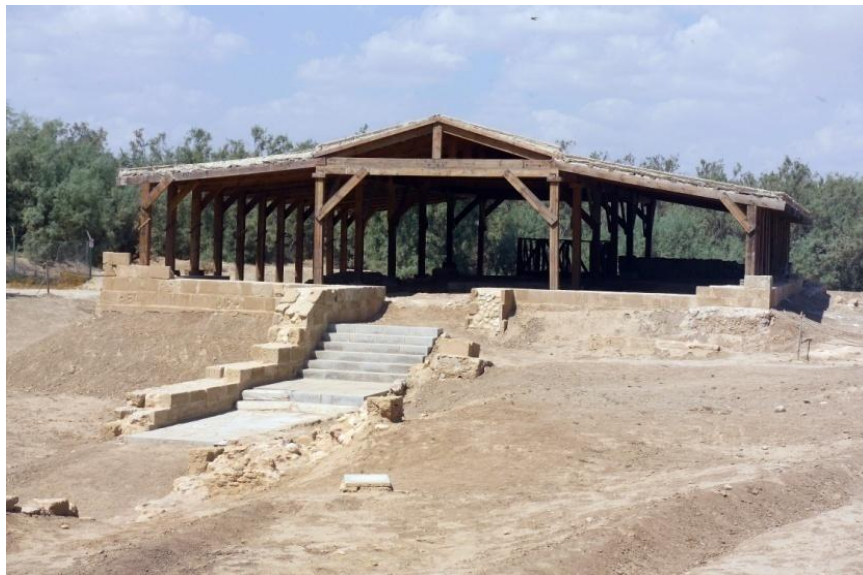
**Image (158):** Reversible wooden columns (lower part of the Protective Shelter)

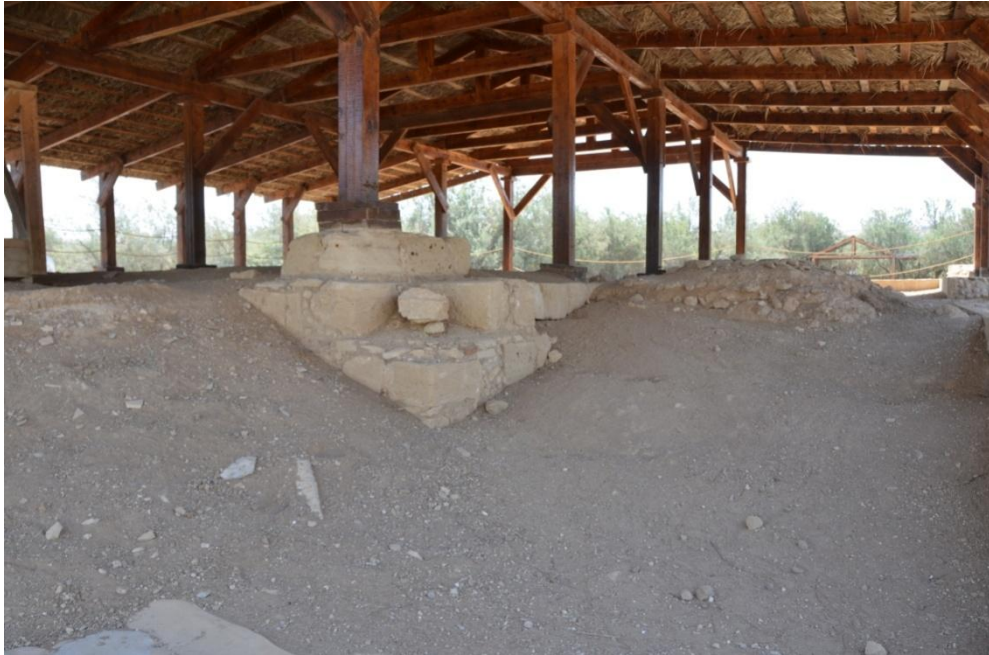
**Image (159):** The Basilica from the east after restoration and the addition of a protective shelter

These shelters were not (by any means) considered as attempts for reconstruction, but rather a level of intervention that falls within the approach of stabilization and minimal intervention. Furthermore, these protective shelters are affordable and sustainable, contrary to other examples of protective shelters in other Jordanian archaeological sites that were extremely expensive and needed continuous maintenance which was high-tech and not affordable. The local community was involved in the building of these protective shelters gaining a sense of ownership and stewardship with the Site.

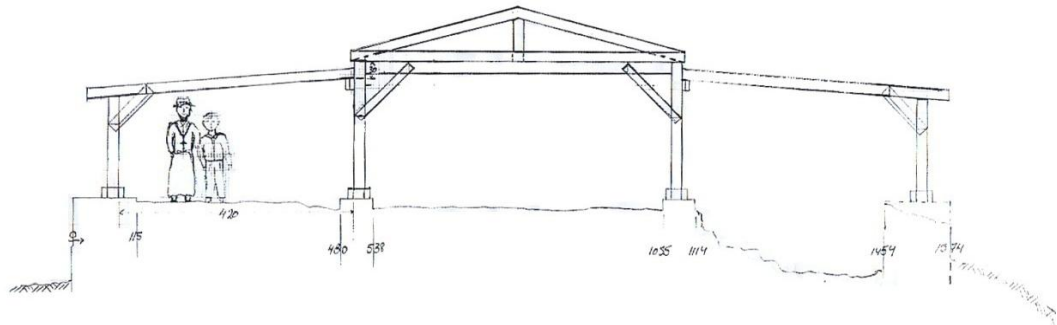
**Figure (5):** An Illustrative drawing explaining the details of the protective shelter the Upper Basilica within the complex of "St John the Baptism" Area

An Illustrative drawing explaining the details of the protective shelter the Upper Basilica within the complex of "St John the Baptism" Area

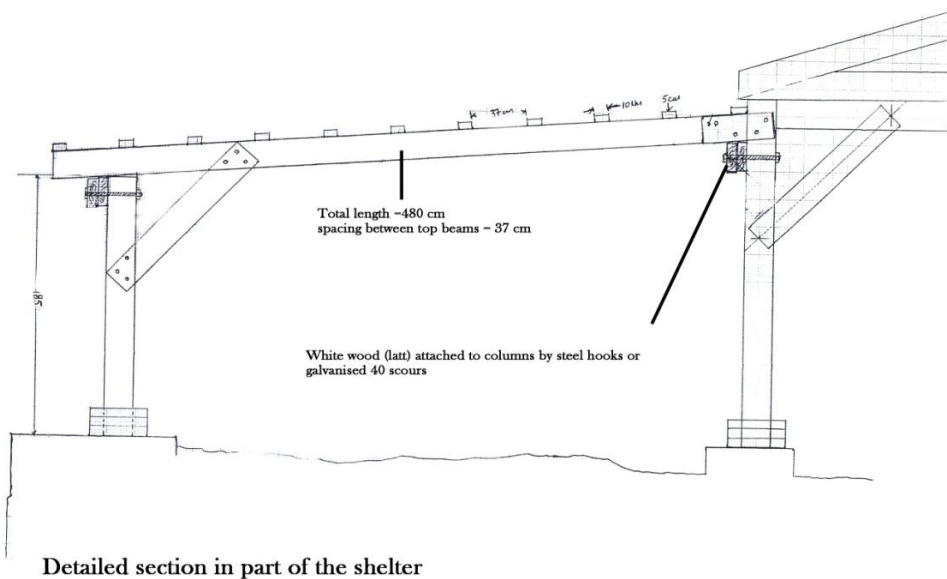
**Figure (6):** Section through the shelter looking east

Section through the shelter looking east

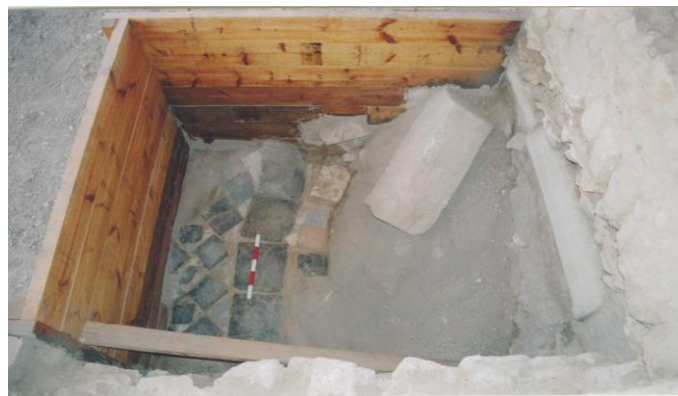
**Image (183):** A Wooden Retaining Wall Being Built

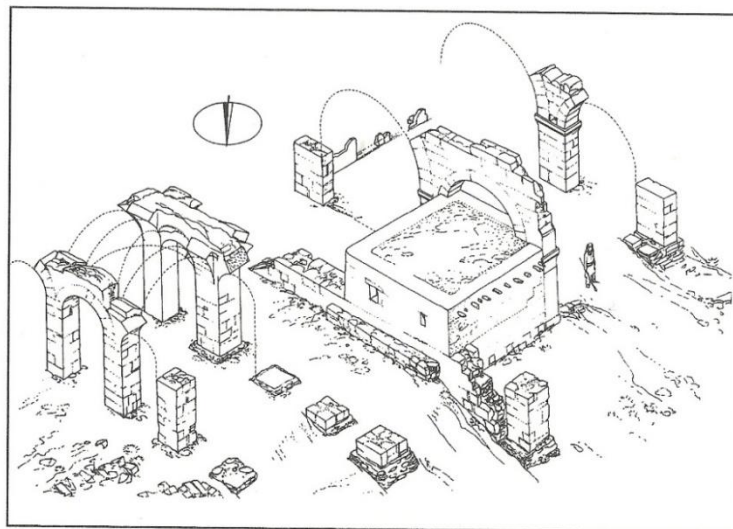
**Image (186):** Hypothetical reconstruction of the “small chapel” church built on the piers of an older, ruined bridge over Wadi Al-kharrar (drawing by Chrysanthos Kanellopoulos)

In the center of the chancel screen there is a reused white marble capital with sandstone ashlar around it. The architects made use of the best-preserved pier (the NW pier) as the main foundation for the Chapel. But it is important to note that the chapel was not built parallel to the pier walls. In other words, the Chapel is oriented almost exactly east-west, and was larger than the pier (Mkhjian & Kanellopoulos 2003, p 15). Hence the following can be deduced:

- Floods and/or earthquakes had destroyed whatever superstructure the four piers carried, and debris filled the area. Archaeologists reconstruction rendering assume that the 4 piers were the foundation of a mantle chapel that stood over the 4 piers and no longer exists today. After the destruction of the Mantel Chapel, a small chapel was built on the ruins of the NW base (pier).
- The baptistery area below the structure of the four piers was no longer in use.
- The staircase had partially collapsed and was covered by alluvial deposits.
