# Ministry of Culture, Tourism and Antiquities State Board of Antiquities & Heritage International Organizations Department State of Conservation report

#### Samarra

**Decision 44 COM 7A.8**

Baghdad Jan.2022

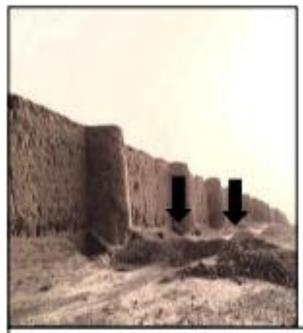
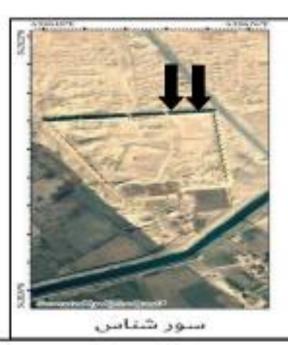
A bombing car blast used by terrorists close to (Ashnas Wall) in Arabic (Sur Ashnas), on February 28, 2015, caused a great damage to the ancient wall (figure 1).

Image and figure show the location of Ashinas and the damage caused by the blast close to it (n. 1)

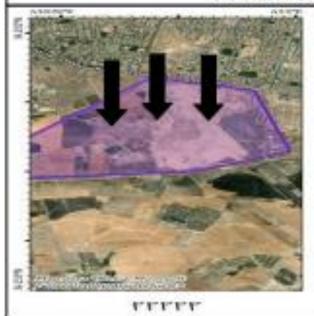
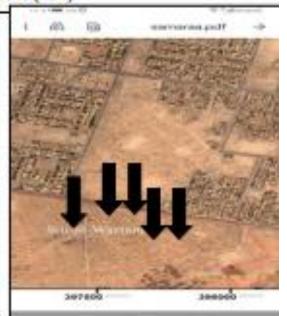
- 1- 22/ Al-Jubairiya district, where a large land was bulldozed and converted into residential area.
- 2- Another bulldozing took place in the 23rd district of al-Qadisiyyah Octagonal Fort.
- 3- Inside al-Manqur Palace (Image 5).
- 4- Part of the outer wall in the southwest side of Sur Esa(figure 6).
- 5-30/Zangour (Archaeological Tells and monuments adjacent to the river).
- 6- Inside and outside the Mutawakiliya Palaces complex.
- 7- Al-Isba'ain archaeological site (figure 2,3,3).
- 8- Al-Istablat site, bulldozing carried out by farmers (figure 7).

Image illustrates (22 al-Jubairia) site before and after bulldozing

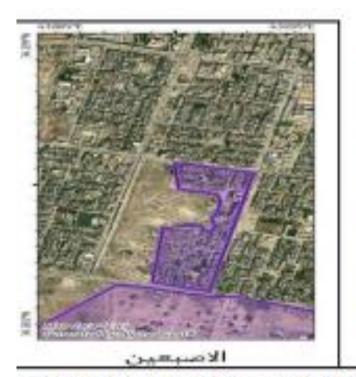
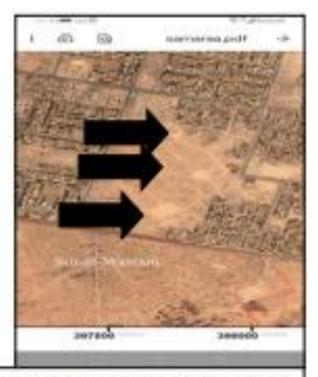
(figure 3) shows the location of al-Istablat and encroachments upon the site caused by people in 10 years that increased in the last five years

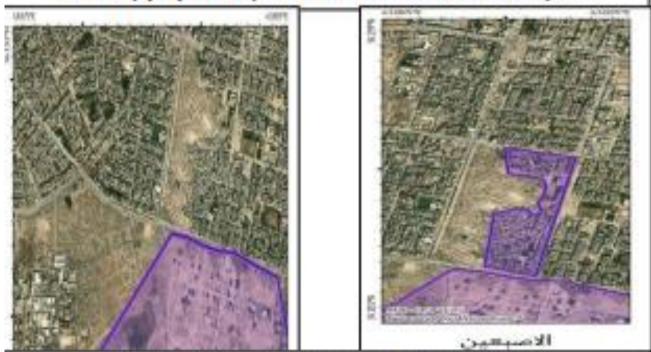
(figure 4) showing the location and land grabbing

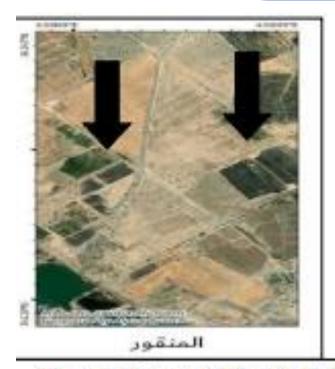
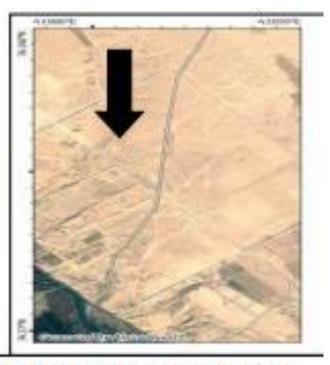
(figure 5) illustrates al-Mankoor Palace (Belquara Palace) location before and after land grabbing caused by farmers

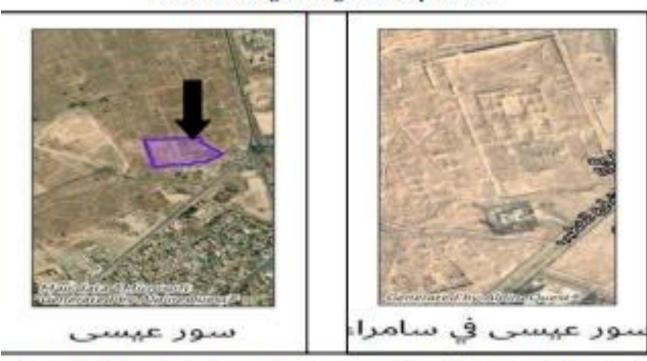
(figure 6) illustrates Esa Wall (Sur Esa) before and after bulldozing

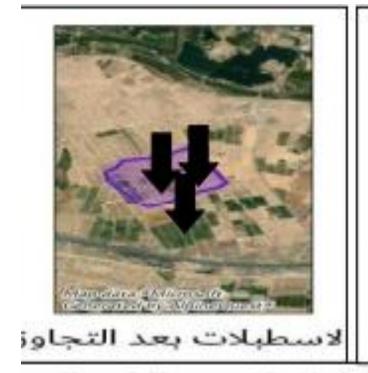
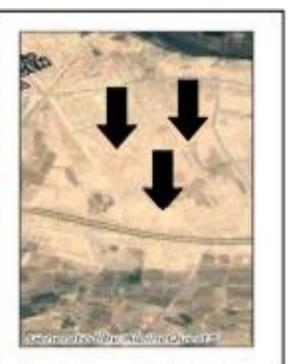
(figure 7) illustrates al-Istablat location before and after land grabbing

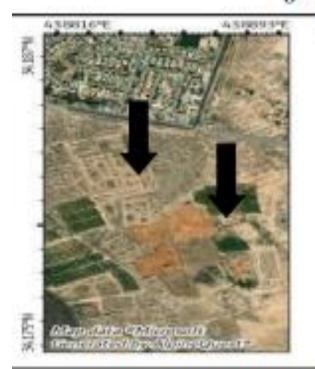
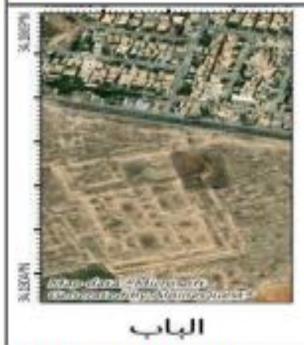
a-The central wall, which is located in 22 al-Jubairiya section, needs an urgent salvage excavation due to the large number of encroachments upon the perimeter of the Tell and on the Tell itself (Image 8).

(figure 8) al-Wastani Gate and the crabbing close to it

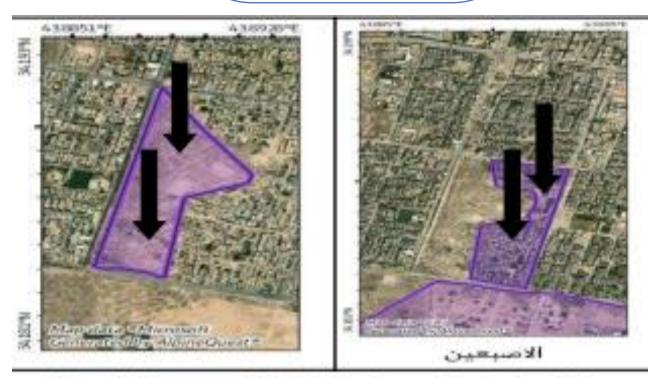
b- Al-Isba'ain archaeological site needs an urgent salvage excavation due to the large number of encroachment upon it (Image 9)

(figure 9) illustrates al-Isba'ain section and the land grabbing

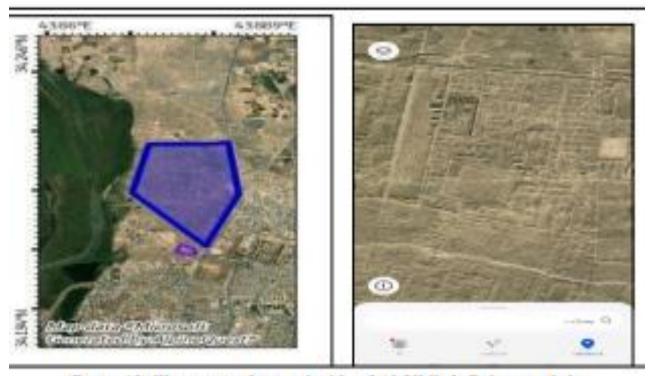
d-The area extending to the south of the Caliphal Palace (Qasr Alkhalipha), with an estimate area of 2500 m and a width exceeding 2 km, is in need of excavations for that it includes a group of important palaces and ancient buildings. Being a major destination for tourists, the Great Mosque (Al Malwiya) with its annexes are in need to continue excavations and so the rest of the Caliphal Palace annexes. More Samarra sections like Tell Toukan, Ashnas Wall (Sur Ashnas), Shaikh Wali Wall (Sur Shaikh Wali), Abu Dulaf Mosque, Al-Ja'faria Palace are in need of excavations for many reasons like reveling facts, studying, knowing the historical period ...etc. (Image 9-10).

(figure 10) illustrates, the south side of Al-Khilafa Palace and the archaeological areas in need of excavation

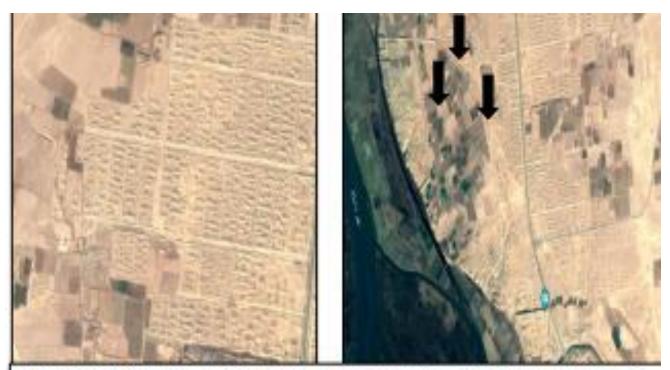
(figure 11) illustrates Shaikh Wali Wall and state offices that is in need of excavation
