# Earthen architecture in today's world

Proceedings of the UNESCO International Colloquium on the  
Conservation of World Heritage Earthen Architecture

UNESCO Headquarters, Room XI – Paris, France

17 – 18 December 2012

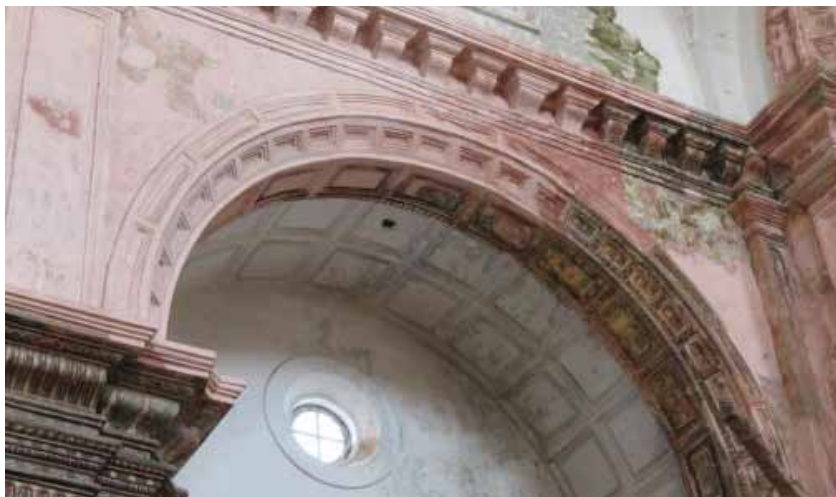
Figure 9: (L) Exposed laterite walls of the Basilica of Bom Jesus showing deterioration of the laterite blocks. (R) Water seepage from the roof affects the wall paintings inside the Church of St Francis of Assisi. © T. Sharma

remarkably intact over the centuries. All conservation works on the protected sites are carried out by ASI. Given the high rainfall and humidity in this tropical area, related problems of water seepage, termite infestation in the timber, and deterioration of exposed laterite can be seen in some of the buildings.

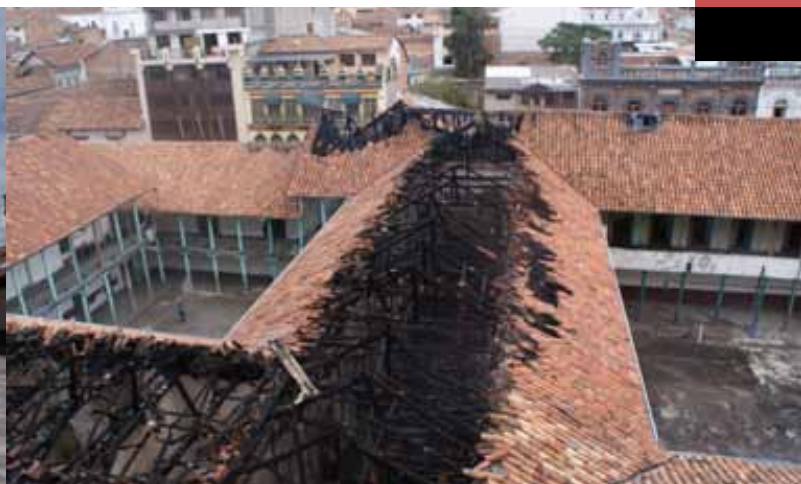
Figure 7: San Luis Seminary, after the fire, August 2012. © María de Lourdes Abad

The lack of economic resources, together with the prohibition against public spending on private holdings, has led to the abandonment of old buildings. These were some of the reasons for the fire that damaged one of the most important historic monuments in the city, the Old San Luis Seminary, noted for its magnitude, its location and its historical significance. The fire destroyed the central part of its roof as well as an interior chapel that contained wall murals and had recently been restored.

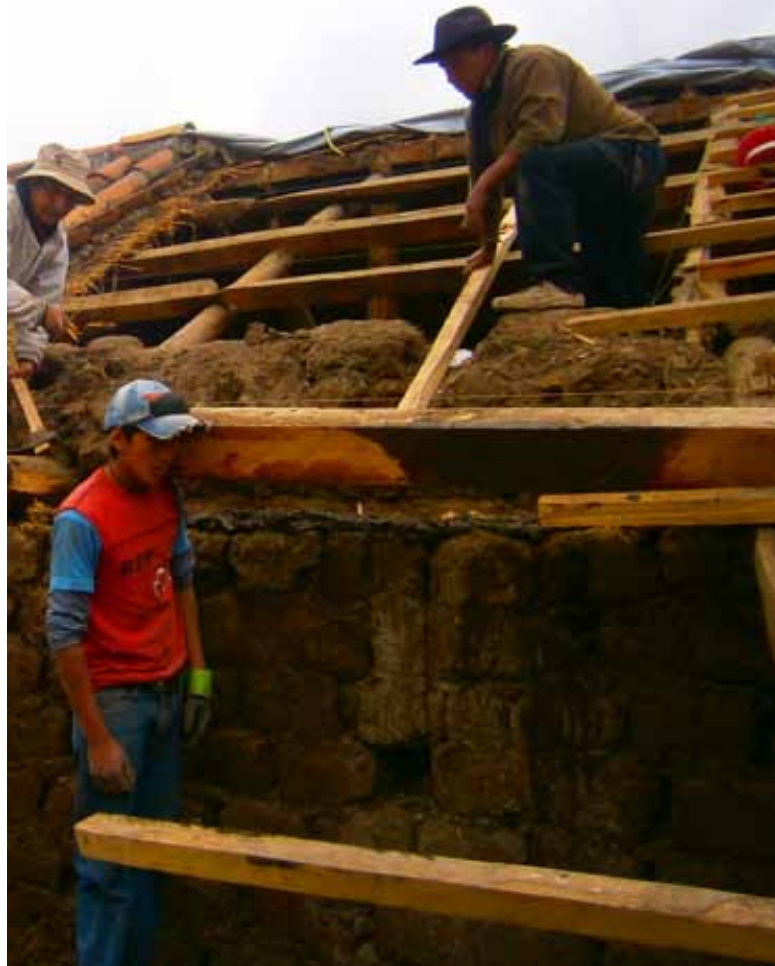
Figure 10: Tile roof with wood, bamboo and mud support structure. © María de Lourdes Abad

Another common problem is that the wooden structures used to hold roofs and floors lack support beams to distribute weight uniformly. This leads to deformations in roofs and floors. The use of bamboo and mud as a base underneath the tile roofs compensates for the deformations in the wooden structures and helps to prevent leaks.

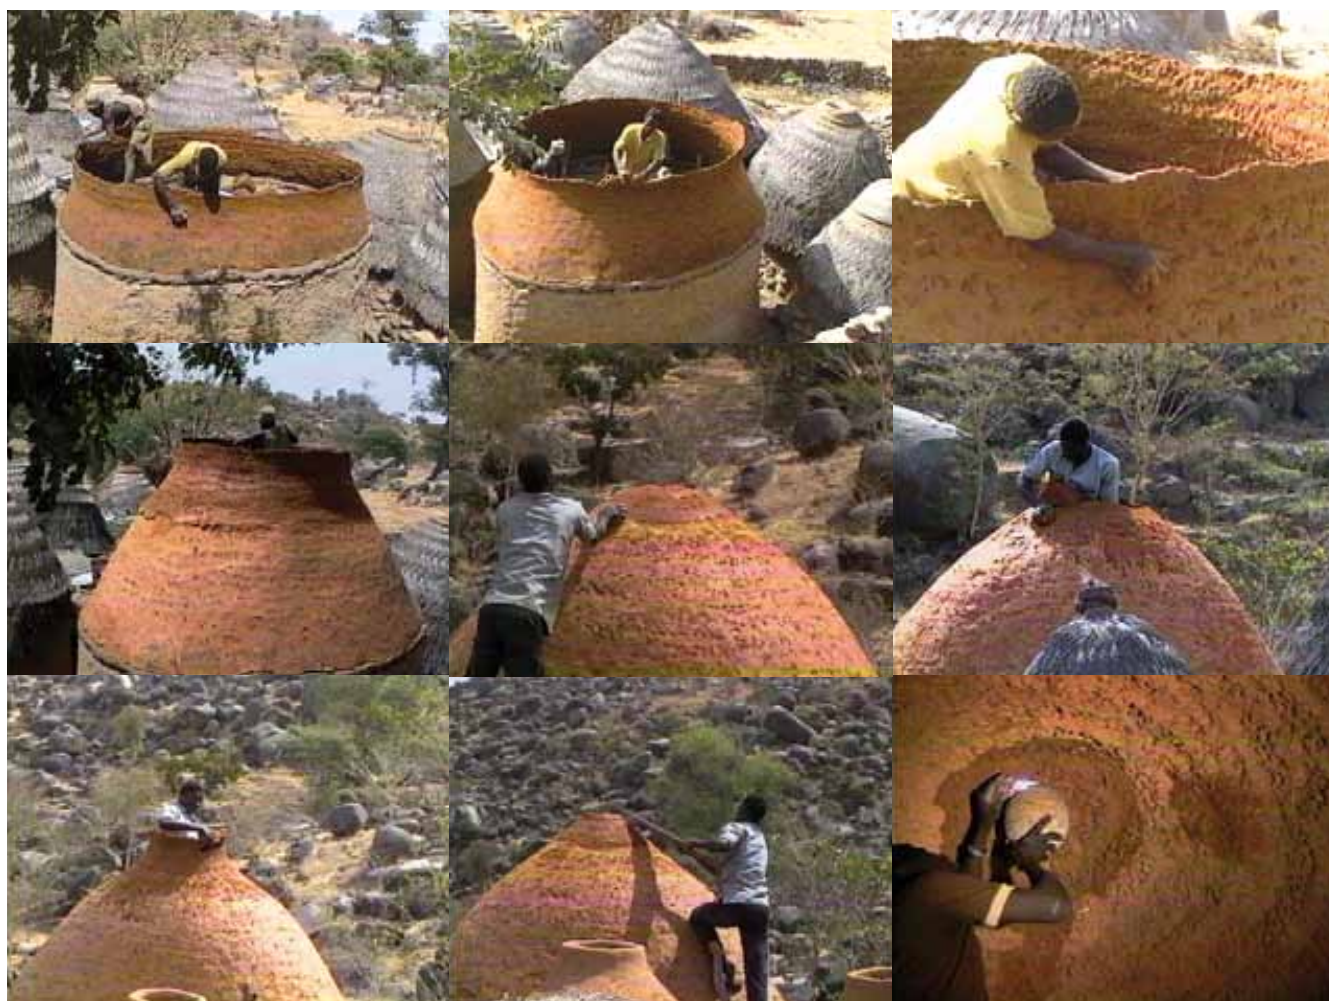
Figure 5: Construction of a Sakun vaulted ceiling, or *huruk*. © David, 2010

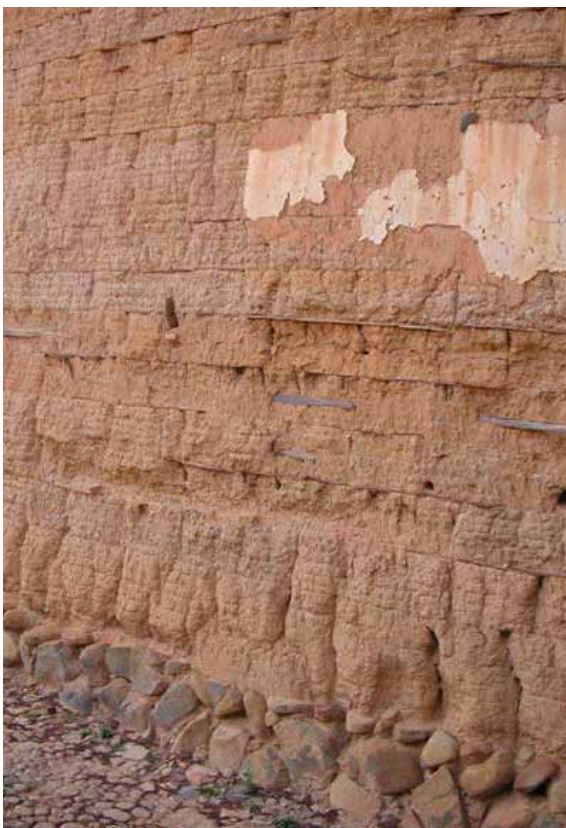
Figure 6: Features of tulou construction: a stone basement wall showing the bamboo wall bones.  
Source: [http://amuseum.cdstm.cn/AMuseum/hakla/image/jianzhuljianzhu\\_082\\_1.jpg](http://amuseum.cdstm.cn/AMuseum/hakla/image/jianzhuljianzhu_082_1.jpg)

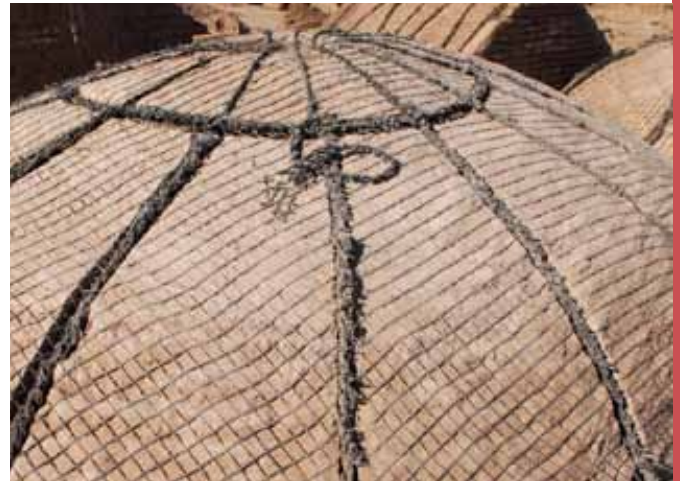
*Figure 1: A dome covered in Geogrid mesh.*

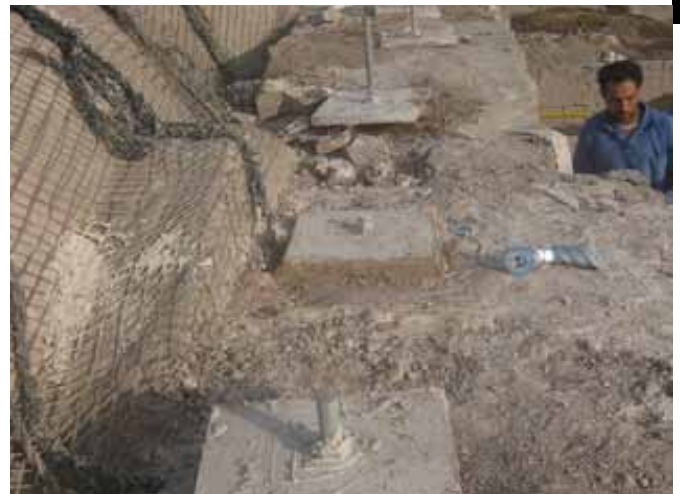
*Figure 2: Strengthening the join between a pillar and an arch with Geogrid mesh and plastic (Teflon) plate.*

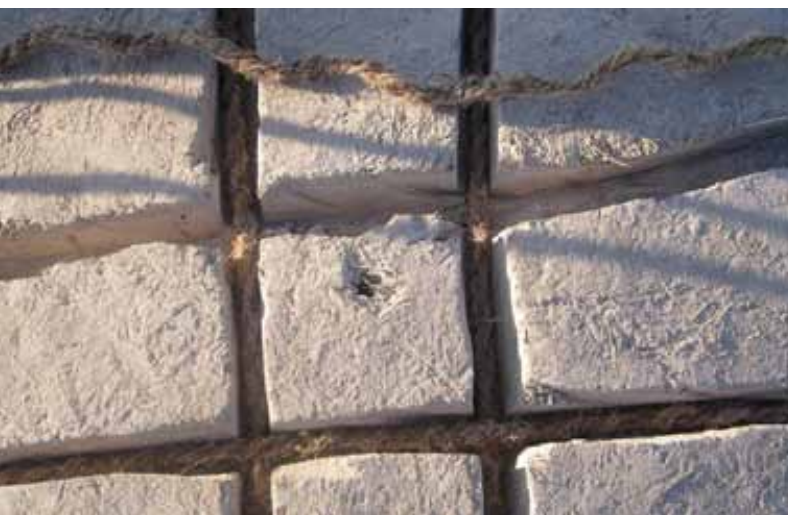
*Figure 5: Detail of strengthening a dome by inserting rope made from palm fibre (SIS).*

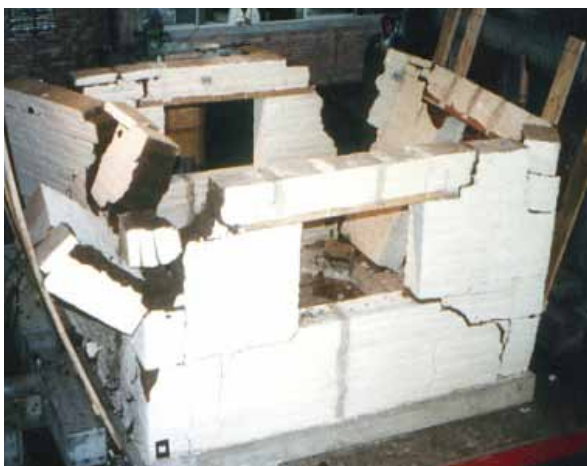
*Figure 4: Module reinforced with a synthetic mesh or geogrid. Total area reinforcement, with half the module plastered. © J. Vargas-Neumann*

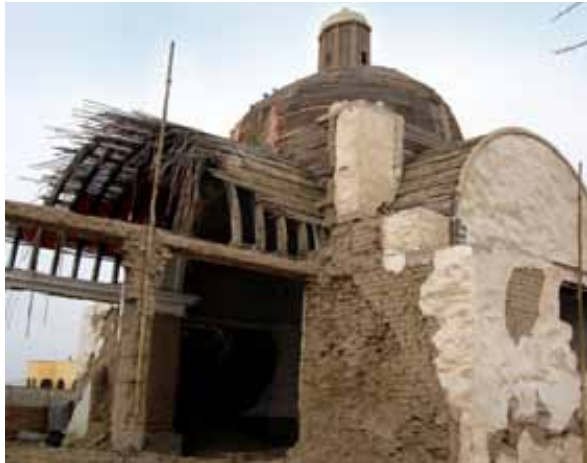
Figure 5: Avoid reinforcements based on beams and reinforced concrete columns, as their different behaviour in earthquake conditions can lead to collapse rather than protect the adobe walls. Damage to the San Luis de Cañete Church in the Pisco earthquake of 2007. © J. Vargas-Neumann
