WORLD HERITAGE LIST

N° 365

Nomination: Khami Ruins

KHAMI RUINS

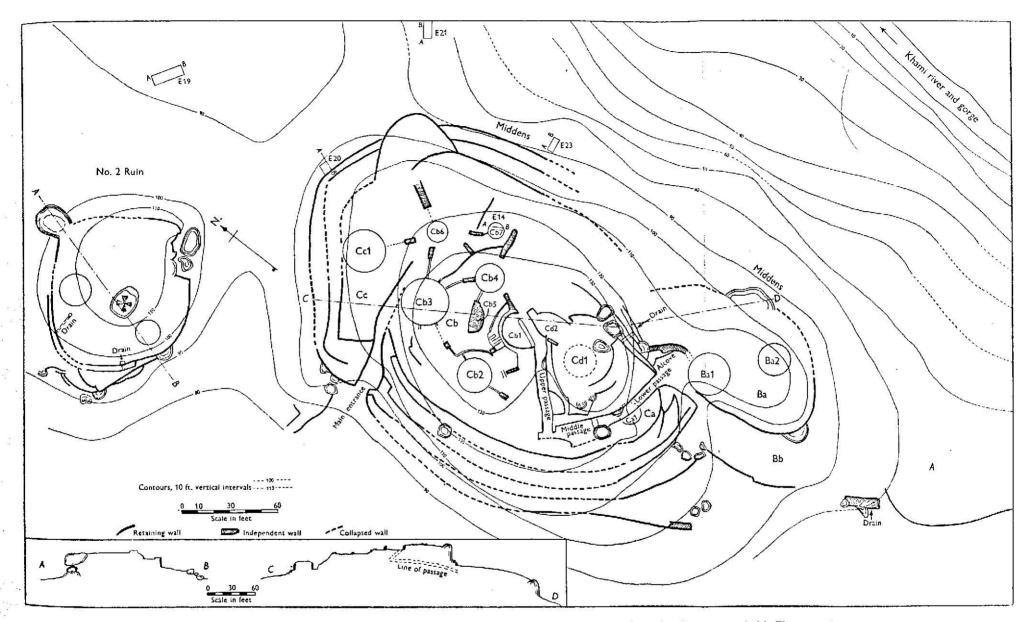
Fig. 3. Plan of Hill Ruin and Cross Ruin (No. 2), and the immediate surroundings. Excavation sections other than those marked in Fig. 13 are shown,

sectors which are clearly differenciated in terms of use. The chief's residence (Mambo) was located toward the north, on the Hill Ruins site, which is a hill created largely of alluvial land used to level the terraces, contained by bearing walls. In this sector some highly significant imported goods were found: 16th century Rhineland stoneware, Ming porcelaine pieces which date back to the reign of Wan-Li (1573-1619), Portuguese imitations of 17th-century Chinese porcelaine, 17th-century Spanish silverware, etc.

There is a possibility that Khami was visited by Portuguese merchants and even missionaries, because a monumental cross consisting of small blocks of granite can still be seen traced on the rocky ground of Cross Hill, a small hillock immediately north of the mambo residence.
