Introduction guide to the preservation of

# Traditional thatching

of the  
Buganda community in Uganda

December 2019

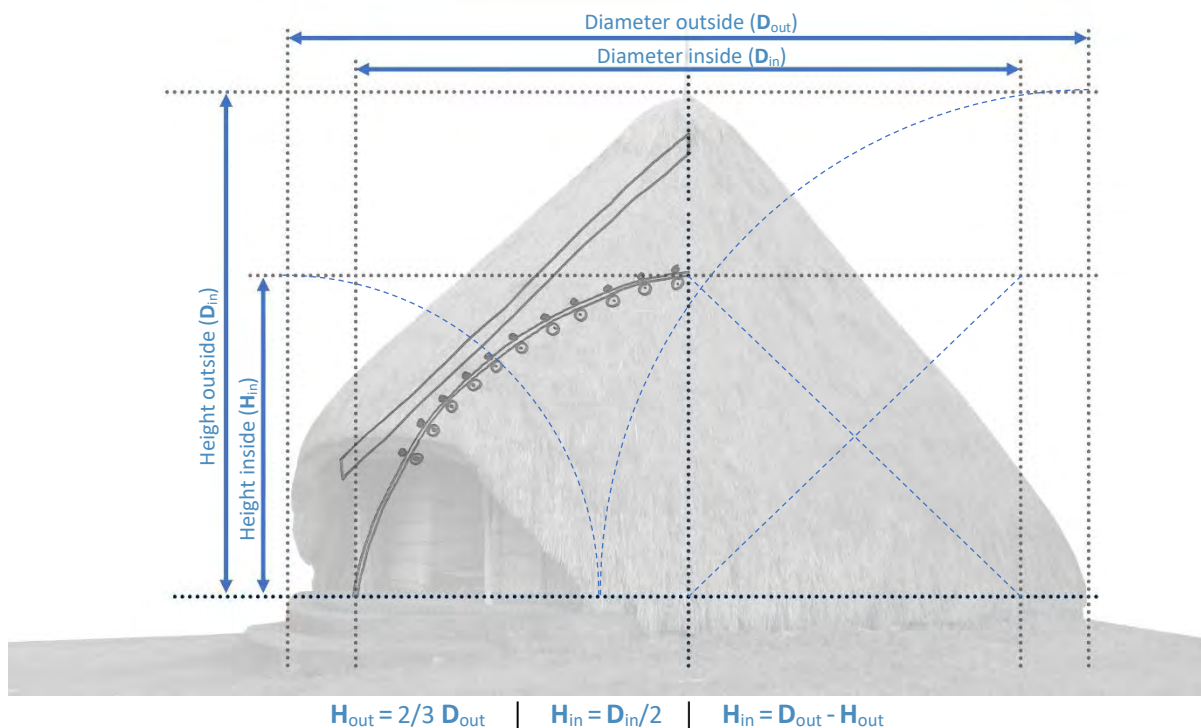
The sketch below shows the common proportions observed on existing roofs.

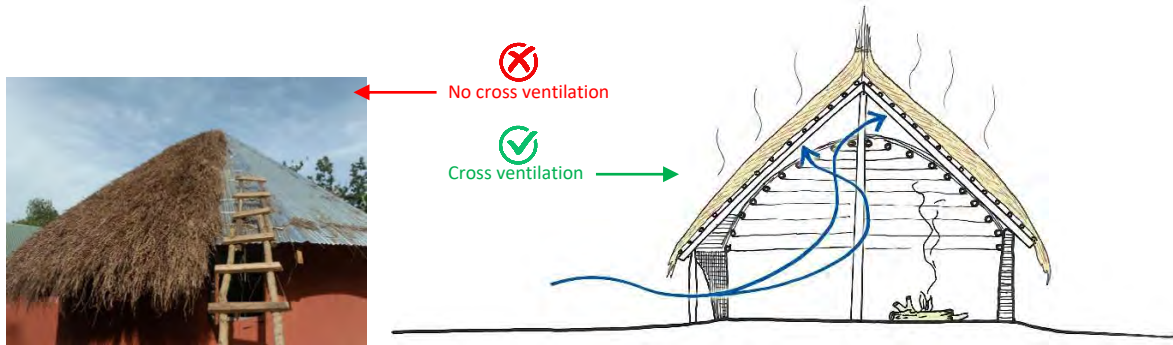
Doubling the thatch with another material to ensure the long-term waterproofing of the roof is tempting. Many builders have tried to lay thatch on corrugated iron sheets, as shown below. These attempts usually give disastrous results because the iron sheets block natural ventilation and accelerate the natural decomposition process of the thatch.

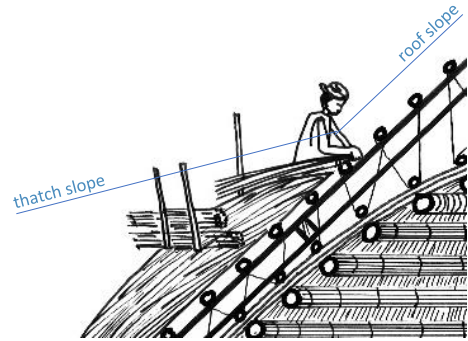
The roof slope has a direct impact on durability and maintenance needs. It should be noted that thatch bundles are positioned with a lower gradient than the final roof slope, as shown in the drawing on the right. If you want the roof to last for long with the lowest possible maintenance, then you should aim for the steepest possible slope.

In financial terms, while it is true that a shallow slope will require less material and cost less to build, it will be ruinous to maintain, because the straw will not be able to dry between rains and serious deterioration will appear very quickly.

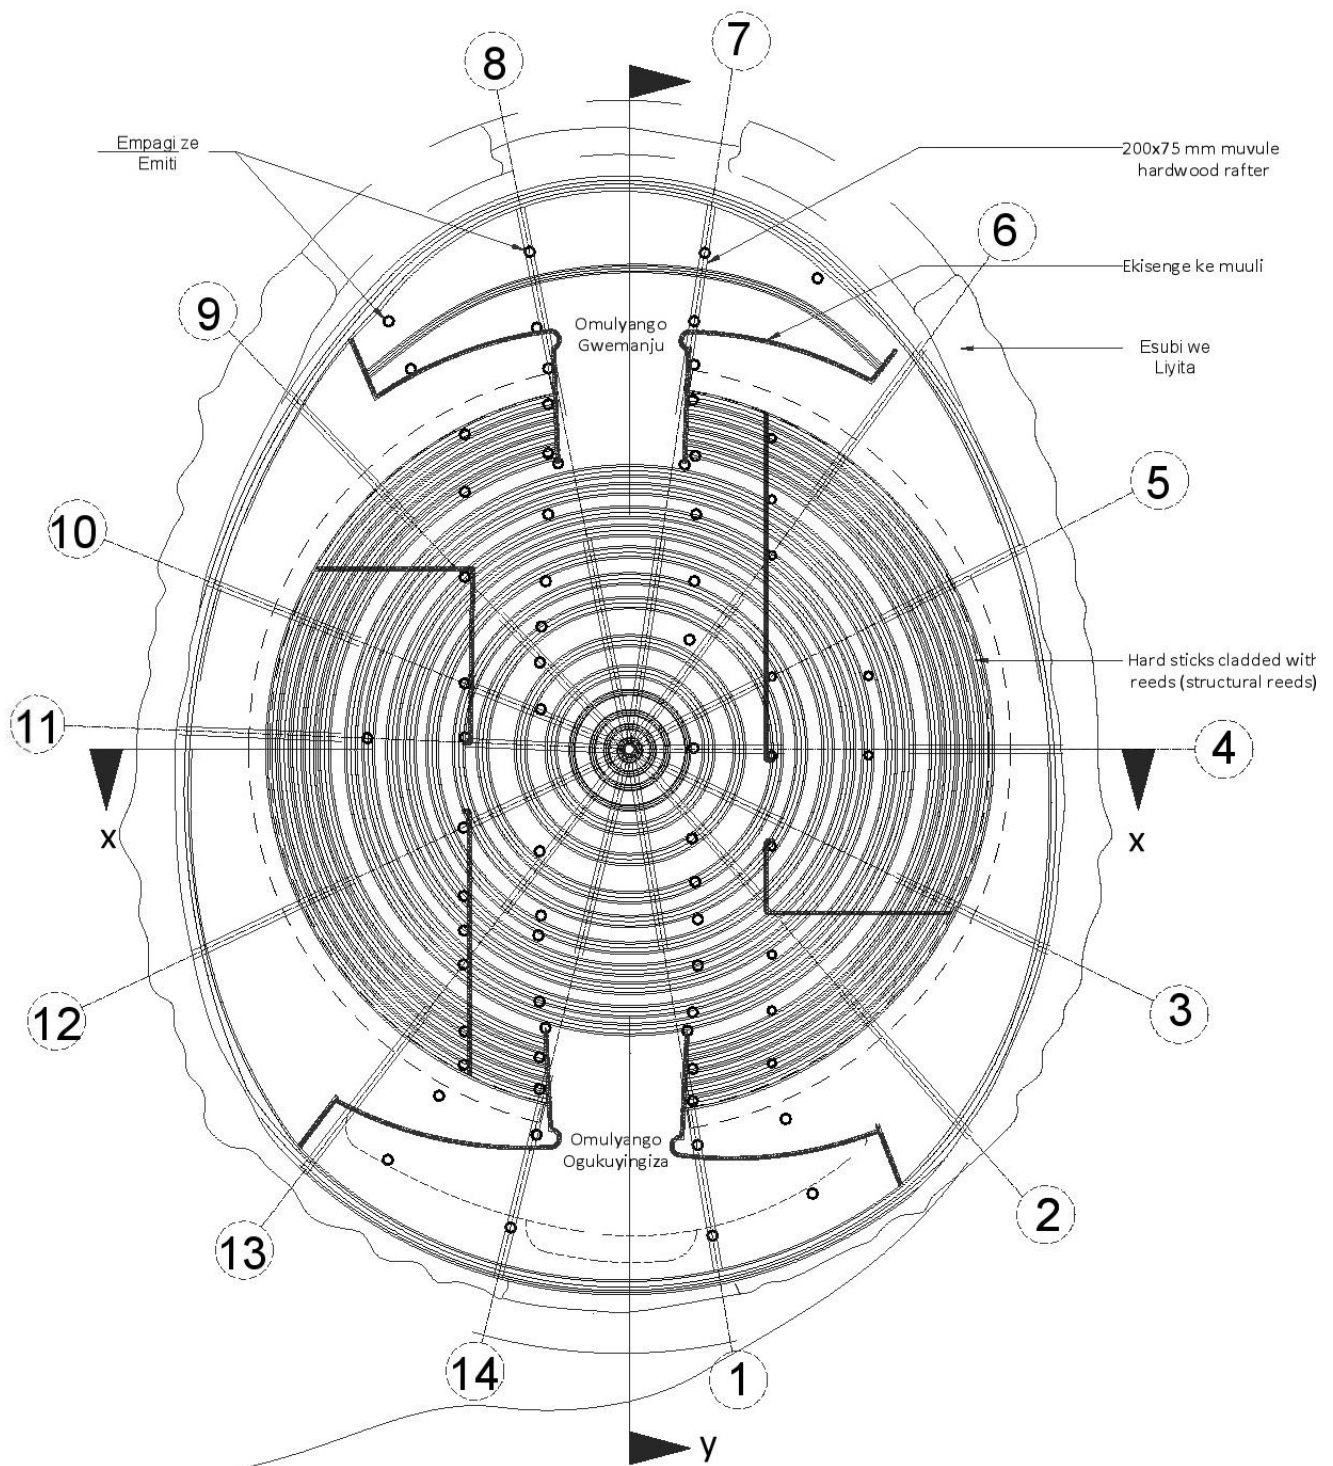
The numbers (1 to 14) refer to the rafters.

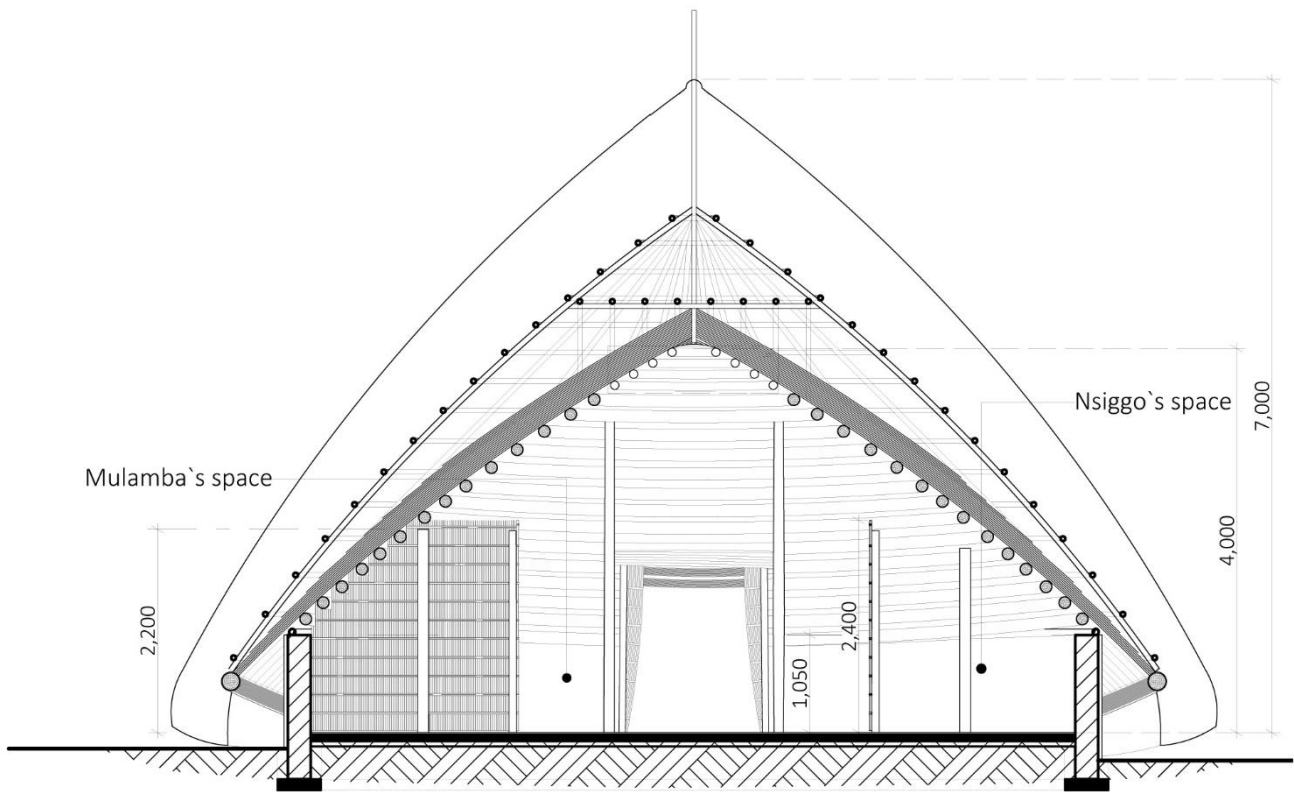
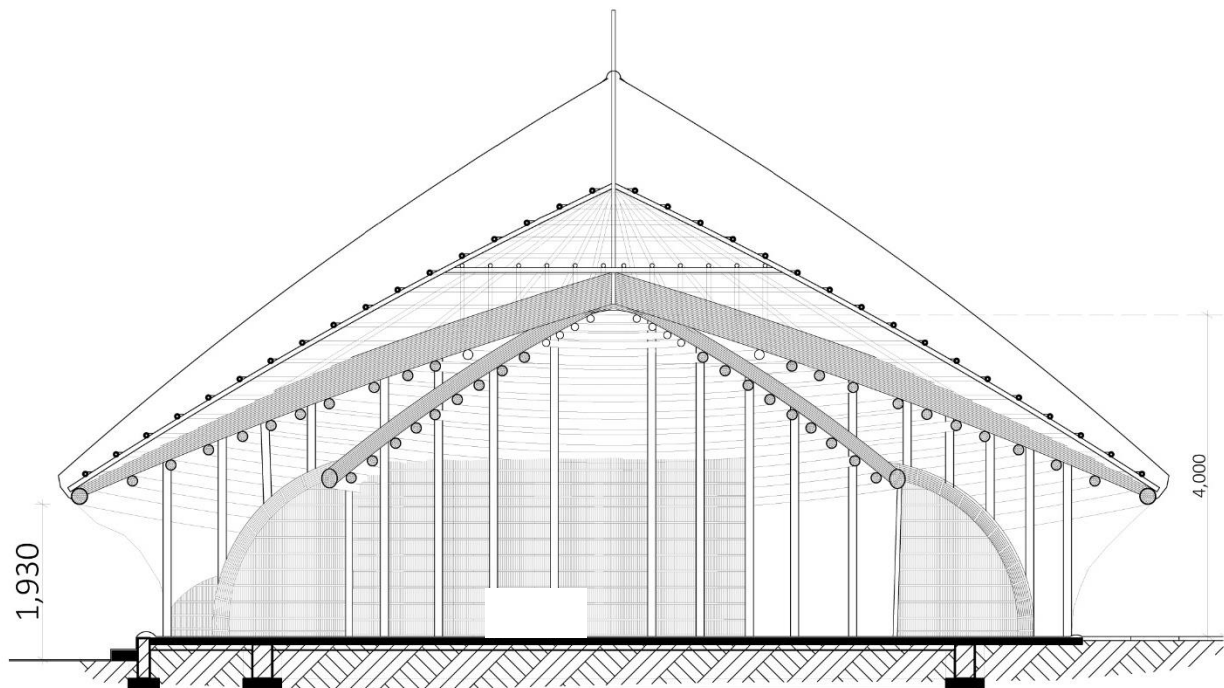
Bujjabukula restoration drawings by Jonathan Nsubuga & Associates

## Sections

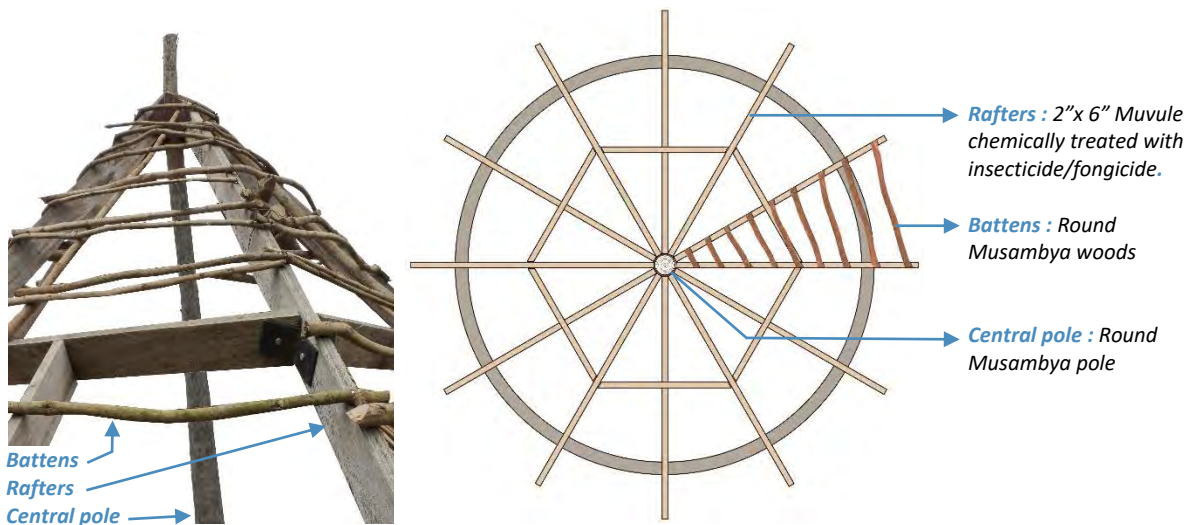
The battens are fixed with 5" nails, but also with binding wires for those that are difficult to bend.

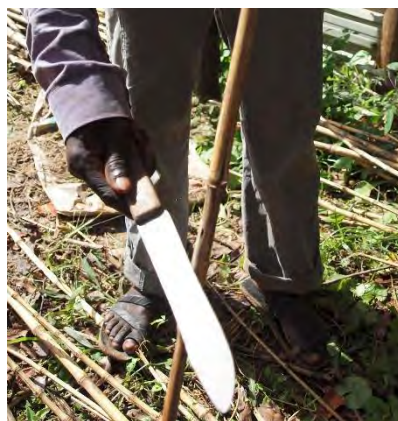
Once the bundles are opened, the reeds are selected to eliminate fragile and partially rotten ones. Then, the reeds are smoothed with a knife blade to remove the remaining leaves attached to the stem but also to smoothen the knots. For the reeds that remain visible (for ceilings or fences), they are polished with sand using a cloth, which makes them smooth and shiny.

Smoothing the reeds with a knife

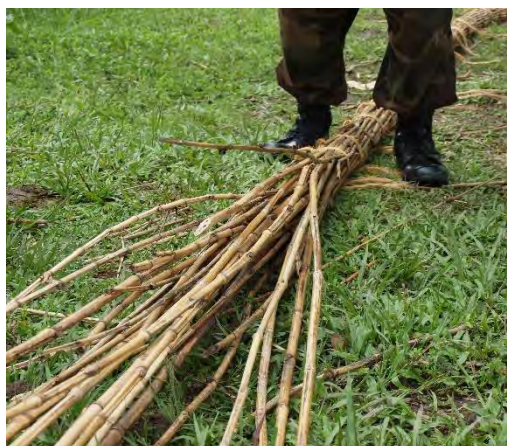
To make the rings, the reeds are tied together with sisal rope. For the visible inner rings, they are covered, once the ceiling is finished, with palm frond sticks (*Amavuvuume*), themselves tied against the rings with water grass rope (*Enjulu*).

Tying the reeds with sisal rope to prefabricate rings

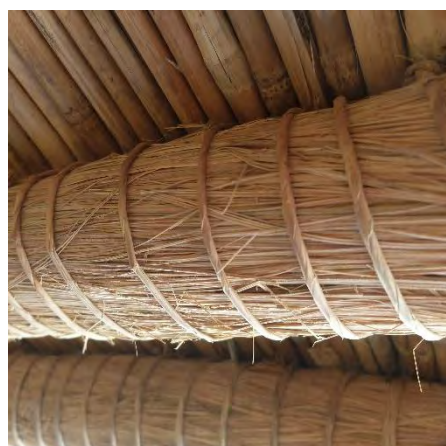
Inner rings covered with palm frond sticks (*Amavuvuume*) tied with water grass rope (*Enjulu*)

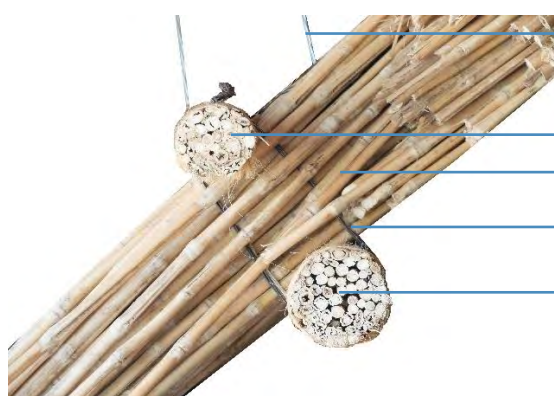
The large lower rings (visible ones) and the smaller upper rings (hidden ones above the ceiling) are tied together to hold the ceiling reeds firmly in place with quadrupled metal binding wires (1 mm). The ceiling itself is held to the roof skeleton with strong metal wires (2 mm).

2 mm metal wire (*doubled*) to tie the ceiling to the roof skeleton

Small upper rings : 20-30 reeds tied with sisal rope

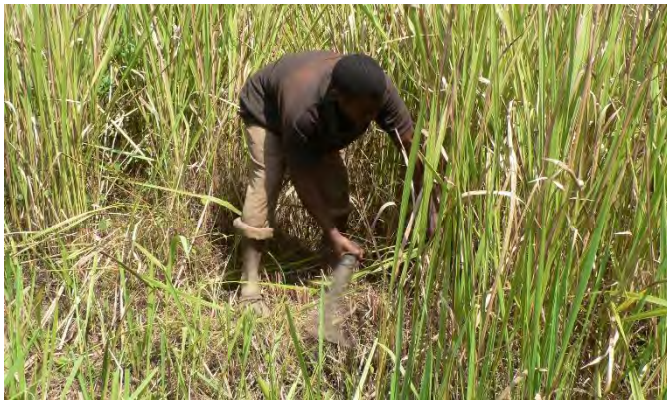
Cutting spear grass at the base

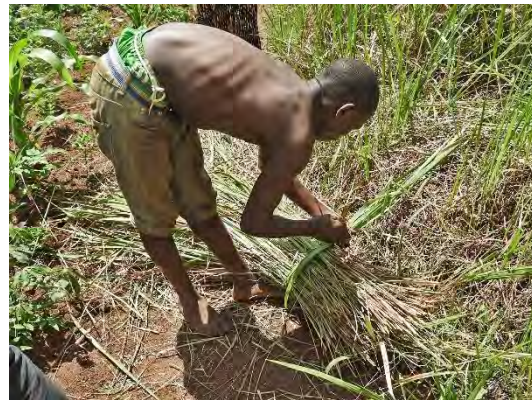
Bundling spear grass in the field

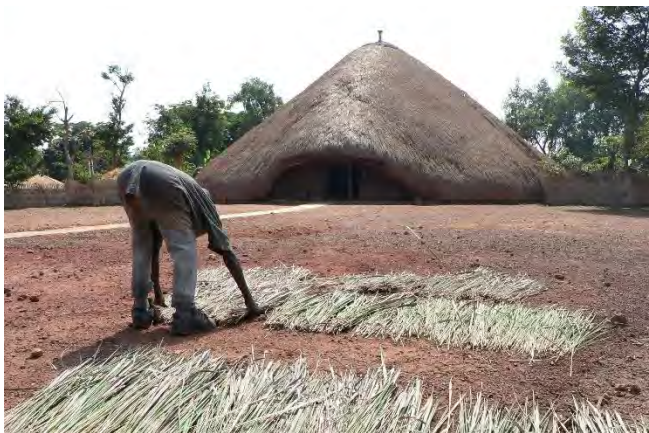
Laying spear grass on the ground for drying and removing unsuitable elements (other plants and broken stems)

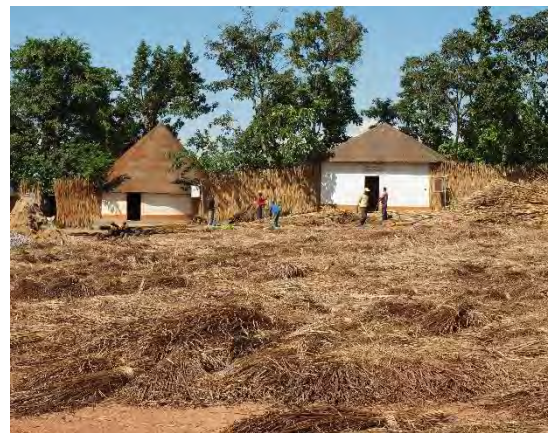
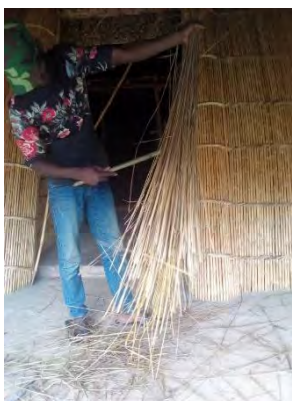
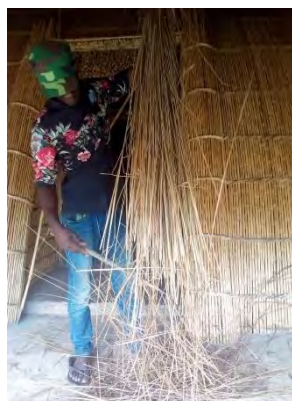
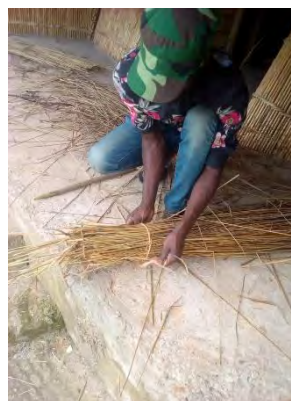
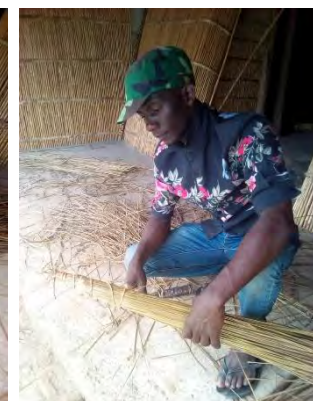
Once on site, the big bundles are sorted out and the good quality spear grass stems are kept to manufacture smaller bundles with a diameter of 5-6 cm. Bigger bundles with a 10-15 cm diameter are also prepared for the base of the roof. The bundles are tied to the battens either with tree bark fibre (*Ebinsambwe*) or with sisal rope. The bundles are then attached to the roof using the same ropes/fibres: sisal or *Ebinsambwe*.

Combing a bundle with a stick to remove unwanted elements and tying the bundle in a conical shape with a sisal rope

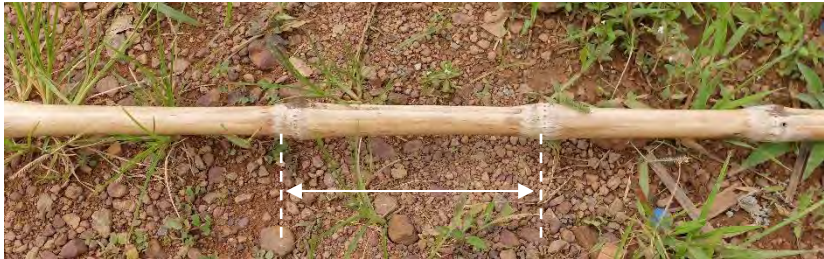
The craftsmen do not use measuring tapes, although they constantly measure elements during the construction process, such as the spacing between the rings to ensure that the circles are perfectly round. According to the thatchers, the eyes play an essential role. The senior thatcher spends most of his time observing the roof from a distance, to ensure that the curves, the spacing between the rings and other details are perfect. Reeds also serve as measuring tools, using the gap between 2 knots as a unit. In that case, all measurements are made with the same reed.

Reeds are used as measuring tools, using the knots as a unit

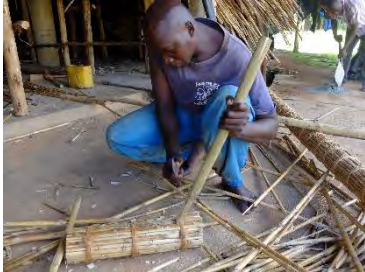
This stick called "*Embwa*", about 70 cm long and 4 to 5 cm in diameter, bevelled at one end, is used by the thatchers for many actions. They make it themselves by pruning a branch of the *Musambya* tree. The tool is used as a lever to adjust the reeds or spread the reeds to pass binding wires. It also serves as a wedge to hold the thatch bundles on the roof slope before installing them or as a grip to climb the roof. They also use the stick to beat the thatch bundles and remove the loose elements such as dead leaves.

Preparing an *Embwa*

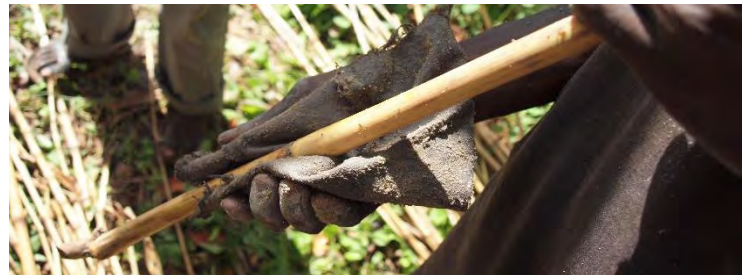
Rags filled with sand are used to smoothen the reeds.

Smoothering reeds with a rag filled with sand

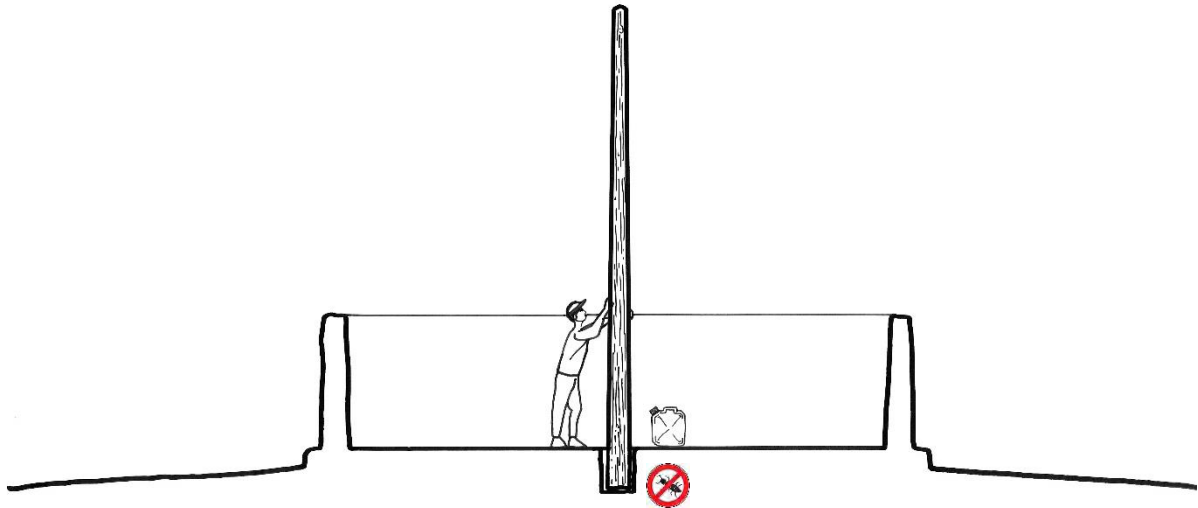
The central pole, made of *musambya* wood is set in a prefabricated hole, sealed in concrete. The hidden base should be treated with insecticide. The installation of the central pole is a strong symbolic act that involves rituals.

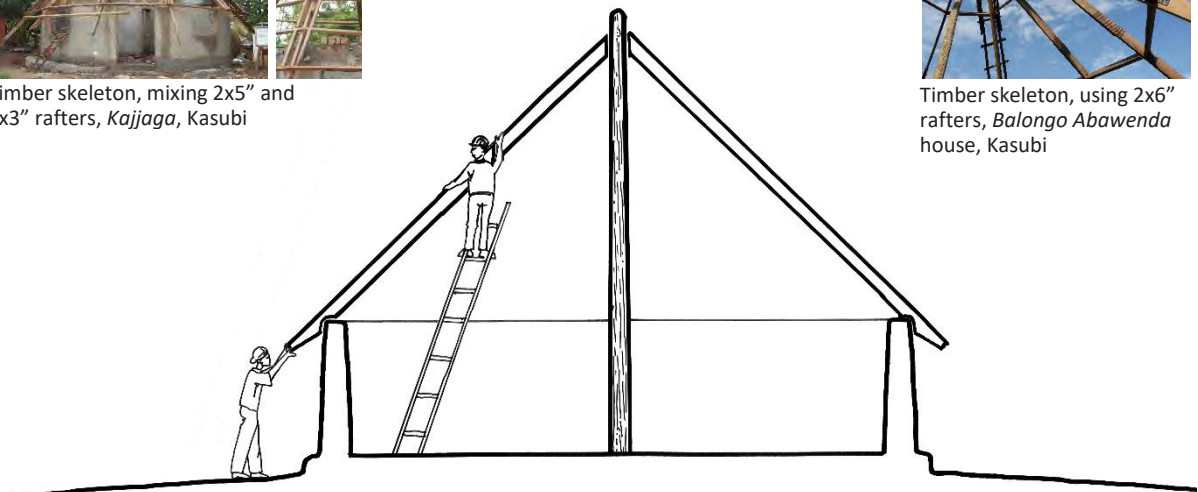
The number and size of the rafters depends on the roof span. The rafters should be resistant enough to carry both the weight of the thatch and the weight of the ceiling. Small structures (6-10 meters diameter) can use ordinary *Muvule* rafters. All wooden rafters are pre-treated against humidity and insects before being assembled.

Timber skeleton, using 2x6" rafters, *Balongo Abawenda* house, Kasubi

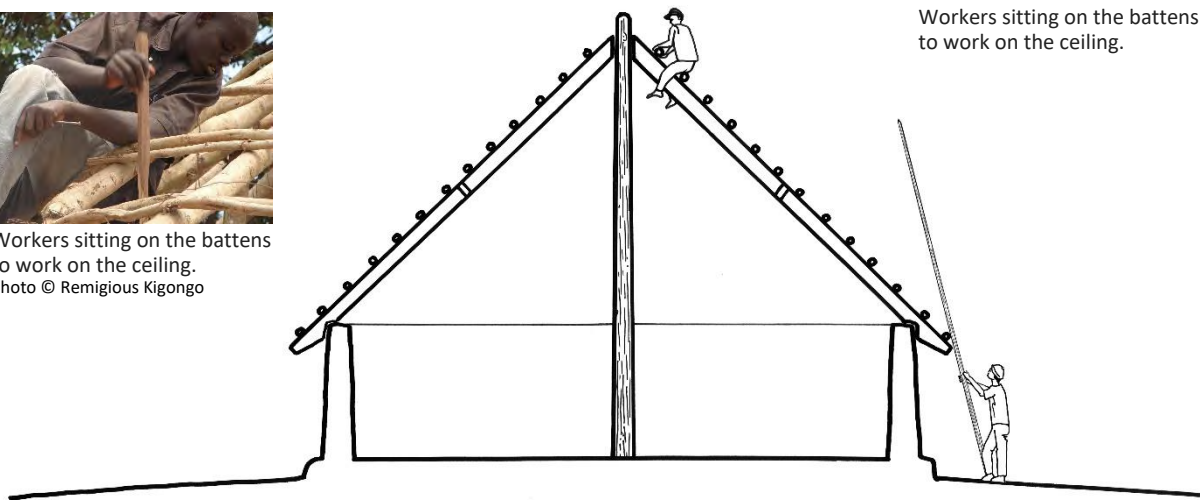
The round *Musambia* battens are nailed onto the rafters with a spacing ranging between 1½-2' (40-50 cm). The spacing should not be too small because the workers on the roof must be able to easily pass the arms to install the suspended ceiling and then install the reeds. They must also be able to pass their legs to sit easily on the battens while working.

Workers sitting on the battens to work on the ceiling.

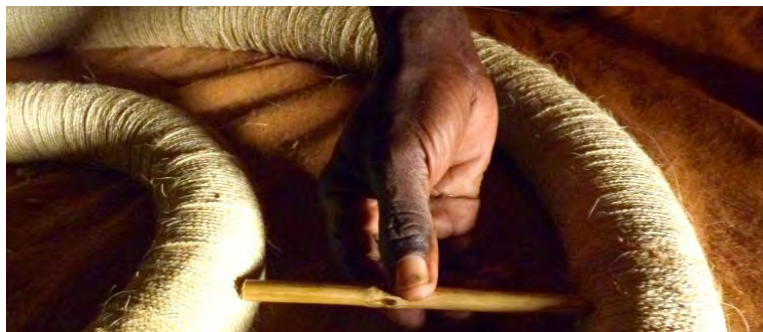
The spacing between subsequent rings is always the same

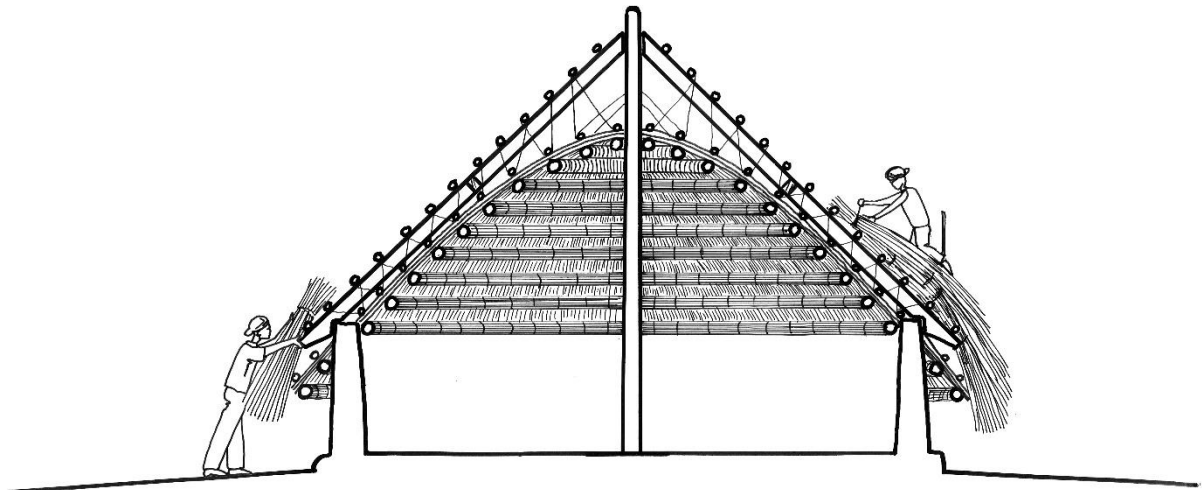
Thatch bundles are attached starting from bottom moving upwards. They are linked to the battens using tree bark fibre (Ebinsambwe) or sisal rope. An additional battens structure is sometimes added to the roof, as shown in the pictures below. The lower eaves are neatly trimmed with a knife at the end.

Tying thatch bundles to the battens  
3 photos by Remigios Kigongo

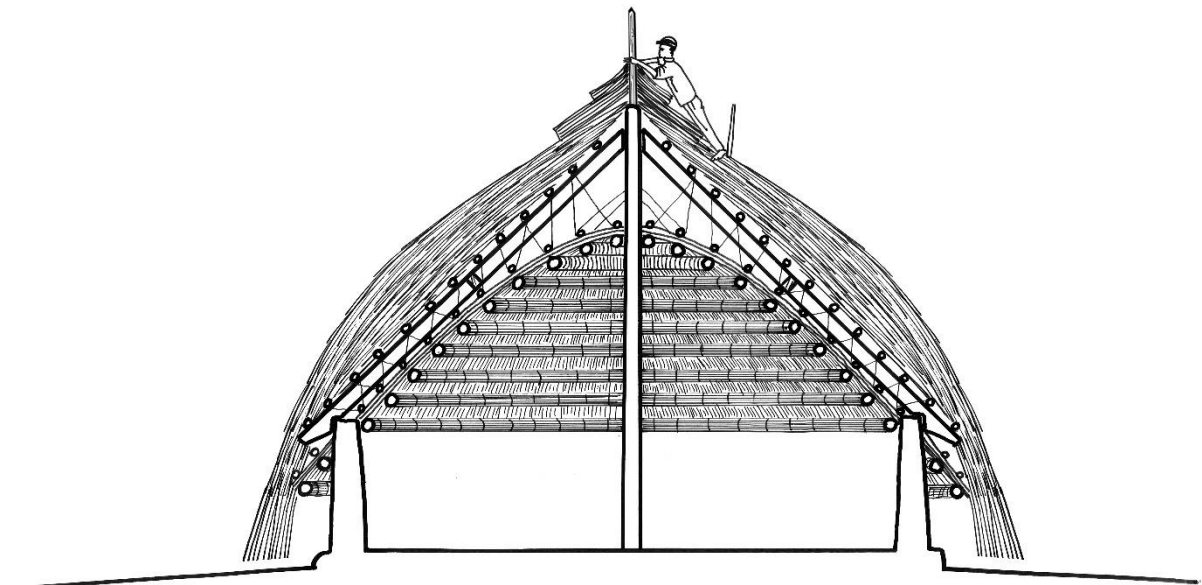
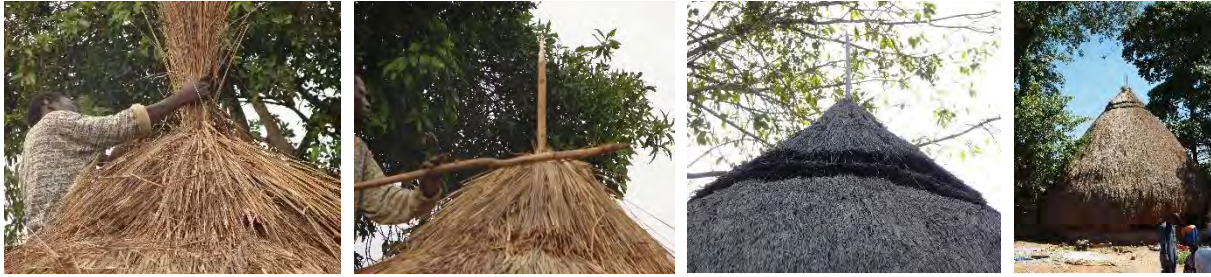
Particular care is taken with the hat that covers the top of the roof. This straw hat is attached to a Musambya stick planted in the straw.

Examples of top finishes  
2 photos on the left by Remigious Kigongo

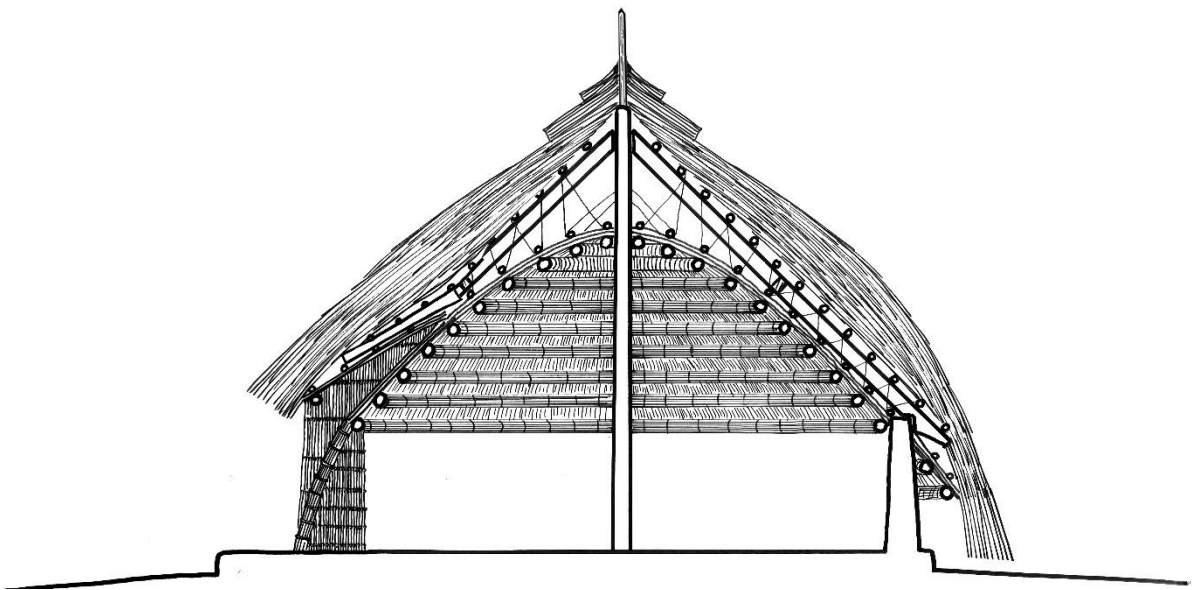
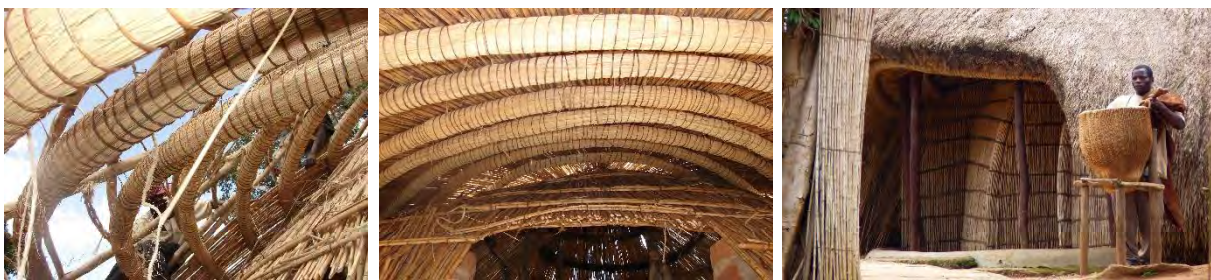
Details on the extra ceiling covering the entrance  
2 photos by Remigious Kigongo

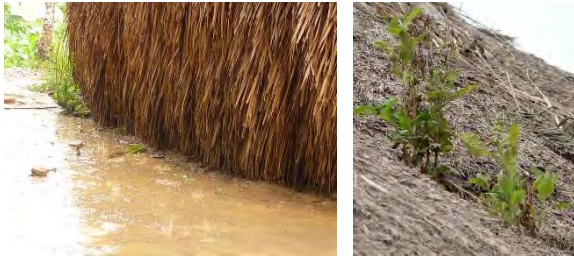
Strong windstorms move the straw and create gullies in which dead leaves and seeds penetrate.

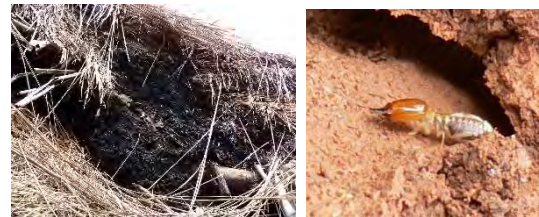
Termites can easily climb into the thatch, especially when it touches the ground. Termites need a very humid environment to develop. The deteriorating wet straw offers them a conducive environment and a perfect source of cellulose that they can easily digest.

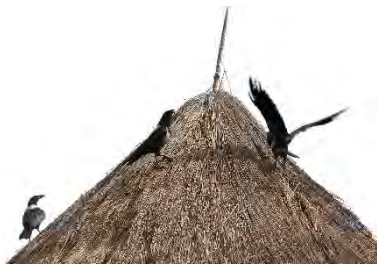
Once installed in the straw, termites attract some birds such as crows who come to search the straw with their beaks to eat them, which causes significant damage, and also increases infiltration. Birds also bring new seeds through their faeces, favouring the development of additional vegetation.

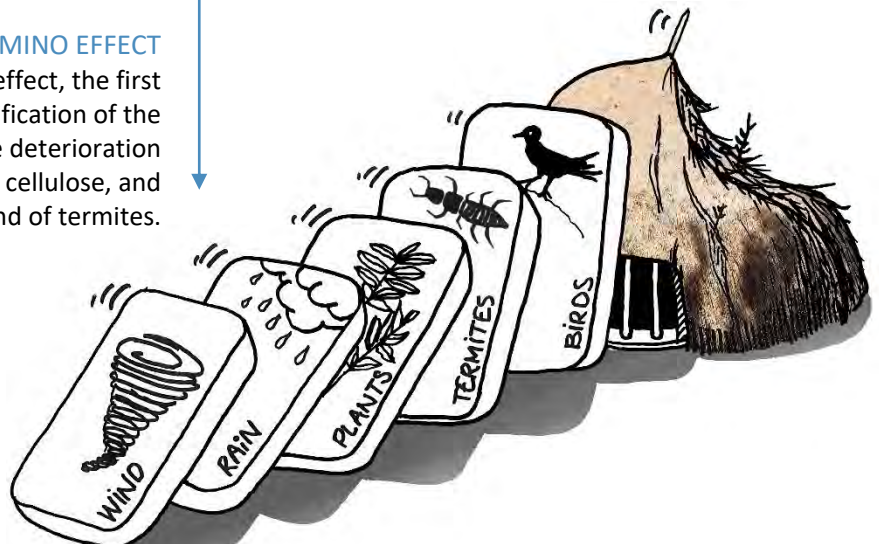
We therefore observe a domino effect, the first infiltrations leading to the humidification of the straw and therefore its progressive deterioration which attracts termites, fond of cellulose, and birds, fond of termites.

If infiltration problems are not addressed by regular replacement of damaged straw, the process can go as far as partial or collapse of the roof.

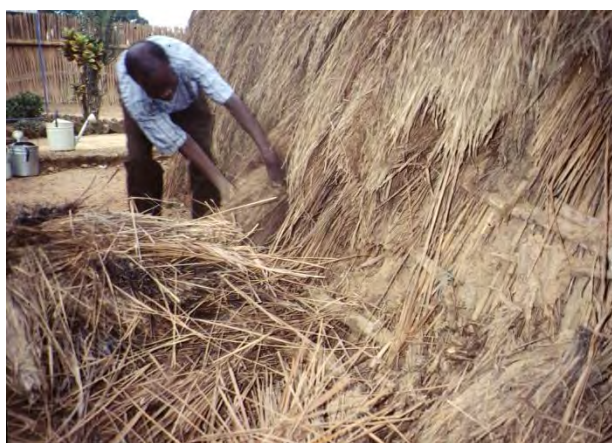
Removal of decayed thatch at Kasubi

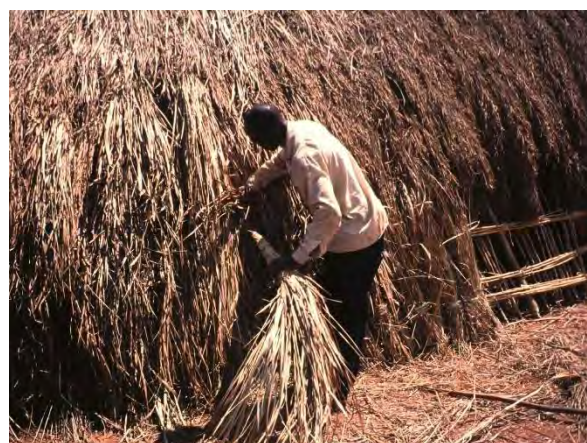
Insertion of new bundles at the base of BujjaBukula, Kasubi

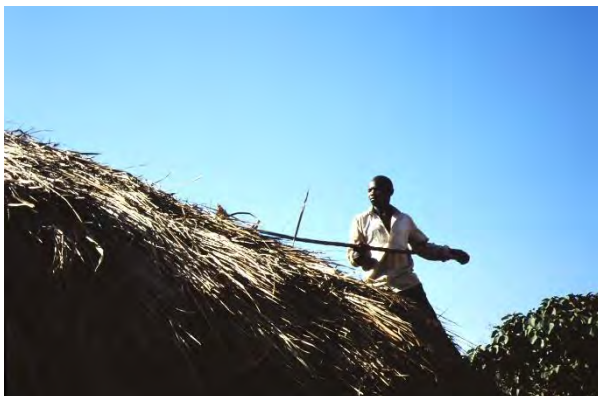
Cleaning and readjusting the thatch with a stick

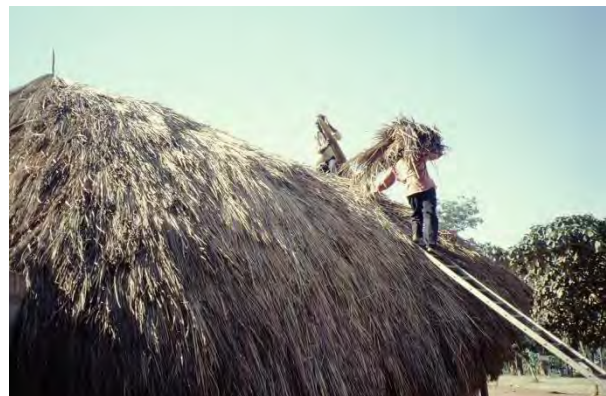
Bringing new spear grass bundles on the roof to fill gullies

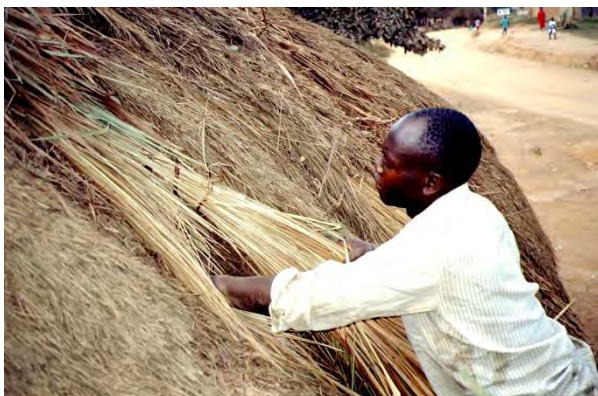
Plants growing in the gullies should be removed as soon as possible. The longer we wait, the deeper the roots penetrate into the straw, creating waterways that are extremely damaging to the roof. Once the plants are removed, the decayed wet straw must be replaced by dry one.

Inserting new bundles in a gully after removing decayed grass

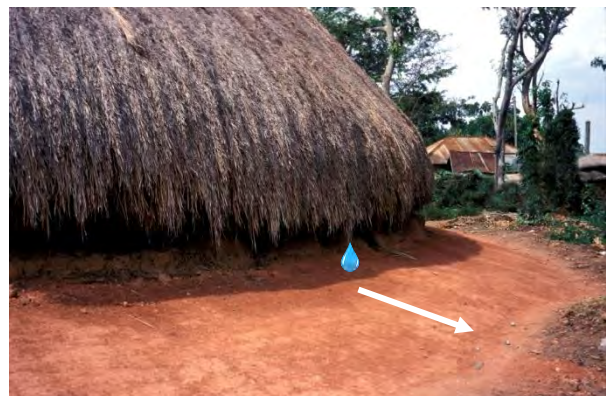
The drainage of the site also limits the presence of humidity and termites, by diminishing the amount of water absorbed by the ground. Slopes should be provided to drain runoff rainwaters from the buildings towards farmland areas.

Drainage slopes made of compacted laterite

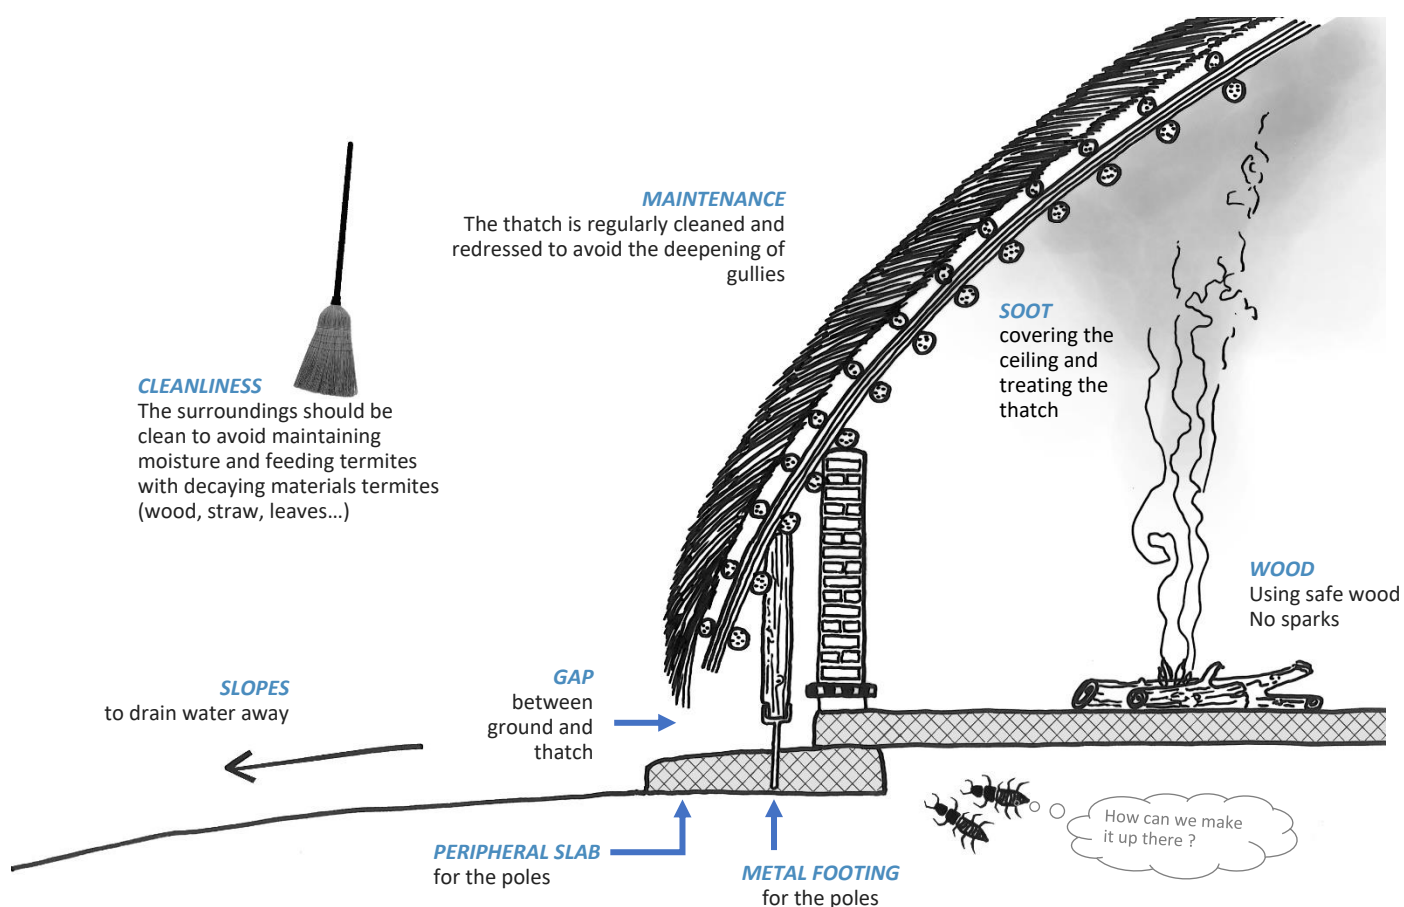
- For a new construction, it is advisable to multiply the number of termite barriers. The wooden pole bases must be treated, and if possible disconnected from the ground using a metal connector.
- Walls can integrate a termite barrier, i.e. a protruding element that termites cannot climb.
- A peripheral slab around the building also reduces the risk of a direct soil-to-straw invasion.

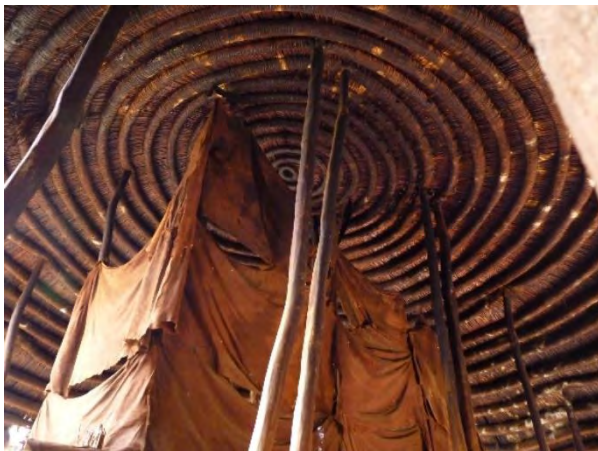
Thatched roofs are traditionally treated by smoking. Straw coated with soot is more resistant to moisture on the one hand, and discourages termites on the other. Ideally, smoking should be done several times a week, using dry wood that does not spark while burning. Wood species used include *Kasaana* (clears evil), *Musizi*, *Endagi*, *Muzanganda* (to connect with the spirits), *Mwule* and *Muwafa*. In any case, *eucalyptus* and *Twalabafo* are totally prohibited.

Rings protected by a layer of suit at Wamala tombs.
