STATE PARTY REPORT

On The State of Conservation
of The

Syrian Cultural Heritage Sites
(Syrian Arab Republic)

For Submission By
1 February 2024

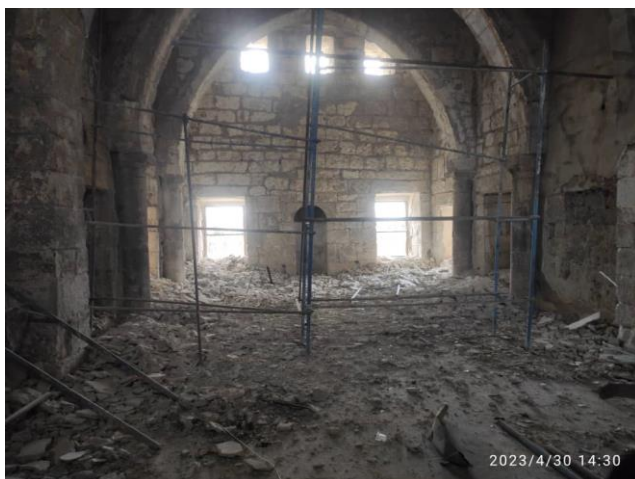
Cracks were detected in the facades. Repair work was carried out.

The DGAM has been carrying out repairs on the madrasa abû al-Fidâ, applying various treatments for long-term preservation of this stone structure.

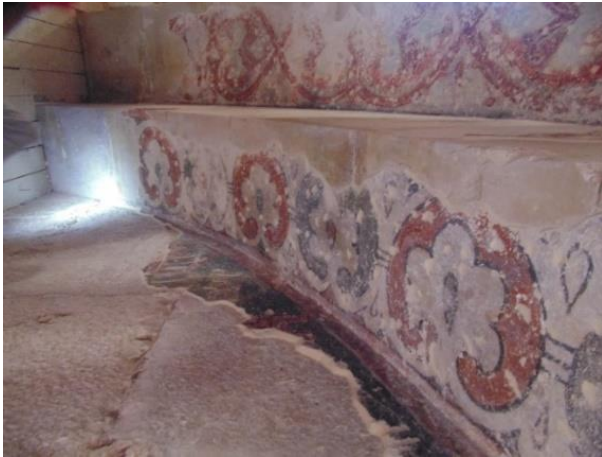
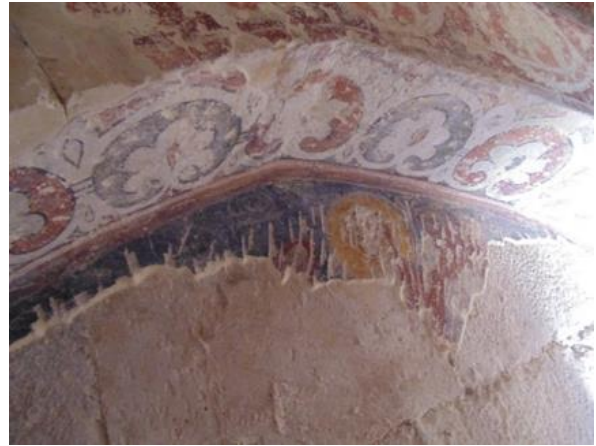
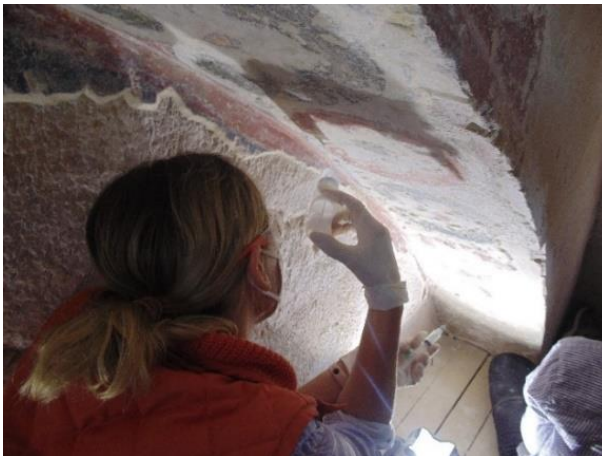
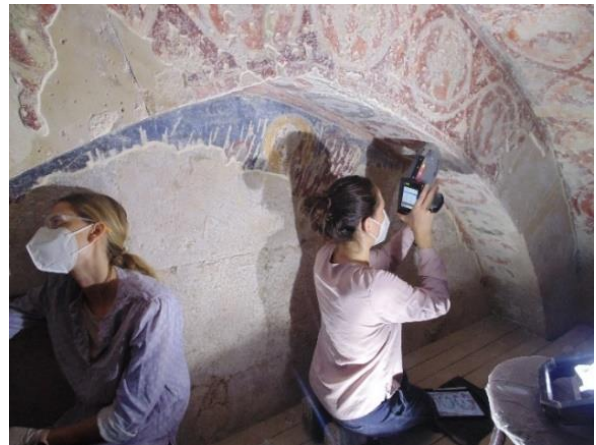
- A. **Restoration works on the frescoes in the castle's Church / Phase Four (Final):** The work of enforcing the frescoes was summed up by completing and finishing the work that had been started during the previous seasons. These works include the following:
- The removal of the subsequent undecorated plaster that completely covered the frescoes and posed a threat to them.
 - The preliminary cleaning of the recently exposed painted surfaces.

- The injection of the newly discovered painted surfaces.
- The stabilization of the edges of the frescoes' remains.

This season, the work of stabilizing the condition of the frescoes in the church tower in the Castle was completed, and the wooden scaffolding was dismantled.

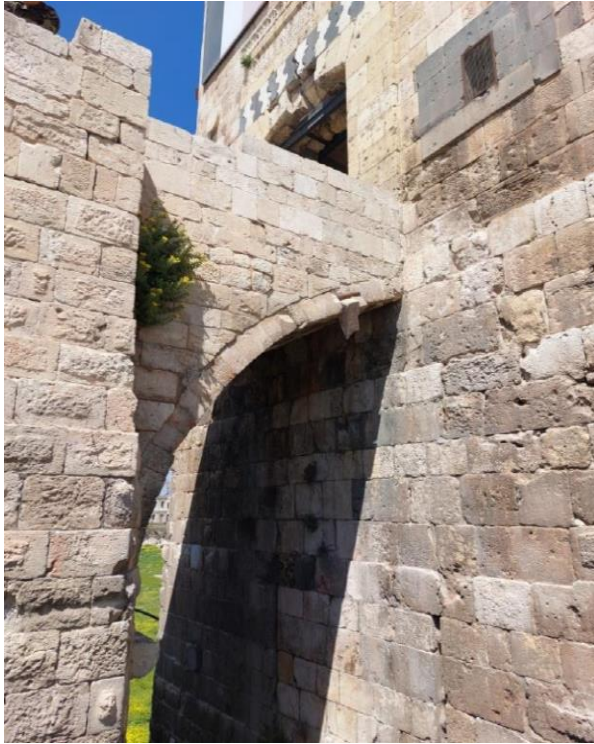
Before

- The stone arch of the vault was dismantled and an examination of the arch stones was conducted then it was reassembled using the original stones and replacing the damaged stones with similar ones.

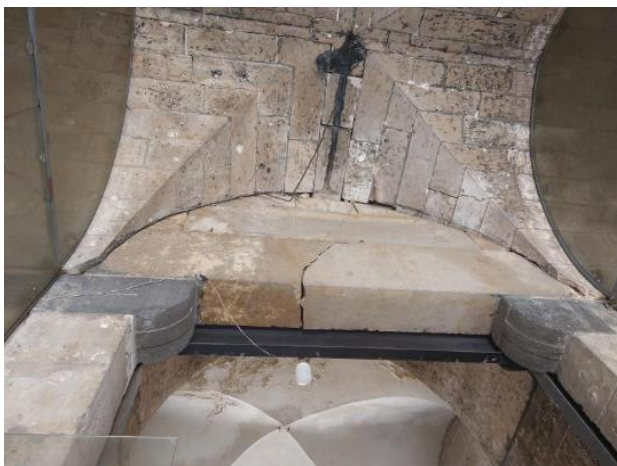
Before

Consolidation works of the lintel, dismantling the loose stones and reassembling them, in addition to plaster the surface of the vault.

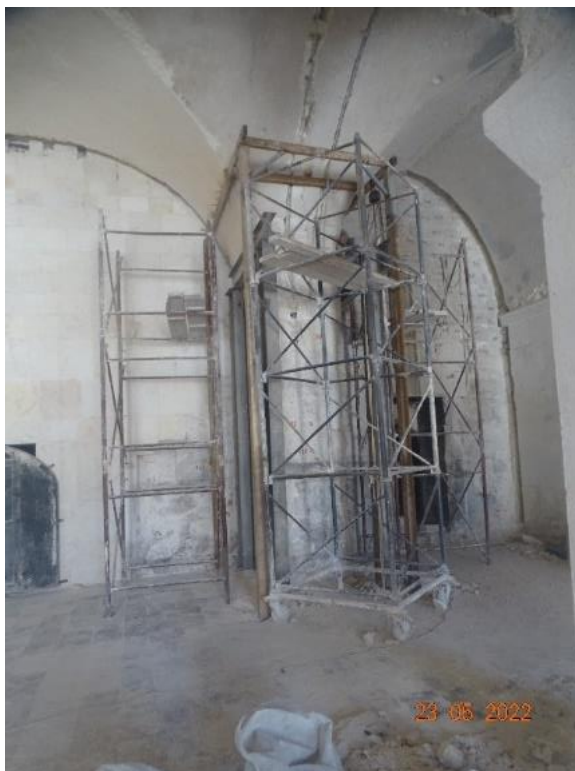
The columns in Al-Hejazia were enforced, documented, dismantled and rebuilt

Dismantling the damaged parts of the joints separating the Hejazia from the northern peristyle and rebuilding.

- Replacing stones and rebuilding the damaged parts of the walls.
- Doing plaster works of the inner ceiling of the dome in the Hejazia.
- Completing the restoration works of the rooms of the eastern peristyle.
