STATE PARTY REPORT

On The State of Conservation
of The

Syrian Cultural Heritage Sites
(Syrian Arab Republic)

For Submission By
1 February 2024

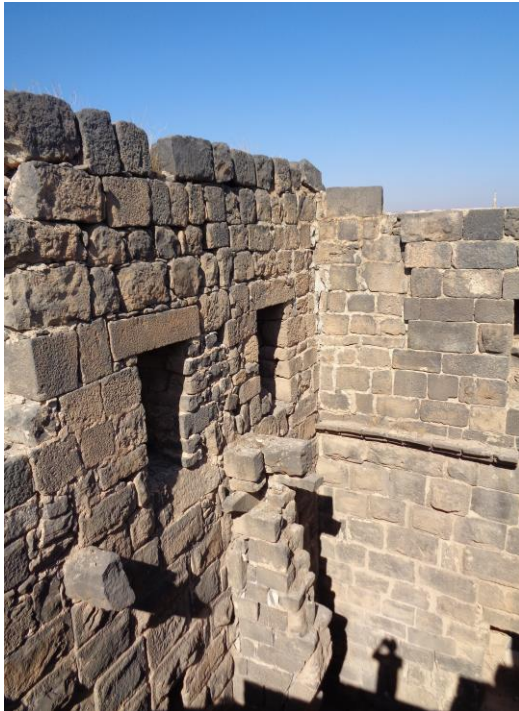
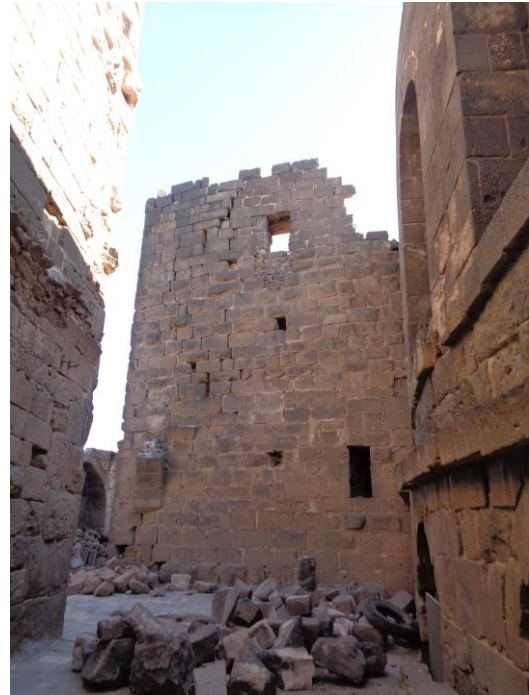
The current state of external façade of the tower dressed stone walls, had developed assorted cracking as a result of historic ground movement. Structural repairs were required which would secure the masonry, stabilize the buildings and mitigate the chances of further cracking in the future.

The current state of external façade of the tower

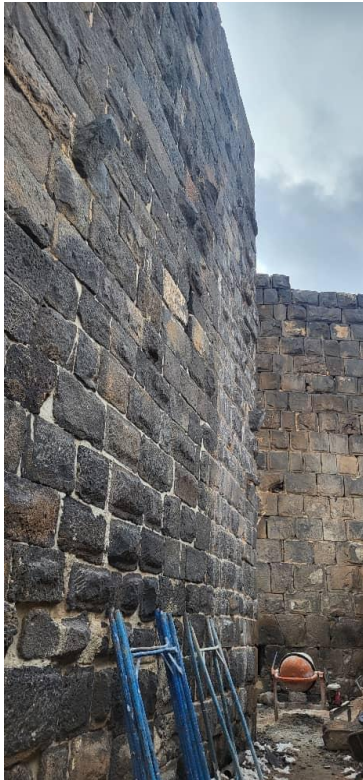
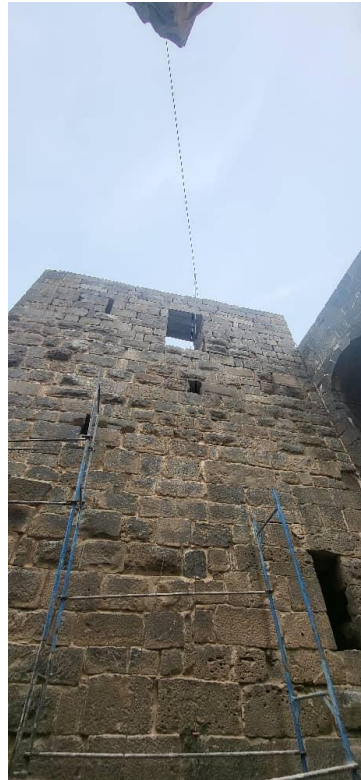
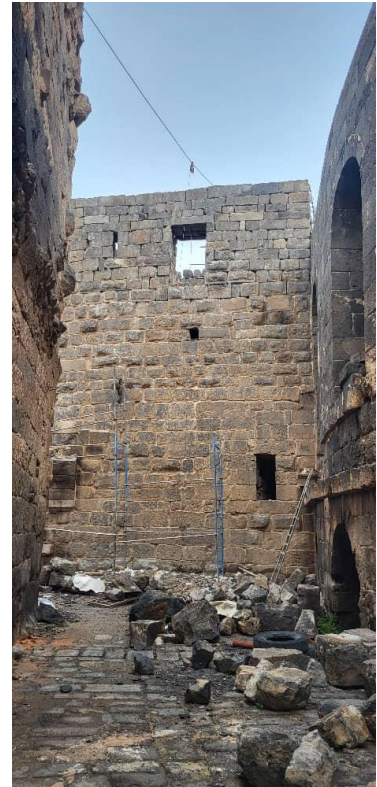
To help ensure the restoration and retention of structural integrity numbering and sorting the ancient stones and debris were developed.

The well proven repairs restored integrity to the tower while retaining its original character and visual appearance.

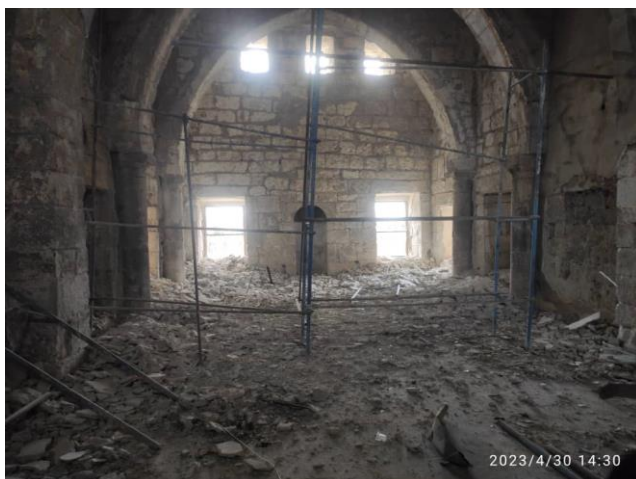
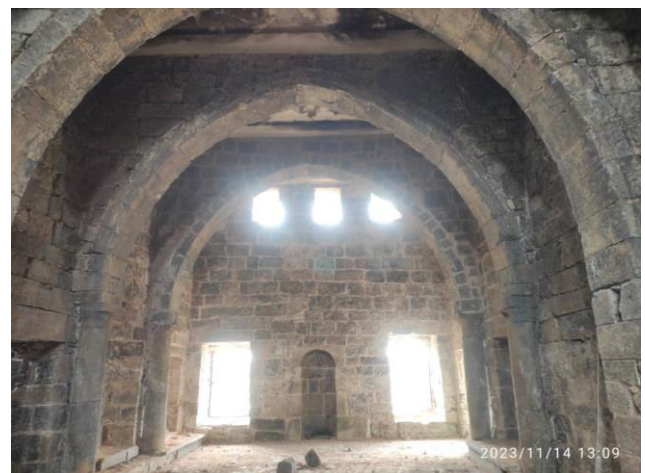
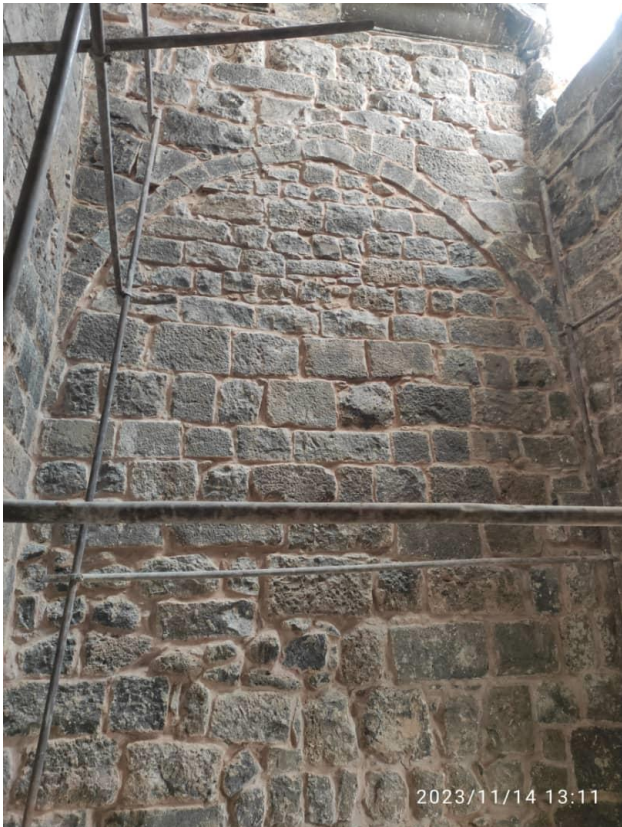
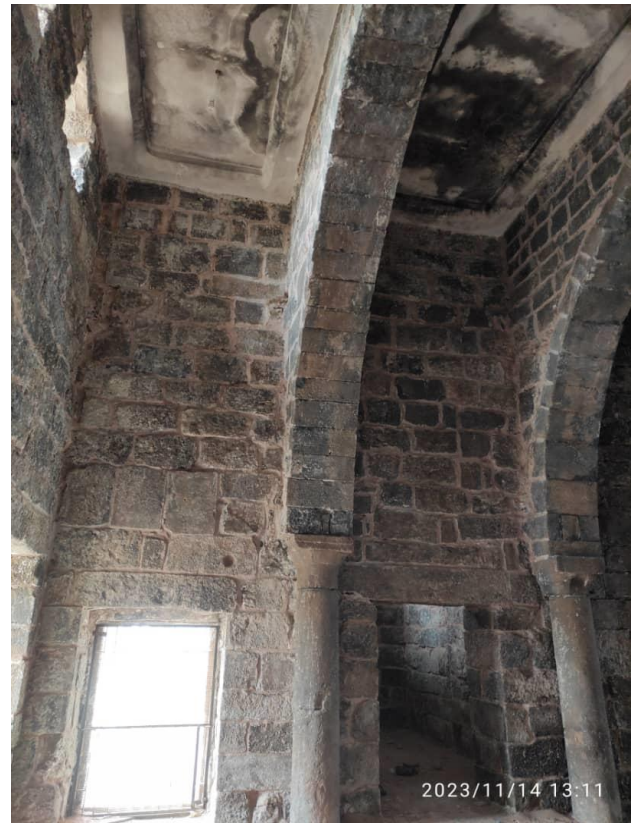
Cracks were detected in the facades. Repair work was carried out.

The DGAM has been carrying out repairs on the madrasa abû al-Fidâ, applying various treatments for long-term preservation of this stone structure.

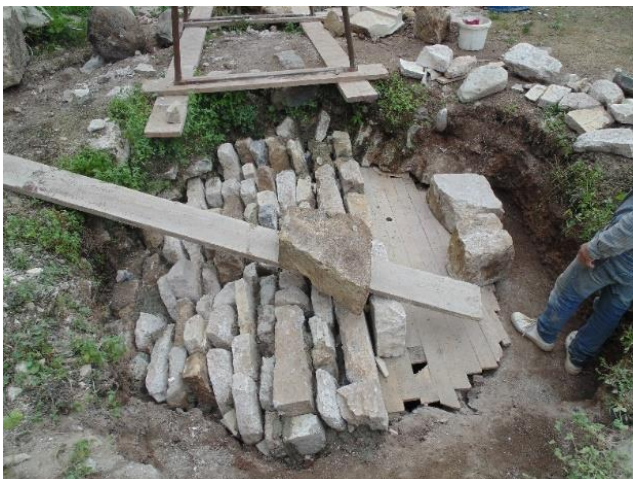
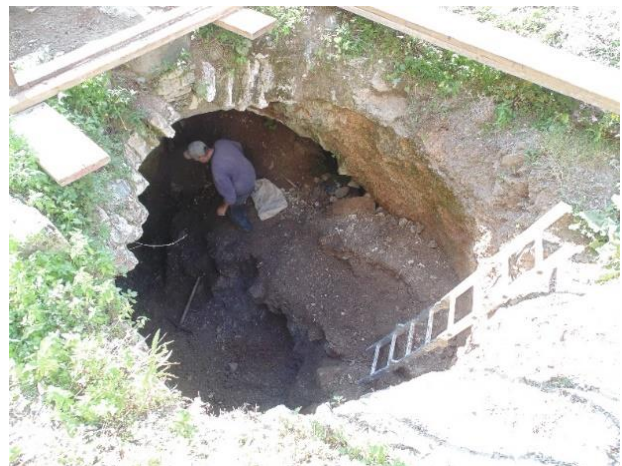
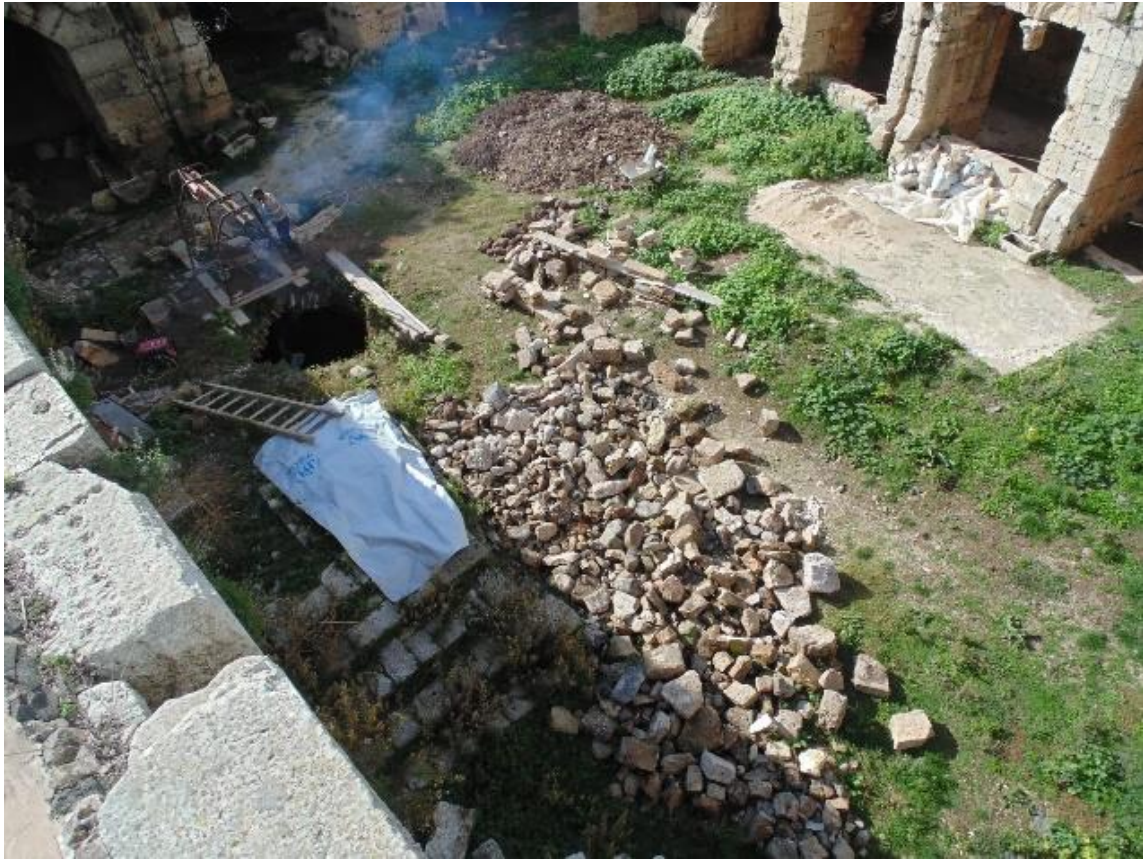
2. **The vault of the cistern in the inner court:** According to the intervention's priorities set in the master plan, restoration started at the vault of the cistern in the inner court of the central castle after sorting the rubble and moving the unusable material and garbage outside the site.

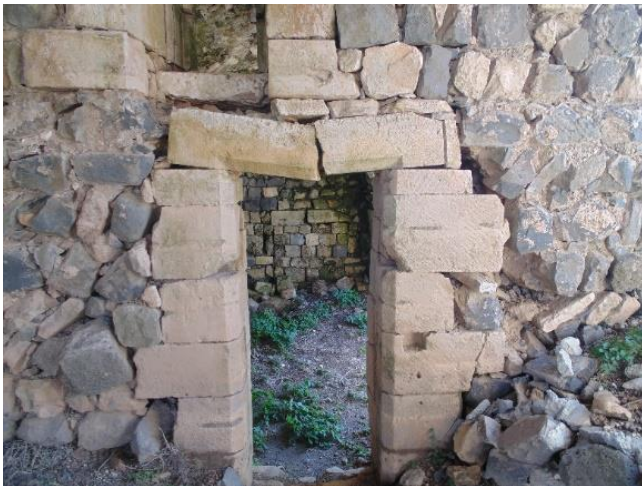
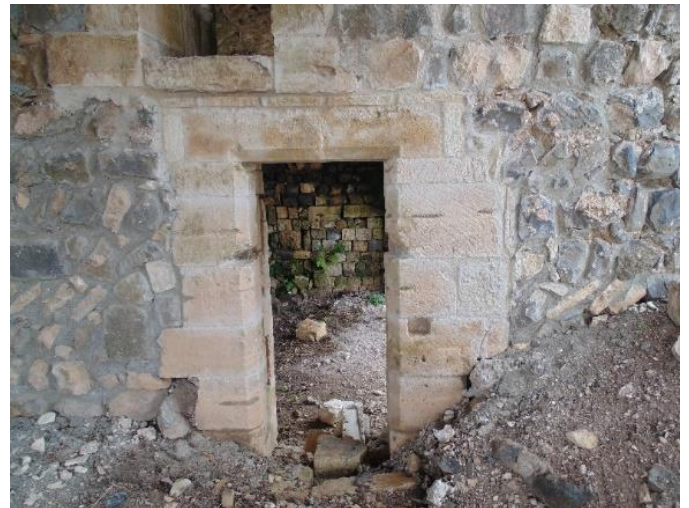
3. Dismantling, reinforcing and reassembling the broken lintel in the part number 27 in the inner castle.

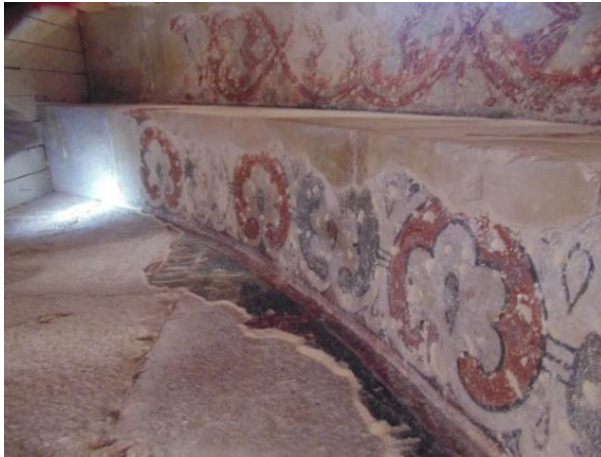
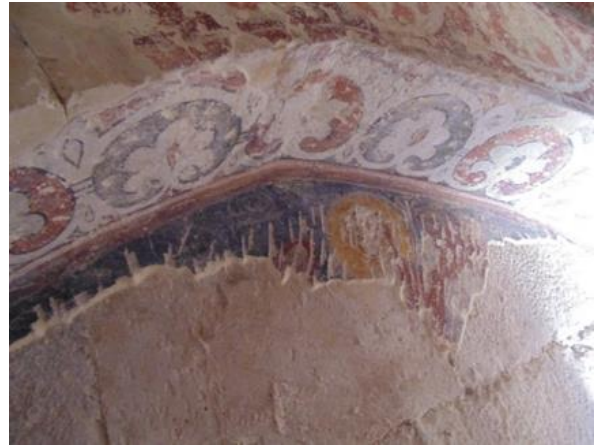
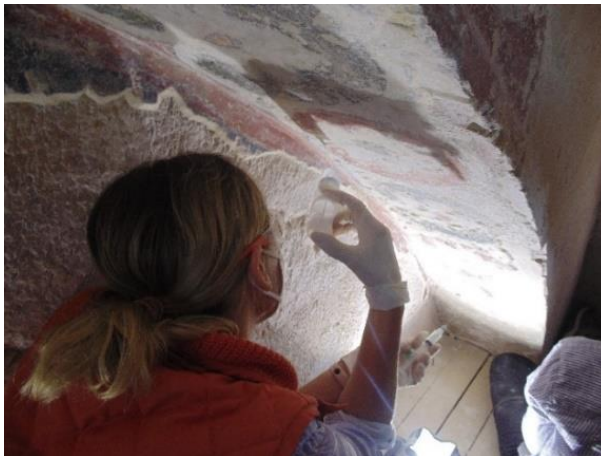
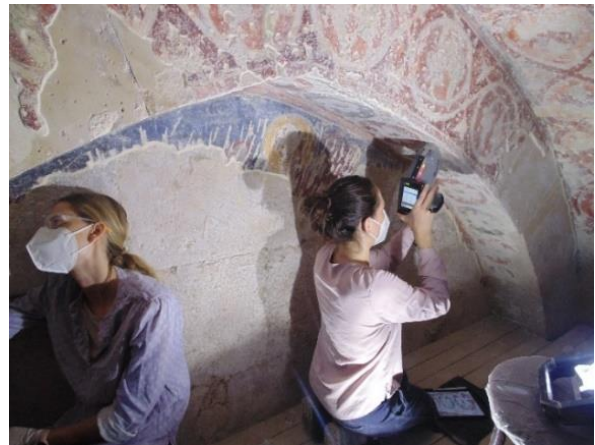
- A. **Restoration works on the frescoes in the castle's Church / Phase Four (Final):** The work of enforcing the frescoes was summed up by completing and finishing the work that had been started during the previous seasons. These works include the following:
- The removal of the subsequent undecorated plaster that completely covered the frescoes and posed a threat to them.
 - The preliminary cleaning of the recently exposed painted surfaces.

- The injection of the newly discovered painted surfaces.
- The stabilization of the edges of the frescoes' remains.

This season, the work of stabilizing the condition of the frescoes in the church tower in the Castle was completed, and the wooden scaffolding was dismantled.

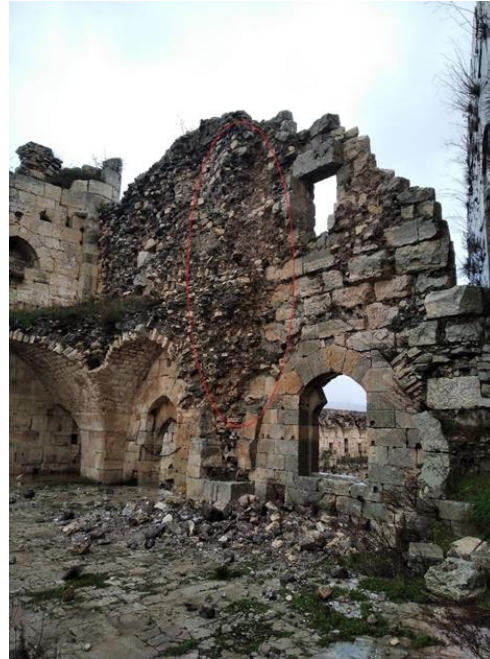
The wall connecting the Commander's Tower and the Knights' Tower in the southwestern corner of the inner castle (northern wall of space No. 51): wall suffers severe collapse that leads to instability. The curtain wall is tall, poorly attached to the building, have large slenderness (height-to-thickness) ratios, and carry no vertical loads. The severe collapse of top of the wall is observed serious damage type.

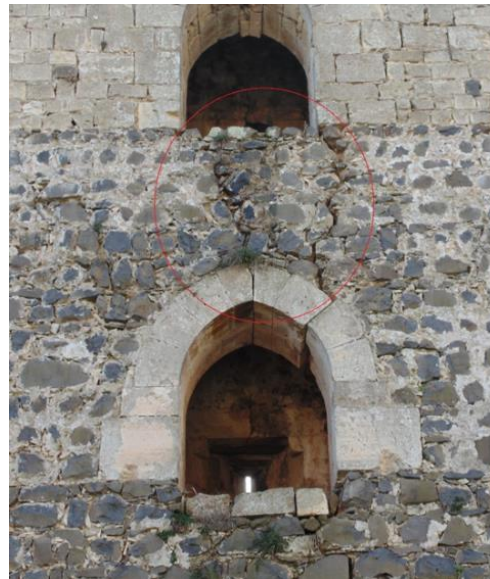
Preexisting cracks have opened slightly from the eastern main entrance (Tower No. 101) to (Tower No. 114) located in the southeastern corner of the outer castle

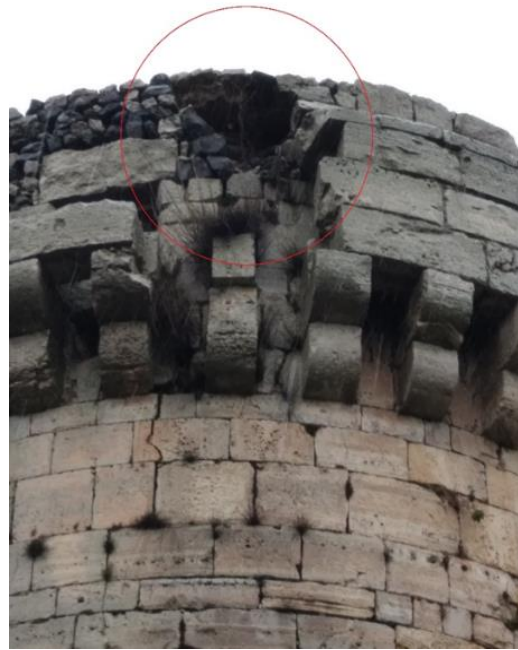
Tower No. (137) located in the outer castle north of Al-Zahir Baybars Tower: The tower suffers from collapse of some stones at the top of the wall.

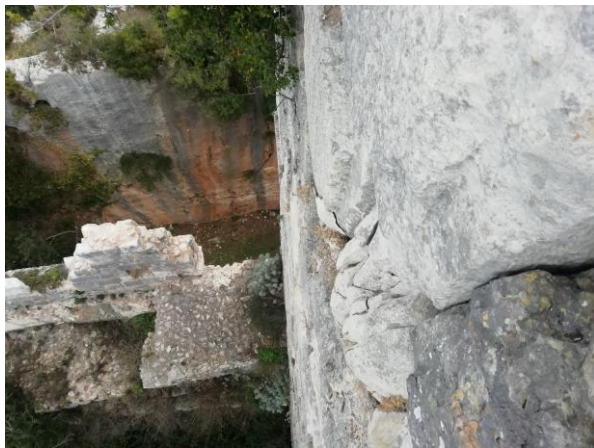
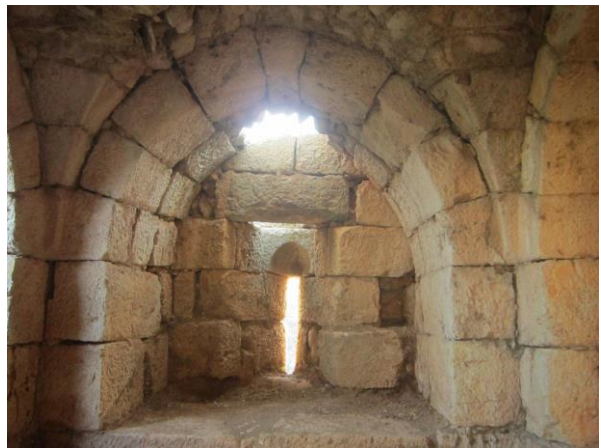
The damage at the defense's walls north of the Royal tower which is weak masonry walls without mortar had diagonal or inclined shear cracking.

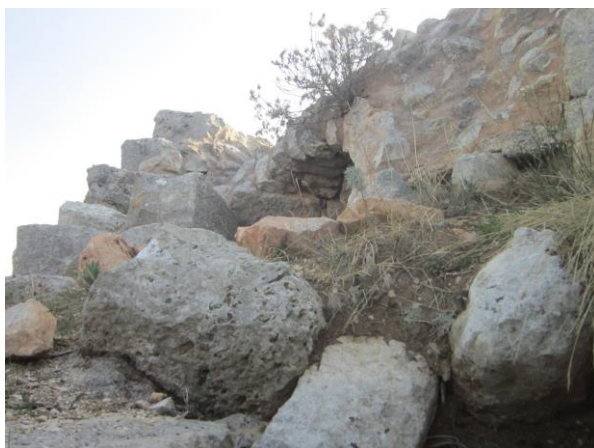
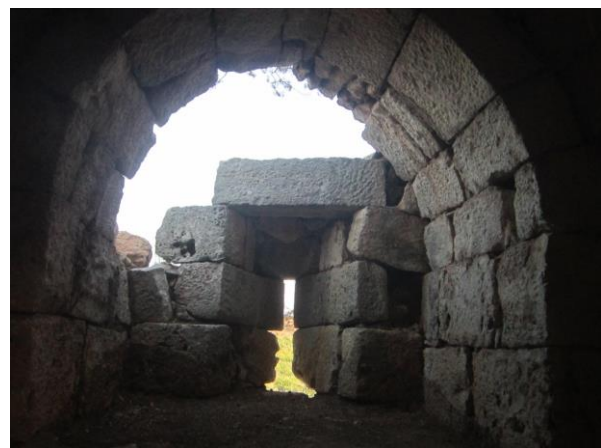
Cracks and chipped or loose stones, found all along the structure at the tops of openings.

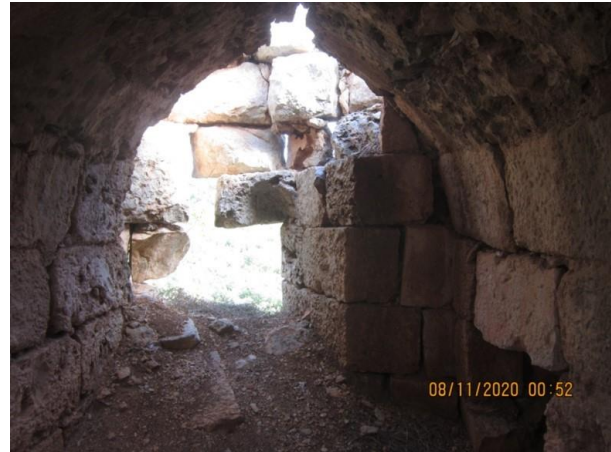
The recent earthquake caused existing cracks to be significantly widened and extended.

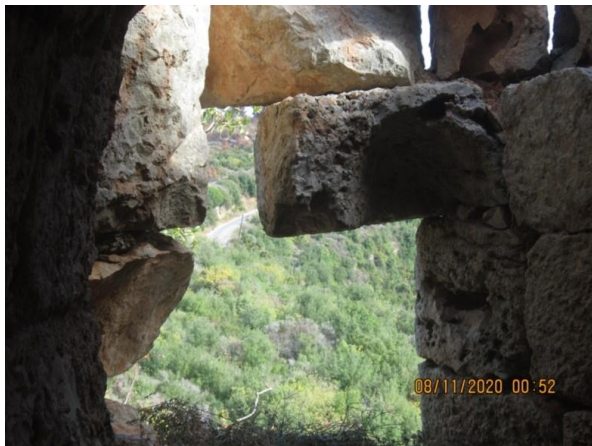
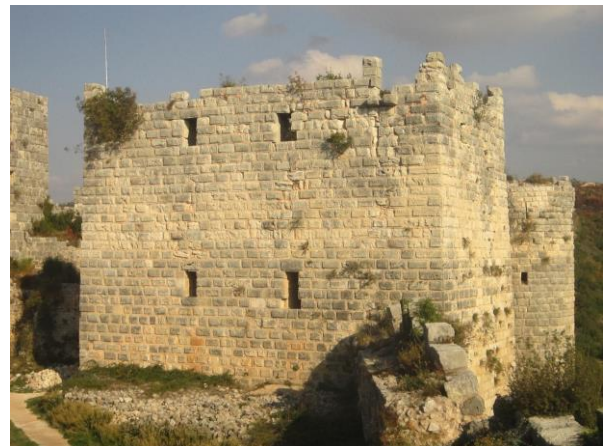
Damage to the Qal'at can be generally described as having resulted from the continuous degradation of foundation and structural masonry from environmental effects, especially rainwater, inadequate lateral structural resistance and the subsequent imposition of earthquake forces.

A significant amount of patching was evident on walls and parapets accessible from the roof. The tower has large vertical cracks between the masonry stone as shown in figure.

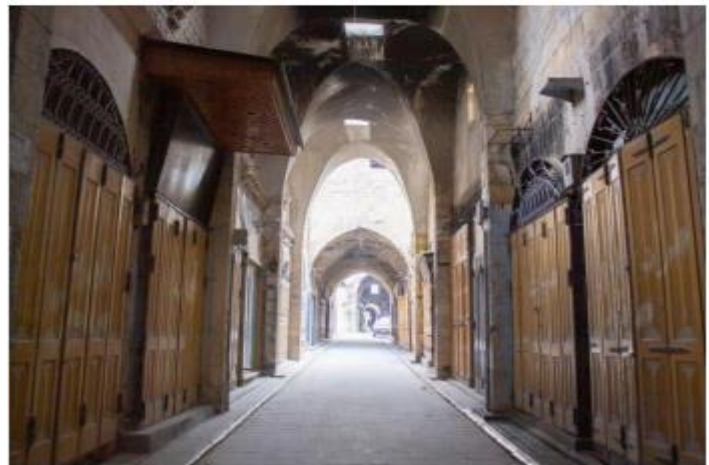
Al-kesh souk after restoration

Al- Khesh souk is one of the important souks due its strategic location between the restored souks, it's links Al-Habbal souk with Sahat Fistok and Khan Al-Harir souk (Al-Majidiya), in addition to its direct connection with Al- Haddadeen souk, it has a total length of 75 meters and was not damaged by the earthquake, the infrastructure is in a good condition, so it needs minor restoration work on the stone facades, plastering and cleaning the roof and the walls. Accordingly, it was agreed between the STD, Aleppo council city and the ONG Rescate to finance a restoration work after preparing the required study, supervised by the DGAM and the Directorate of the Ancient City. Restoration works have begun, and it is expected to be completed at the end of this year.

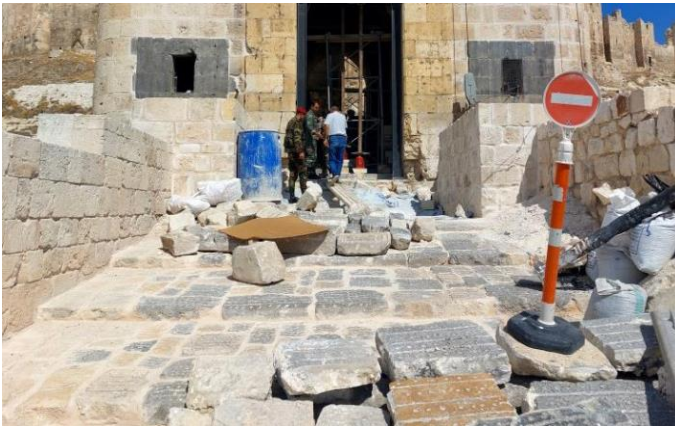
The stone stairs of the entrance before restoration After

The restoration works in the defenses tower and the stone stairs of the entrance by removing the damaged mortar in the floor tiling, refilling them with similar mortar and replacing the missing tiles and stones in the floor with similar ones.

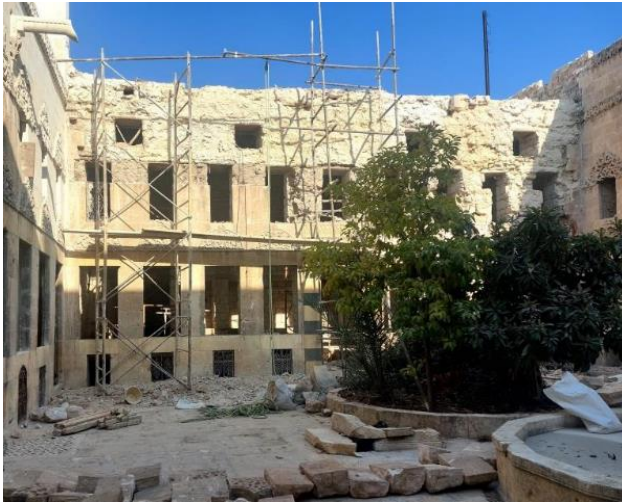
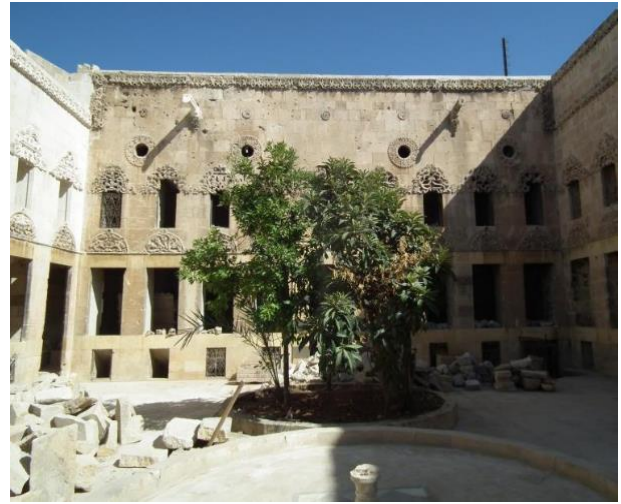
The interior northern façade during and after restoration

The project includes restoration for the walls and façades in addition to addressing the earthquake damage.

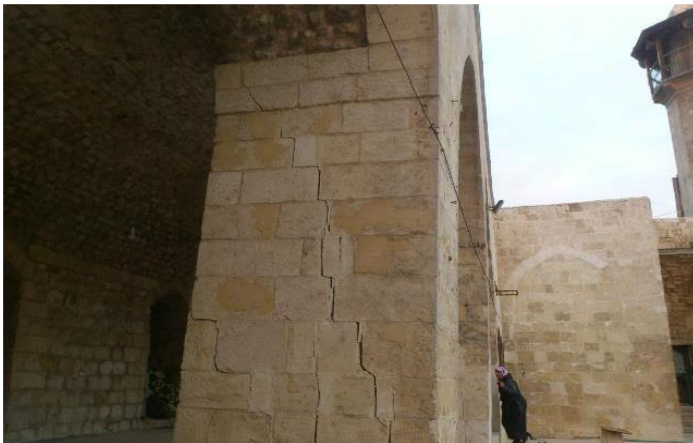
Al Haddadeen mosque: Reinforcement work on the northern corridor damaged by the earthquake

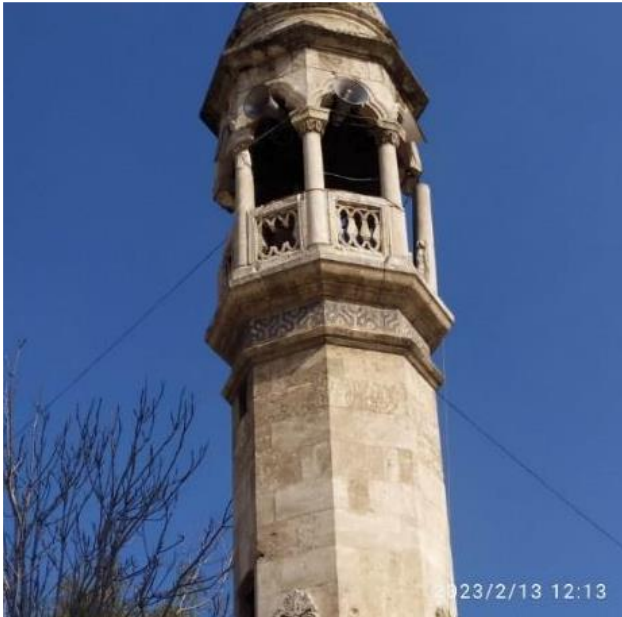
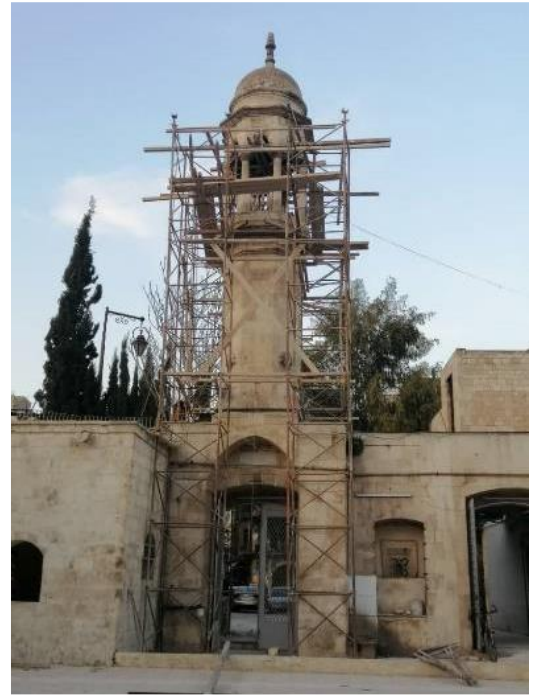
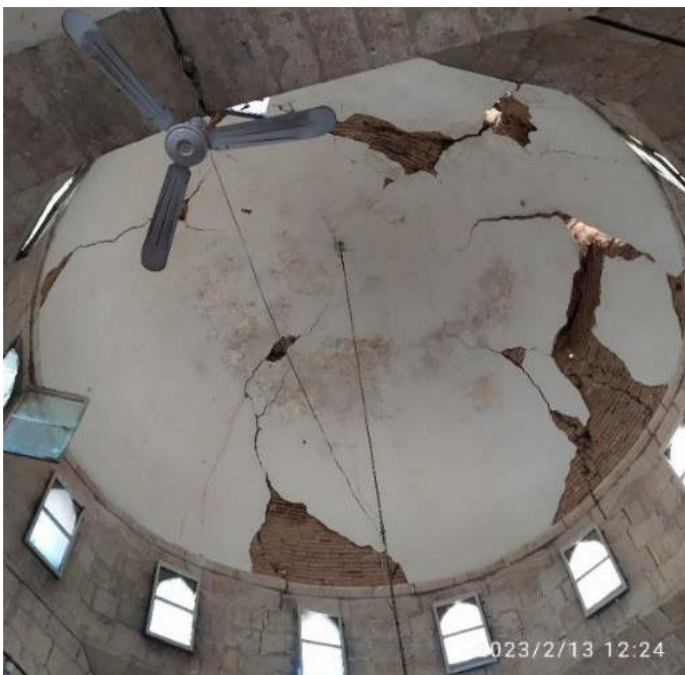
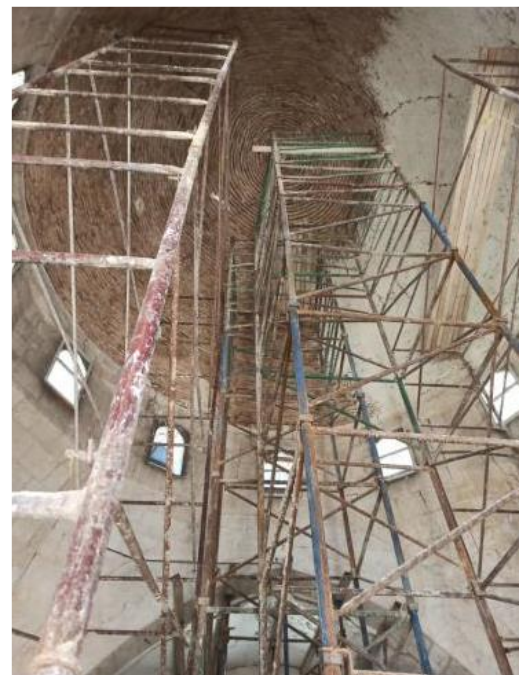
Minaret of the Tekkiyya Melawiyya - Al-Malkhana Mosque - (Bab Al-Faraj): Strengthening, consolidating and dismantling the dome of the minaret balcony with its supporting columns, and rebuilding damaged columns in conformity with the original form. Emergency strengthening work for the Hijazi Dome with initial injection of bonding materials in preparation for final restoration work.

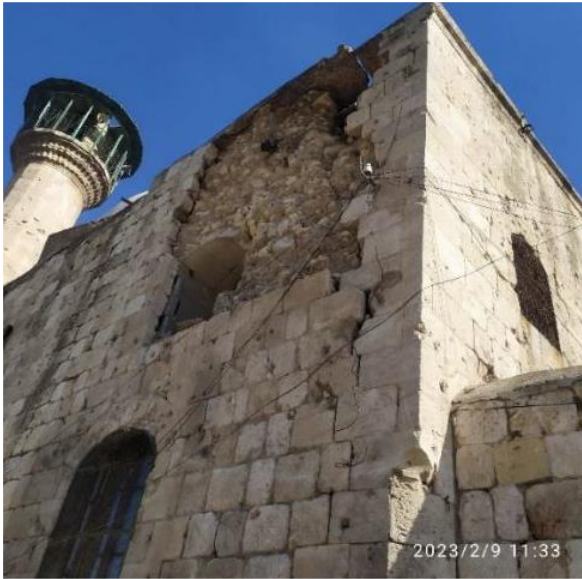
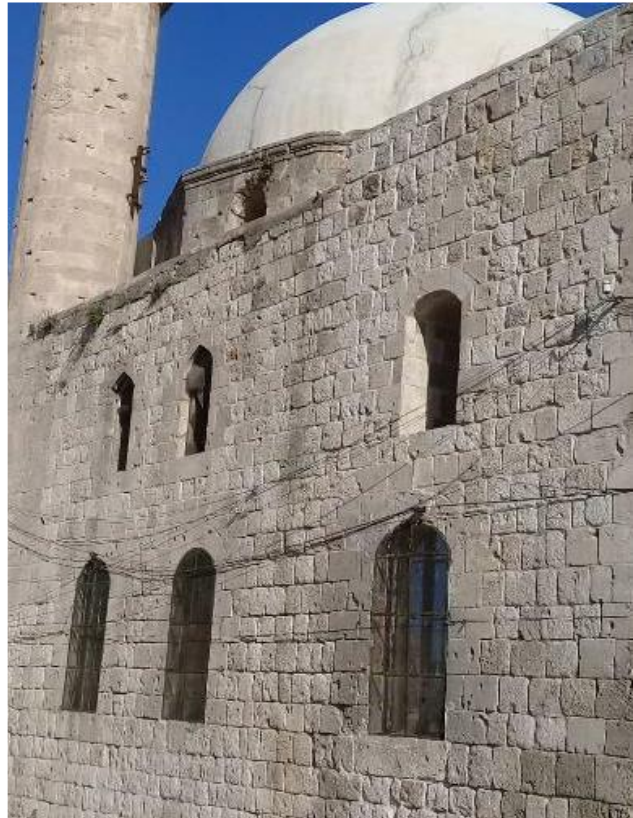
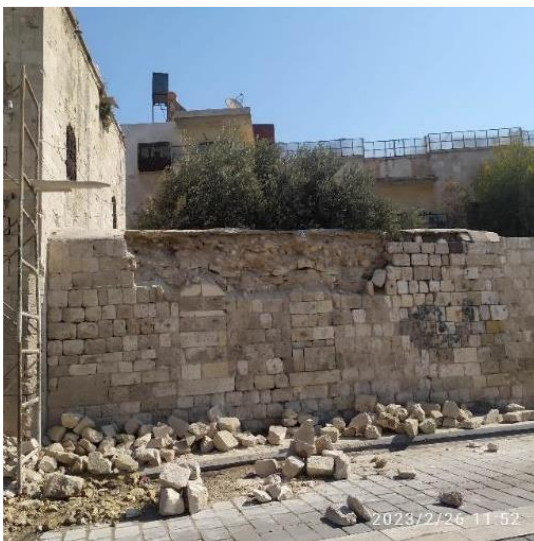
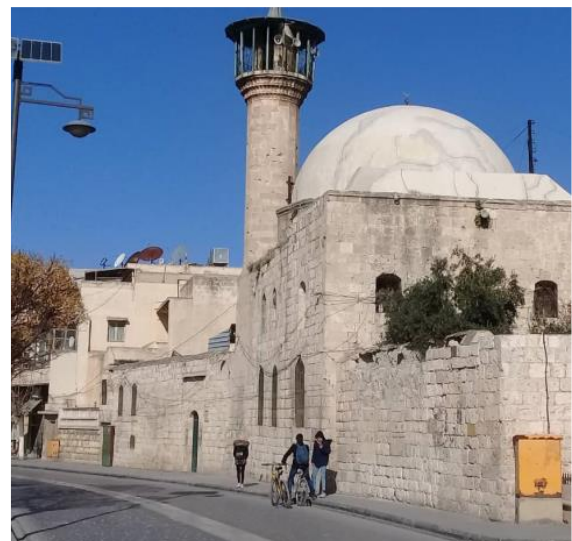
Al-Hamwi Mosque (the citadel parameter): Strengthening, consolidating, dismantling the facades and rebuild in accordance with the original shape of the facades. Installing lime mortar and facade cleaning.

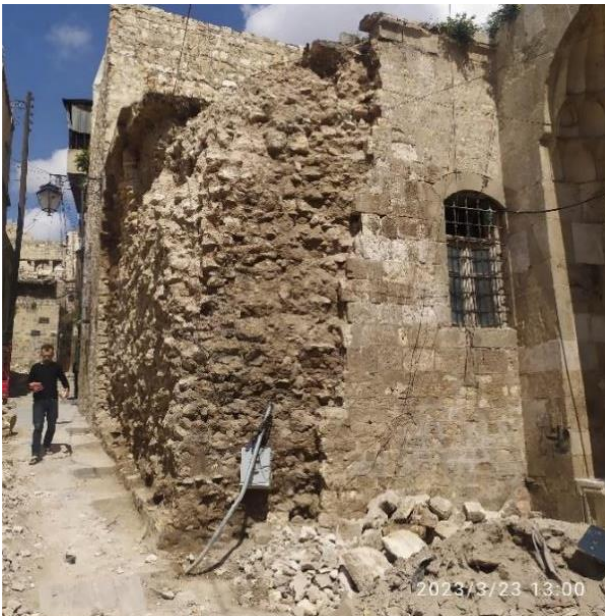
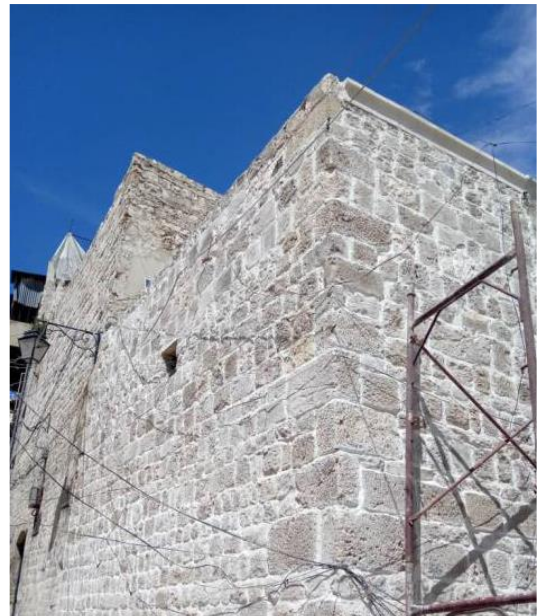
Kamaliyya Mosque (Al-Jaloum): Strengthening, consolidating and dismantling the facades and rebuilding in accordance with the original shape. Installing lime mortar and facade cleaning.

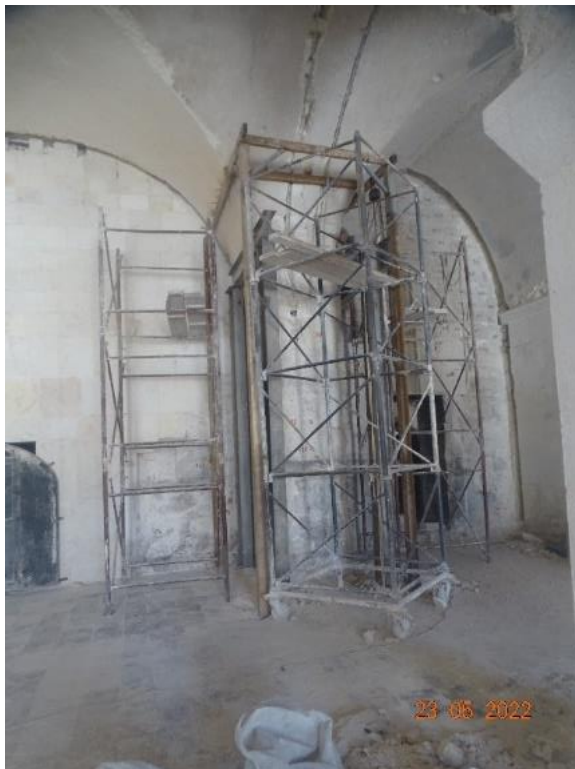
The columns in Al-Hejazia were enforced, documented, dismantled and rebuilt

Dismantling the damaged parts of the joints separating the Hejazia from the northern peristyle and rebuilding.

- Replacing stones and rebuilding the damaged parts of the walls.
- Doing plaster works of the inner ceiling of the dome in the Hejazia.
- Completing the restoration works of the rooms of the eastern peristyle.
