STATE OF CONSERVATION
FOR
TOMBS OF BUGANDA KINGS AT KASUBI – (UGANDA)

PROPERTY ID NO C1022

IN RESPONSE TO WHC: 45 COM 7A.25

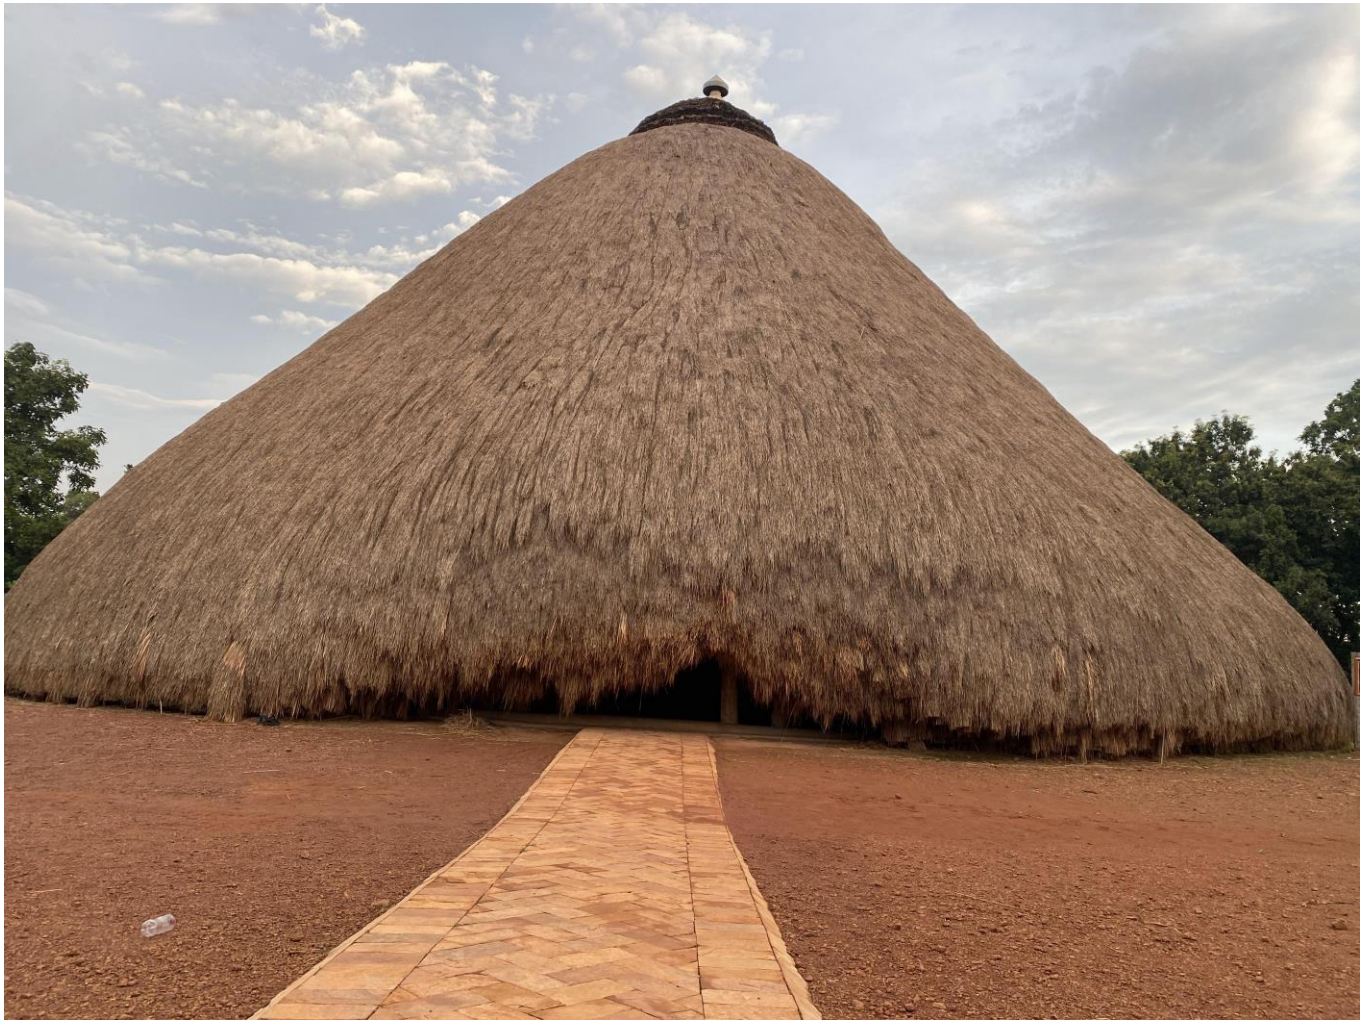
The Image (*front side*) showing the External present status of the Muzibu – Azaala – Mpanga (MAM), the main Building at the Site.

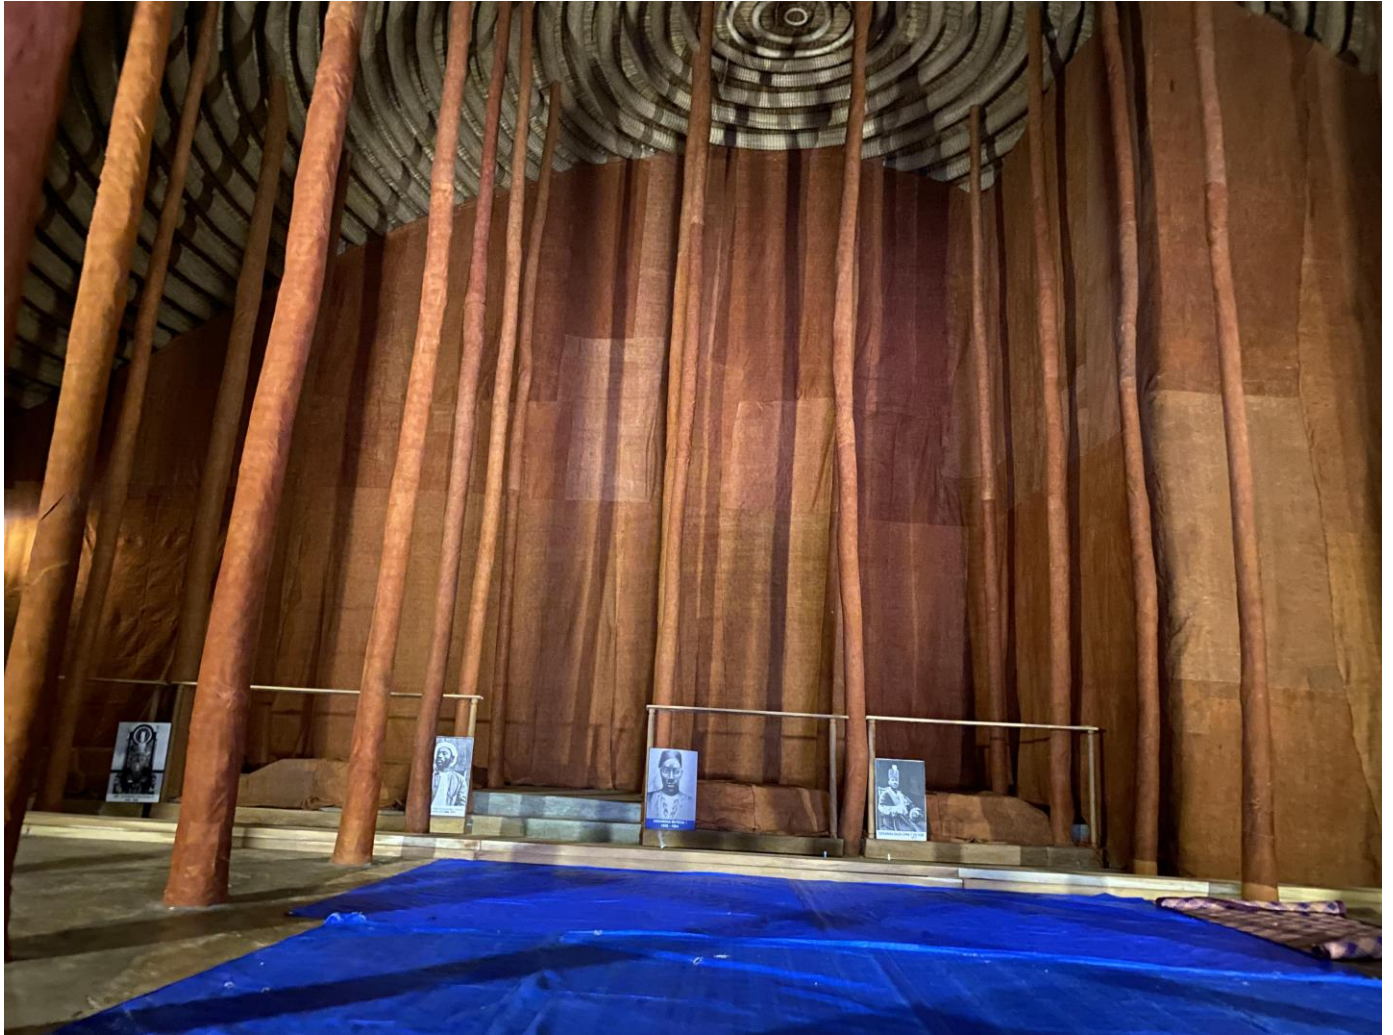
The Image showing the interior present status of the Muzibu – Azaala – Mpanga (*MAM*), the main Building at the Site.

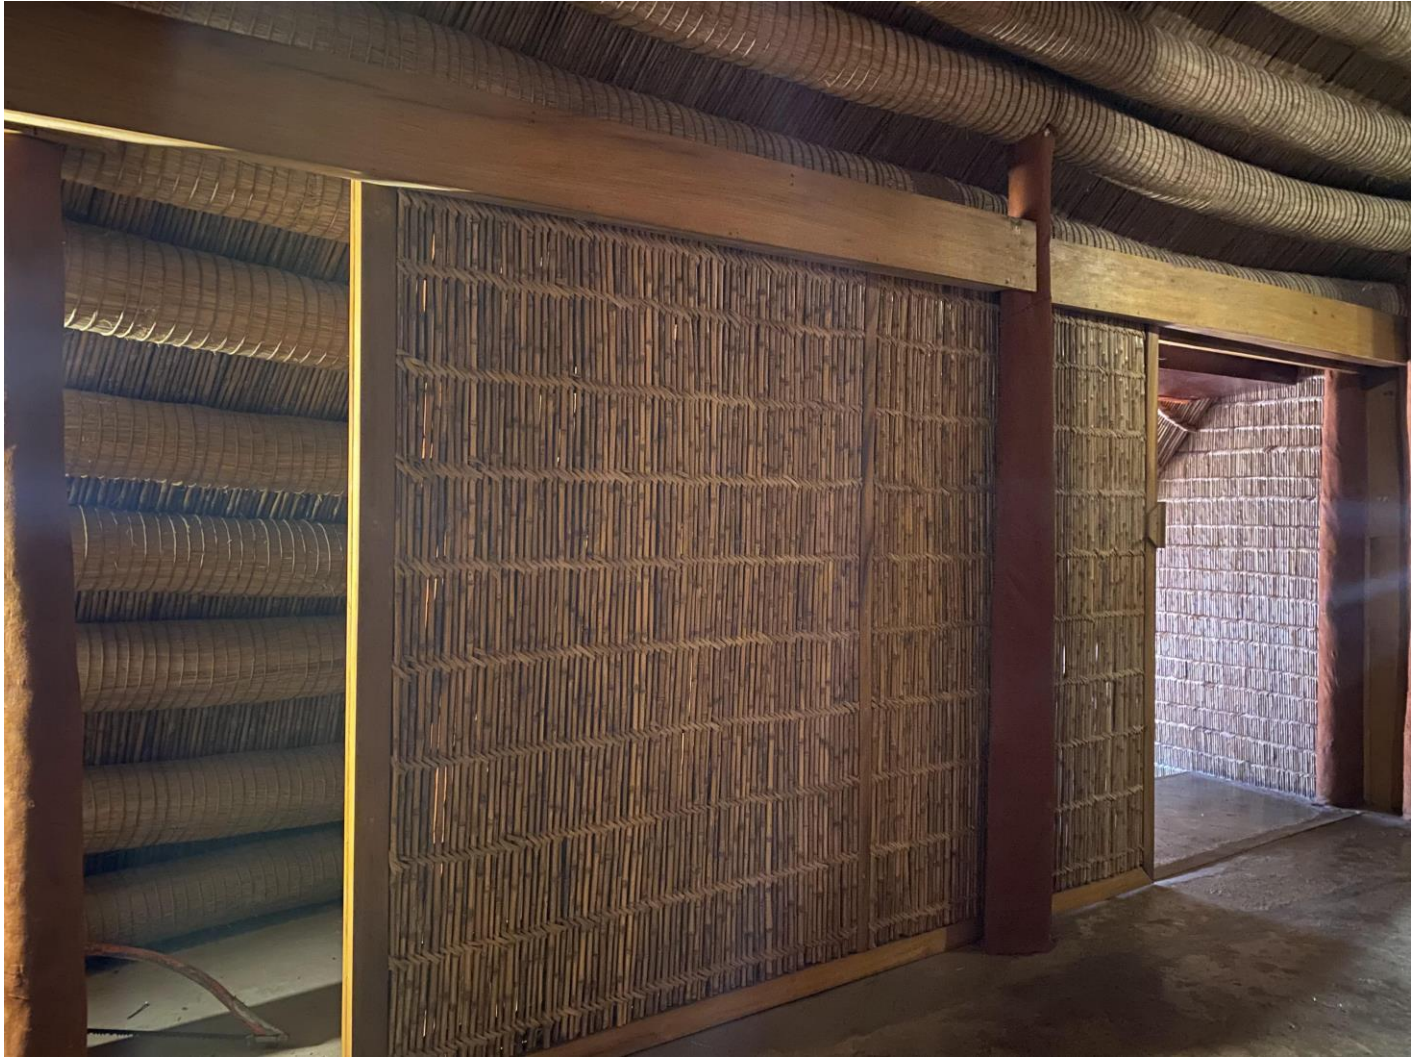
The Image showing the interior side of the reeds-make door of the Muzibu – Azaala – Mpanga (MAM) with an open section of the door-way.

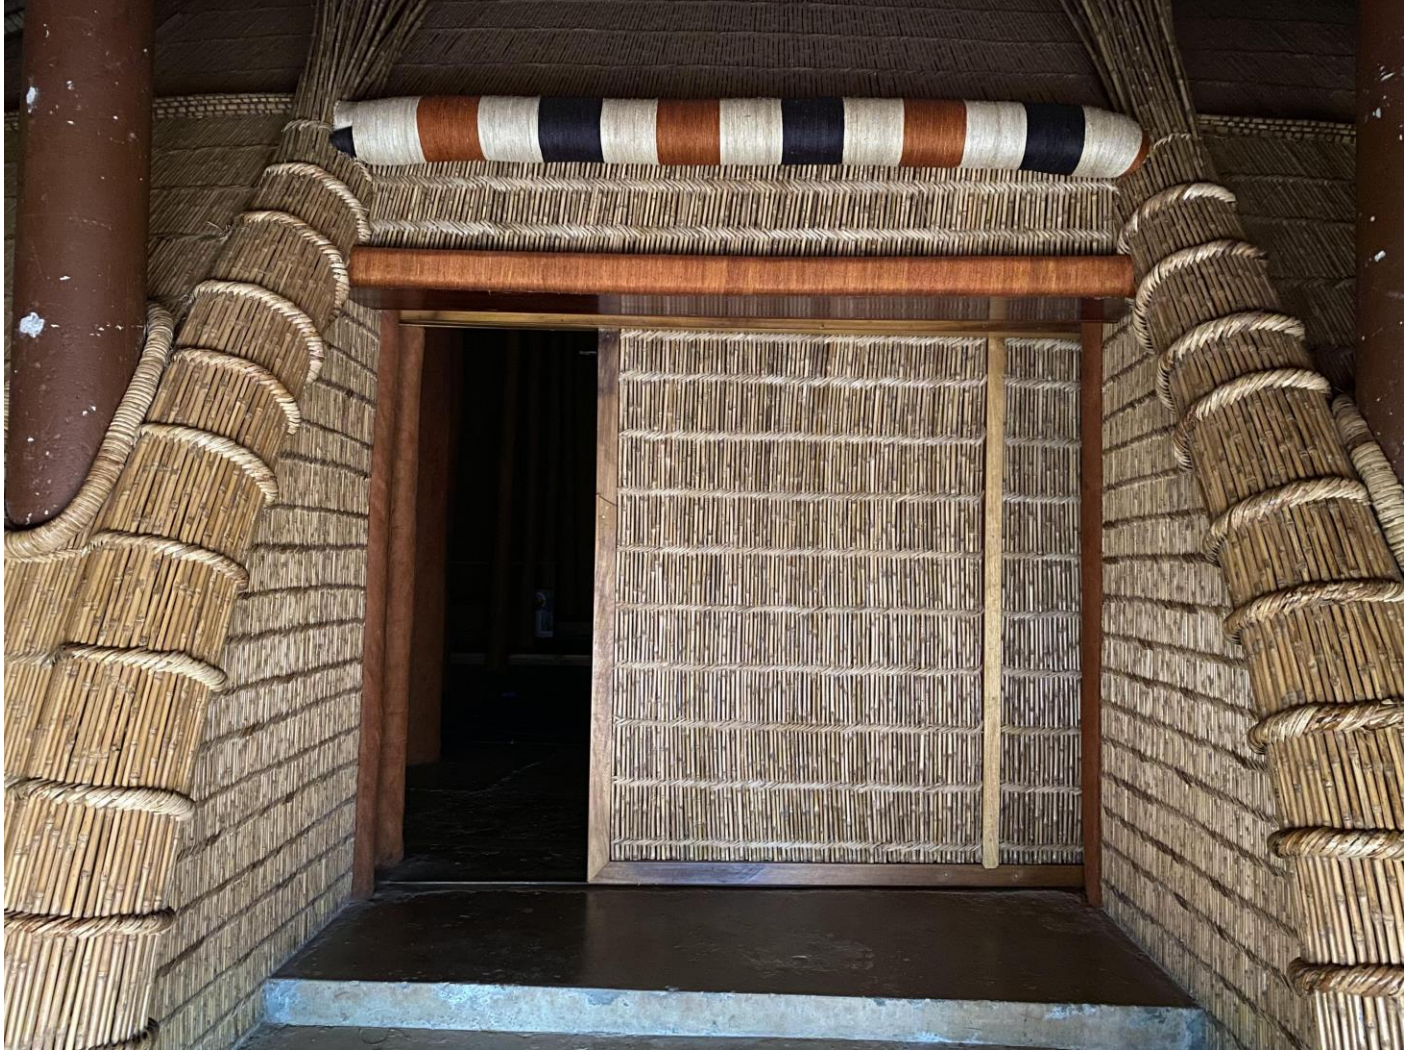
The Image showing the main entrance of Muzibu – Azaala – Mpanga (*MAM*) with a closed section of the door-way.
