REPORT
of the joint World Heritage Centre/ICOMOS
Reactive Monitoring mission
to the World Heritage property ‘Centennial Hall in Wrocław’ (Poland)
10-12 September 2024

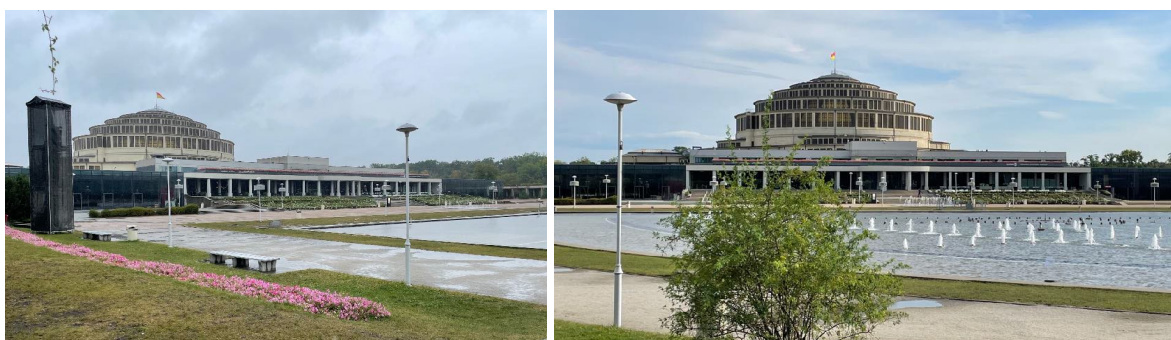
In view of its relevance for the OUV of the property, the restoration and rehabilitation of the Centennial Hall should be regarded as successful. The mission found only some aspects of the exterior views less successful. For one thing, the yellowish tinct of the Hall has been criticised by third parties and the question was raised whether the current appearance conforms to the original colour of the structure. Apparently, it is the effect of later measures, and whilst it is debatable whether the colour is in itself a problem, there is a certain dissonance with the neutral and cold grey of the Terrace Restaurant and Event Centre, which, however, were reconstructed at a later stage.

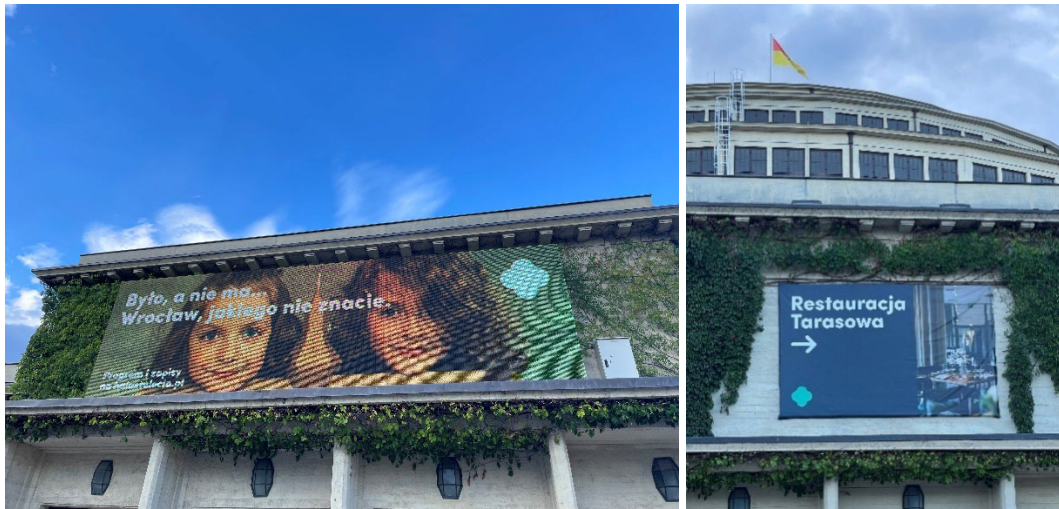
The south front of the building bears a very large video screen showing animated advertisements. This screen clashes with the design and quality of the Hall. Another somewhat insensitive and intrusive element is the signage affixed at some points of the Hall's walls, for example for the Terrace Restaurant. These elements are not in keeping with the OUV of the property and its central building and should be removed.

- Remove the large video screen with animated advertisements and the signage posters on the exterior walls of the Centennial Hall.
- Consider replacing the asphalt walkway underneath the pergola with a mineral surface conforming to the original situation.

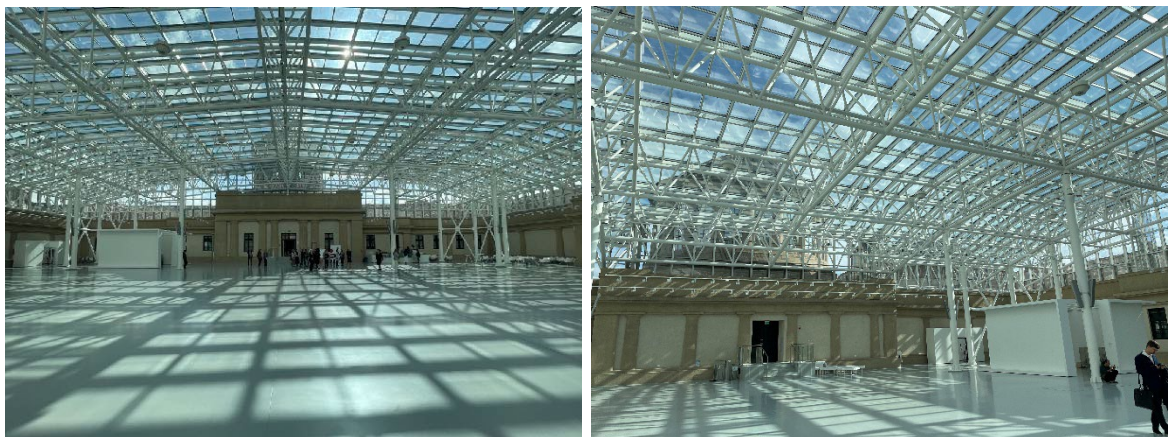
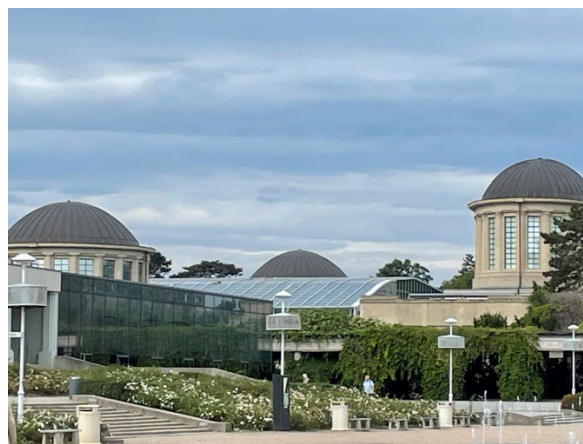
The new steel construction surmounting the whole of the interior yard creates such a dense and impenetrable network of girders and profiles that the four domed pavilions surmounting the centres of the four sides can only dimly be seen from within the courtyard. Furthermore, the formerly dominant view towards the Centennial Hall is now obstructed to such a degree that only a visitor who is actively searching for a glimpse of the neighbouring building will be able to ascertain that it is fact there. For all intents and purposes, the original dialogue of the two buildings, that was clearly intended by Poelzig as a feature and quality of the design, has been destroyed. Moreover, the glass roof over the courtyard is seen from one of the key viewpoints in the property, where many visitors pass – from the area in front of the Terrace Restaurant thus impacting the visual integrity of the property.

It remains unclear whether the new roof serves a sensible purpose, let alone whether there was a need for it. The area cannot be used to display paintings since it is not protected from sunshine. In view of the fact that the doorways opening onto the courtyard are all rather small in size, it can neither be used for displaying larger statuary. Moreover, there does not seem to be a dire shortage of space in the rooms of the four wings around the yard. But even if there had been a need for a roof, a far less obstructive structure and a more delicate design could have been considered. The State Party should have ensured that a Heritage Impact Assessment was carried out as a pre-requisite for such a major development project within the

As it is, the new roof over the courtyard of the Four Domes Pavilion must be assessed as a serious impairment to the OUV of the property, impacting negatively not only the Pavilion, which is one of its key attributes, but also the significance of the overall architectural concept in relation to the Centennial Hall. The mission therefore recommends planning the new roof's removal at the earliest possible time, despite the costs incurred in its construction, in order to restore this important attribute to its original shape.

- Plan the removal of the glass roof over the courtyard of the Four Domes Pavilion at the earliest possible time in order to restore this important attribute to its original shape.

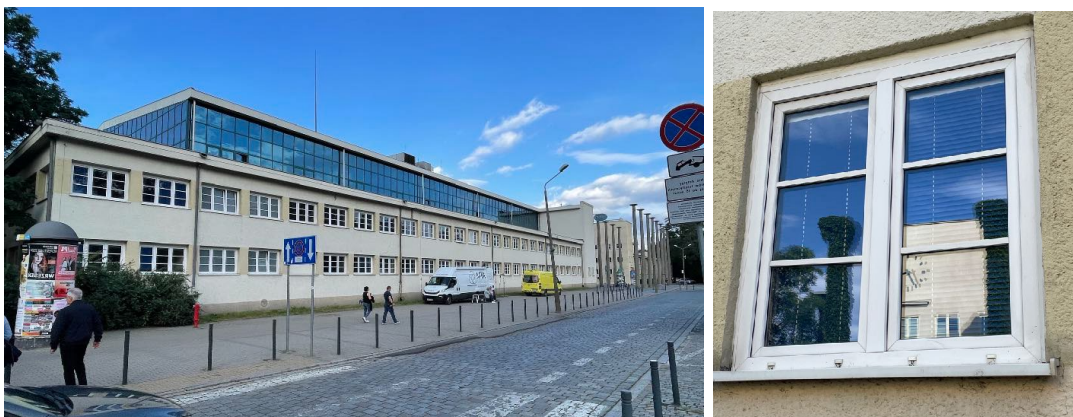
The building of the IASE (Institute for Power System Automation) flanking the western approach to the Centennial Hall on its southern side has seen a certain amount of interior reorganisation and reshaping to make it usable for a wide variety of events and purposes, providing space for exhibitions or conferences. In view of the fact that the building suffered damage during and after World War II, these changes and adaptations do not seem to have caused any loss of significance. On its exterior, the building's appearance is impaired by elements that seem to go back to repairs and restorations before the inscription of the property on the World Heritage List – namely the wide areas of blue glass characterising the modern windows facing west and east, but also the UPVC windows on the northern facade towards the access area of the site which seem to be near the end of their expected lifespan. Both these window elements would seem to be obvious candidates for more sympathetic replacements. The mission recommends replacing the plastic windows with new windows in appropriate material and construction.

- Continue efforts to identify funding to restore the historic building of the Children's Sanatorium within the property.
- Replace the plastic windows in the building of the Institute for Power System Automation with new windows in appropriate material, design and construction.

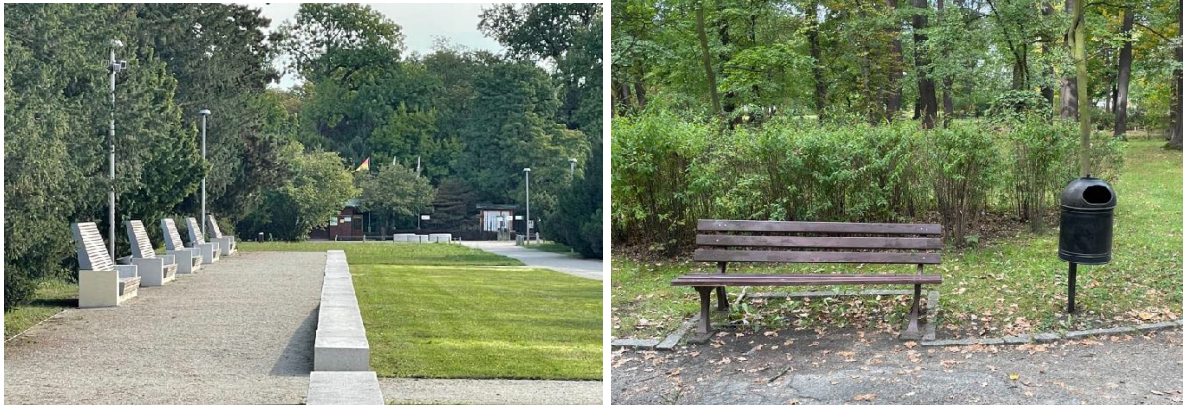
The World Heritage property extends to include a small but significant portion of the historic Szczytnicki Park, whereas a larger portion of the park is included in the buffer zone towards the north and the east of the property. The park is being managed according to principles in which aspects of ecology and of popular expectations appear to have rather more weight than established principles of managing historic gardens. This becomes apparent in the attitude

towards dying and dead trees which are left to decay and to become habitats for all sorts of animals rather than being removed and replaced by appropriate new plantations. Having said that, it is not suggested that this approach is necessarily detrimental to the OUV of the property. There are projects afoot to modernise and beautify aspects of the park, such as replacing the rather unsympathetic asphalted walkways with mineral ones. Unfortunately, this also includes introducing newly designed park benches and rubbish bins: with their massive concrete bases and very high backs, the benches introduce an alien and overdesigned element into the park, in comparison to the harmless and traditional benches currently in place. The mission recommends abandoning the introduction of the new over-designed benches in the Szczytnicki Park.

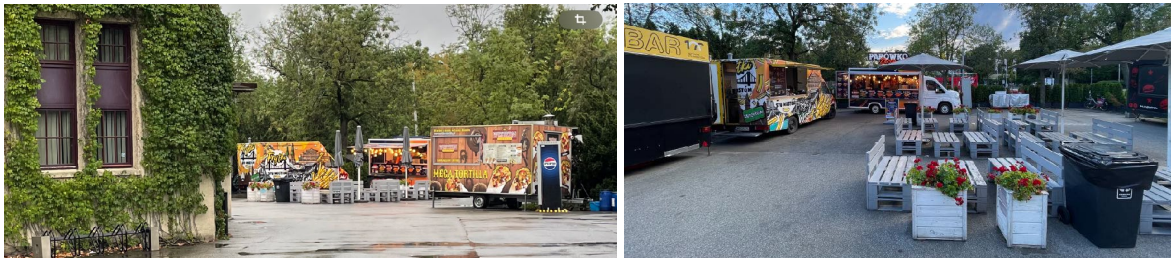
Directly adjoining the south side of the Centennial Hall, and facing the large video screen mentioned above that is mounted on the building's south front, is a dedicated food truck area consisting of several brightly coloured pavilions offering fast-food that can be consumed in a seating area in front of them. With its bright colours and the odours produced by the frying fast food, the establishment clashes intrusively with the central element of the World Heritage property and should be removed.

- Remove the Fun Park and the food truck area from the territory of the property and its buffer zone.
- Abandon the introduction of the new over-designed benches in the Szczytnicki Park.

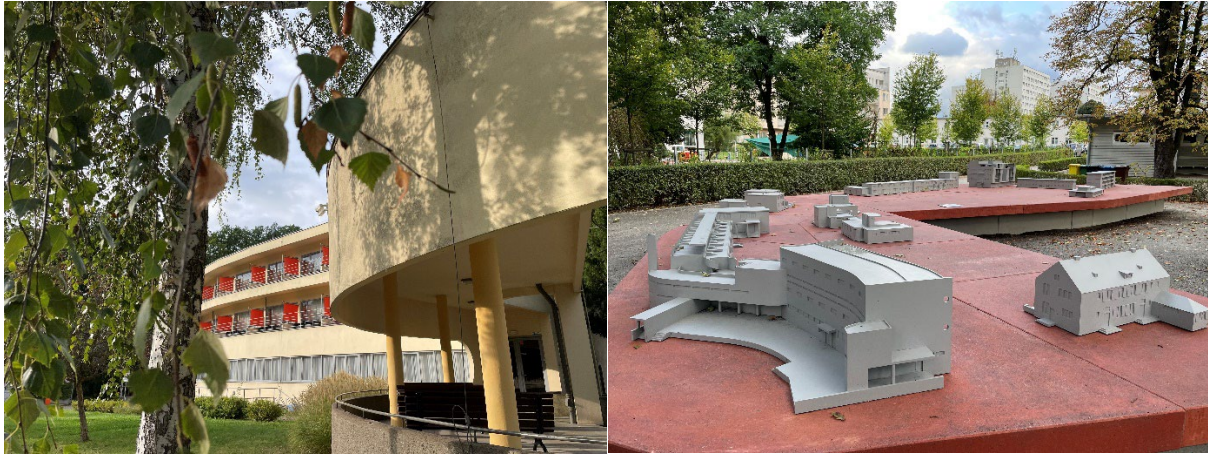
The landscaped area in the buffer zone east of the property includes the WUWA (*Wohnung und Werkraum Ausstellung*) housing estate, a model residential estate produced as an architectural exhibition in 1929 and consisting of buildings by a number of prominent architects at the time. These buildings have been well restored, and their significance is communicated by some added interpretation elements such as a large model of the estate.

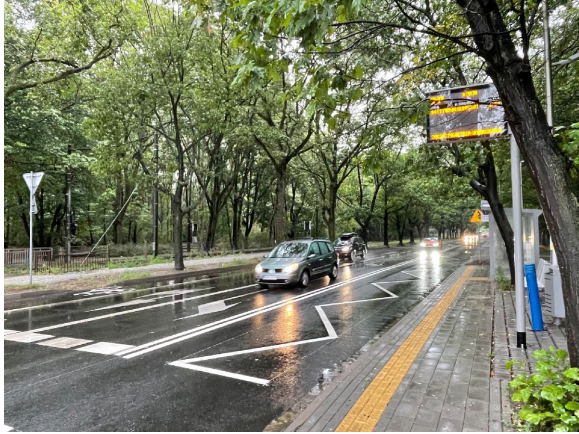
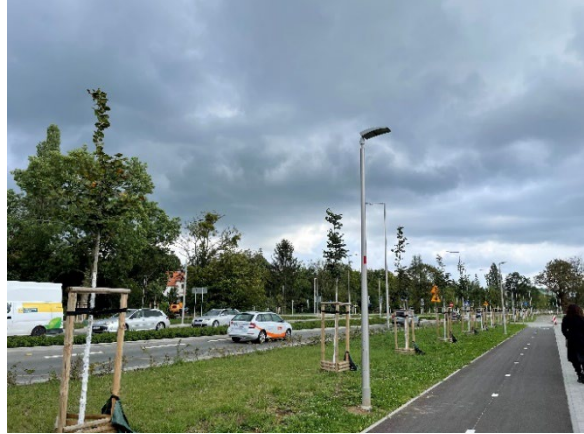
The road has since been built and completed, without a Heritage Impact Assessment. The project produced a stretch of fast road around three kilometres in length, including two new bridges. The road is very wide: its broad overall area includes bicycle tracks separated from the two-lane road by a very wide green strip planted with trees; further trees are planted on the outsides of the bicycle tracks – four rows of trees altogether. Although offering – as the result of protest against the originally planned four lanes – only two lanes for motor traffic, the gash produced by the road could easily accommodate four lanes if that would to be deemed desirable by the city planners at some future point in time.

There can be little doubt that this road project brought significant changes to the area east of the buffer zone of the World Heritage property and that these changes were painful to witness and to experience for some of the residents, particularly those in the immediate vicinity. The project, carried through without regard to established consultation processes regarding World Heritage properties, as outlined in Paragraphs 172 and 118bis of the Operational Guidelines for the Implementation of the World Heritage Convention, is now a *fait accompli* and it is difficult, if not impossible, to say what would have been the outcome had those consultation processes been followed.

Regarding its immediate effect on the World Heritage property however, the mission is of the opinion that no obvious negative impact on the property and its OUV could be identified. There has no doubt been loss of vegetation along the eastern side of the buffer zone, but it seems that those were trees of spontaneous growth and without historic or cultural significance. The mission has also been assured that no new building structures will be erected in the area along the road in this part. Nor could it be said that the new road appears to have any negative impact on the amount of car traffic on the Zygmunt Wroblewskiego Street passing between property and buffer zone just south of the Centennial Hall.

The mission therefore recommends vigilance in view of potential future developments. To that end, it is recommended that the World Heritage Committee seek assurances from the State Party that the Great Island Avenue will not be continued northwards and impact on the buffer zone of the property.

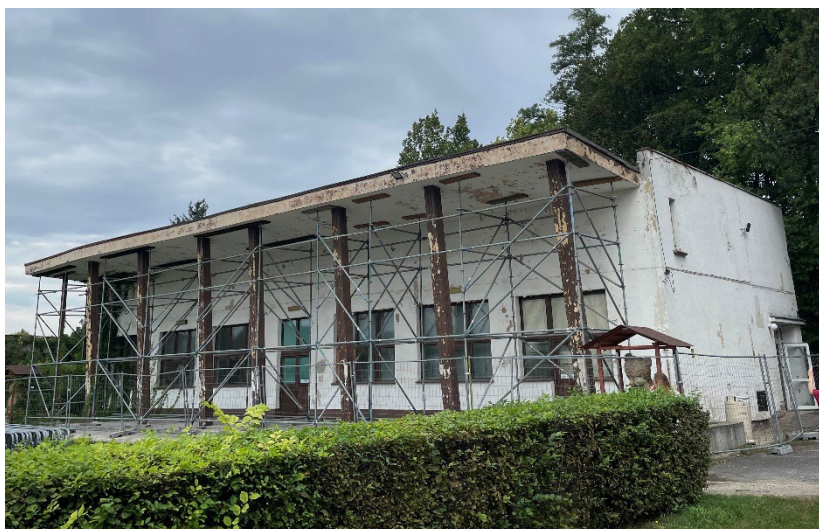
One possible project concerns the rehabilitation and re-use of the building of the day-care centre for children with pulmonary problems designed by the architect Richard Konwiarz in the context of the 1929 WUWA exhibition. It is situated just north-east of the pergola surrounding the pond and fountain. Whilst not part of the original scheme, the building added a significant new layer to the history of the place and should therefore be preserved if feasible. It is however in a very bad state of preservation, and funding for its rehabilitation has not yet been secured. According to the information received, there are plans to renovate the building for educational activities for children and older people and make it also suitable for training courses and conferences. A garden is planned in front of the building, which will not only be used for relaxation but will also allow for outdoor activities. The mission encourages the State Party to identify funding to restore this historic building within the property.
