Conservation Plan for Abila Archaeological Site

Al-Naddaf M.

Department of Conservation and
Management of Cultural Resources,
Yarmouk University
Irbid-Jordan

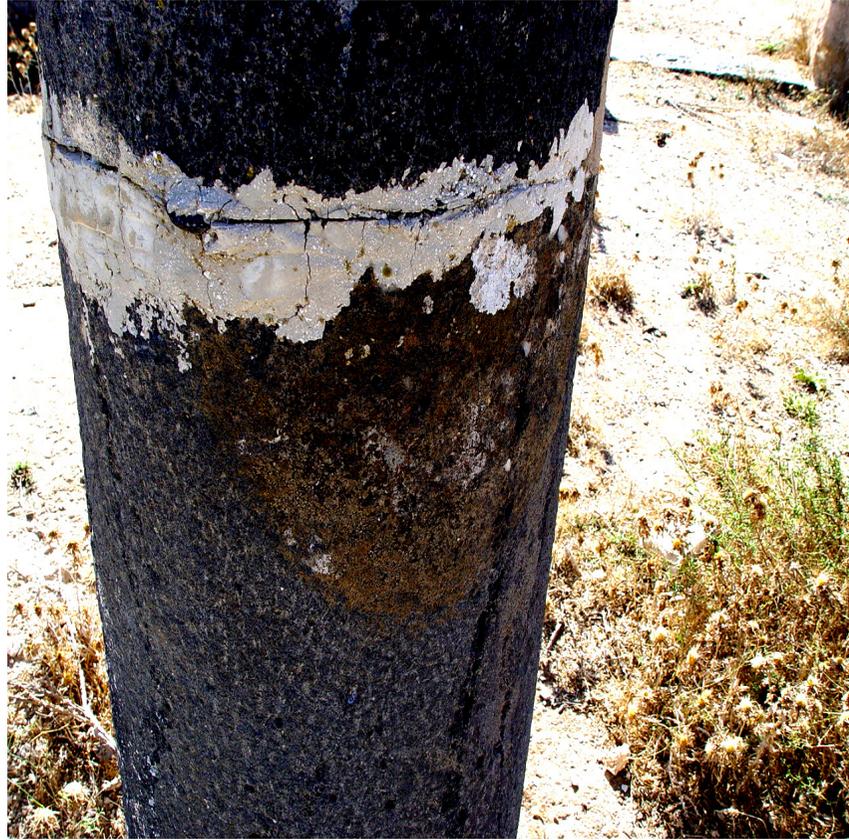
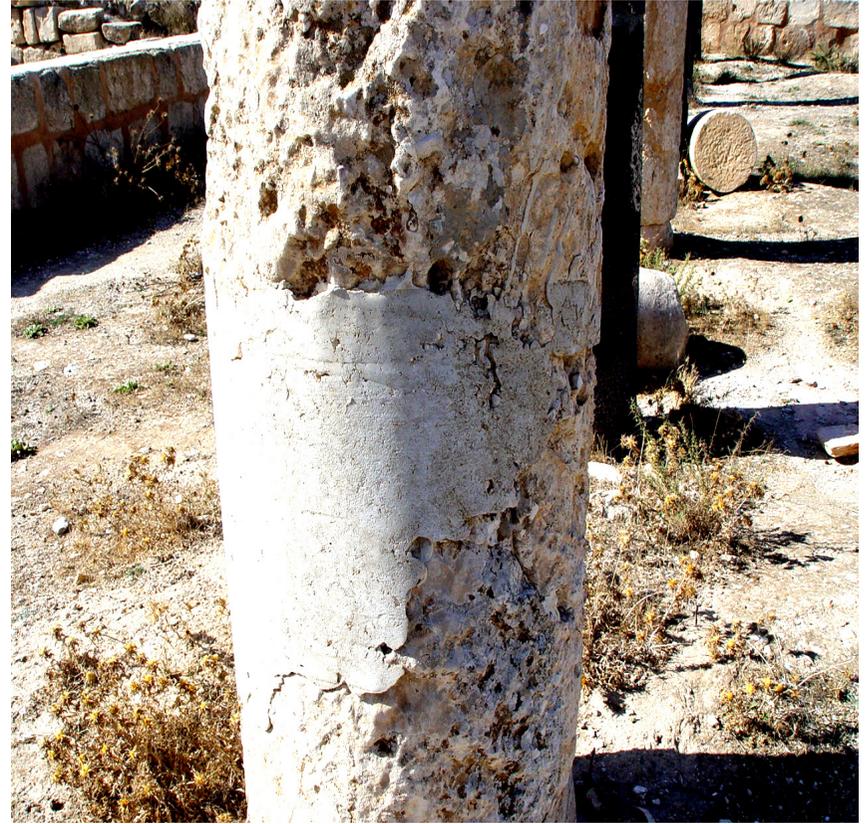
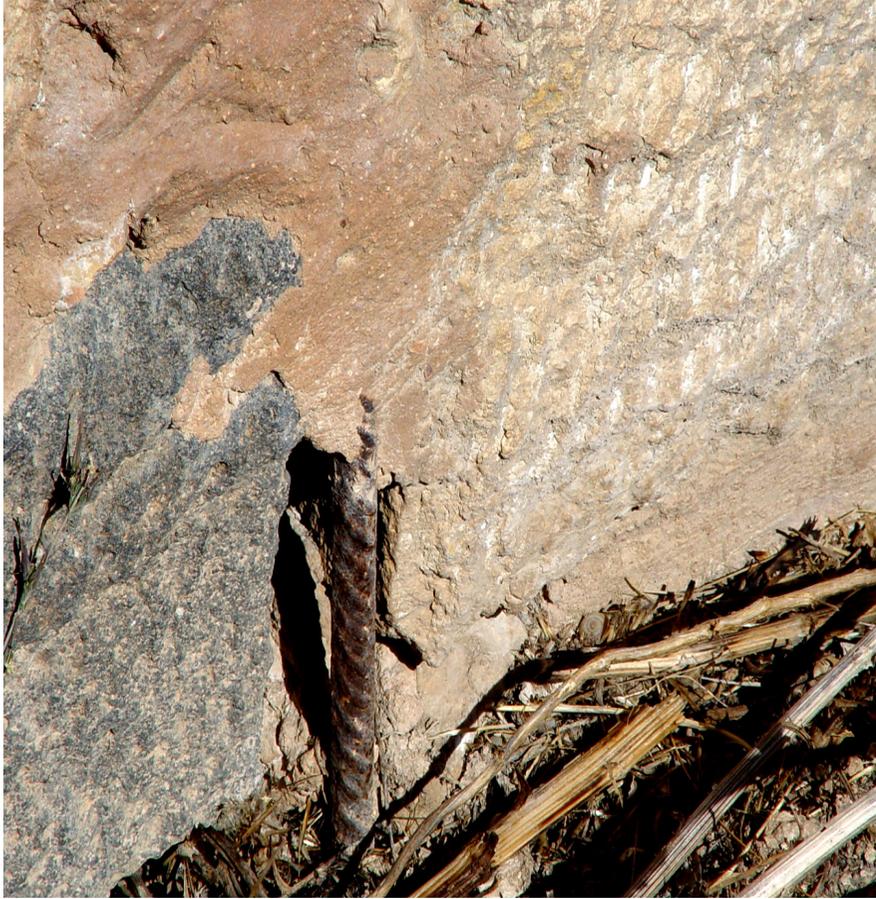
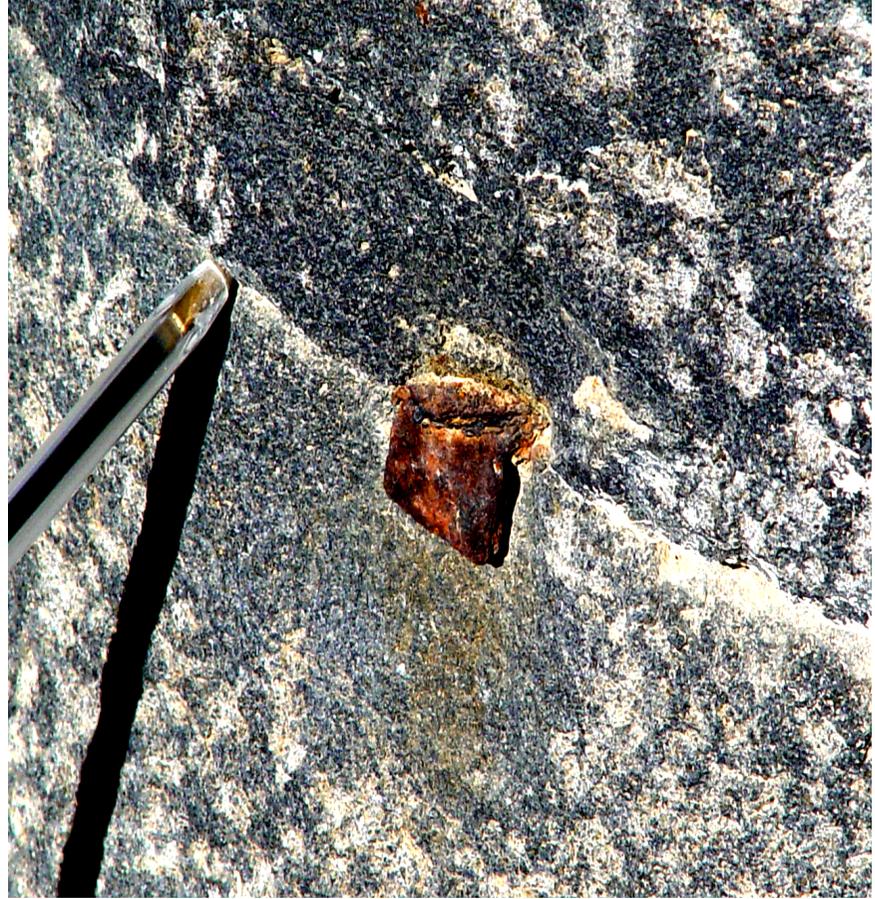
- The deterioration forms that could be documented at the site include:
- cracking,
- soiling,
- blackening,
- lost of strength,
- fungal stain,
- harmful growth of plants,
- graffiti,
- erosion of mortar and plaster

- The first step for preparation of a conservation plan for Abila or any other archaeological site is to study and analyze the present situation of that site.
- Wrong previous conservation, cracking of columns, erosion of mortar joints, dampness penetration through the foundation of the walls, and instability of the foundation, are the main symptoms of deterioration at the site.
- It must be emphasized here that the site is not fully excavated, and even the excavated part is suffering from negligence which enhances the action of the different factors of deterioration.
