STATE OF CONSERVATION

TOMBS OF BUGANDA KINGS AT KASUBI(UGANDA)

PROPERTY ID NO C1022

1stFEBRUARY 2017

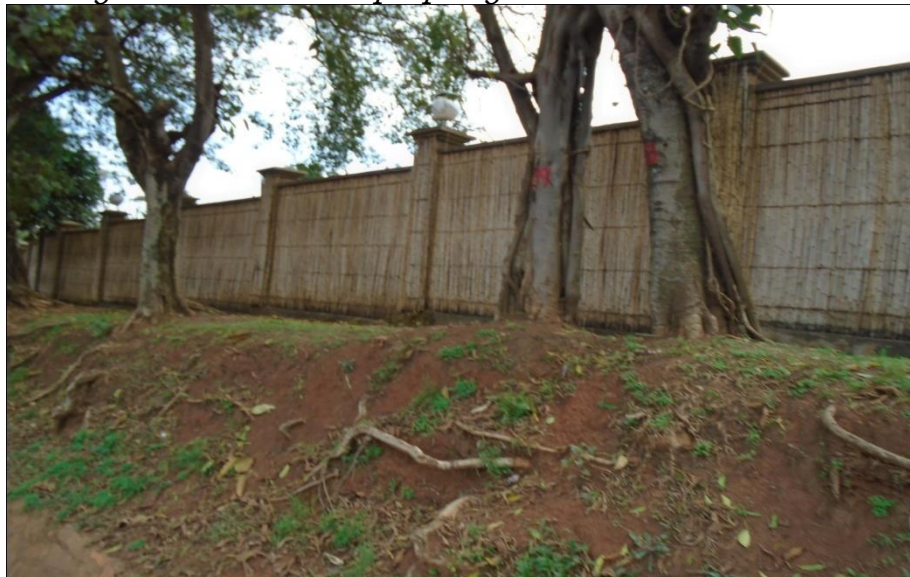
Property wall/bark cloth trees on the Hoima Road.

the bark cloth trees are close to the boundary wall of the property as seen above and 3.5 metres away from the road. This is less what the required road reserve of 5 meters. Therefore the road expansion will be inclined to the opposite side of the property. Annex H .

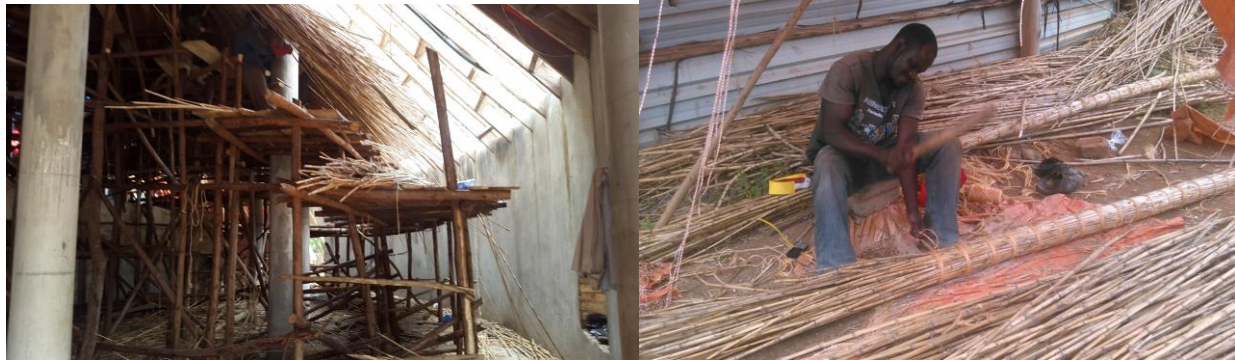
Fig.2a: the ceiling stage in October, 2016 (b) one of the workers bundling and tying reeds together to make a ring bundle.

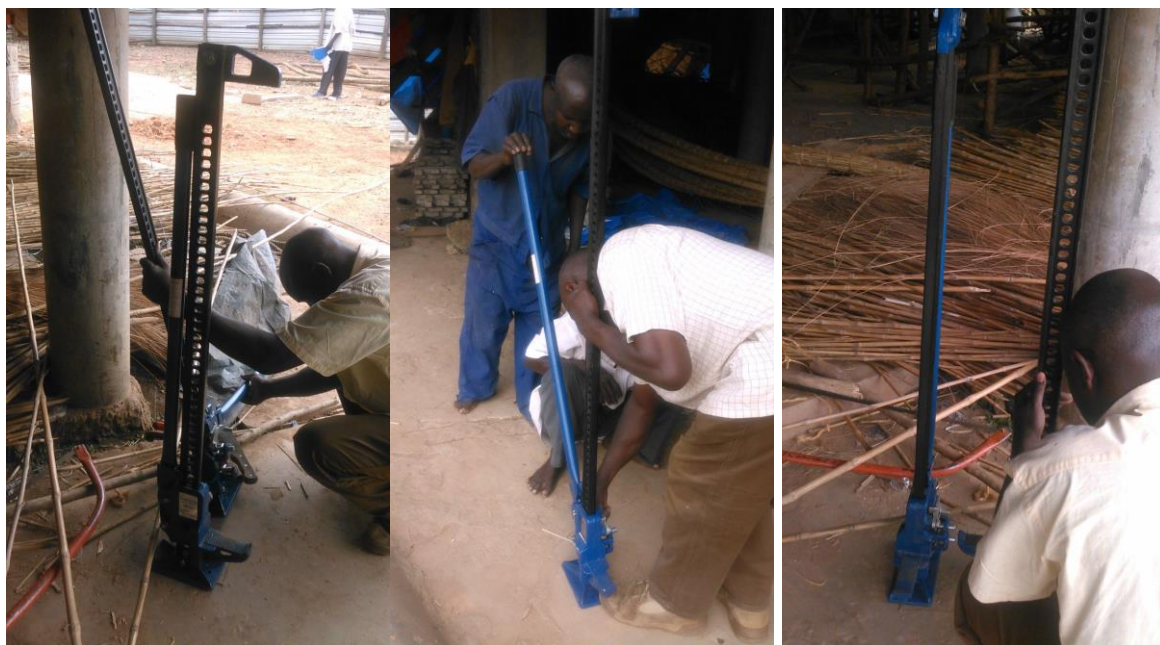
Fig.3: the vehicle jack that is to be used to lift and level the rings on the ceiling reed surface.

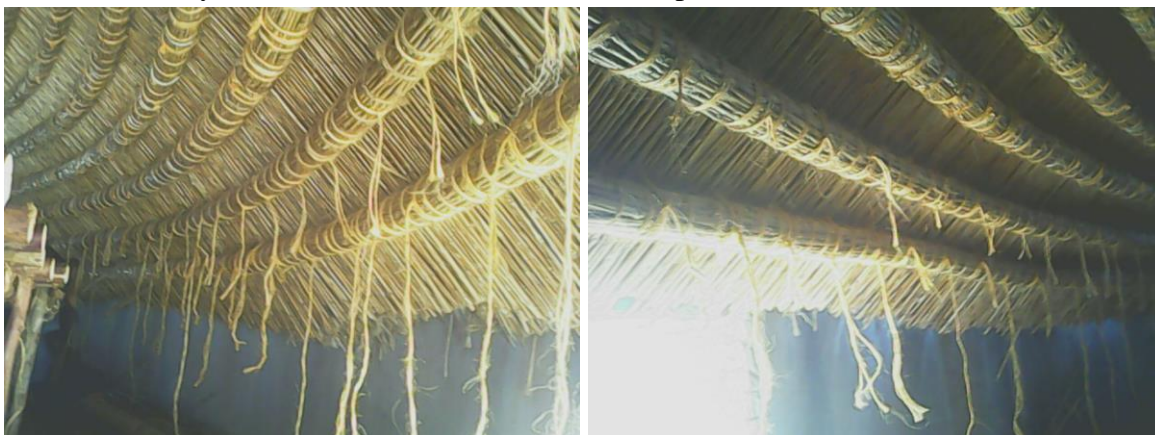
Fig.4: the rings are fixed and tightened onto the reed surface by sisal.

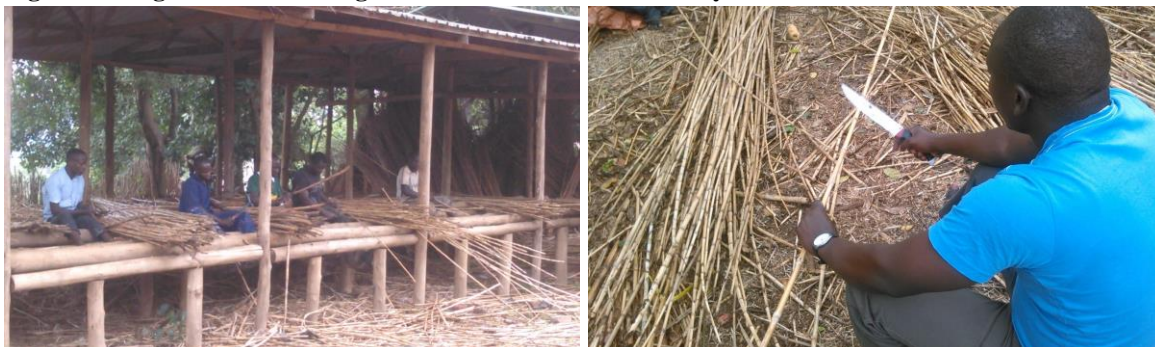
Fig.5: cleaning and sorting reeds, preparations to the reeds to be used.

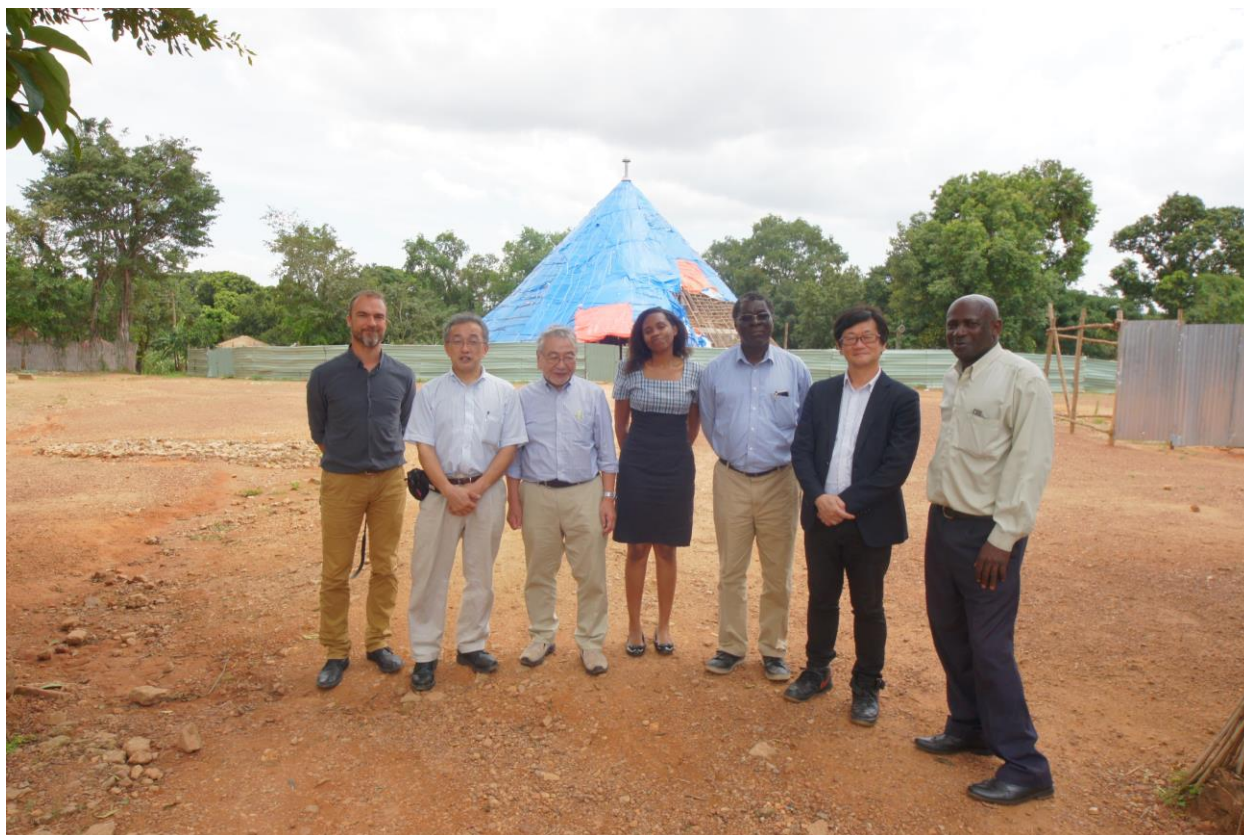
Fig. 13: (L-R): Sebastien Moriset, Junichi Hasegawa, Nitto Kazuhika, Jacqueline Namayanja, Samuel Sentongo, Sugasawa Shigeru, Kigongo Remigius.

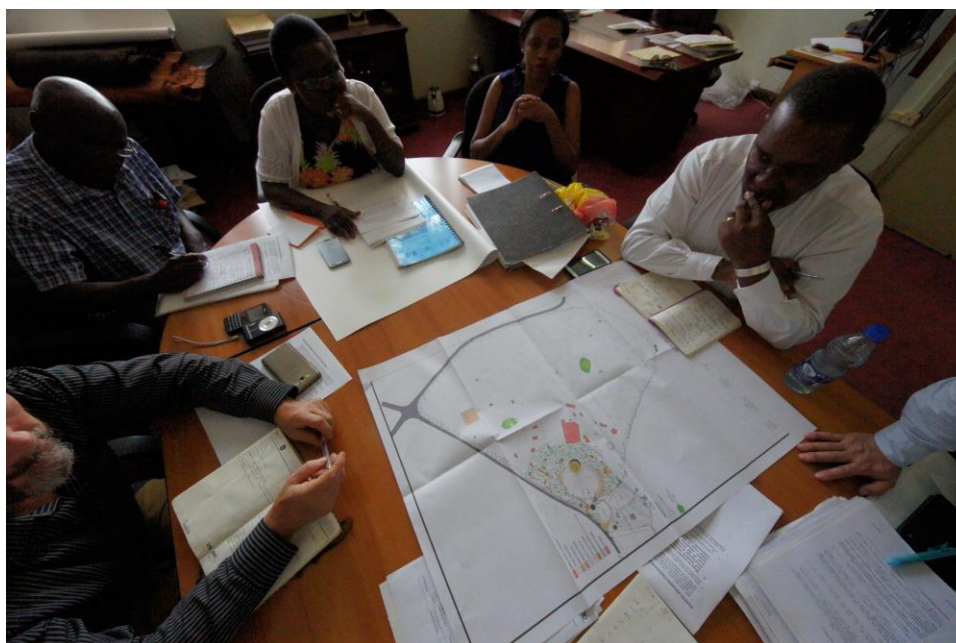
Fig.14: Discussion of the Master plan, at the Museum
(photo by J. Hasegawa)

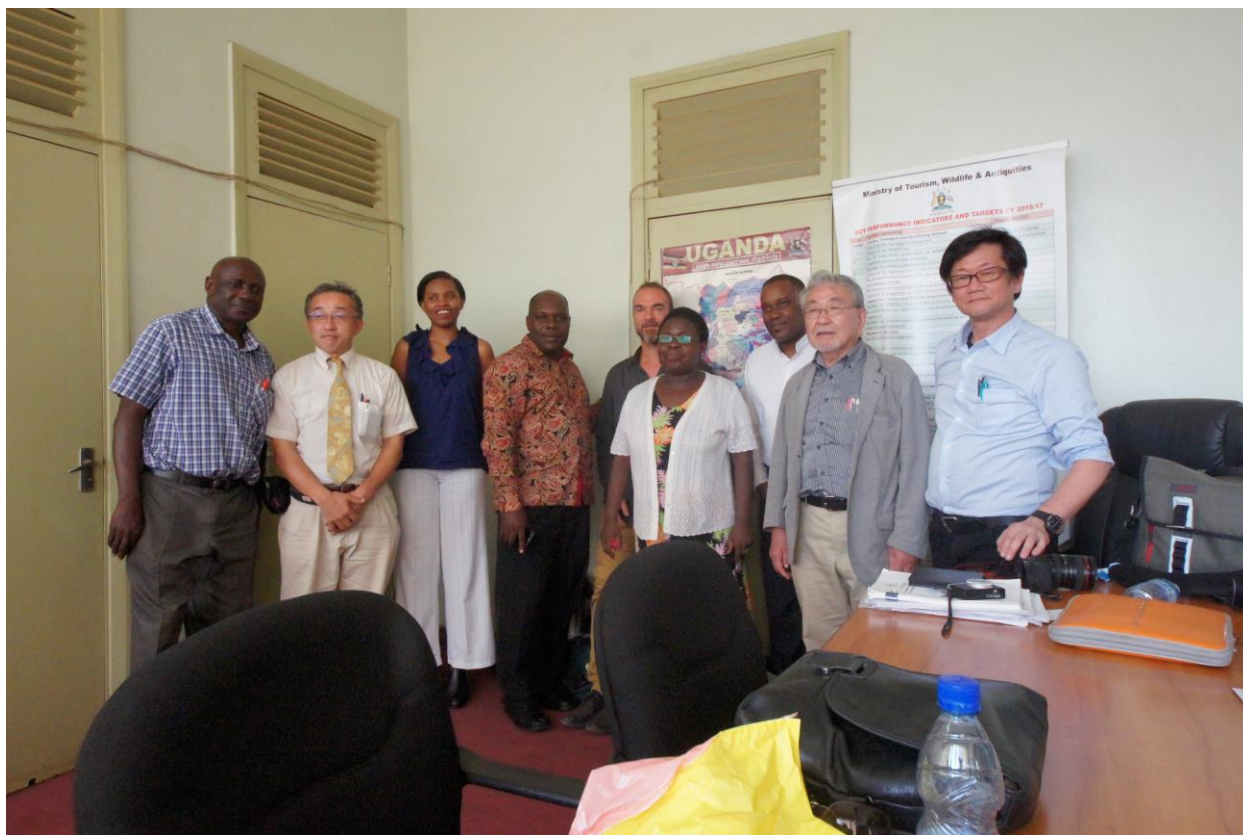
Fig.15: the team takes one more picture after the last discussions on the Master plan.

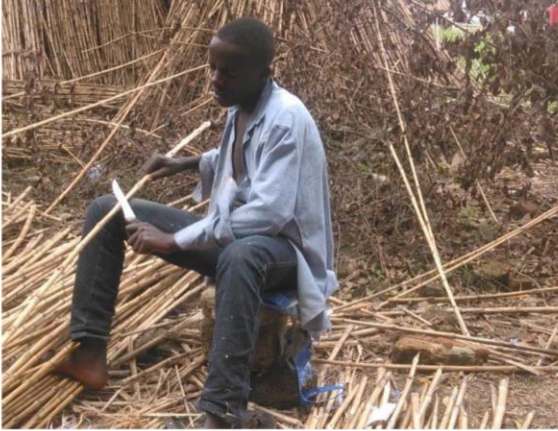
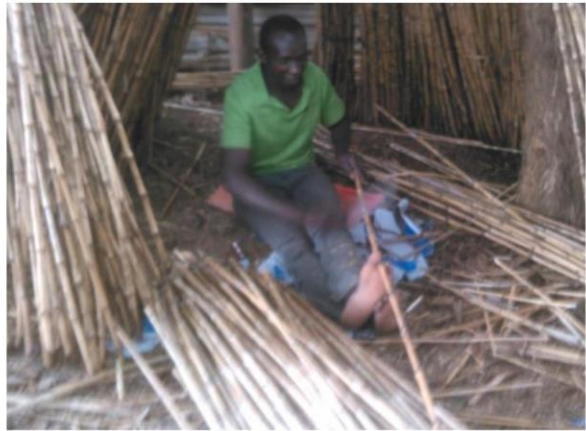
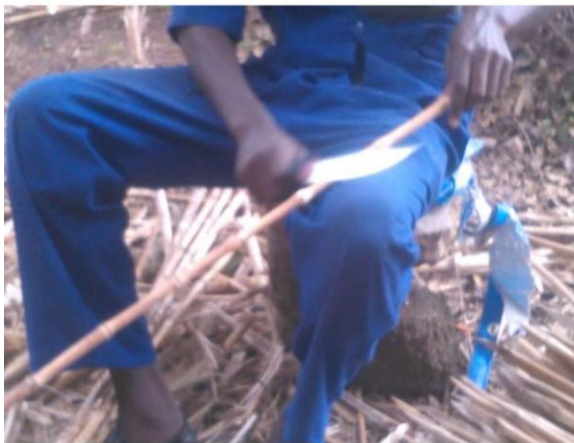
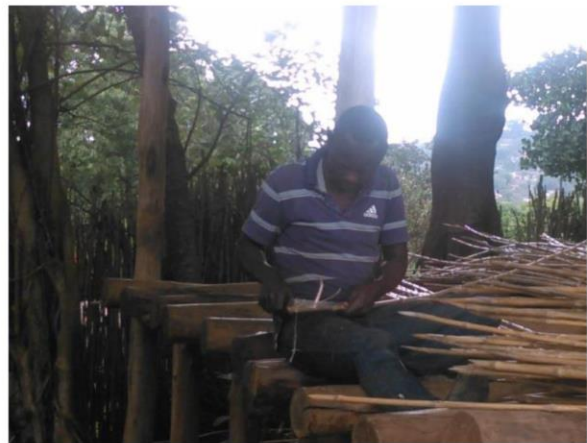
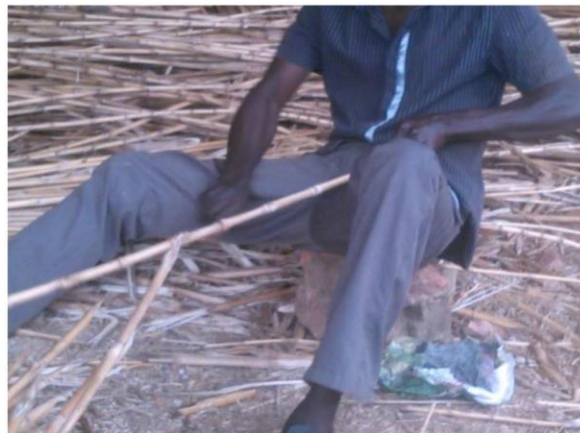
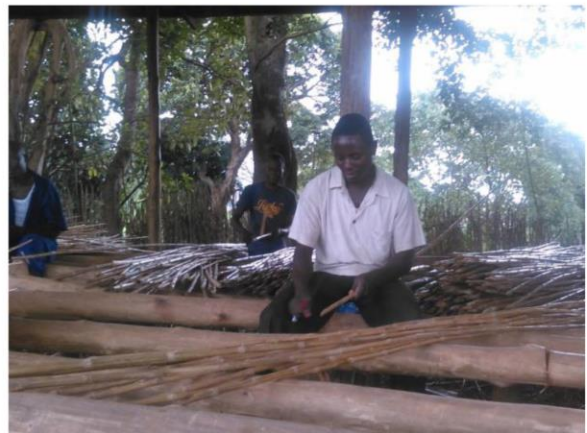
Figure 3: Group C cleaning and wiping reeds

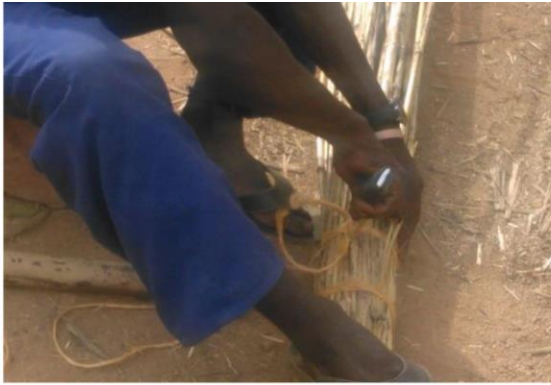
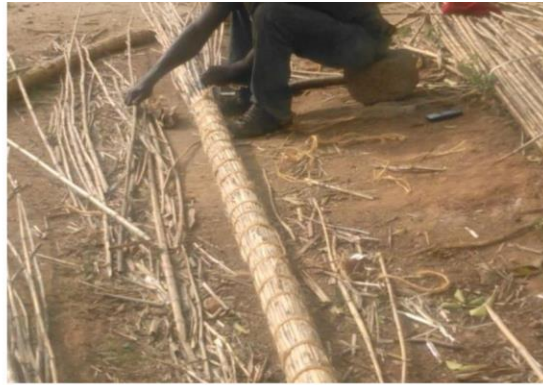
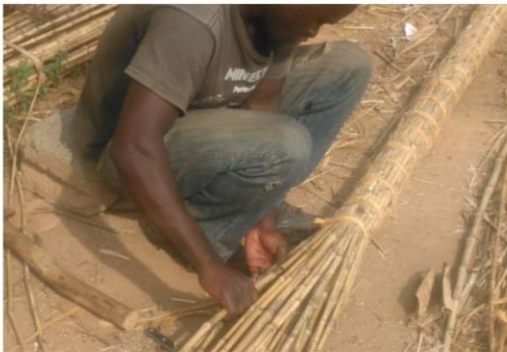
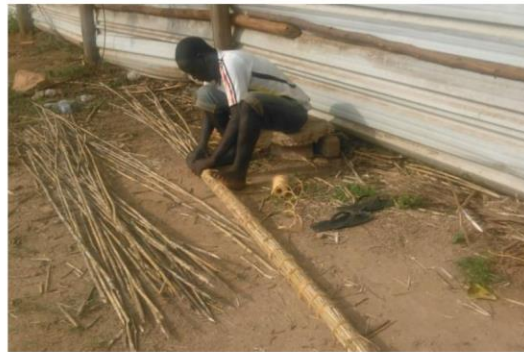
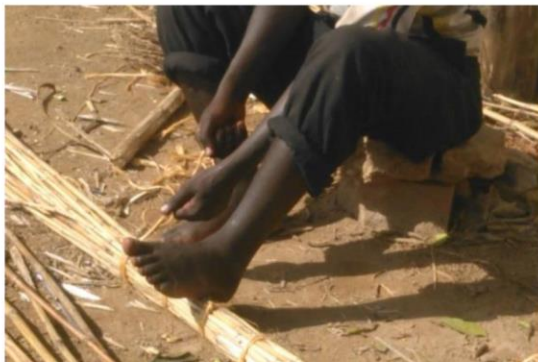
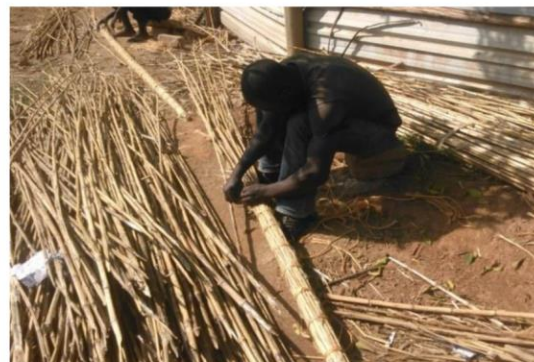
Figure 4: Putting together reeds to make circular rings

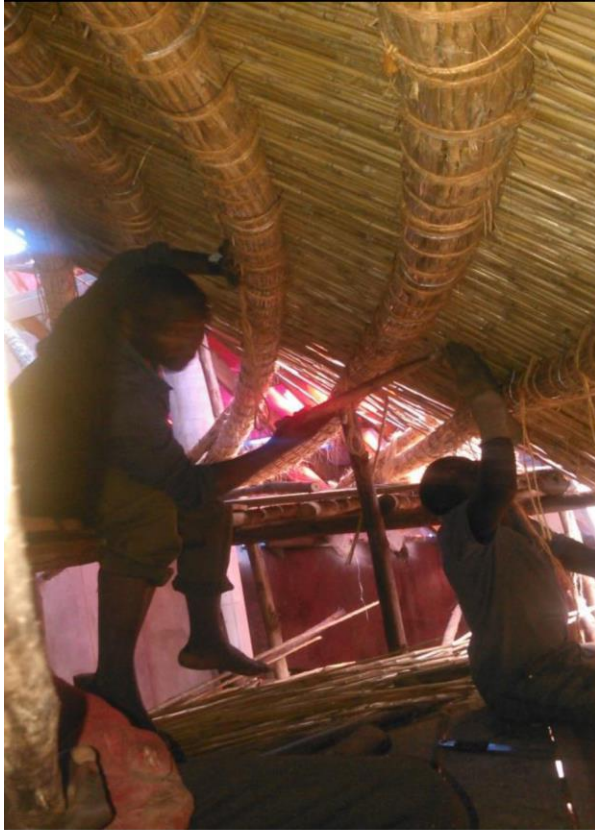
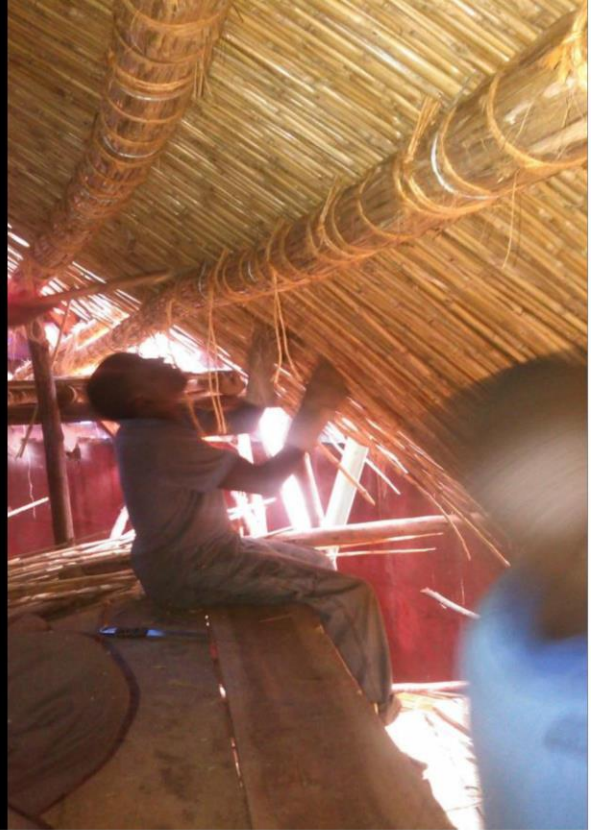
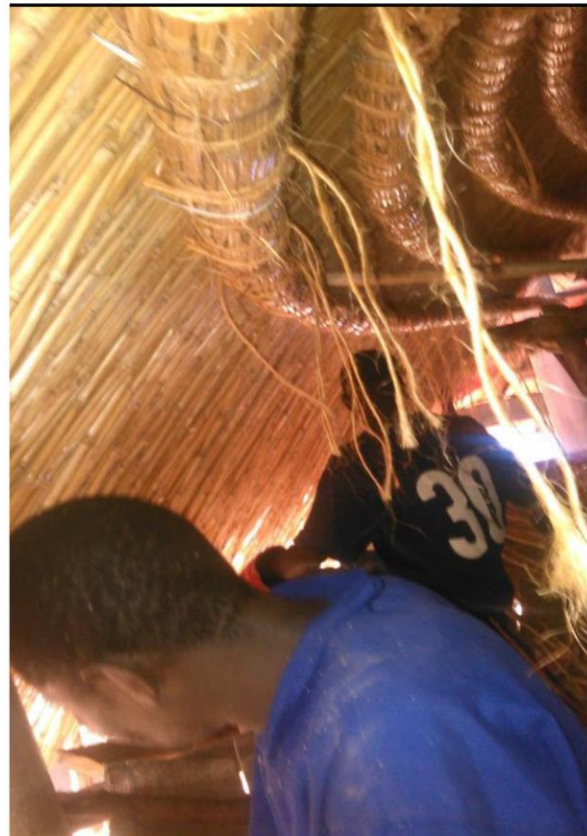
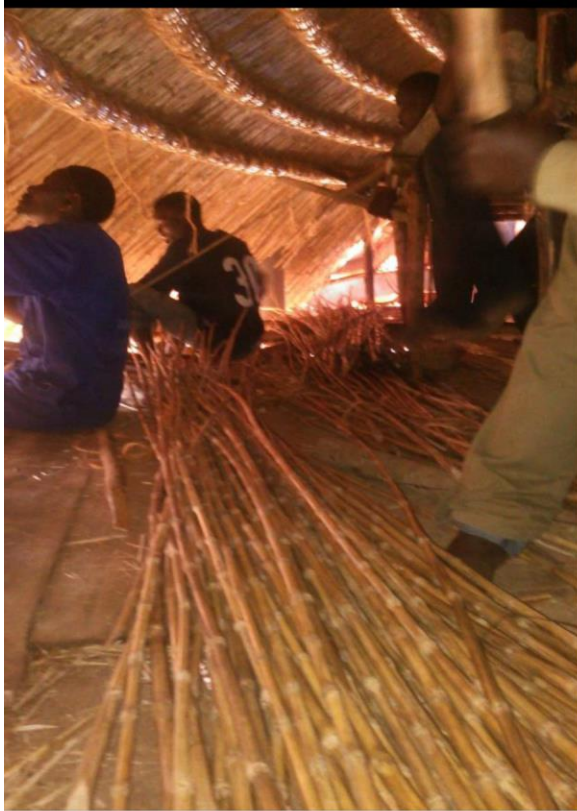
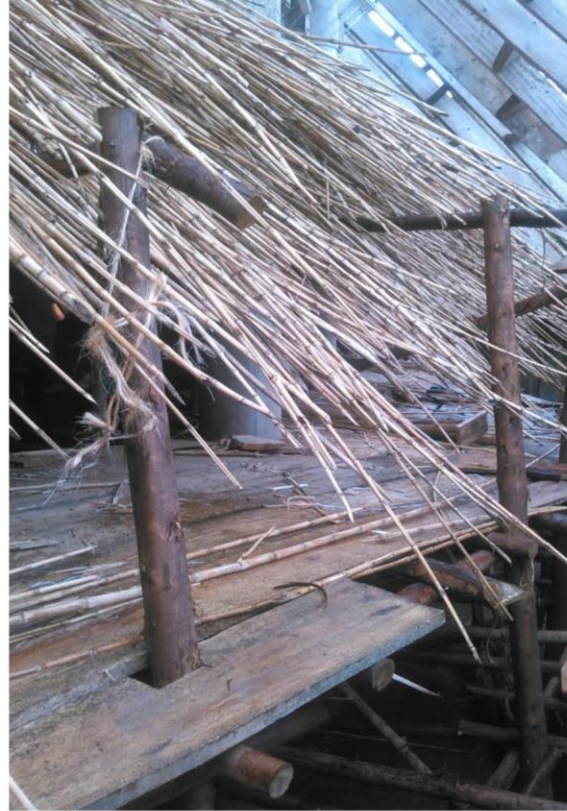
Figure 5: Fixing and aligning reeds

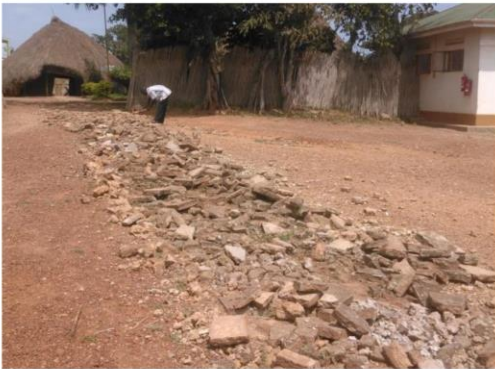
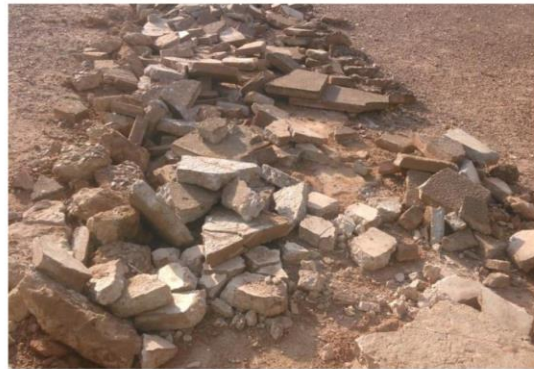
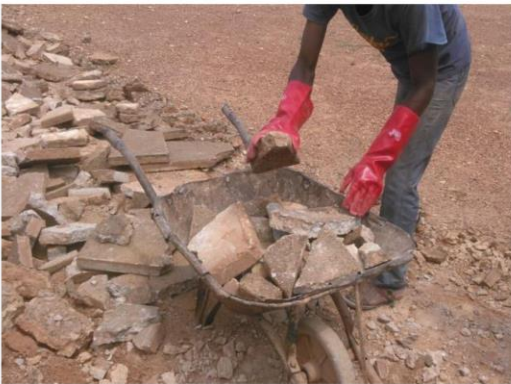
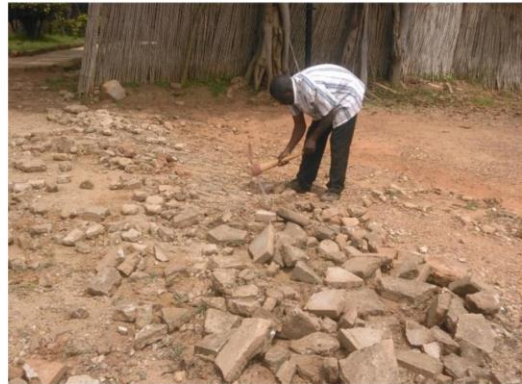
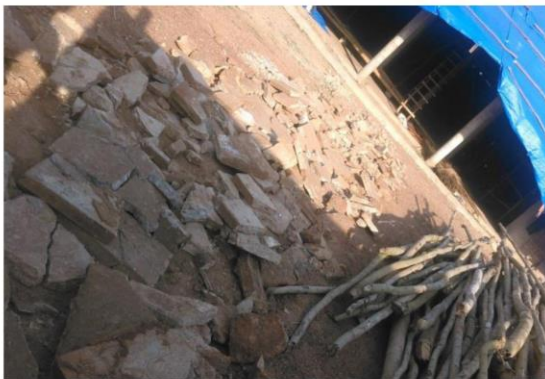
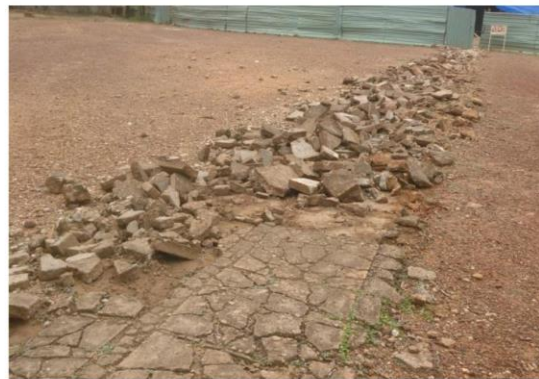
Figure 1: Working removing the broken pavers

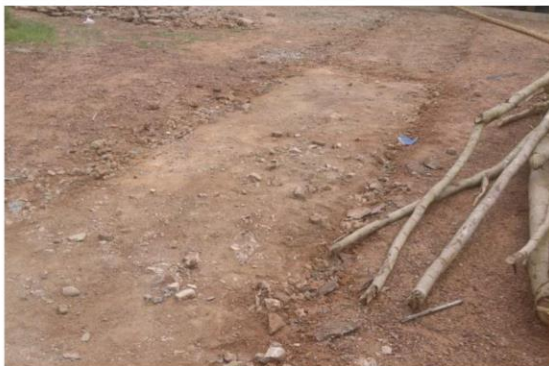
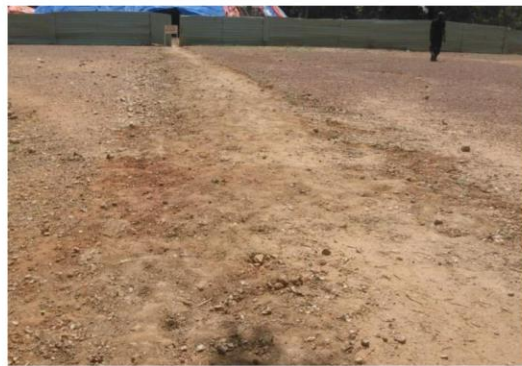
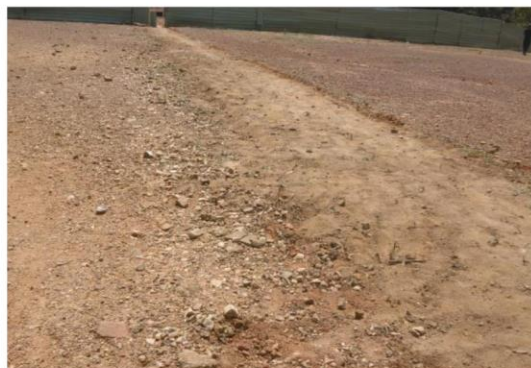
Figure 2: Broken pavers removed and placed in gulleys around site

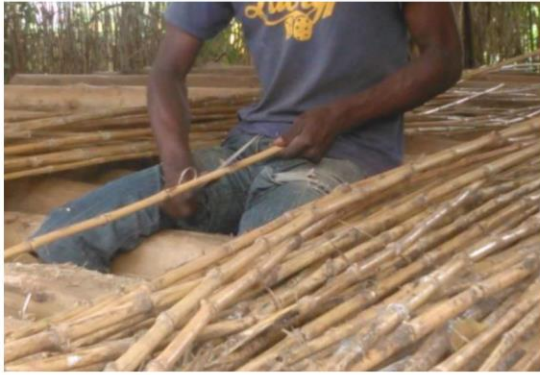
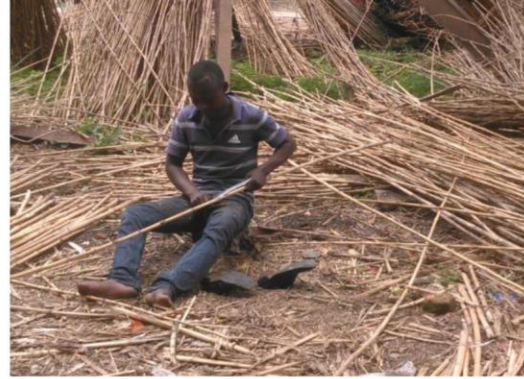
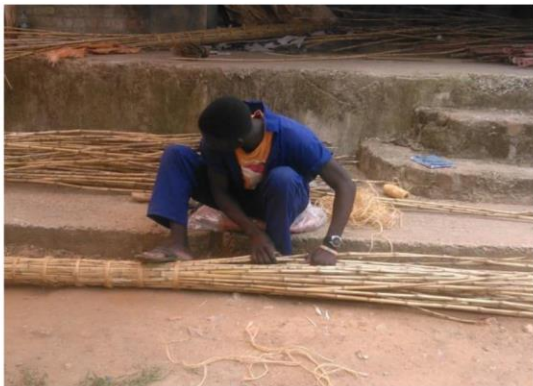
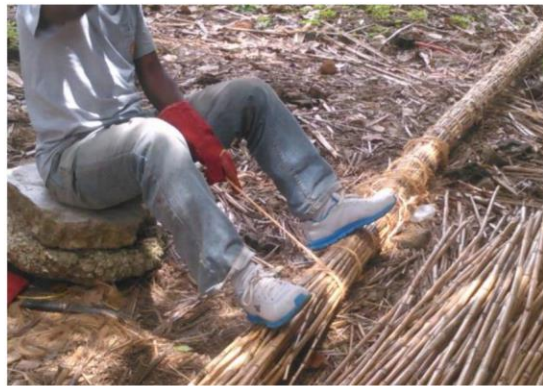
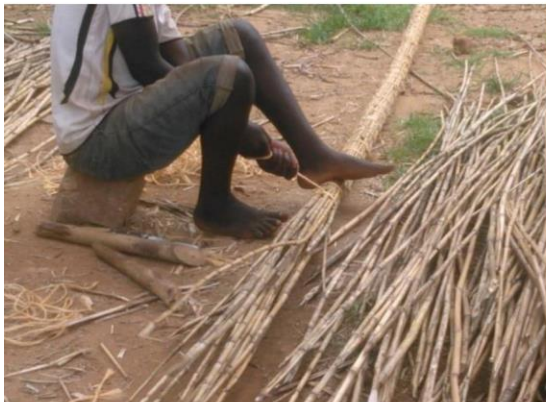
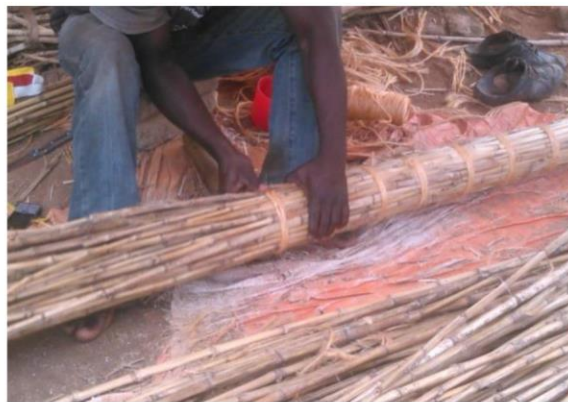
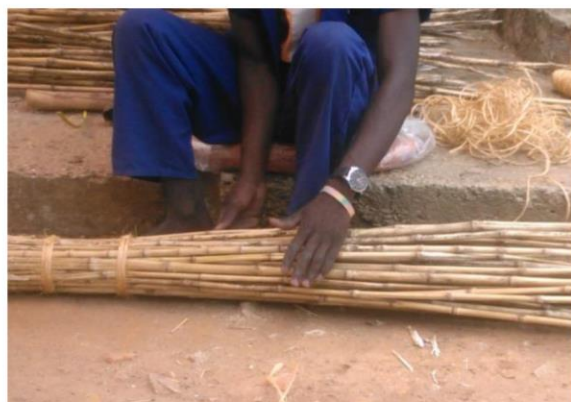
Figure 3: Group C cleaning and wiping reeds

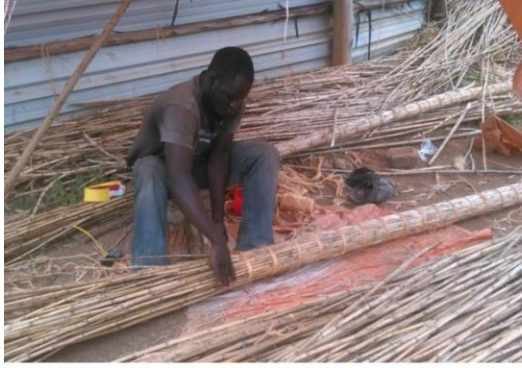
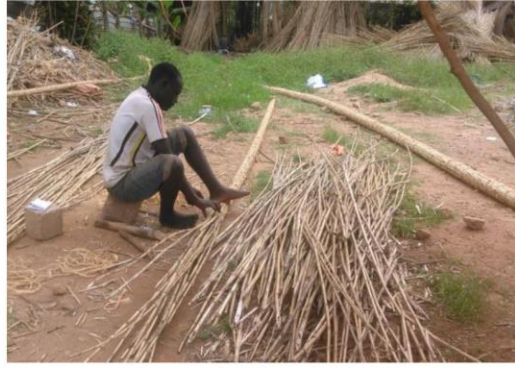
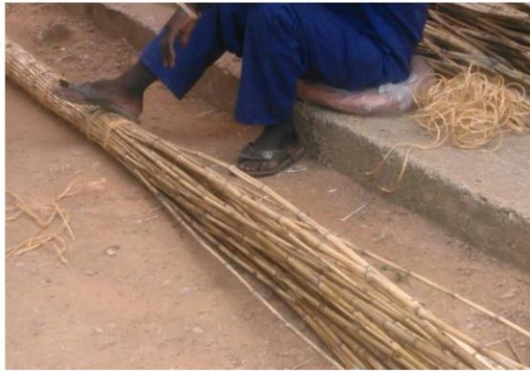
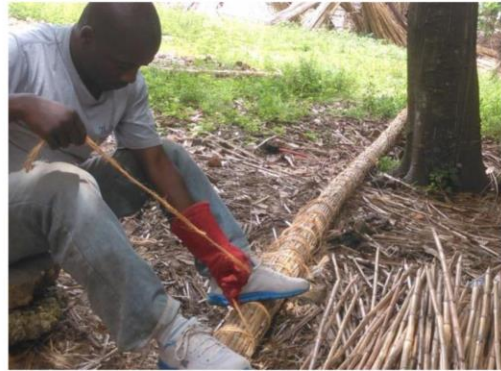
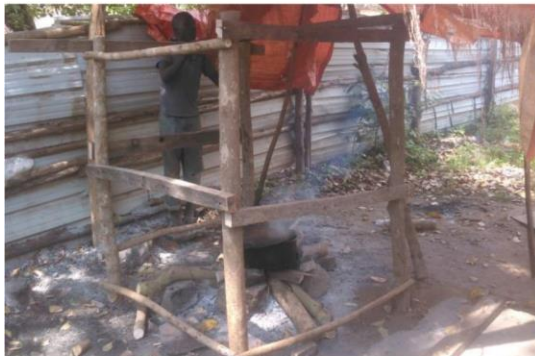
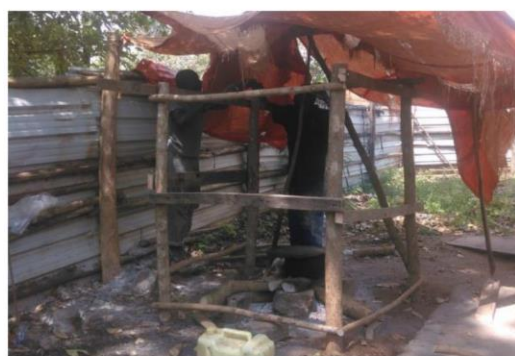
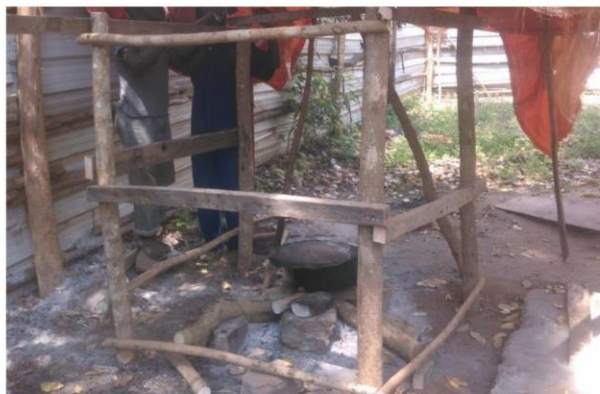
Figure 4: Putting together reeds to make circular rings

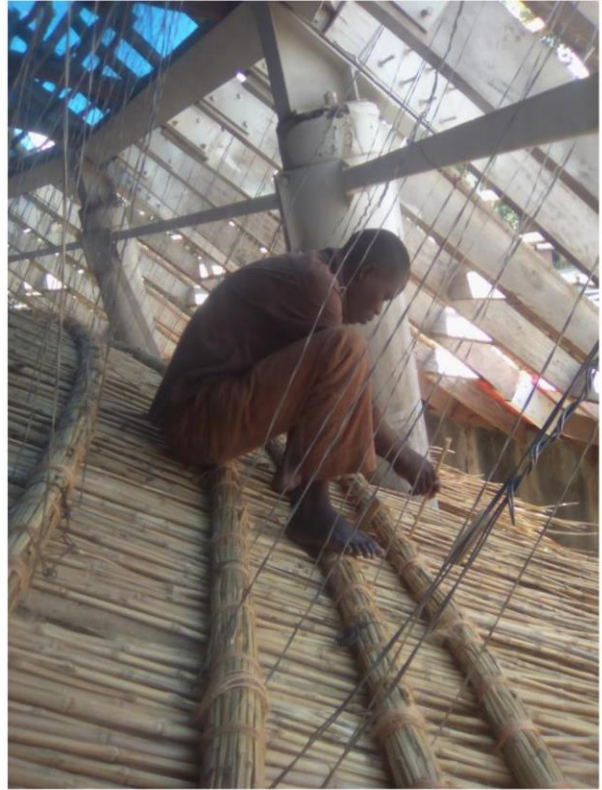
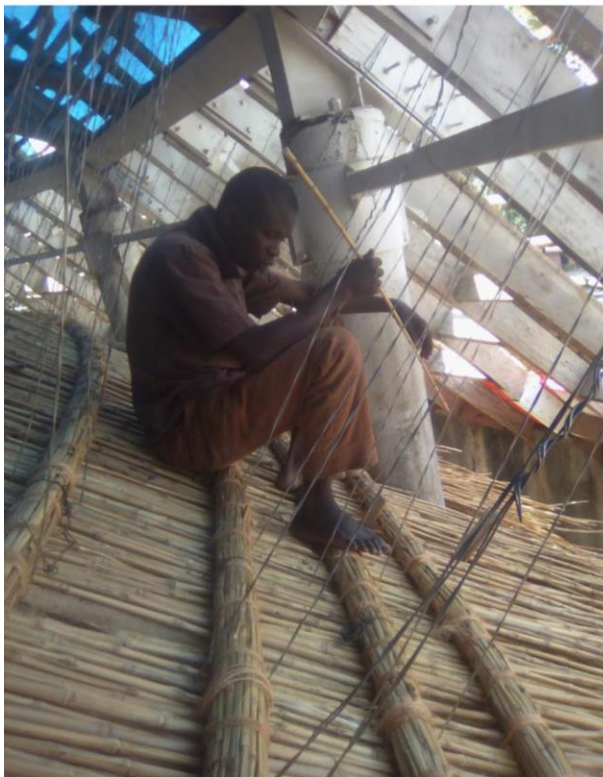
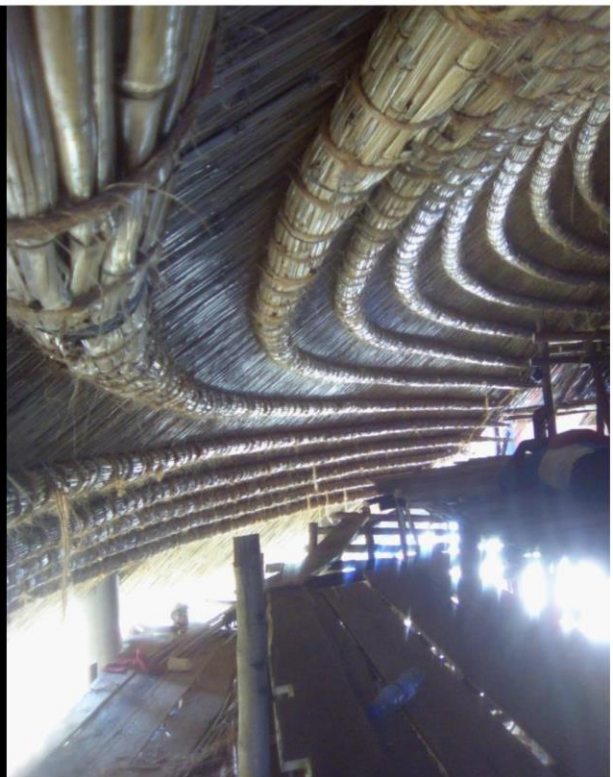
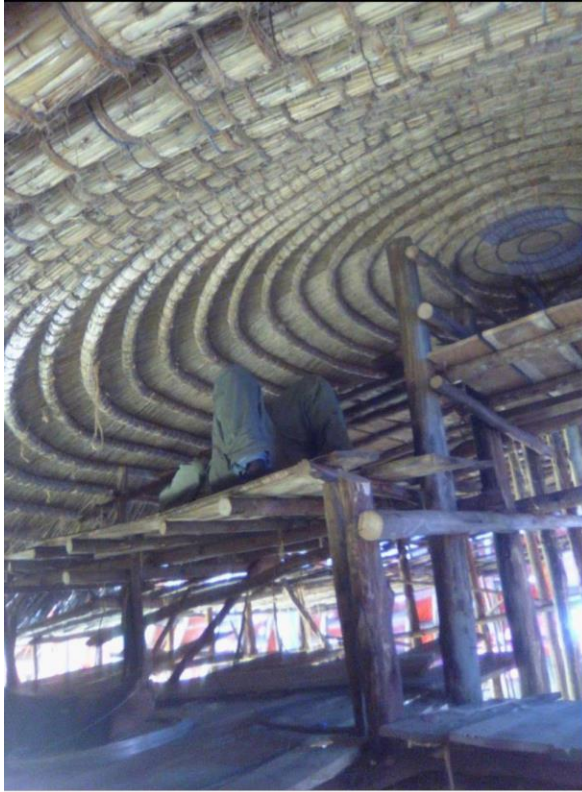
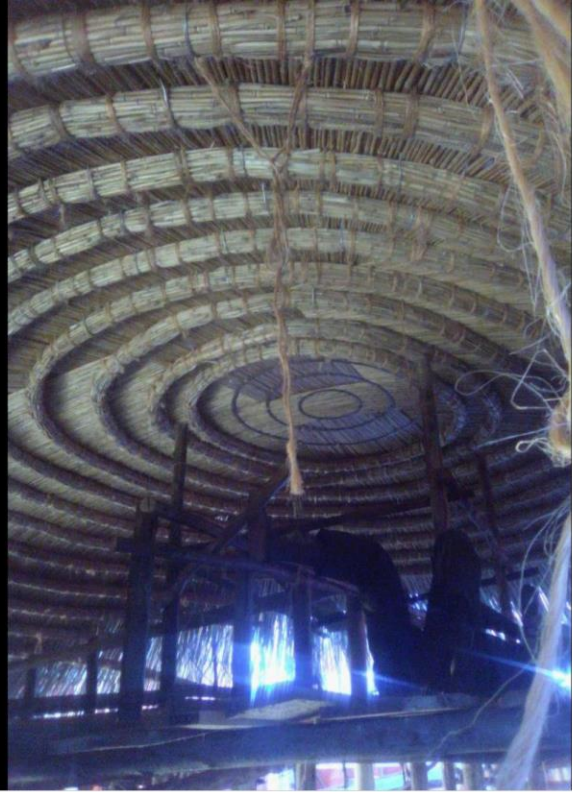
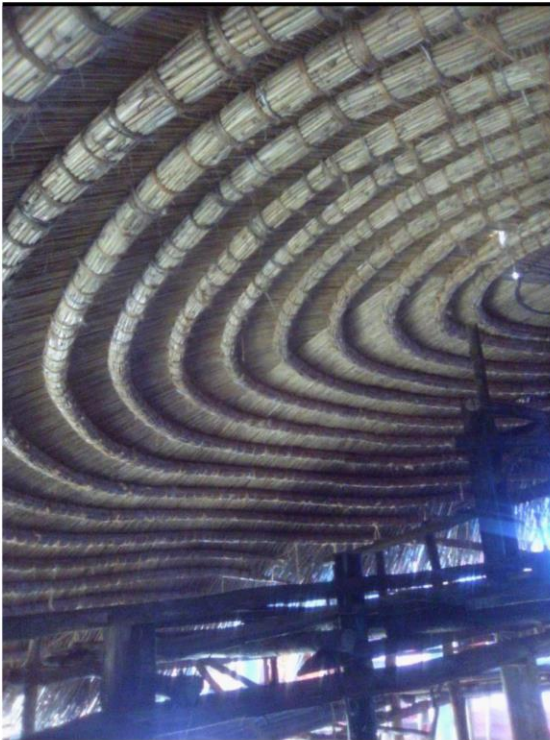
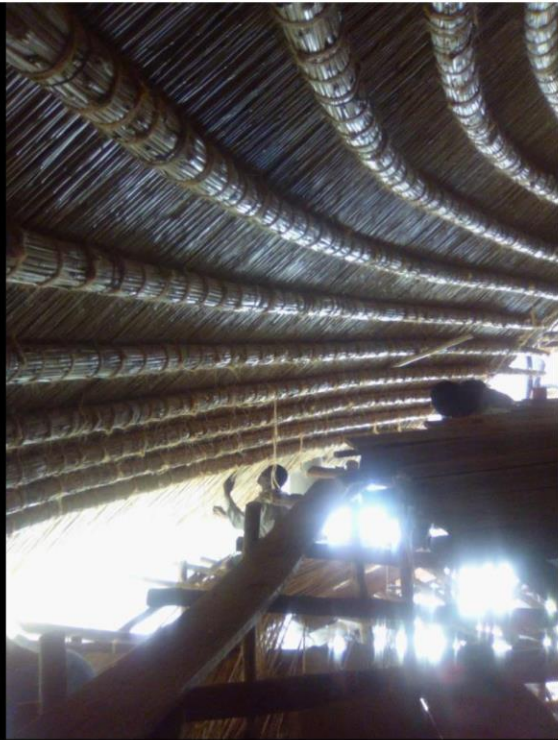
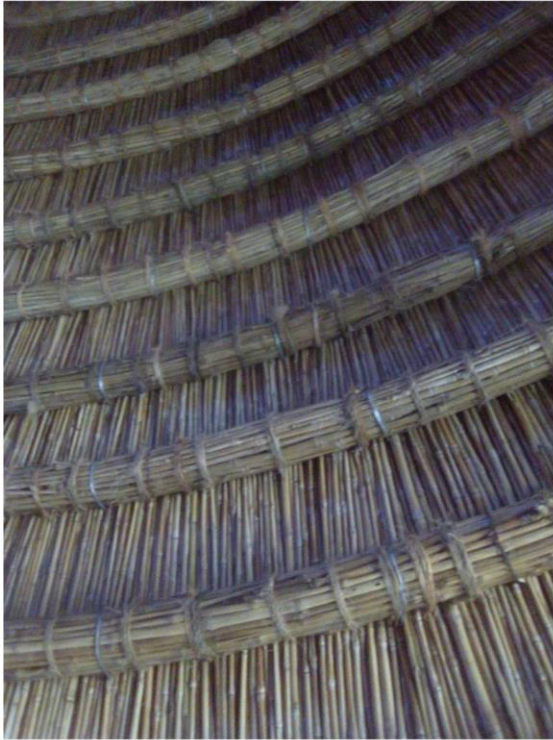
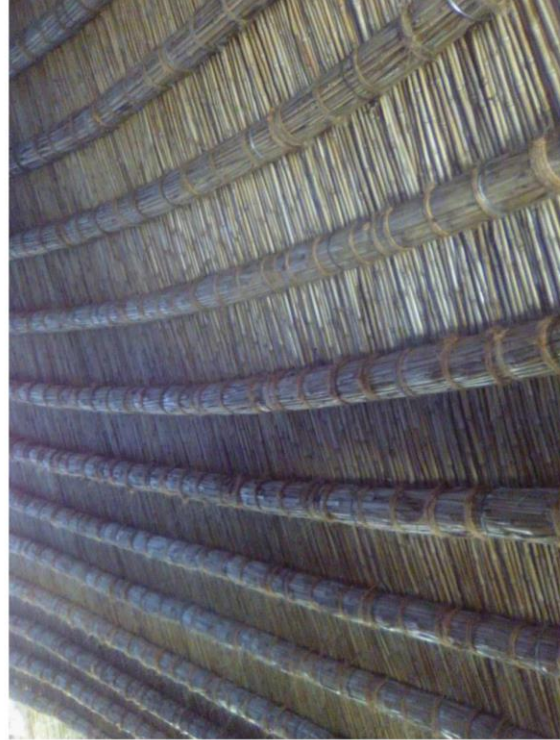
Figure 6: Ceiling works so far

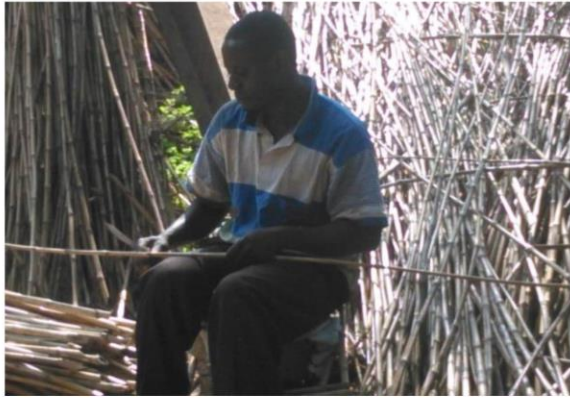
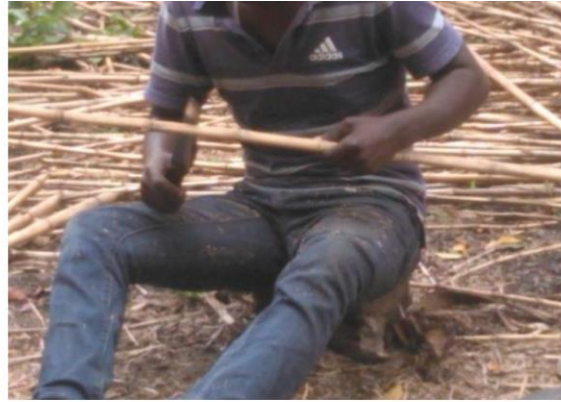
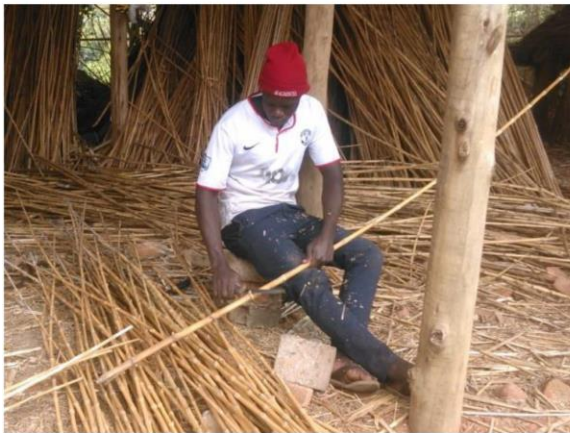
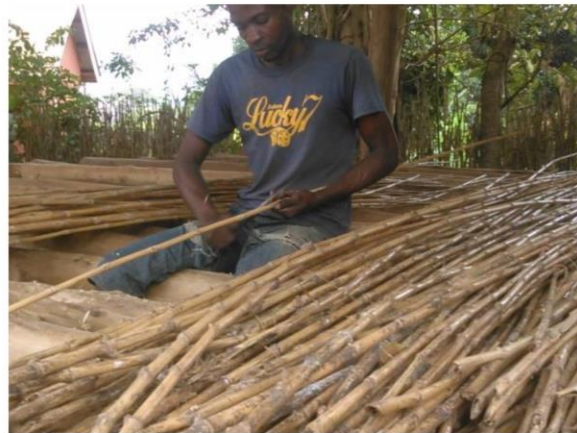
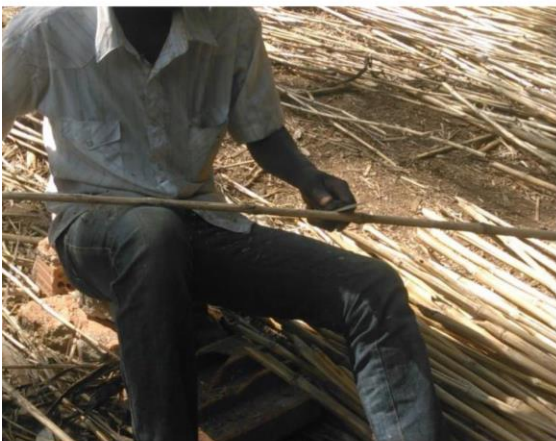
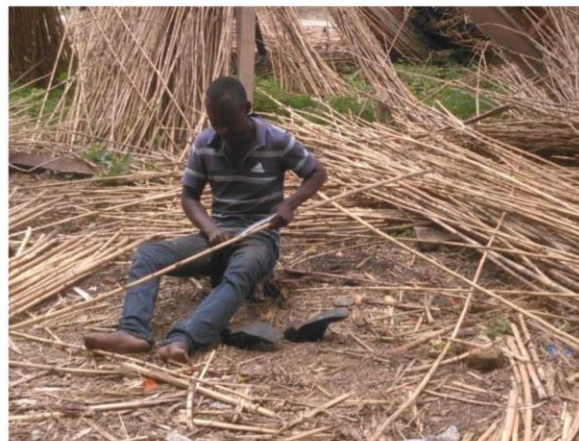
Figure 2: Group C cleaning and wiping reeds

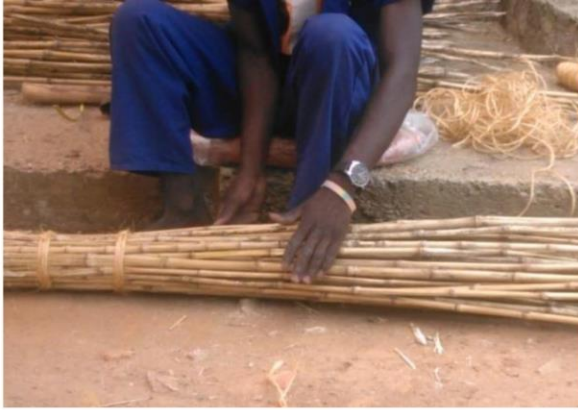
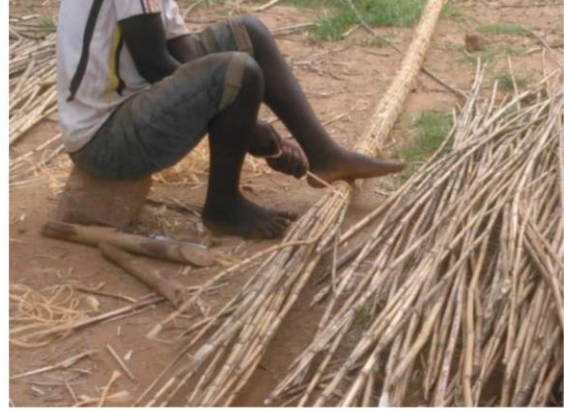
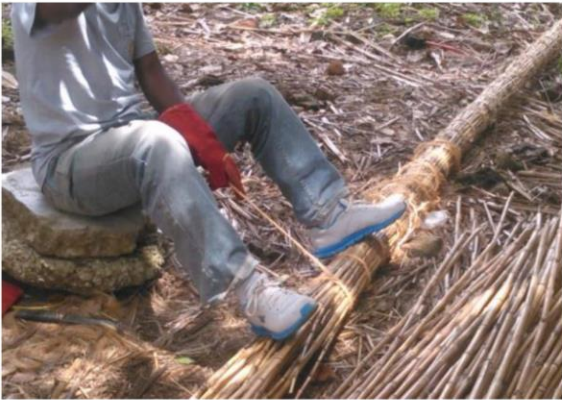
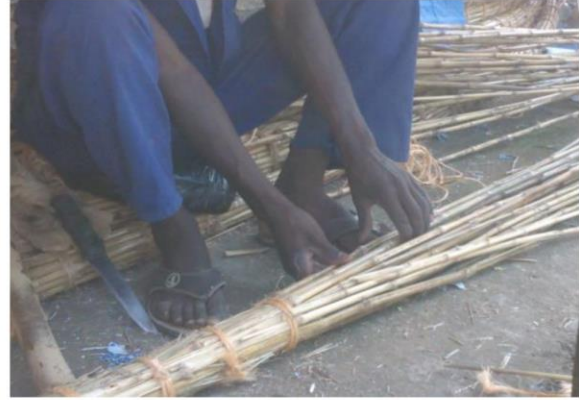
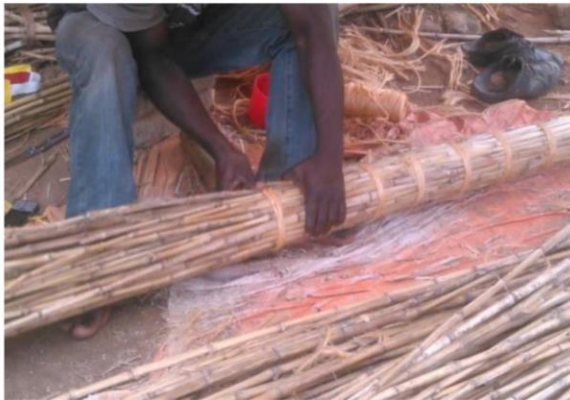
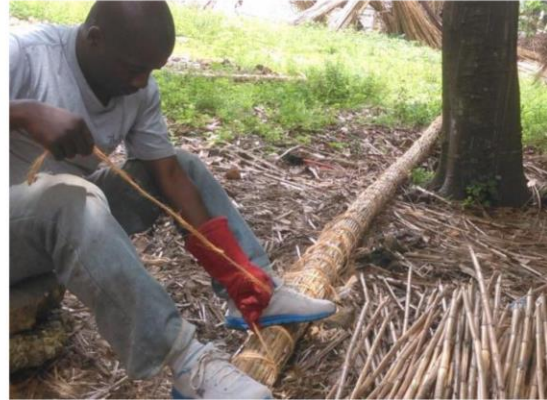
Figure 3: Putting together reeds to make circular rings
