STATE OF CONSERVATION

TOMBS OF BUGANDA KINGS AT KASUBI(UGANDA)

PROPERTY ID NO C1022

1stFEBRUARY 2017

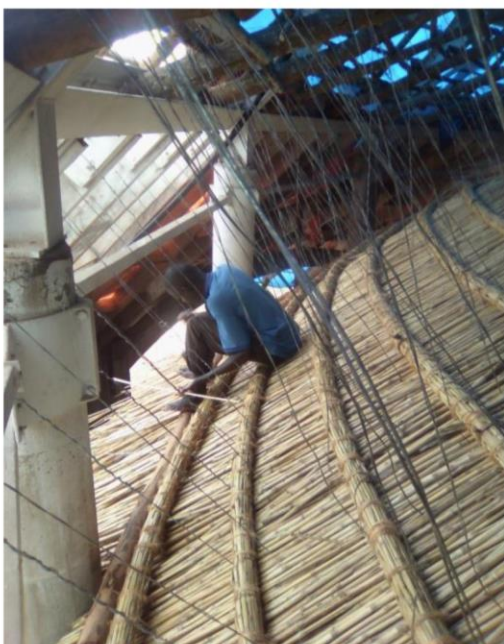
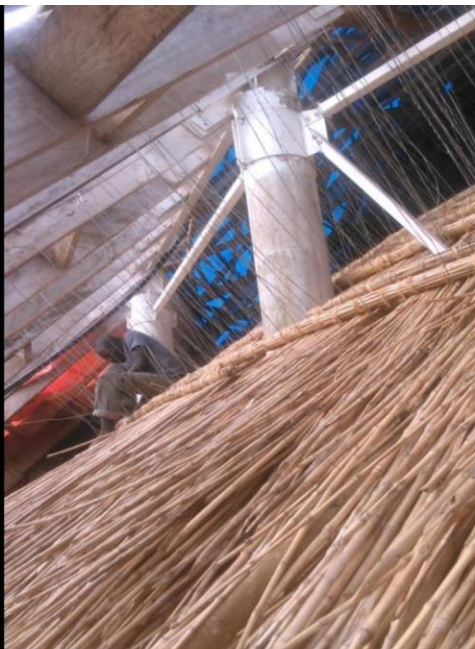
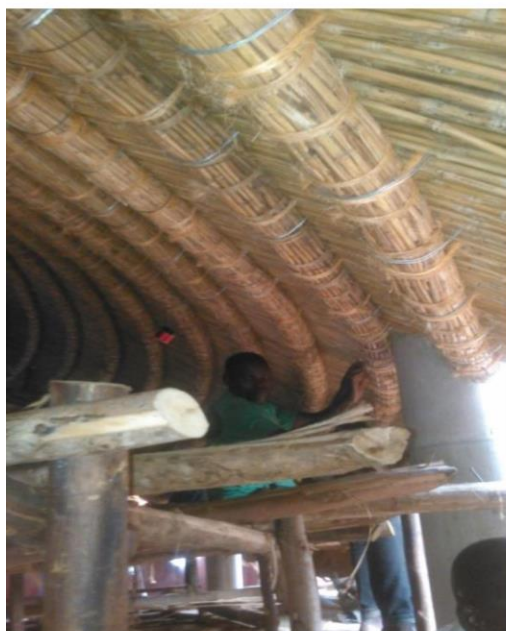
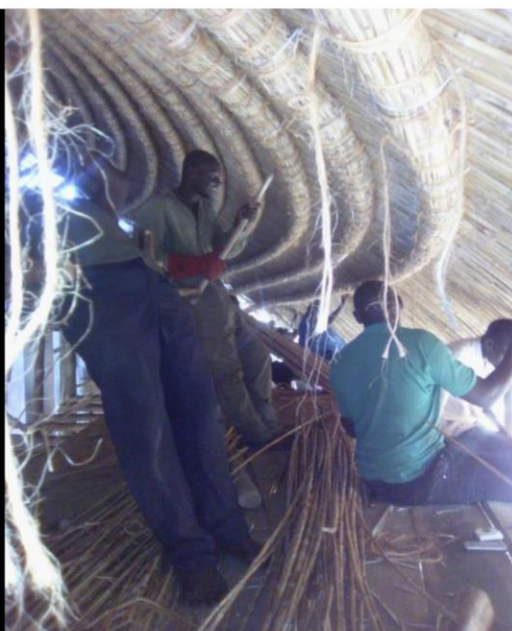
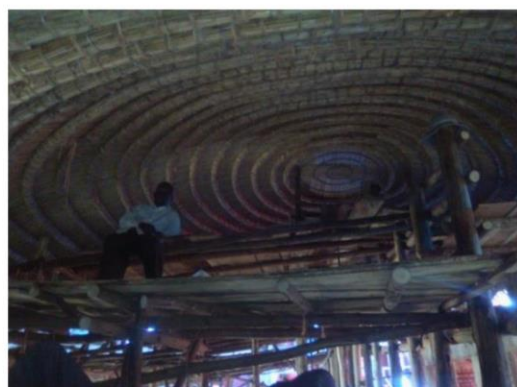
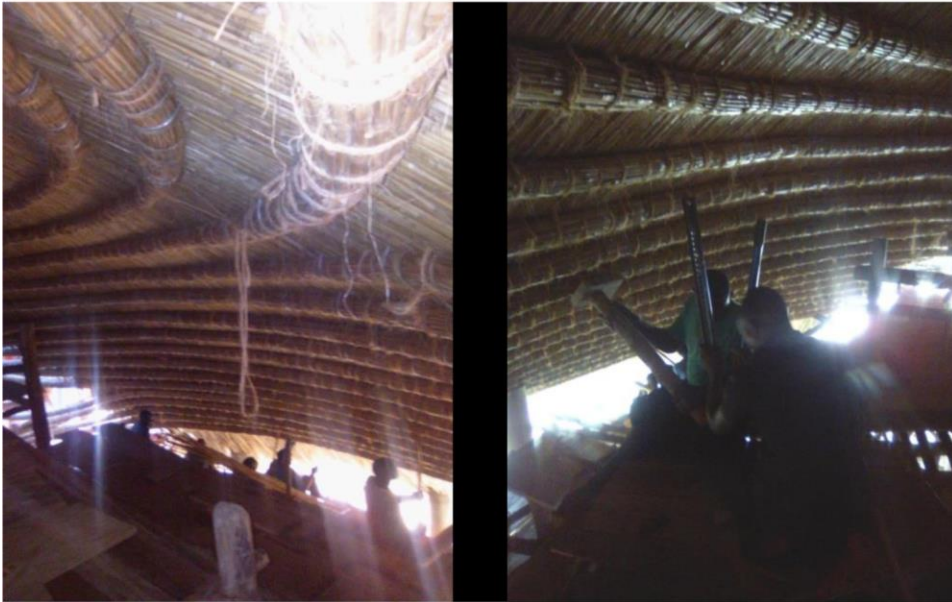
Figure 4: Workers fixing reeds and lifting the ceiling using the jake

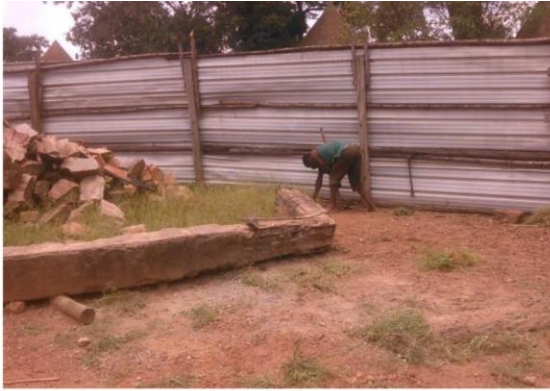
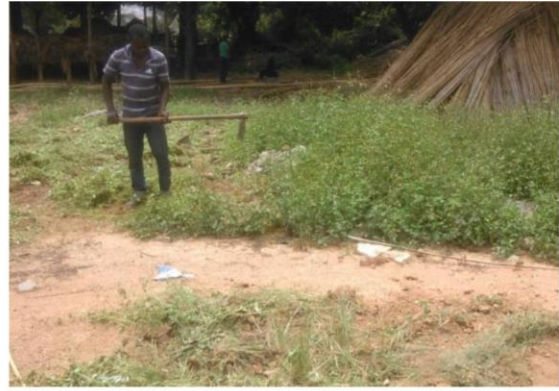
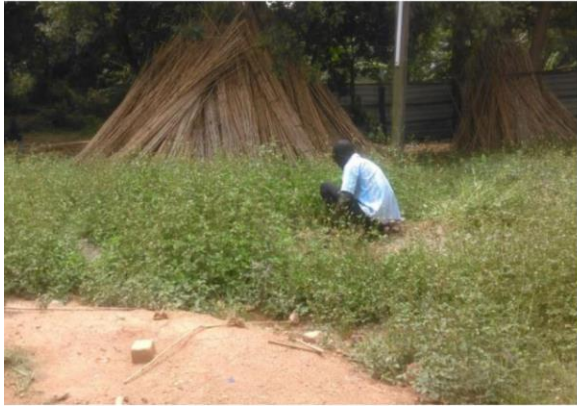
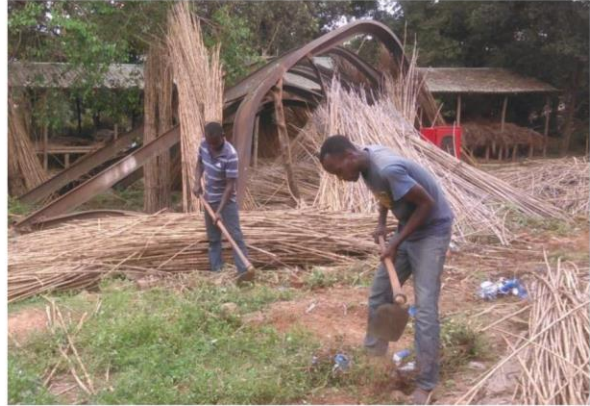
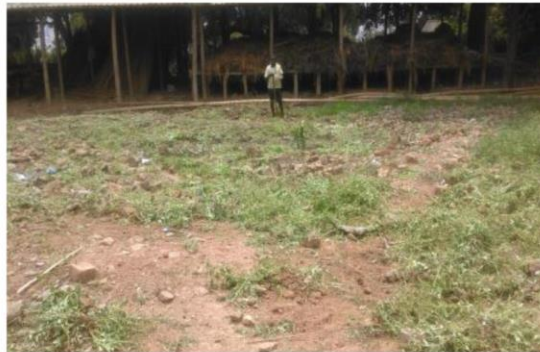
Figure 6: Workers cleaning site

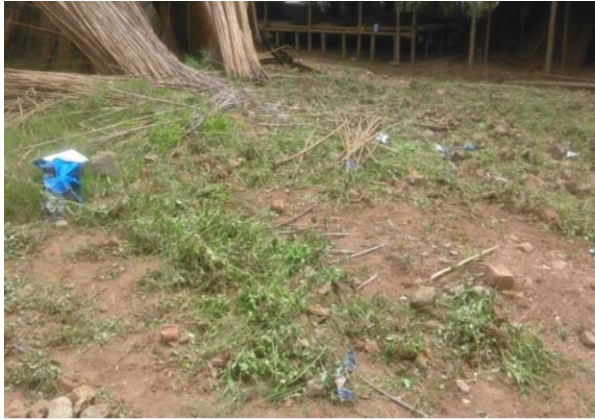
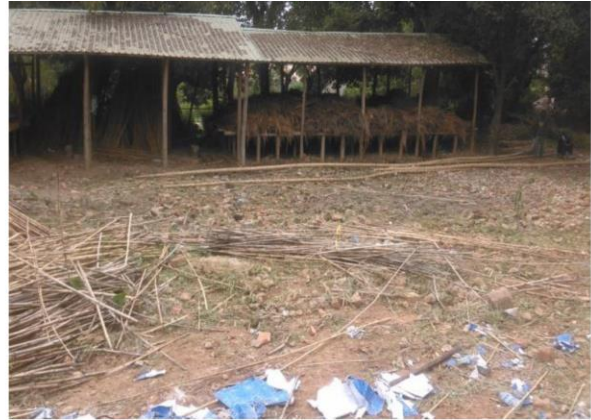
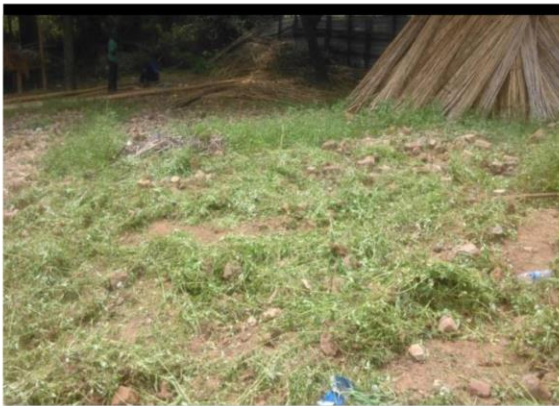
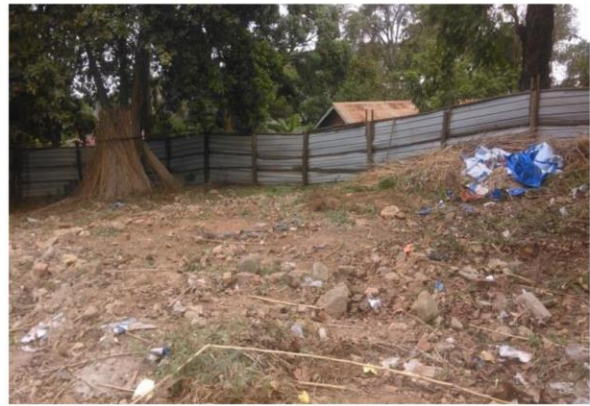
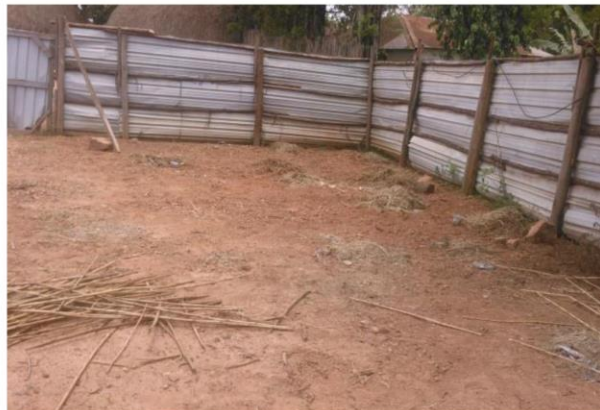
Figure 7: Site cleaned

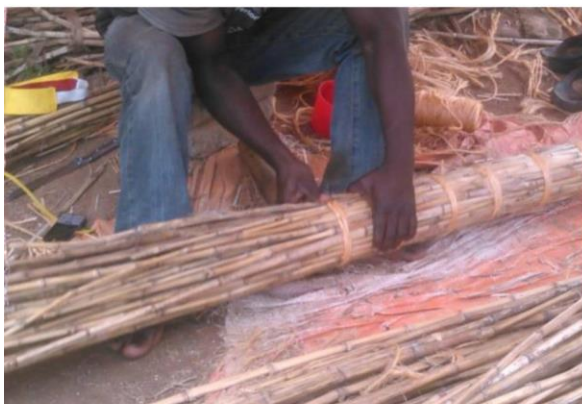
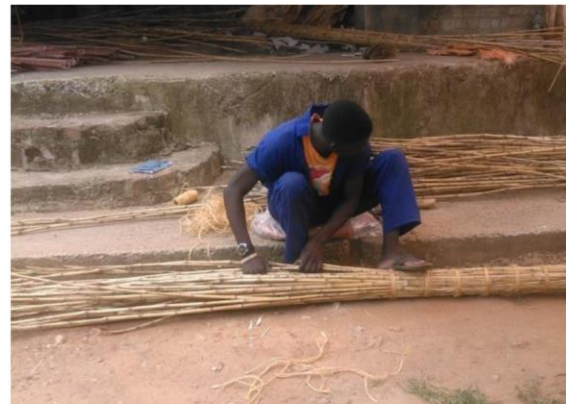
Figure 3: Putting together reeds to make circular reeds

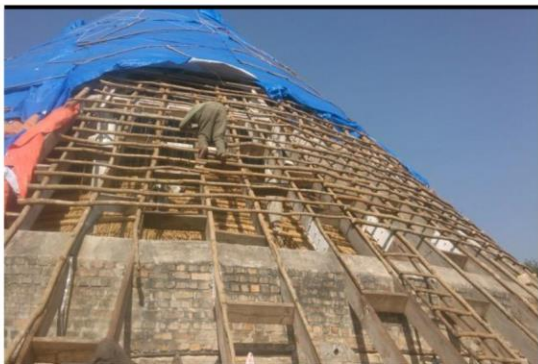
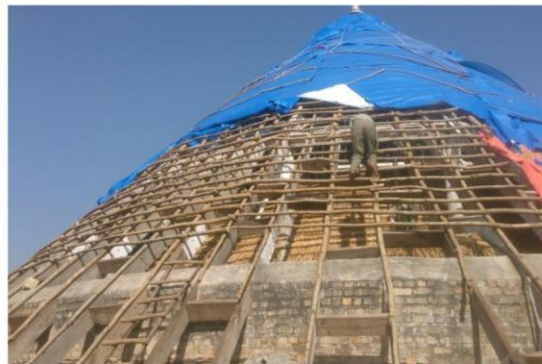
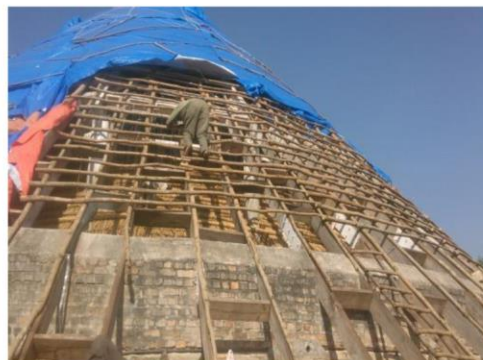
Figure 4: A worker tightening wires

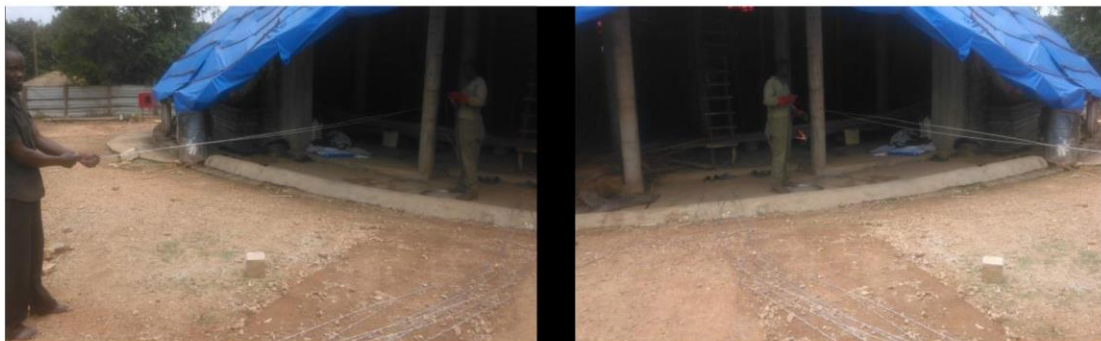
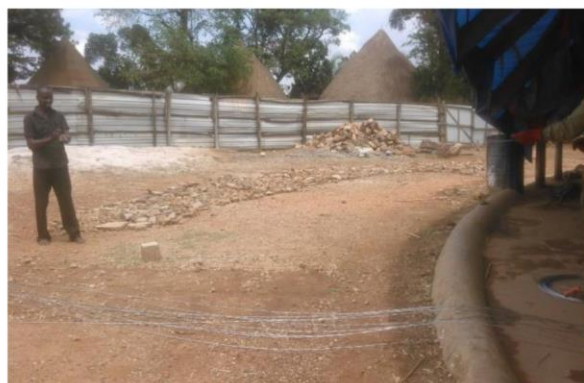
Figure 1; Workers straightening galvanized wire

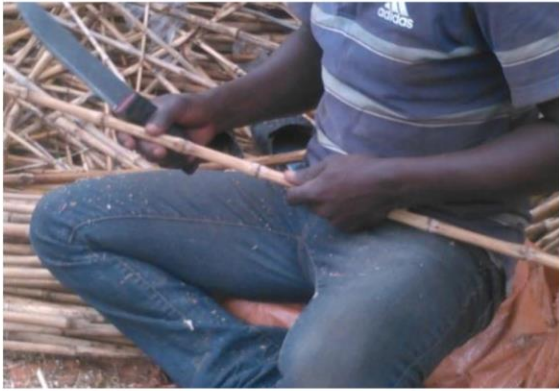
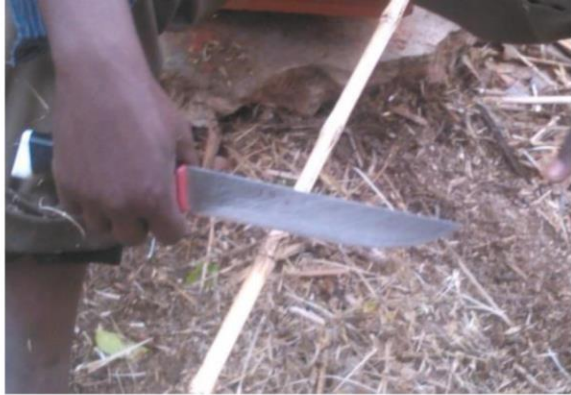
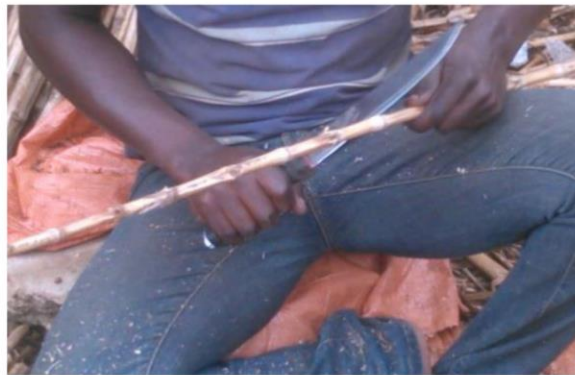
Figure 1: Workers cleaning reeds

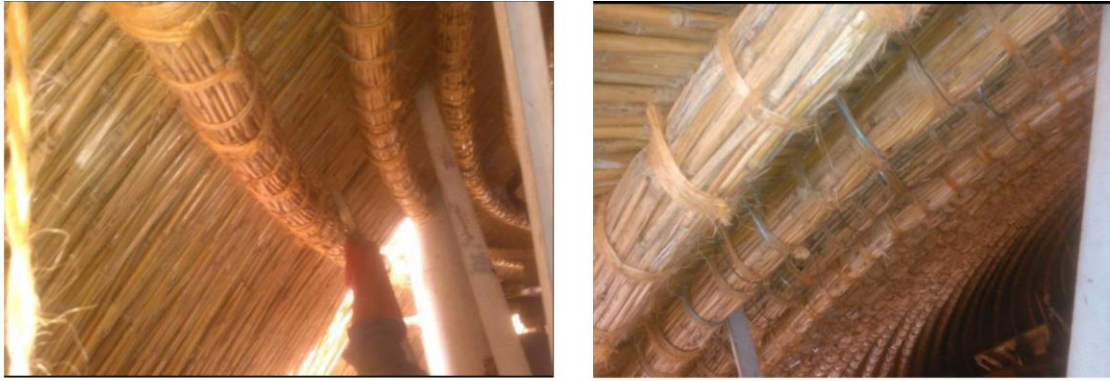
Figure 2: Fixing and aligning reeds

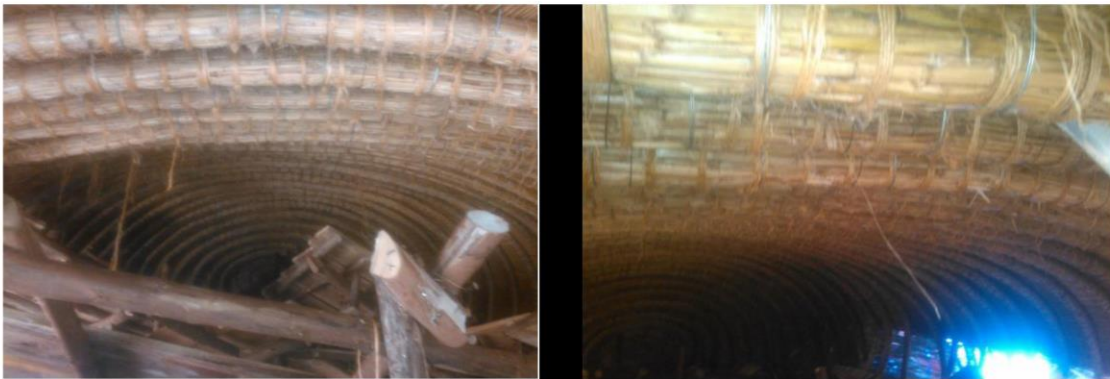
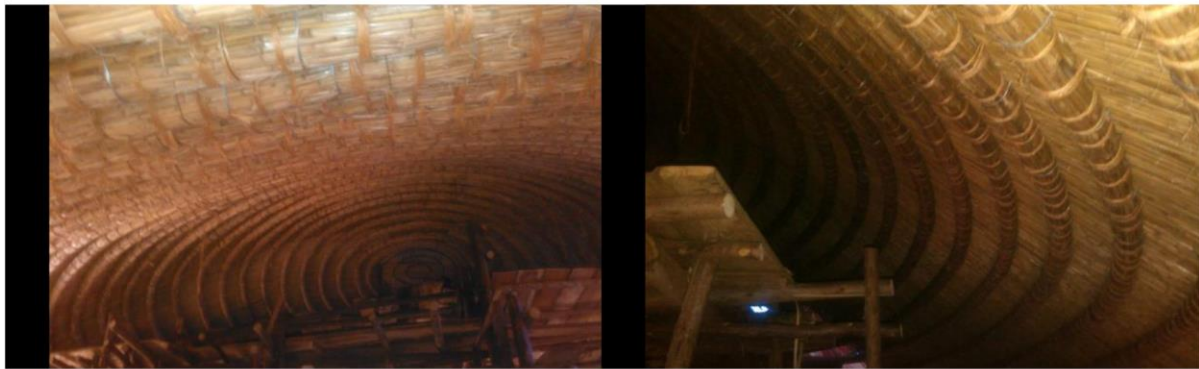
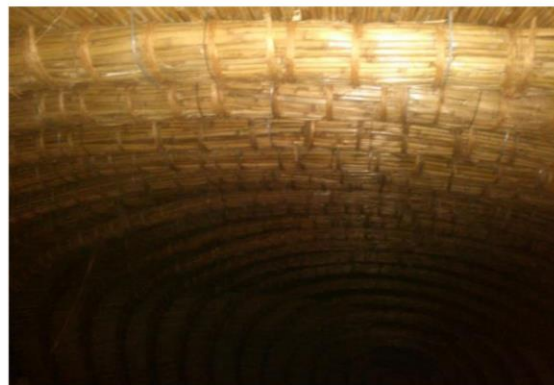
Figure 3: Some of the rings fixed for the ceiling

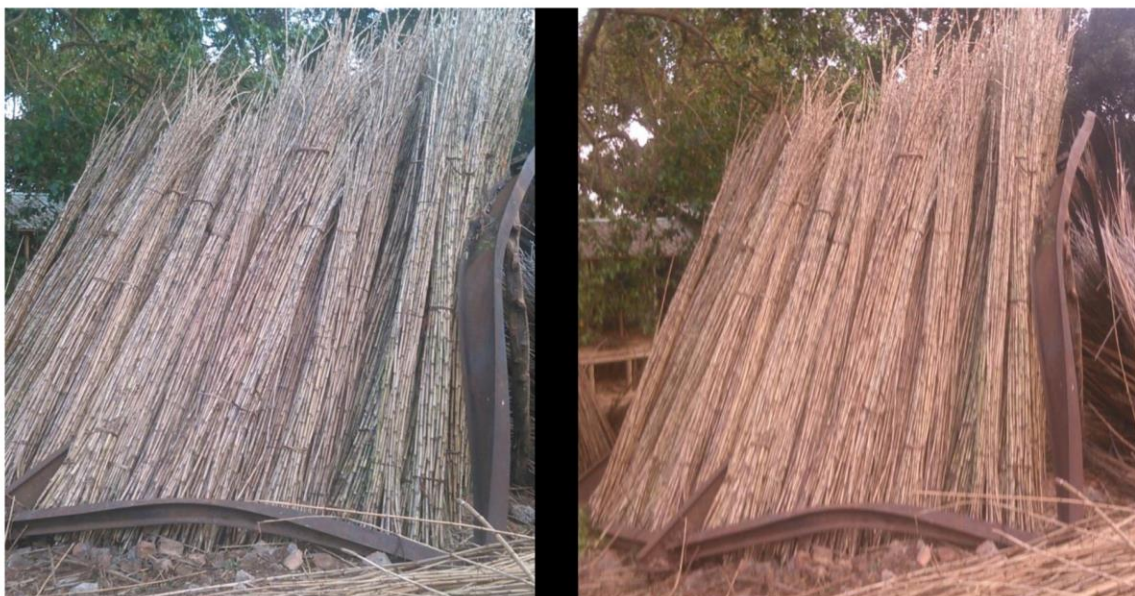
Figure 4; Bundles of reeds delivered on site

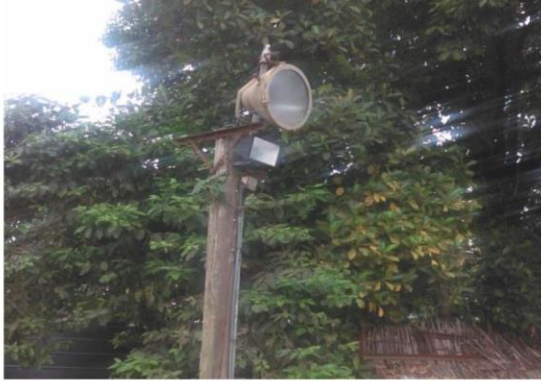
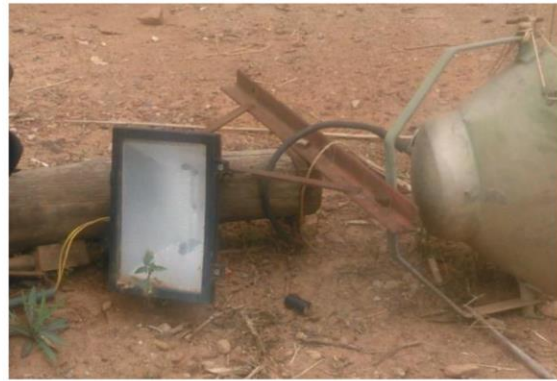
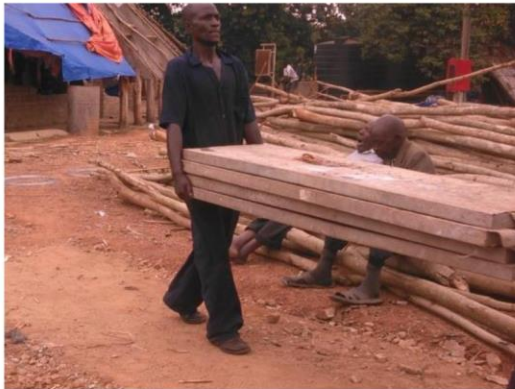
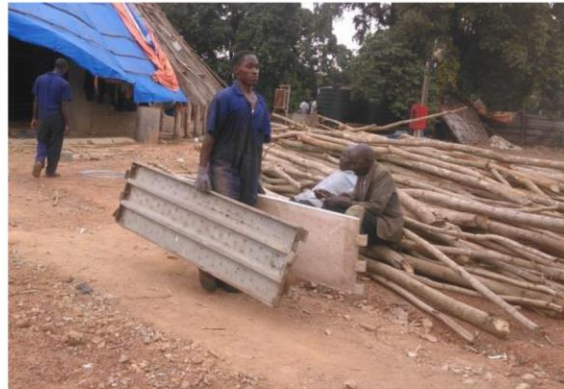
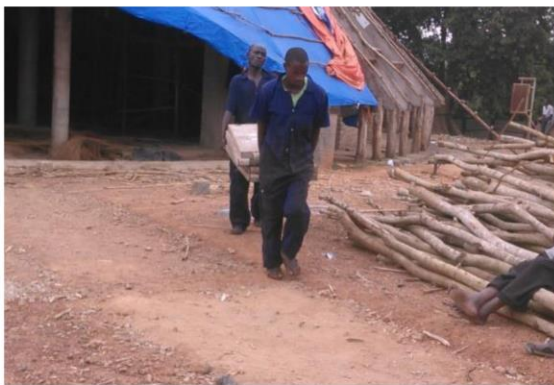
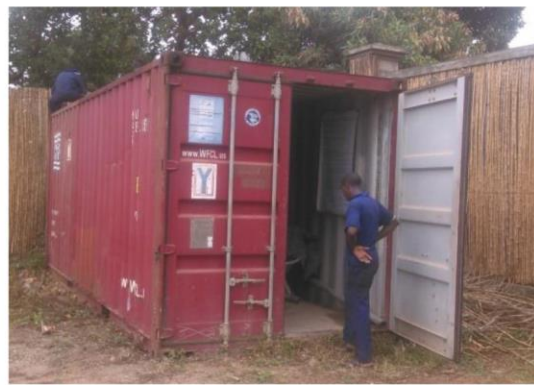
Figure 6: Material or equipment removed from site by Omega

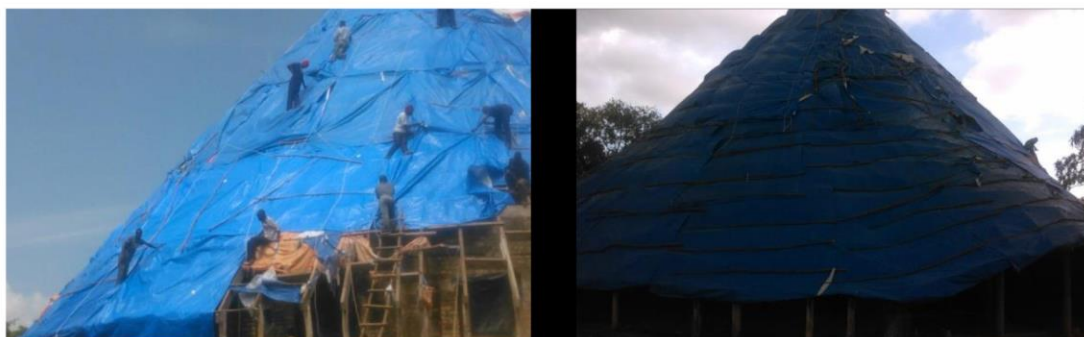
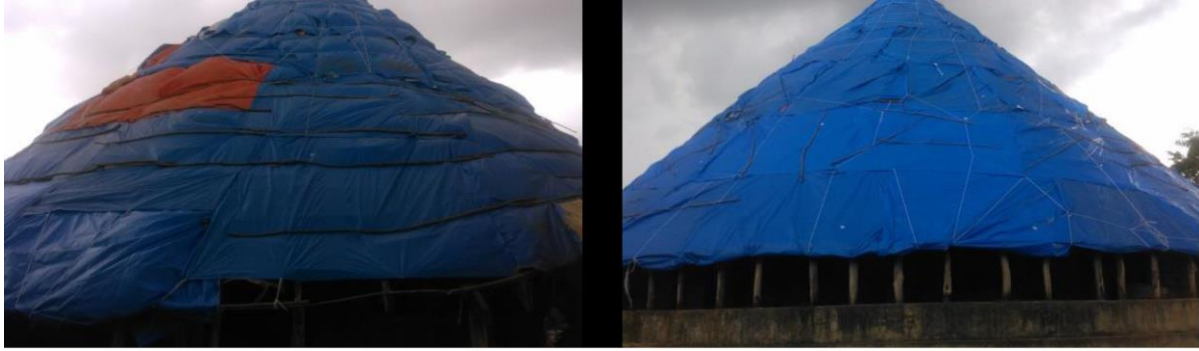
Figure 2: Roof structure covered with tarpaulin sheet

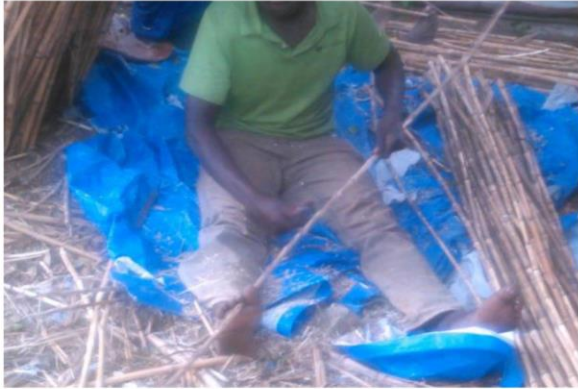
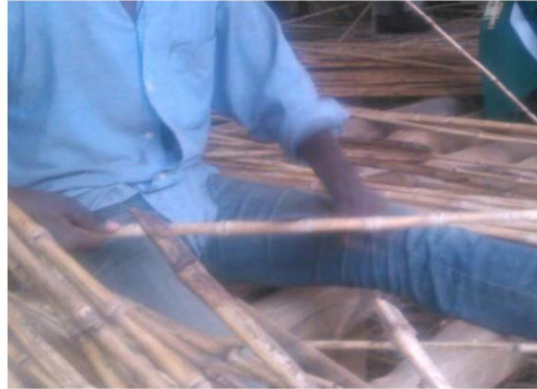
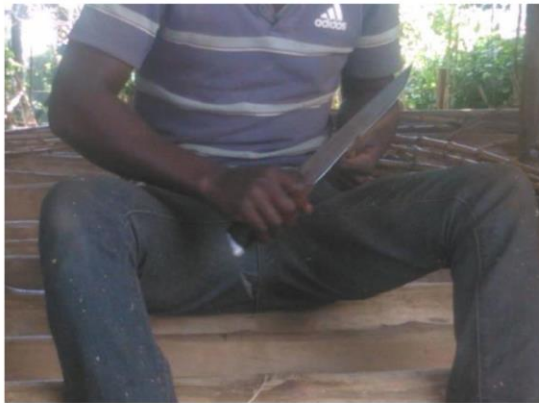
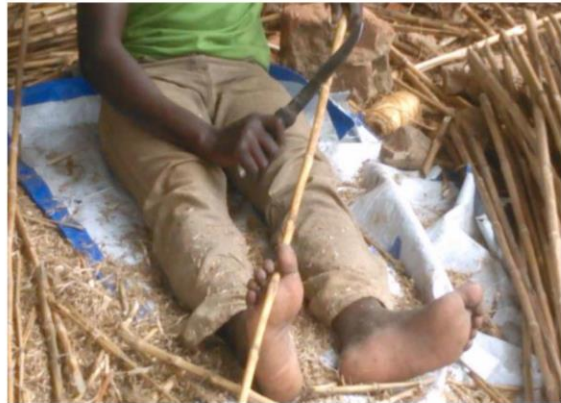
Figure 1: Some of the workers removing nodes off the reeds

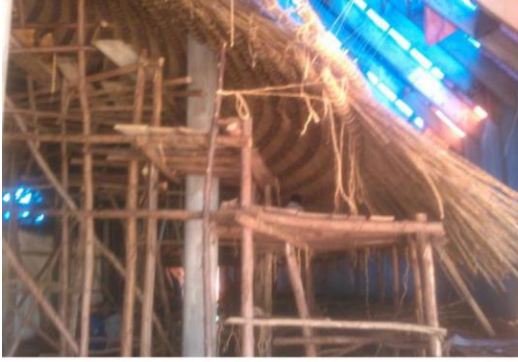
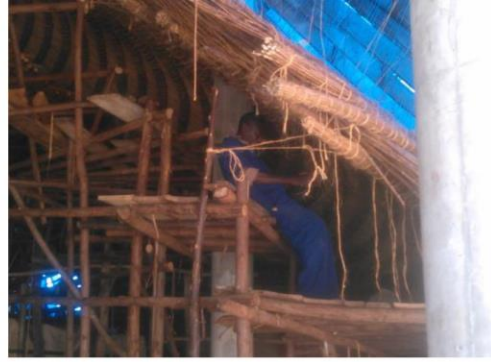
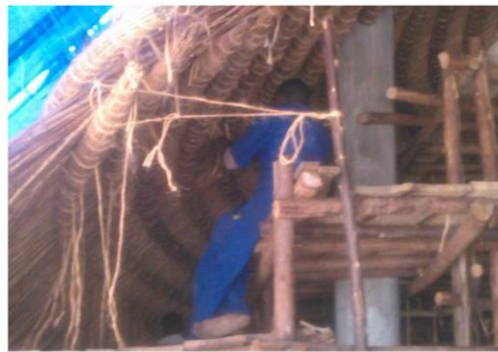
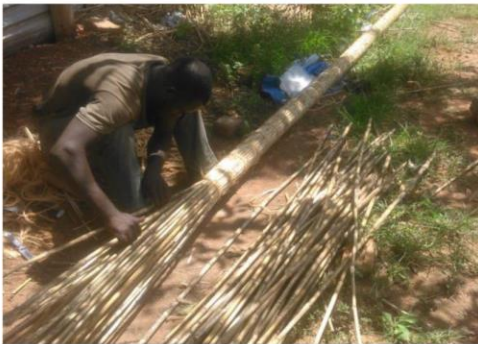
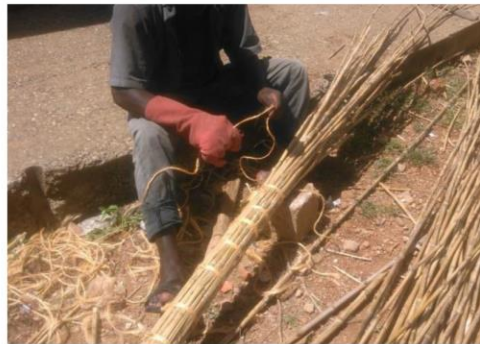
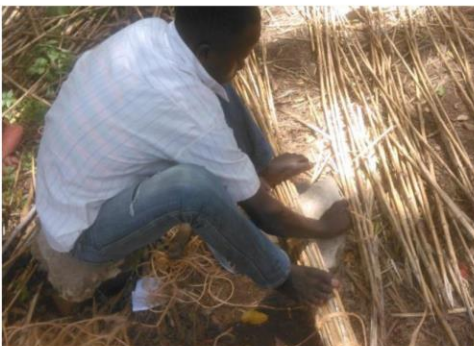
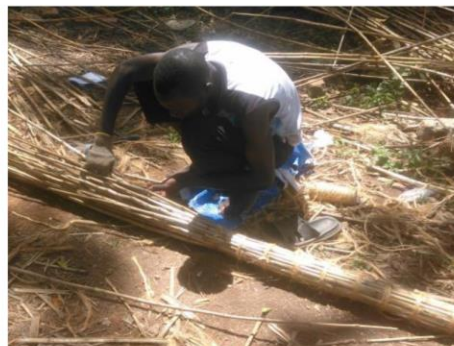
Figure 2: Fixing reeds to fill gaps or spaces in the ceiling

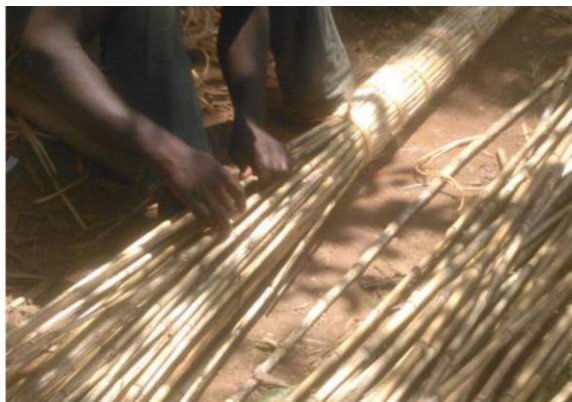
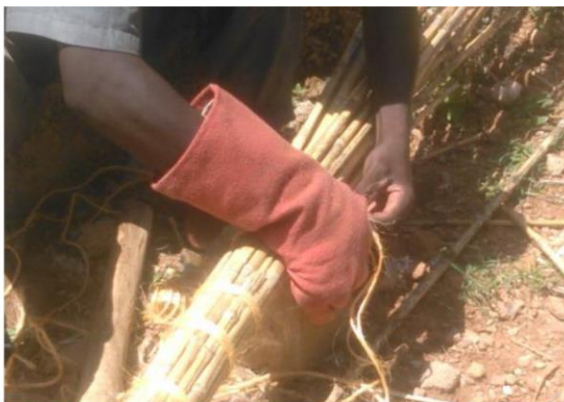
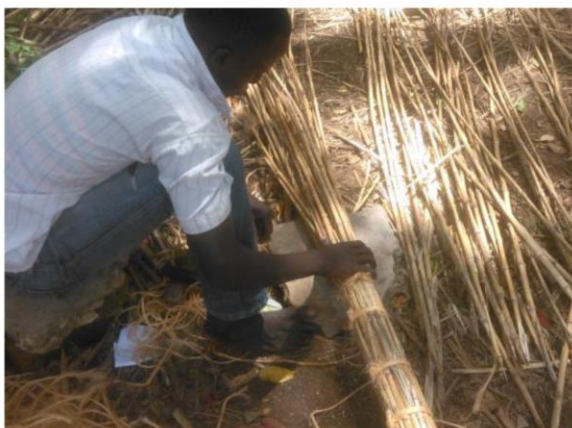
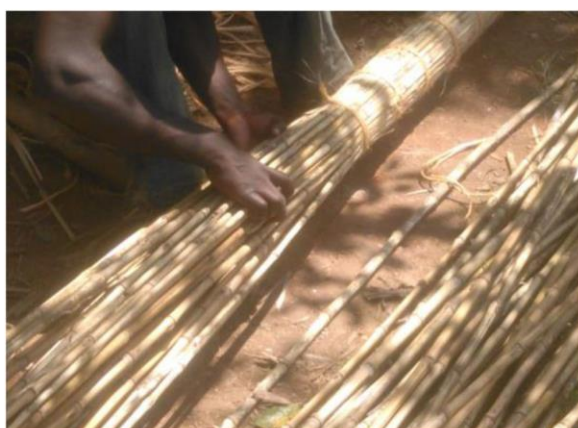
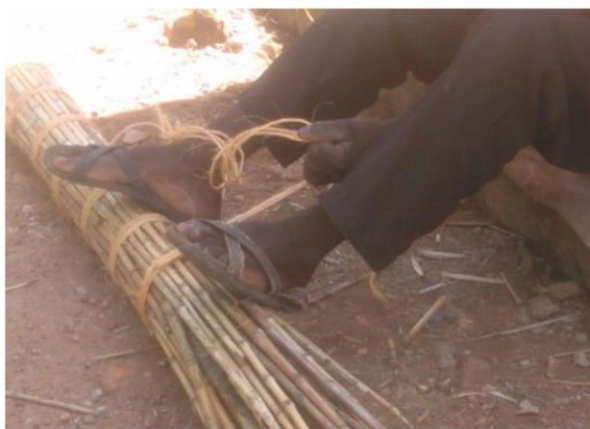
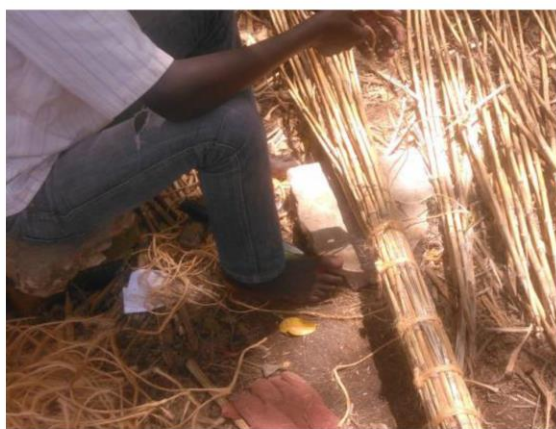
Figure 3: Workers putting together reeds to make circular reeds (bizizi)

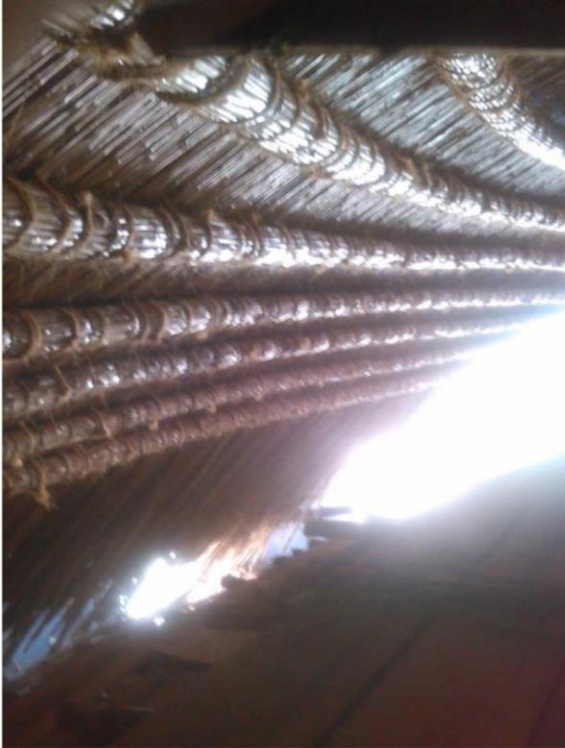
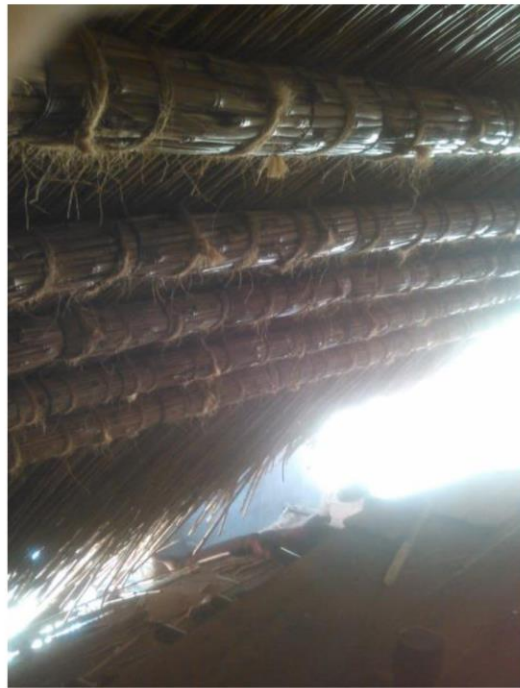
Figure 4: Some of the rings (bizizi) fixed this week

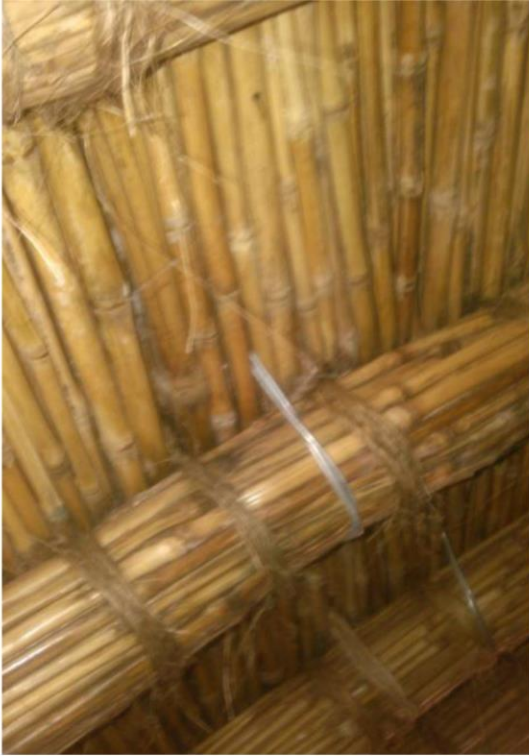
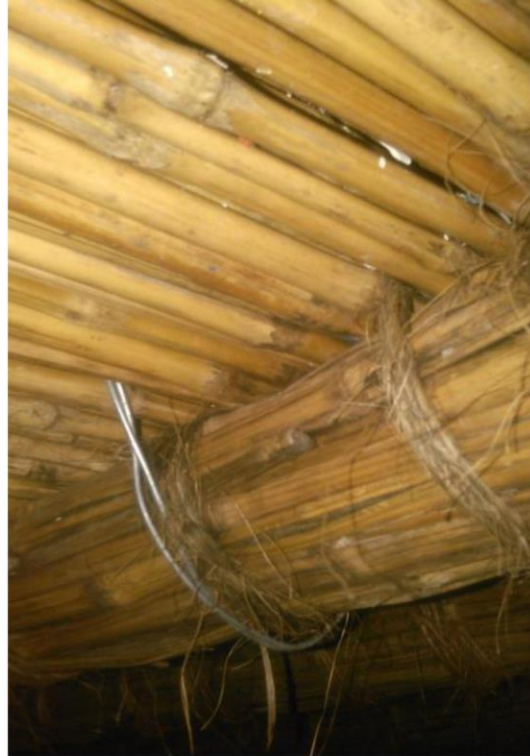
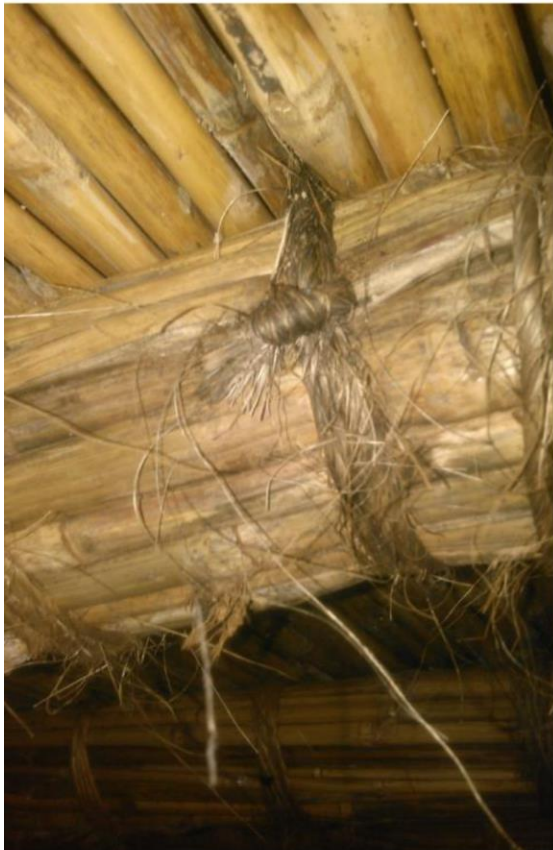
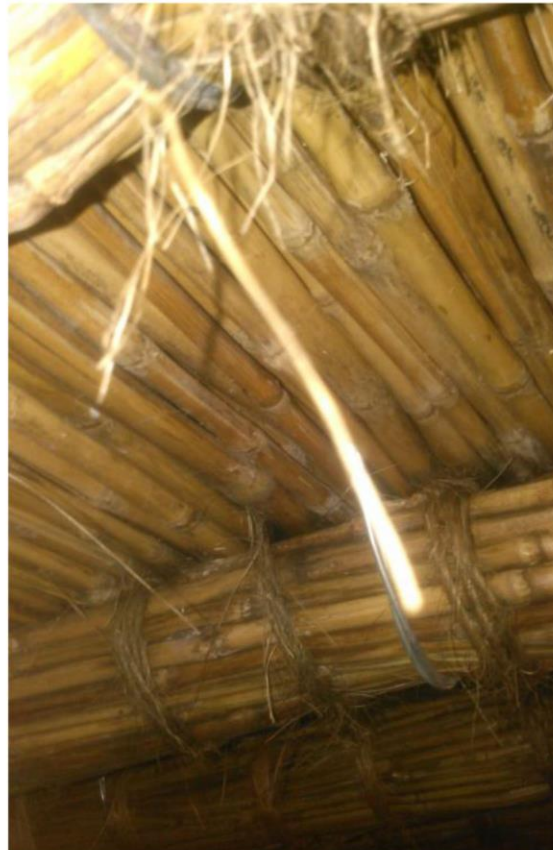
Figure 5: Some of the rings affected by rain

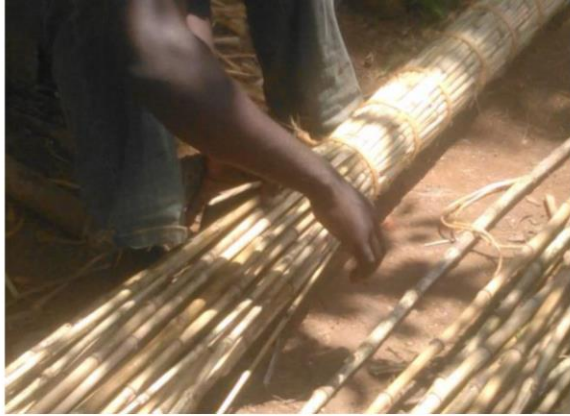
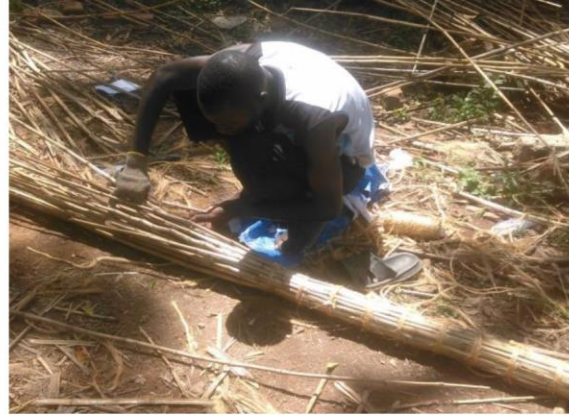
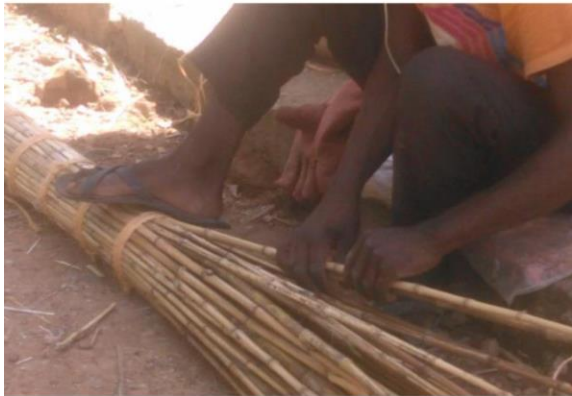
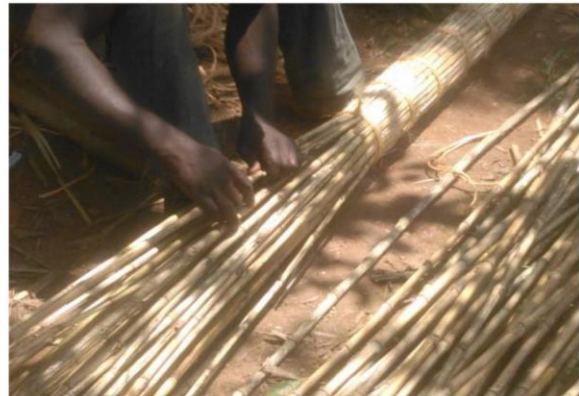
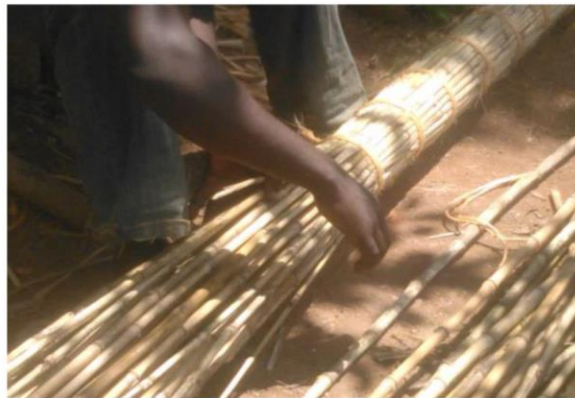
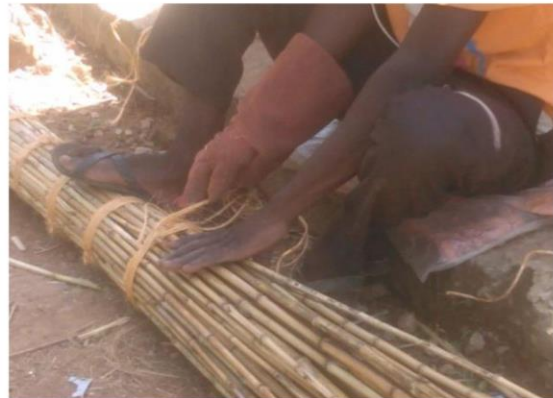
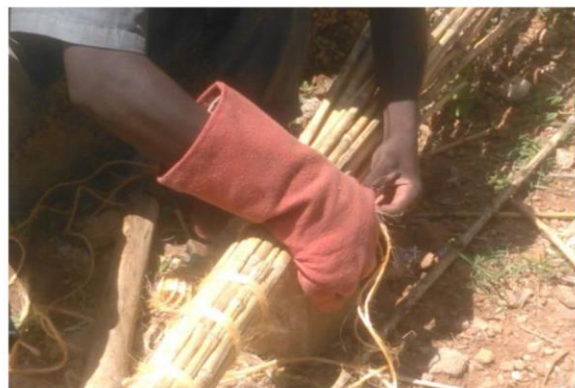
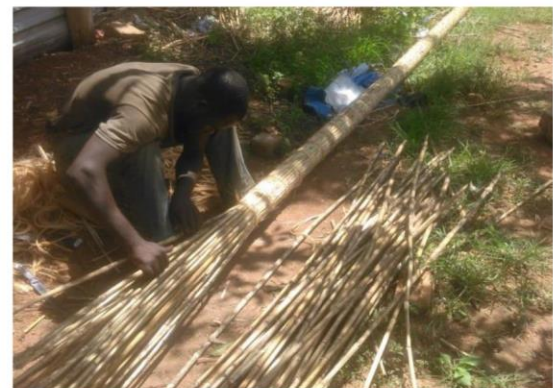
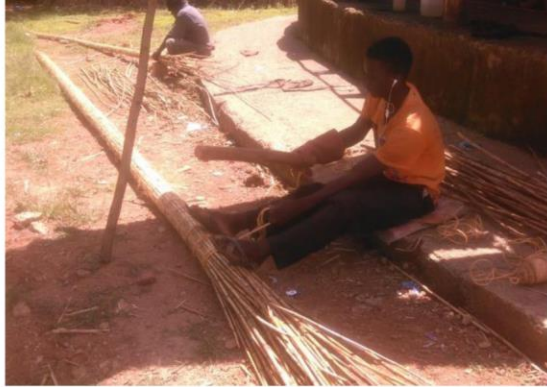
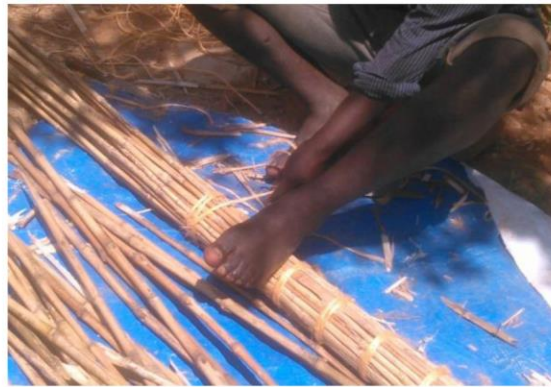
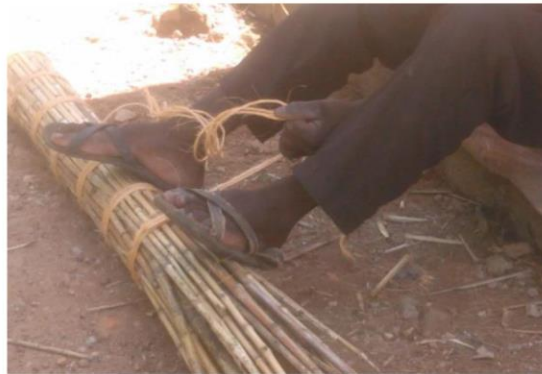
Figure 2: Putting together reeds to make circular reeds (rings)

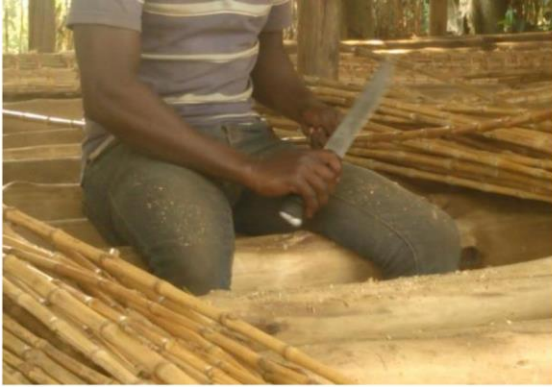
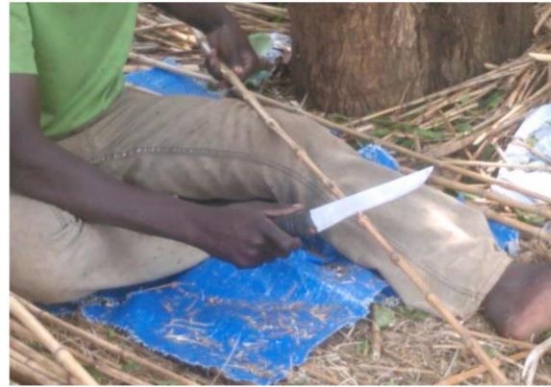
Figure 3: Wiping nodes off the reeds

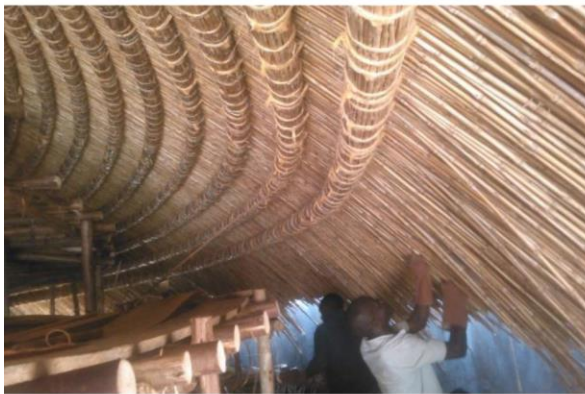
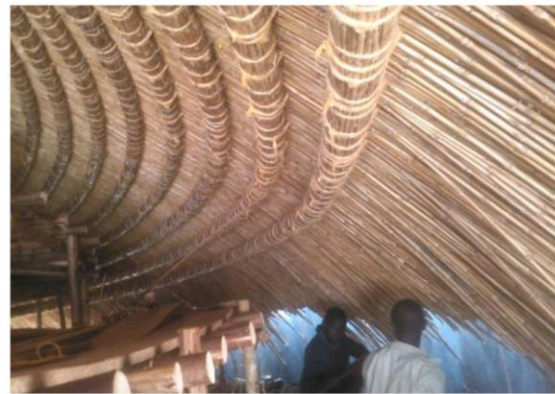
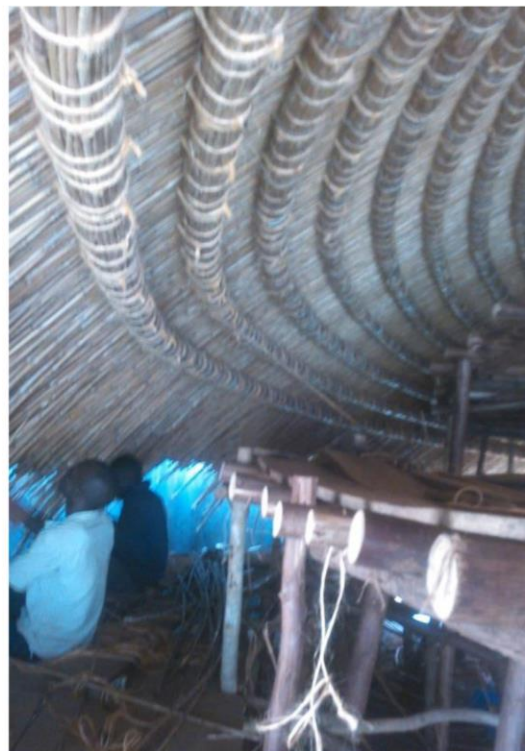
Figure 4; Fixing reeds to fill or block gaps in the ceiling

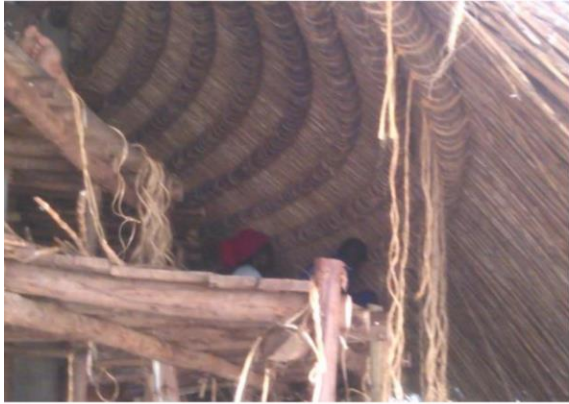
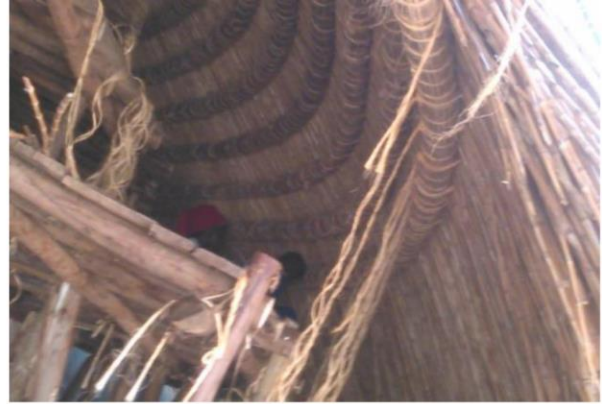
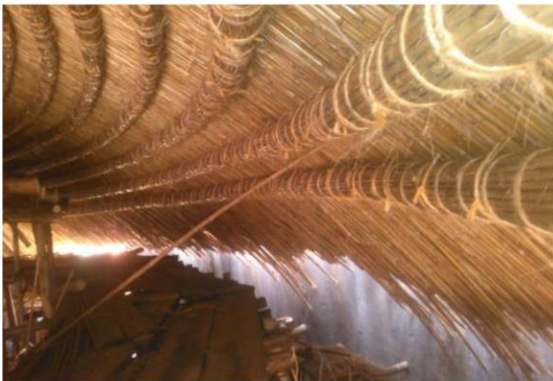
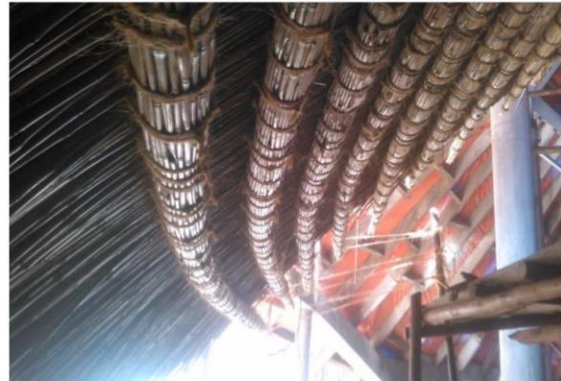
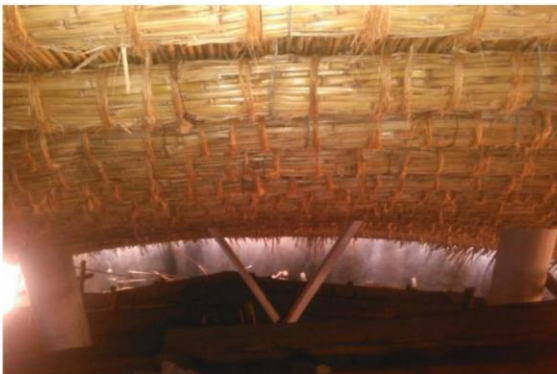
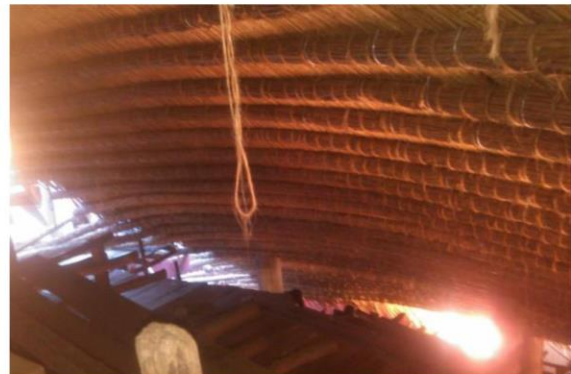
Figure 5: Some of the rings fixed for the ceiling

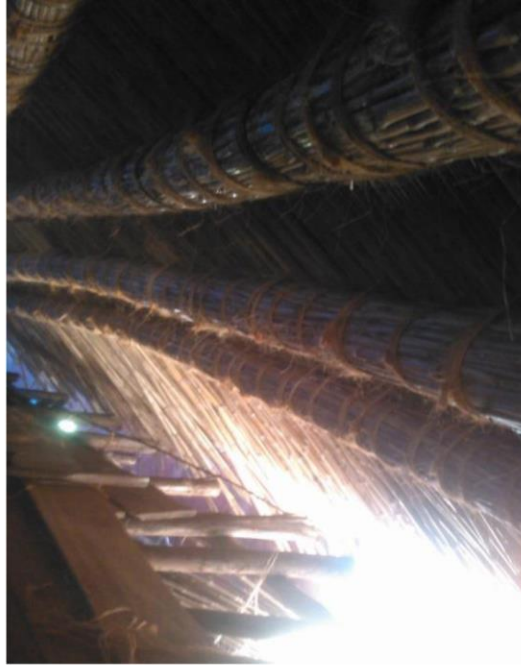
Figure 6: Galvanized wire straightened to be fixed through the rings
