STATE OF CONSERVATION

TOMBS OF BUGANDA KINGS AT KASUBI(UGANDA)

PROPERTY ID NO C1022

1stFEBRUARY 2017

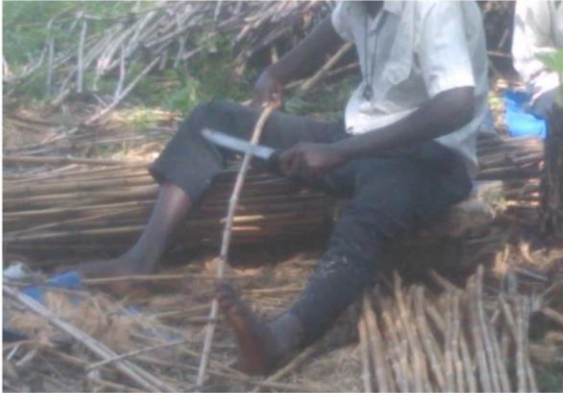
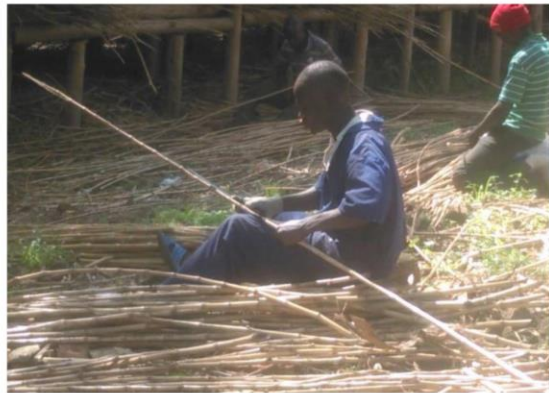
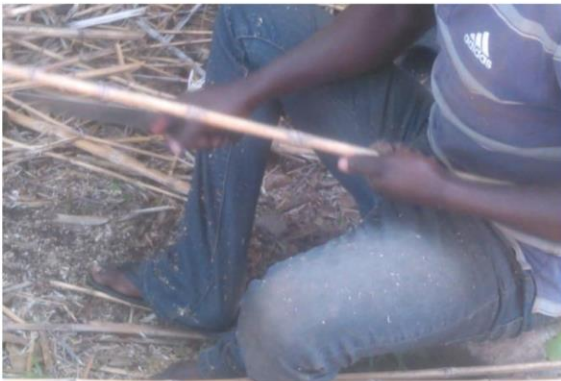
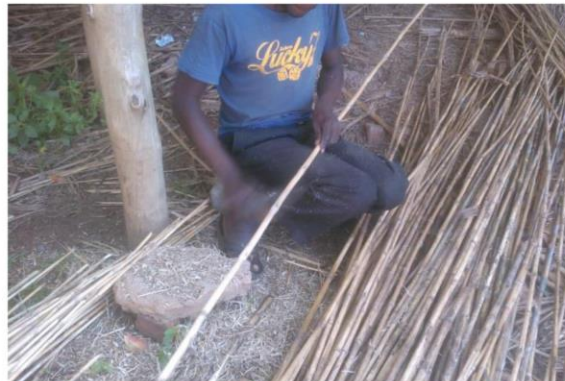
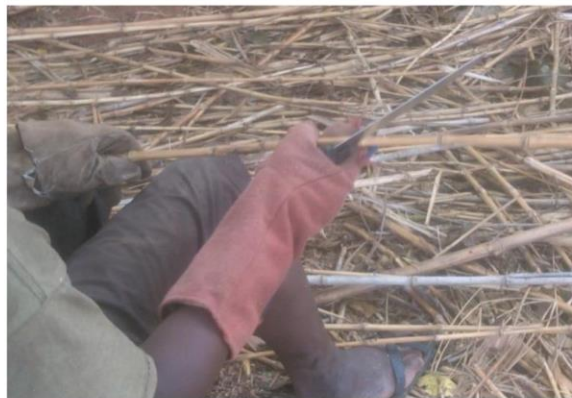
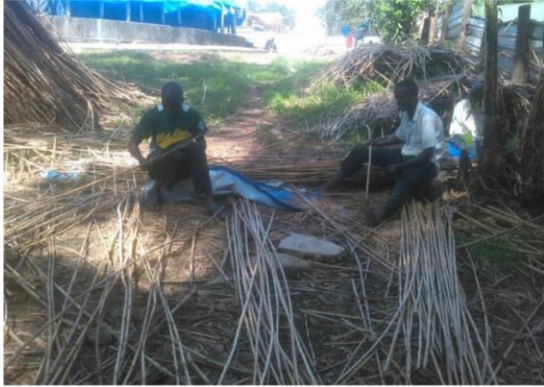
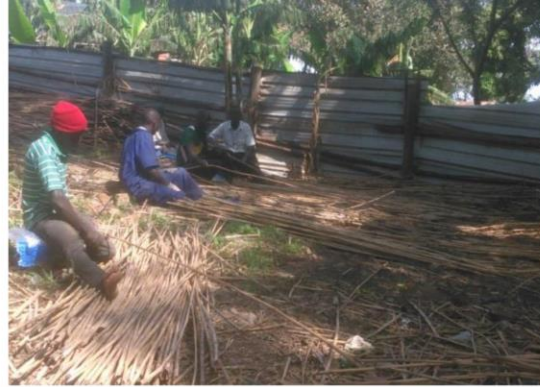
Figure 1; Removing nodes off the reeds

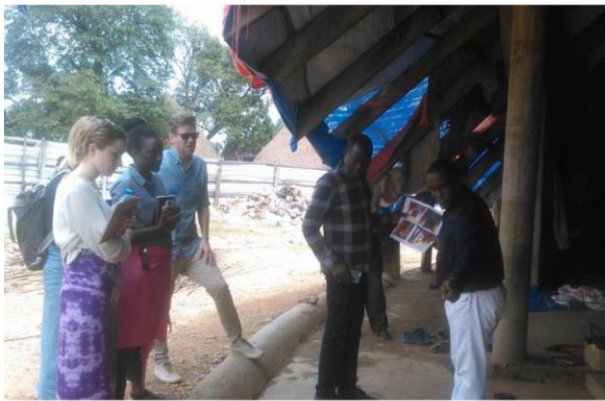
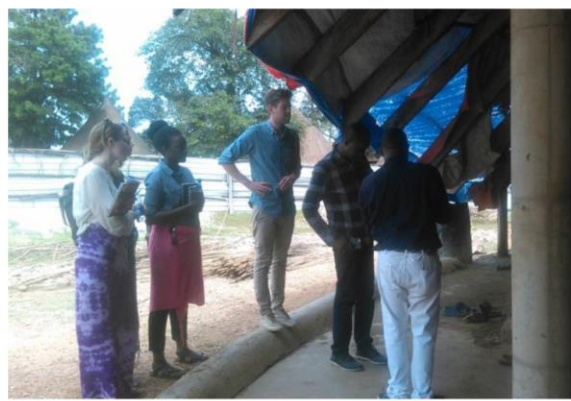
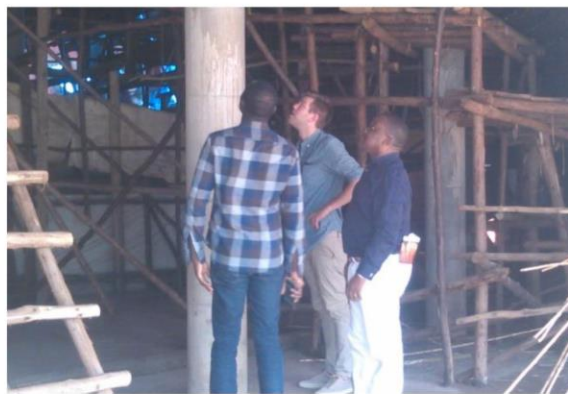
Figure 2: Project Manager briefing visitors about progress of ceiling work
