STATE OF CONSERVATION

TOMBS OF BUGANDA KINGS AT KASUBI(UGANDA)

**THE
BUJJABUKULA ROYAL GRANDIOSE
ENTRANCE BUILDING**
To the Tombs of Buganda Kings at Kasubi – UNESCO World Heritage
Property in Uganda

PHOTOGRAPHIC PROGRESS REPORT

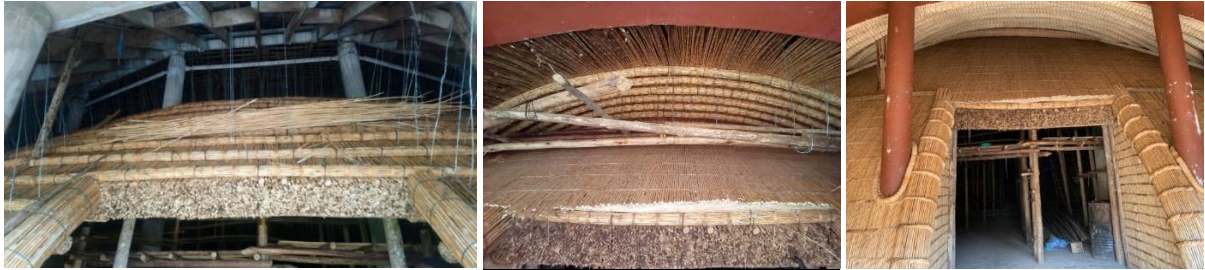
A. Main entrance works

- Peeling and soaking inner part of *enga* in water to soften them for weaving works.
- Weaving works at the second ceiling.
- Cleaning and wiping reeds.
- Piling and compacting reeds to make a reed bed.

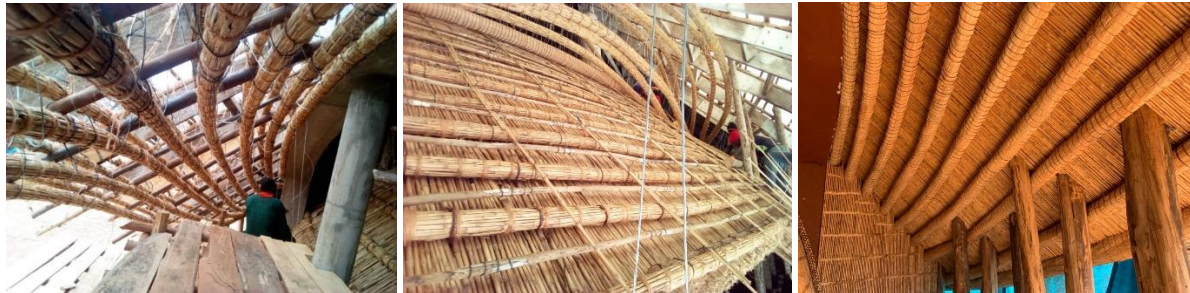
- Making circular rings, *bizizi* for the second ceiling.
- Fixing circular rings on the second ceiling.
- Finishing works on the circular rings.

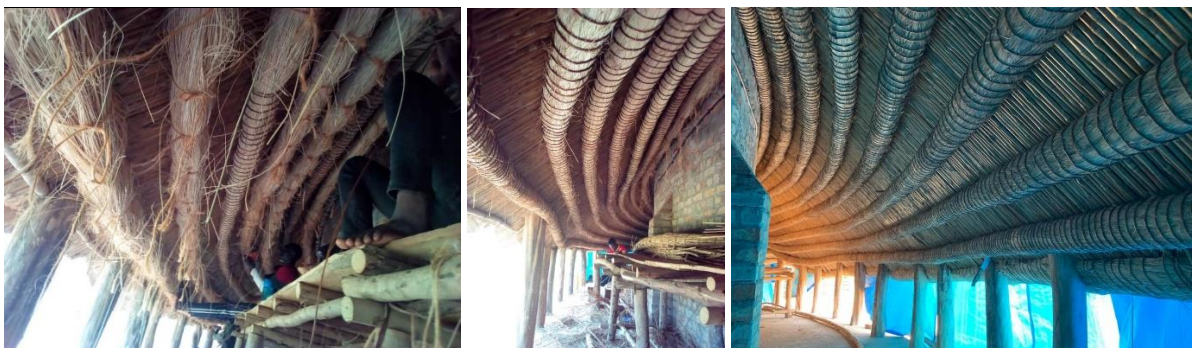
B. Verandah ceiling/ Overhang works

- Cleaning and wiping reeds.
- Piling and compacting reeds to make a reed bed.
- Making circular rings, *bizizi* for the overhang.
- Setting up scaffolds to be used in raising the circular rings.
- Fixing circular rings on the overhang.
- Finishing works on the circular rings.

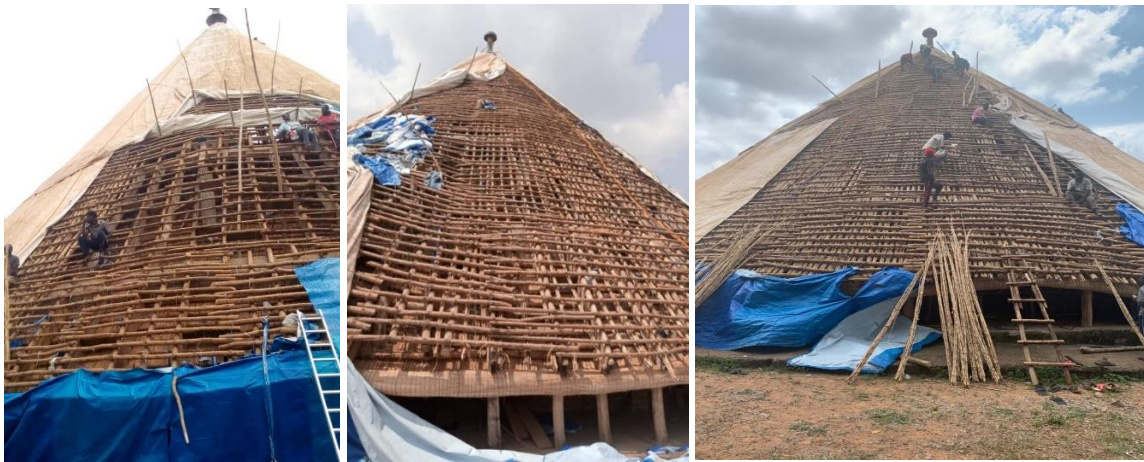
A. Preparation of roof to receive thatch

- Fixing minor rafters and purlins, *misambya* poles.
- Making small reed bundles and laying them below and in between *misambya* poles ready to receive thatch.

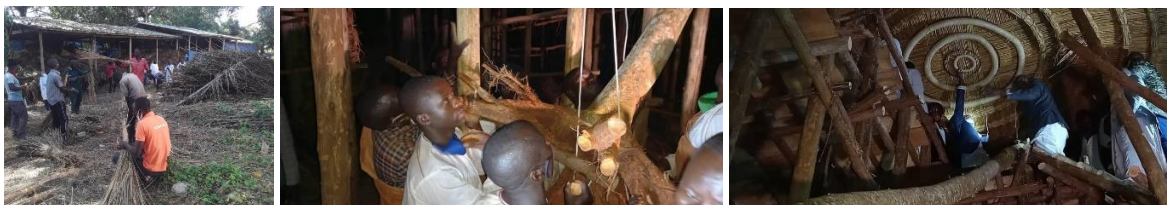
A. Thatching

- Sorting and bundling thatch.
- Sourcing the *Sserugatika*.
- Hacking floor and digging 1.5m pit to receive *Sserugatika*.

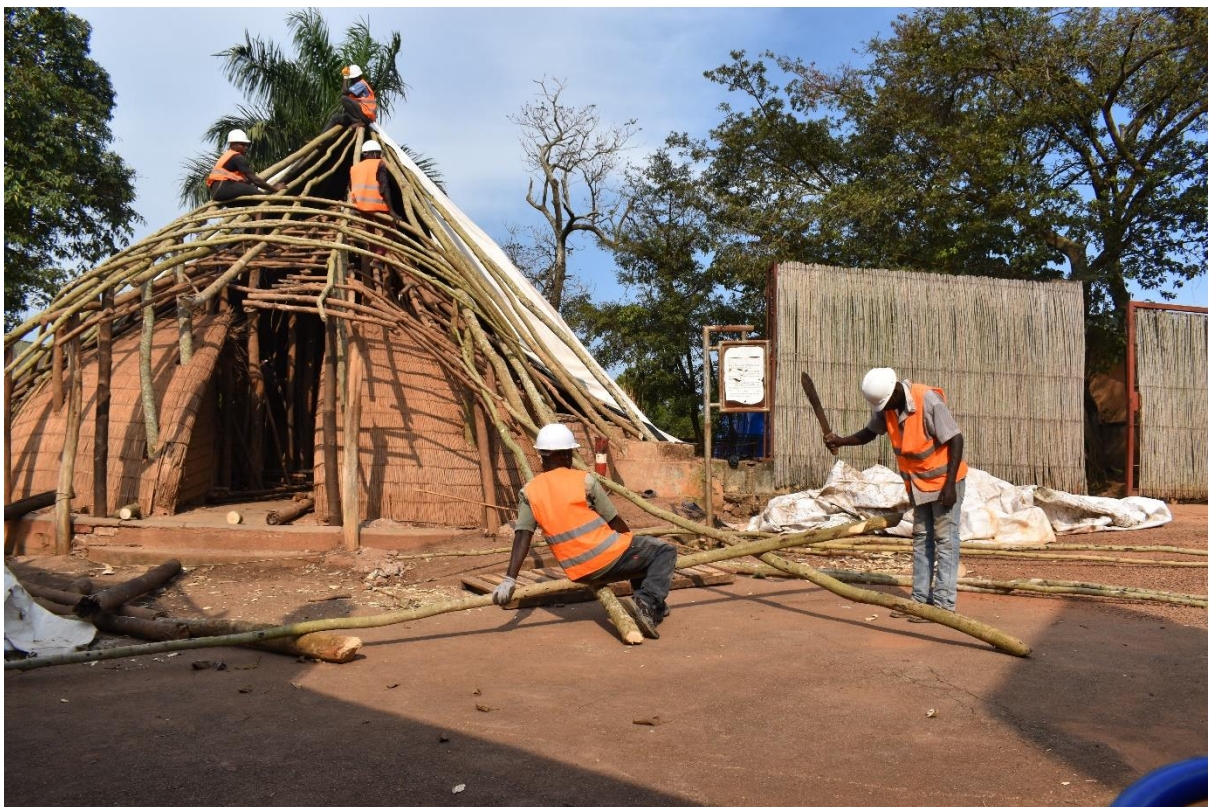
Fixing of the columns at the Royal Veranda.

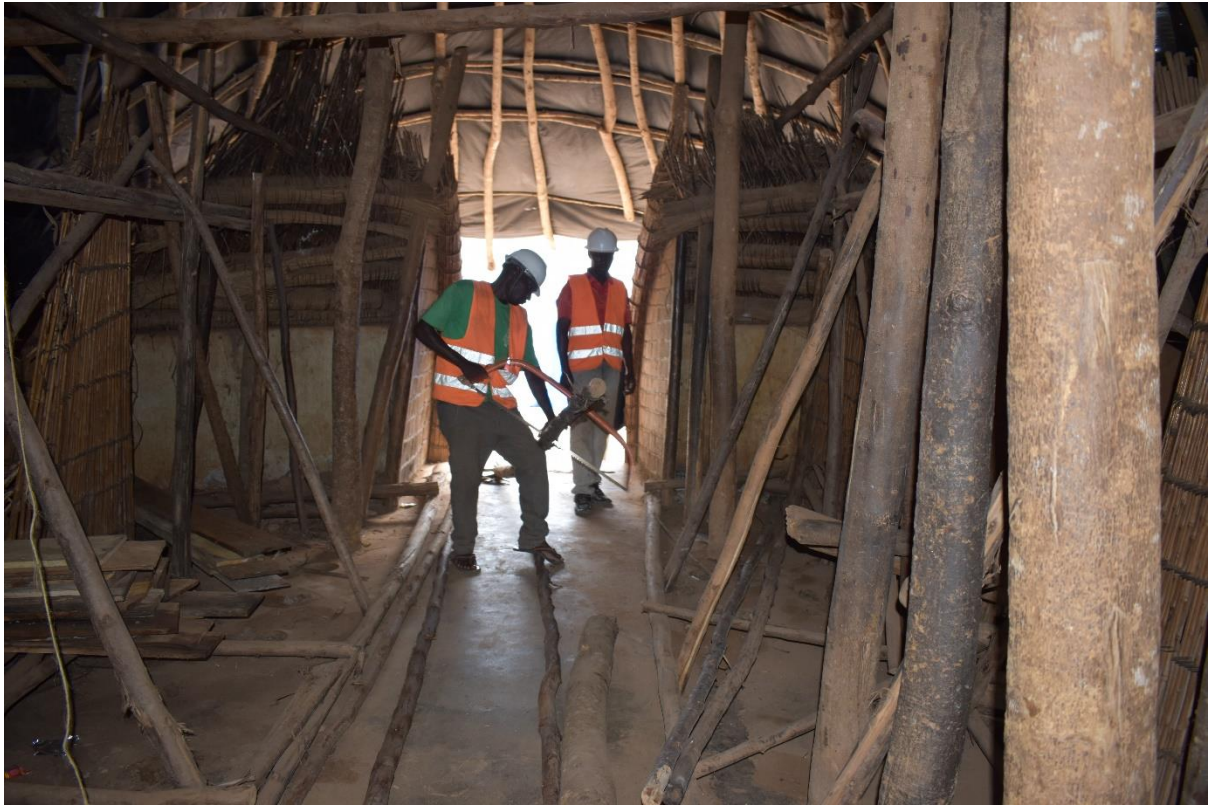
Securing of the Top-Four Sacred Rings before fixing the internal Reeds-make Ceiling.

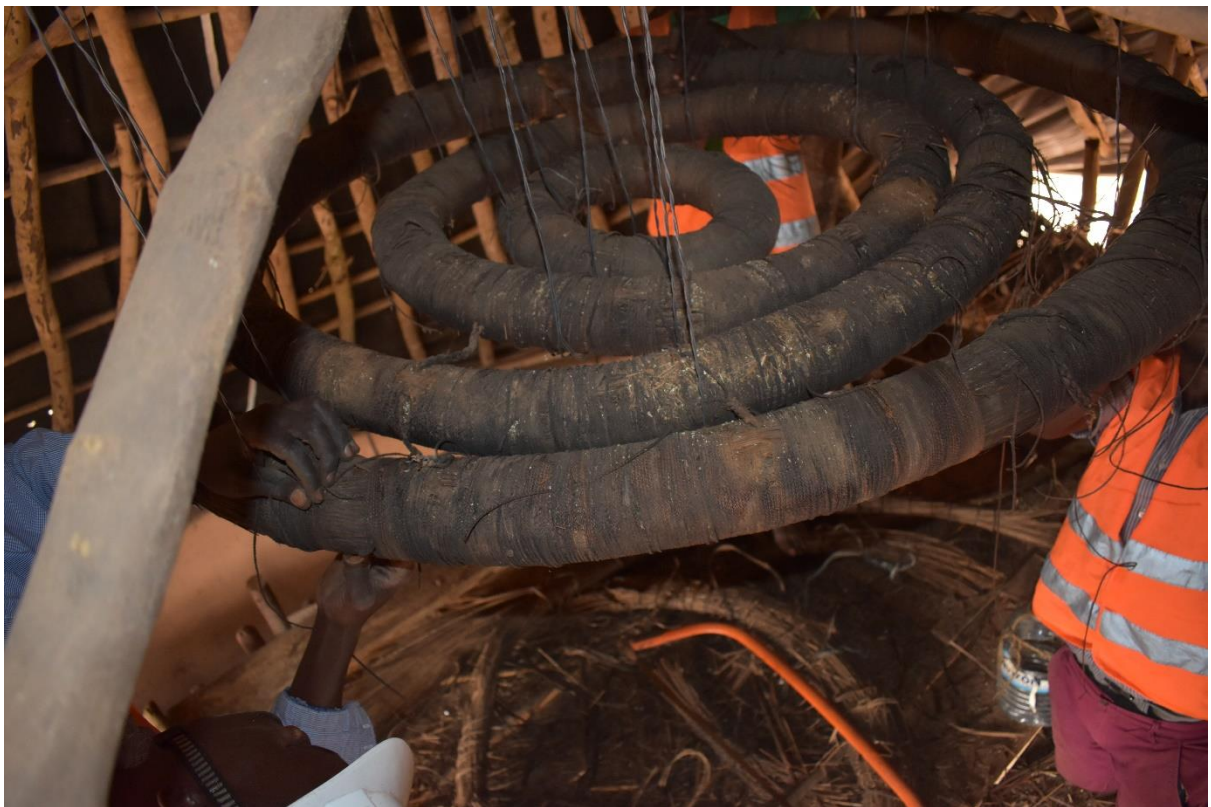
Fixing of the Circular ceiling grippers.

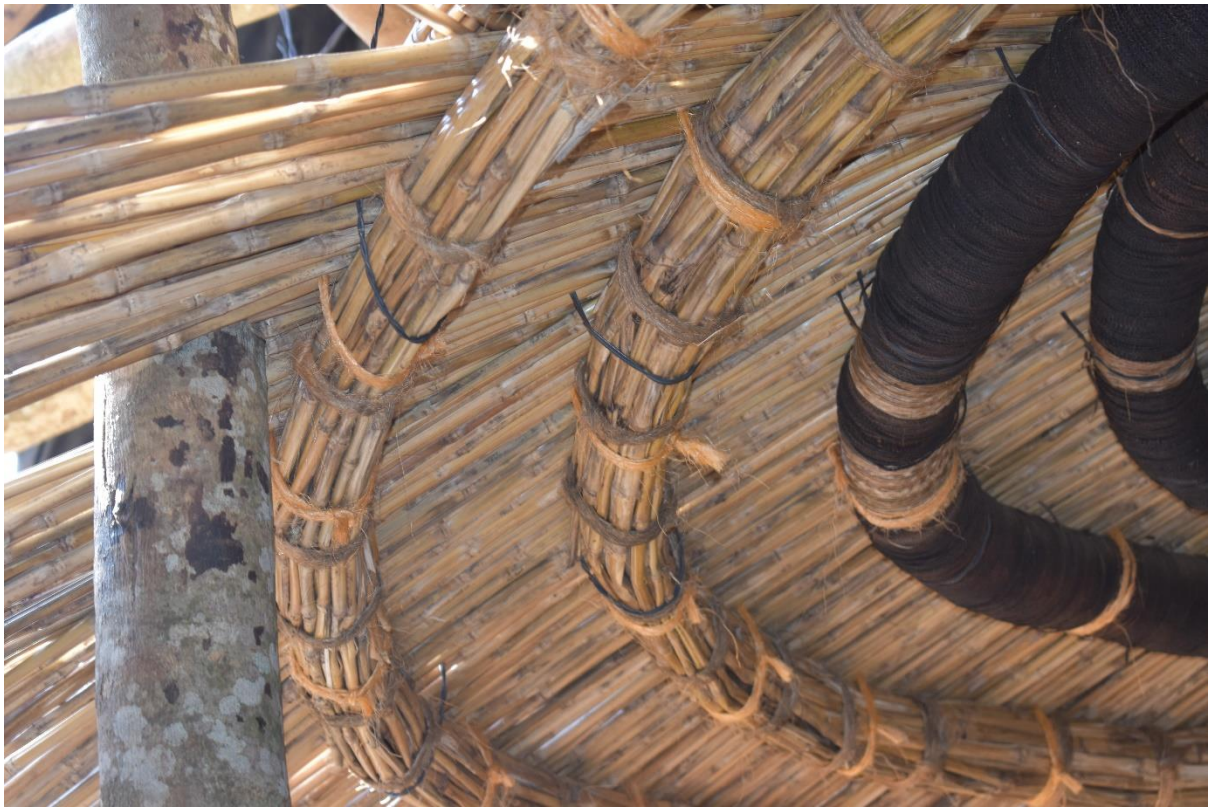
Image of showing the Top sacred rings properly fixed onto the reeds-make ceiling at the centre point.

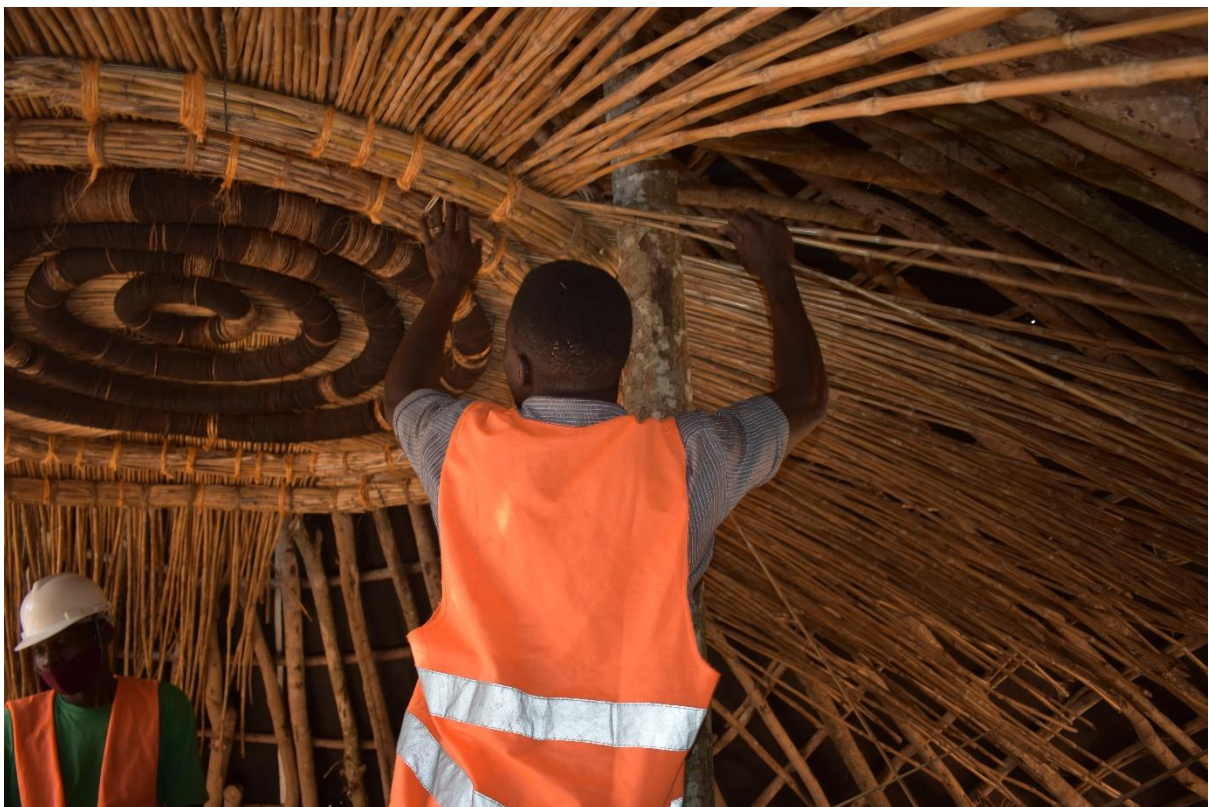
The sharpened reed is in the process of being fixed to make the internal ceiling.

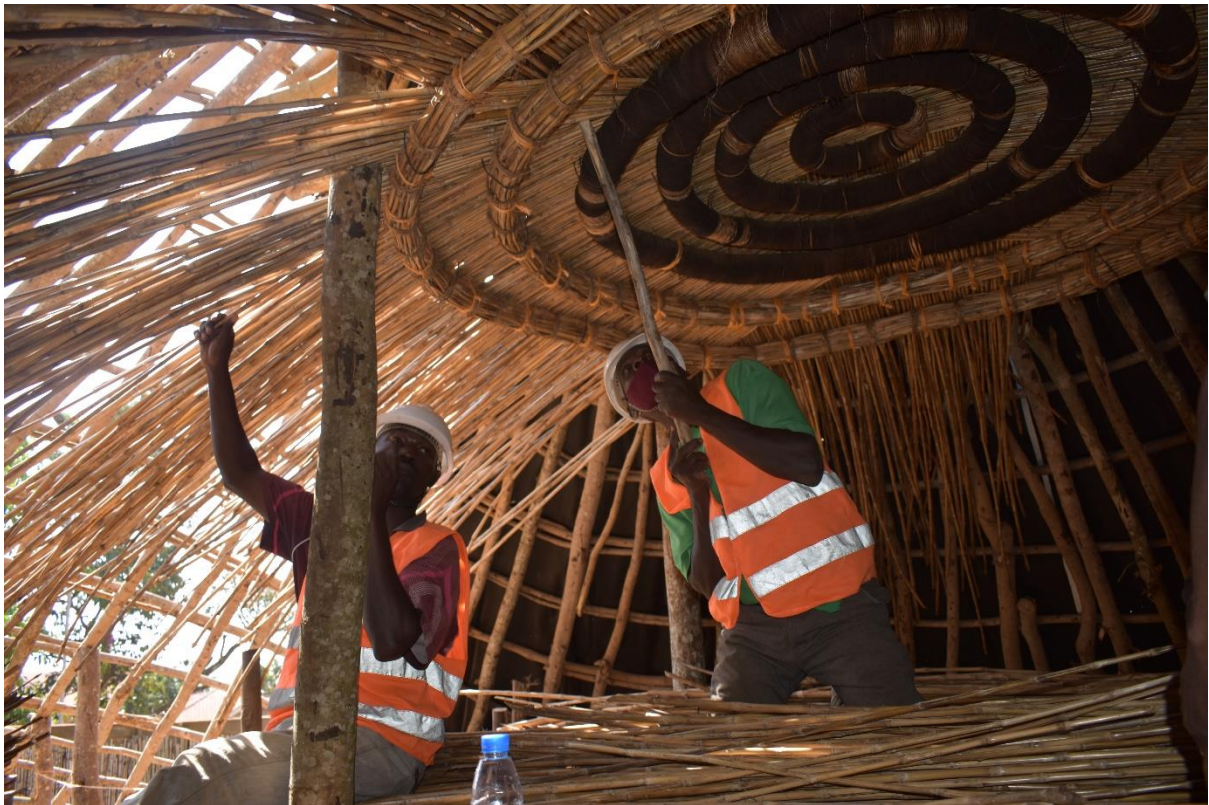
The sharpened reed is being fixed to make the internal ceiling.

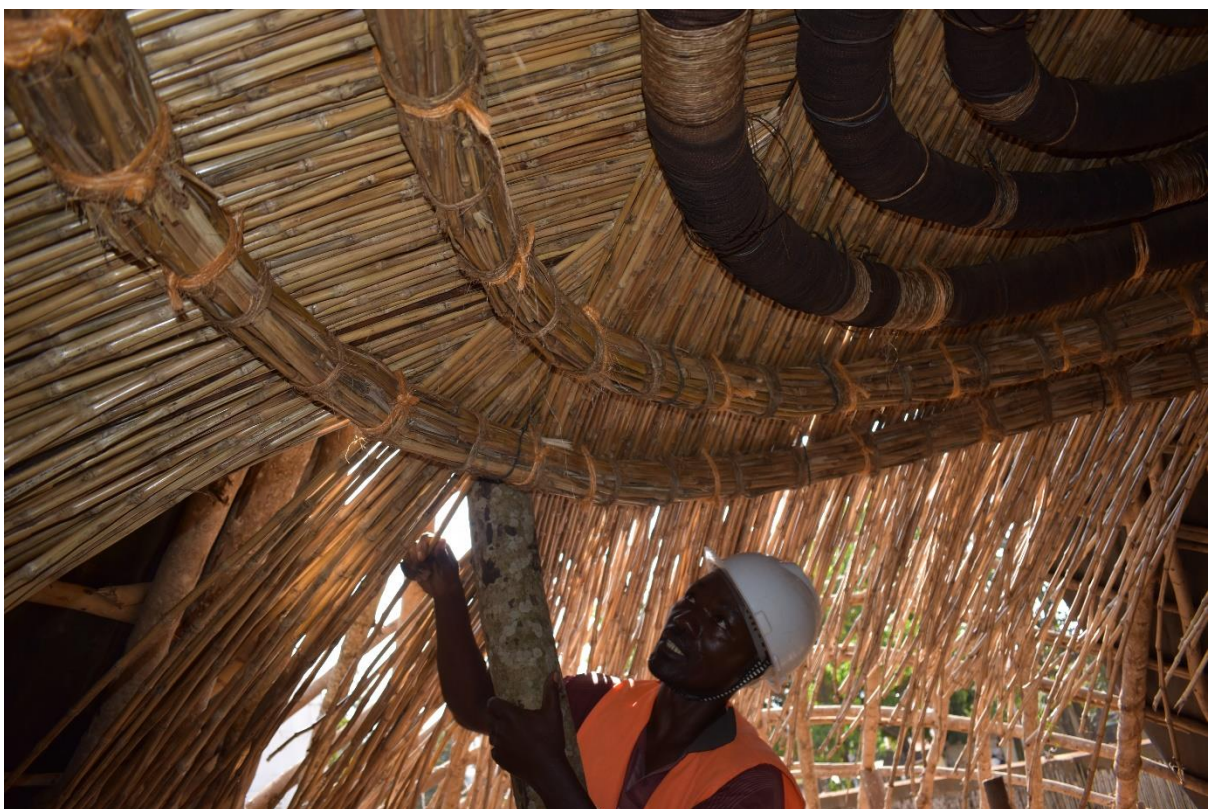
The sharpened reeds are being fixed to make the internal ceiling

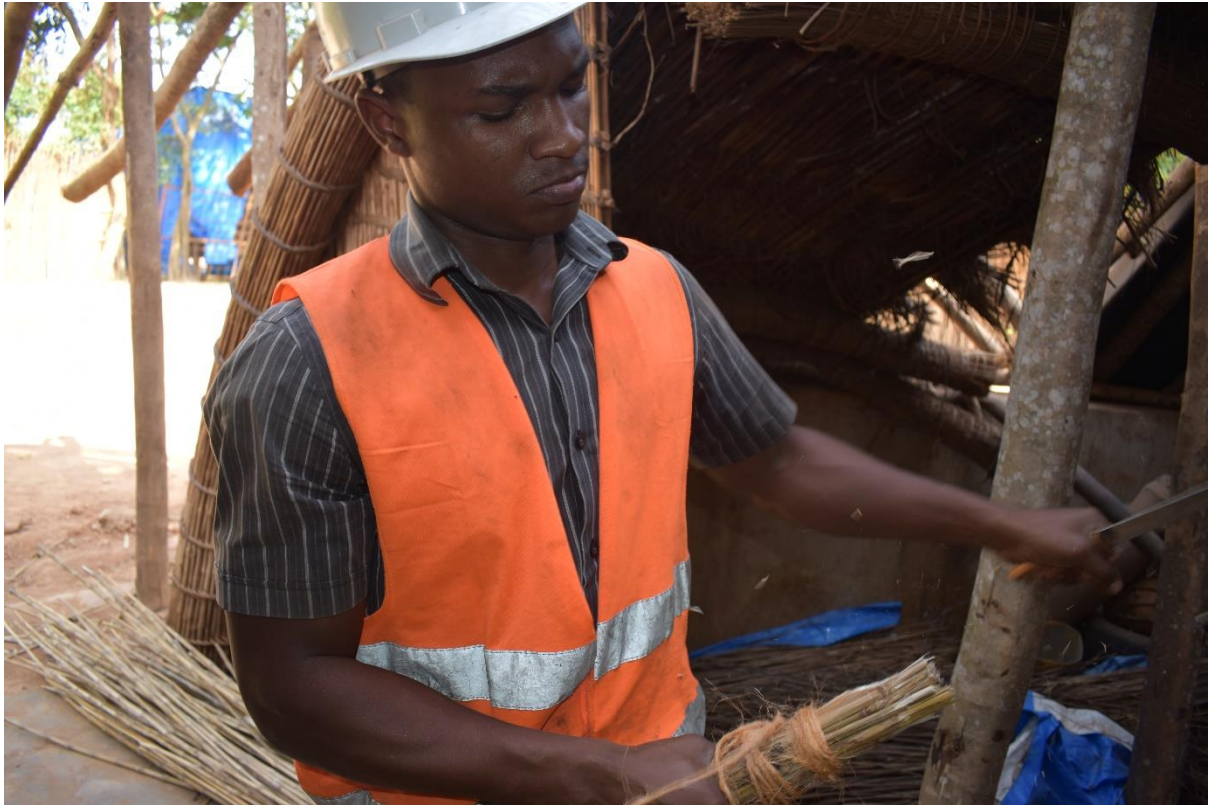
The sharpened reeds are being fixed to make the internal ceiling

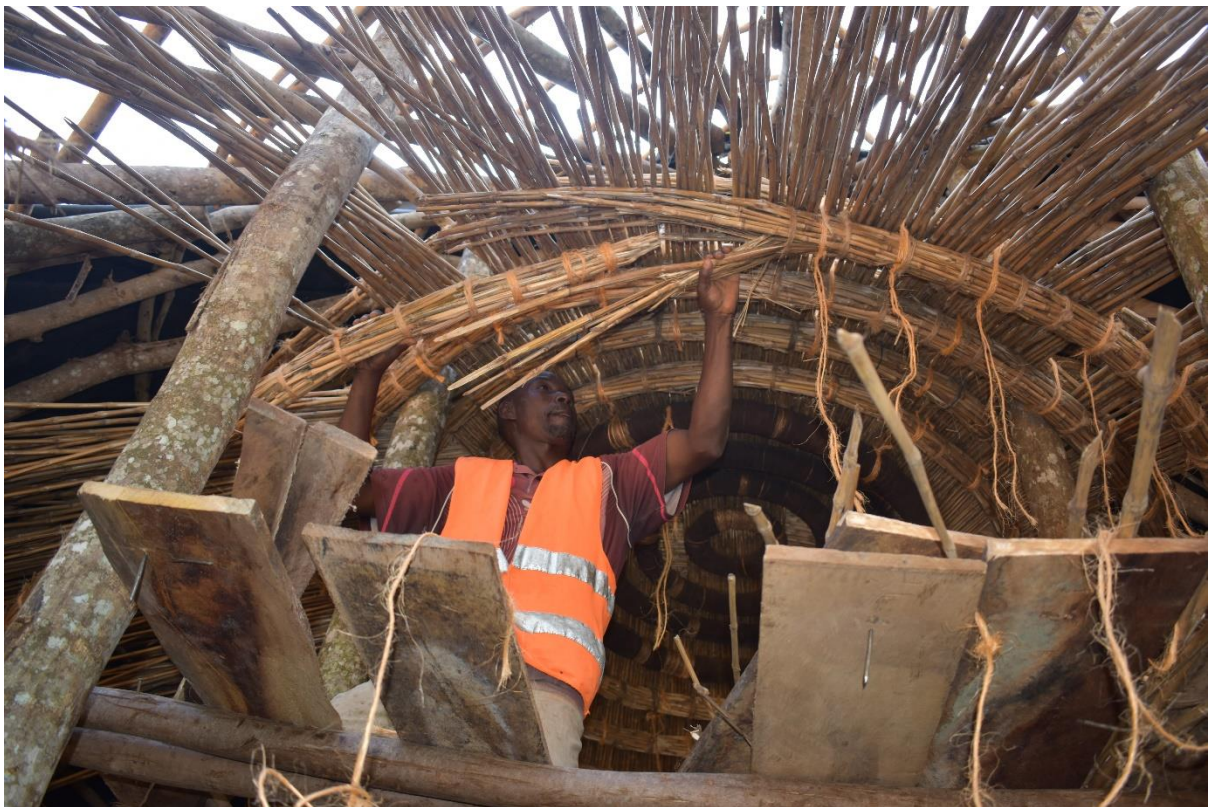
The skeleton of the ring is being sharpened

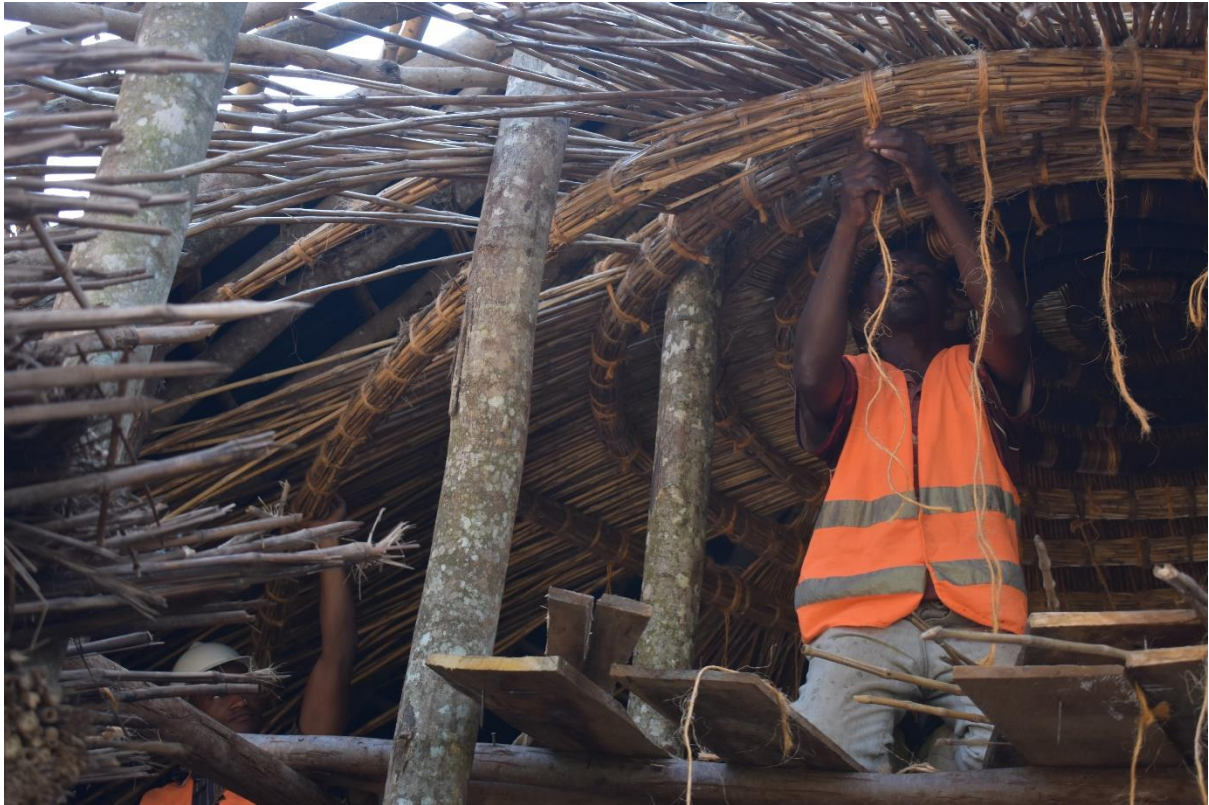
The sharpened skeleton of the ring is being joined to complete the ring's roundness.

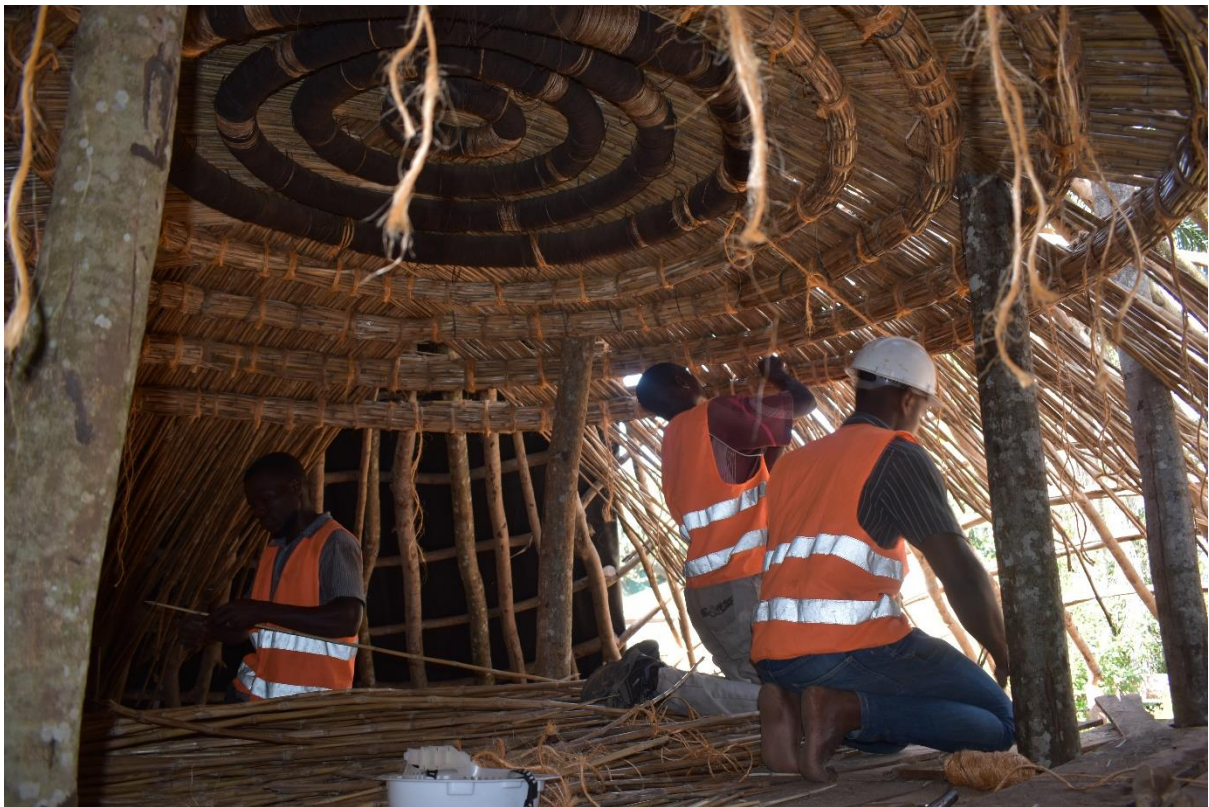
The approved joined skeleton of the ring to complete the ring`s roundness is being tightly fixed.

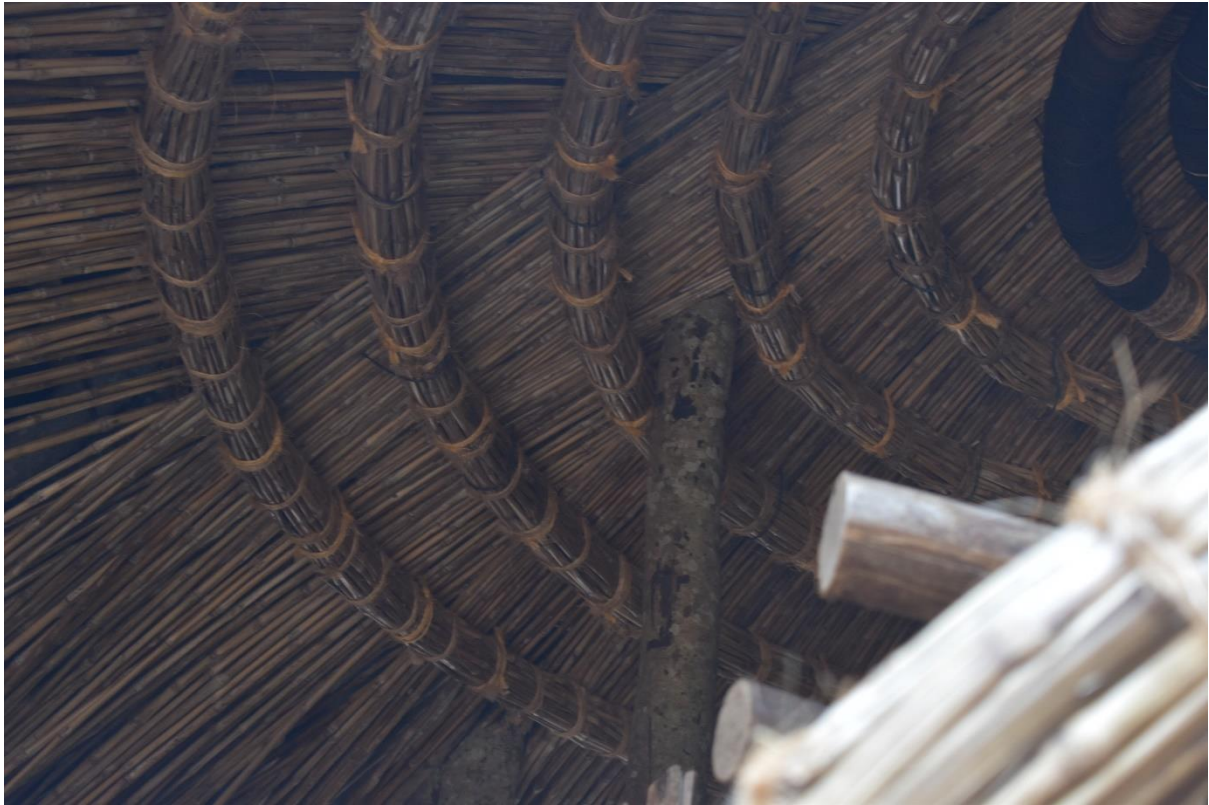
The process for fixing the internal reeds make ceiling is still on-going

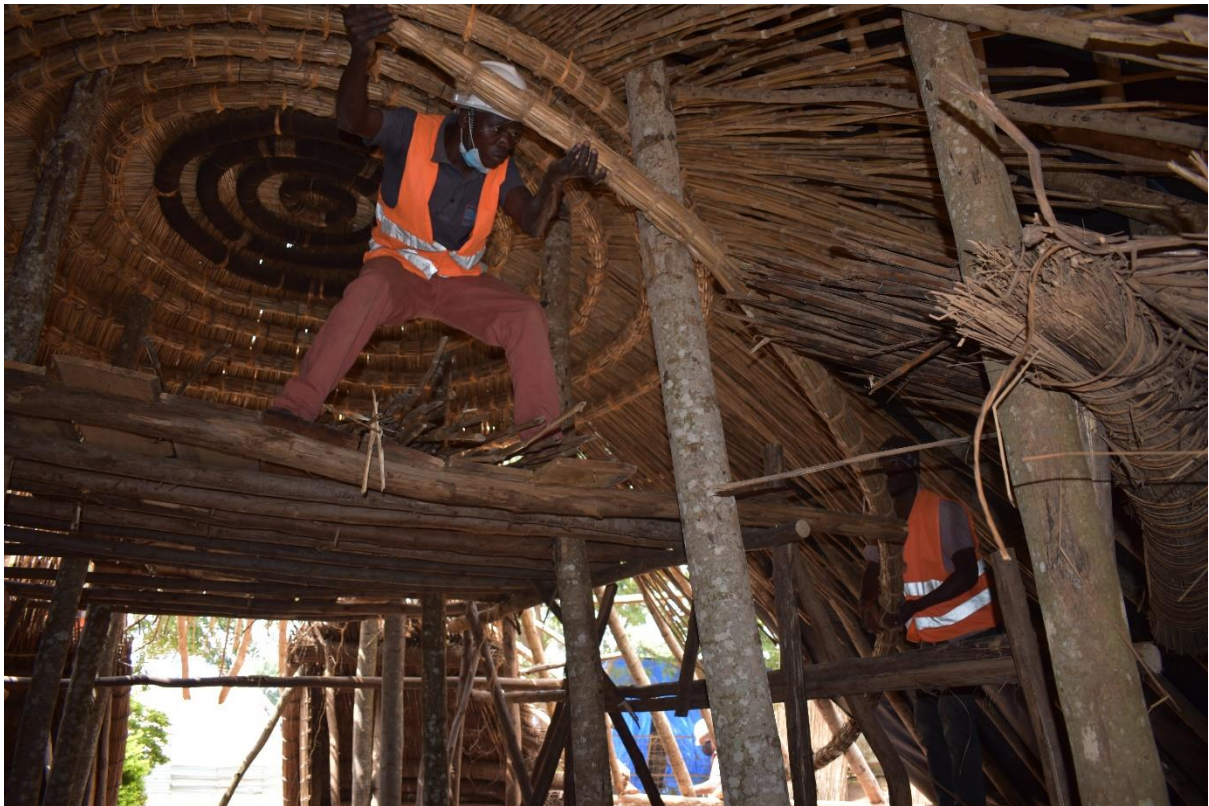
Five rings skeleton for the new approved rings have been appropriately fixed so far.

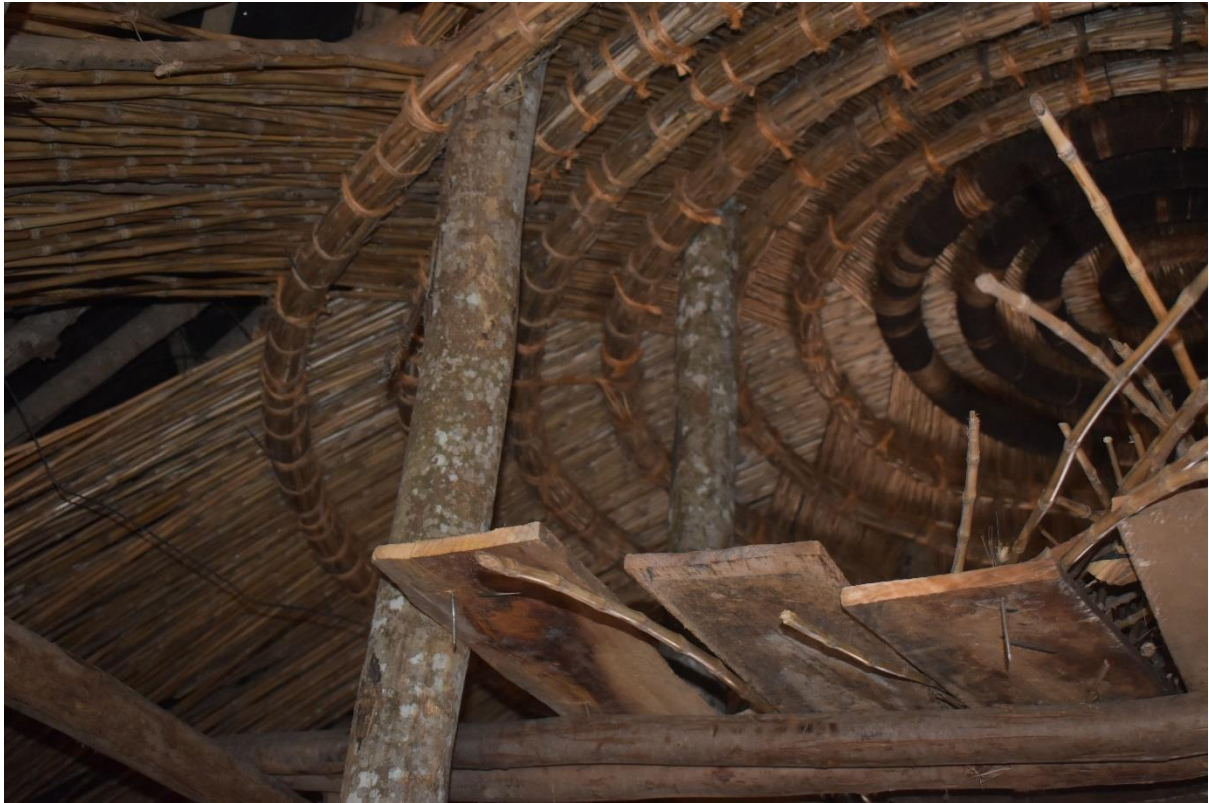
The process for fixing the sixth ring`s skeleton.

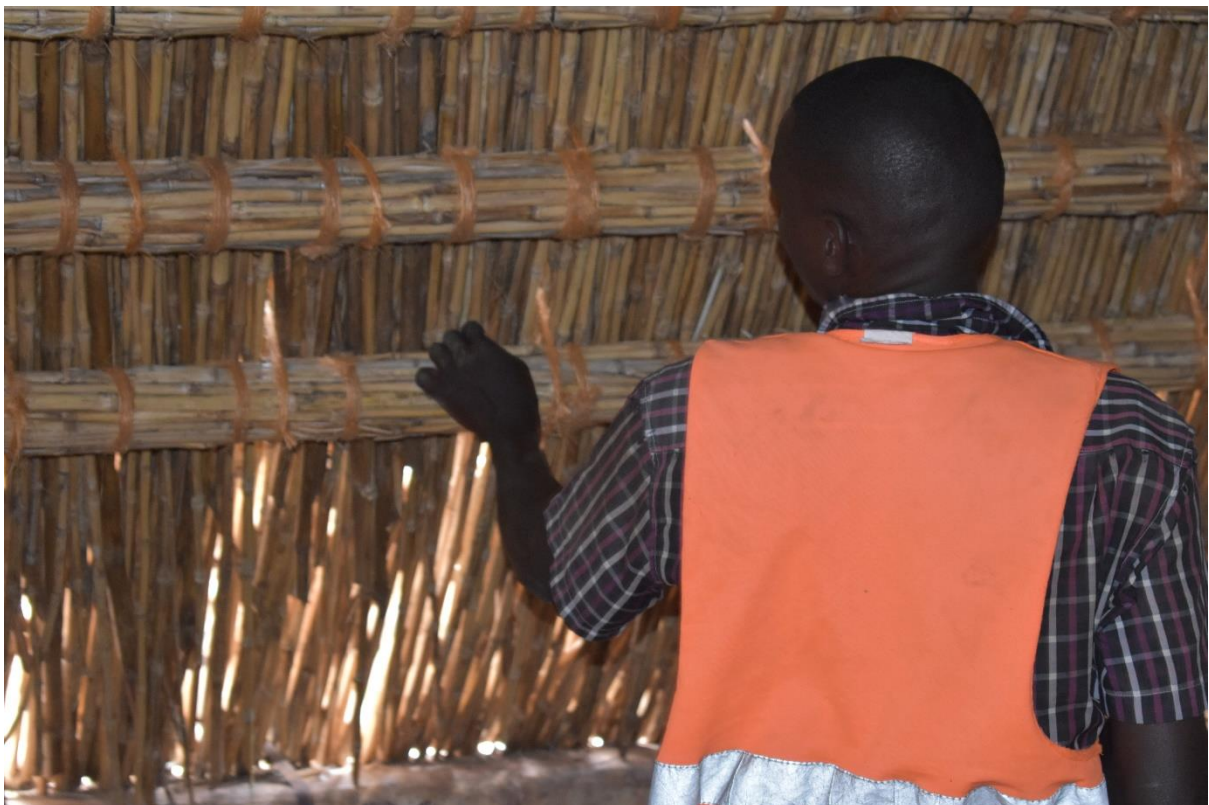
The sixth ring skeleton fixed into the approved position.

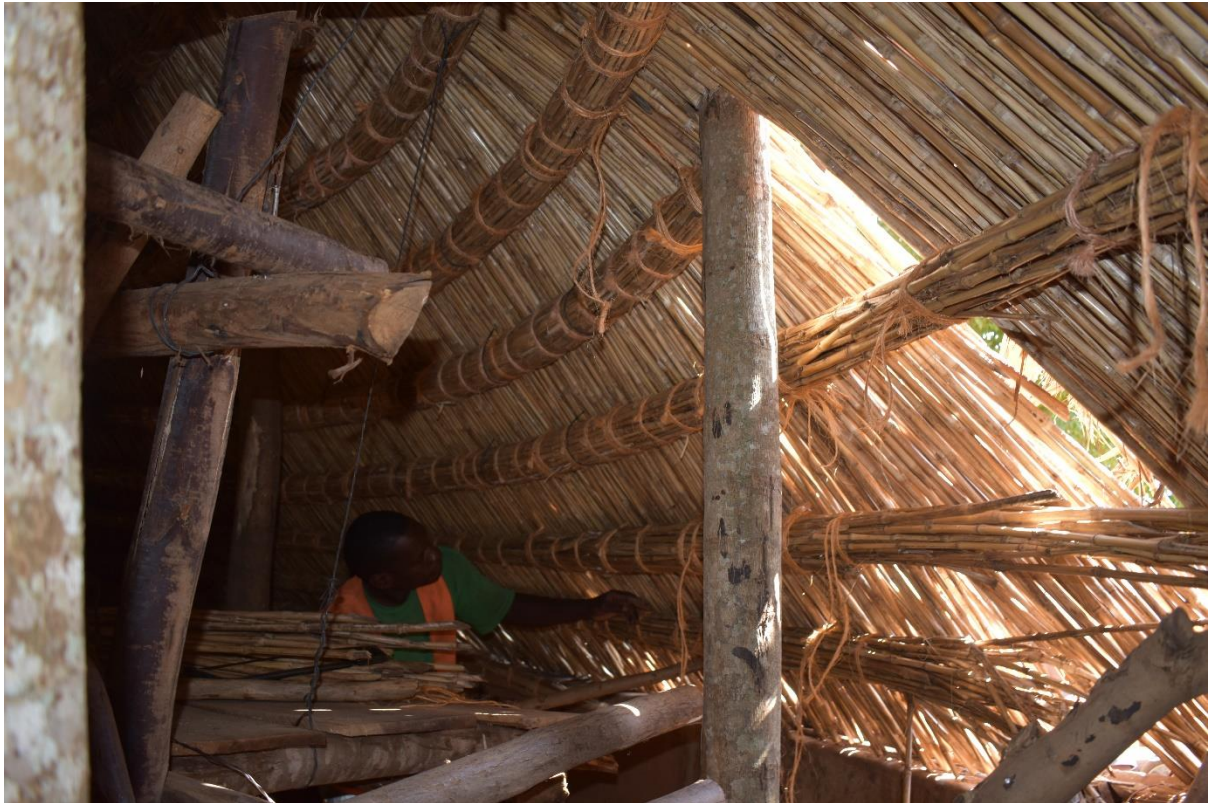
Cross checking the already firmly fixed ring skeletons.

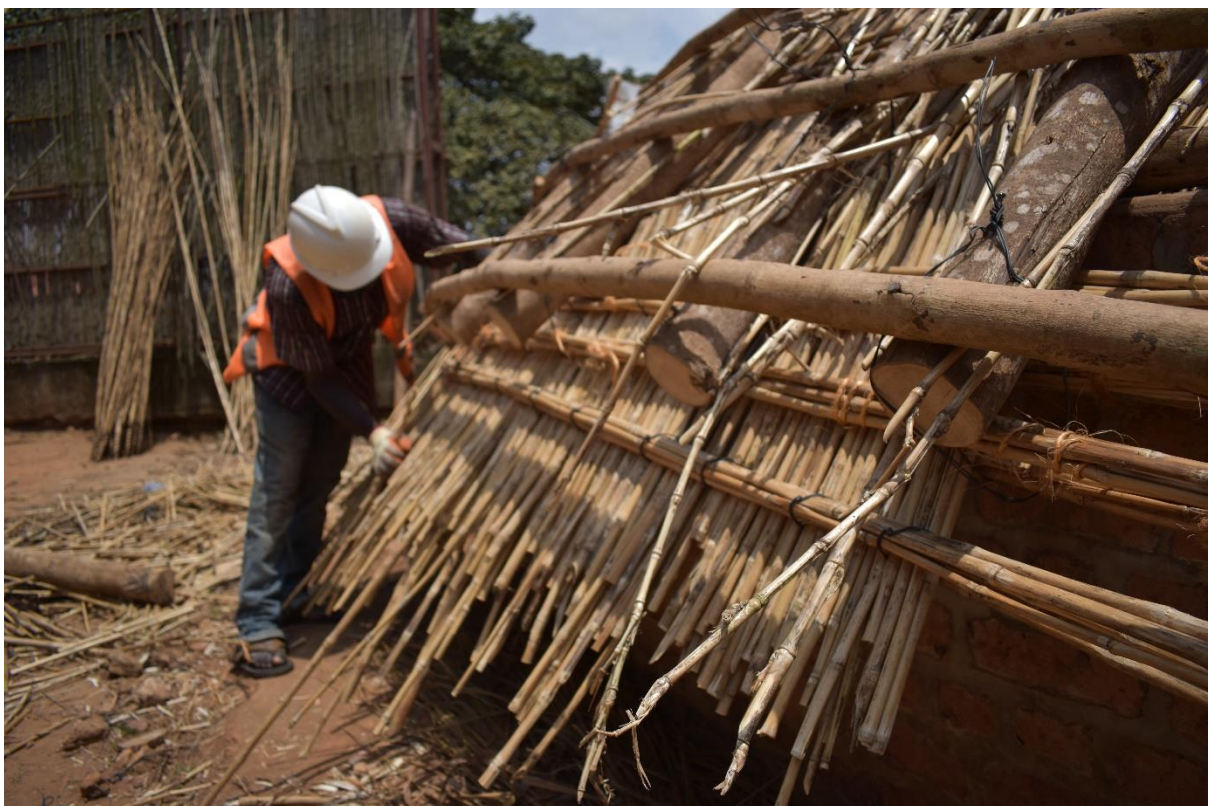
Fixing the remaining ring skeletons to complete the required number at Mulamba`s side.

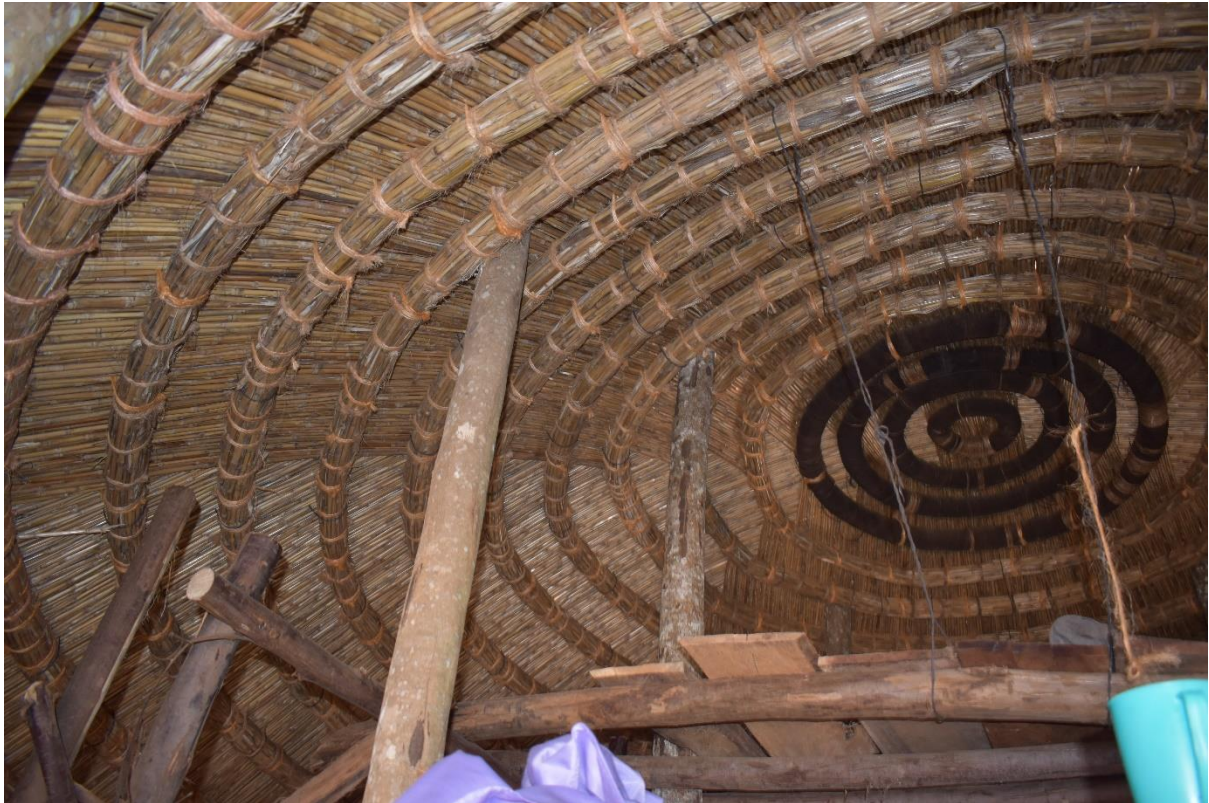
Firmly fixing the eaves overhung at Mulamba`s side.

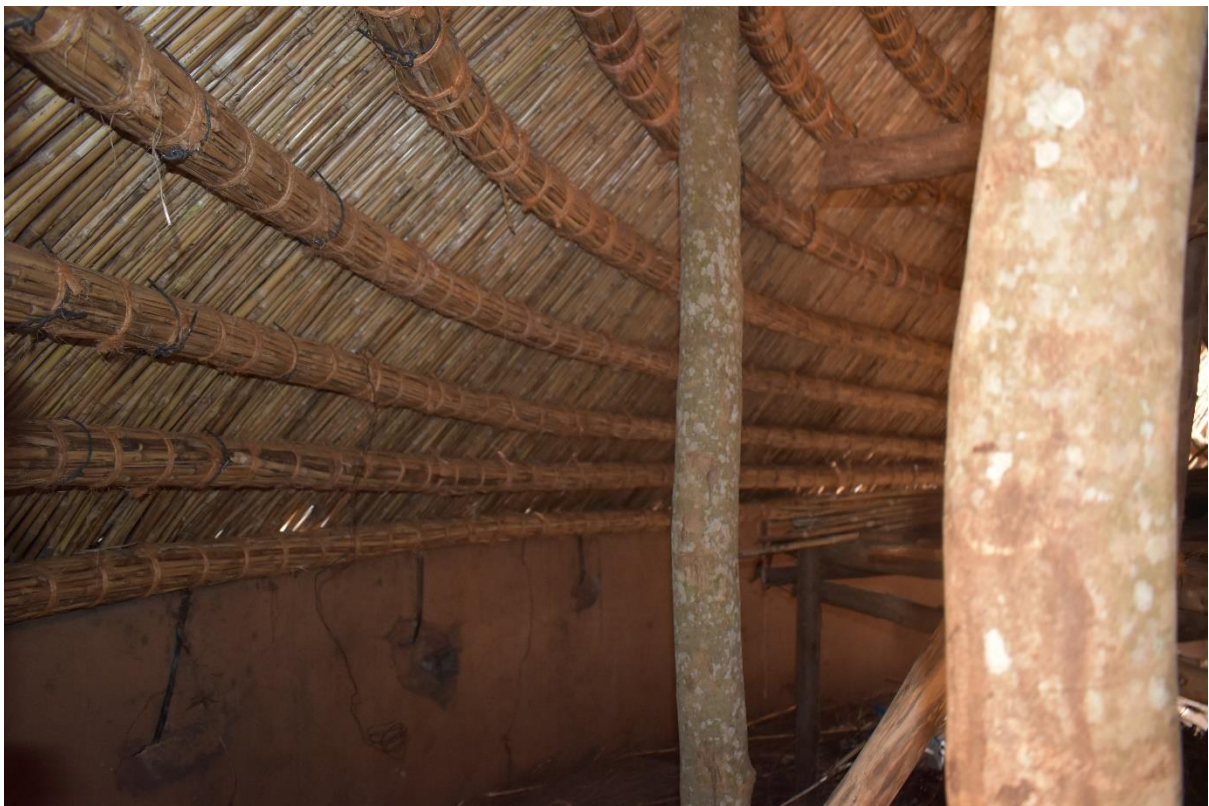
View of the already approved firmly fixed Interior Ring Skeletons from the repaired existing Sacred rings.

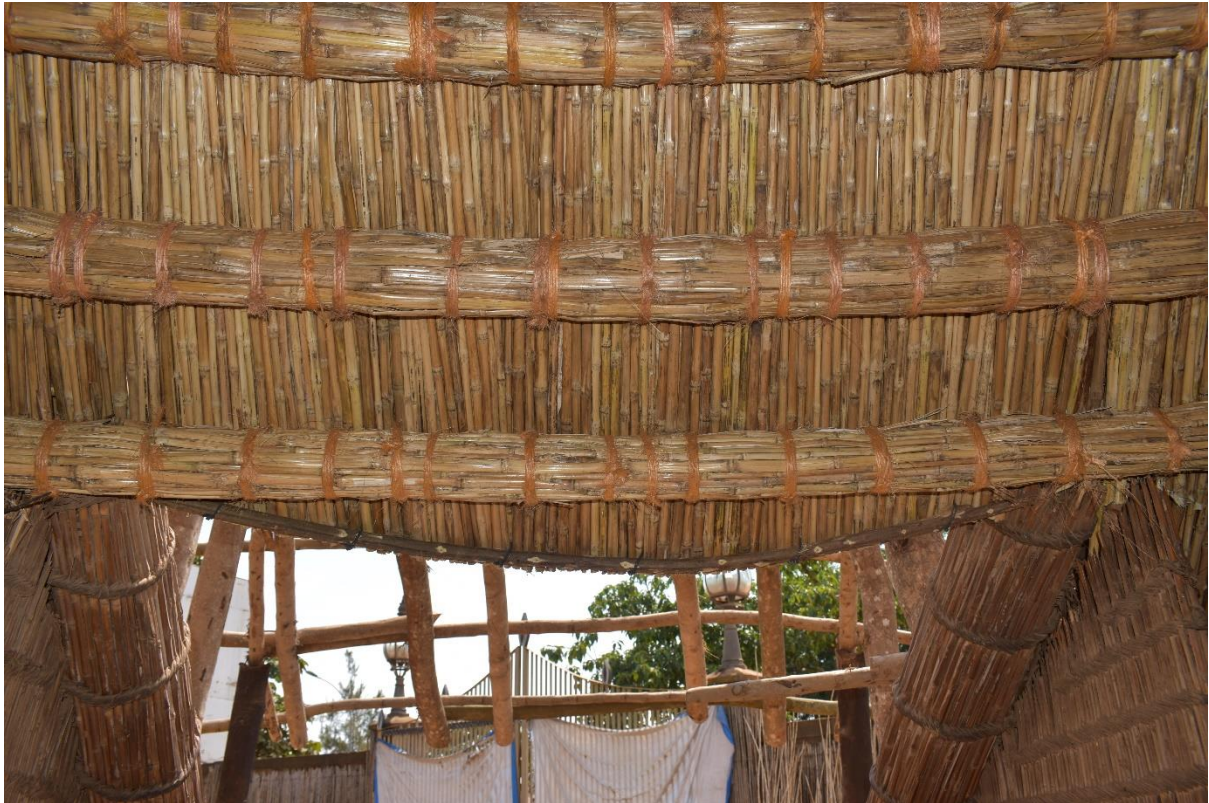
View of the already approved firmly fixed Interior Ring Skeletons from the central point to the Load bearing wall.

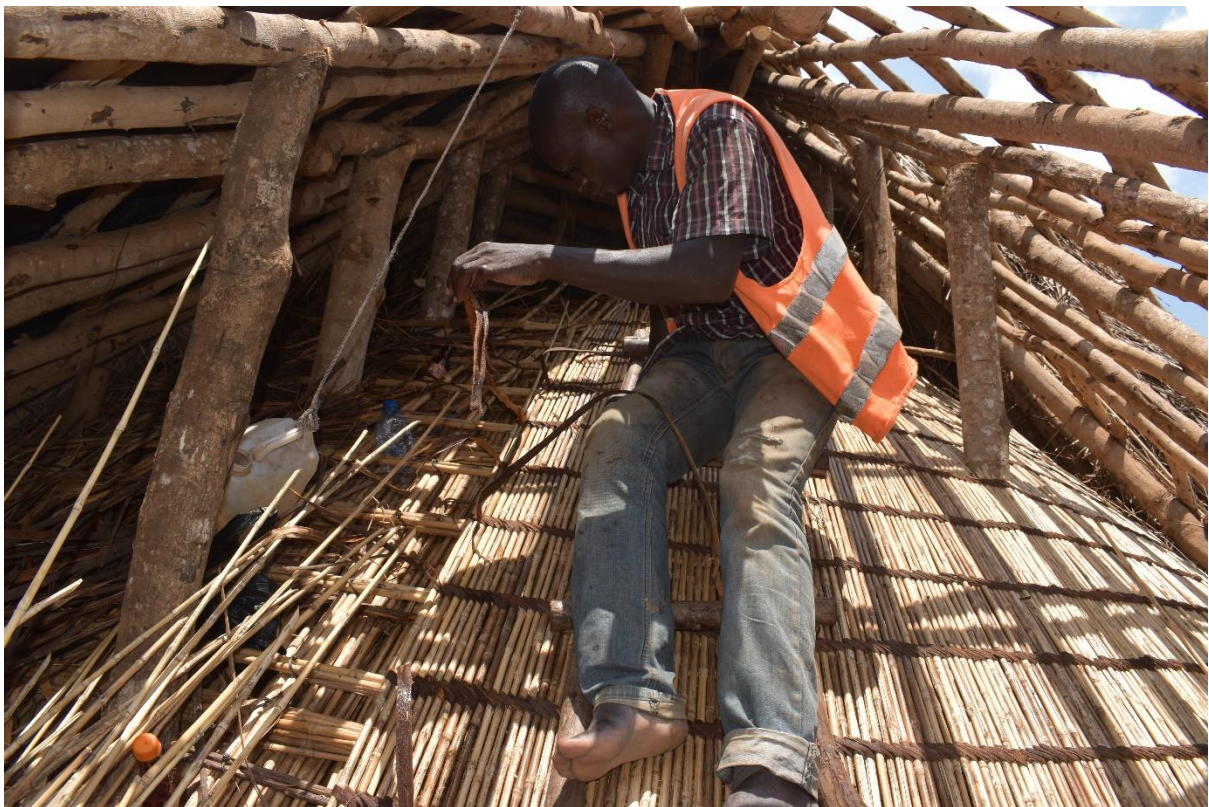
View of the already approved firmly fixed Interior Ring Skeletons with the reeds make ceiling at the Front side entrance.
