STATE OF CONSERVATION

TOMBS OF BUGANDA KINGS AT KASUBI(UGANDA)

**THE
BUJJABUKULA ROYAL GRANDIOSE
ENTRANCE BUILDING**
To the Tombs of Buganda Kings at Kasubi – UNESCO World Heritage
Property in Uganda

PHOTOGRAPHIC PROGRESS REPORT

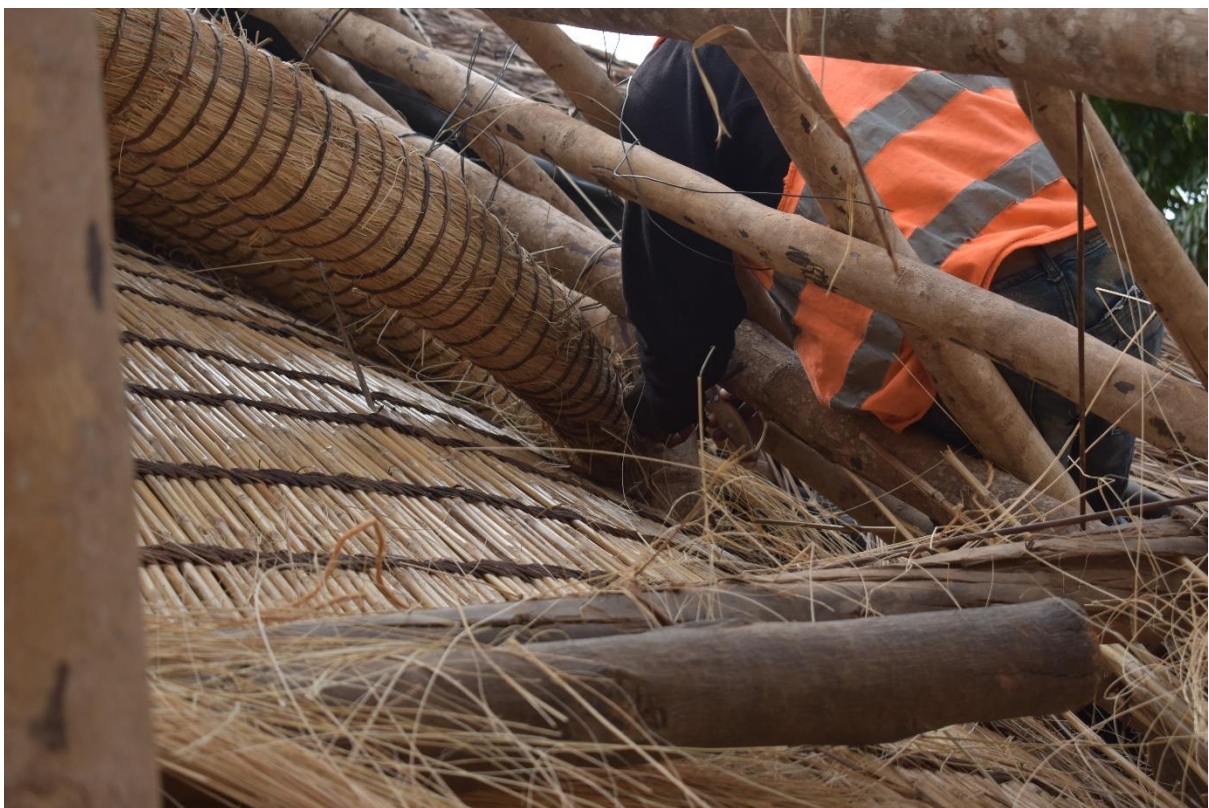
Positioning of the external rings before fixing the external reeds-make Ceiling at the rear side of the entrance.

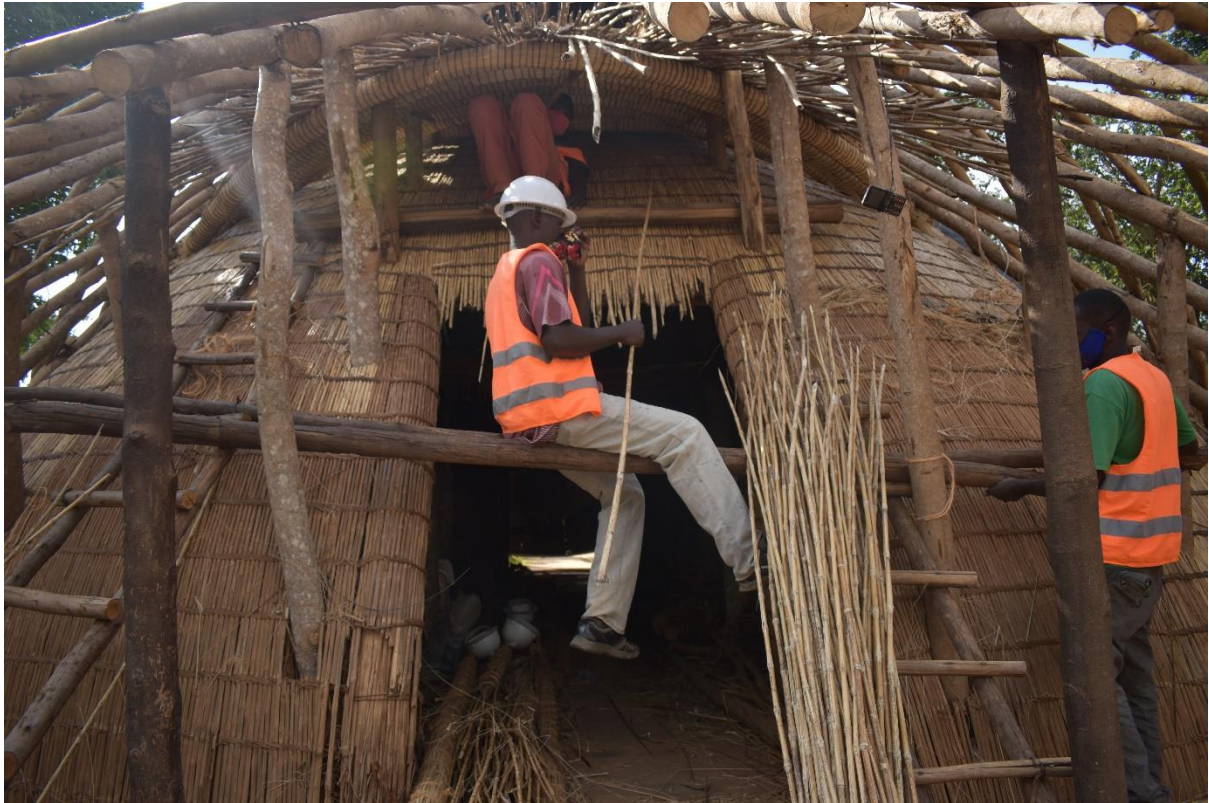
Fixing of the already positioned external Rings.

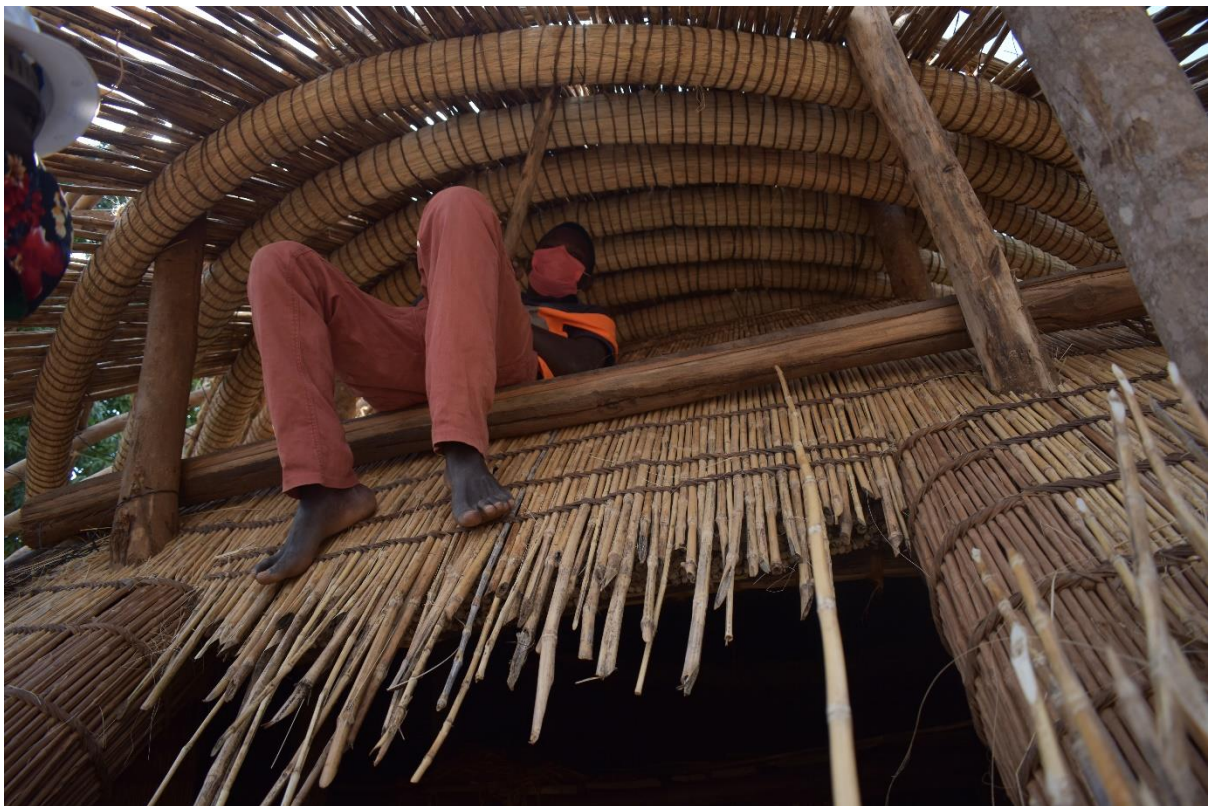
Reinforcing the already fixed Rings with the Fixing of the reeds-make External ceiling.

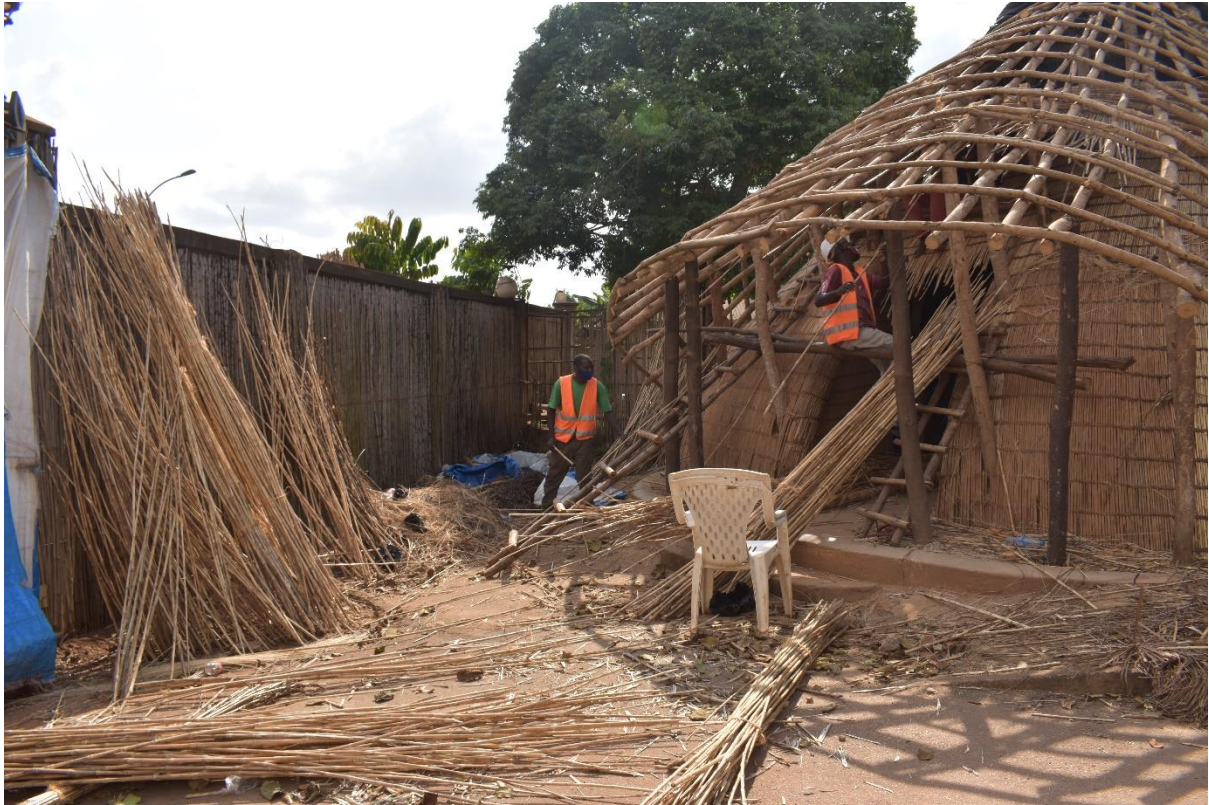
Fixing of the External reeds-make ceiling.

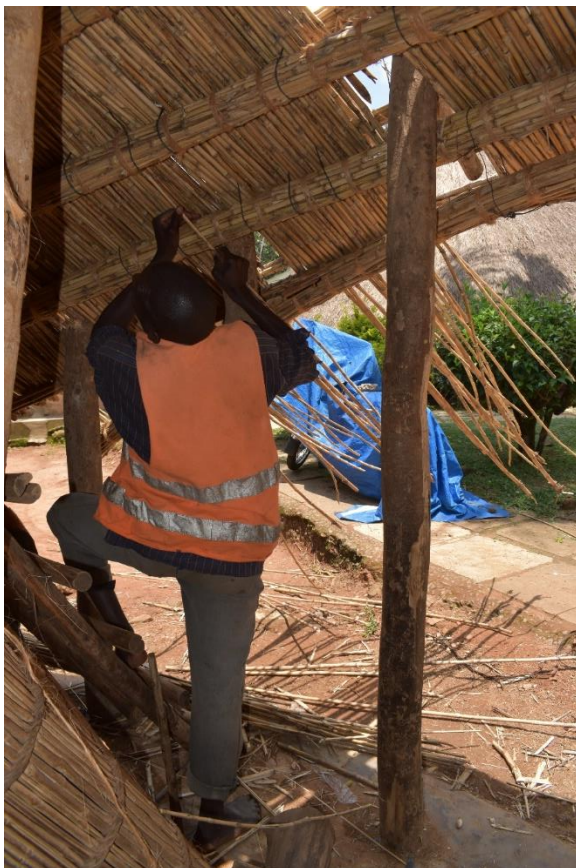
View showing the Fixing of the External reeds-make ceiling.

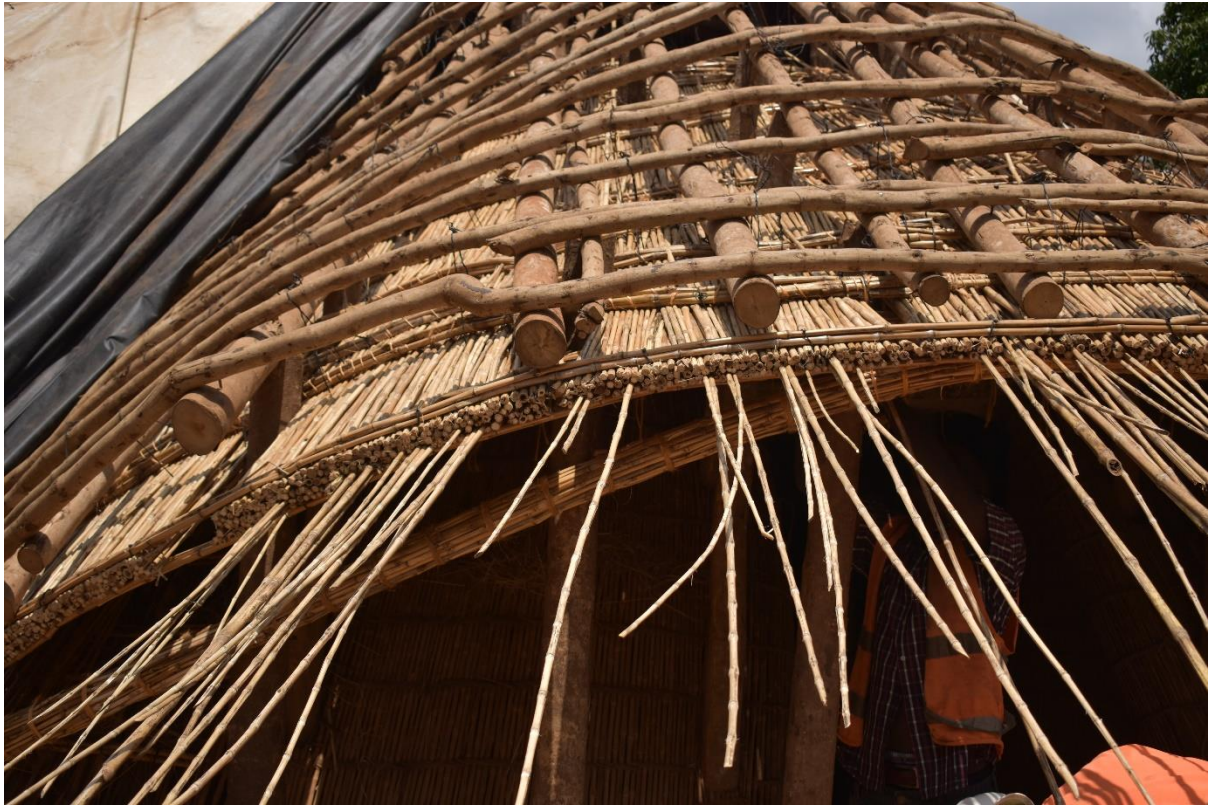
Internal view showing the Fixing of the External reeds-make ceiling.

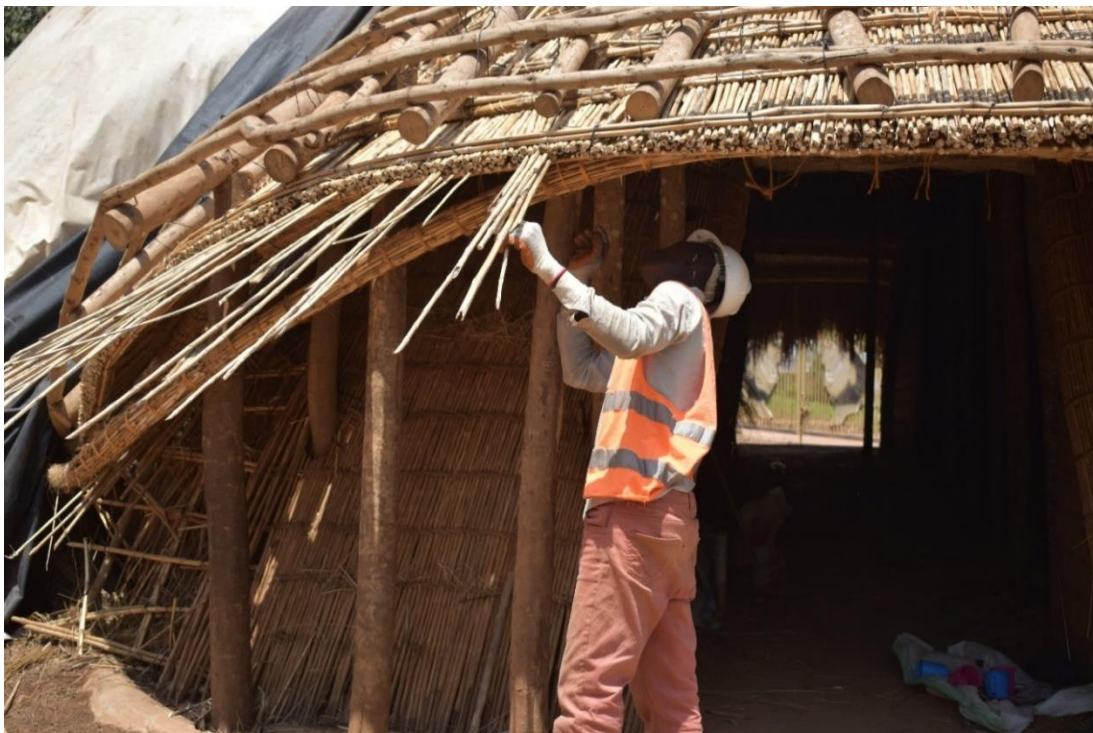
Fixing of the final ring onto the External reeds-make ceiling.

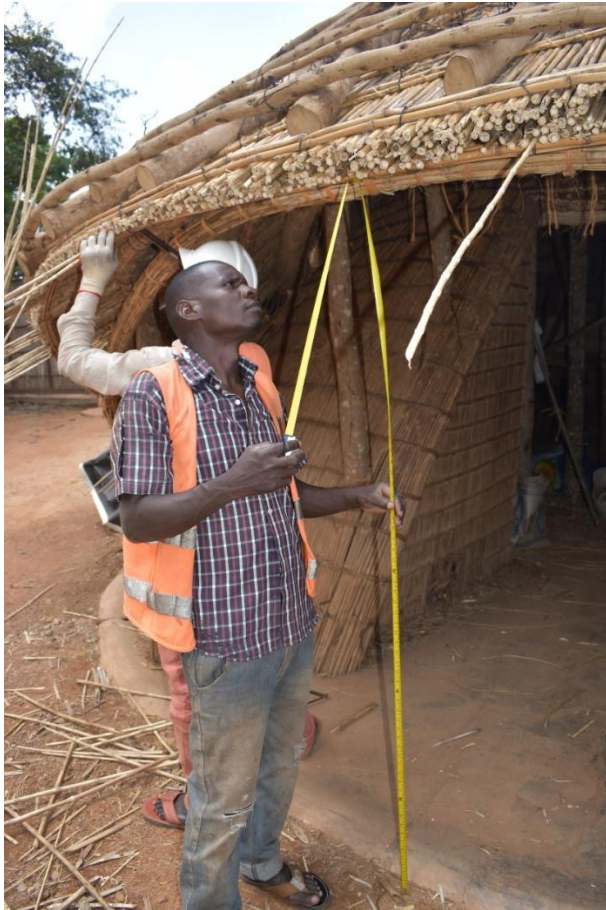
The image is showing the Fixing of the External reeds-make ceiling to completion.

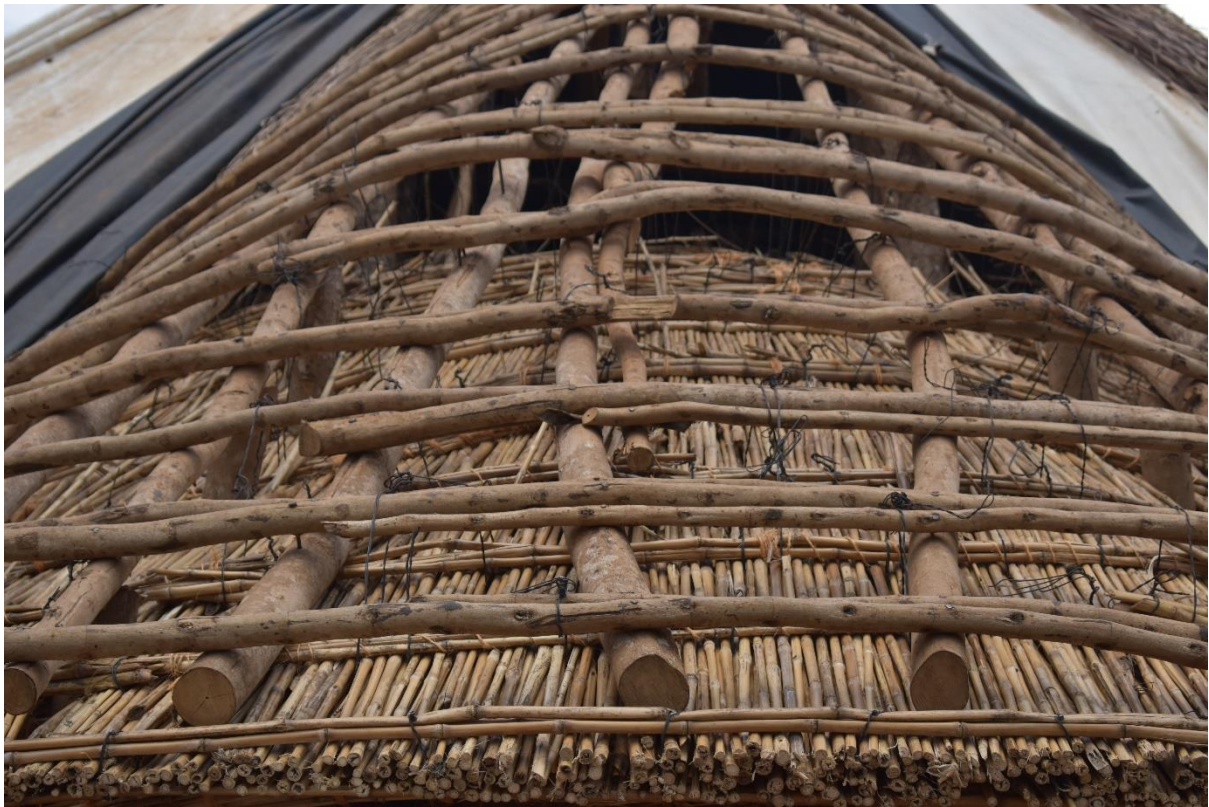
Trimming off of the protruding external reeds-make ceiling to the approved required length.

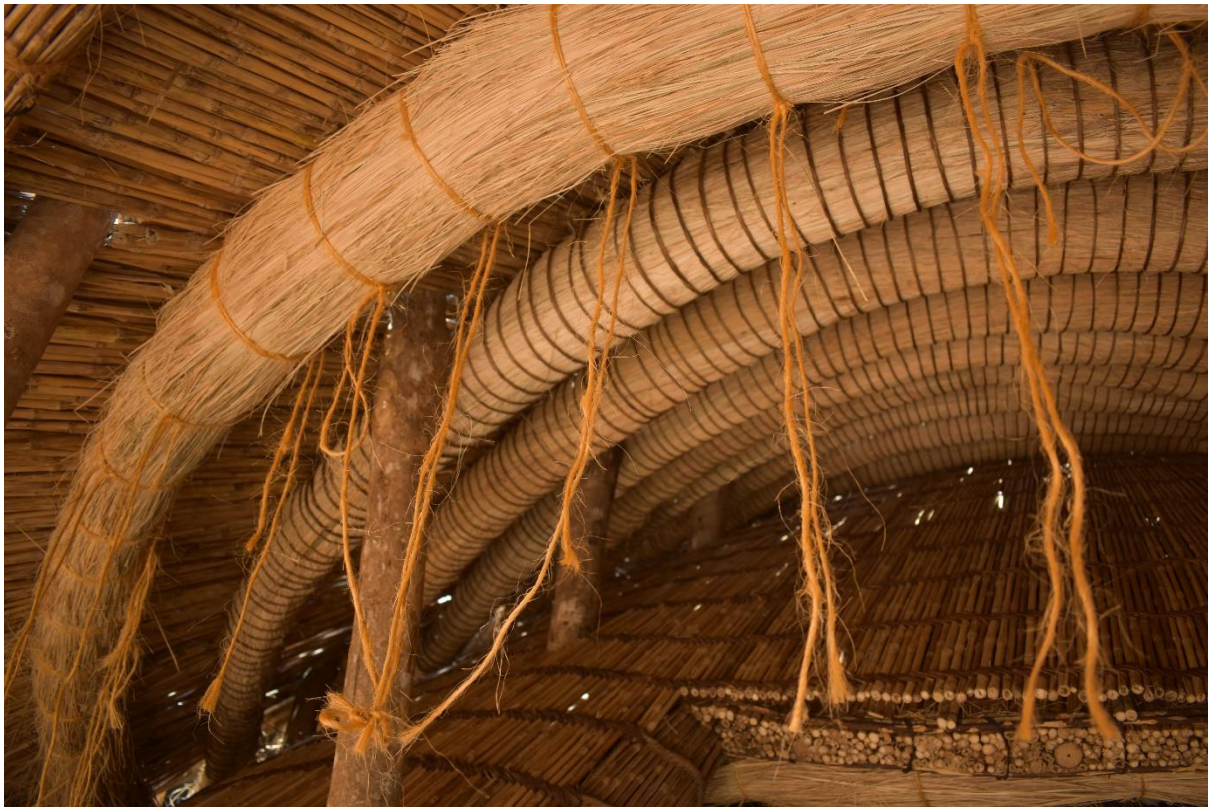
Internal appearance of the approved firmly fixed external reeds-make ceiling with the already approved fixed rings in position.

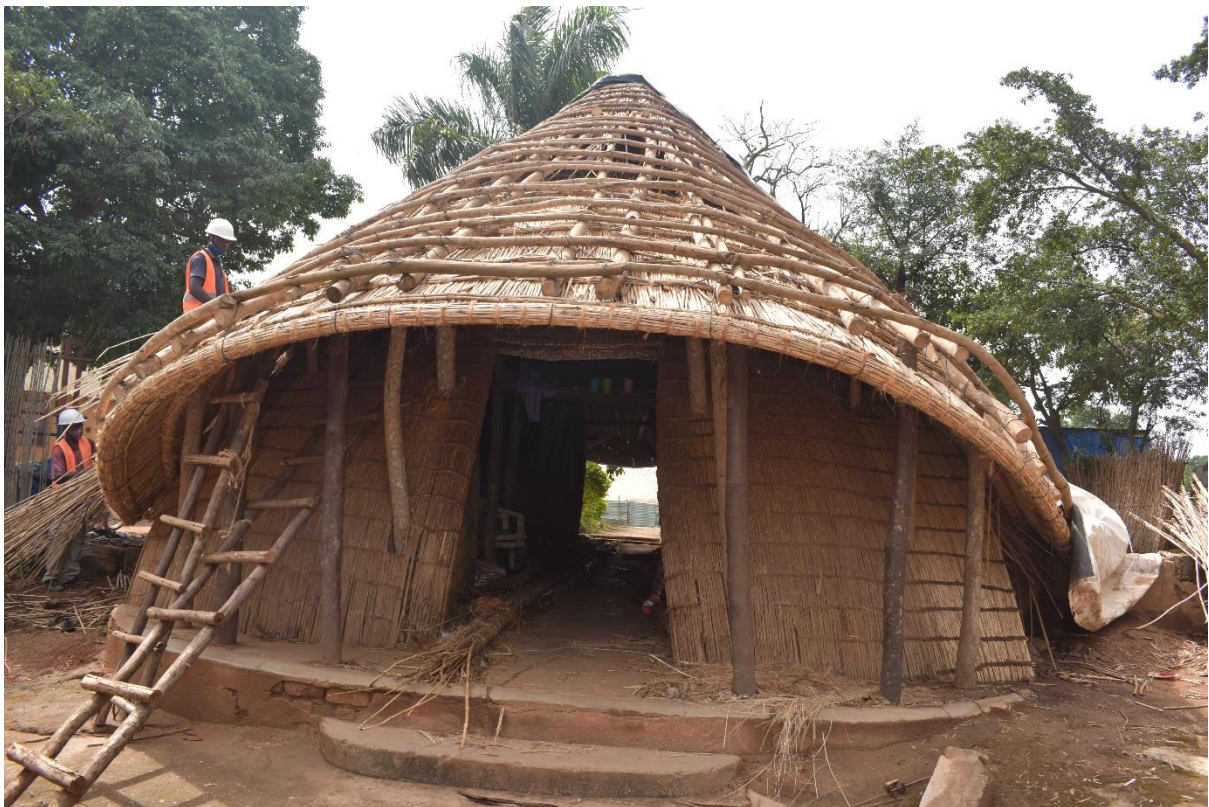
The Image showing the approved covering of the reeds-make skeleton rings with Amavuvume natural fibre.

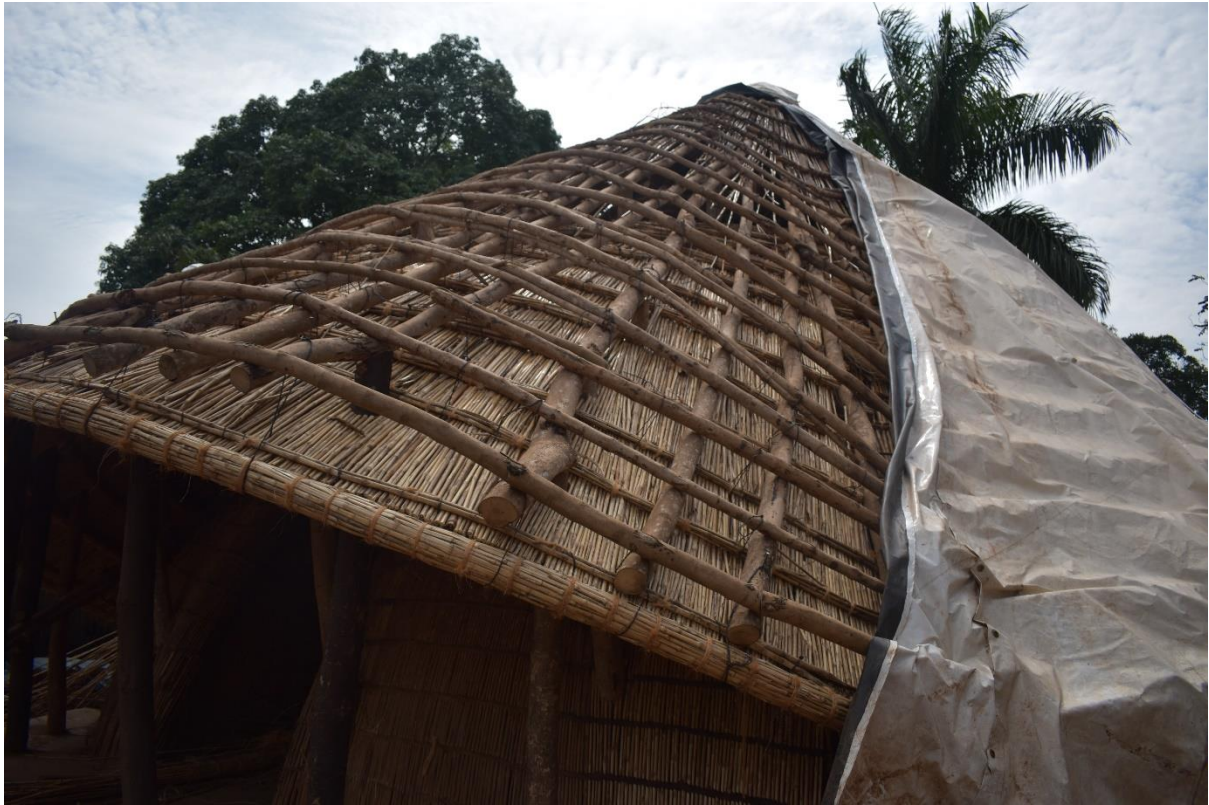
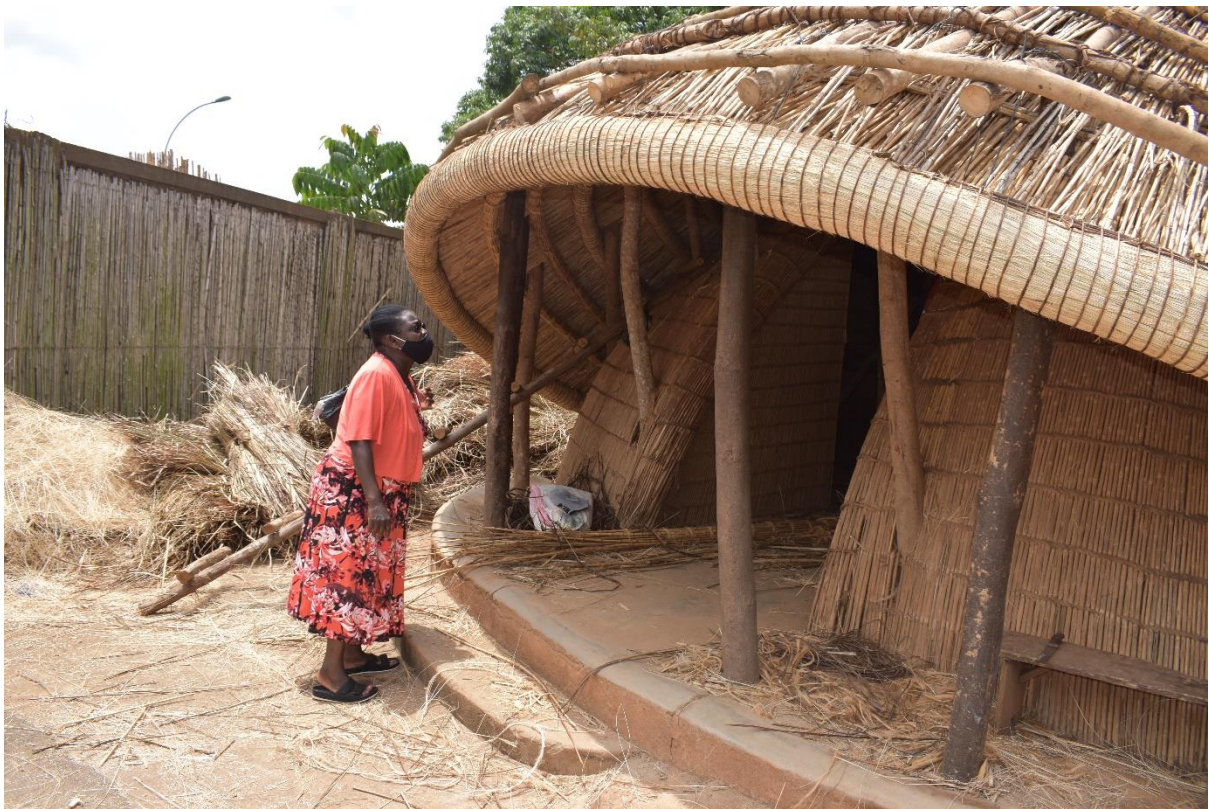
Inspection of the executed approved restoration works by Madam Commissioner Museums and Monuments.

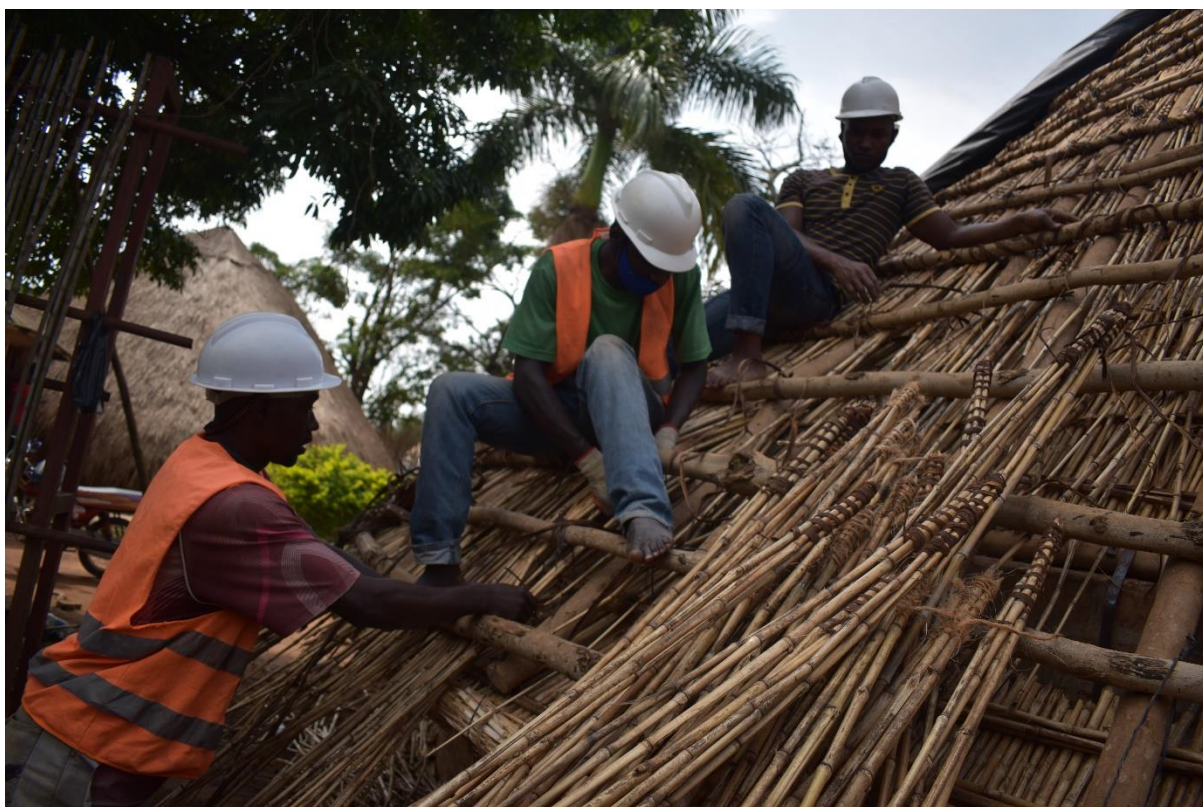
Fixing the roof reeds-make screen to receive the grass thatch.

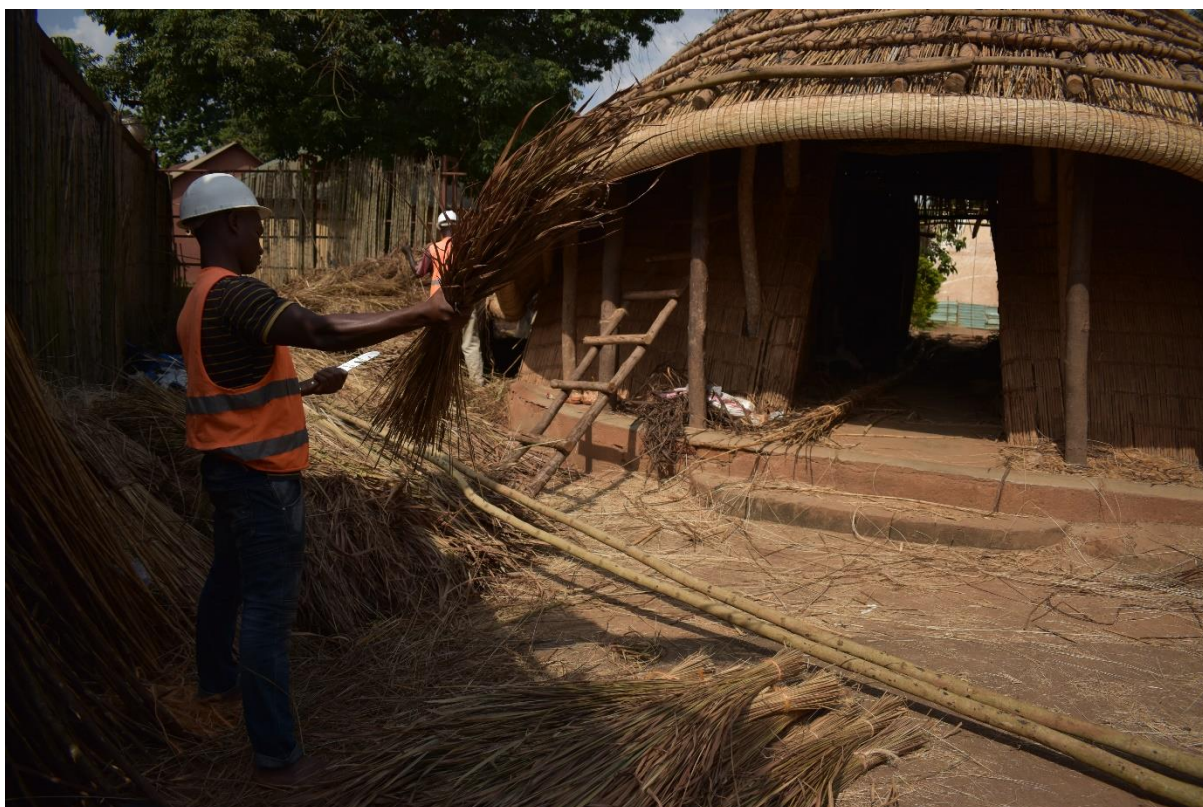
Final sorting of the grass to be used for thatching.

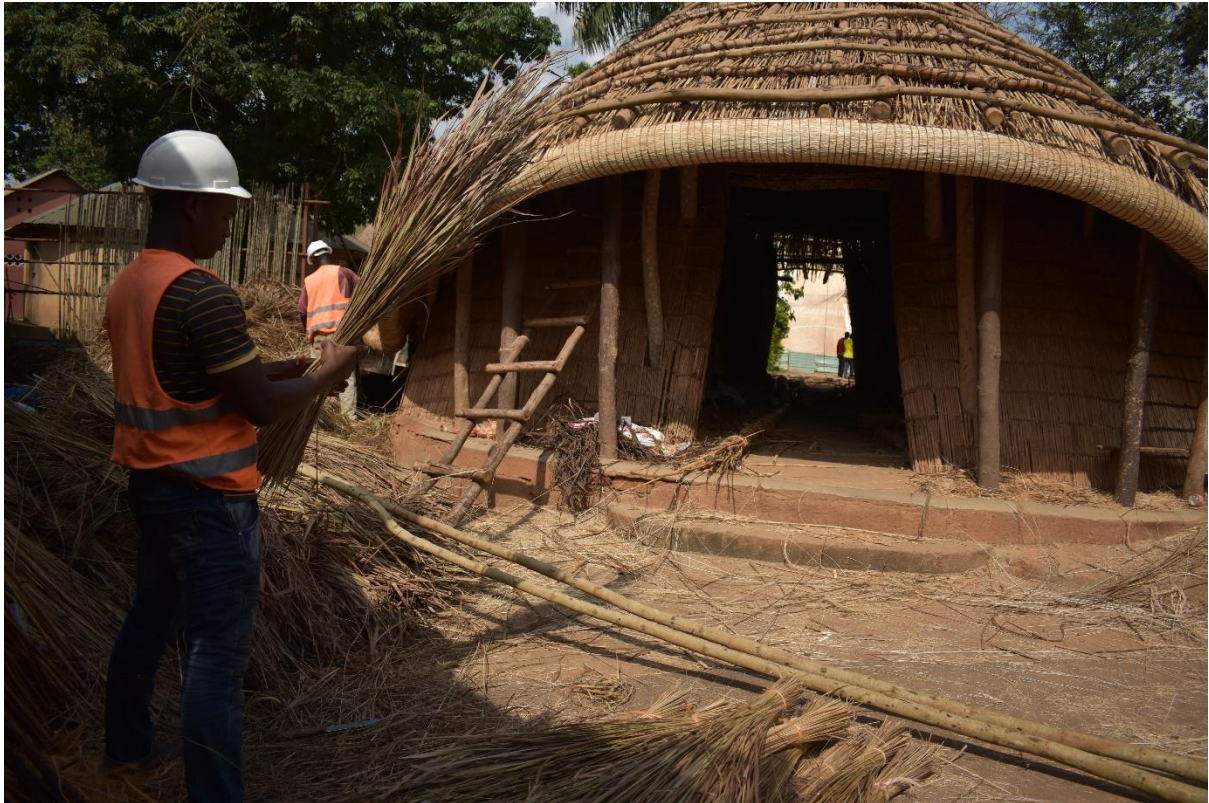
Binding of the approved sorted grass ready for thatching.

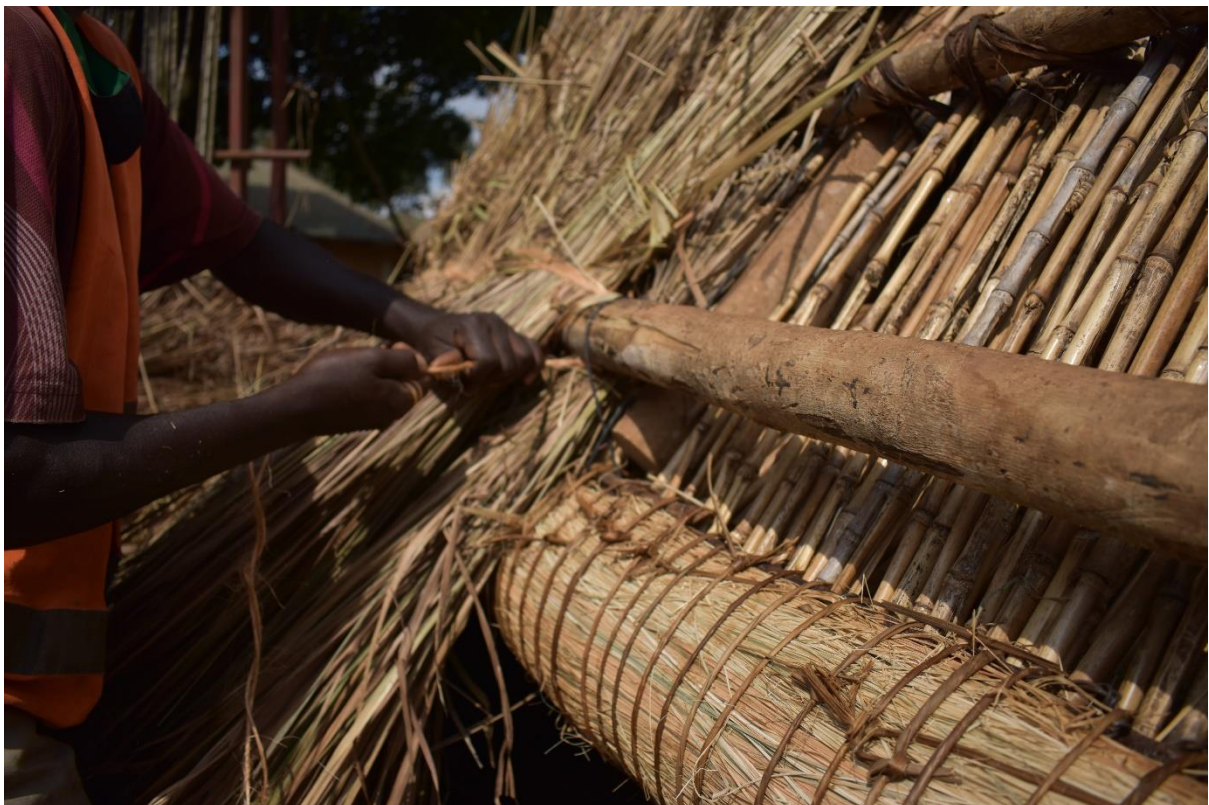
Commencement of the thatching process with the prepared approved grass.

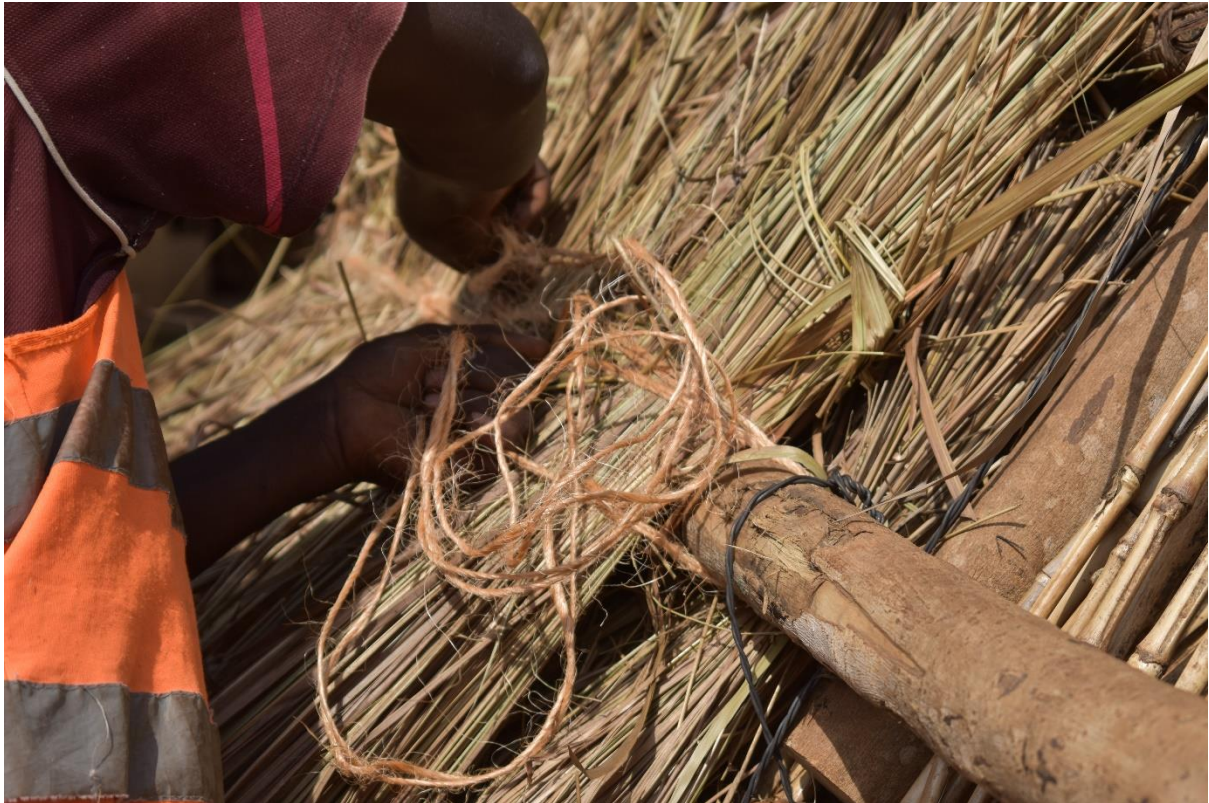
Tightly fixing the grass-thatch onto the battens with the sisal ropes.

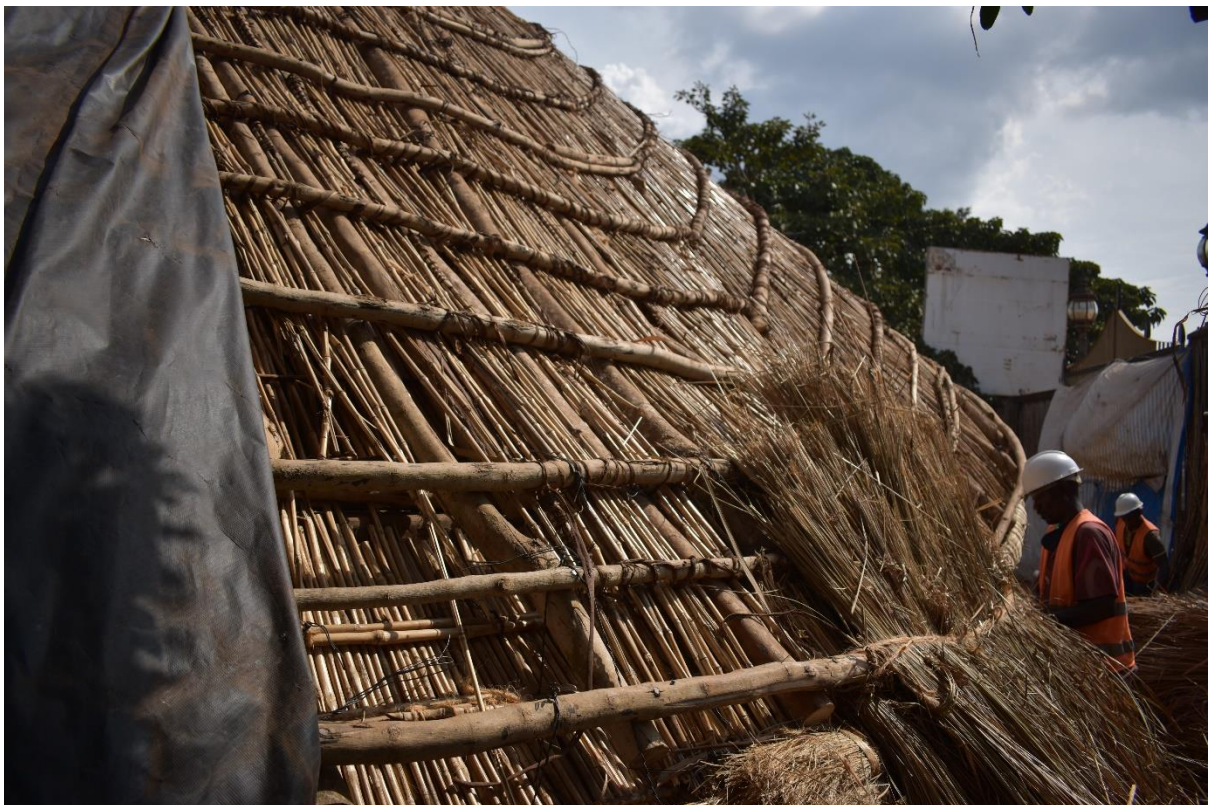
Grass thatching on-going in consideration with the approved standards.

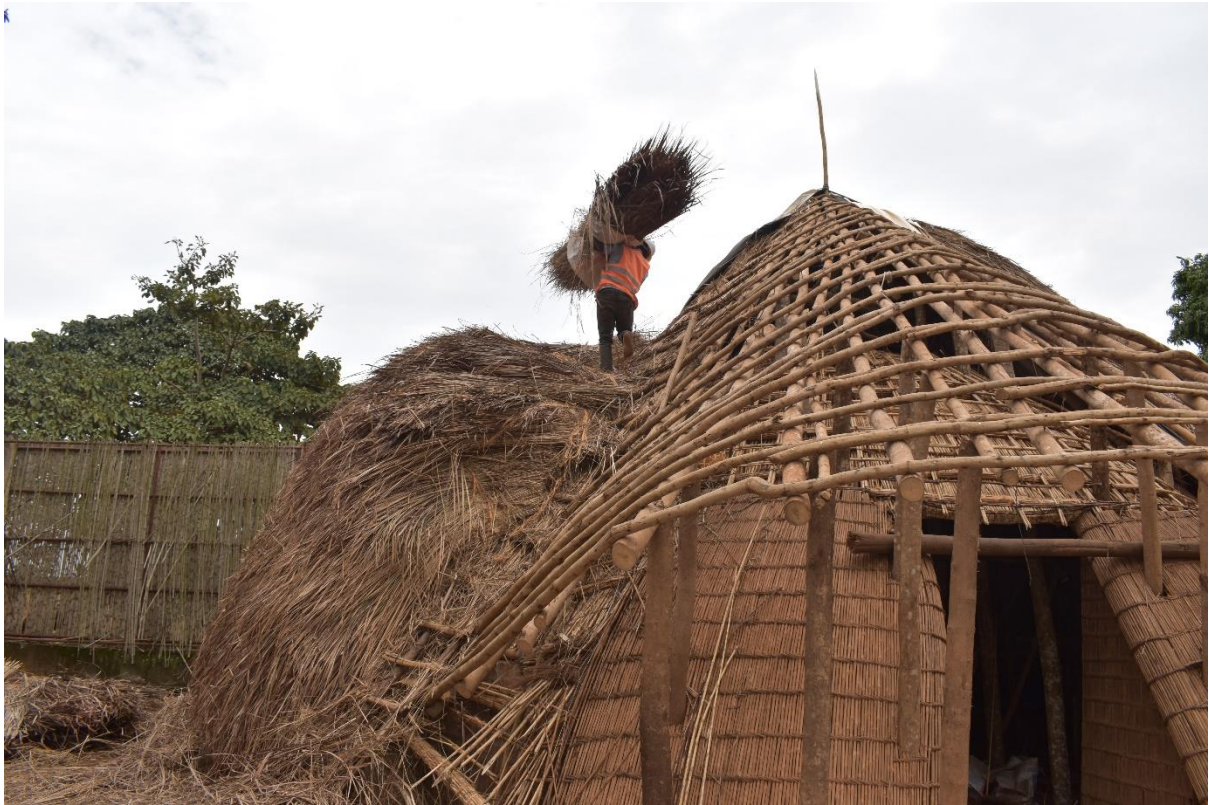
Prepared approved grass bundle carried onto the roof top to enable continuation of the grass thatch at the top of the building.

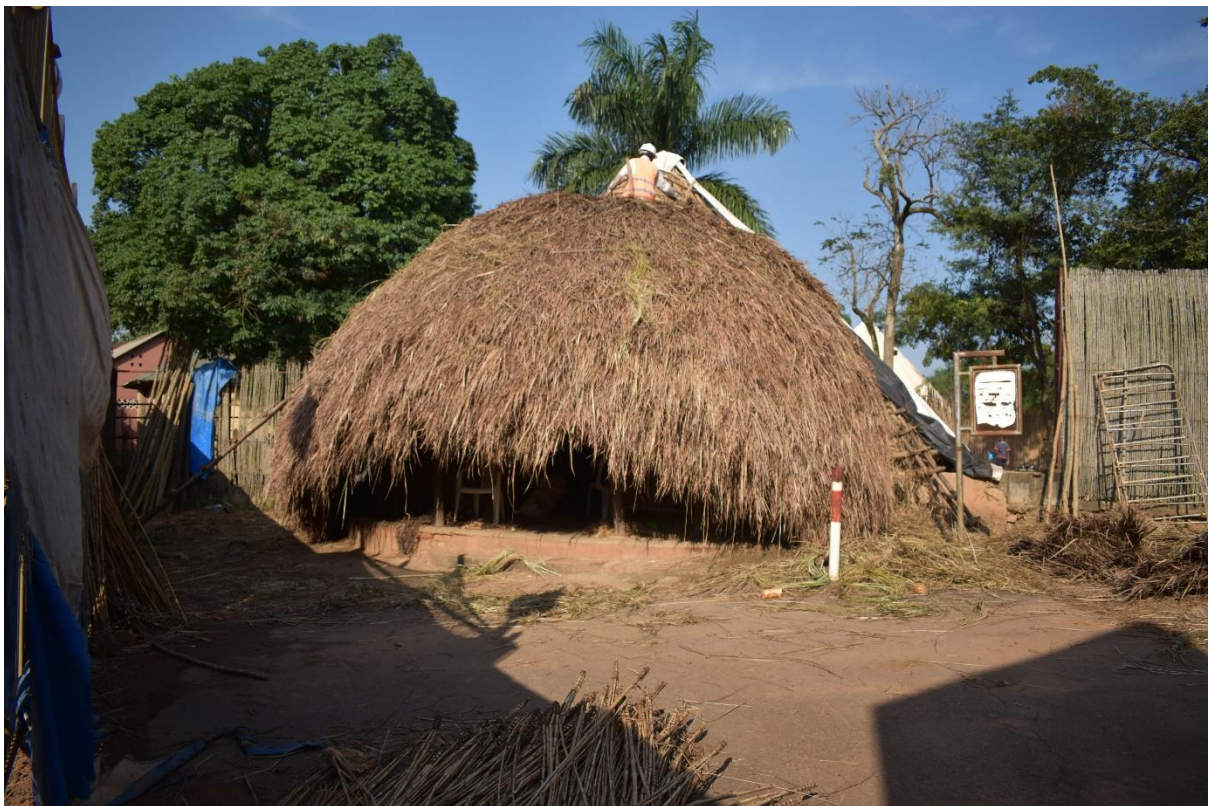
Appearance of the front side of the building with 25 percent of the entire building grass thatch.

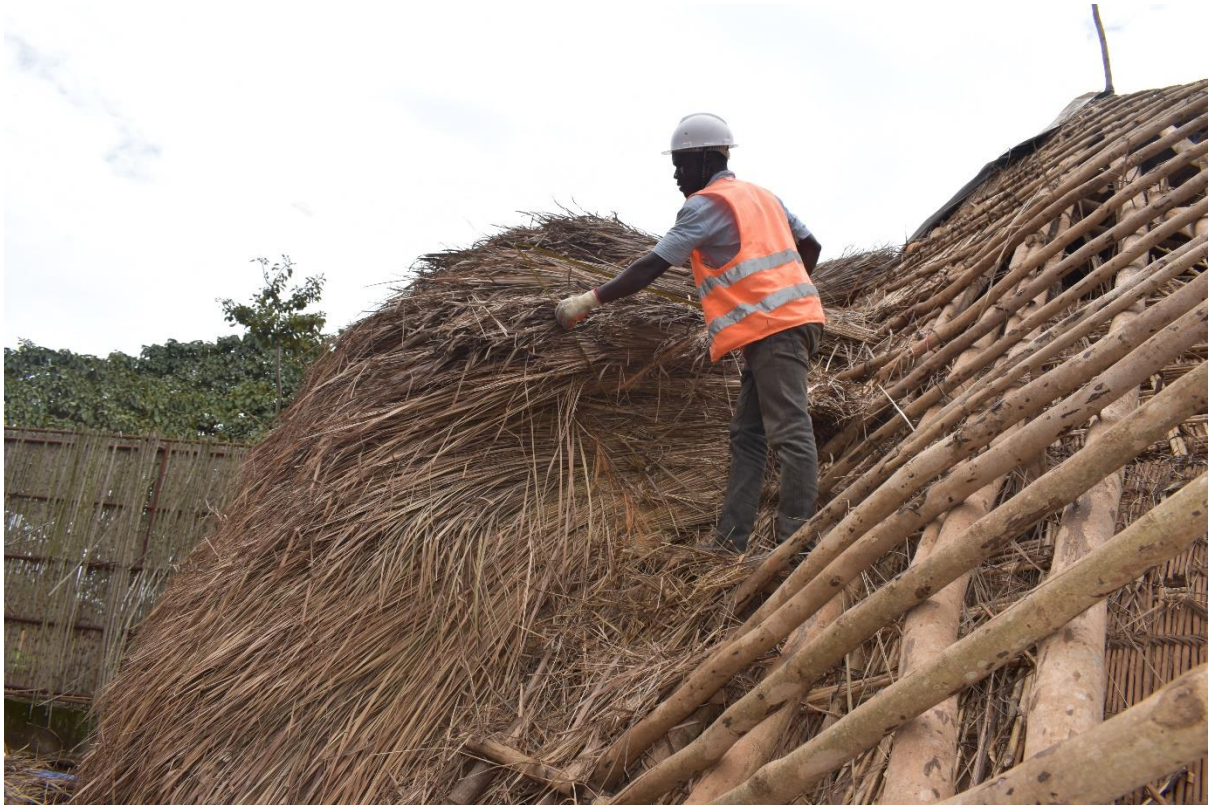
Measuring the thickness of the grass thatch already fixed onto the roofing structure of the building.

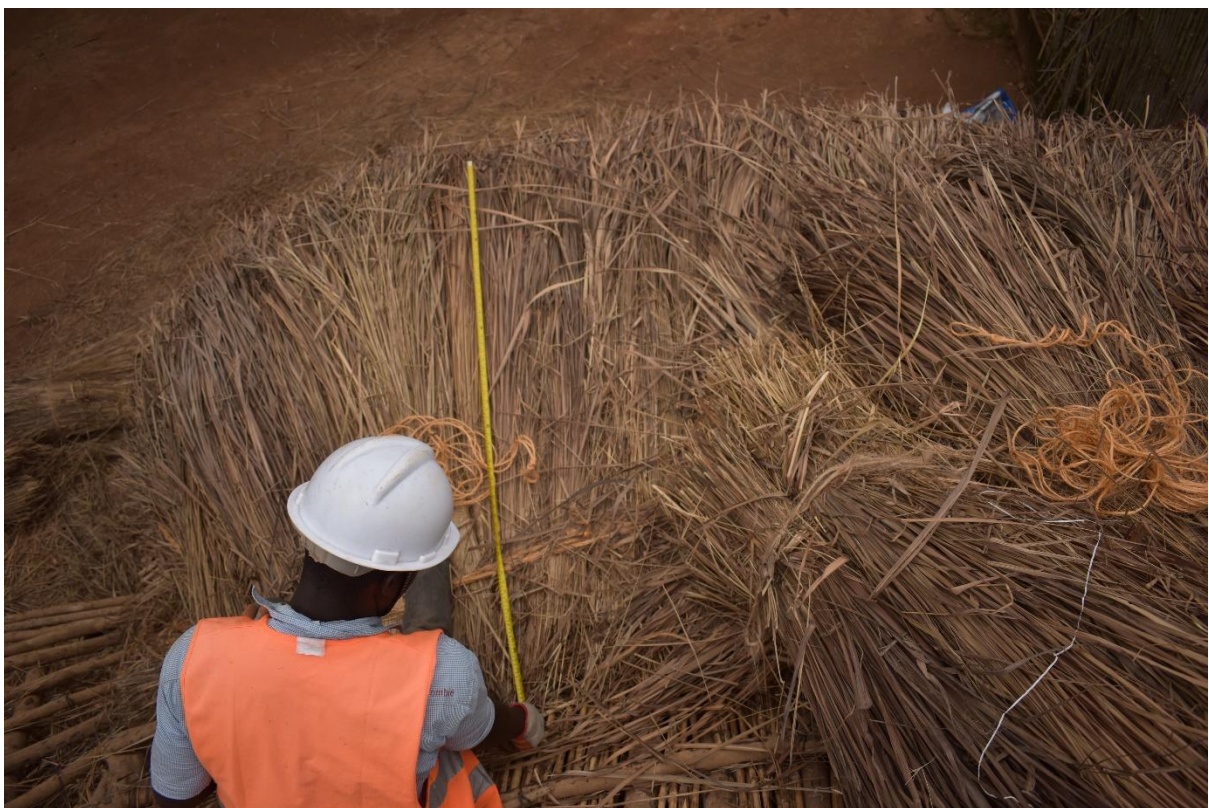
Measuring of the grass thatch length.

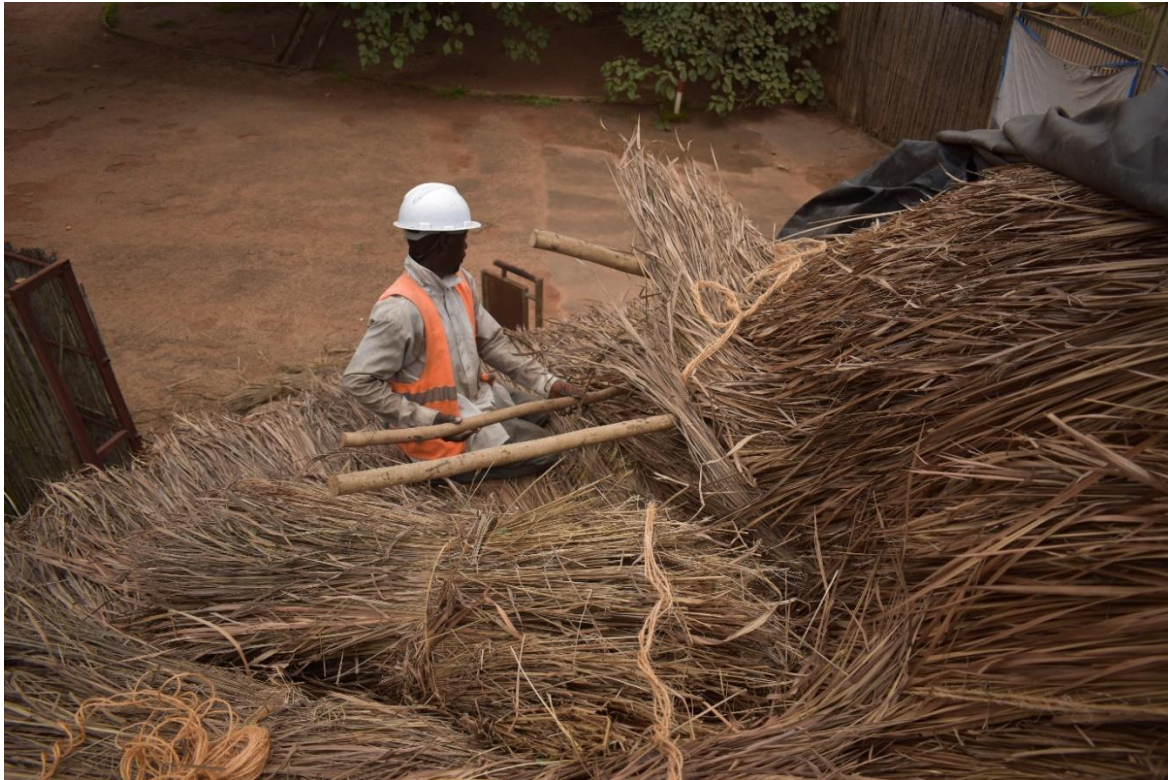
Image showing how space is created in the already tightly fixed grass thatch to enable fixing of small grass bundles to appropriately cover the gaps left within the thatch.
