STATE OF CONSERVATION

TOMBS OF BUGANDA KINGS AT KASUBI(UGANDA)

**THE
BUJJABUKULA ROYAL GRANDIOSE
ENTRANCE BUILDING**
To the Tombs of Buganda Kings at Kasubi – UNESCO World Heritage
Property in Uganda

PHOTOGRAPHIC PROGRESS REPORT

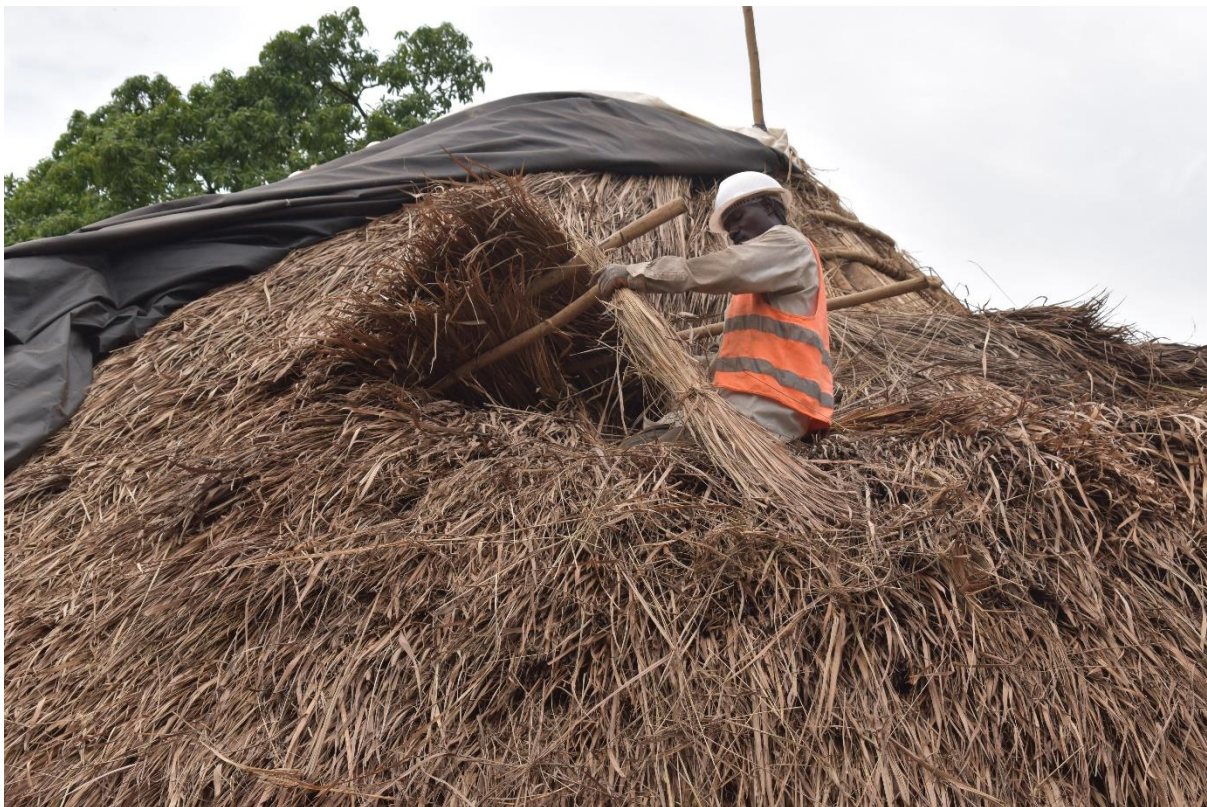
Preparing and binding the small grass bundle.

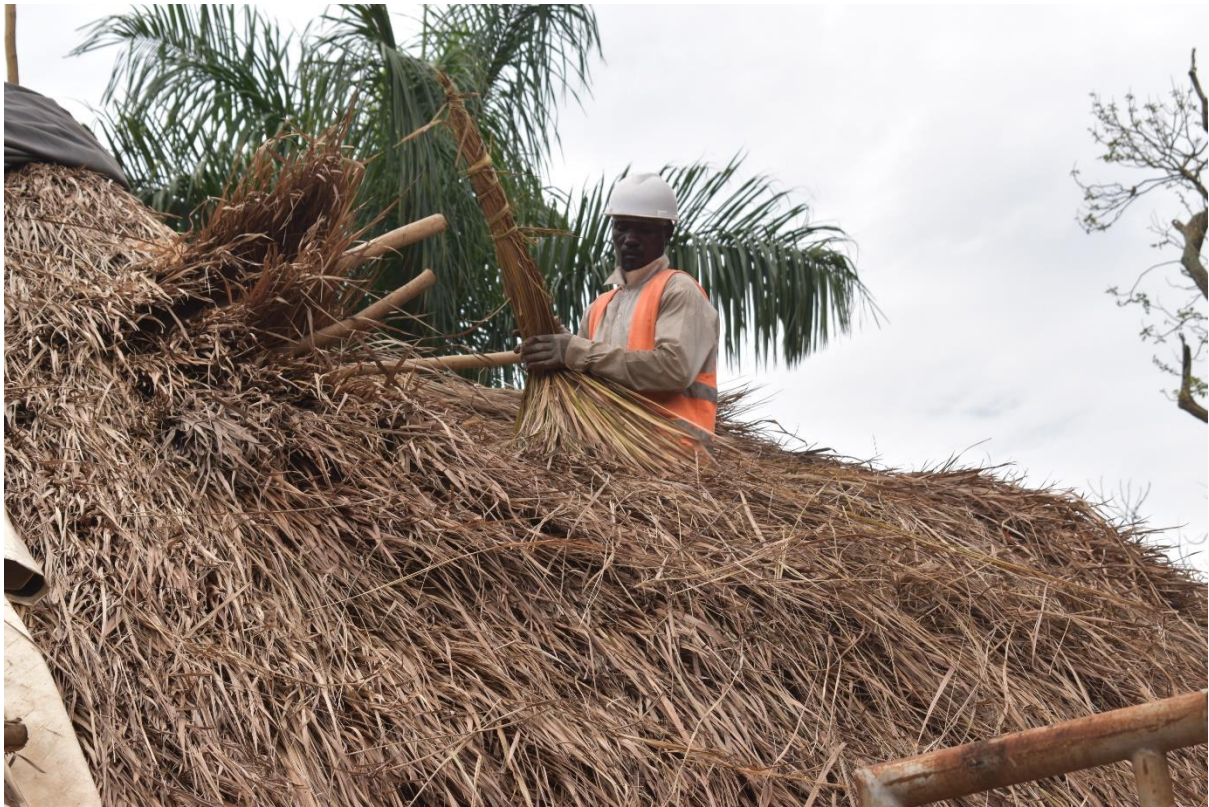
The small grass bundle tightly tied and ready to be fixed in the already thatched grass cover.

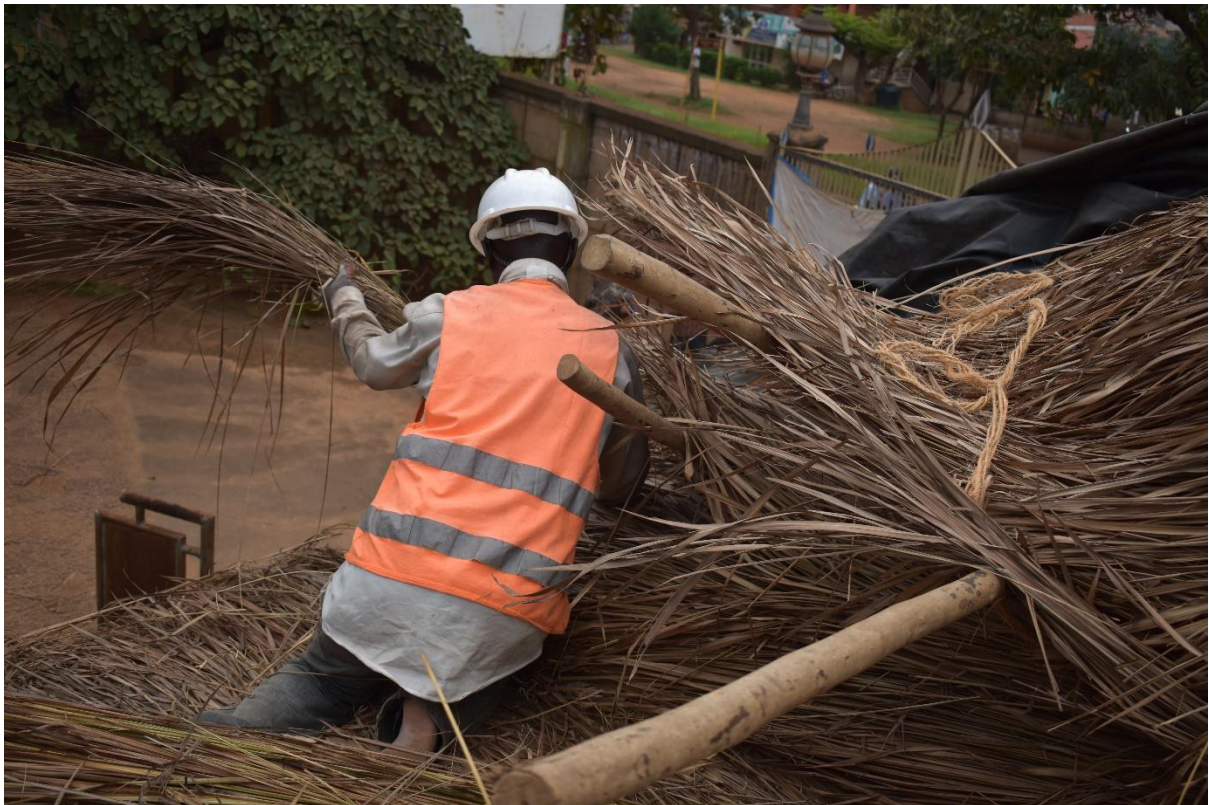
Small approved tightly tied grass bundle being fixed in the already appropriately fixed grass roof thatch.

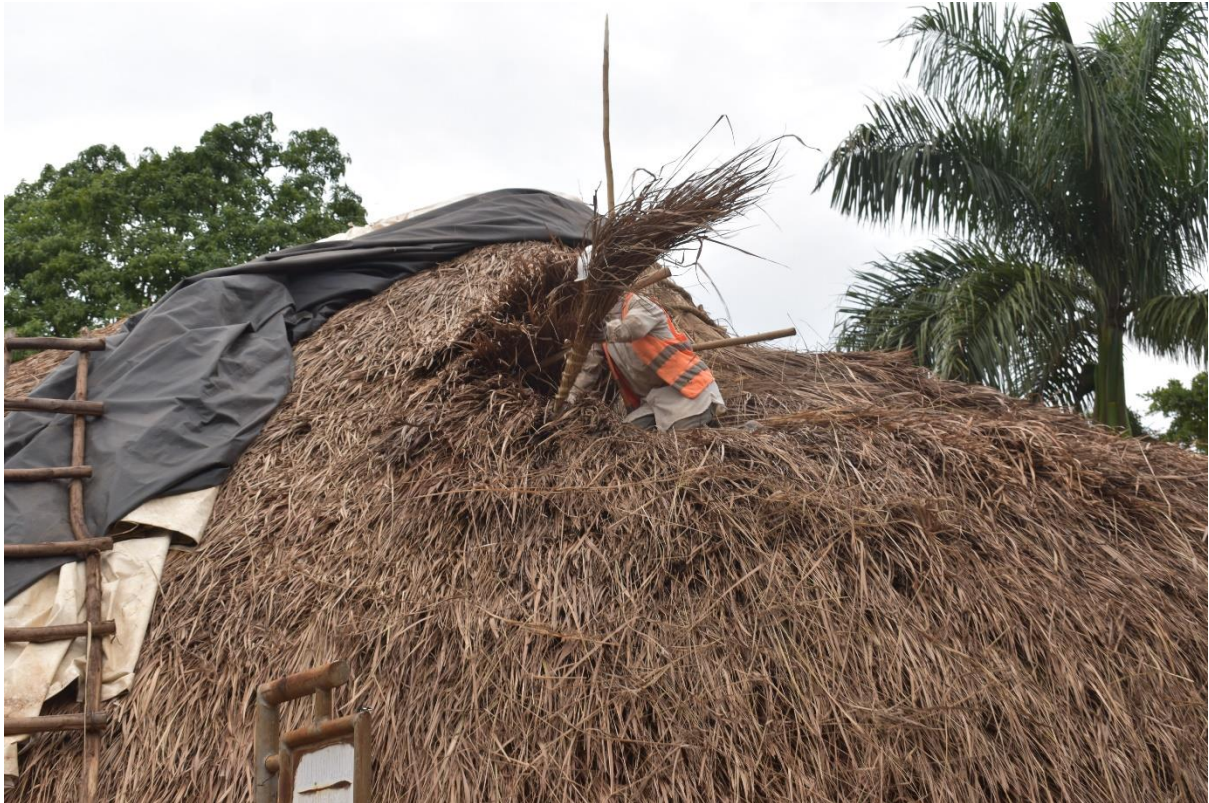
Small approved tightly tied grass bundle being fixed in the already appropriately fixed grass roof thatch.

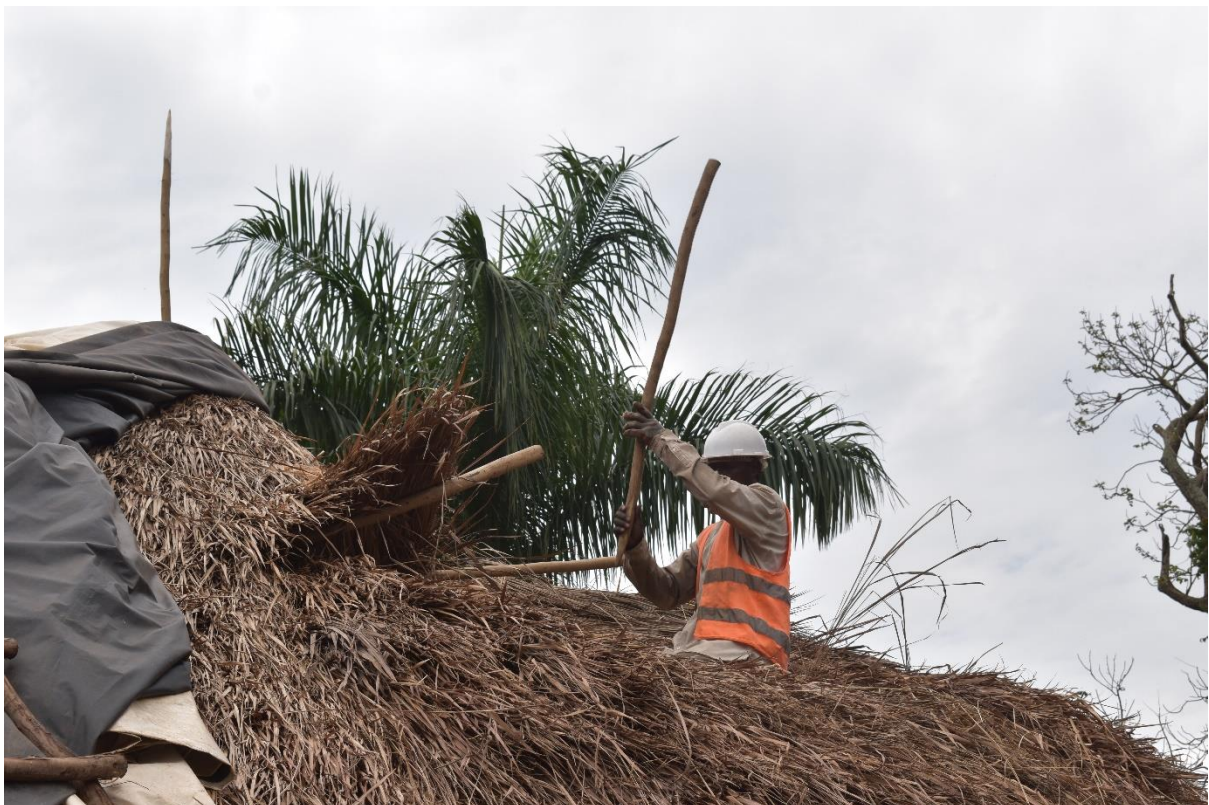
The already fixed grass thatch being levelled in regard with the requirements by hitting it with a stick.

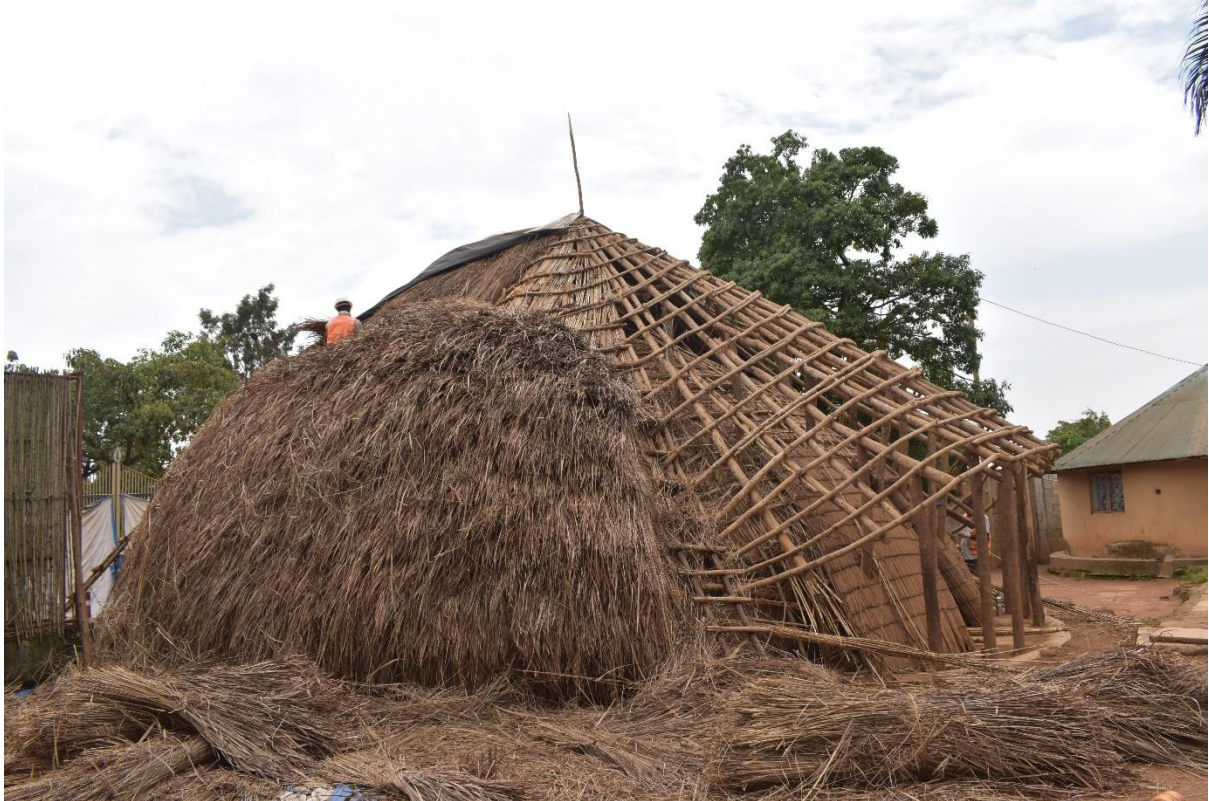
The process of fixing the Grass thatch for the entire building in progress, Mulamba side view.

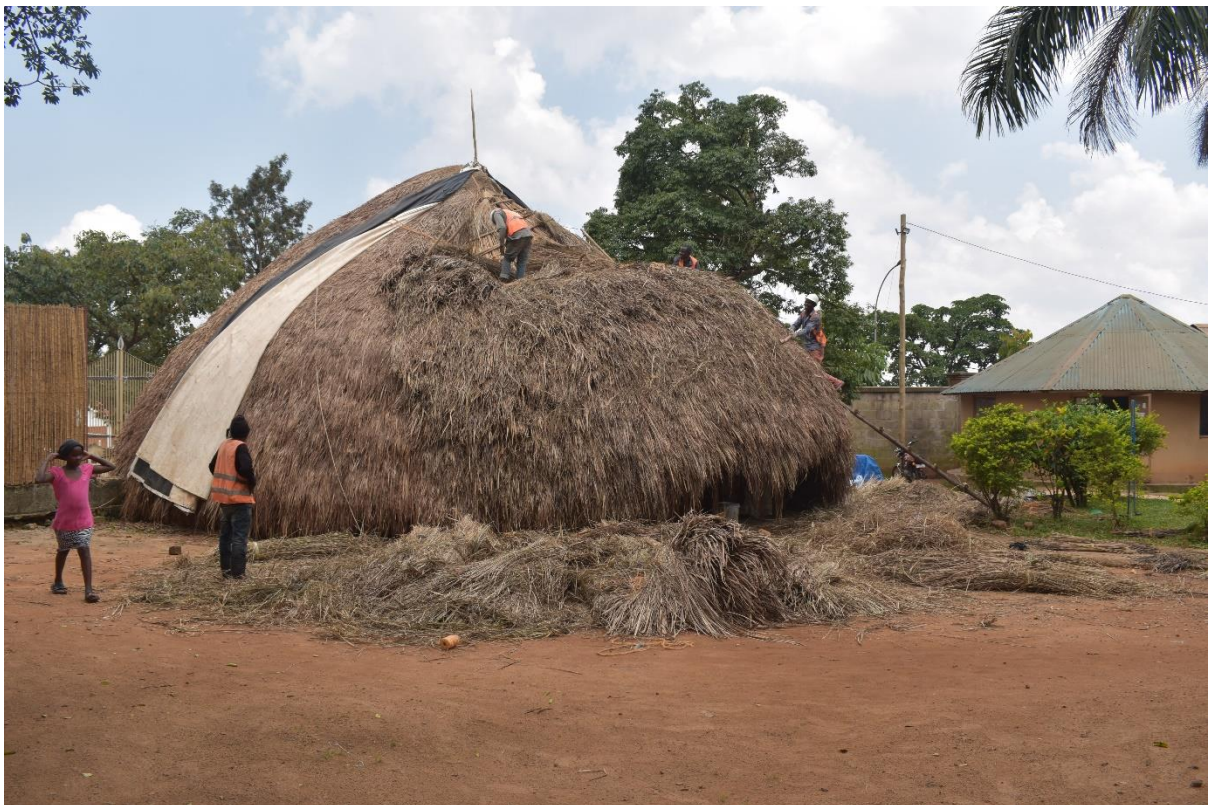
Continuous process of fixing the Grass thatch for the entire building, Mulamba side view.

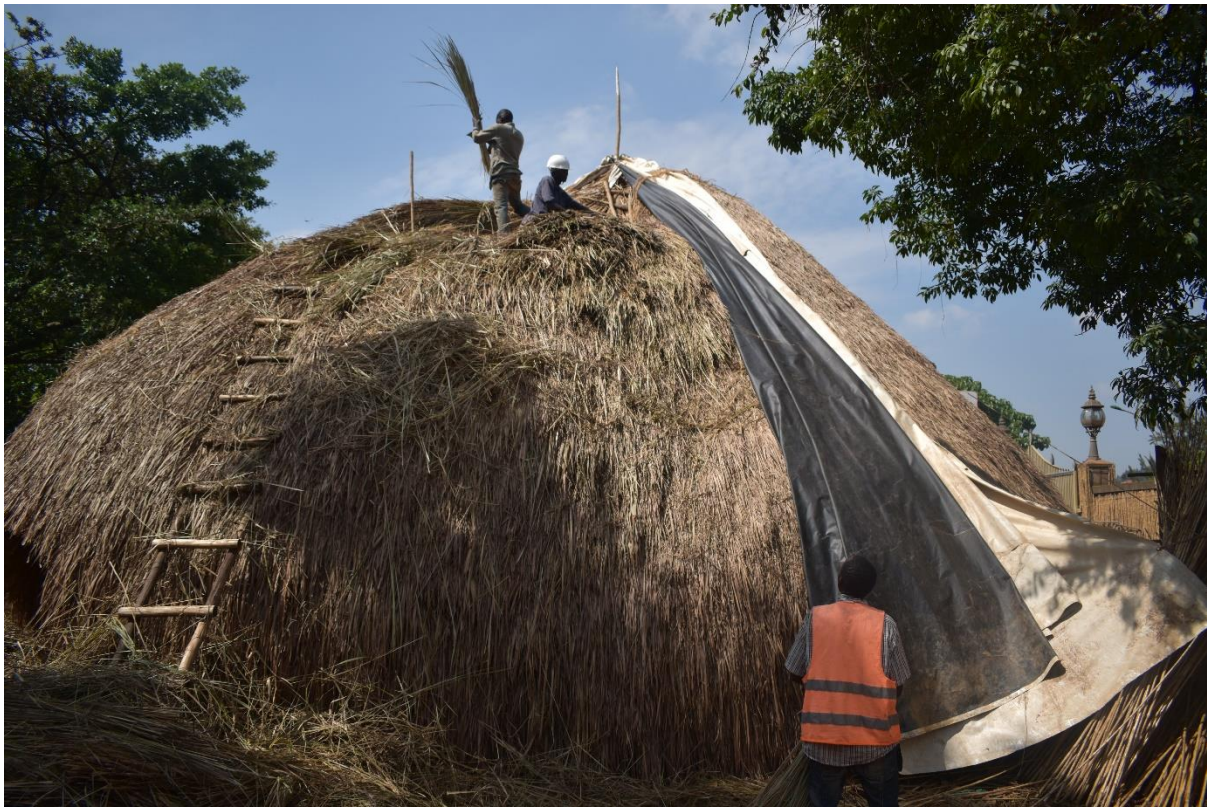
Continuous process of fixing the Grass thatch for the entire building, Nsiggo side view.

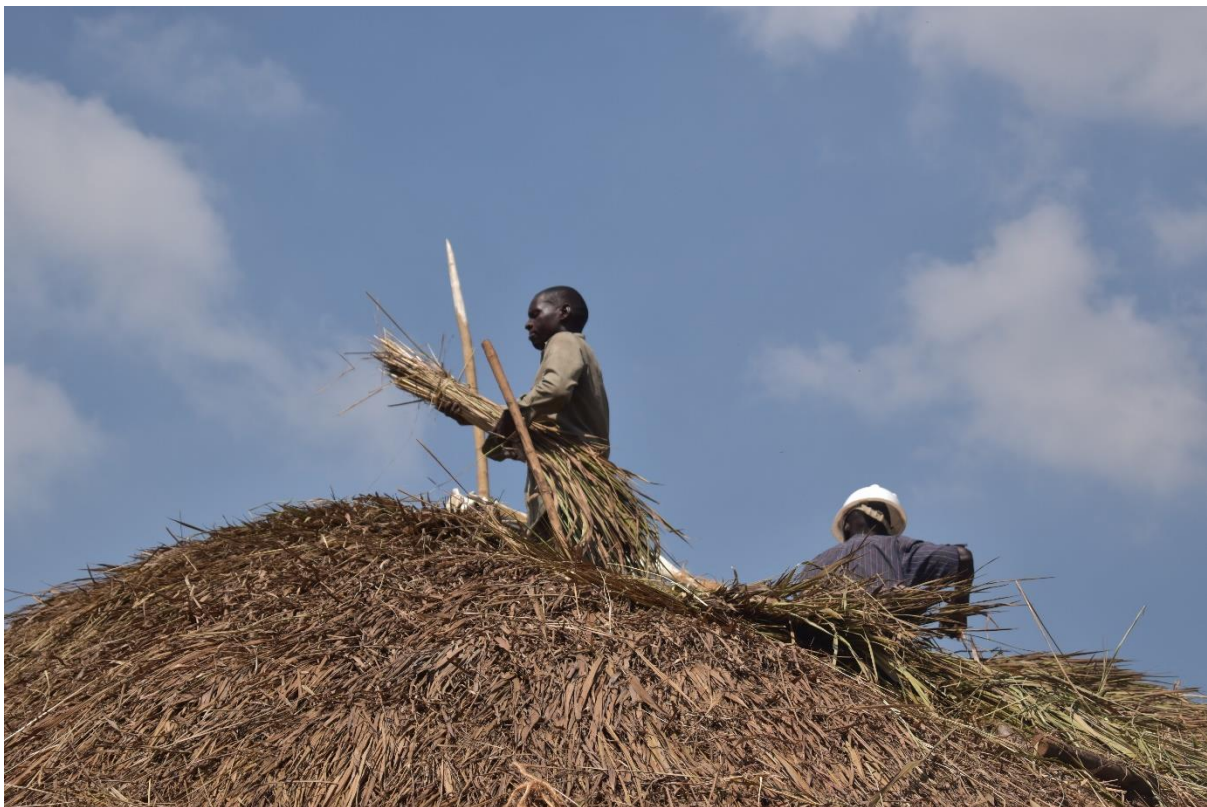
Thatching the Top most point of the building.

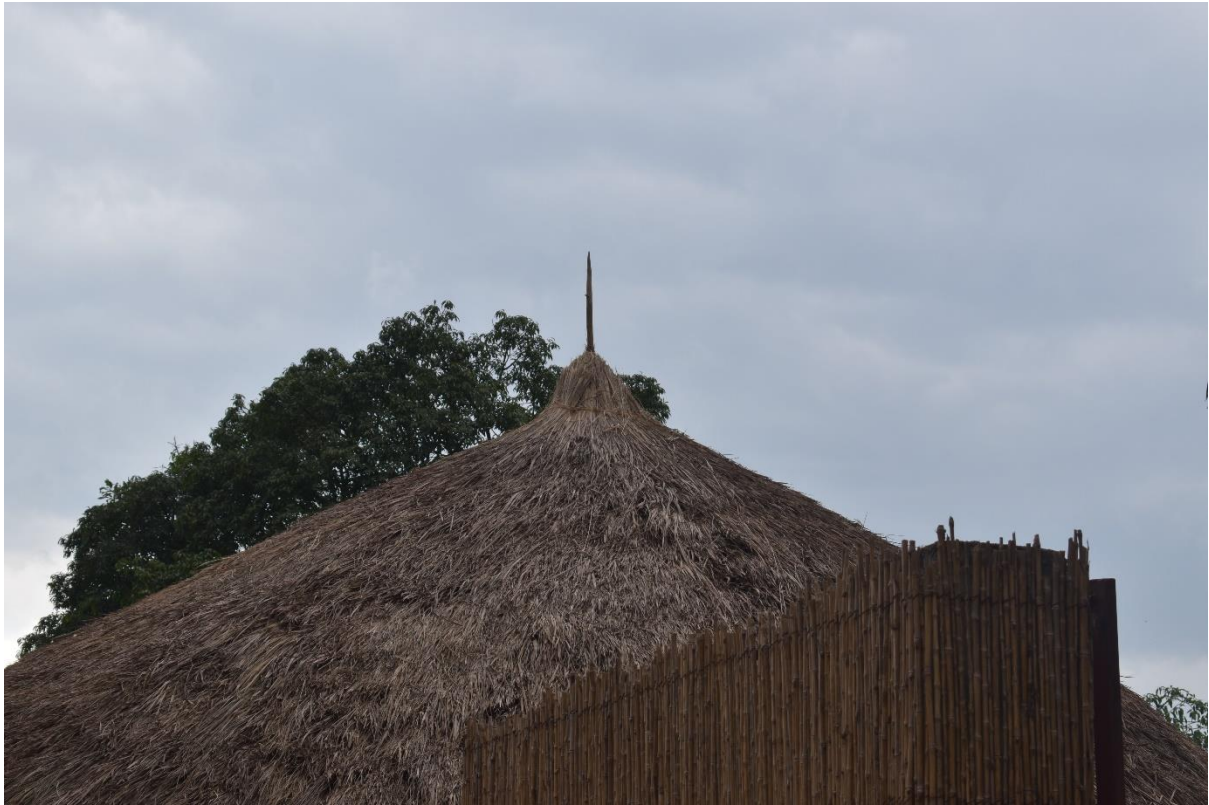
Appearance of the firmly thatched top most point of the Bujjabukula building`s roof.

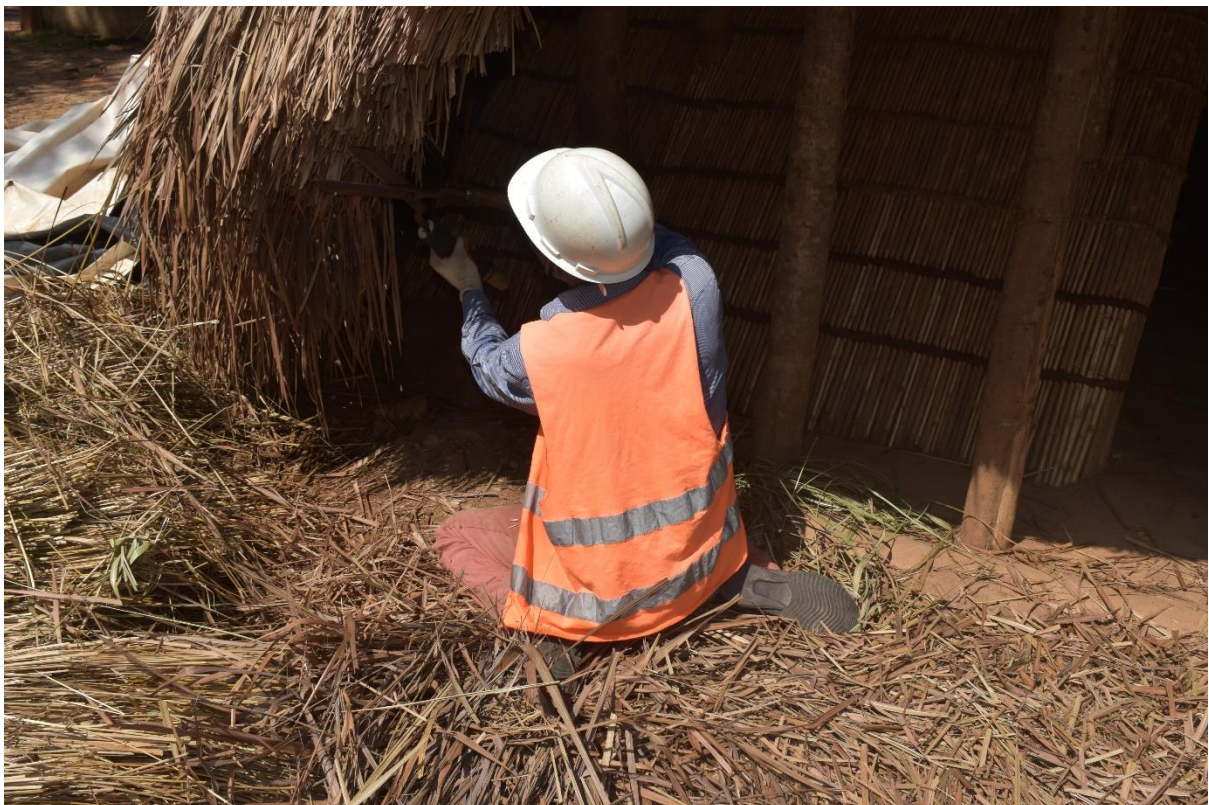
Trimming of the protruding grass at the entrance to provide the required headroom.

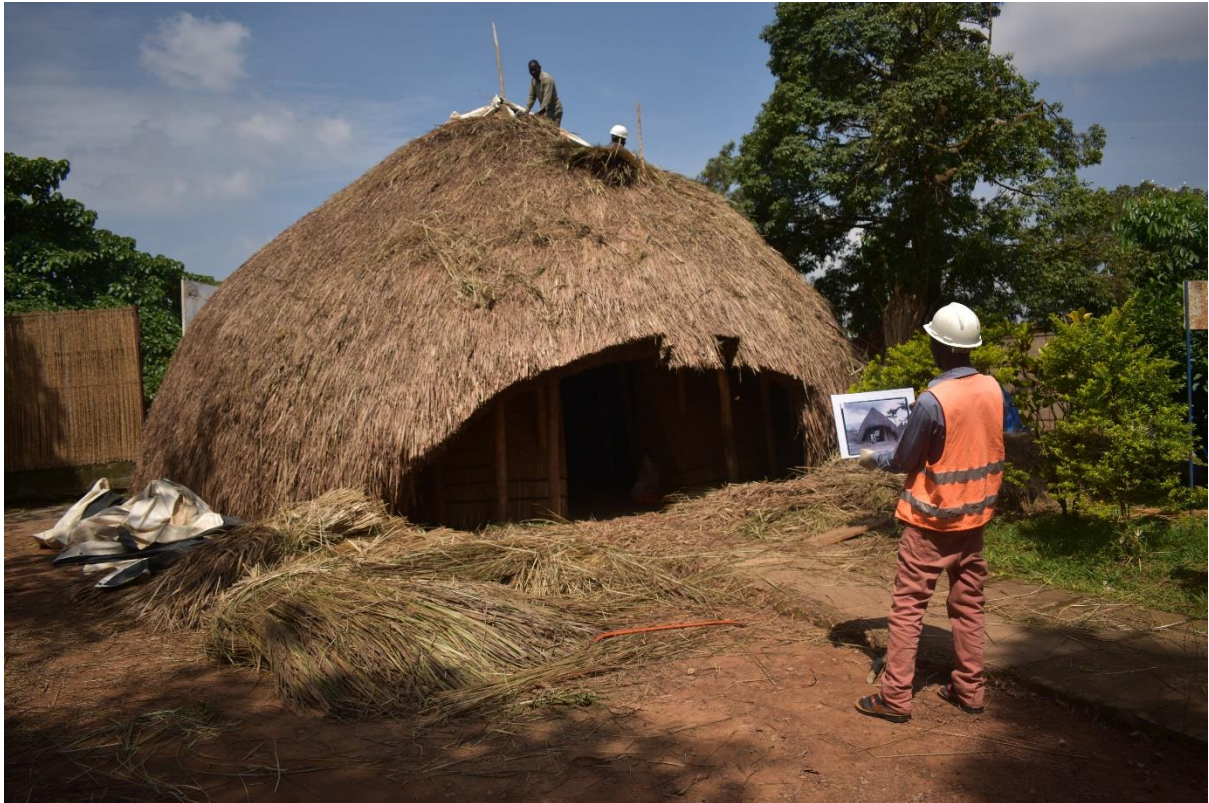
Verification of the trimmed area at the entrance using the provided image of the building taken before any substantial roof repair to this building.

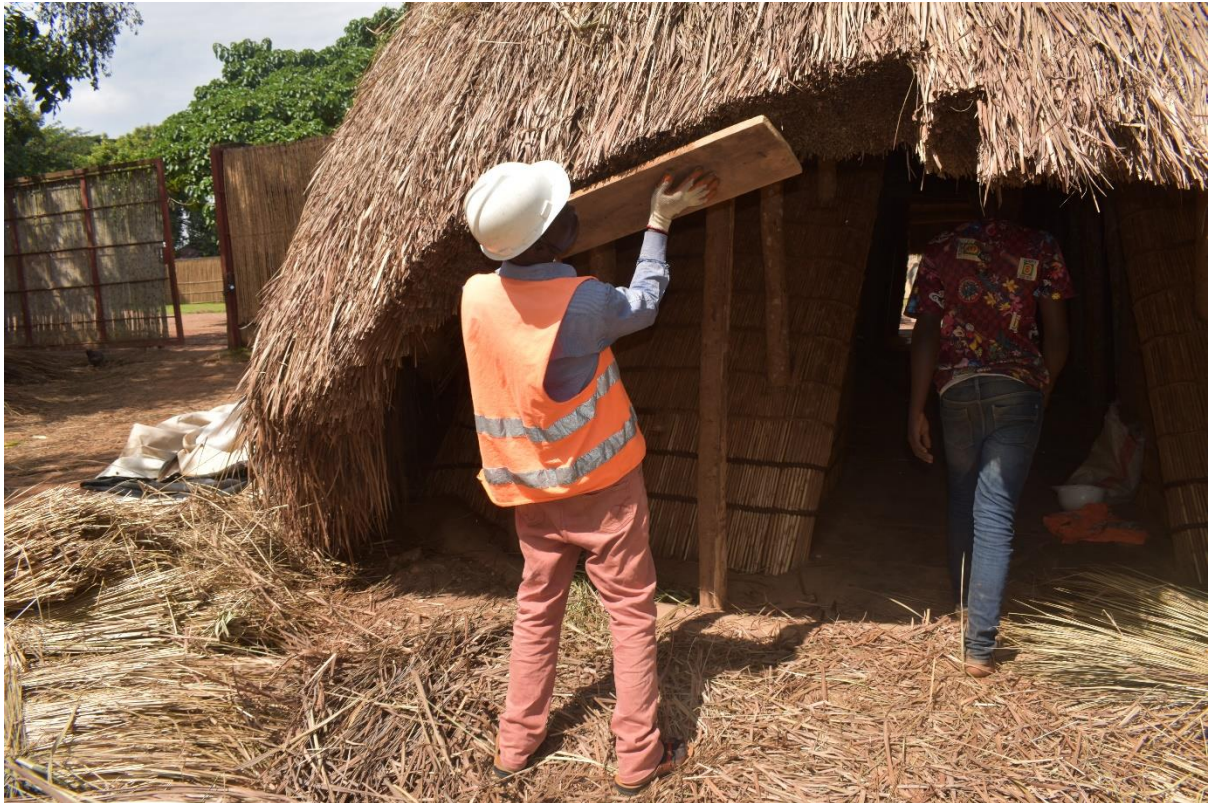
Levelling of the trimmed part of the grass thatch.

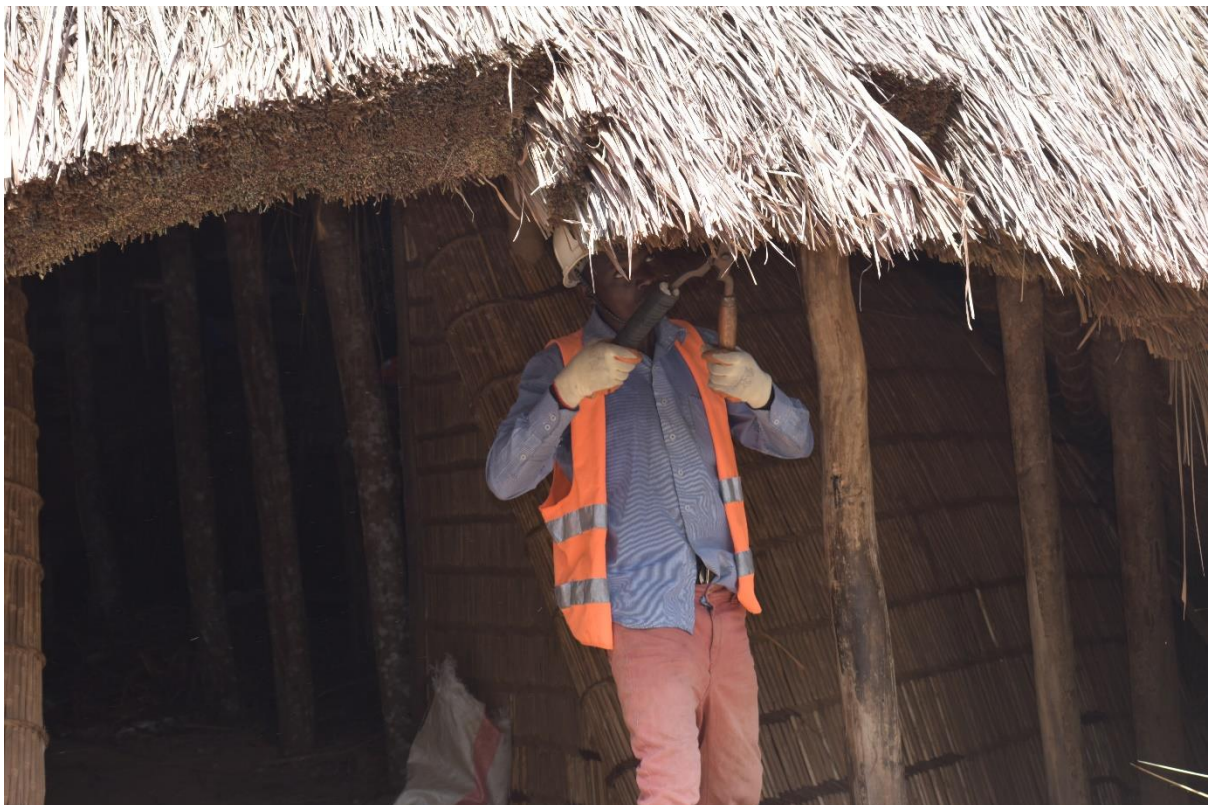
Trimming of the protruding grass at the entrance to provide the required headroom.

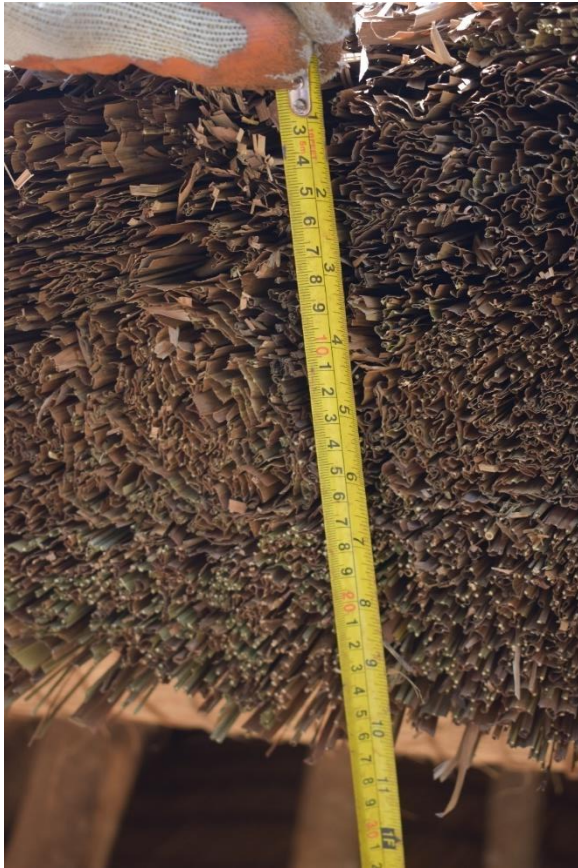
Measuring of the trimmed grass thatch thickness at the rear entrance.

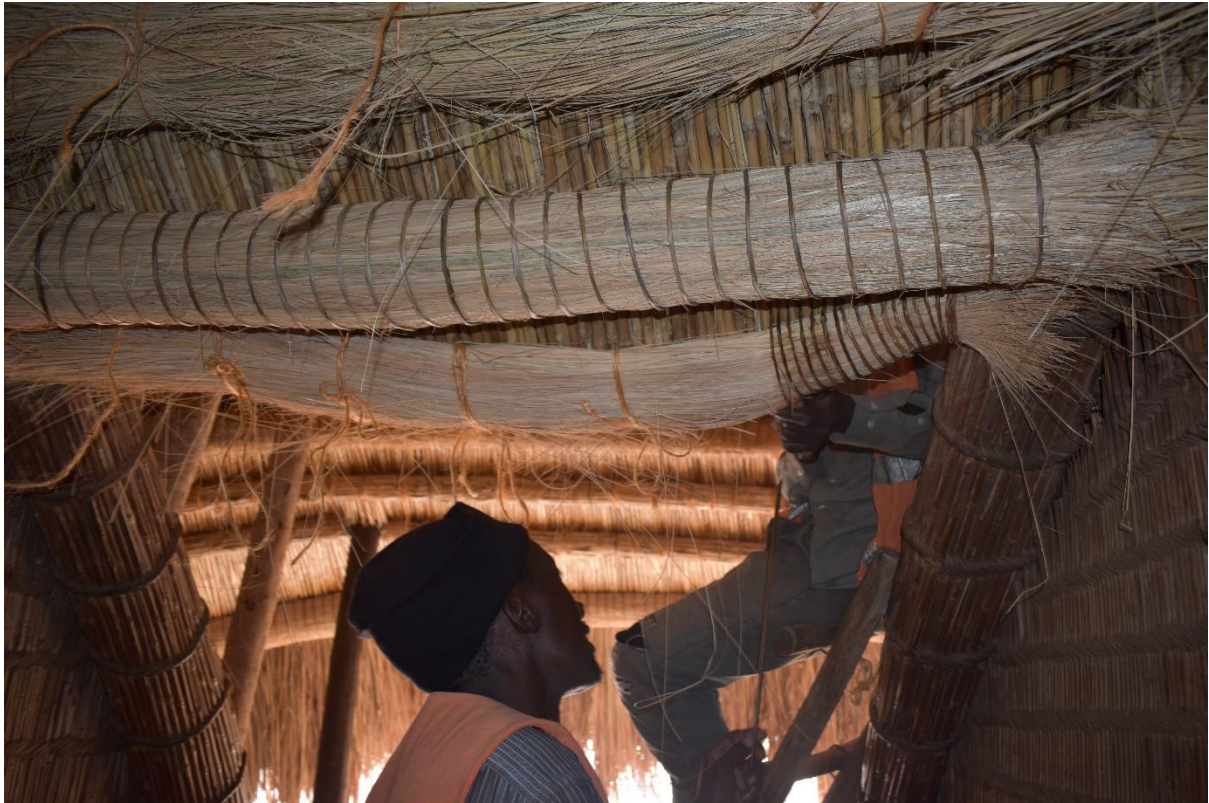
Interior view showing the fixing of the entrance ring to cover the cut reeds of the internal reeds-make ceiling.

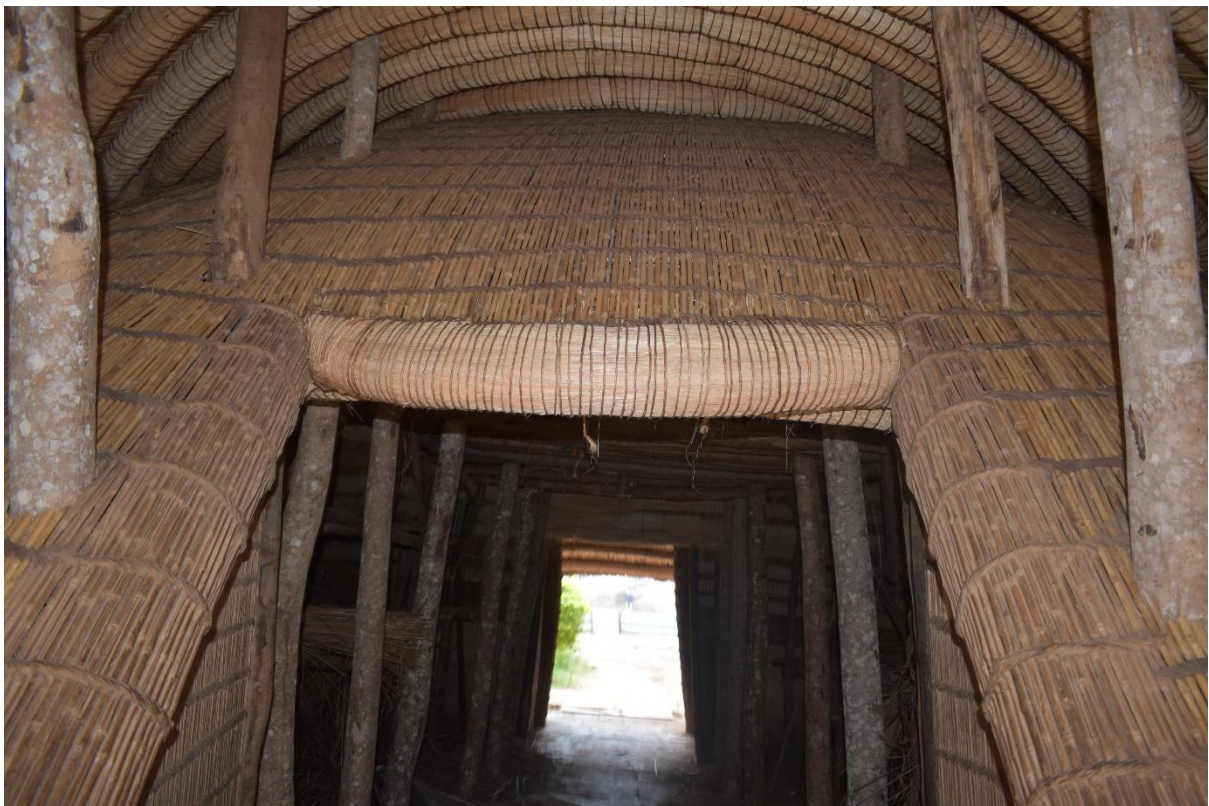
Appearance of the finished approved entrance ring with the approved repaired reeds-make cladding and part of the rings fixed onto the external ceiling.

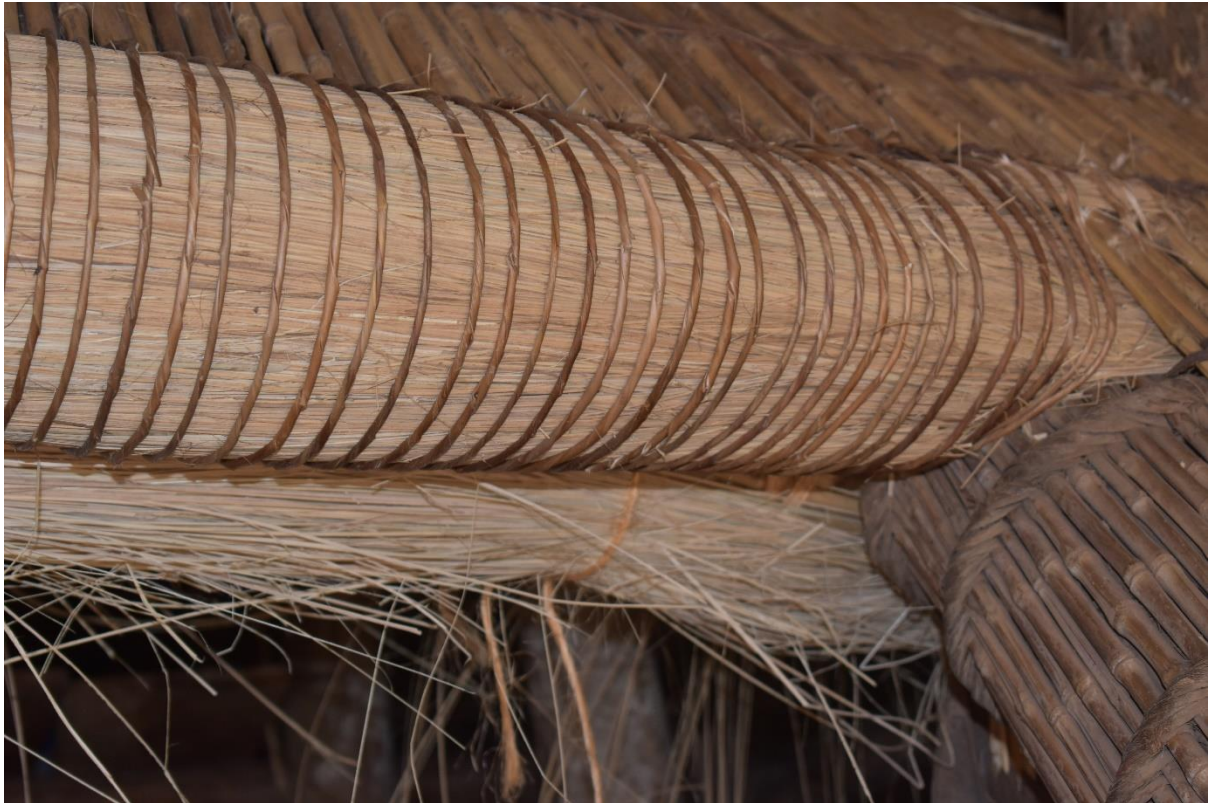
Detail of the already fixed approved entrance ring.

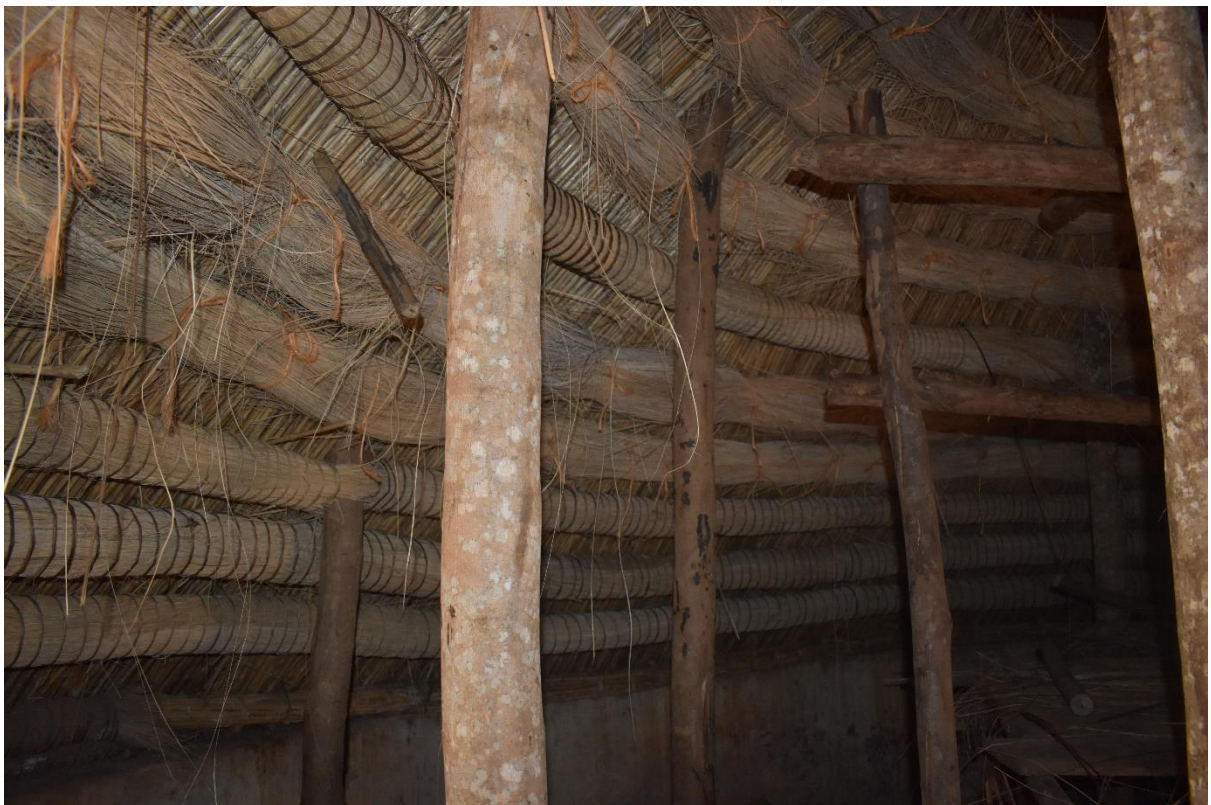
The on-going ring skeletons covered with Amavuvume as the final finish.

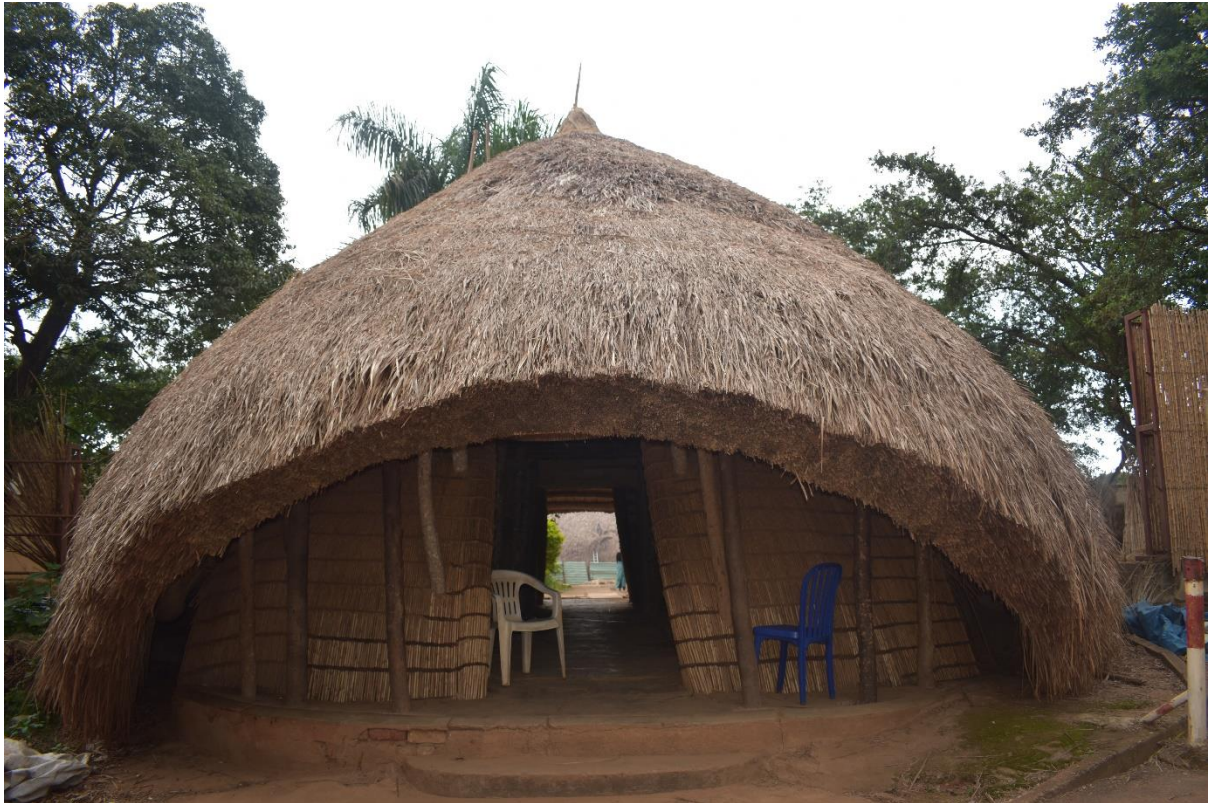
Appearance of the front side of the firmly thatched Bujjabukula building.

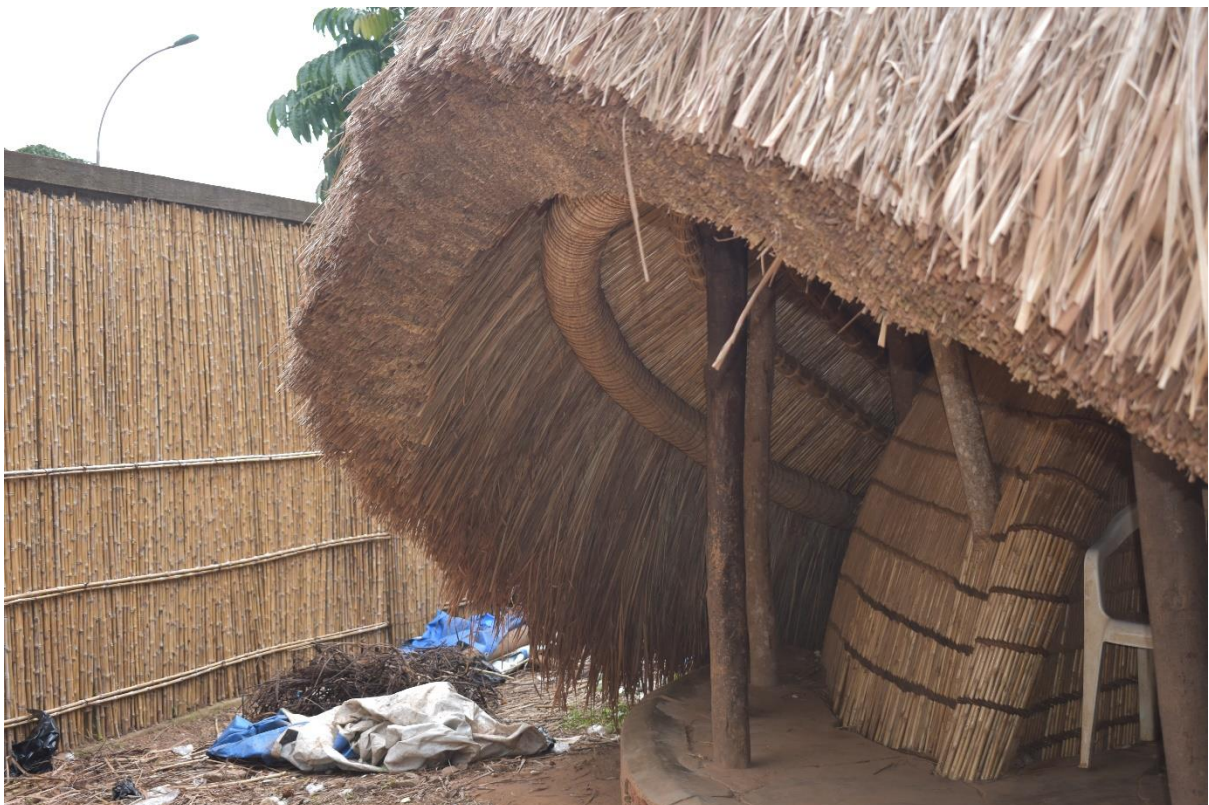
The image showing the appearance of the front side of the firmly thatched Bujjabukula building with the approved repaired reeds-make cladding and the restored Nzingu vertical natural poles.

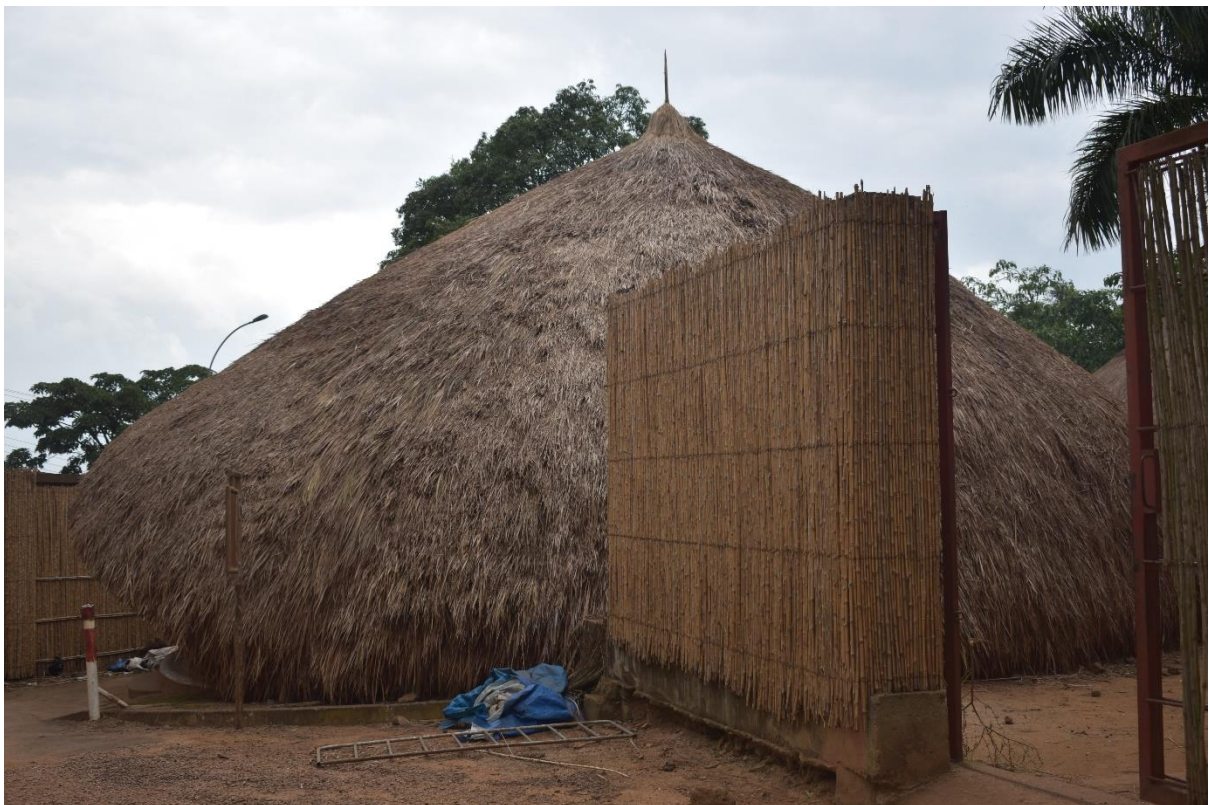
Appearance of Nssigo/Southern side view of the approved firmly thatched Bujjabukula building.

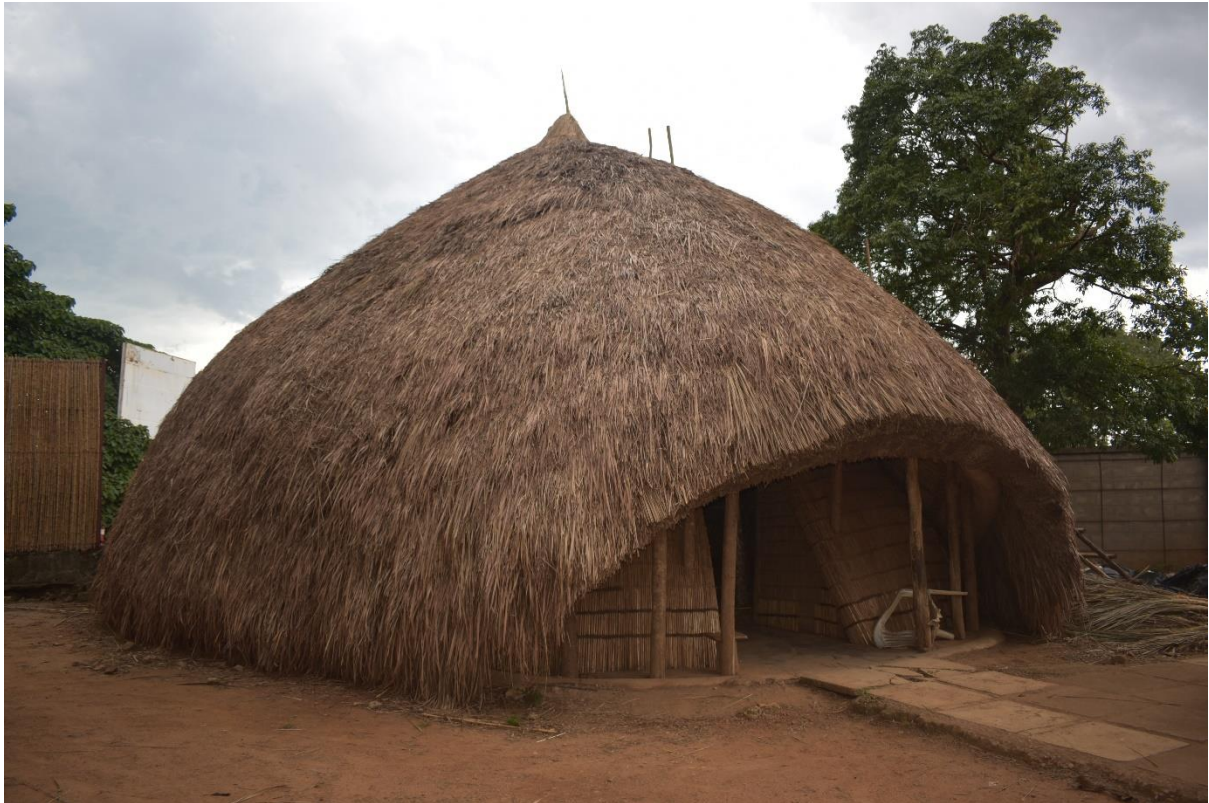
Appearance of the rear, Nssigo side view of the approved firmly thatched Bujjabukula building.
